ULAN COAL MINES PTY LTD

Ulan Underground Mine: Longwall W5
End of Panel Subsidence Report

ULA5114

DATE 19 April 2020

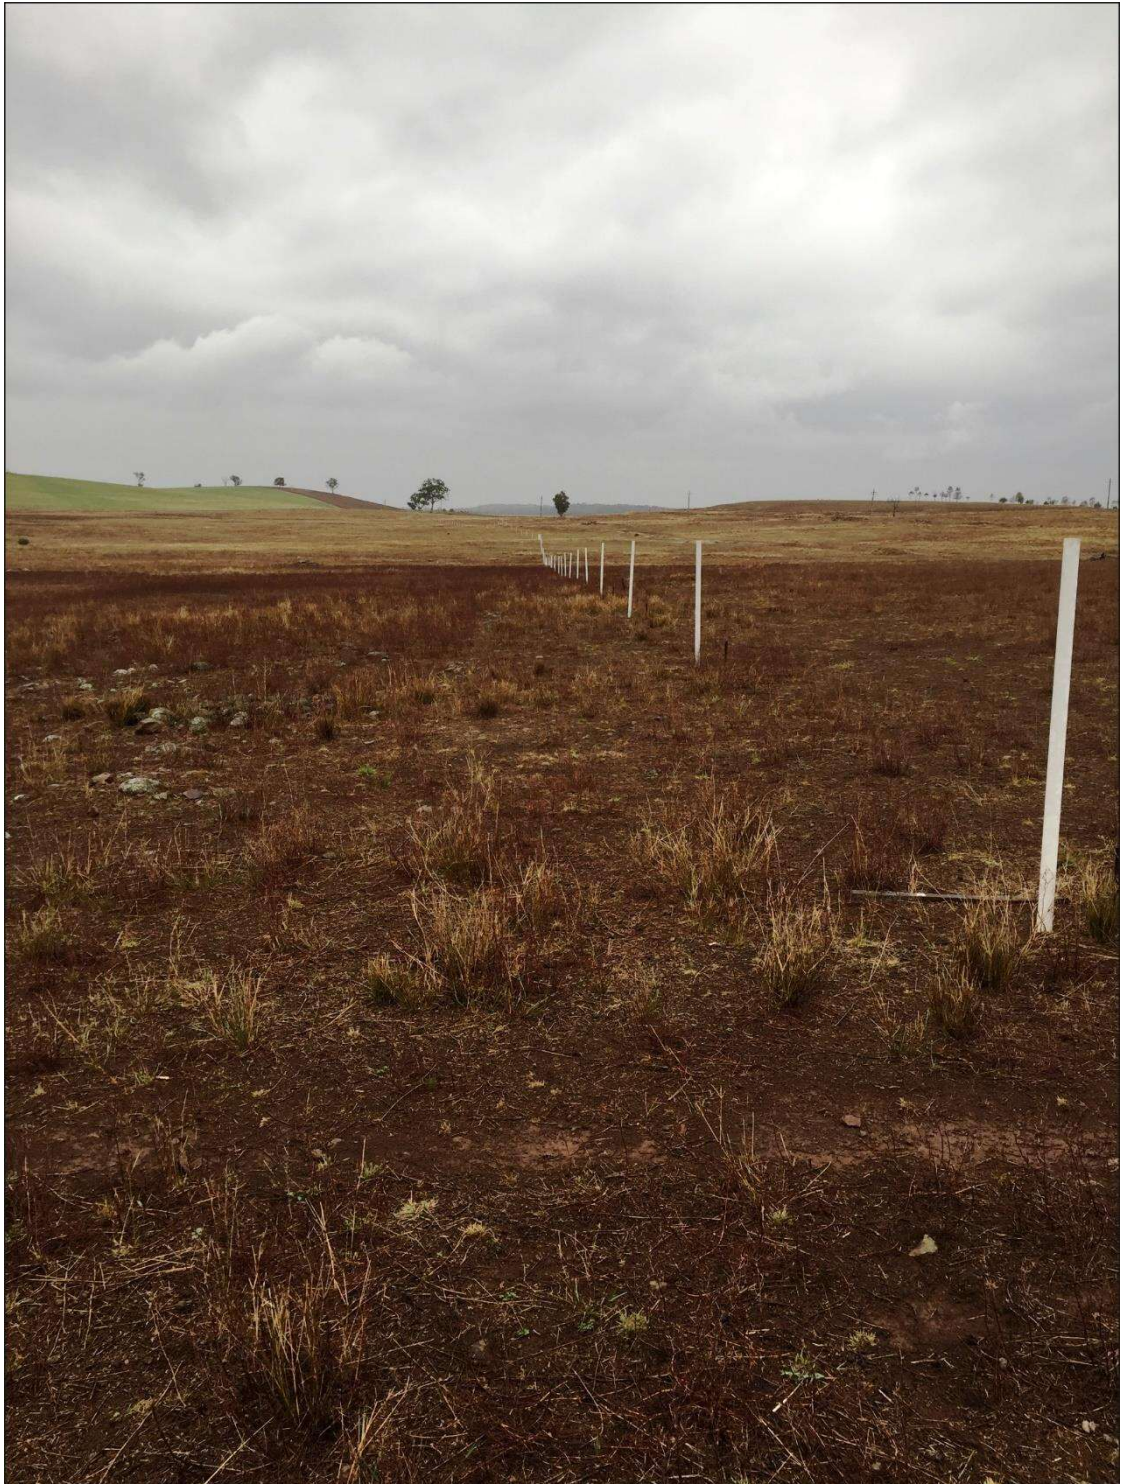
Figure 3: Surface along H Line.

H Line is the main subsidence monitoring line for the western domain longwalls at UUG. The line traverses the longwall panels from south to north almost perpendicular to the panel direction. Figure 3 shows the grazing land along H Line above Longwall W5.

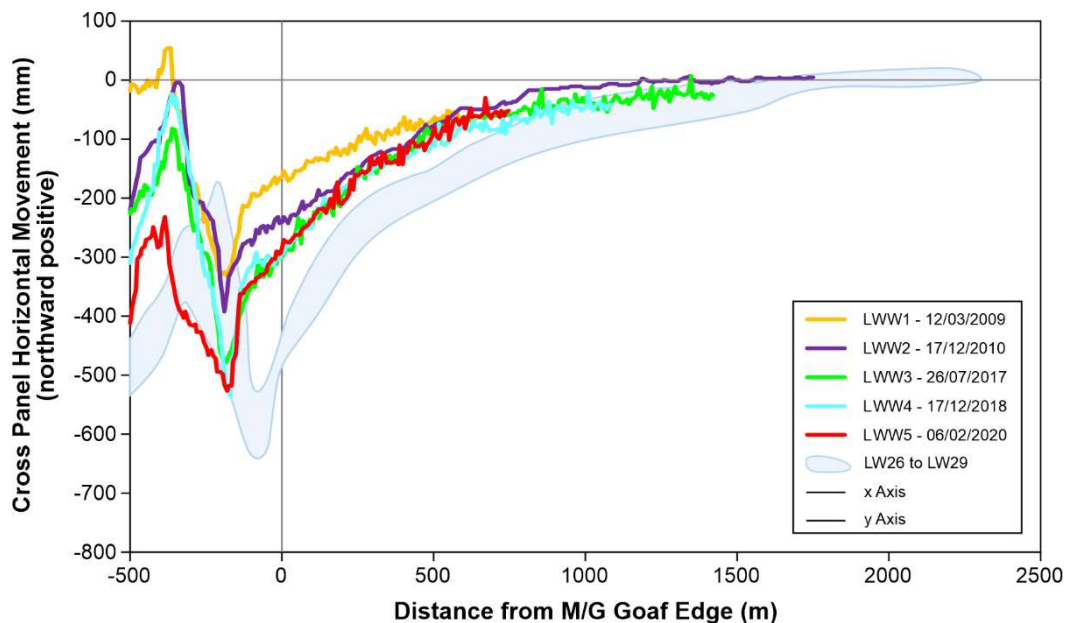
Figure 5: Cross panel horizontal movements measured on H Line at the end of Longwall W1, W2, W3, W4 and W5.

Figure 5 shows the cross panel horizontal movements measured on H Line at the completion of Longwalls W1-W5 plotted as a function of distance relative to the northern goaf edge of Longwall W5. The overburden depths at the goaf edge of these five panels range from 220m to 240m. Horizontal movements measured relative to the goaf edges of Longwalls 26, 27, 28 and 29 in the eastern domain at UUG are also plotted for reference. The overburden depth above these eastern domain panels ranges from 240m to 300m.

The horizontal movements measured over the goaf and panel edge of Longwall W5 are almost the same as those measured for Longwalls W4 and W3 and less than the those measured over Longwalls 26-29 where the overburden depth is greater.

These measurements indicate a consistent pattern of horizontal displacement that increases in magnitude with overburden depth. The horizontal displacement profile implies that the far-field horizontal movements are a consequence of horizontal stress relief toward the extracted panels. As the overburden depth increases, the magnitude of horizontal stress increases so the magnitude of stress relief is greater. The greater stresses cause the larger magnitude displacements to extend for a greater distance outside the mining area.

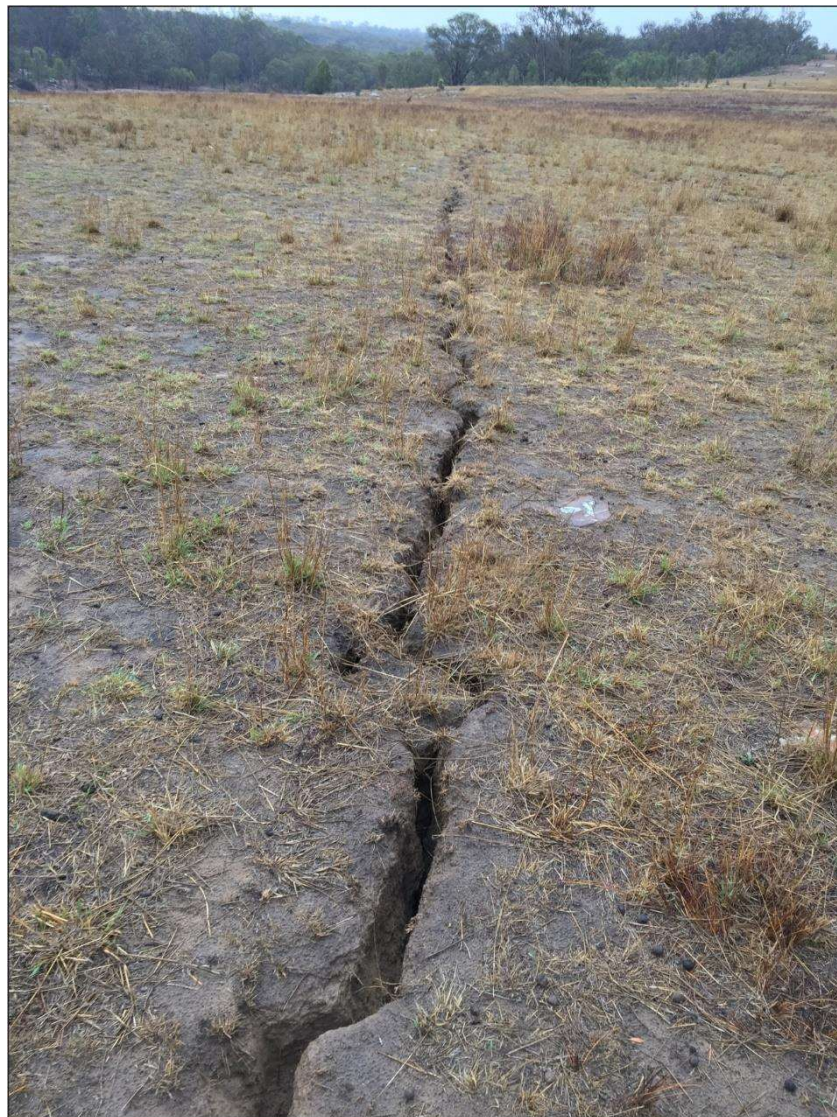
Figure 6: Surface crack that crosses H Line.

Surface cracks observed during site visits were generally less than 50-100mm wide and most are located near panel edges. The low frequency of cracks observed is consistent with expectation based on experience in the adjacent panels.

Figure 6 shows a crack, parallel to and inside the northern panel edge of Longwall W5 where it crosses H Line.

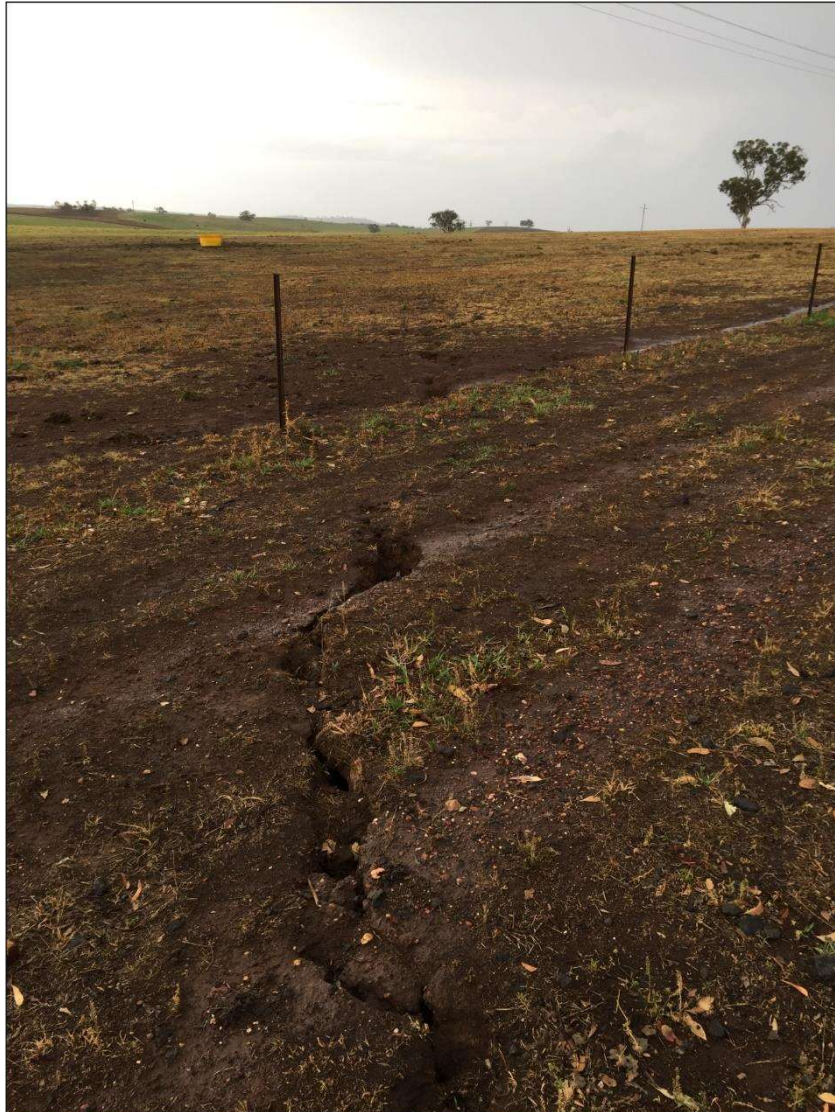
Figure 7: Cracking adjacent to Irrigation Road.

Figure 7 shows similar cracking, near the northern side of Longwall W5 further to the east, that crosses Irrigation Road below the single pole overhead powerline at this location. No significant impacts or consequences to these built features were reported.

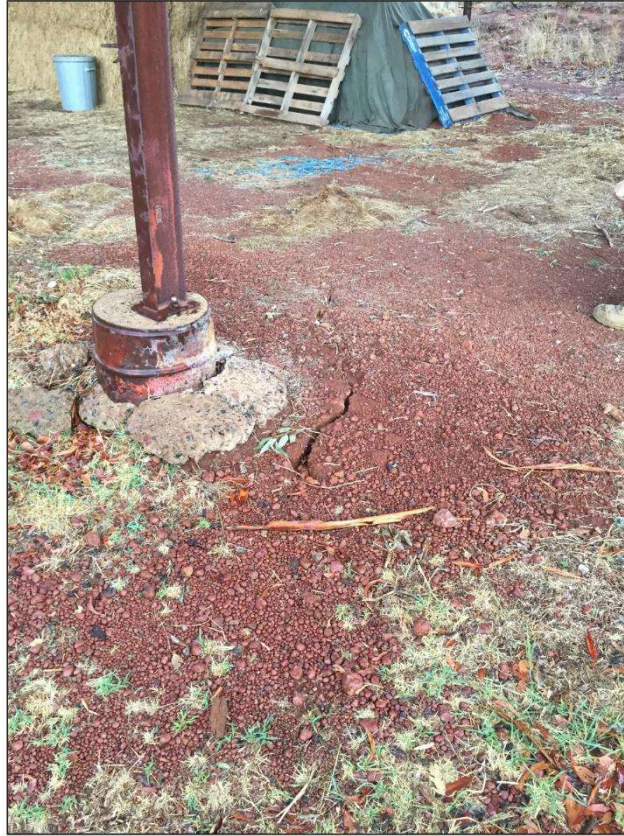
a) Cracking near foundation.

Minor cracking was also observed above the southern side of Longwall 5 at the hay shed 500m to the west of the Bobadeen Homestead site. Figure 8 shows the cracking parallel to and approximately 40m in from the southern panel edge at the hay shed location. There were no perceptible impacts to the hay shed structure.

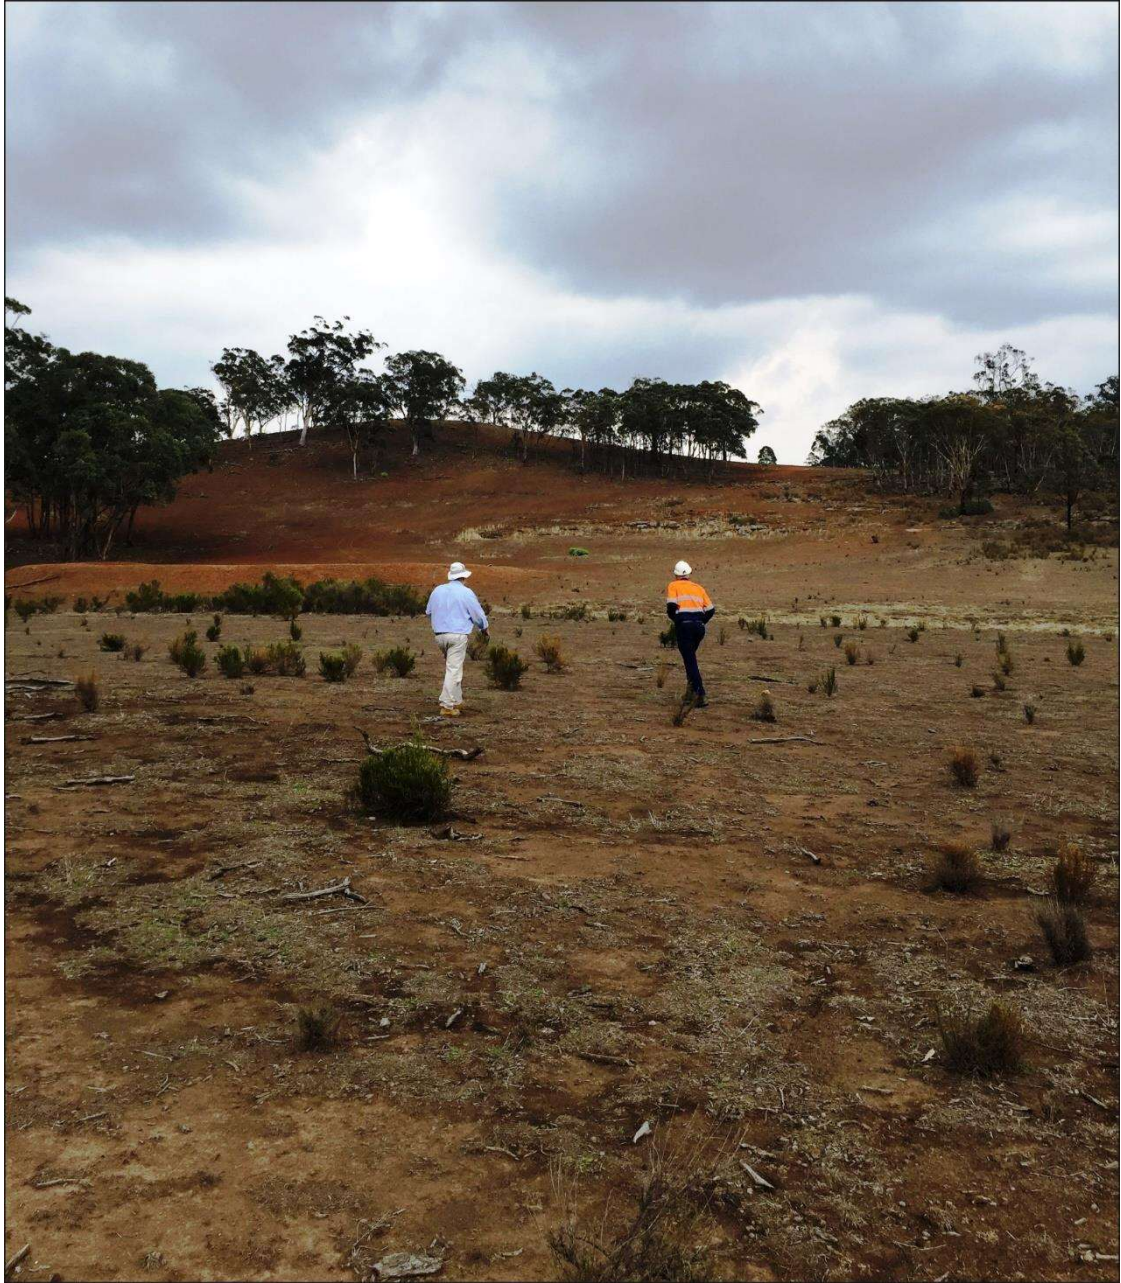
Figure 9: General view of section of 'Woodbury' property above Longwall W5.

The section of the Woodbury property above Longwall W5 was inspected on 17 January 2020 in company with the landholder. The impacts observed were consistent with expectation and less than the maximum forecast in SCT (2009) and in the SMP/EP.

Figure 9 shows a general view of the surface above Longwall W5. The farm dam embankment just east of the start line of the panel is in the middle ground on the left in the photograph. Cracking was observed near the panel edges both inside and outside the panel edge. The sandy soil was observed to slump into cracks in some places giving the appearance of “potholes”. Figure 10 shows an example of this type of impact.

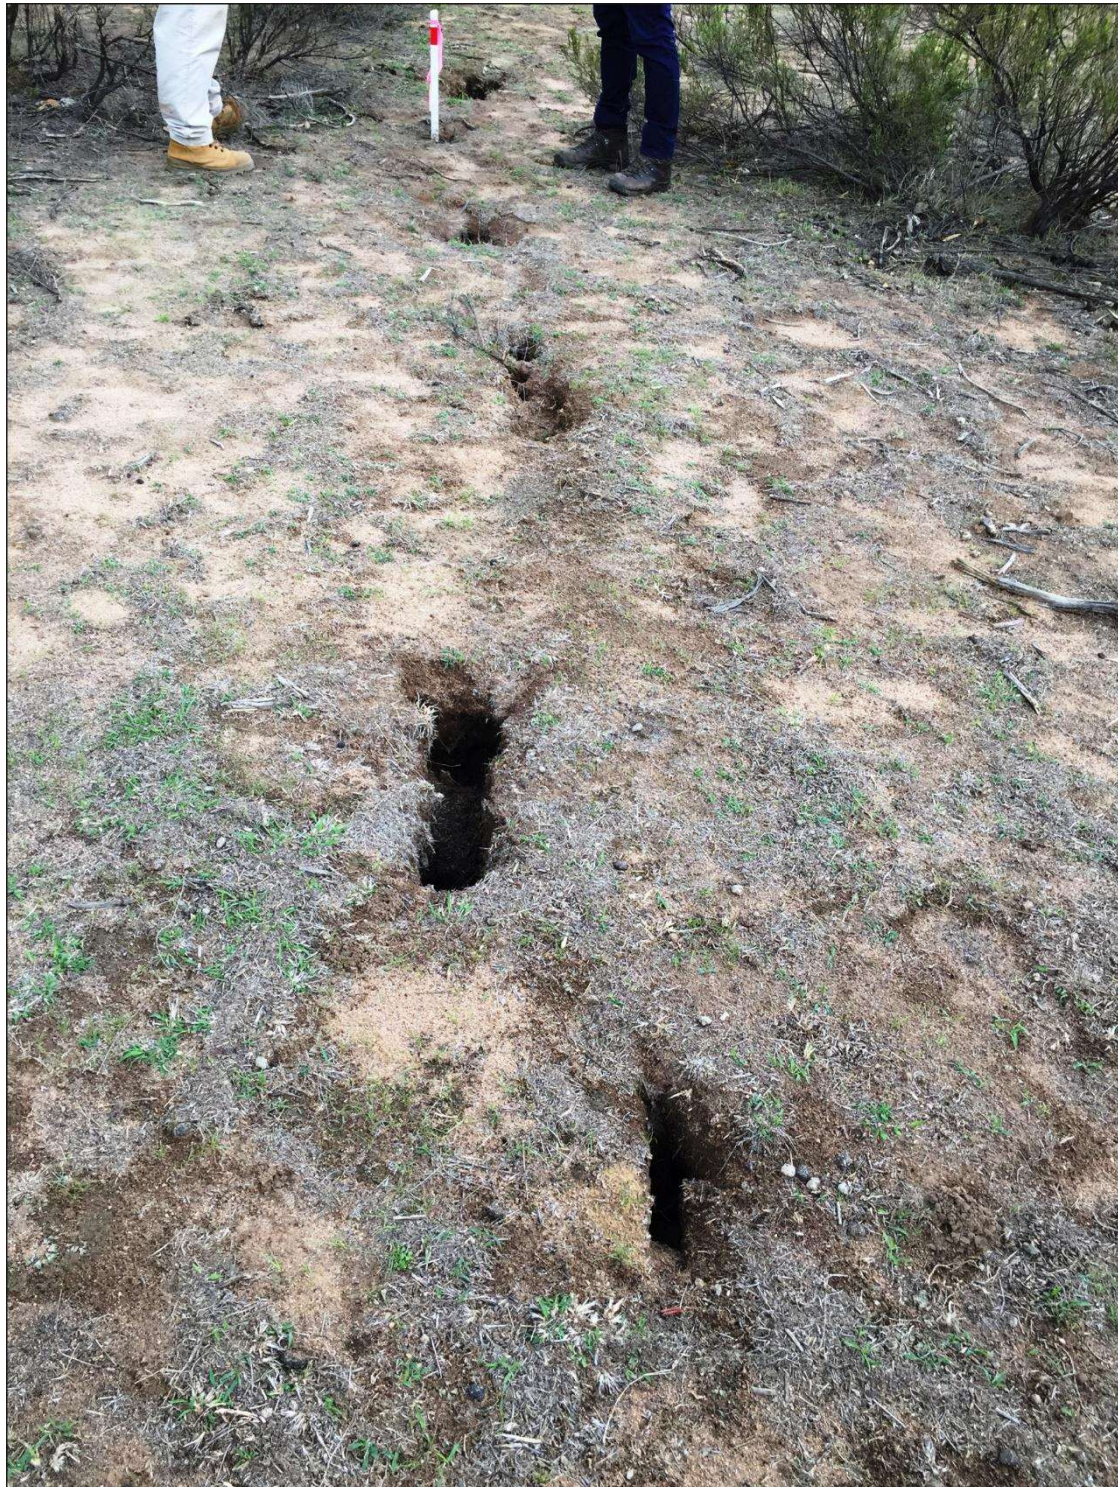
Figure 10: Cracking near northern edge of Longwall W5.

The width of cracks parallel to the start line of Longwall W5 are expected to be larger than elsewhere along the panel because of the subsidence mechanics that generate horizontal movement. Crack width at the start of Longwall W5 is further magnified by the surface terrain sloping in the direction of mining. The largest horizontal movements occur at the start of longwall panels with the direction of movement in the direction of mining.

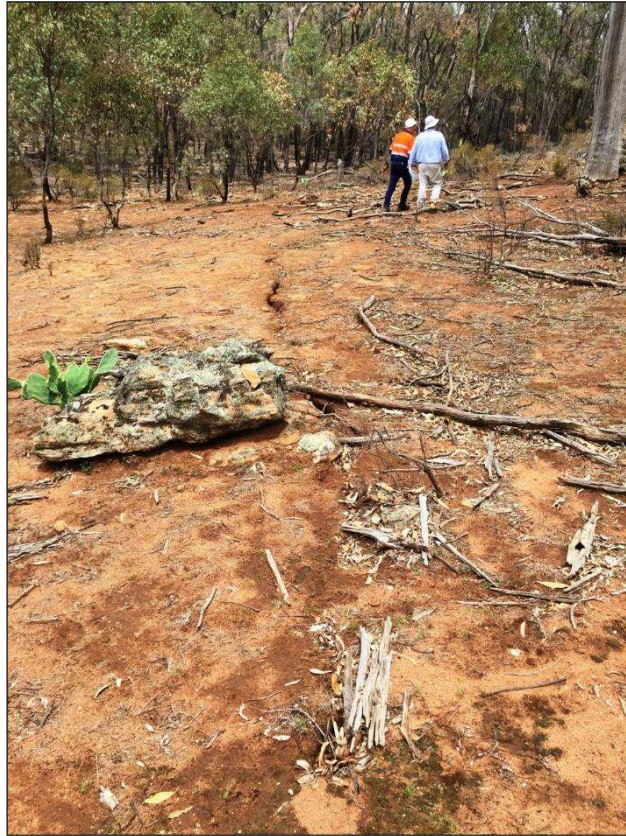
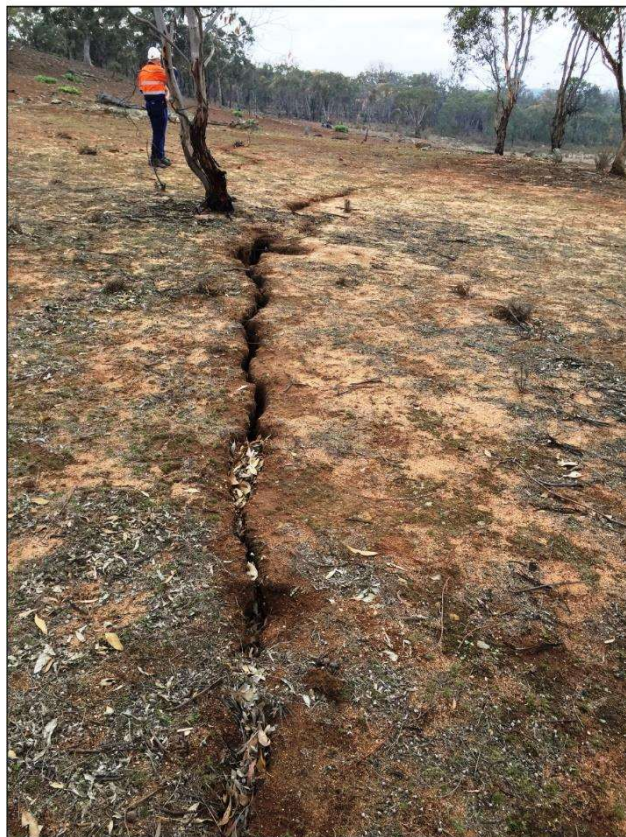
Figure 11: Cracking in sloping terrain near start line of Longwall W5.

Cracks that form above the start line of longwall panels are permanent and usually larger than elsewhere. The interaction of subsidence and sloping terrain causes horizontal movements to develop in a downslope direction. This effect is greatest when mining from high ground towards lower ground. The combination of sloping terrain in the direction of mining at the start of a longwall panel leads to the type of cracking shown in Figure 11.

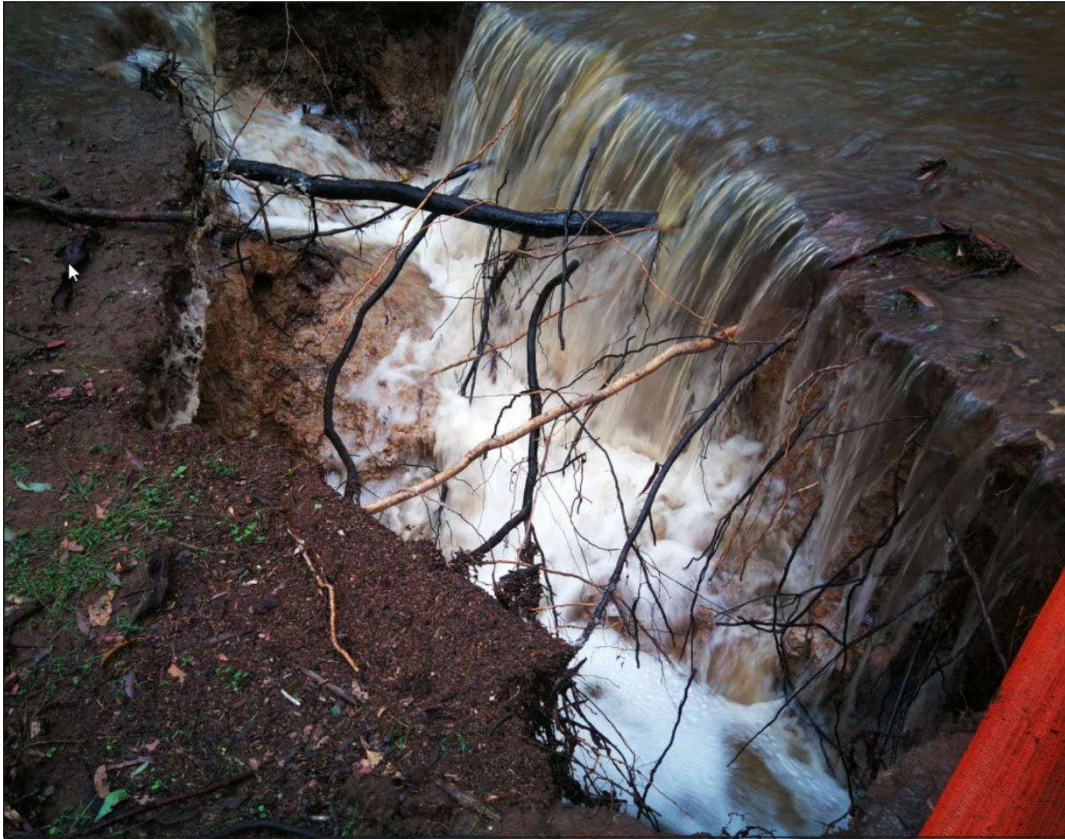
The start of Longwall W5 is located below an ephemeral drainage line that eventually flows into Mona Creek. Potholes were observed along this drainage line during the site visit on 17 January 2020. Sandy soil had eroded into a subsidence crack during a period of overland flow along the drainage line. Two heavy rainfall events in February and April 2020 have caused further erosion and an increase in the size of the potholes observed. Figure 12 shows overland flow entering subsidence cracks and the resulting erosion. A strategy of regrading the eroded areas and moving the drainage line to avoid a recurrence is expected to be effective in controlling further erosion.

a) Example of flow into a subsidence crack during an overland flow event.

Figure 12: Erosion associated with interaction of overland flow and subsidence cracks.

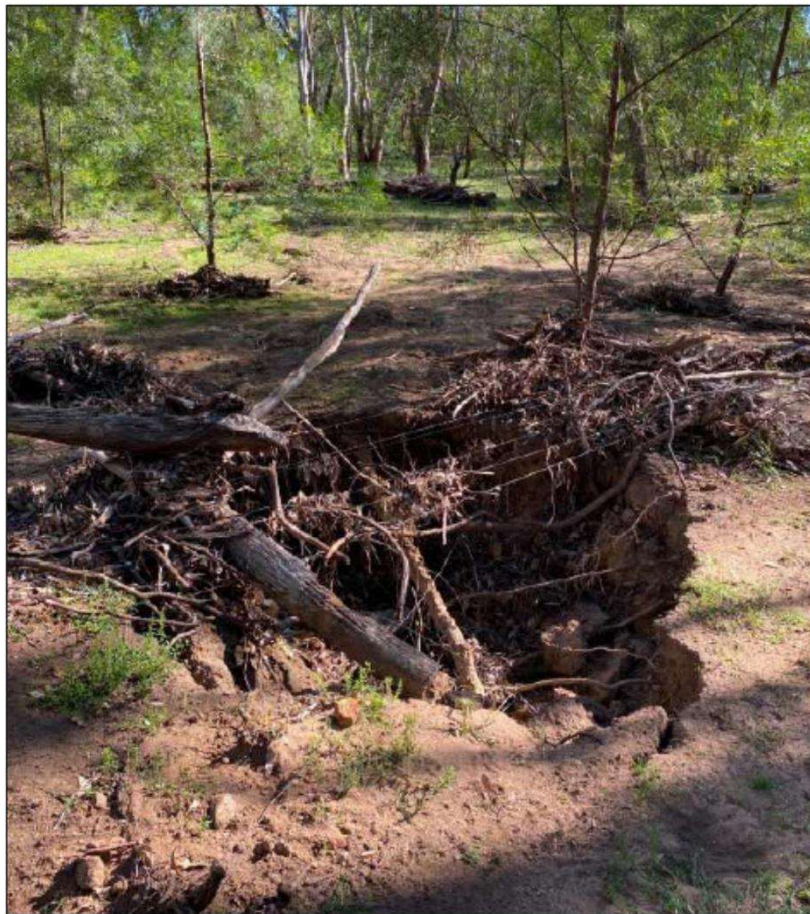
b) Example of erosion along a drainage line following an overland flow event.
