REPORT OF INVESTIGATION

Fatal Powered Haulage Accident

June 5, 2008

**Robinson Run No. 95
Consolidation Coal Company
Mannington, Marion County West Virginia
MSHA ID No. 46-01318**

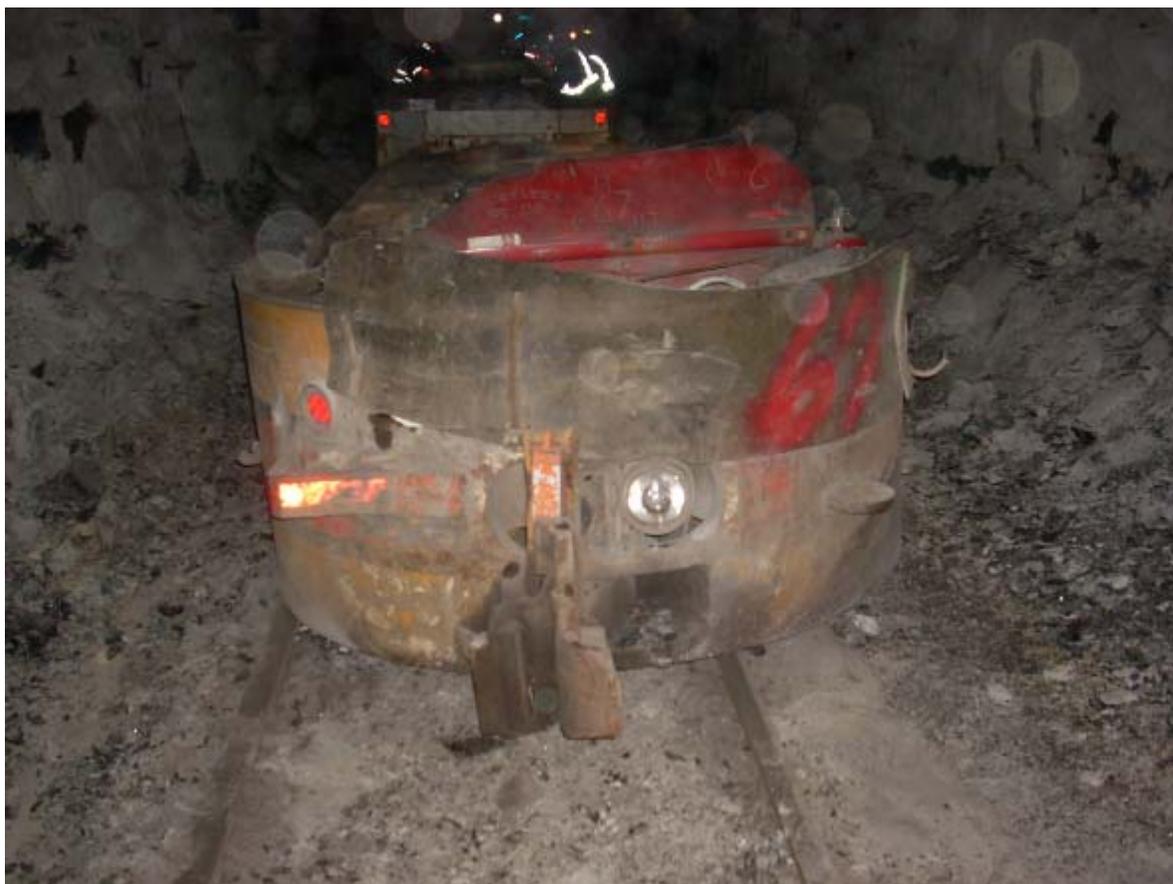
PHOTO OF ACCIDENT SCENE

On Thursday, June 5, 2008, locomotive operator (motorman) Gary Hoffman was fatally injured when he lost control of a 20 ton locomotive and two flat cars loaded with donut cribs. The victim fell, jumped, or was knocked off the company Number 67 locomotive. The victim was unable to maintain control of the locomotive and loaded flat cars due to condensation and moisture on the rails.

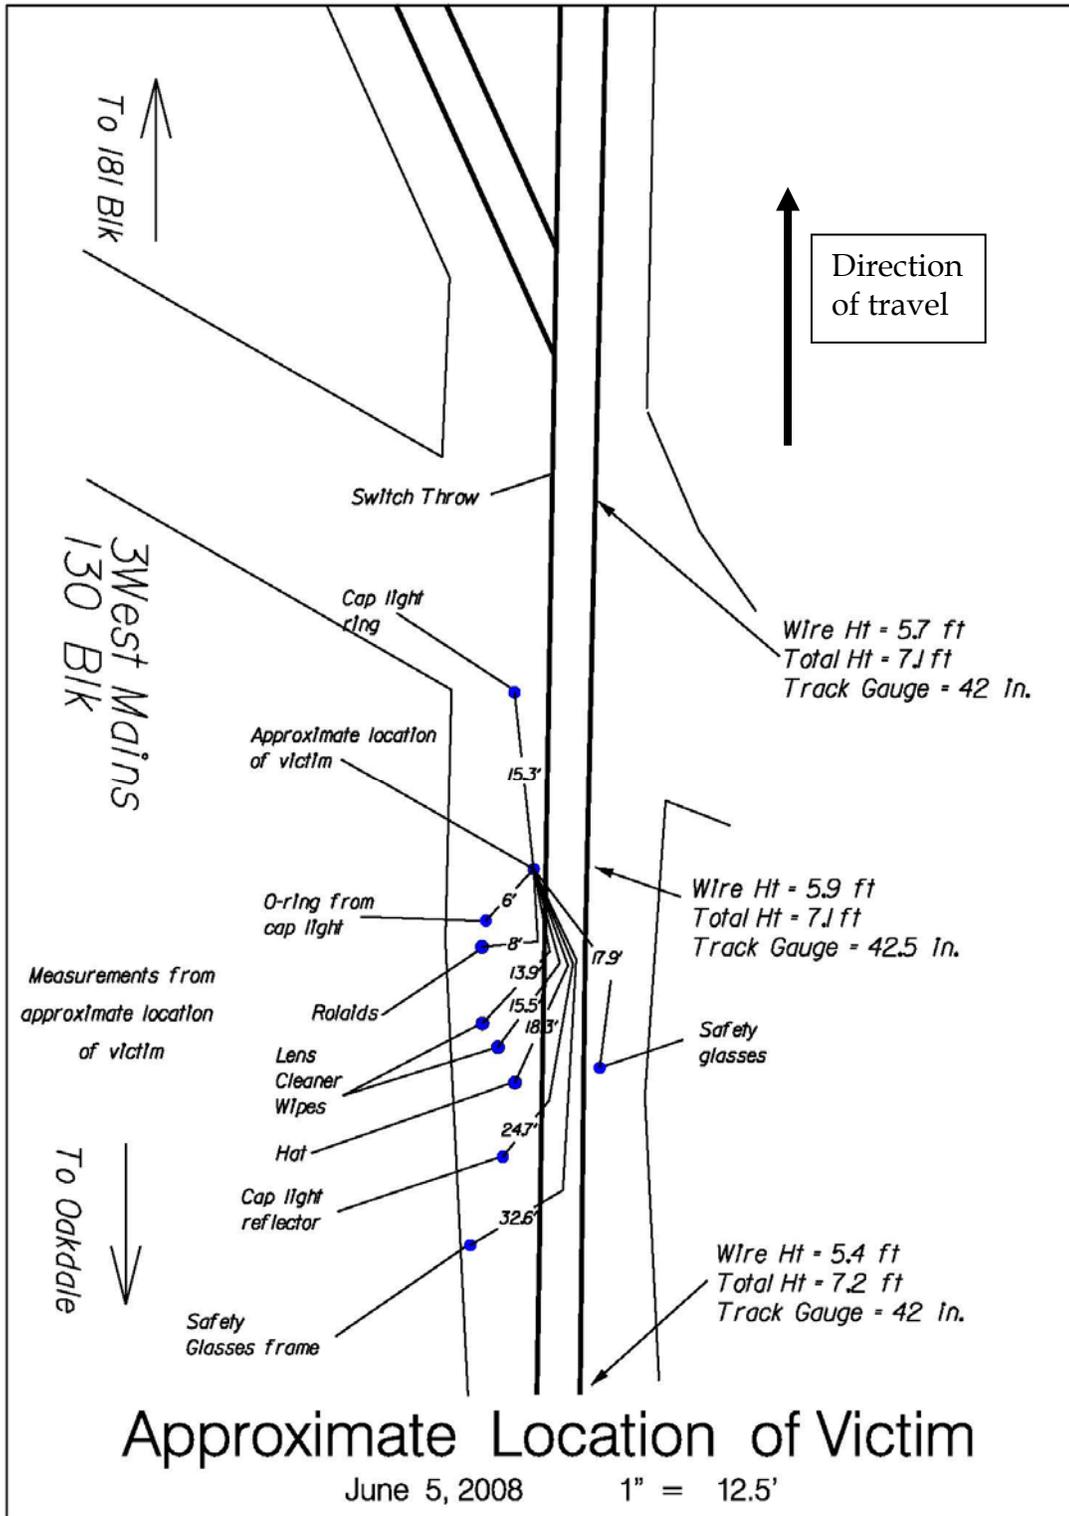
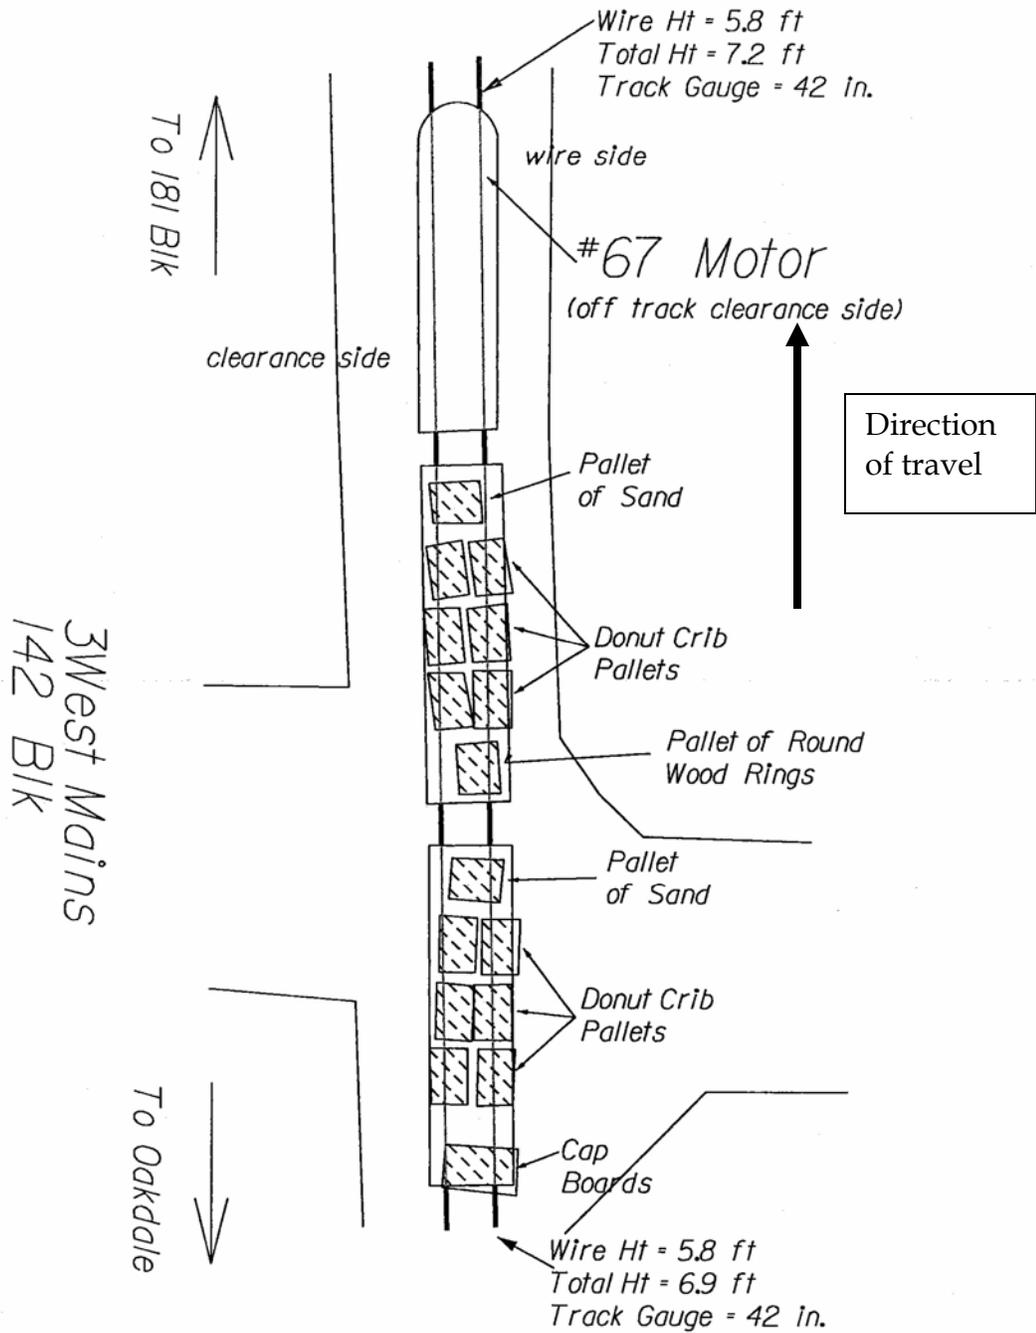
APPENDIX A - Drawing of the Accident Scene

Hoffman was discovered by Carson at the 130 block in the 3-West area; however the Number 67 locomotive and the attached load continued to travel down the 2.5% grade. Physical evidence indicated that the locomotive began to de-rail at the 140 block area for a distance of approximately 1,200 feet inby the victim. The locomotive stopped with the wheels off the track at the 142 block area (An additional distance estimated to be 200 feet). The wheels of the locomotive were off the track 6 inches on the clearance side. There was no damage to the locomotive as the result of the de-railment. The loaded flat cars remained on the track.
