REPORT OF FATALITY
HAULAGE ACCIDENT
UNDERGROUND COAL MINE

JUNE 4, 2018

CARTER ROAG COAL COMPANY
MORGAN CAMP MINE
PERMIT #U00201297

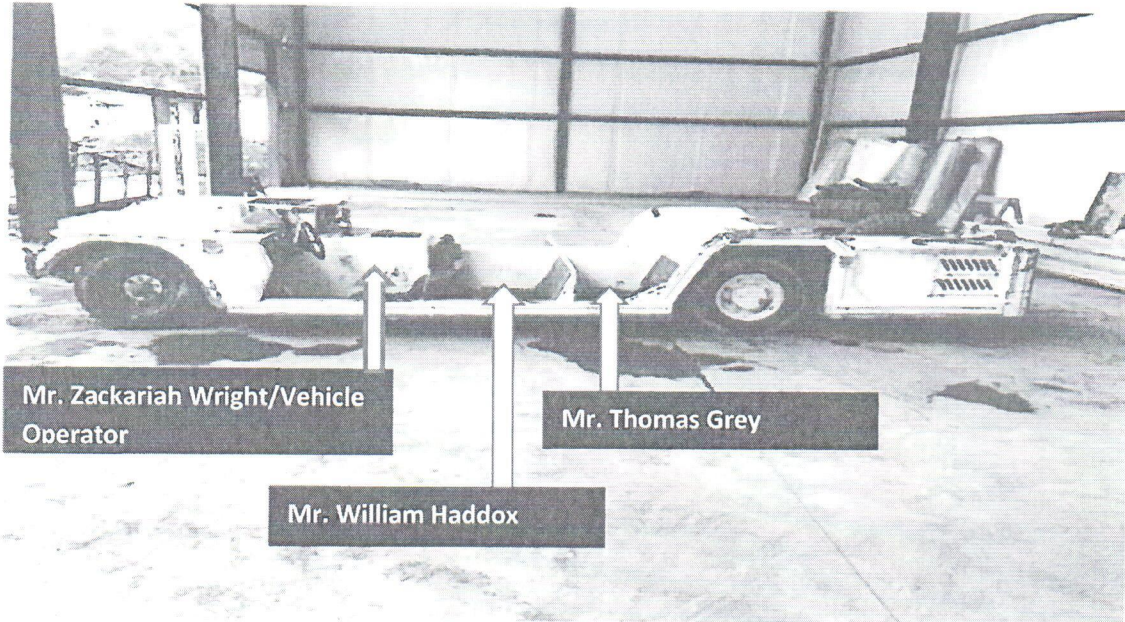
788 Wallace Diesel Powered Personnel Carrier/Operator Side

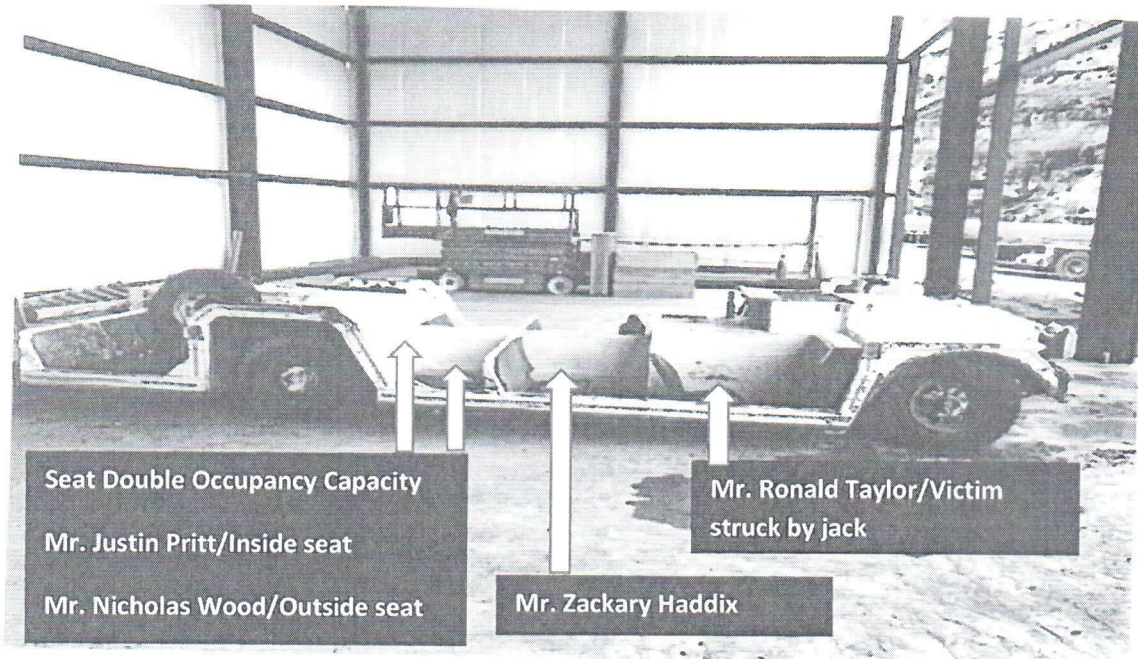
788 Wallace Diesel Powered Personnel Carrier/Passenger Side
