Number: ULNCX-1862890609-23

Name of operation	Ulan Coal Mine		
Name of operator	Ulan Coal Mines Propriety Limited		
Development consent / project approval #	PA 08_0184		
Name of holder of development consent /	Ulan Coal Mines Propriety Limited		
project approval			
Mining lease #	CCL 741, MPL 315, ML 1341, ML1365, ML 1366,		
	ML 1467, ML 1468, ML 1511, ML 1554, ML 1656,		
	ML1754, ML1796, EL 5573, EL 7542, & EL 8687		
Name of holder of mining lease	Ulan Coal Mines Propriety Limited		
Water licence #	WAL41492, WAL19047, WAL37192, WAL37192,		
	WAL41906, WAL42900 & WAL34921 (only		
	allocation Licences listed).		
Name of holder of water licence	Ulan Coal Mines Propriety Limited		
MOP/RMP start date	01/12/2017		
MOP/RMP end date	01/12/2024		
Annual Review start date	01/01/2020		
Annual Review end date	31/12/2020

This consolidated Annual Review¹ (AR) was prepared to satisfy consent conditions and reporting obligations as specified by NSW Department of Planning, Industry and Environment (DPIE). The reporting period for this AR is from 01 January 2020 to 31 December 2020, with the AR due by 31 March 2021². In accordance with Condition 3, Schedule 5 of PA08_0184, a copy of this report wi

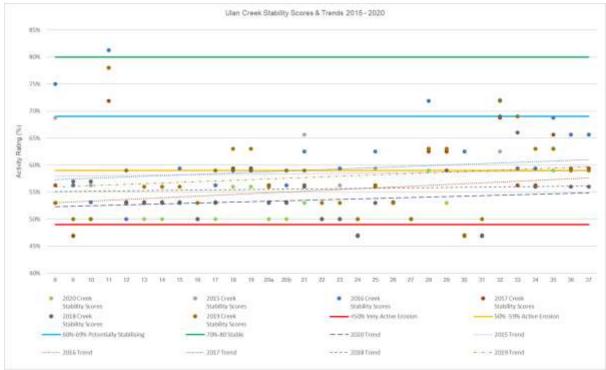
Figure 7-13 Ulan Creek Stability Monitoring Assessment Scores

The 2020 Ulan Creek stability assessment results indicate a deteriorating trend in the overall creek stability from Site UC08 to UC37 when compared to historical monitoring from 2015. Although a slight improving trend in 2019

was observed, one or more high flow events in 2020 has caused significant instabilities and further exacerbated the existing erosion along the creek inspected.

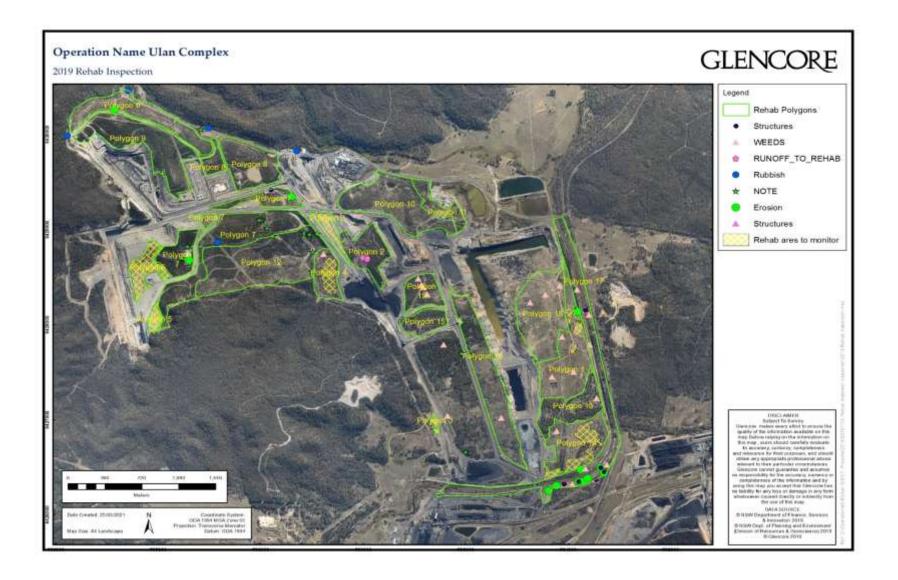
Figure 8-3 2020 Rehabilitation Inspection - Issues Identified

15	Monitor	4-5	Poor species diversity predominately acacia species with little tree establishment - low presence of eucalypts in large areas	Monitor and planting of eucalypts trees may be required	Walk over inspection weed spraying
16	Monitor	4-5	Poor diversity (This area is proposed for capping and potential tailings facility Weed spraying	Continue with weed spraying No other work proposed	Weed control Area will be used for tailings capping
17	Monitor	4	Weeds small areas of erosion	Continue monitoring for bank and revetment stability and repair erosion issues weed spraying	GRD stable weed spraying Walk over inspection Lidar survey of revetment completed after flood event
18	Rework	3	Failed rehab area from 1990-2000 (Final Land form in this area is subject to change)	Area to be replanted within the current MOP period once final landform is confirmed.

- Planting and seeding of failed rehabilitation areas;
- Soil sampling
- · Removal of rubbish; and
- Weed spraying conducted early in 2020.
