COBAR MANAGEMENT PTY LTD

The CSA Mine

Annual Environmental Management Report (AEMR) 2021

Name of Mine CSA Mine

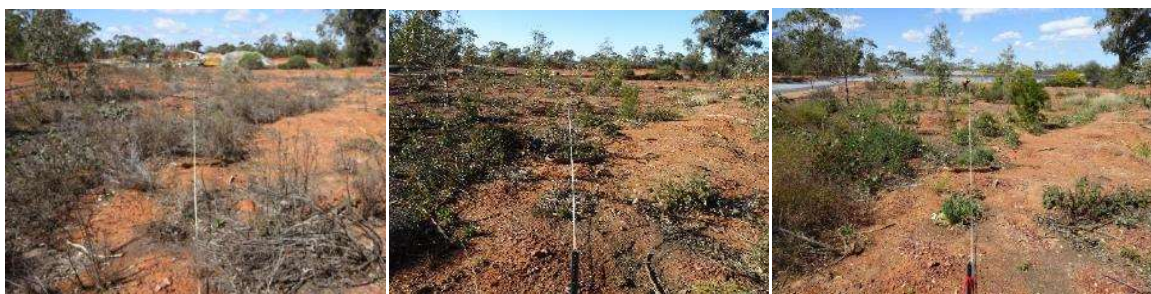
This site is situated over an old subsidence area which was built up in the late 1990s. Topsoil stripped from the tailings extension area was applied over the area in 2004/05. The area contains an extensive pile of large trees, logs and branches which were removed from the tailings extension area. The area has not been seeded but in 2011 and 2012 there were scattered shrubs and ground cover species establishing amongst the woody debris including *E. sturtii*, *Geijera parviflora*, *Acacia aneura*, *Dodonaea viscosa* subsp. *mucronata* and *D. lobulata*. There was a wide range of ground cover species in patches, but they provided limited ground cover. Several weed species were also recorded. In 2013, there continued to be extensive movement of exposed soils with the log piles providing critical retention. Sulfate crystals continued to be evident on the soil surface and feral goats continued to significantly impact on any establishing vegetation. There continued to be a relatively high diversity of species, but these provided limited ground cover. In 2014, there continued to be further degradation of the site with a decline in the diversity and abundance of ground cover as a direct result of grazing. Persisting shrubs had grown. In 2015, there continued to be extensive movement on the site with the logs piles appearing to be slowly sliding down the slope resulting in extensive erosion and sedimentation of exposed soils. Sulfate crystals continued to be evident on the soil surface and feral goats continued to significantly impact on establishing vegetation. In 2015 there continued to be a relatively high diversity of species, but these provided limited ground cover. In 2016 although there continued to be pockets of annual ground covers the site continued to be unstable with active erosion occurring within the bare and contaminated interpatch areas. In 2017 the area had been fenced off however it continues to be subjected to grazing (gates not closed?). Persisting shrubs have grown but otherwise there was little to no live ground cover. The new areas of rehabilitation on the lower batters contained patches of cryptogams and scattered shrubs were colonising the area and appear to be performing better than the upper slopes, perhaps due to the healthier soil chemistry. In 2018, several more shrubs had died, while the remainder had significantly grown, and there was little other apparent change. In 2019, the persisting shrubs had grown, however there continued to be extensive movement on the site with the

log piles appearing to be slowly sliding down the slope and there was extensive erosion and sedimentation of exposed soils. Sulfate crystals continued to be evident on the soil surface. Not much change was observed in 2021

The OS rehabilitation site requires additional amelioration via methods such as capping and/or placement of healthy topsoil. Previous trials at CSA indicated that soil contaminants are capable of leaching upward via capillary processes and requires intervention. This may include the capping of the contaminated soils with NAF waste rock, use of geotechnical fabric and/or clay capping followed by the placement of 'healthy topsoil'. Trials and liaison with other local mines or geotechnical experts to determine outcomes of any similar trials or treatments is recommended. Complete removal of unsuitable surface material and its replacement with more suitable topsoil material may also be a viable option in some areas where this is possible.

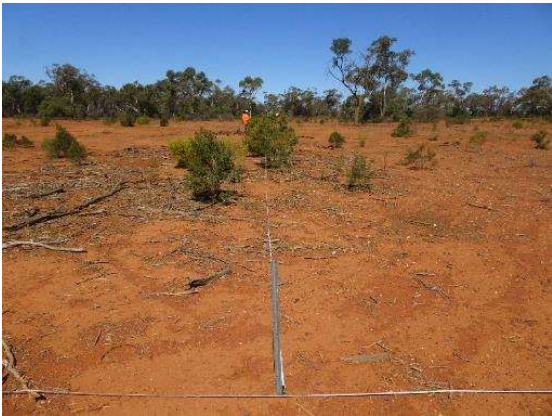
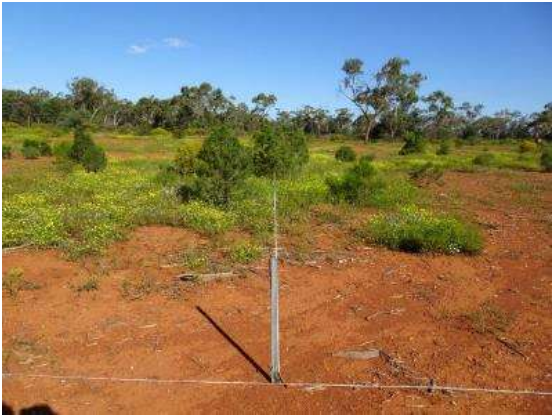
2019 Photo-point	2021 Photo-point
<p>PVP 01: This site was cleared in 2014 as part of the PVP project initiated by the LLS. There were large bare patches, and occasional litter patches had developed (annual plants had died off). There were occasional large deep holes which were probably created with the removal of mature trees. Scattered were scattered seedlings of <i>Senna</i> (two species), <i>Geijera parvifolia</i> (Wilga), <i>Eremophila mitchellii</i> (Budda) and <i>E. sturtii</i> (Turpentine). The soil was extremely hard. In 2018 there was little live ground cover and the litter and cryptogam patches had also deteriorated. Some <i>Calotis</i> spp. had germinated after relatively recent rainfall. Persisting shrubs had grown. In 2019, persisting shrubs had grown however there has been further loss of and deterioration of the litter and cryptogam patches, and there was limited live ground cover. In 2021 patch area continued to be very low ranging from 0 – 14%.</p>

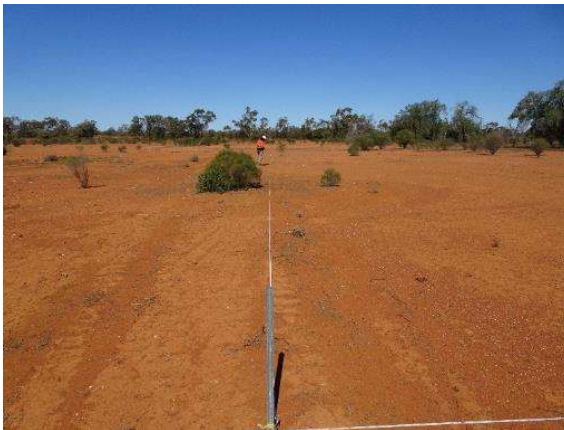
<p>PVP 02: This site was cleared in 2014 as part of the PVP project initiated by the LLS. There were large bare patches, and occasional litter patches had developed (annual plants had died off). There were scattered <i>E.</i></p>

2019 Photo-point	2021 Photo-point
<p><i>sturtii</i> (Turpentine) seedlings. The soil was extremely hard. In 2018 there was little live ground cover and the litter and cryptogam patches had also deteriorated. Some <i>Calotis</i> spp. had germinated after relatively recent rainfall. Persisting shrubs had grown. <i>Medicago</i> seed had accumulated in some depressions. In 2019, persisting shrubs had grown however there has been further loss of and deterioration of the litter and cryptogam patches, and there was limited live ground cover. In 2021 patch area continued to be very low ranging from 0 – 14%.</p>

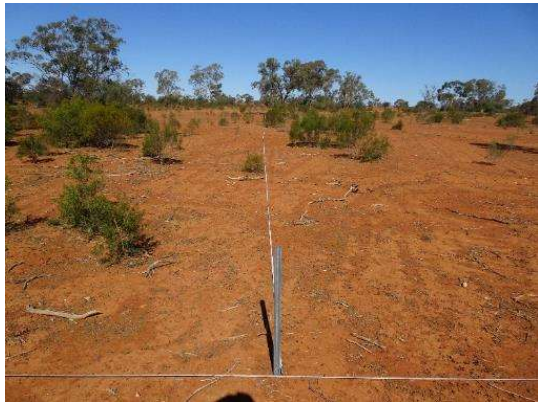
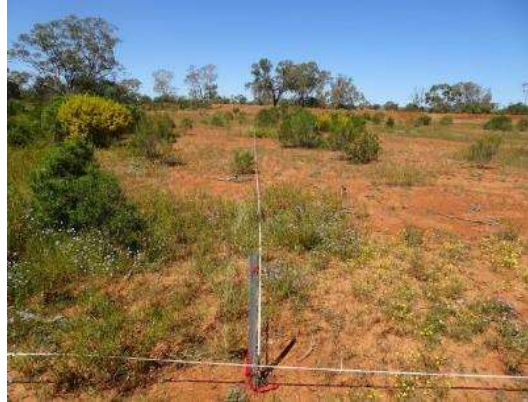
<p>PVP 03: This site was cleared in 2014 as part of the PVP project initiated by the LLS. There were large bare patches, and occasional litter patches had developed (annual plants had died off). There were scattered seedlings of <i>Senna</i> (two species), <i>Eremophila mitchellii</i> (Budda) and <i>E. sturtii</i> (Turpentine). The soil was extremely hard. In 2018 there was little live ground cover and the litter and cryptogam patches had also deteriorated. Some <i>Calotis</i> spp. had germinated after relatively recent rainfall. Persisting shrubs had grown. <i>Medicago</i> seed had accumulated in some depressions. In 2019, persisting shrubs had grown however there has been further loss of and deterioration of the litter and cryptogam patches, and there was limited live ground cover. In 2021 patch area continued to be very low ranging from 0 – 14%.</p>
