REPORT OF INVESTIGATION

Fatal Machinery Accident
June 13, 2017

Gateway Eagle Mine
Rockwell Mining, LLC
Wharton, Boone County, WV
ID No. 46-06618

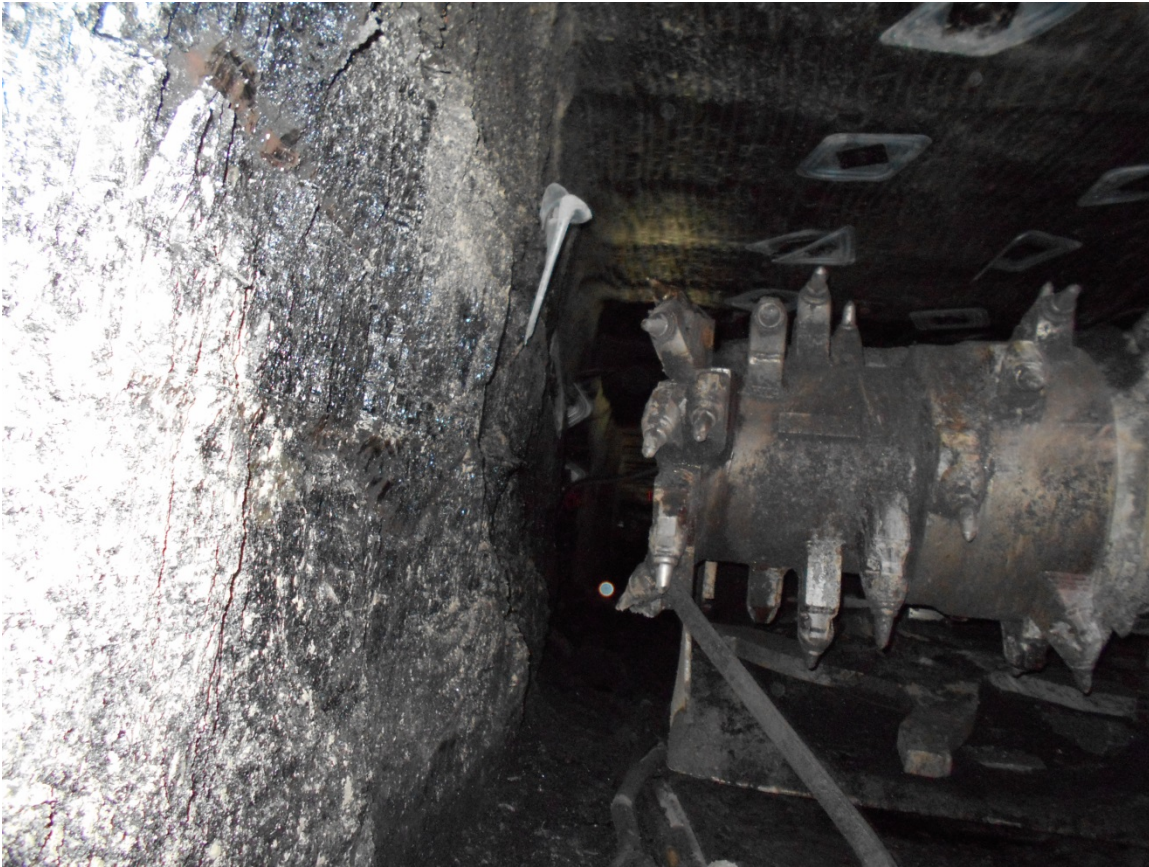
PHOTO OF ACCIDENT SCENE

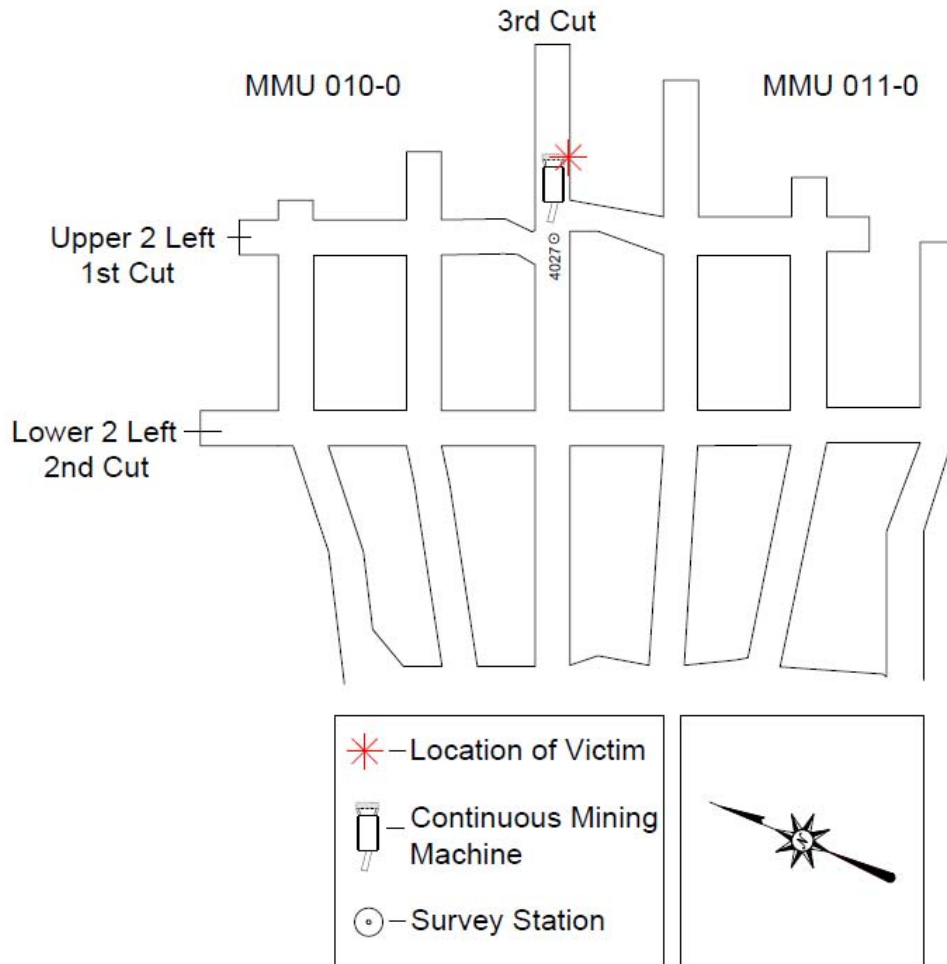
APPENDIX B
Sketch of Section at Time of Accident

2 Left room. He then mined coal in the Lower 2 Left room and in the No. 3 entry (see Appendix B).

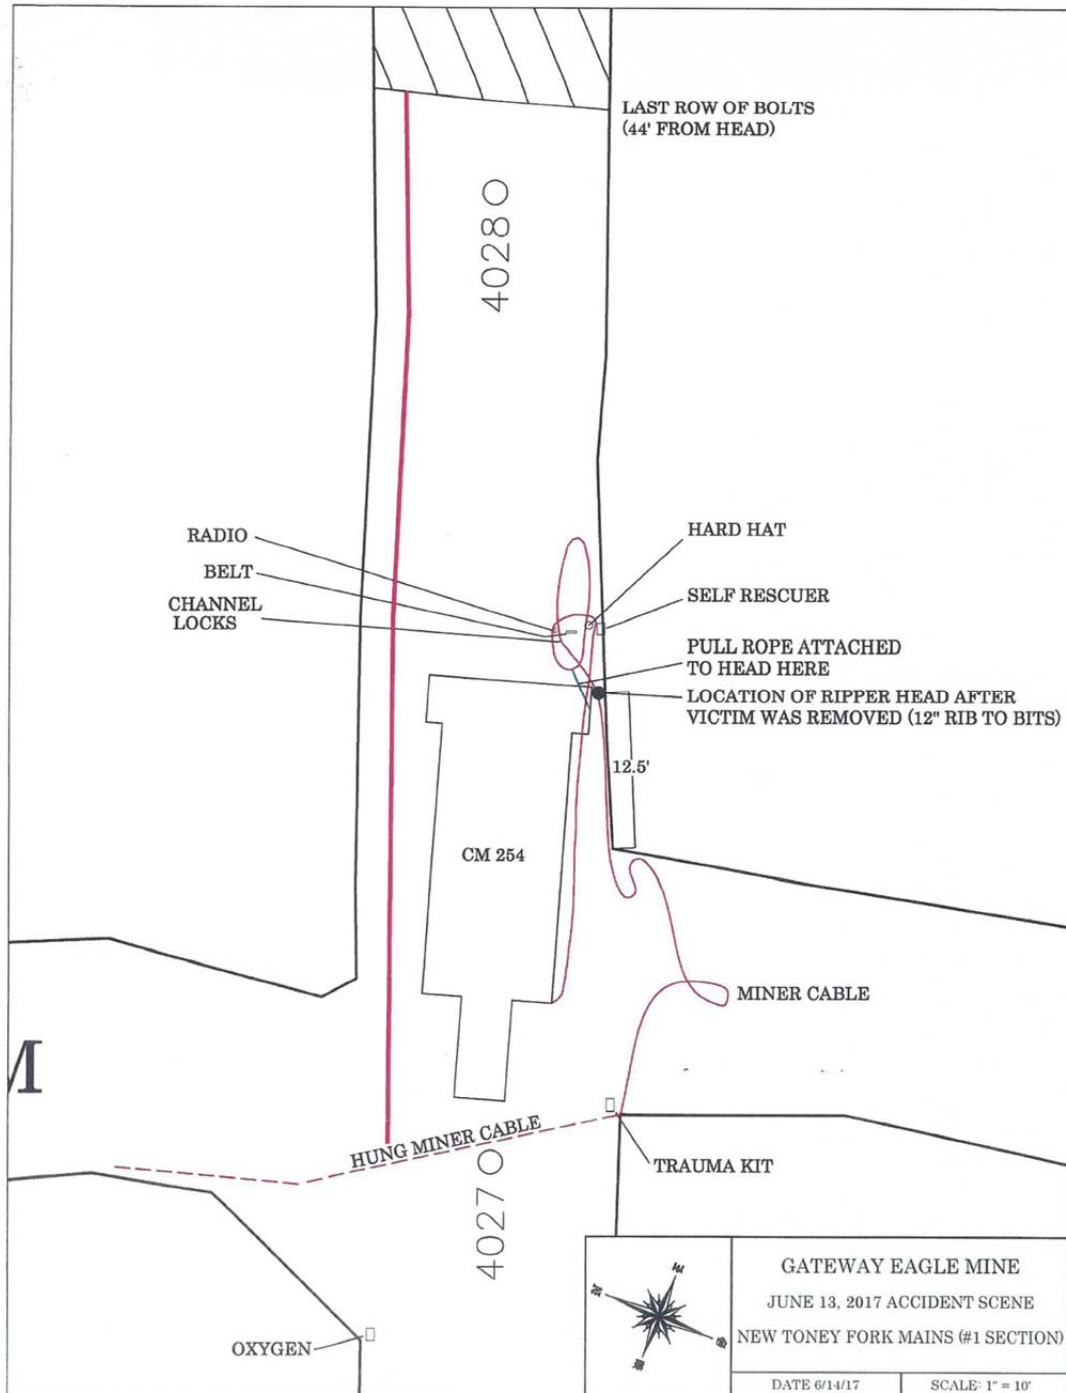
Sketch of Accident Scene

The accident occurred on the left side (010-0 MMU) of the 010-0/011-0 MMU No.1 working section, in the No. 3 Entry, approximately 12.5 feet in by the last open crosscut, along the right rib. Entries Nos. 1, 2, and 3, and the associated crosscuts and rooms, made up MMU 010-0. All other entries and crosscuts were a part of MMU 011-0. The mine floor in the area was wet with a small ledge on the left side of the entry, which was not a factor in the accident. The CMM was trammed numerous times in this area during the investigation with no adverse effects. The width of the entry at the location of the accident measured approximately 19 feet wide by 8 feet high. After the victim was removed, the cutter head of the CMM was located 12.5 inches from the right coal rib (see Appendix C).

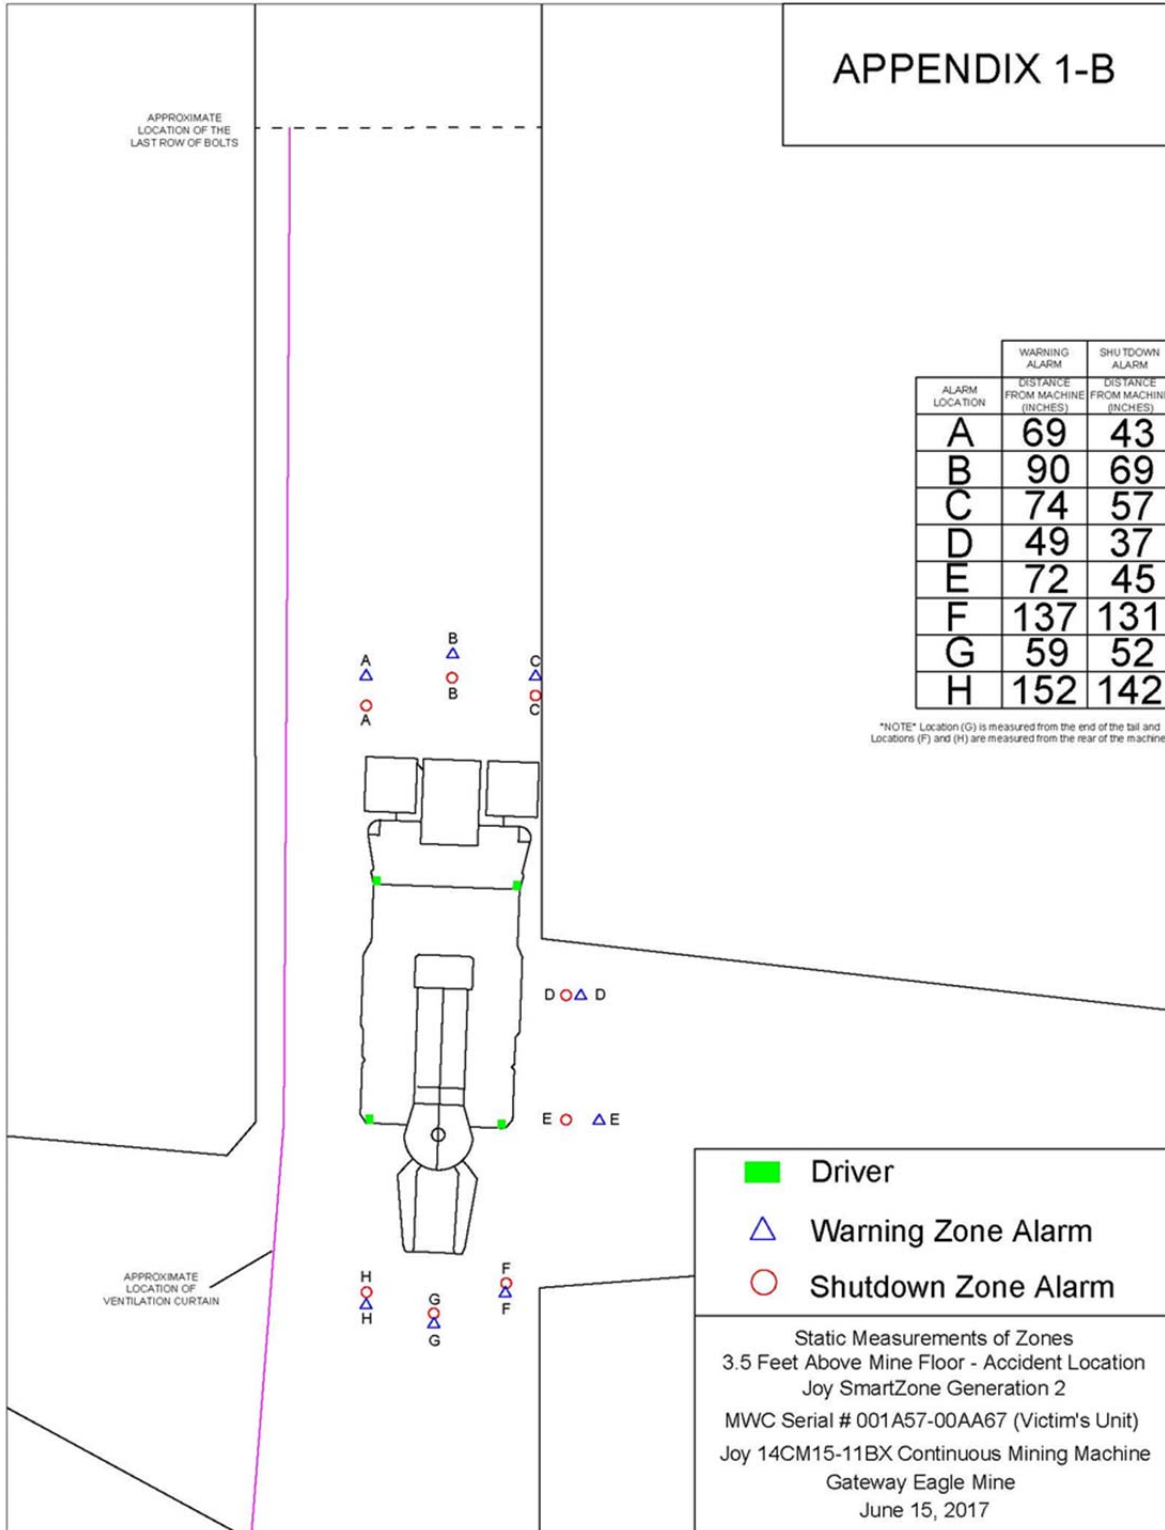
APPENDIX D Proximity Measurements

The PDS and MWCs for the CMMs were examined by the investigation team, which found no physical damage or abnormalities that would affect the ability of the PDS to stop the machine before contacting a miner. Data retrieved from the PDS on the No. 254 CMM indicated that the victim's MWC was properly communicating with the PDS. Static measurements and dynamic tests of the PDS indicated the CMM would stop before contacting a miner (see Appendix D).
