# MT OWEN COMPLEX ANNUAL ENVIRONMENTAL MANAGEMENT REPORT

1 January 2012 – 31 December 2012

Name of Mine: Mt Owen Complex – Consisting of Mt Owen, Ravensworth East and

Glendell Mines

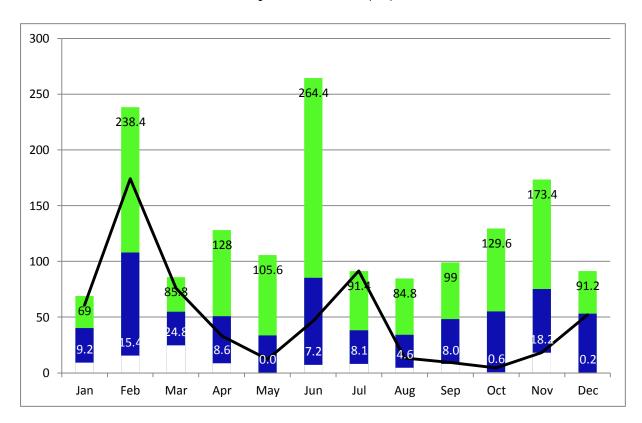
Figure 4 - Rainfall 2012 (Sx8)

Mt Owen Complex received 592mm in 2012 as recorded by Sx8 as compared to 1018 mm of rainfall in 2011. When compared to the long term annual average of 724 mm recorded at Singleton between 1969 and 1990 (Bureau of Meteorology 2010) demonstrates the extent of the dry conditions that have been experienced in 2012.

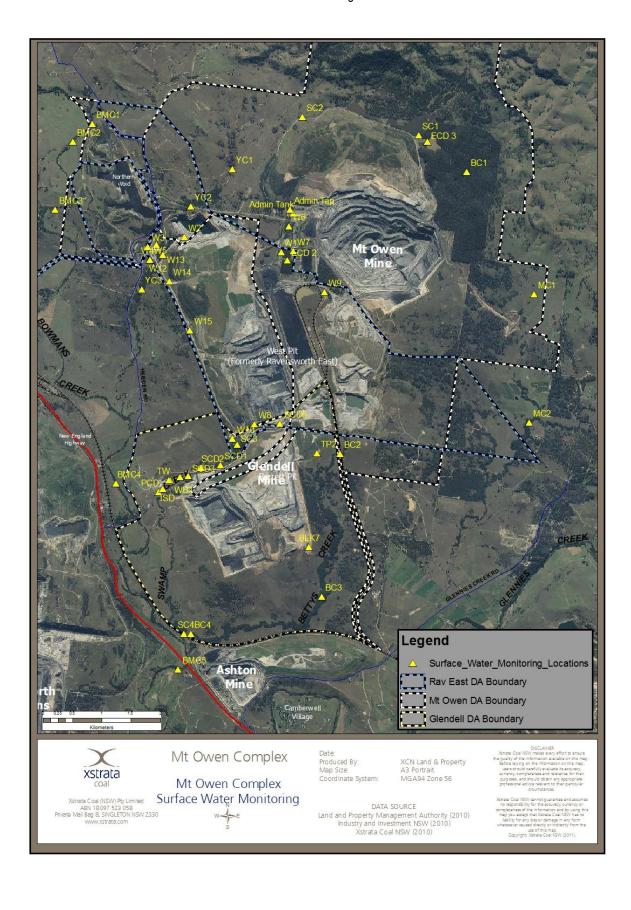
Figure 7
Surface Water Monitoring Locations

In accordance with planning approval conditions Mt Owen Complex undertakes surface water monitoring of Bettys Creek, Swamp Creek, Bowmans Creek, Yorks Creek and Main Creek. Surface water monitoring locations are shown on Figure 7.
