ILLAWARRA
METALLURGICAL COAL

BULLI SEAM OPERATIONS

ANNUAL REVIEW FY19

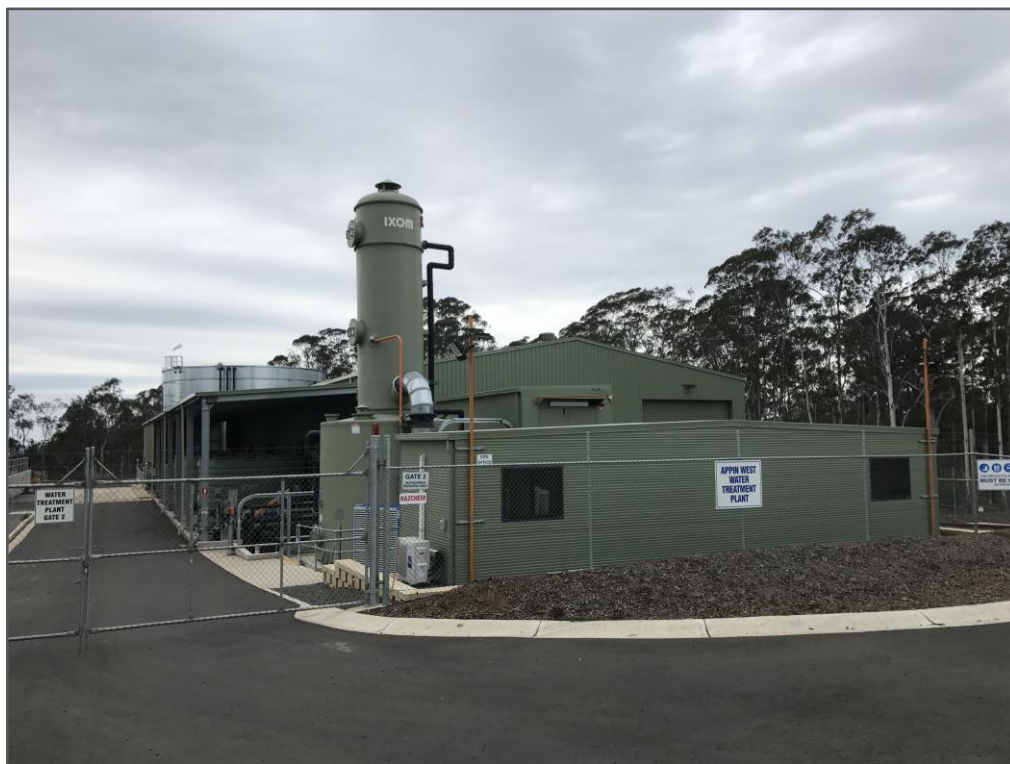
Figure 1: Water Filtration Plant Expansion (IMS2a) - Main processing facility.

Integration of the new systems with the old systems have resulted in stable peak operations of the system with expected positive outputs, however consistency in operational throughput has been variable, in part due to mine water supply for processing and the necessity to undertake some modifications for defect rectification and/or plant operational improvement.

Works have progressed to install online monitoring of discharge quality and volume to the environment. Further technical studies and data collection has been undertaken as part of an impact assessment for the anticipated changes to the Environment Protection Licence (EPL) 2504 conditions.

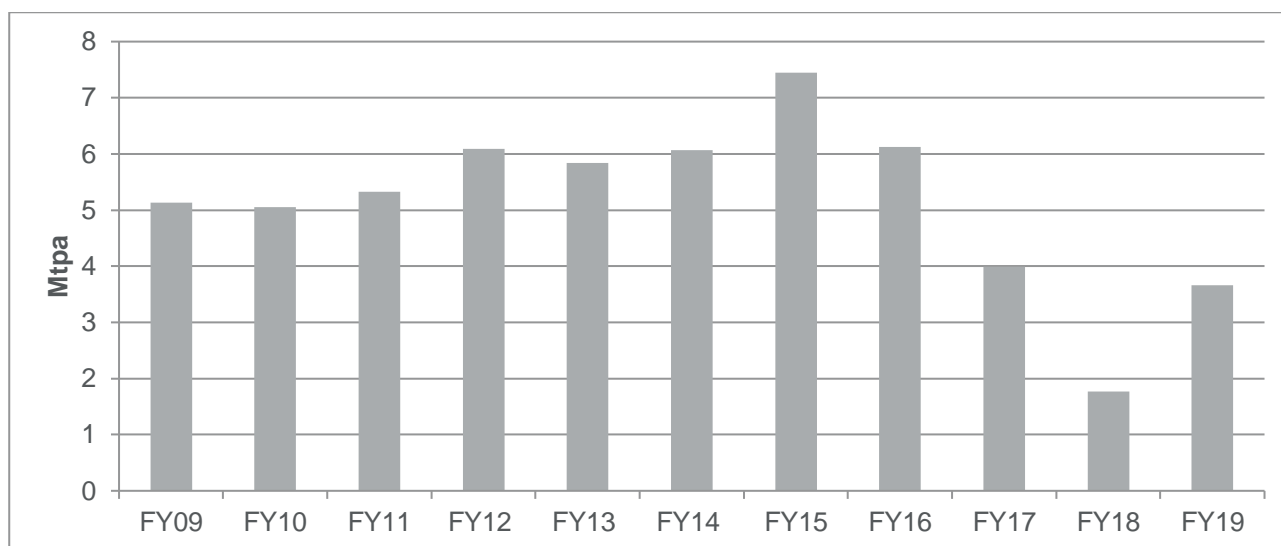
Figure 2: ROM production – BSO (in million tonnes per annum [Mtpa])

Appin extracted 3.66 million tonnes of Run of Mine (ROM) coal via roadway development and longwall extraction methods for the reporting period, a 106% increase from the FY18 reporting period. The ROM production levels from FY09 through to the current reporting period are provided in Figure 2.

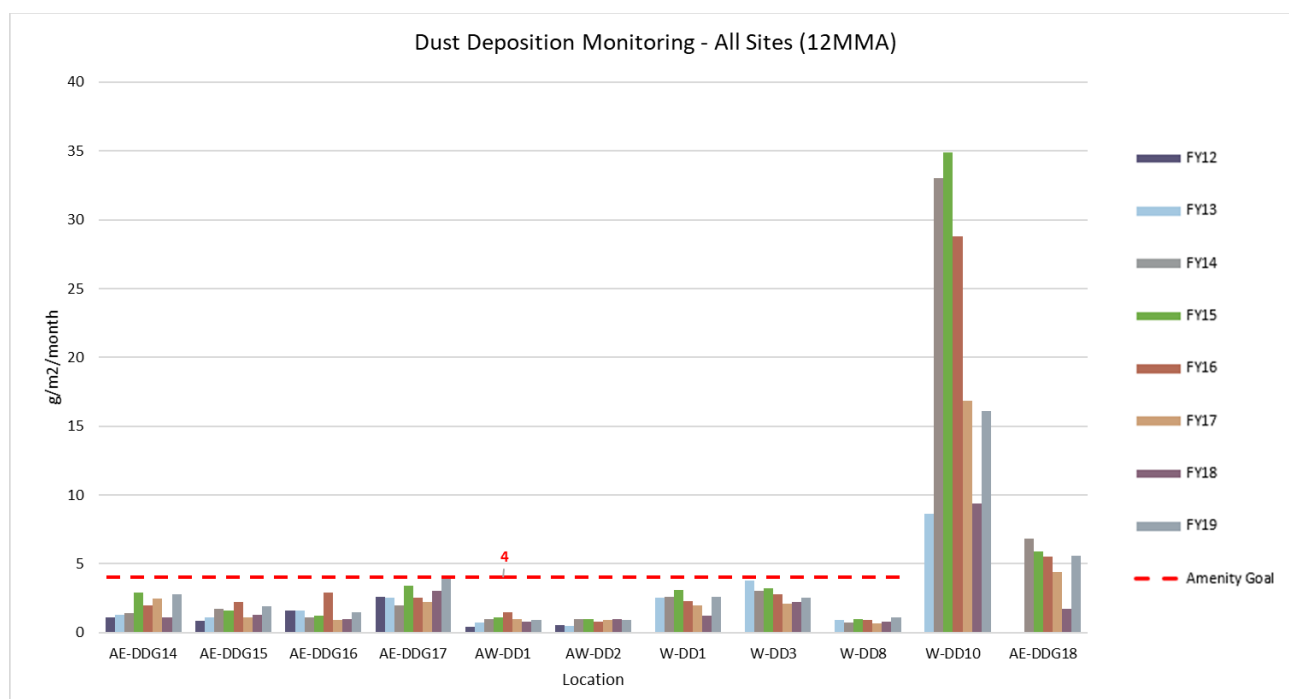
Figure 3: Comparison annual averages from FY12 to FY19 for insoluble solids.

The Appin West, Appin East and Appin North sites non-operational gauges were below the long-term criteria/amenity goal of 4 g/m²/month for deposited dust during the reporting period that applies to particulate emissions on any residence on privately owned land. This is evident at all sites located near the perimeter of the Appin West, Appin East and Appin North sites (i.e. AE-DDG14, 15, 16 and 17; AW-DD1 and DD2; and WC-DD1, DD3 and DD8). The long term trends are consistent across all sites.

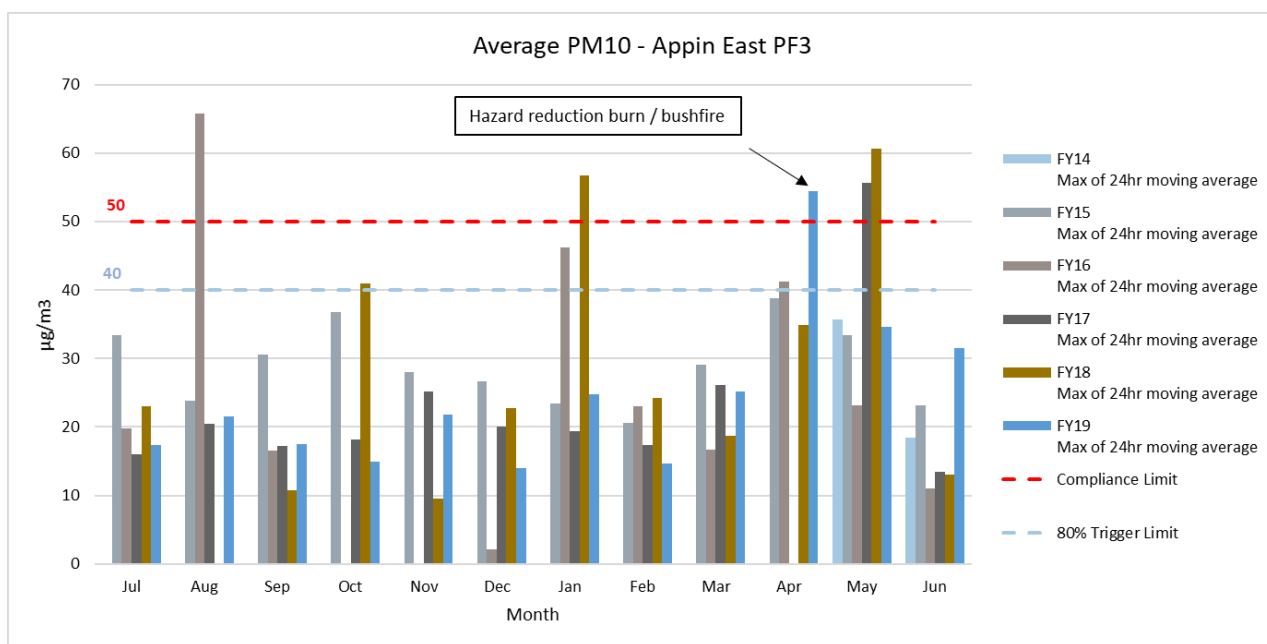
Figure 4: PM₁₀ average 24-hour levels and maximum 24-hour levels at Appin East.

As described in the BSO AQGHGMP, if the optical photometer at Appin East (AE-PF3) indicates average dust levels greater than 80% of the air quality criteria in Condition 9 of Schedule 4 of the Project Approval, additional monitoring will be undertaken using the HVAS (AE-HV1) to assess compliance. The apparent maximum average PM₁₀ dust levels were measured above the 80% criteria once during the reporting period. This exceedance was attributed to regional bush fires and hazard reduction burn events, along with severe dust events, rather than dust emissions generated by BSO activities.

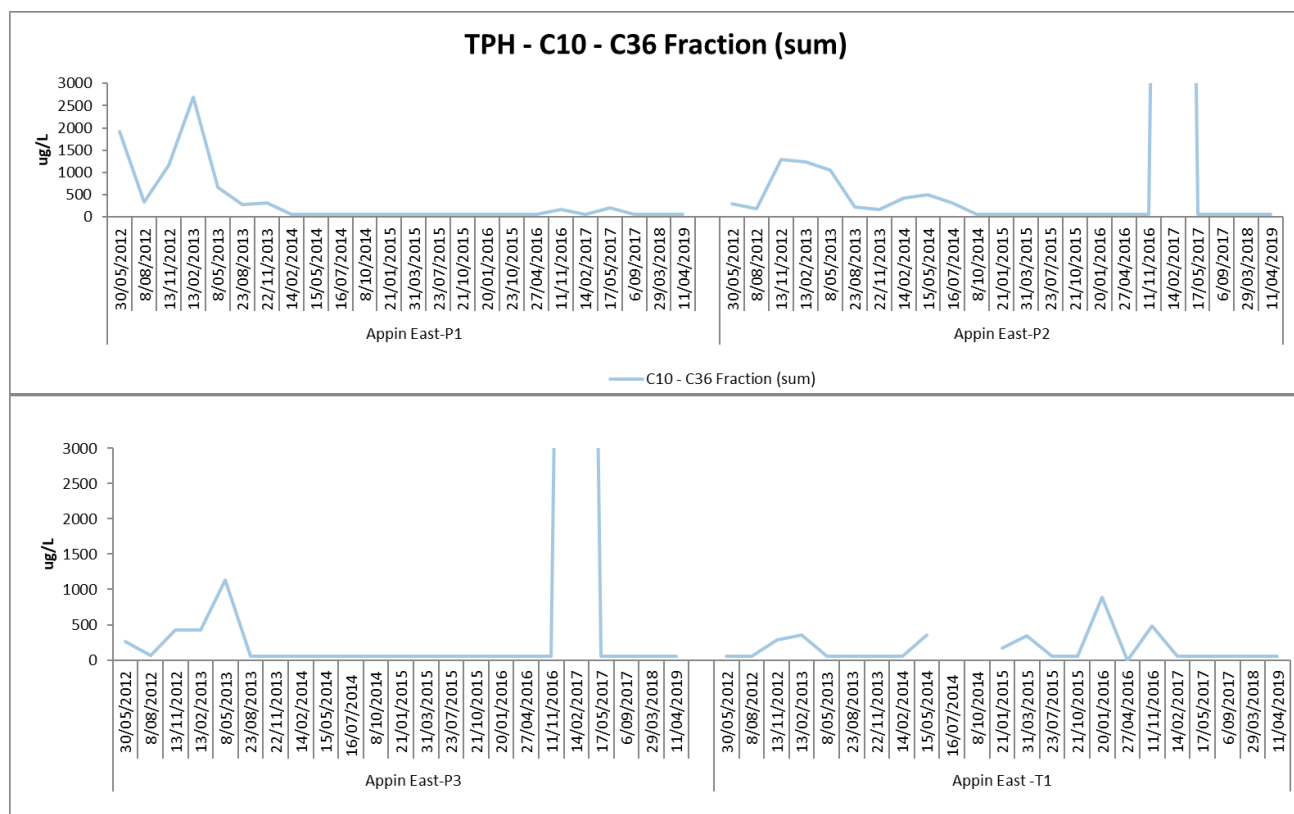
Figure 6: Total Petroleum Hydrocarbons (C10 – C36 Fraction (Sum)) since monitoring began in 2012 at Appin East

During the FY19 reporting period, the results from all boreholes were below the observable limit for TPH (50 µg/L). Samples taken at three of the boreholes in the previous reporting period show elevated levels of TPH, however this is attributed to potential contamination during the sampling process as samples taken since show TPH below the observable limit. The most recent samples taken at T1 showed TPH levels below the Limit of Reporting, indicating that there was no potential contamination from the old Appin Tip.

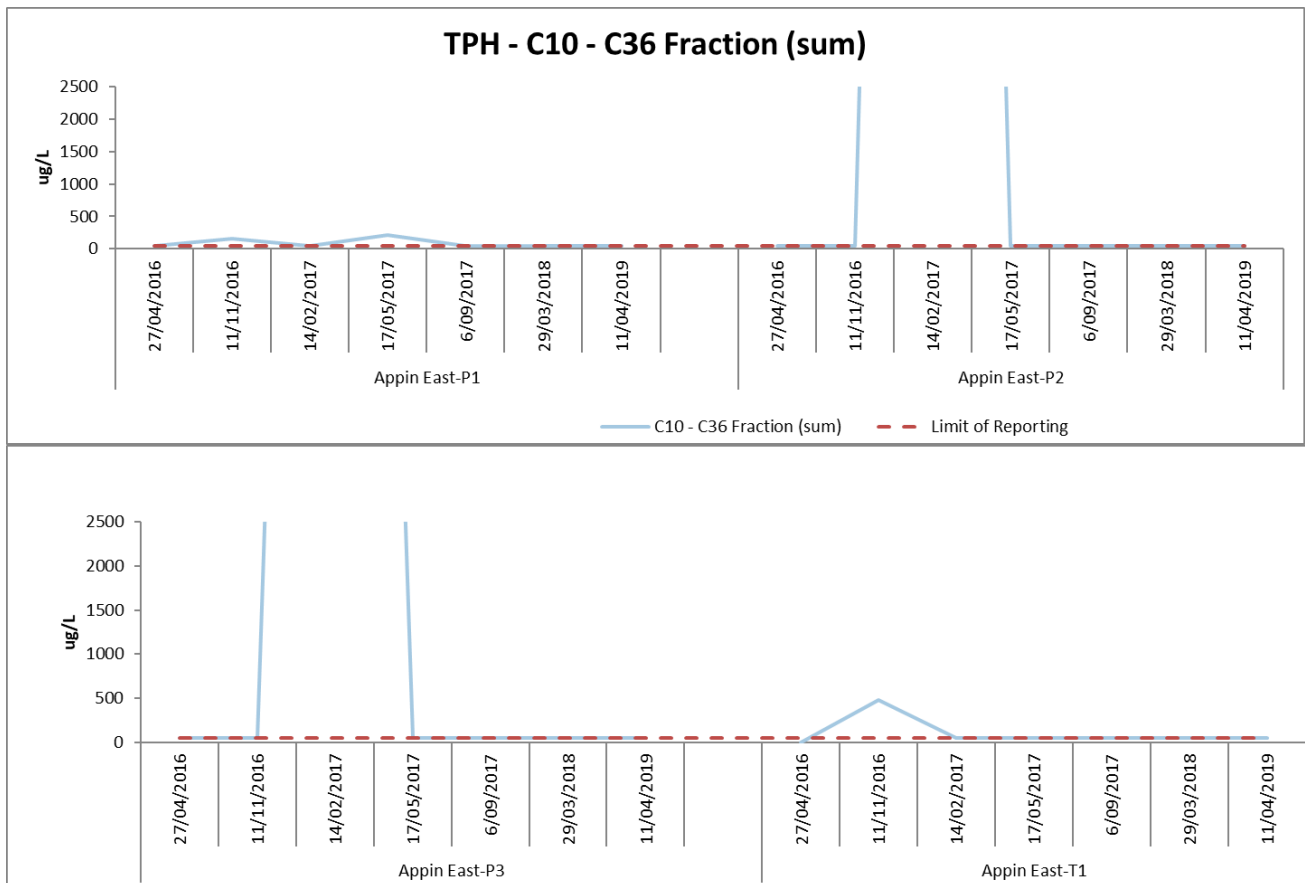
Figure 7: Short-Term Total Petroleum Hydrocarbons (C10 – C36 Fraction (Sum)) at Appin East

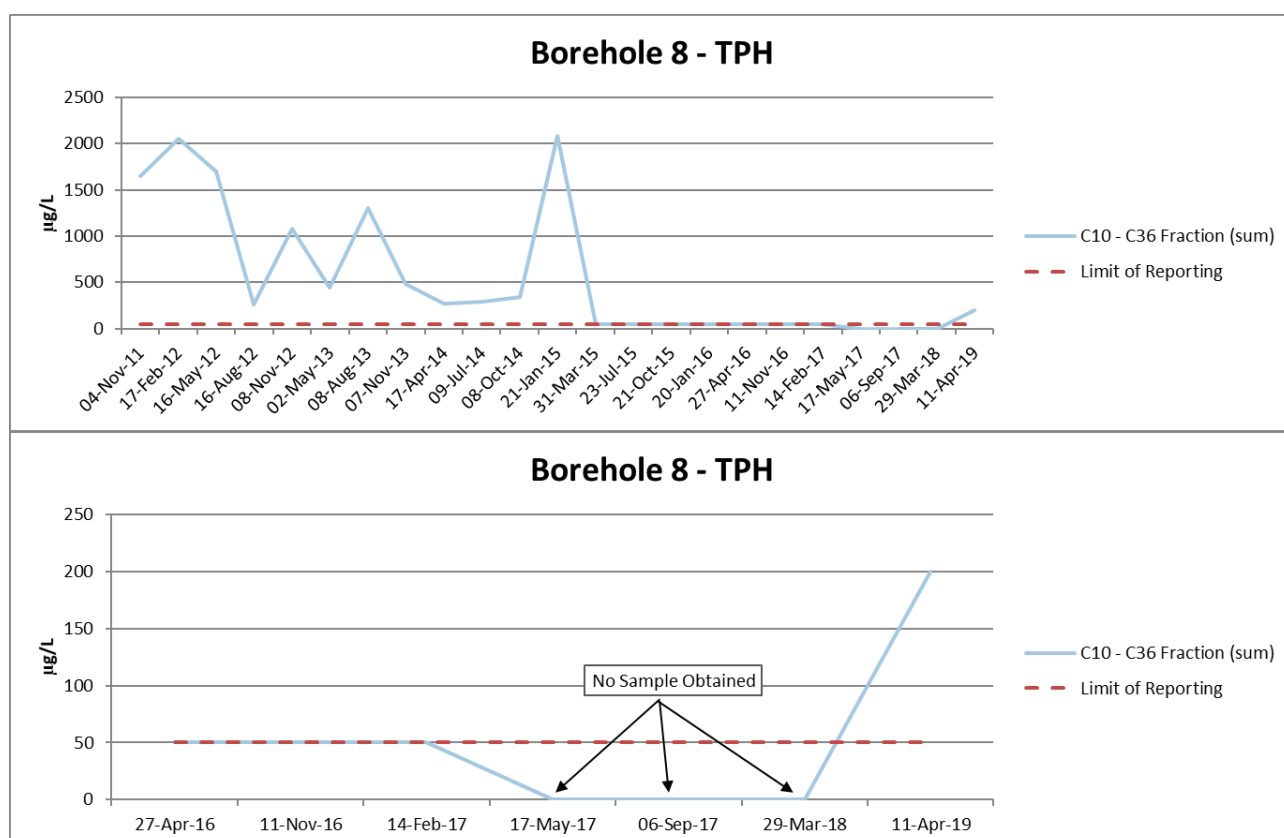
Figure 8: Long & Short-Term Total Petroleum Hydrocarbons (C10 – C36 Fraction (Sum) µg/L) in BH8 at Appin North.

BH8 was unintentionally buried by coal wash material in FY18, meaning the hole was unable to be sampled. During the reporting period, the borehole was recovered and resampled in April 2019. The results indicate a C-fraction concentration of 200 µg/L. Further analysis will take place in October 2019.

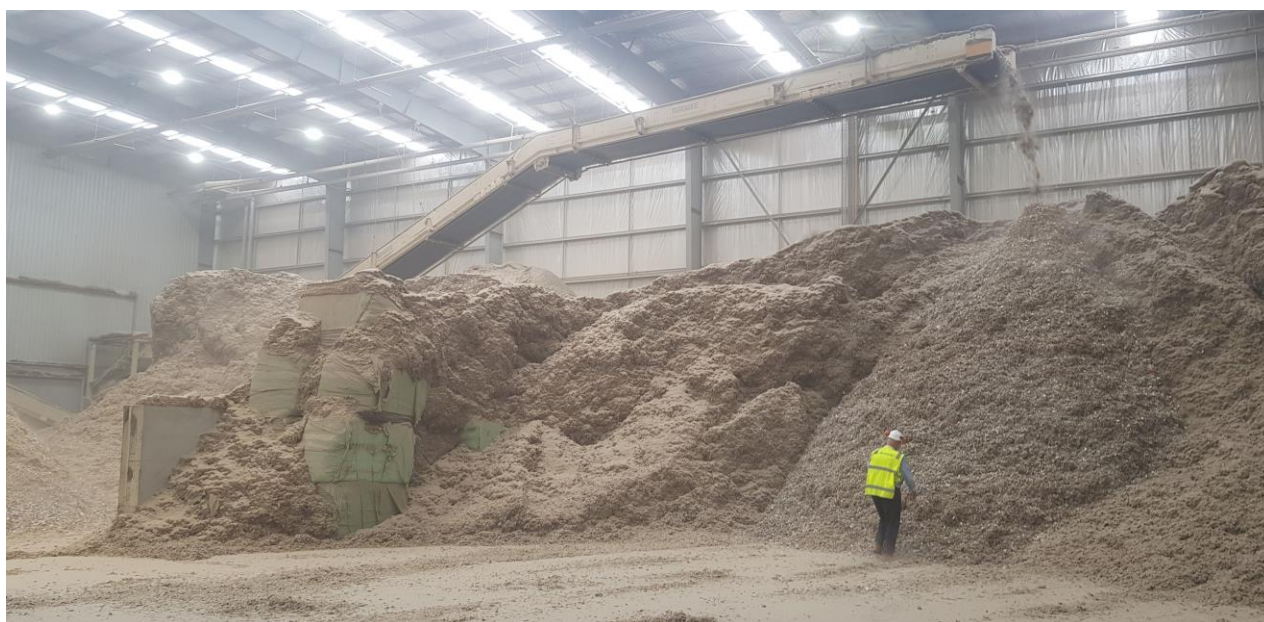
Figure 9: Processed Engineered Fuel (PEF) Stockpile at the ResourceCo facility

Based on FY19 waste figures from BSO, 75 tonnes of timber and 22 tonnes of cardboard waste were generated on site. Redirecting this waste to the recycling facility is an alternative end-of-life treatment and final disposal of products opportunity. A portion of the 1023 tonnes of general sorted waste may also be sent to the recovery facility in future.

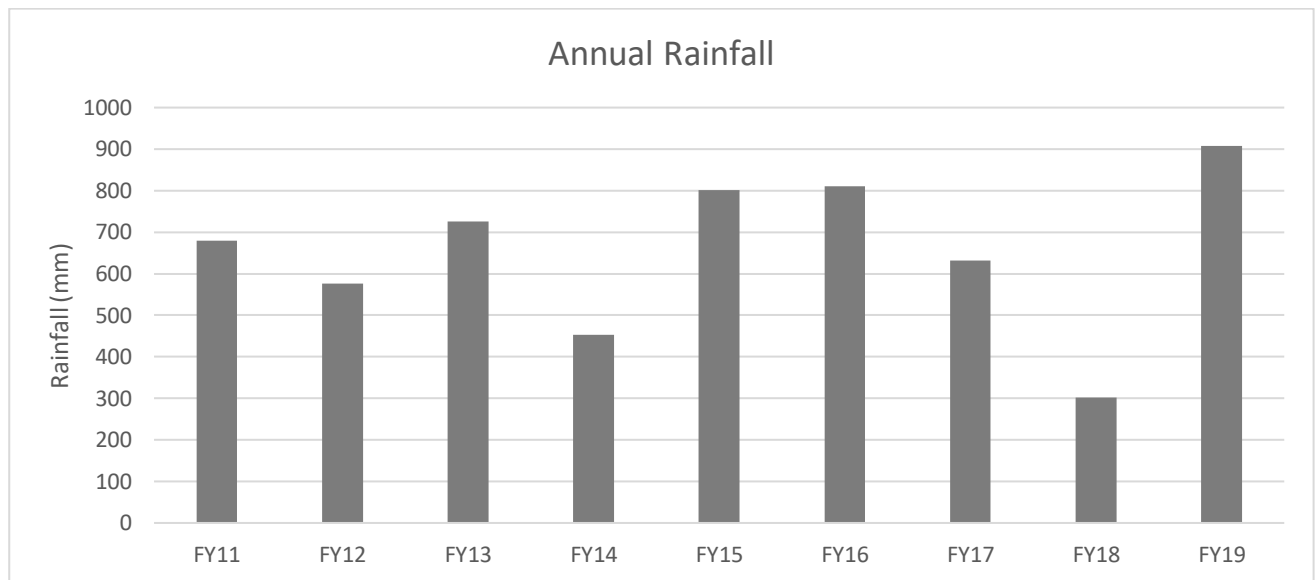
Figure 10: Annual rainfall – Menangle (BOM site #68216).

Figure 10 displays the annual rainfall for the region since FY11 at Menangle (Menangle Bridge), NSW.

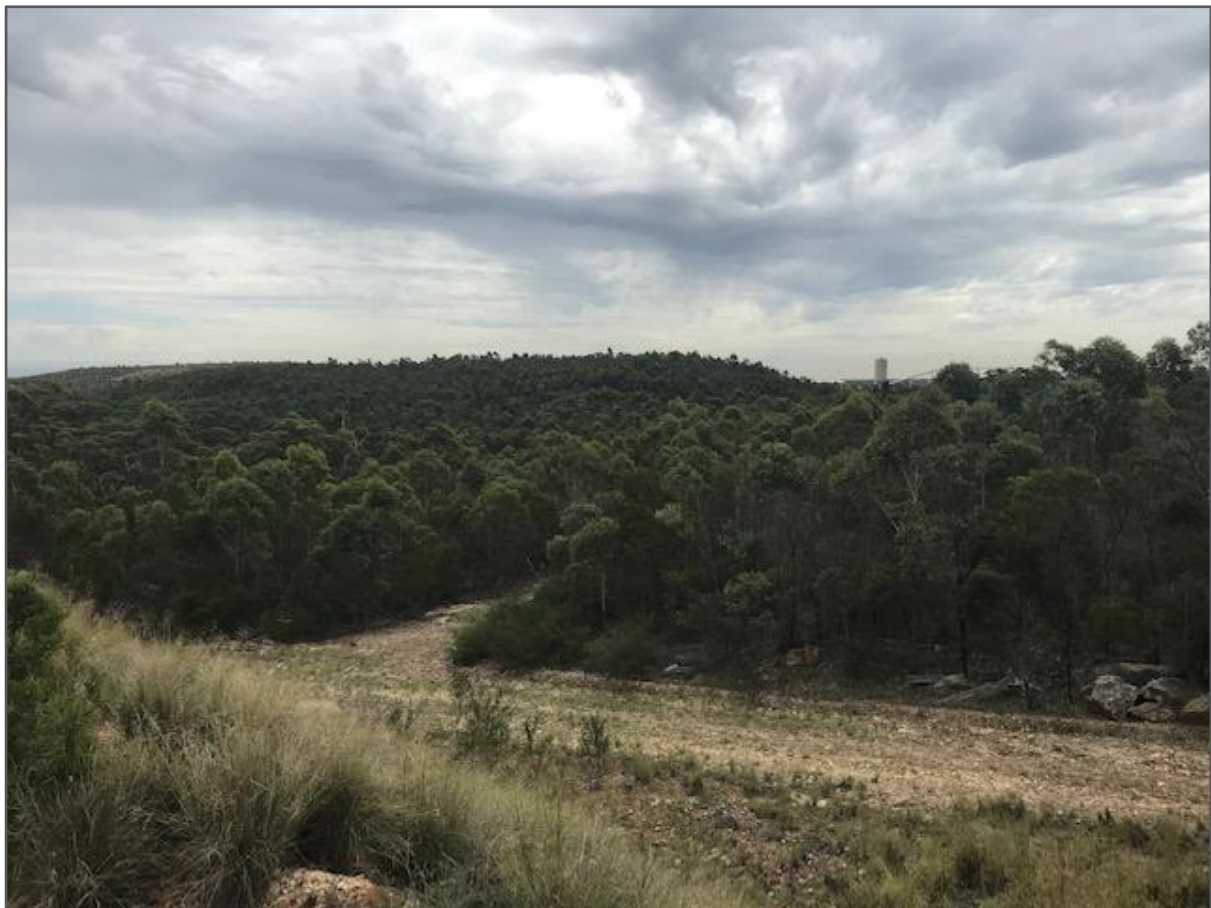
Figure 11: Stage 2 emplacement rehabilitation (Seeded in 2007).

Figure 11 shows the performance of rehabilitation on Stage 2 of the emplacement.

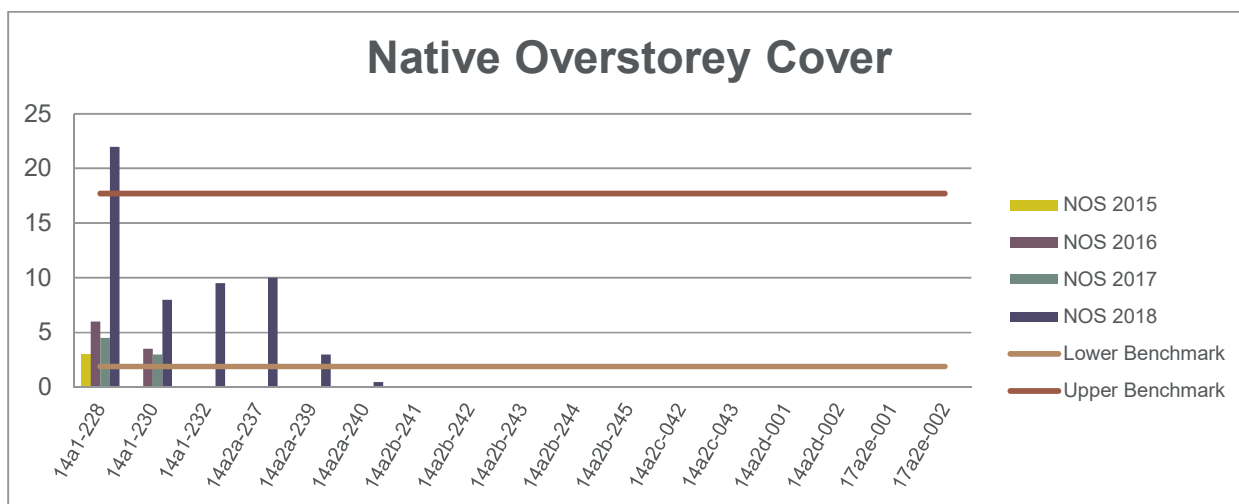
Figure 2 Native overstorey cover collected at the monitoring plots for rehabilitation areas 1, 2a, 2b, 2c, 2d and 2e for 2018

Local benchmark for Native Overstorey Cover is 1.9 – 17.7 percent foliage cover.

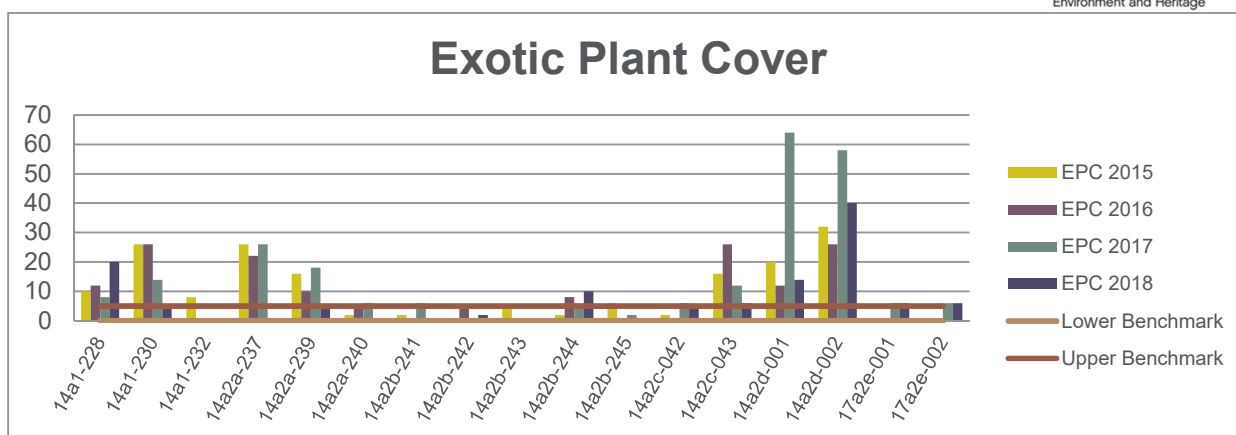
Figure 7: Exotic Plant Cover at the monitoring plots for rehabilitation areas 1, 2a, 2b, 2c, 2d and 2e for 2018

There is no local benchmark for exotic plant cover. Whilst it is assumed that there would be 0 – 5% exotic plant cover within the control plots, a target of <20% has been chosen for all rehabilitation areas.

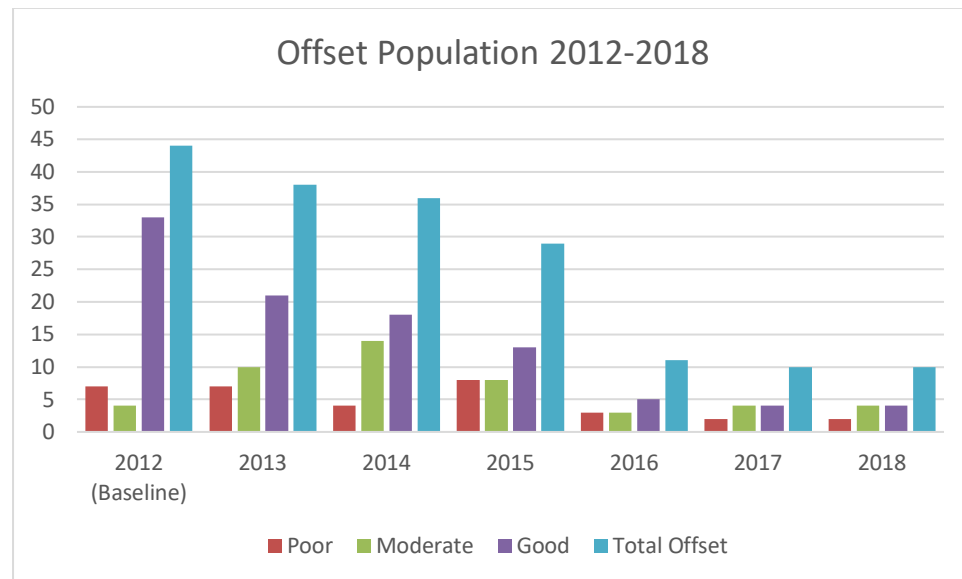
Figure 1: Comparison of *Persoonia hirsuta* condition and population within the Offset across years.

- 28 plants have died likely due to age related causes (since the baseline in 2012);
- 16 plants were burned as part of the approved conservation burn trial in April 2016; and
- No new plants were identified in the Offset during 2018.

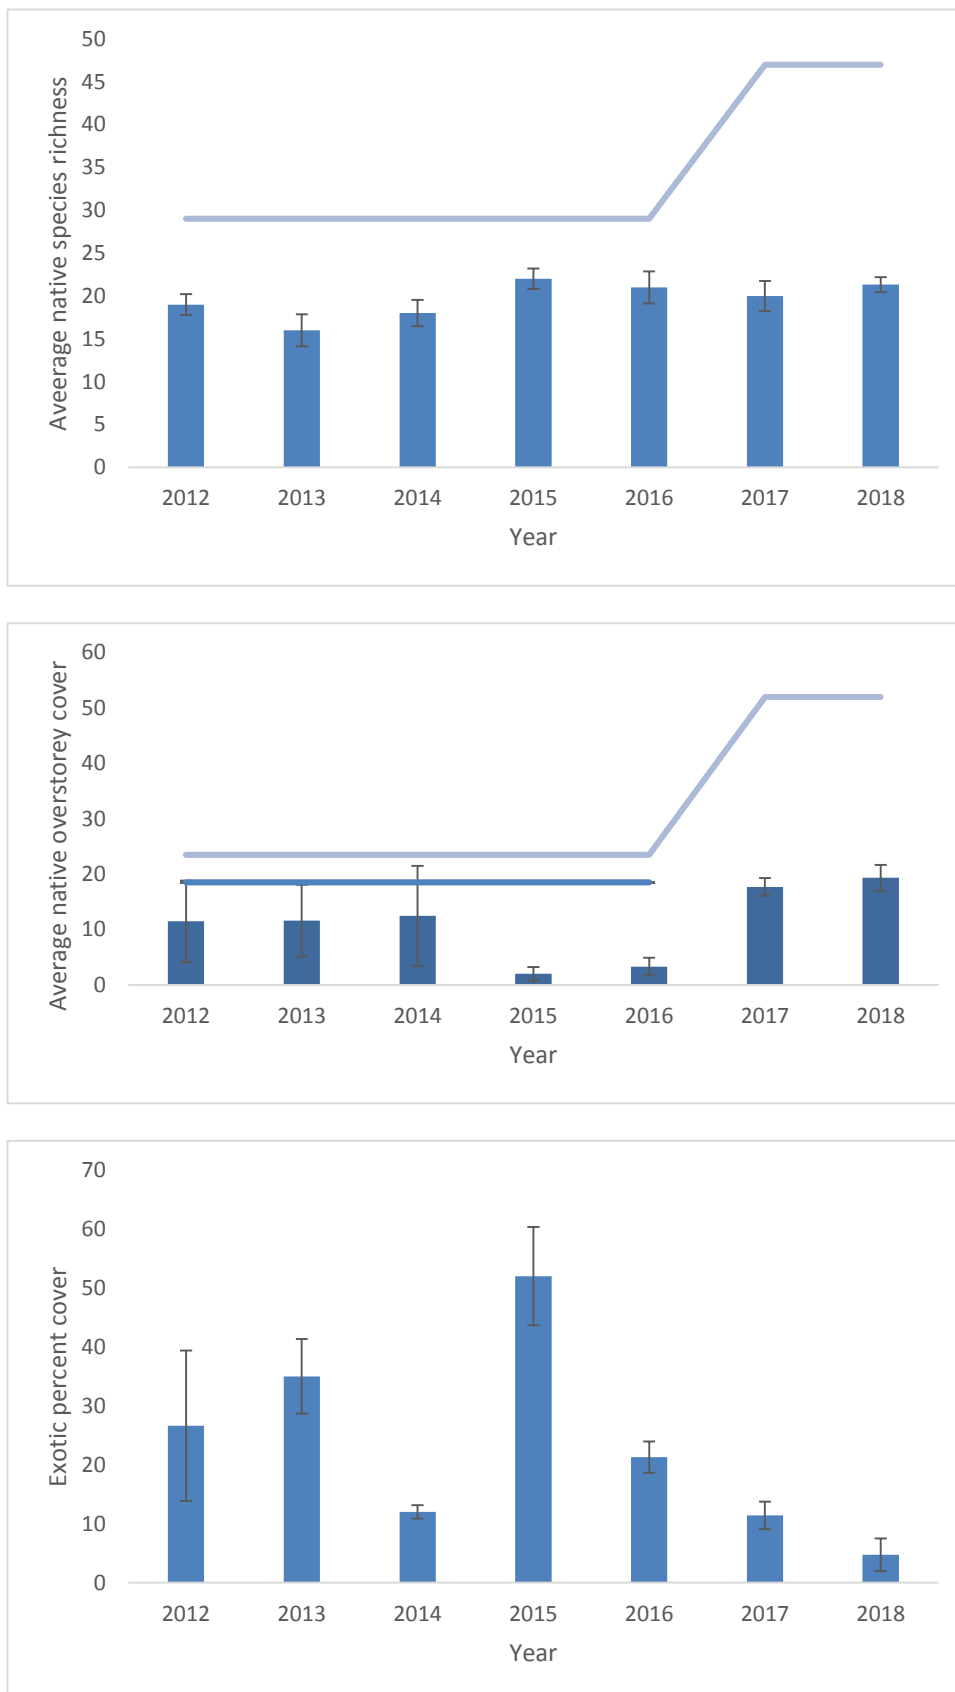
Figure 3: Comparison of key attributes for woodland plots in MZ5 (HN529/PCT850) (Note only High Threat Weeds (HTW) measured in 2017 and 2018, as per BAM methodology)

Mean (±SE) 2012-2018 quadrat data ($n = 3$). Benchmark values/ranges shown as line graphs.

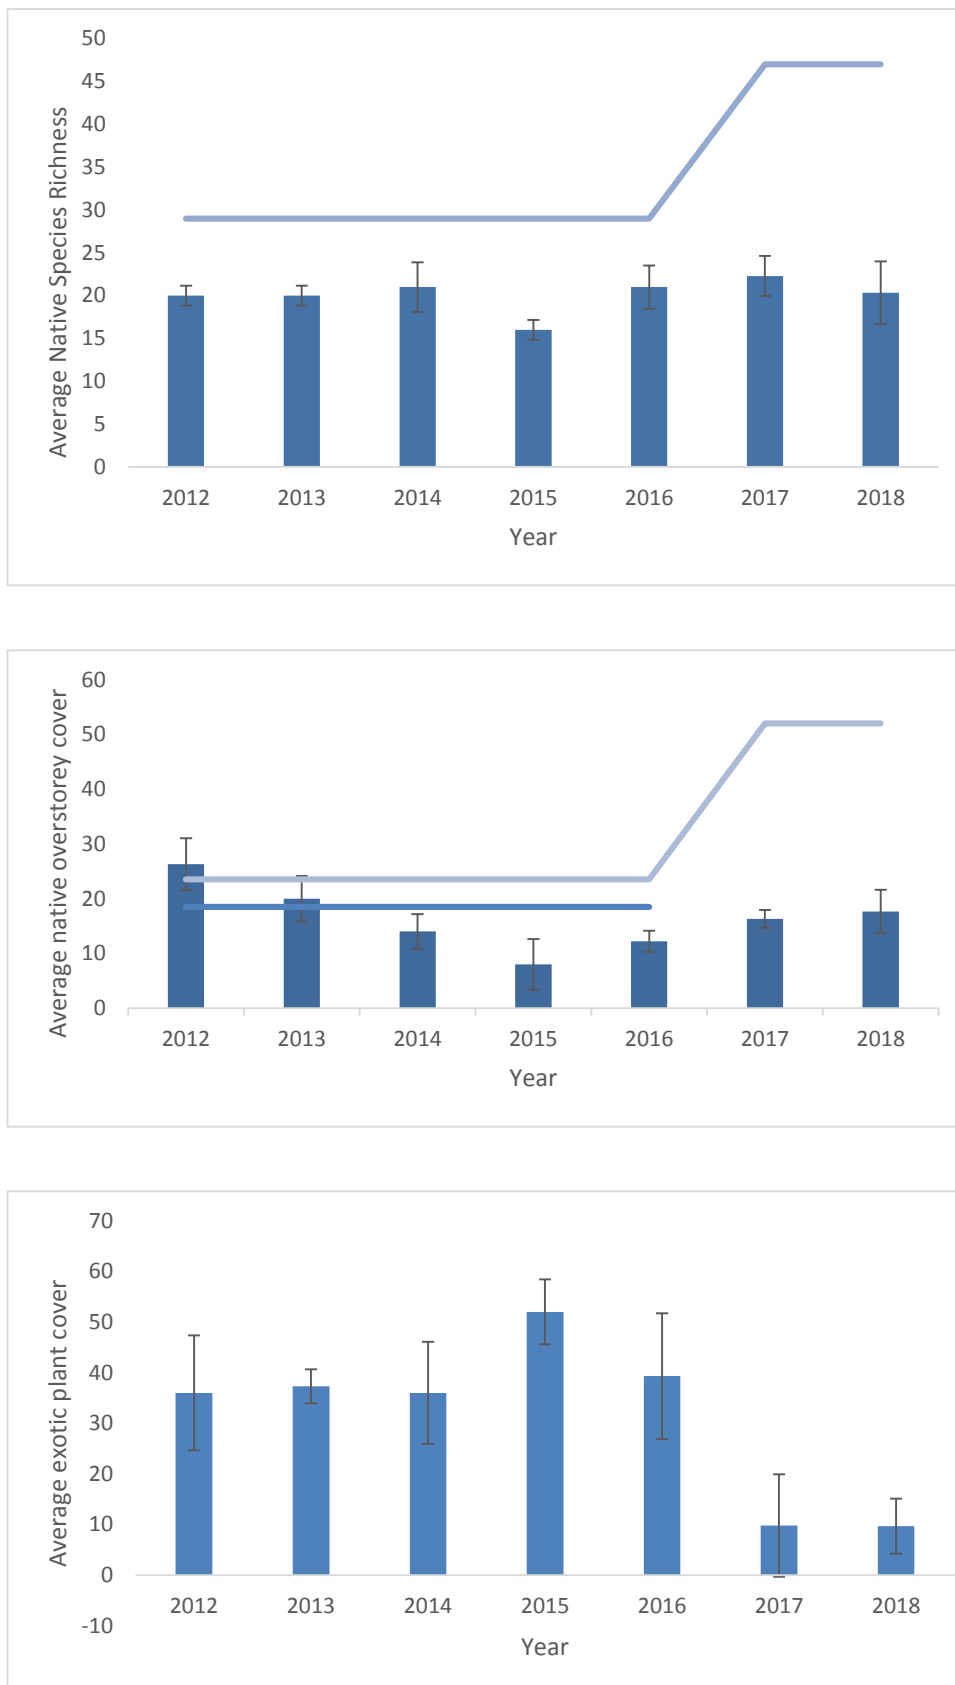
Figure 4: Comparison of key attributes for woodland plots in MZ6 (HN529/PCT850)

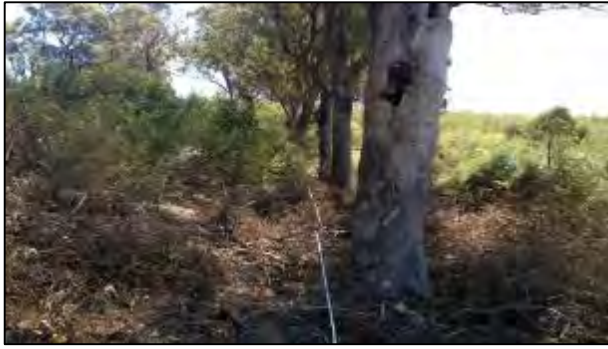
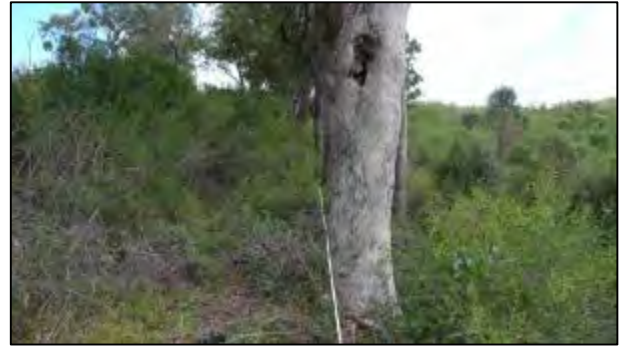
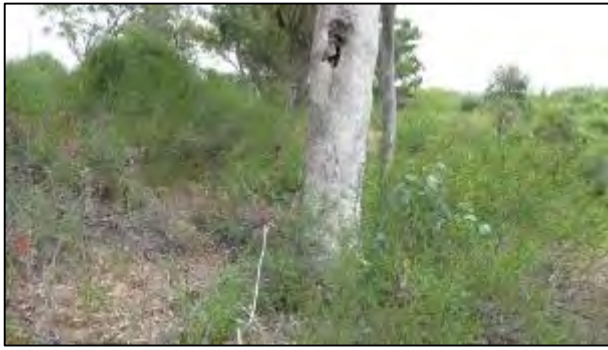
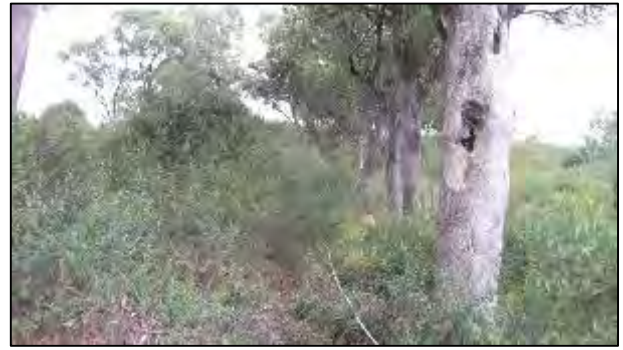
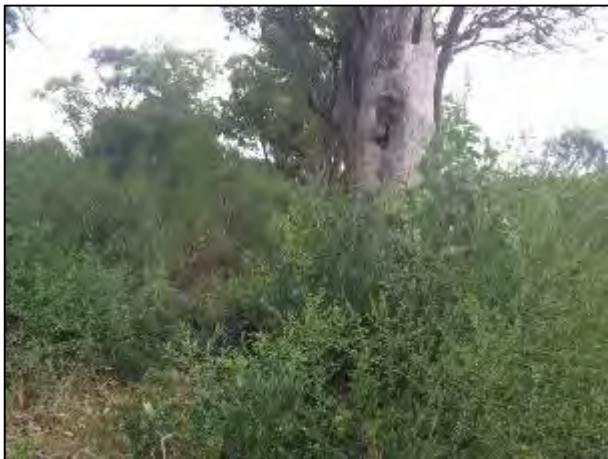
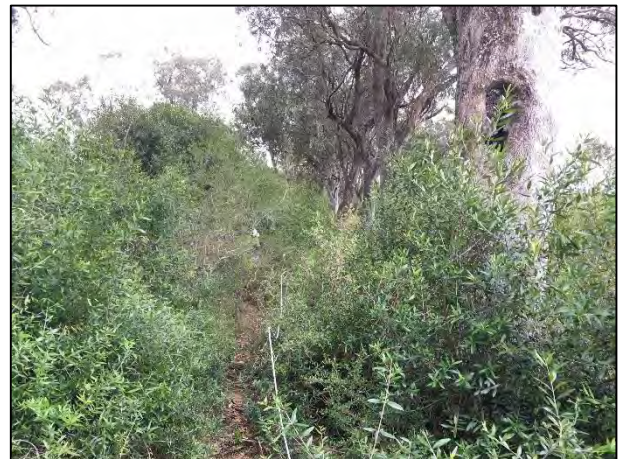
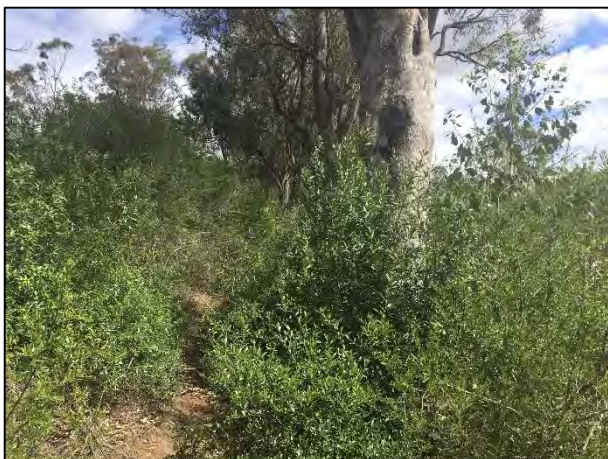
MZ6_007 during 2012, 2013, 2014, 2015, 2016, 2017 and 2018. Note the ground cover since 2012. Woody weed control required in 2019.

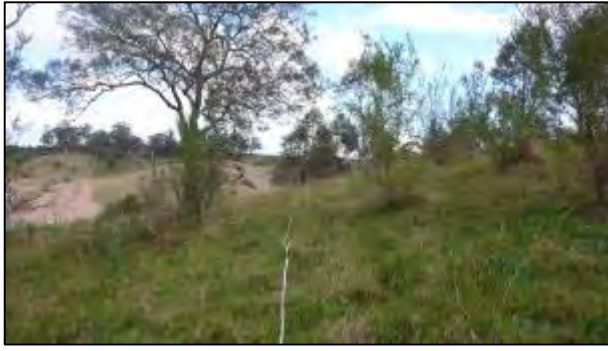
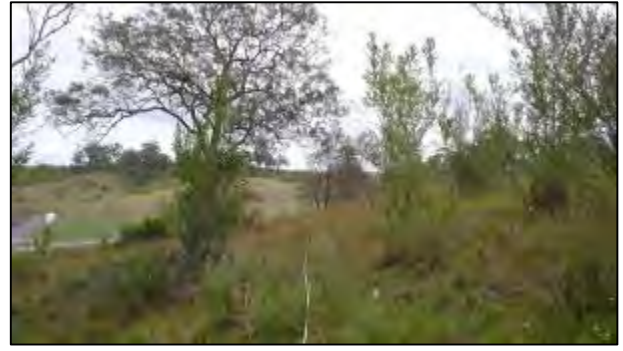
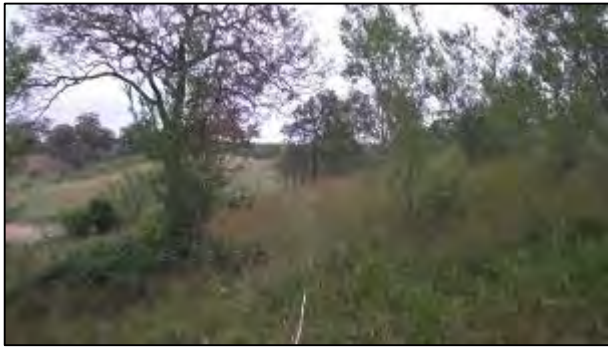
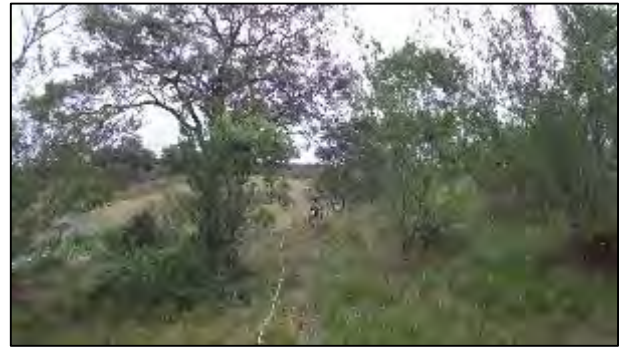
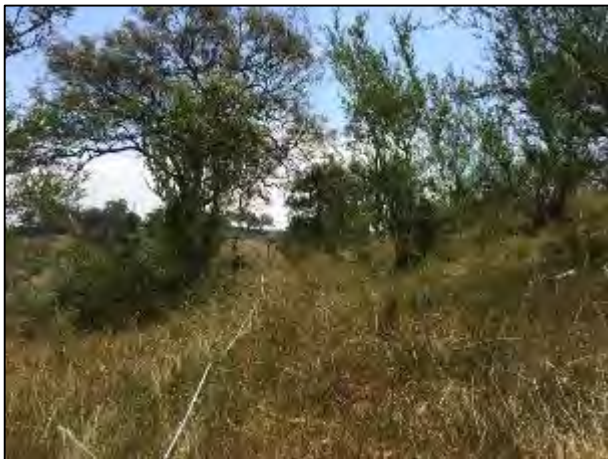
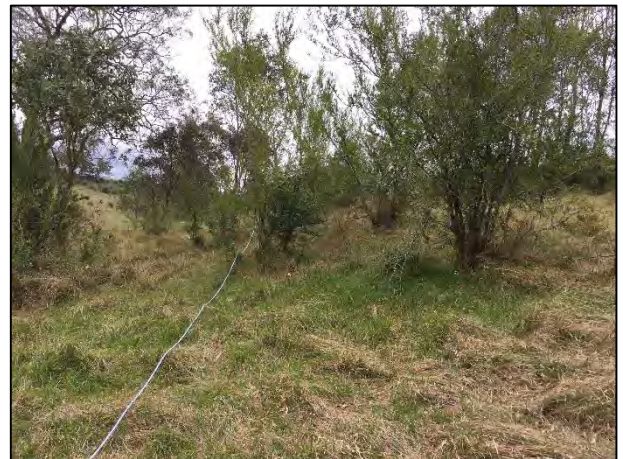
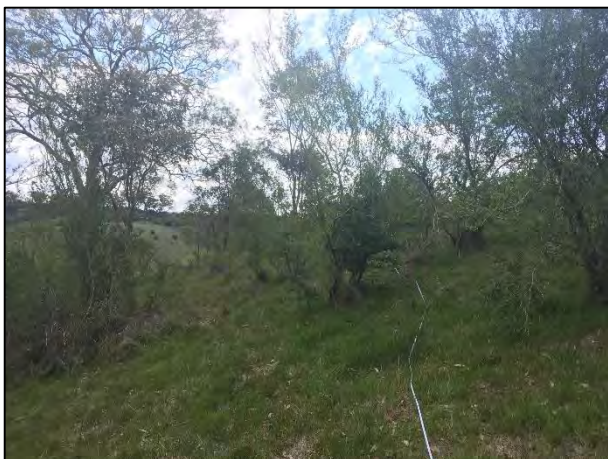
Regenerating woodland from MZ5_002 during 2012, 2013, 2014, 2015, 2016, 2017 and 2018. Note the increase in the regeneration of *Bursaria spinosa* within the woodland understory.

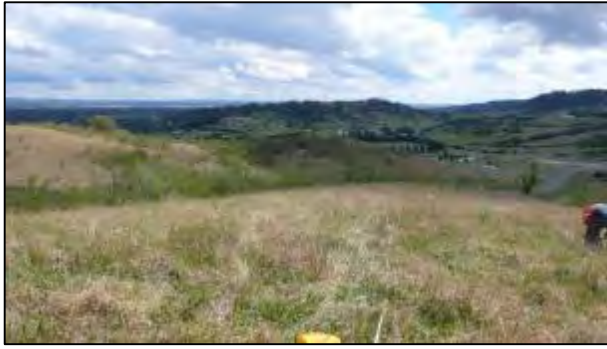
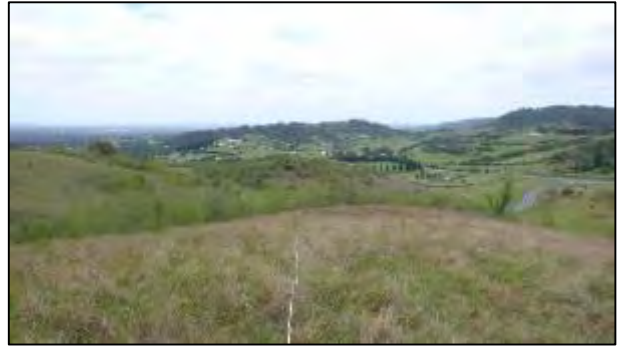
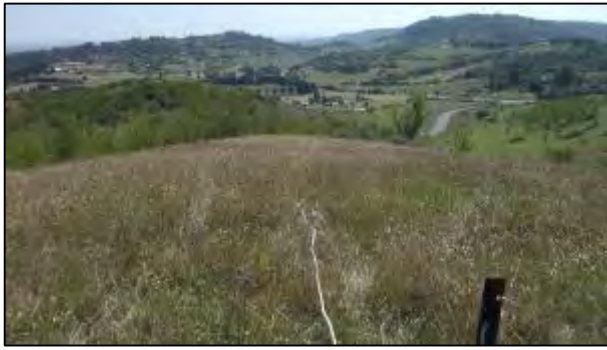
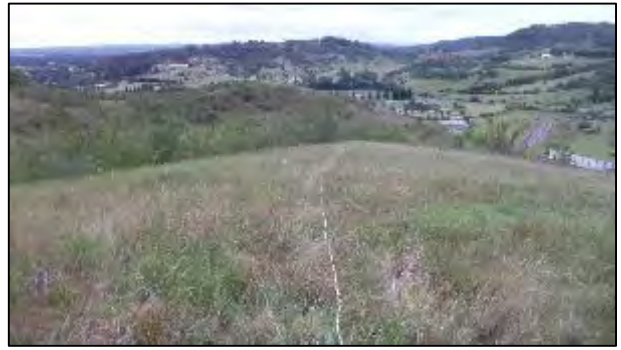
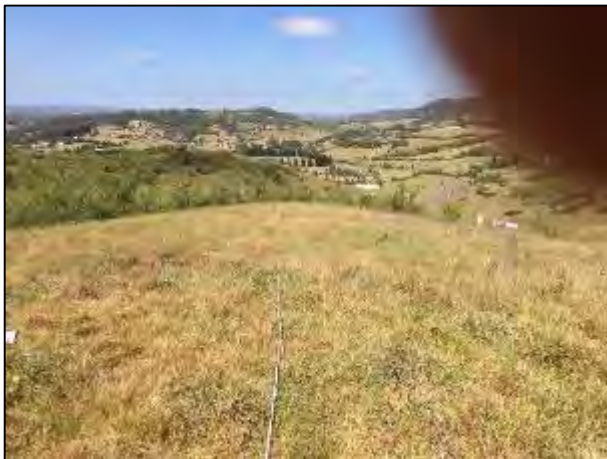
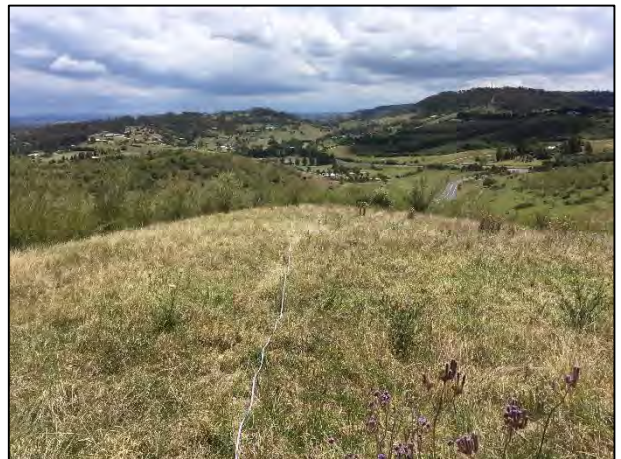
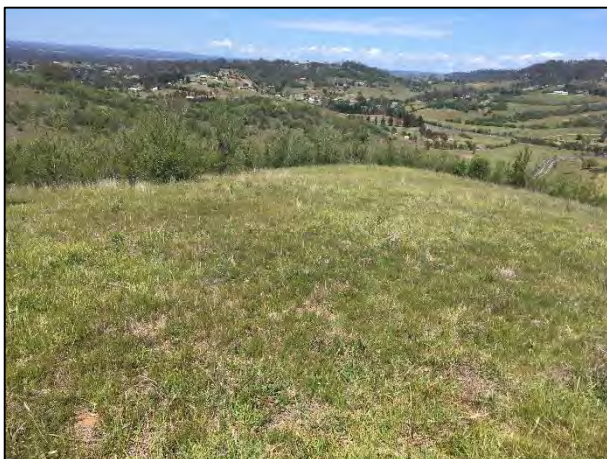
Derived grassland from M5_005 during 2012, 2013, 2014, 2015, 2016, 2017 and 2018.
