2020 Annual Review

**BULGA
COAL**

GLENCORE

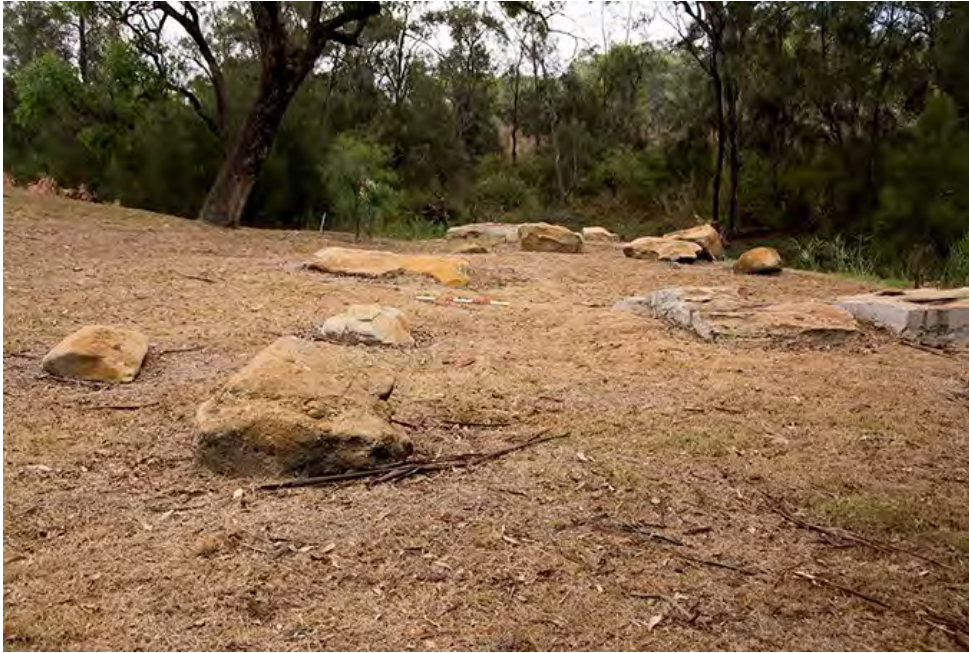
Photo 1 LCGG Photographic Monitoring – 2017 view from Photo Point 3

There has been no discernible weathering of the areas surrounding the grooves since the relocation occurred. In 2019 some exfoliation of small portions of the rock from the edge of the slab was noticed. These portions did not appear to have worsened in 2020.

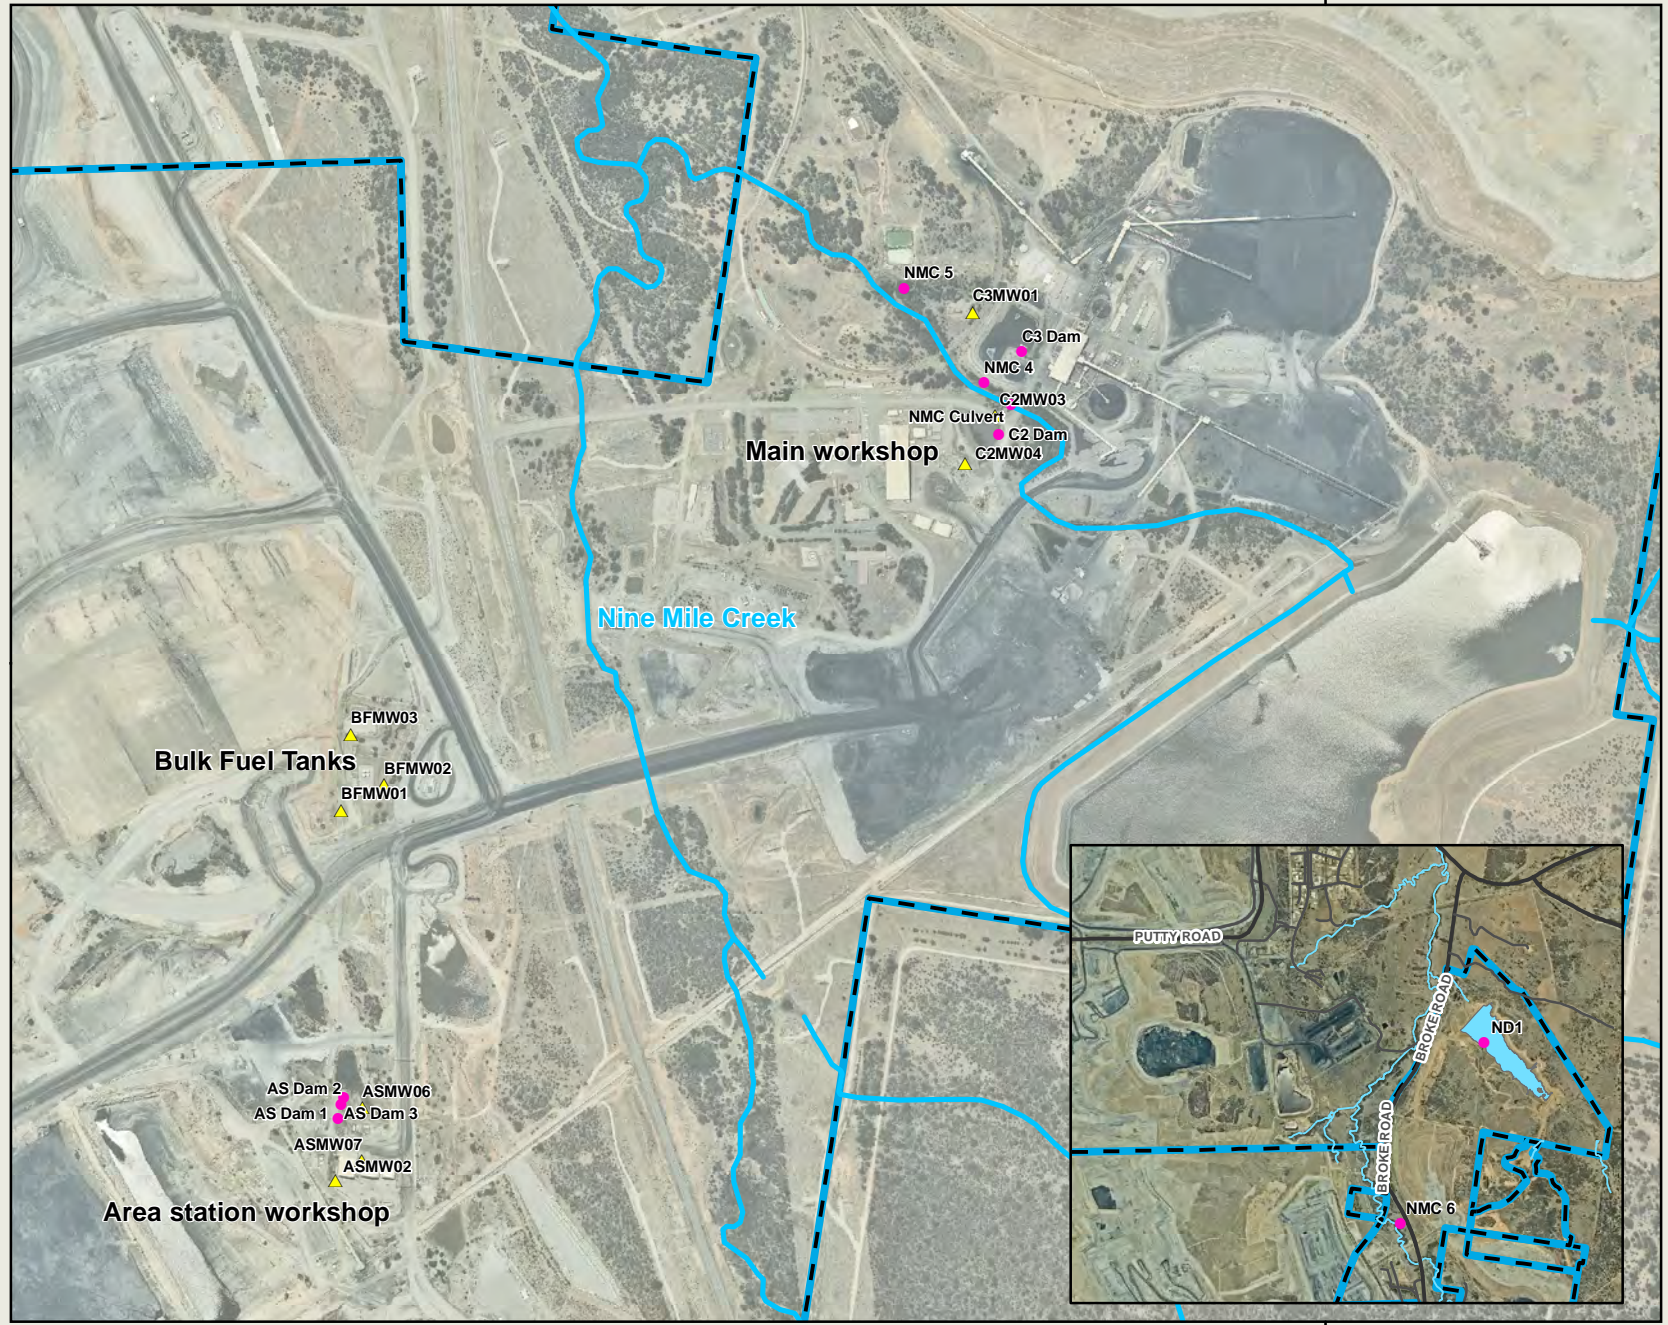
Surface water and groundwater monitoring was conducted at the locations listed in **Table 29** and shown on **Figure 13**. Results were assessed against the Hydrocarbon Trigger Action Response Plan (TARP) triggers in **Table 30**.

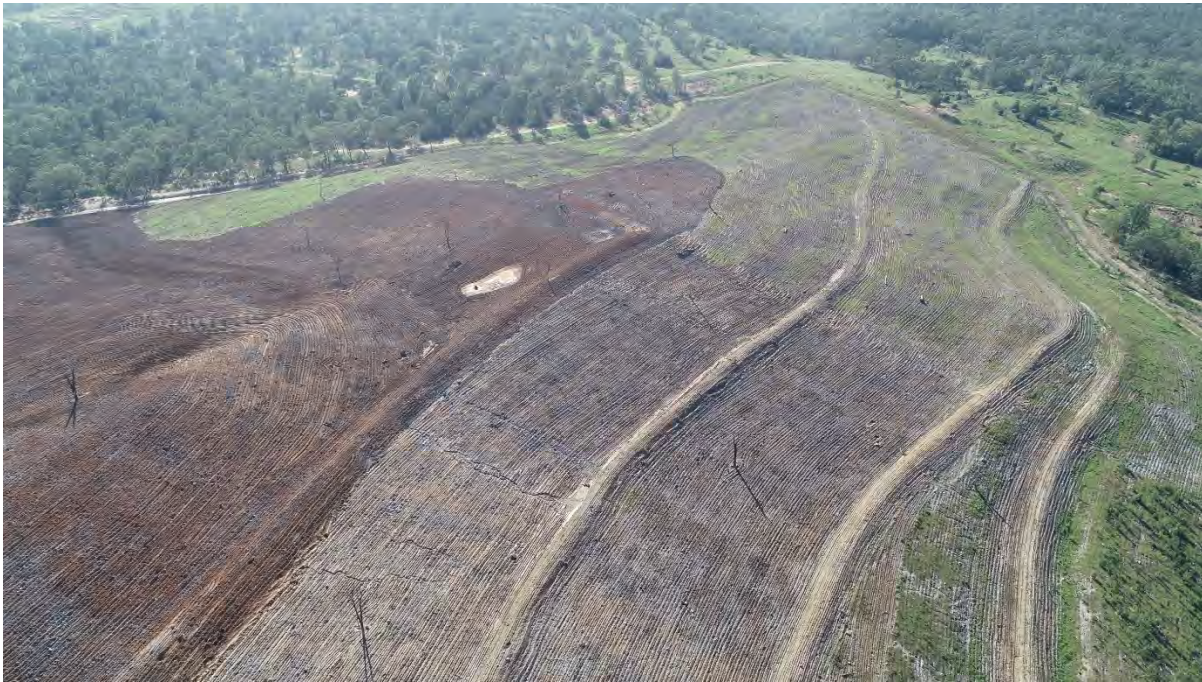
During 2019, a Geofluv natural landform design was developed for the Eastern Emplacement Area southern dump. This design was implemented over a 65 hectare area of rehabilitation in 2020, the remaining 25 hectares was shaped in 2019 and included a detailed design for contour drains and a drop structure, shown in **Photo 5**.

Photo 5 Example of traditional rehabilitation practices with contour banks (shaped in 2019 - right) next to natural landform design (shaped in 2020 - left).

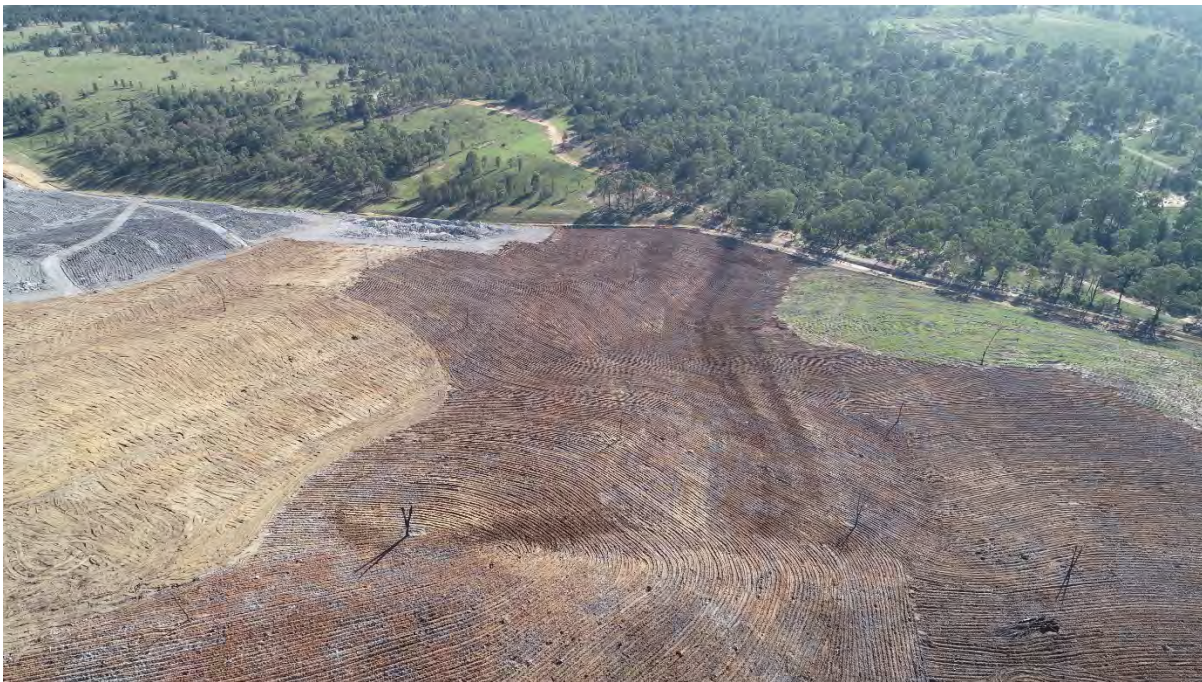
The natural land design follows fluvial geomorphic principles that outlines how landforms develop and function naturally through the power of water flow. The design considers the natural terrain features of the surrounding area and incorporates micro-relief, shown in **Photo 6**.

Photo 6 Built natural landform design surface, Eastern Placement Area Southern Dump

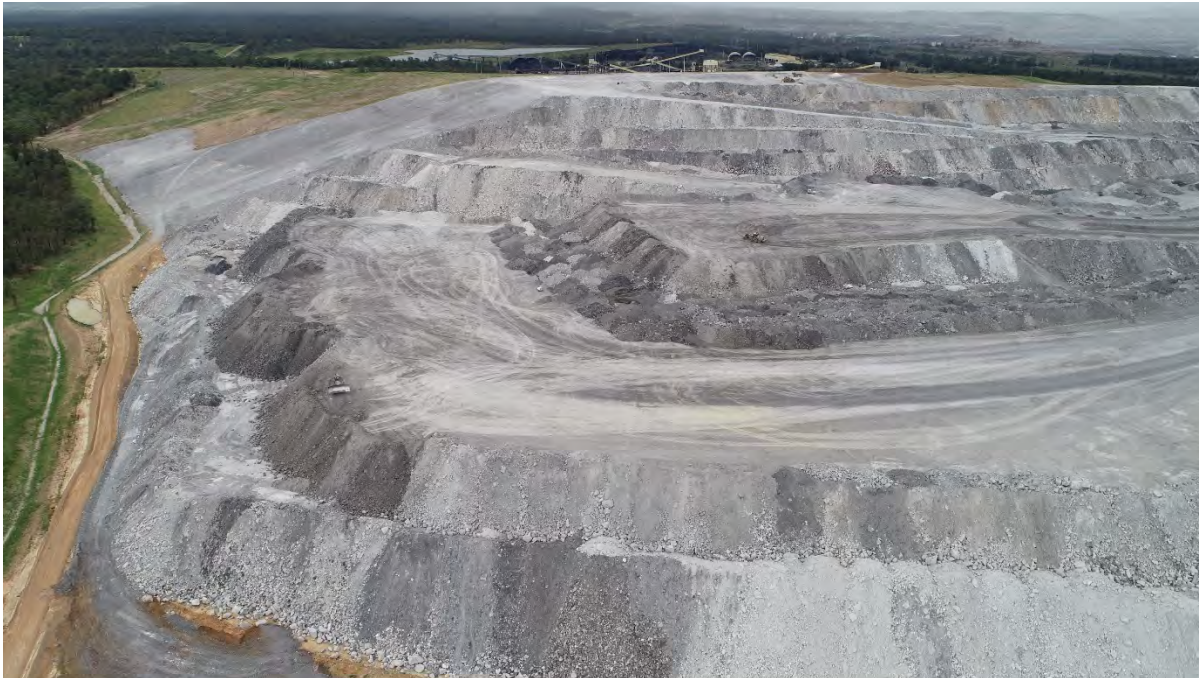
The design is incorporated into the mine planning process to develop dump designs to assist in shaping of the landform. The ridges and drainage lines are dumped in a way to reduce the volume of material required to be pushed to build the final landform, as shown in **Photo 7**.

Photo 7 Dump design surface, showing the shape of ridges and drainage lines dumped out for each bench.
