Australian Strategic Materials (Holdings) Ltd

**Annual Review
&
Annual Rehabilitation Report**

1 July 2019 – 30 June 2020

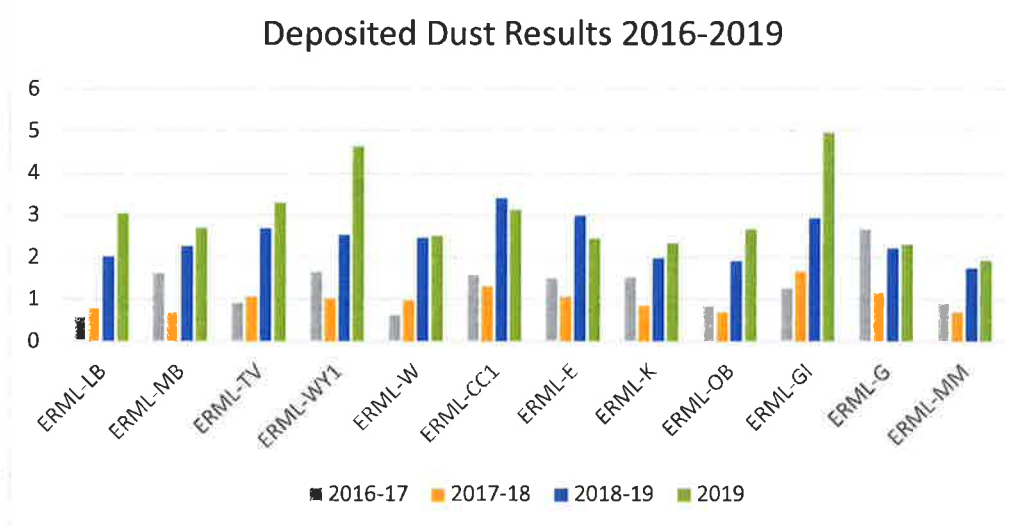
Figure 5: Deposited dust results for 2016-2019

Site ID	Site Name	Annual Dust Deposition Rates (g/m ² .month)			
		2016-2017	2017-2018	2018-2019	2019-2020
		2/6/16 - 2/6/17	4/7/17 - 2/7/18	2/7/18 - 2/7/19	2/7/19 - 3/1/20
ERML-LB	Lifestyle Blocks	0.572	0.815	2.027	3.053
ERML-MB	Malcolm Bye’s	1.613	0.719	2.270	2.713
ERML-TV	Toongi Valley	0.912	1.076	2.694	3.305
ERML-WY1	Wychitella Homestead	1.641	1.032	2.538	4.649
ERML-W	Wychitella	0.614	0.993	2.472	2.52
ERML-CC1	Cockleshell Corner Cottage	1.564	1.320	3.411	3.141
ERML-E	Eulandool	1.493	1.075	2.999	2.458
ERML-K	Karingle	1.514	0.862	1.99	2.347
ERML-OB	Ore Body	0.843	0.708	1.919	2.676
ERML-GI	Glen Idol	1.252	1.680	2.943	4.976
ERML-G	Grandale	2.667	1.178	2.223	2.32
ERML-MM	Mia Mia	0.911	0.713	1.753	1.937

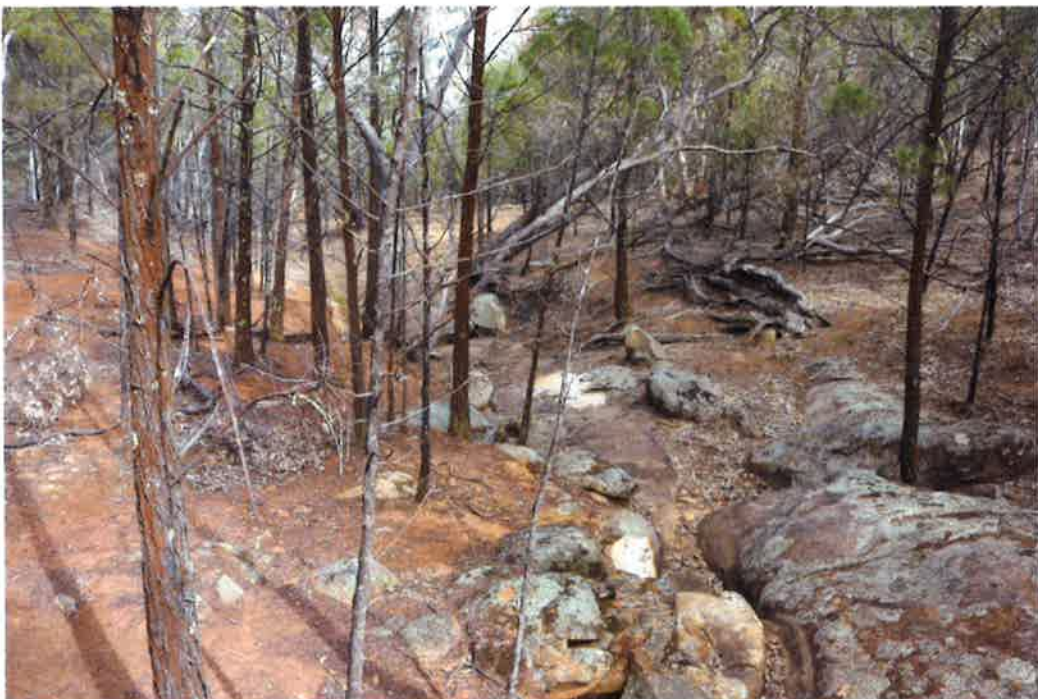
Remnant vegetation monitoring sites are recovering at varying rates, depending on grazing and cultivation history. Plague numbers of Eastern Grey Kangaroos have heavily impacted the BOAs in the winter spring of 2019. Kangaroos have been culled by a licenced contractor.

Dowd's Hill offset (18 months after livestock were removed). Photo taken 15 June 2018 (18 months before the drought started to break). Overgrazing by macropods removed almost all groundcover.

- Eastern Grey Kangaroo (*Macropus giganteus*) will be culled under licence to reduce grazing pressure in the BOAs and across agricultural land,
- Signage in strategic areas will be installed to restrict access to BOAs to authorised personnel only and
- Vegetation plots will be monitored in September 2020 which will likely provide baseline data on the effects of high rainfall (autumn -winter) on vegetation (ungrazed by livestock) that is being protected for its biodiversity value

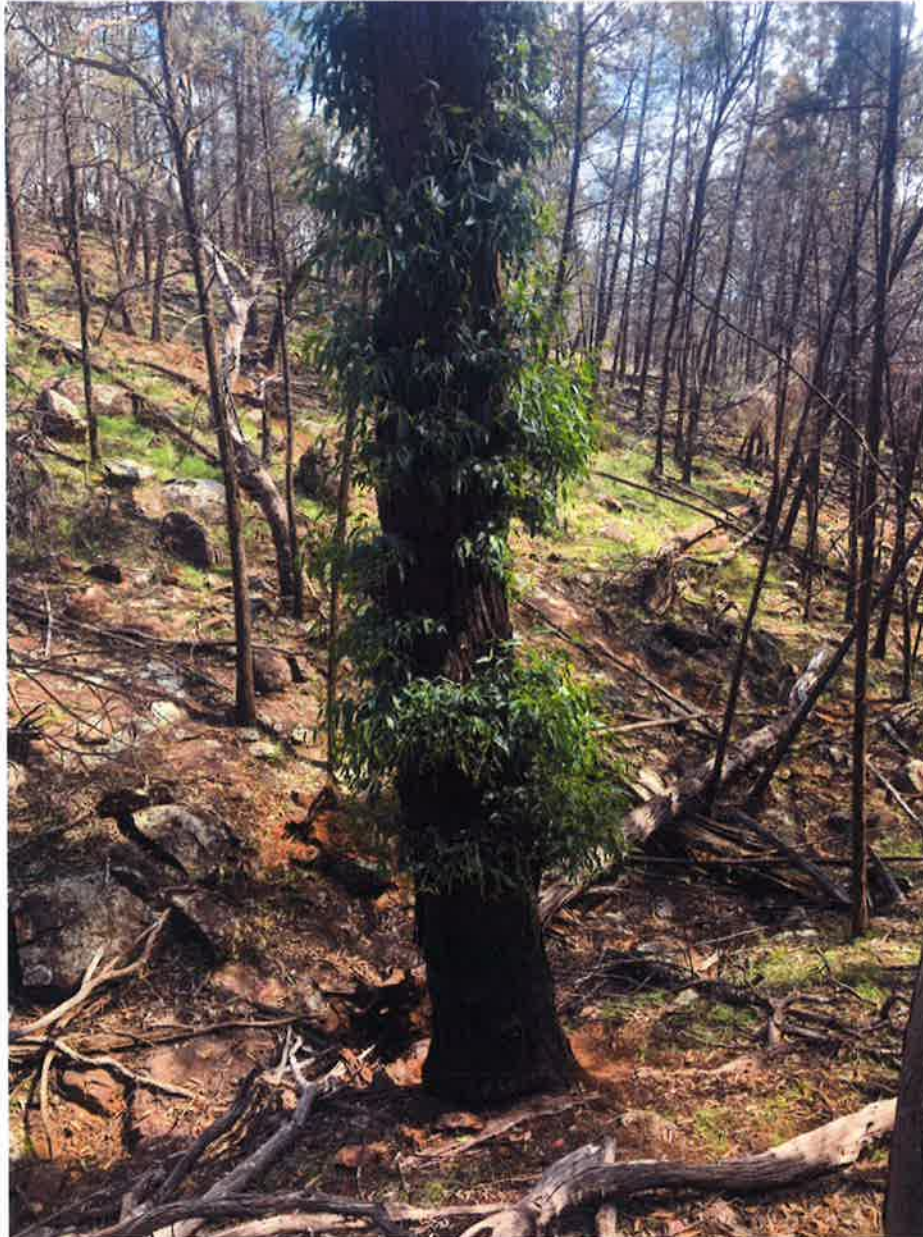
It should be noted that there has been significant dieback of trees across the whole project site from 2017 to January 2020. Black and white cypress pine, hill oak and even red stringybark have died due to prolonged dry. With that dieback more sunlight is reaching the ground which has enabled growth of grasses and forbs as they have not done in a century. Thick stands of pine trees have groundcover up to 100cm where in normal season there would be very low and sparse cover. The photos below illustrate this fact.

Red Stringybark (*Eucalyptus macrorhyncha*) exhibiting epicormic growth due to drought conditions. Some large trees on the slopes of Dowds Hill have died during the extreme drought 2017-2020.

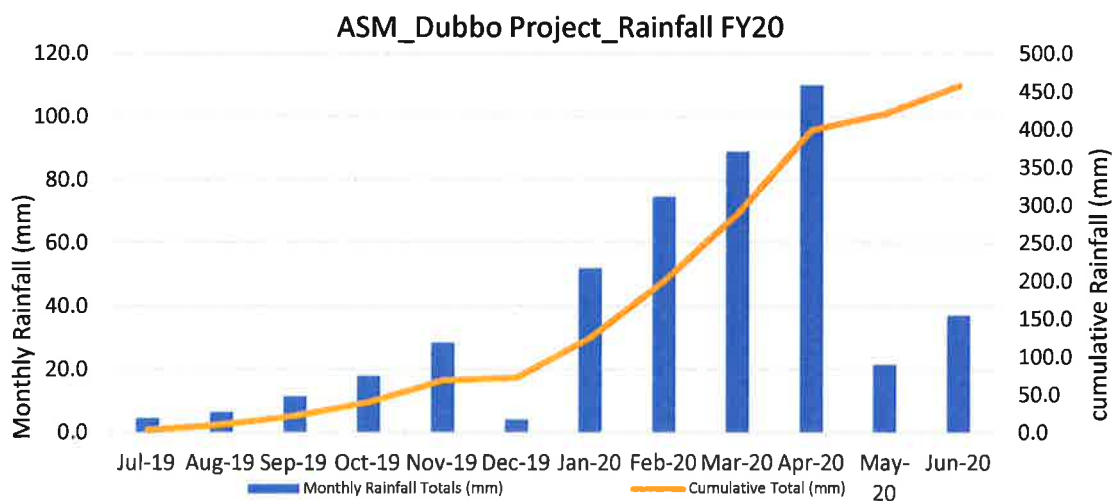
Figure 6: Monthly and cumulative rainfall on project site to 30 June 2020.

A total 458.9mm of rain fell over the reporting period which has seen prolonged drought conditions persist up until January 2020. A below average total of 393.4 mm rain fell in the preceding twelve months.

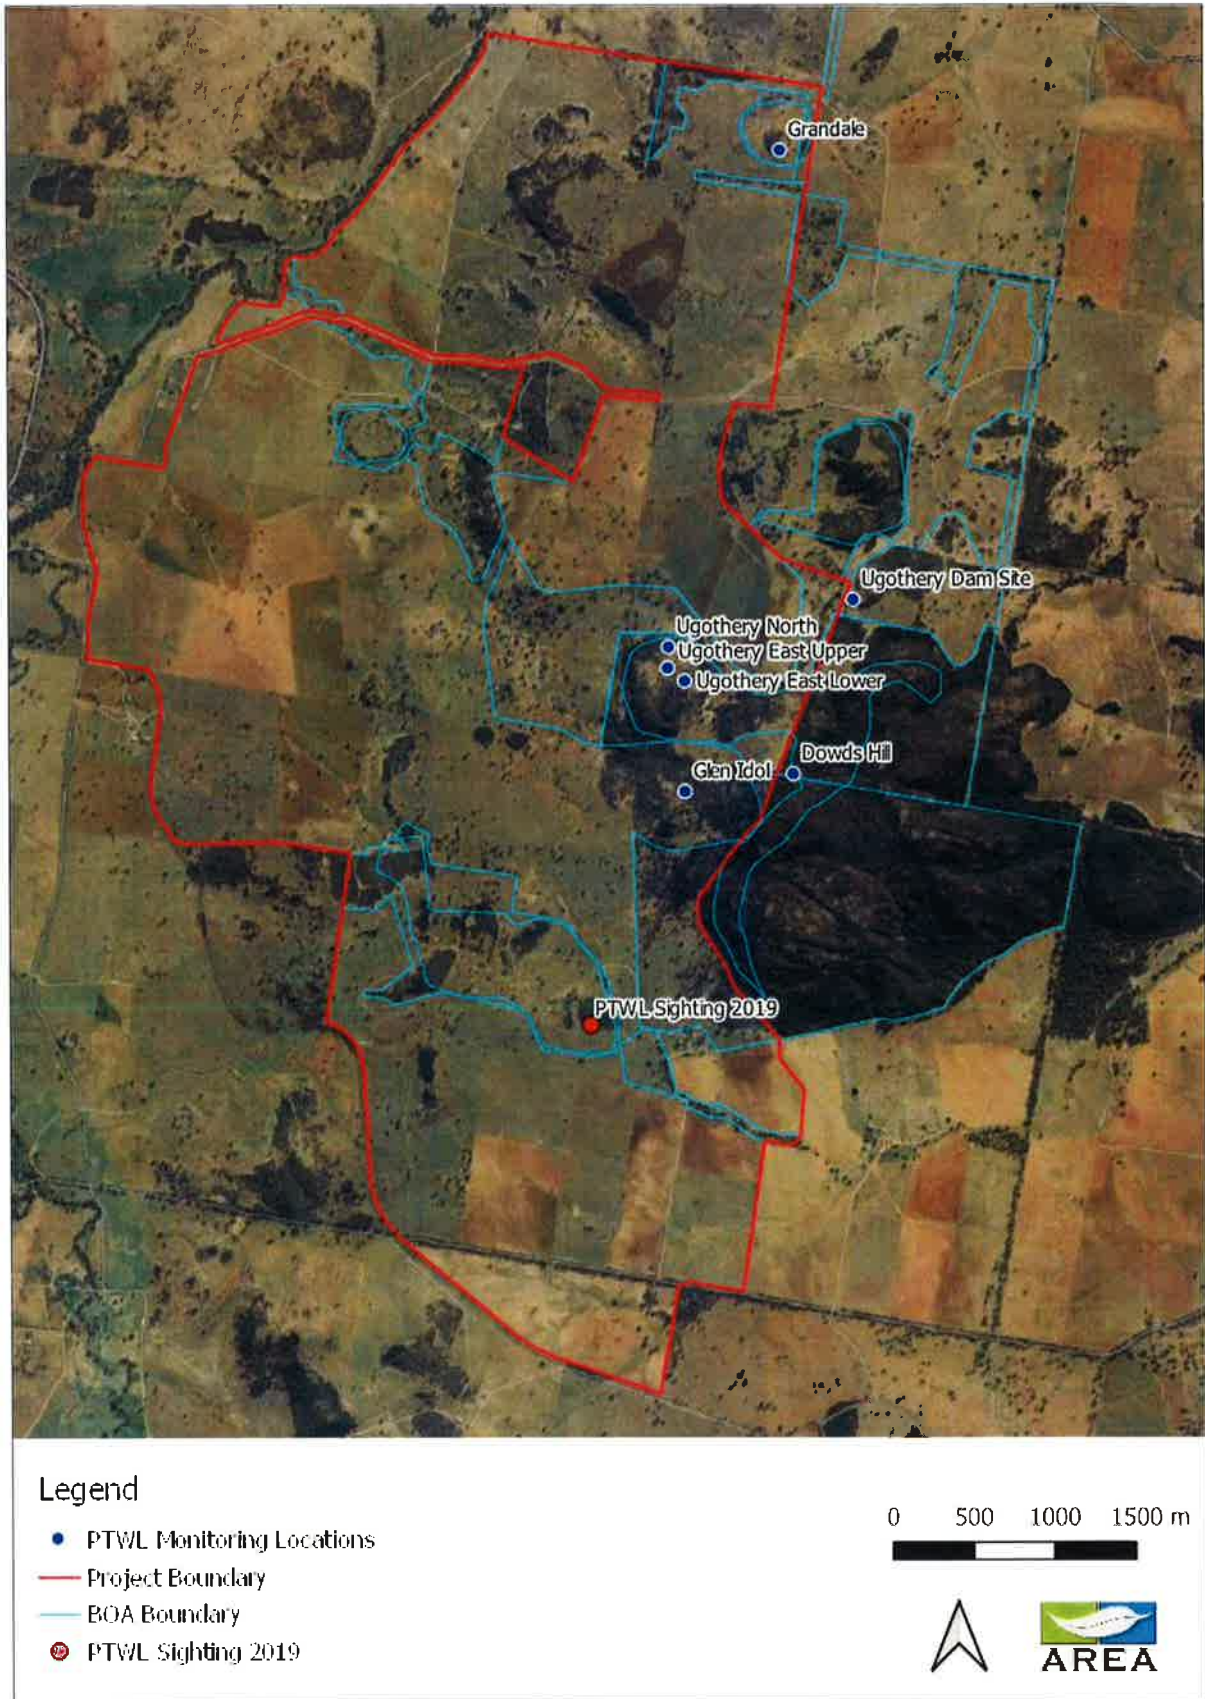
Figure 1-1: PTWL monitoring and detection locations

During a vegetation survey of DP in November 2019 (early in the morning) AREA Principal Ecologist Phil Cameron did sight a PTWL individual under a naturally occurring rock outside the monitoring locations but within the southern extent of the BOA area. Figure 1 shows the locations of monitoring 2020 and PTWL location 2019.

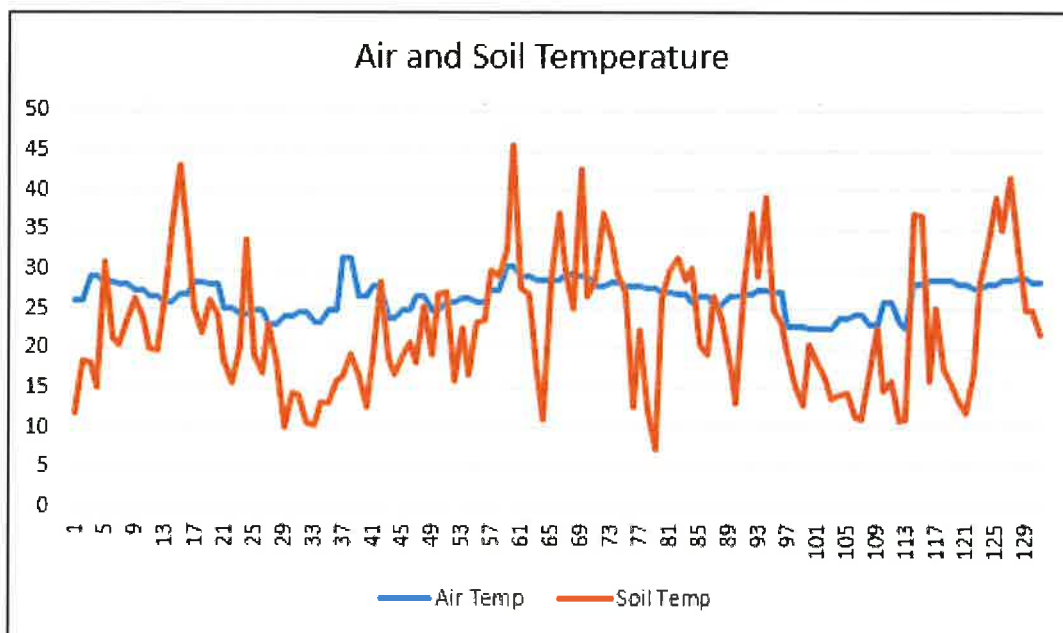
Figure 4-1: Air and soil temperature recorded at each tile location

Monitoring took place between 10am to 3pm when the ambient temperature was between 20°Celsius and 35°Celsius which increases likelihood of detection (P. Cameron pers comms.). Air temperature was relatively stable, however soil temperature beneath the tiles varied greatly from 7.3 to 45.6°Celsius, see Figure 4.1 below.

This extreme variation in soil temperature indicates that the tiles may only provide short windows of habitat suitability for PTWL – they heat quicker and cool quicker than natural rock.

Sun exposure has an impact on soil temperature and moisture beneath the tiles, evident by the fact that tiles in the full sun recorded much higher soil temperatures than those in the shade.

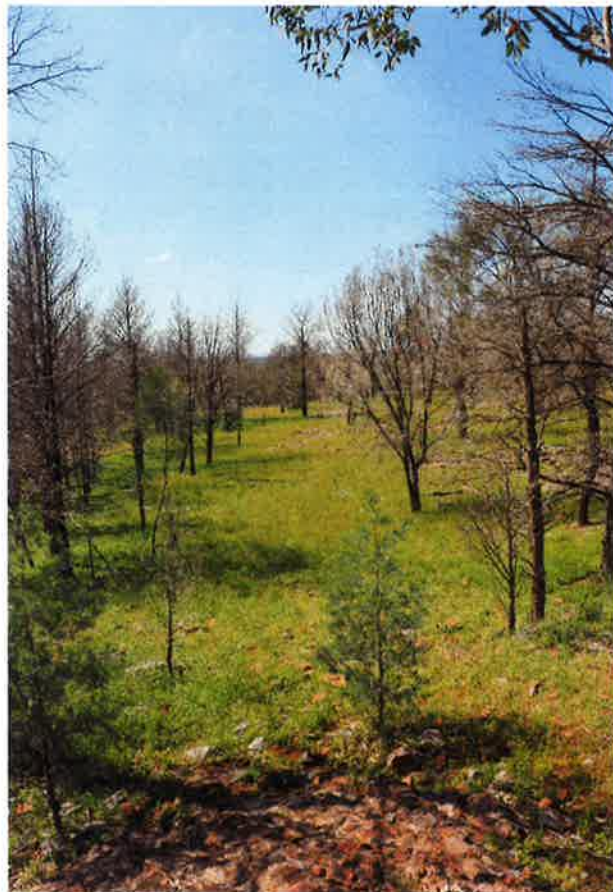
Extensive dieback of *Callitris* and *Allocasuarina* sp. 1 April 2020.

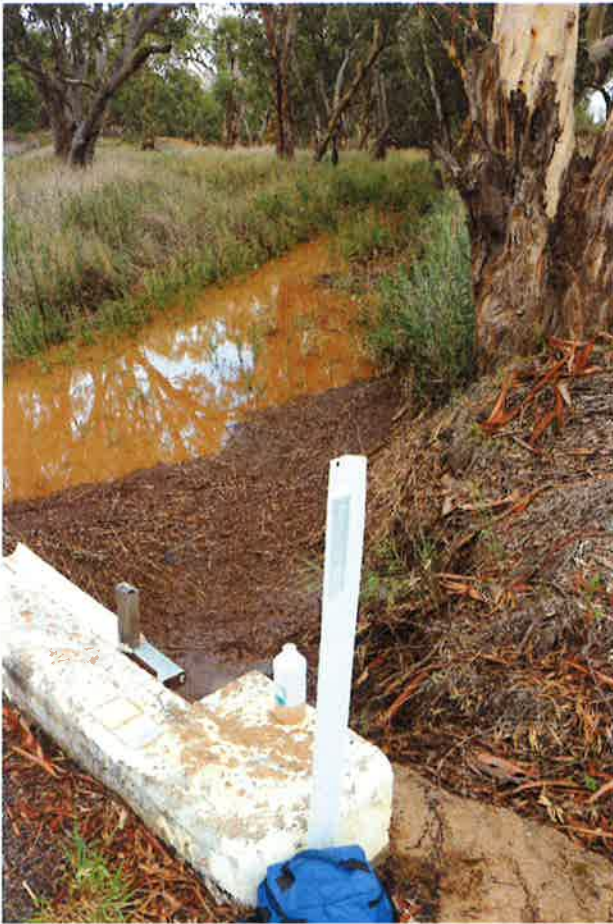
SW007-Wambangalang Creek sampled 10 February 2020.

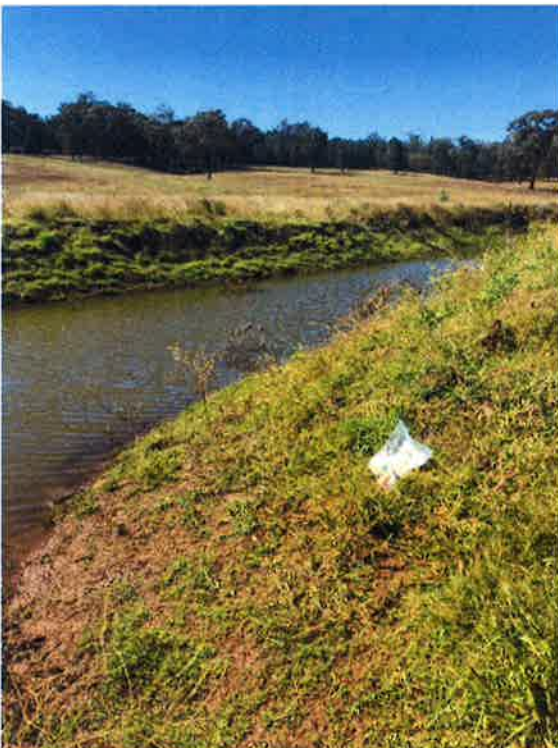
SW003 on watercourse B sampled 10 February 2020

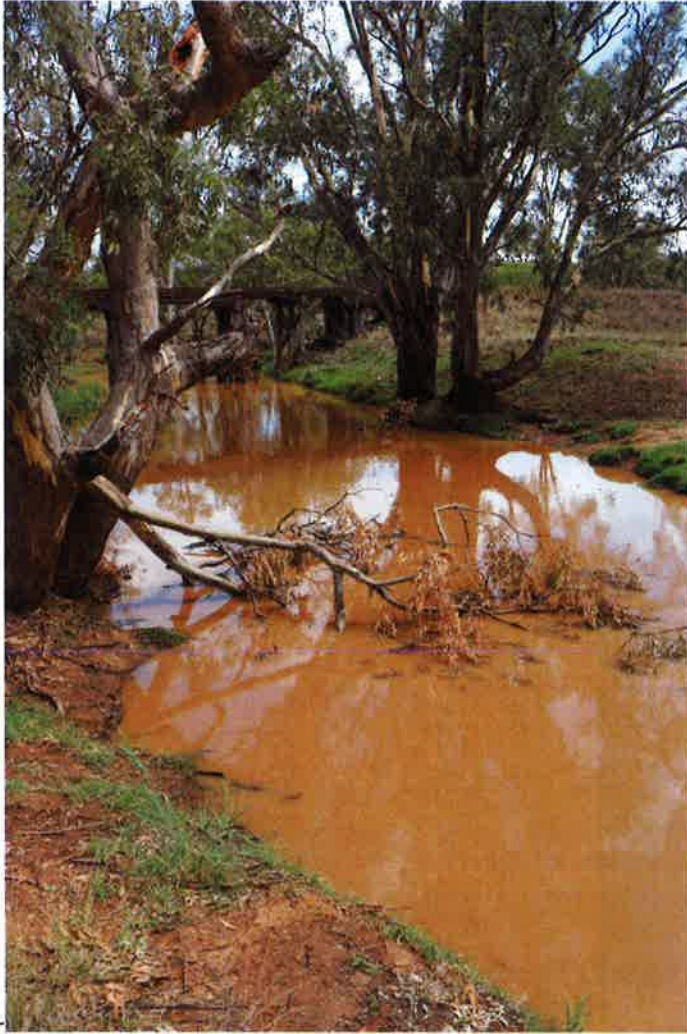
SW005- Wambangalang Creek downstream of railway bridge. Sampled 10 February 2020.

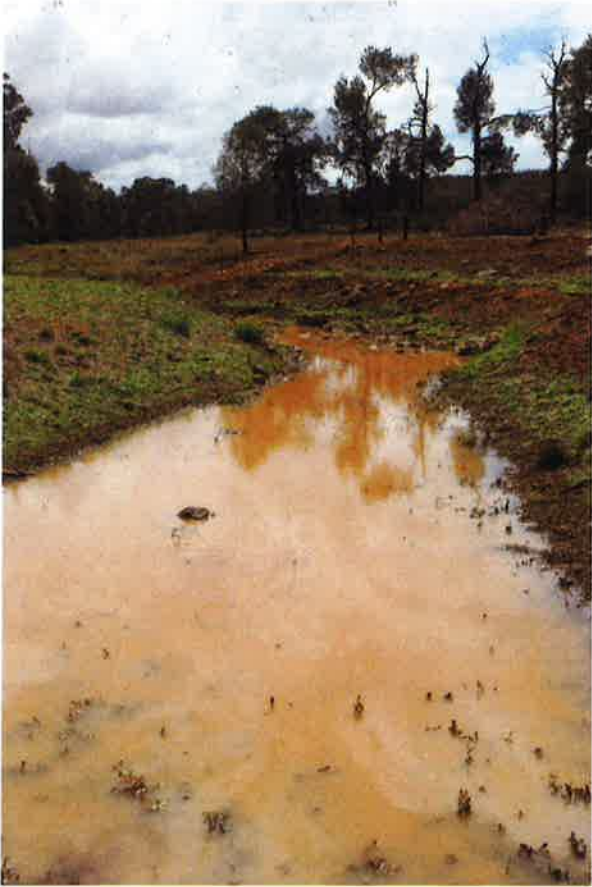
SW001 north arm of Cockabroo Creek draining the orebody. Sampled 10 February 2020.

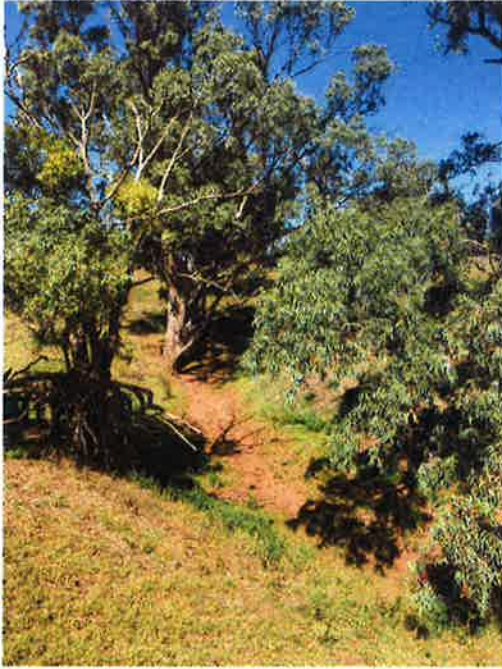
SW004-Paddy's Creek, Wychitella. Normal sample site dry but flowing under sand 26 March 2019.

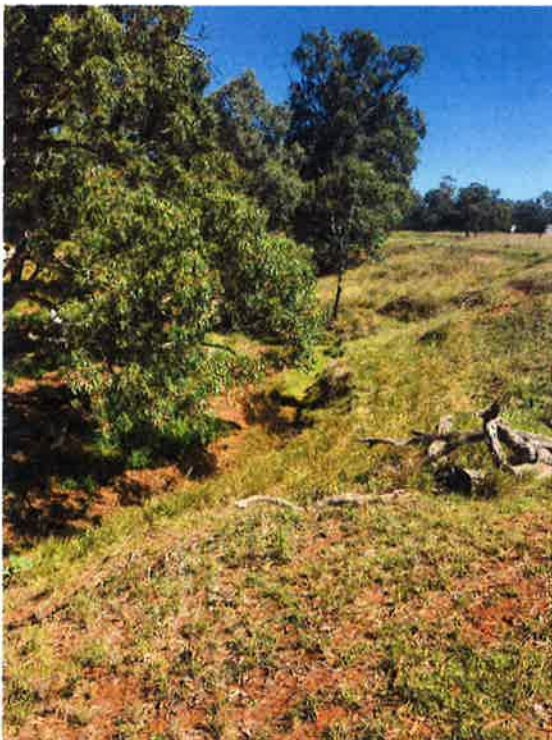
SW004b - Paddy's Creek sampled 25m downstream of usual location. Flowing under sand 26 March 2019. (results reported by ALS as SW004).
