Ekati Diamond Mine

Environmental Agreement and Water Licence Annual Report 2019

Dominion
Diamond Mines

July 2, 2020

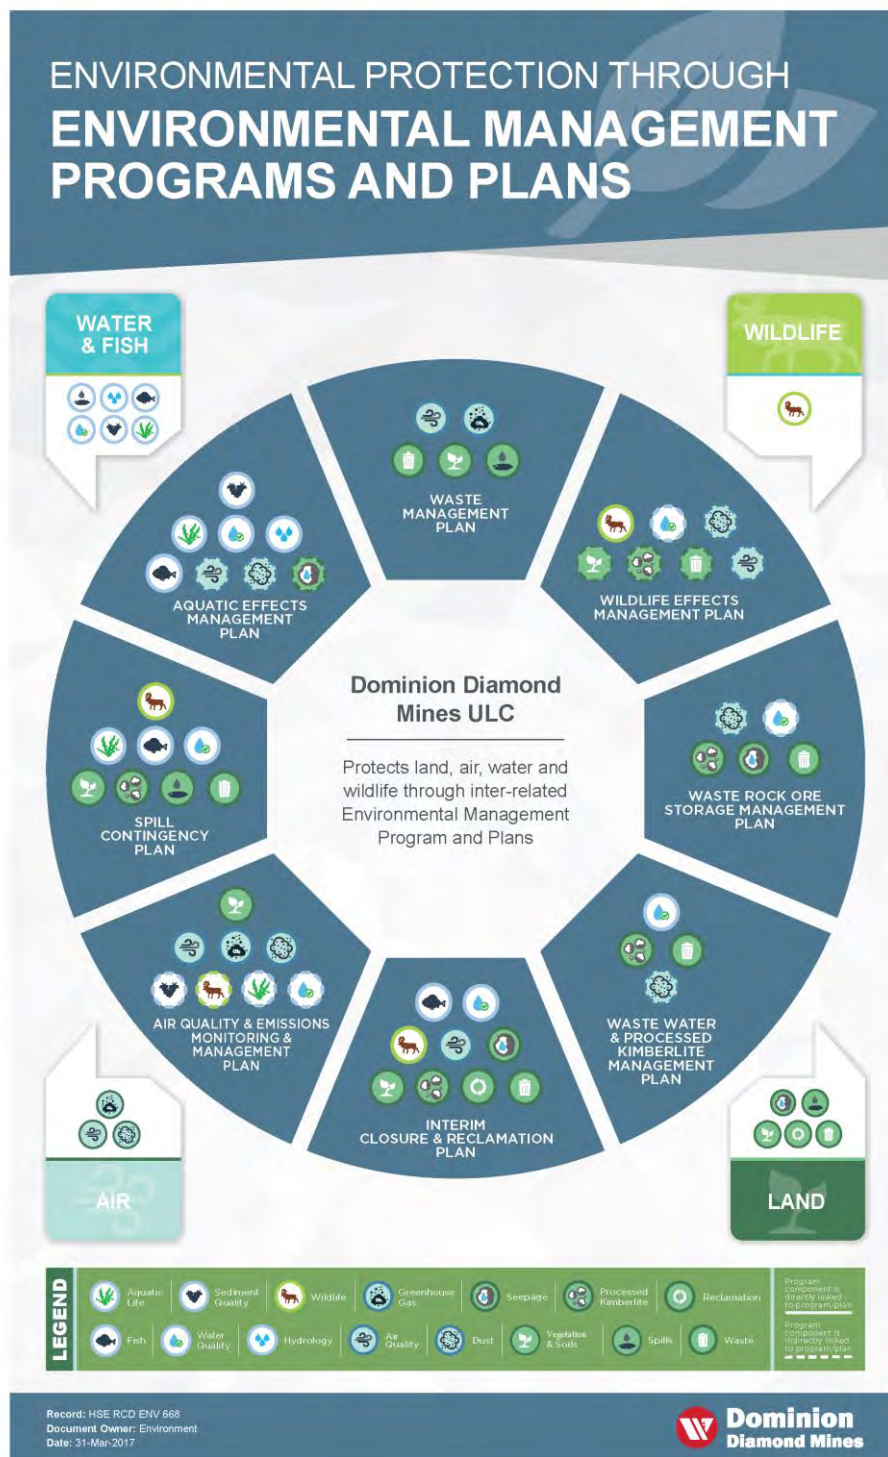
Figure 7 Environmental Protection through Environmental Management Programs and Plans

Figure 7 provides all environmental plans and programs ongoing at the Ekati Diamond Mine. Dominion implements a number of environmental plans and programs at the Ekati mine site, all of which are

interrelated (Figure 7). The results and components of environmental programs are driven directly and/or indirectly by the plans in place each with the overarching goal to protect land, air, water and wildlife.

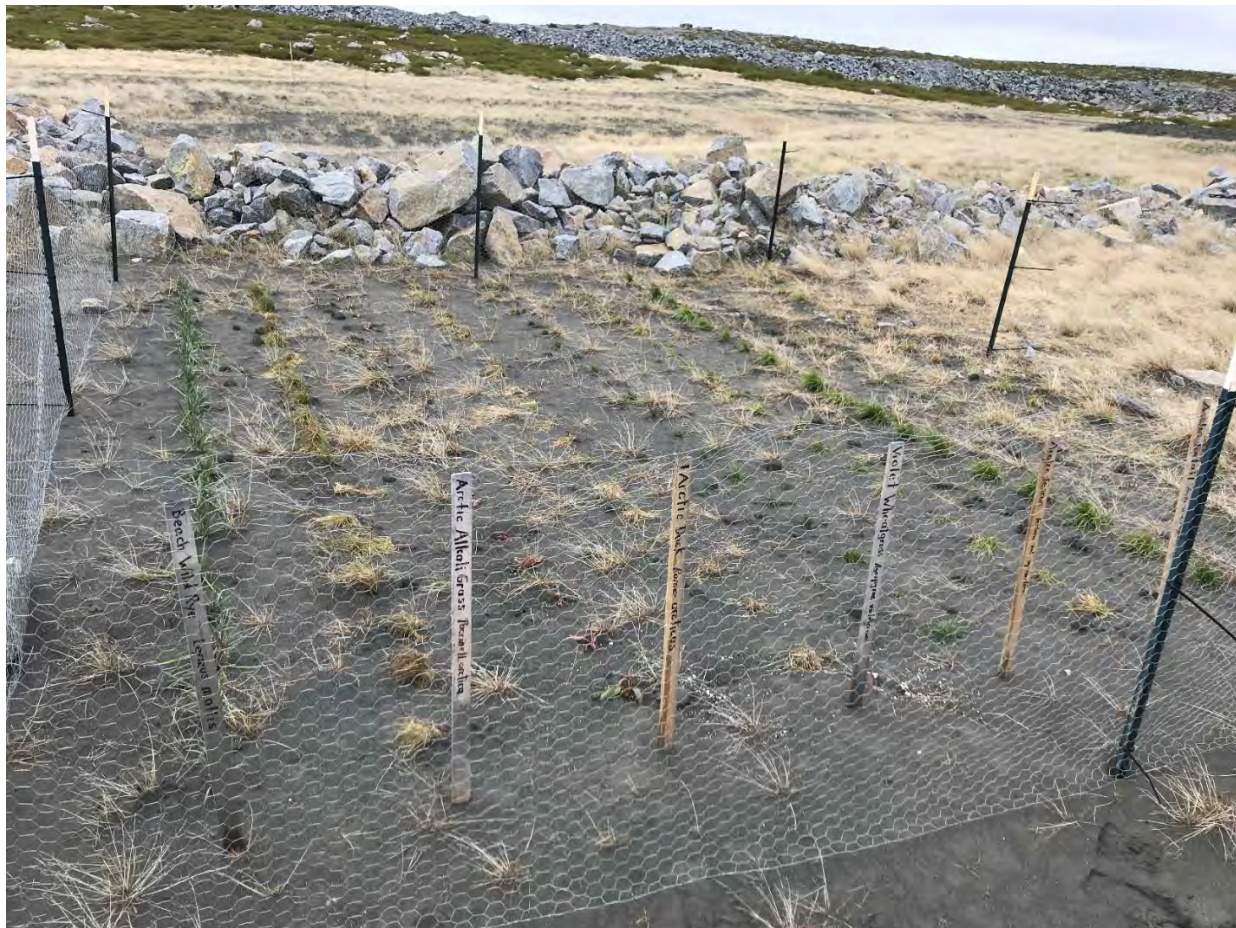
Plate 4.2-1. Trial established with plant materials collected from Kugluktuk (July 2019)

- Establishment of vegetation trials utilizing seed and seedlings collected from Kugluktuk in 2018; and
- Fertilization of trial areas within the boulder field

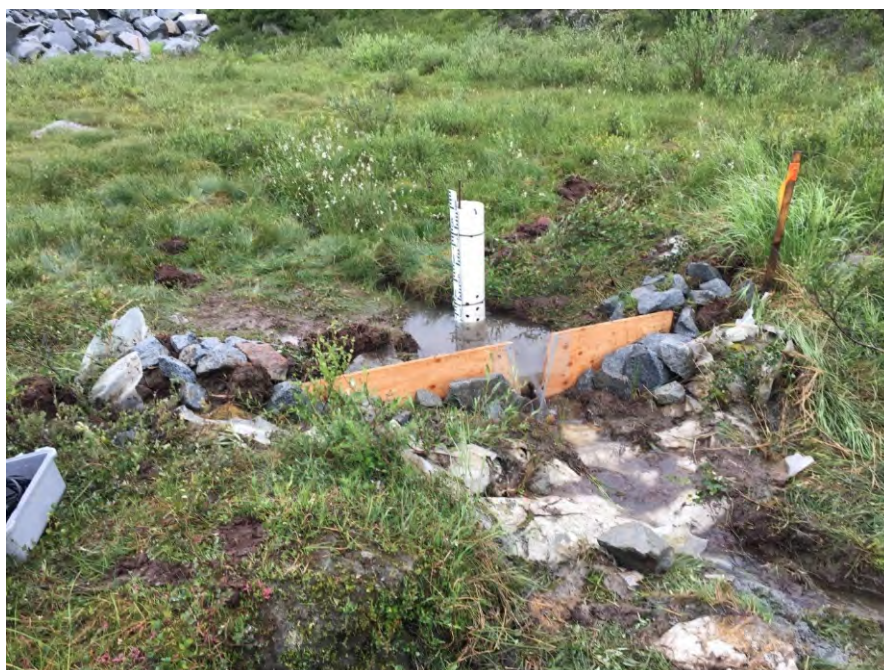
Plate 4.4-1. Seep 018B Weir (July 2019)

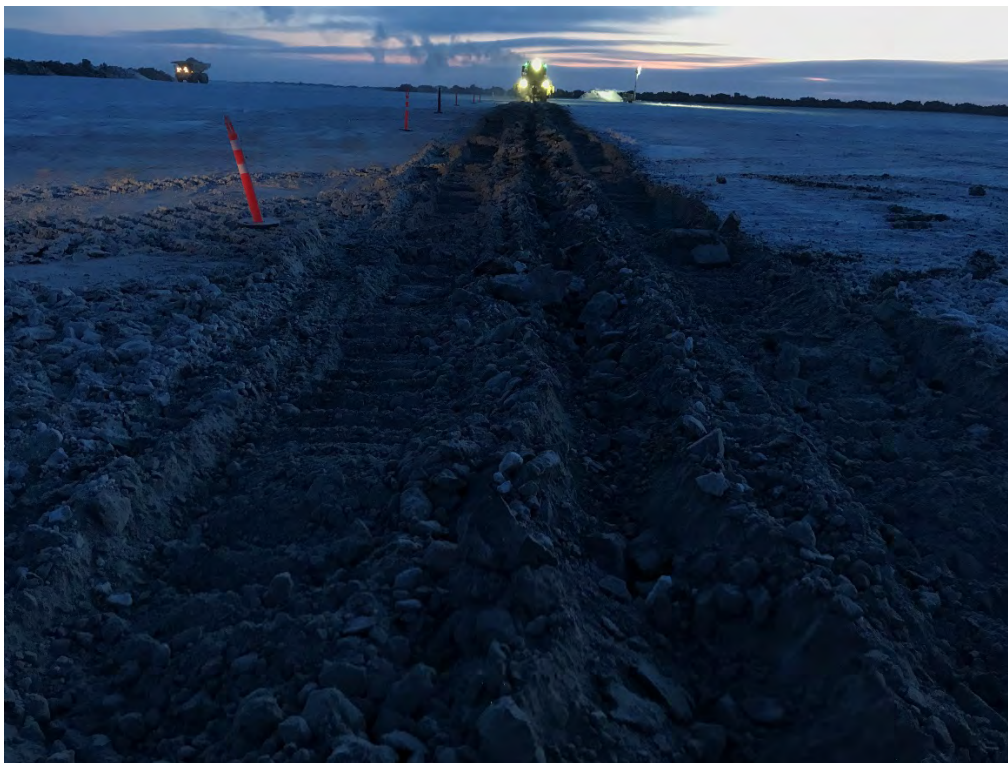
Plate 4.6-1. D10 dozer utilized a ripper shank implement to break up frozen waste rock along the designated trench area (December 2019)

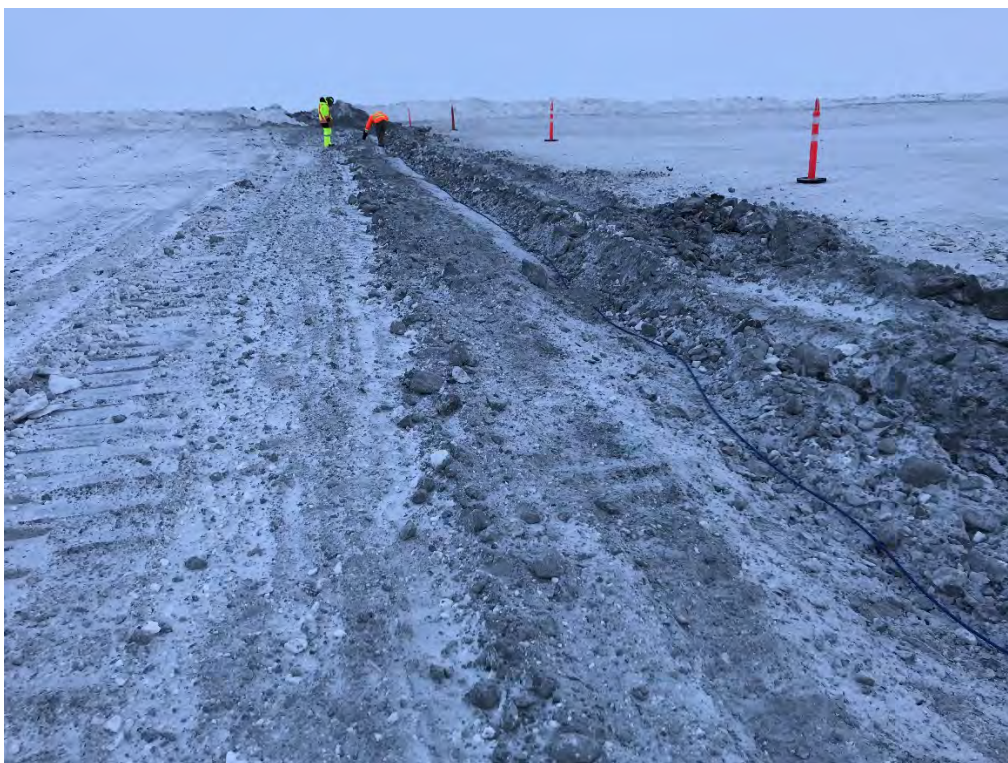
Plate 4.6-2. Placement of thermistor string within horizontal trench along 529 bench of Pigeon WRSA (December 2019)

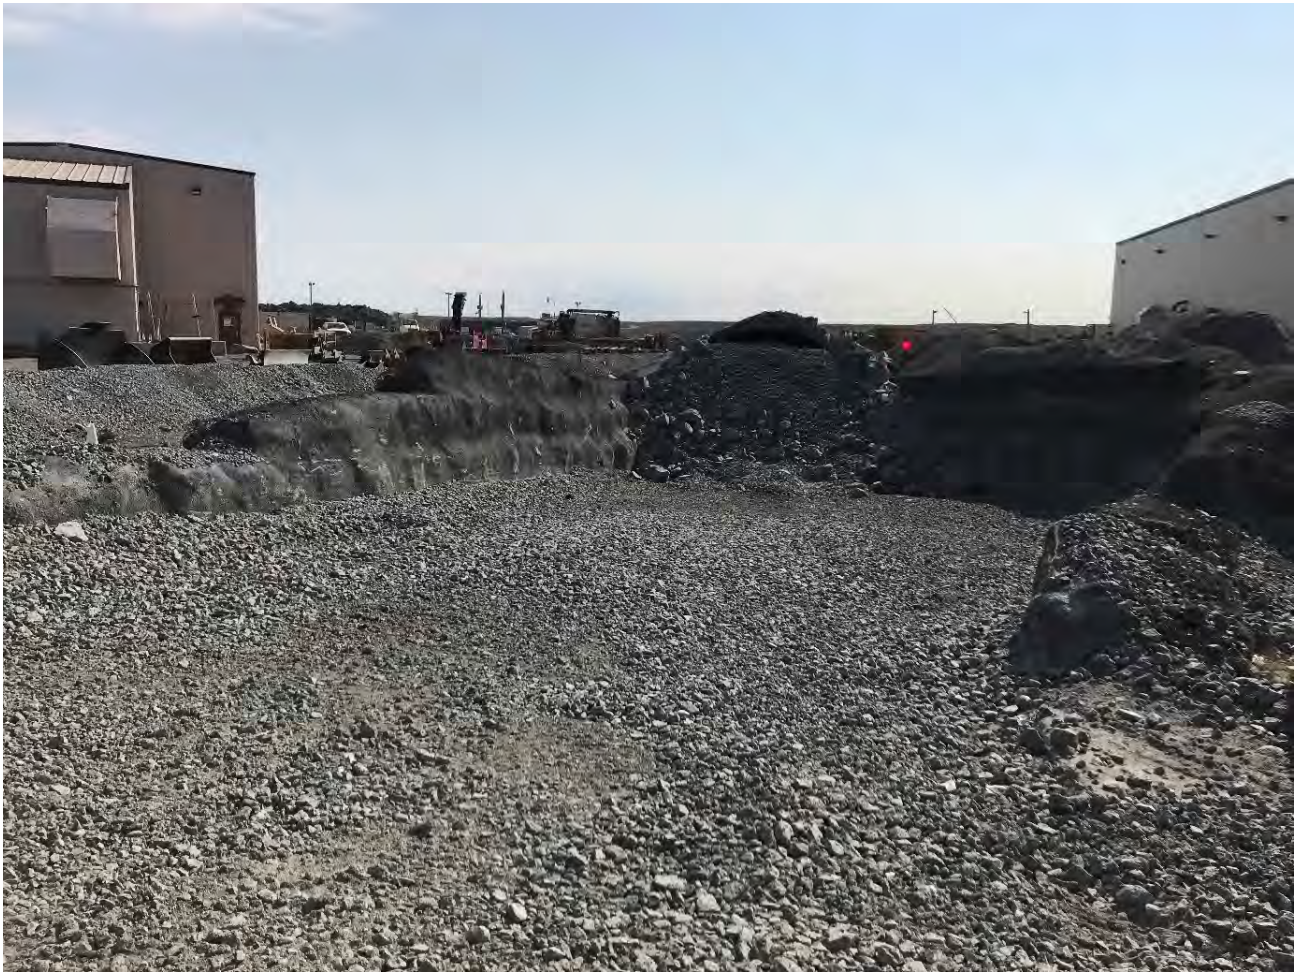
Plate 5.1-1. Portal to Underground Workings Sealed (June 2019)

A Reclamation Completion Report has been completed for the Ekati mine based on progressive reclamation completed within the underground workings of Panda, Koala, and Koala North in 2019. The Reclamation Completion Report for the closure of Panda, Koala, and Koala North Underground Workings is specific to the removal of hazardous materials and mobile equipment. The Reclamation Completion Report is available in Appendix G. This report meets the expectations of WLWB Guidelines for closure planning and closure costing. Dominion seeks that the Reclamation Completion Report is reviewed by stakeholders and WLWB staff confirm that it meets conformity to the WLWB guidelines.

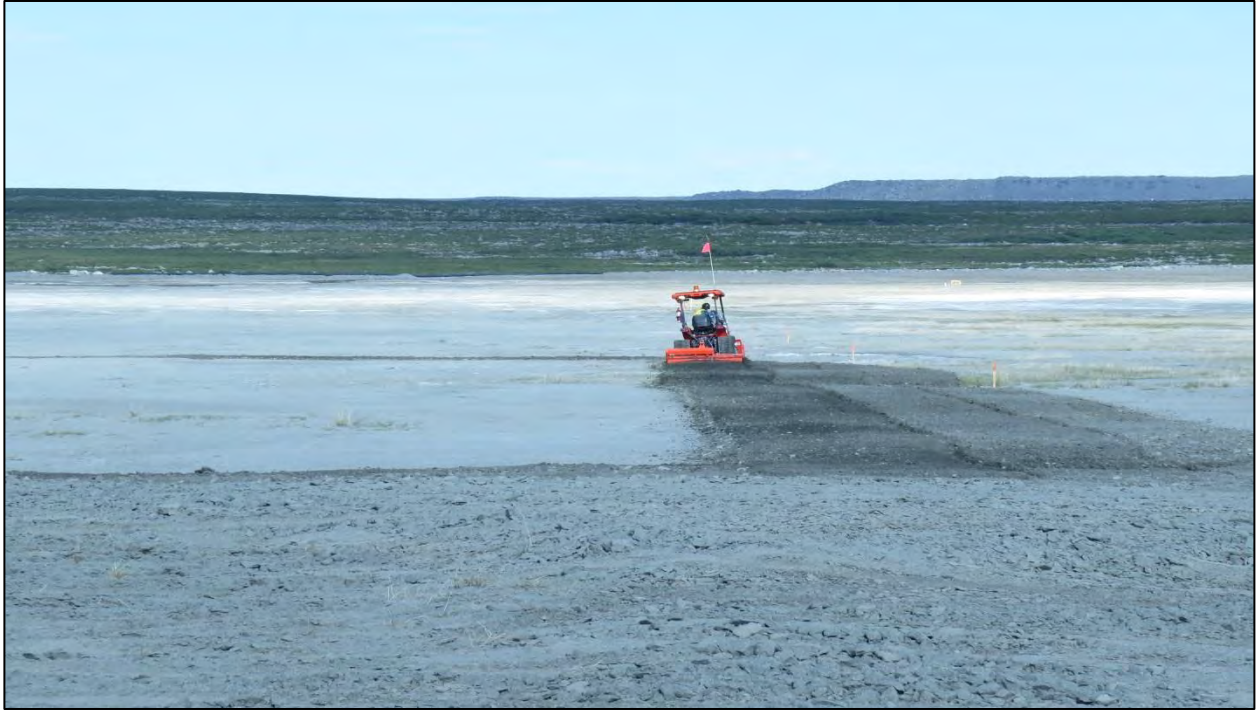
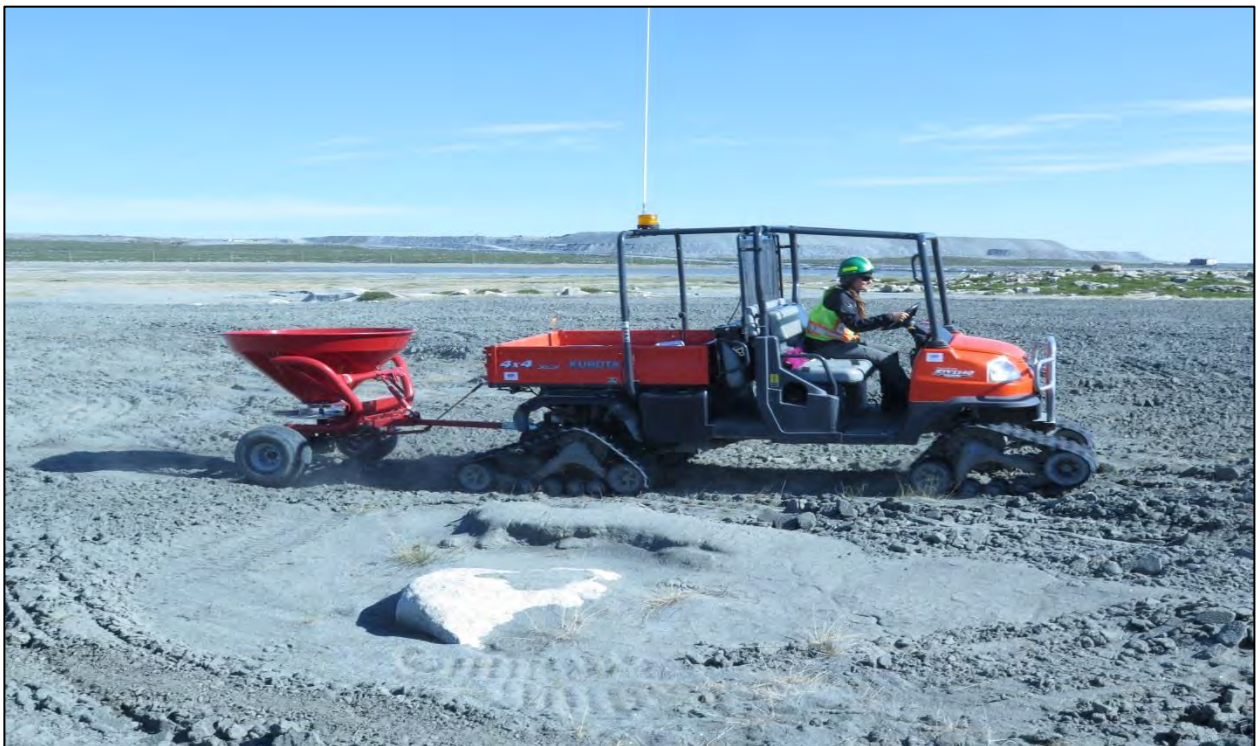
Photo 2.1-1: Seeding annual cover crops at the Ekati mine, July 2018. The top photo shows re-seeding surface preparation with the roto-tiller and a harrowed area in the foreground; and bottom photo shows broadcast seeding.

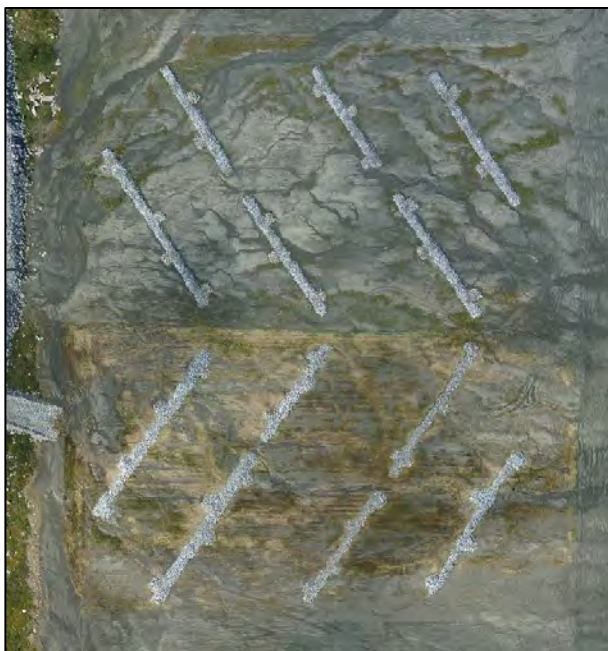
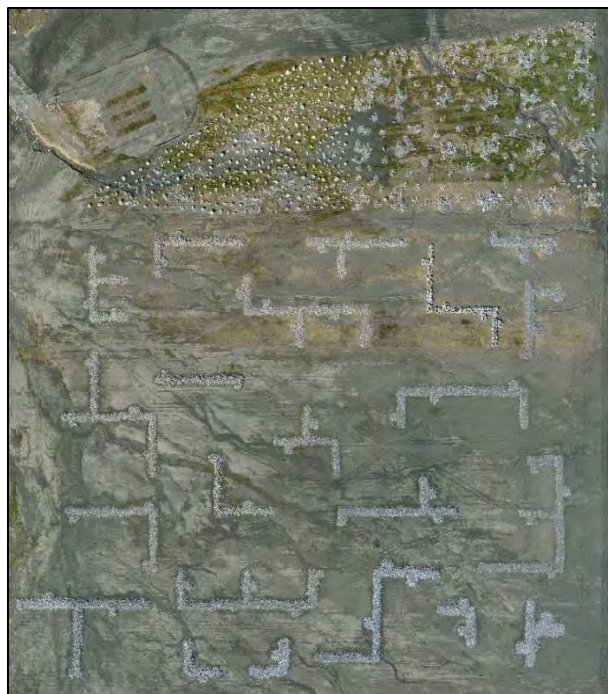
Figure 3.1-2: Aerial Views of the Rock Configurations and Vegetation Treatment Areas, July 2015

Rock Rows

Boulder Field and Rock Grids

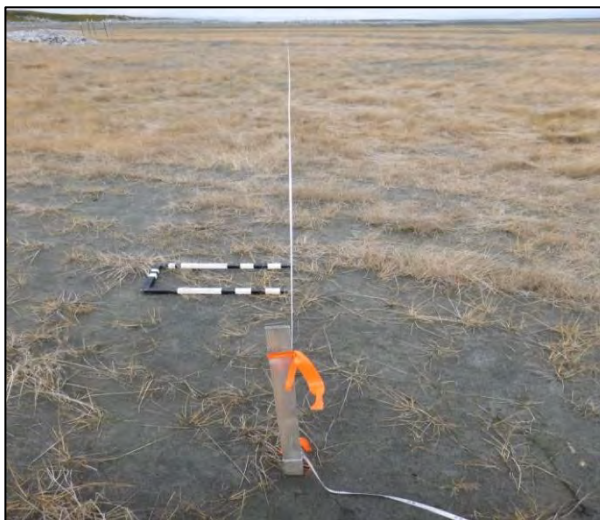
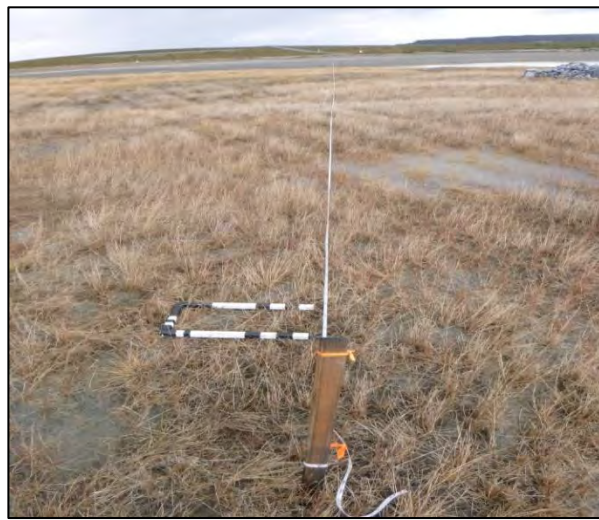
Photo 3.4-1: Site photos of the rock and vegetation trials, August 2018.

Naturally colonized area in the Rock Rows

Seeded area in the Rock Rows

Total cover more than doubled from 2016 to 2018 due, primarily, to a sevenfold increase in litter. The increase in litter could be attributed to the dry conditions experienced at the Ekati mine in 2018 where it becomes difficult to distinguish between live grass and litter. Thus it was possible that some of the material judged as litter in 2018 was, in fact, live. In the Rock Rows in 2018 ground cover by mosses was observed for the first time. Please also see site photos in Photo 3.4-1

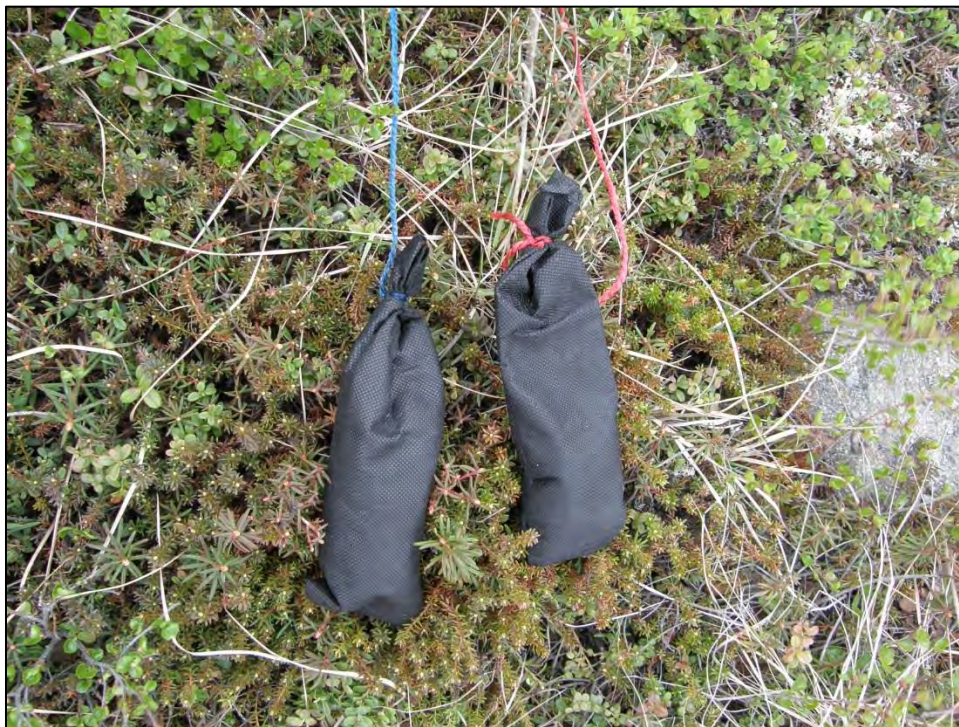
one set of transfer pouches (i.e., one high pH transfer pouch and one neutral pH pouch) was collected from below a selection of the target species and shipped to Mikro-Tek for assessment of hyphae colonisation. Although neutral pH pouches generally had higher hyphae counts all of the pouches were well colonised and were judged suitable as sources of inoculum (Kean, M., pers. comm.).

Photo 4.1-1: Mycorrhizae transfer pouches.

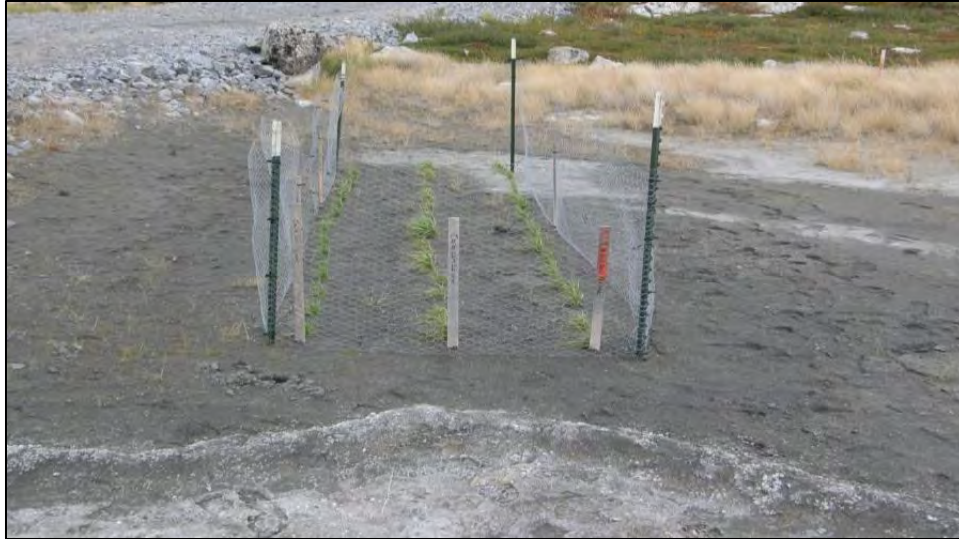
Photo 4.1-2: Bluejoint reedgrass with mycorrhizae trial plot. August, 2017.

The willows were monitored in August, 2017 by measuring plant heights. Plant height and size of the willows and birch were measured in 2018. Plant size is determined by averaging the length of the plant's longest axis plus the length of the axis perpendicular to that and maximum plant height. The fireweed and bluejoint reed grass were monitored by documenting the number of plants with flowers and/or height.

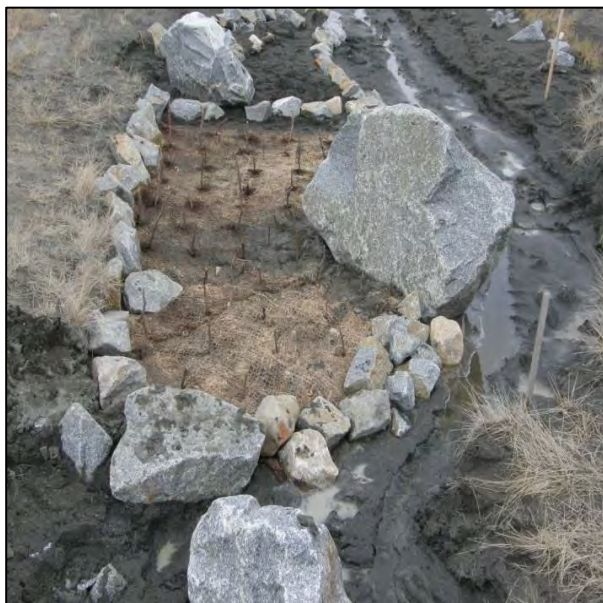
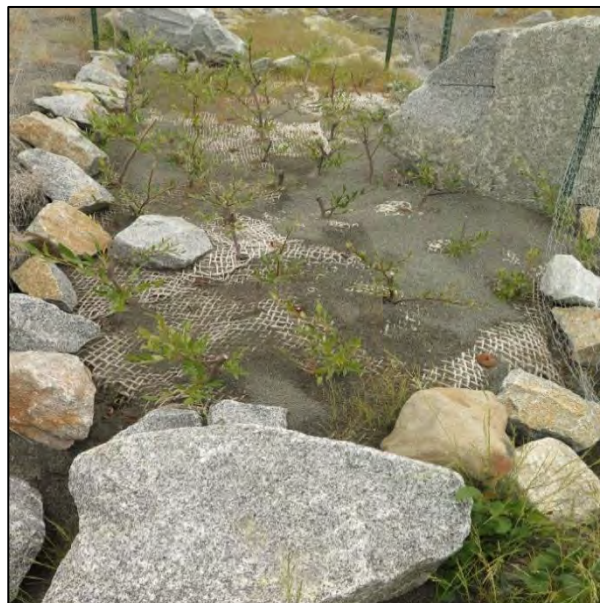
Photo 4.3-1: Upslope willow with mycorrhizae trial plot.

Upslope trial plot in June, 2017

View of the same plot in August, 2018

Only three of the 229 willows originally planted in the downslope plots survived two growing seasons (Table 4.3-1). Those that did survive were treated with mycorrhizae. The 2-year survival was greater in the upslope plants with 93 of 140 (66%) planted judged alive (Photo 4.3-1). The overall survival rate for plants treated with high pH mycorrhizae was slightly better than those treated with low pH inoculum (29% versus 27%) and survival in both groups surpassed that of uninoculated plants (22%). Inoculated plants were also taller and larger on average than those not treated (Tables 4.3-2 and 4.3-3). The biggest plants were those in the group that received low pH inoculum.

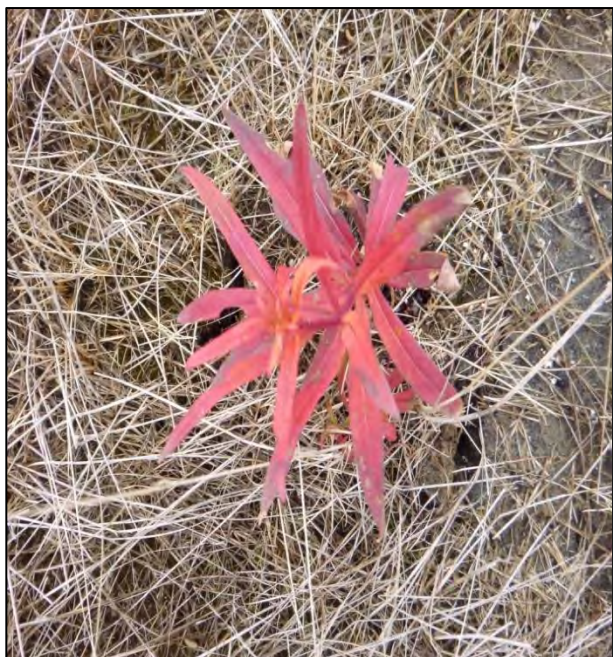
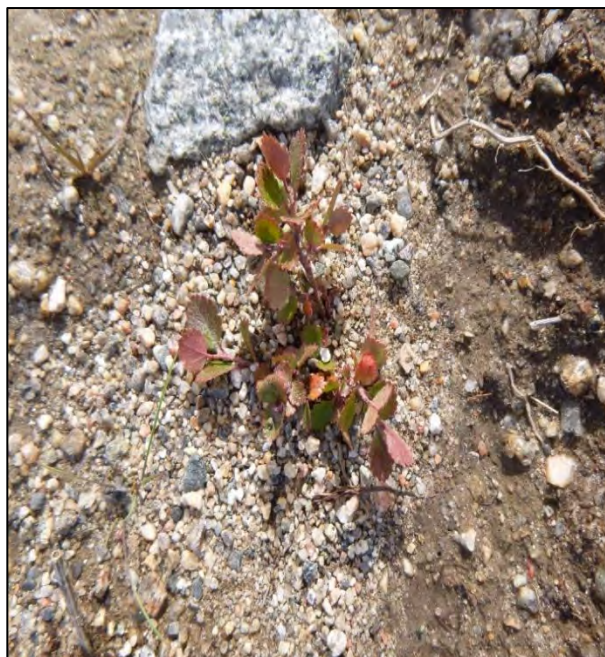
Photo 4-3-2: Healthy seedlings growing with mycorrhizae. August, 2018.

Fireweed seedling

Birch seedling

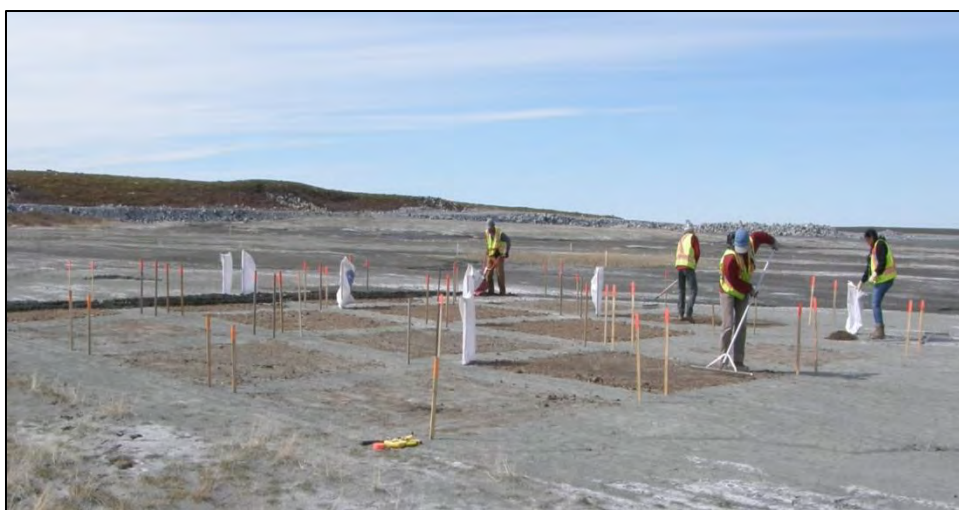
Photo 5.1-1: 2017 MGOM / compost trial plots being prepared, June 2017.

To date most of the processed waste has been landfilled but a potentially beneficial alternative is its use in reclamation. In summer 2016, a trial was set up in a mid to upper slope position on the PK in Cell B to test various rates of mine-generated organic matter (MGOM) application and to assess the value of tilling the material into the PK versus simply spreading it across the surface. The latter question arises due to difficulty accessing unfrozen PK with equipment large enough to deal with significant volumes of material. The trial was set up as three replicates of four application rates (0, 2, 5, and 10 tonnes/ha) with and without tillage after material application. Individual plots are 3 m x 3 m and all plots were roto-tilled prior to applying the organic material. After application and final tillage Boreal creeping red fescue (*Festuca rubra*) was broadcast seeded on all the plots at 15 kg/ha (1878 pure live seeds/m²) followed by light raking to incorporate the seed (Photo 5.1-1). The trial plot layout is depicted below in Figure 5.1-1.

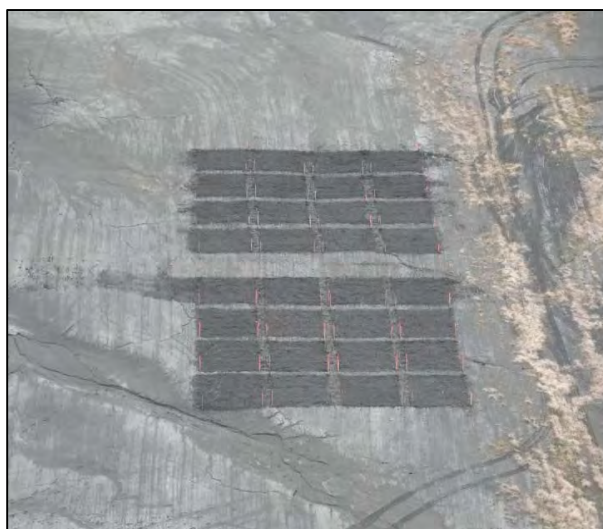
Photo 5.1-2: Aerial views of 2016 MGOM and 2017 Compost / MGOM trial plots, June 2017.

Upper slope 2017 MGOM/compost trial plots.

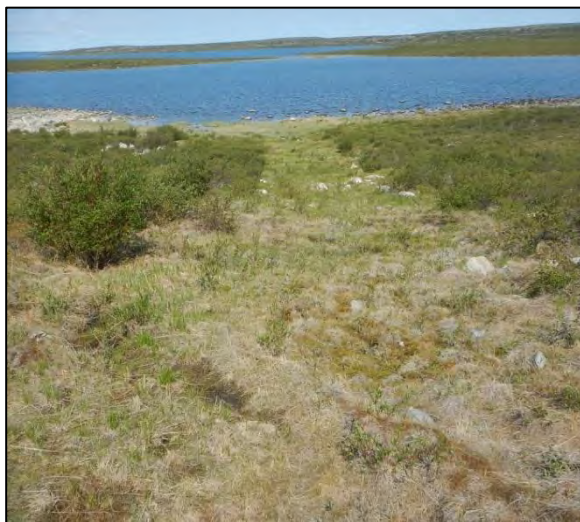
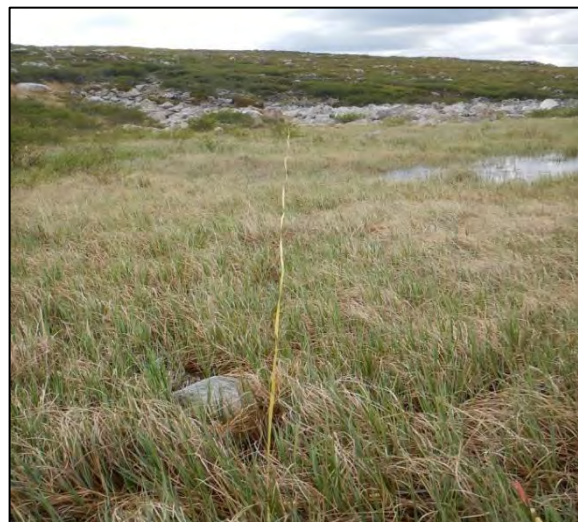
Photo 2.1-1: Site photos of Fay Bay reclamation. July, 2019.

View of the road base (center) and eastern affected area (right).

View along the riparian transect

In the area east of the road base the initial surface disturbance was minimal but a thin layer of processed kimberlite (PK) remained on the ground following the cleanup. Vegetation in this location resembles control vegetation much more closely than does that on the road base (Photo 2.1-1). Cover by shrubs, the dominant vegetation in the undisturbed tundra, has remained fairly stable and comparable to control since 2014.

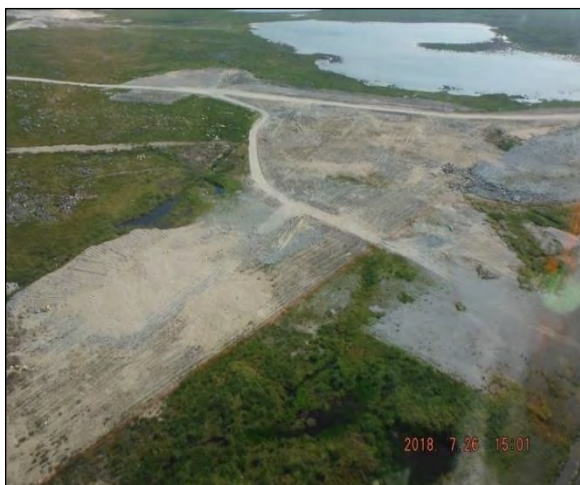
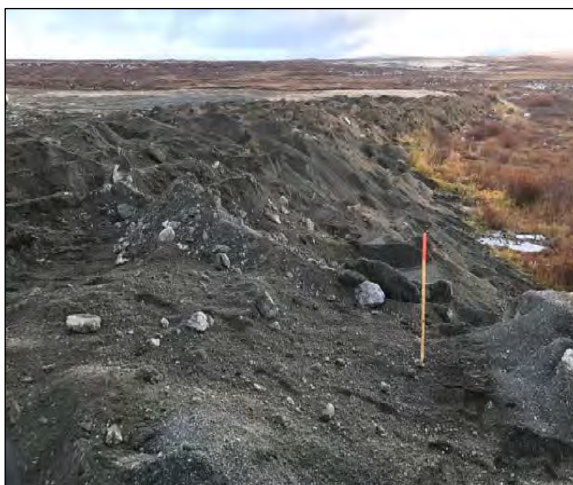
Photo 2.3-1: Surface reclamation at Old Camp.

Aerial view of the upper region of Old Camp in 2018 showing surface roughening.

Mounds and pits along Old Camp's southern slope.

Development at Old Camp began in 1993 in support of exploration and bulk sampling activities. During construction of Main Camp it was also used to house employees. Operational infrastructure included offices and accommodations, a pilot process plant and processed kimberlite (PK) storage area, a tank farm, equipment storage area, truck shop and associated roads. The site occupies approximately 9 ha. Active operations ceased in 2003 and decommissioning of infrastructure was completed the following year. Processed kimberlite and the underlying liner was excavated and removed from the site in 2014 and in 2015 final contouring of the former PK storage pond was completed (Figure 2.3-1). In 2017 salvaged topsoil and stockpiled gravel was spread and the surfaces of accessible areas were roughened by deep ripping with a large grader or by creating closely spaced mounds and pits using a tracked excavator (Photo 2.3-1). The objectives of surface reclamation are to leave the site in a stable condition conducive to natural colonization by native tundra plants (Dominion Diamond, 2017). Seeding and/or planting the area is not planned at this time but is an option should signs of instability develop or native vegetation fail to establish within a few years.

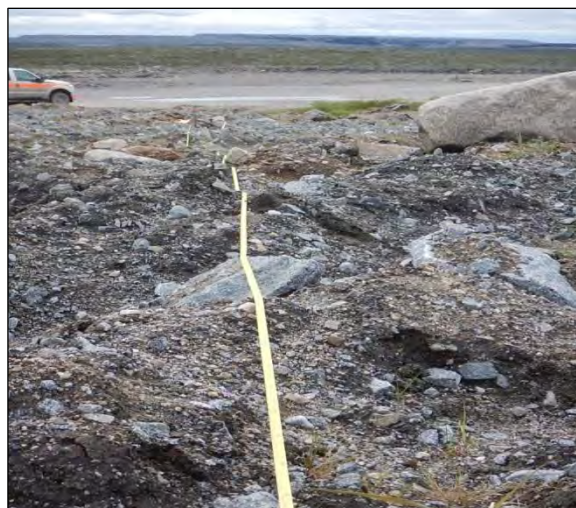
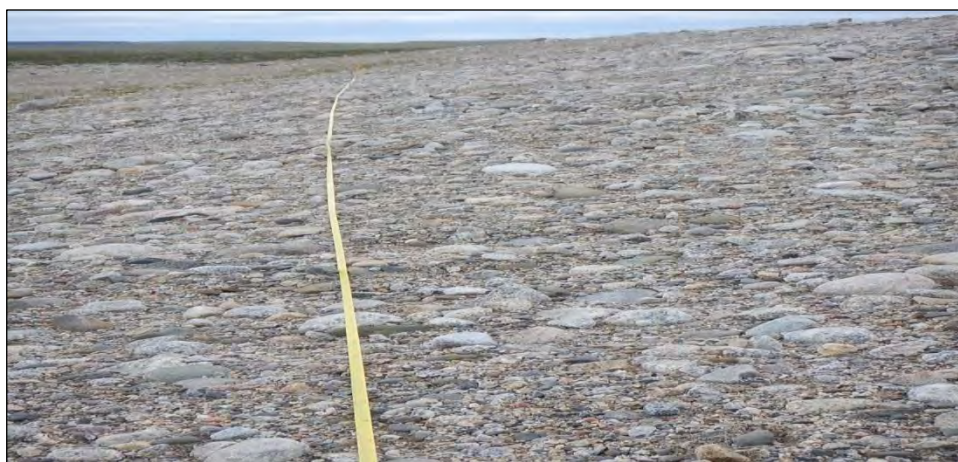
Photo 2.3-3: Old Camp Transects 2, 3 and 4. July, 2019.

View along Old Camp Transect 3 in July 2019

View along Old Camp Transect 3. July 2019

Old Camp Transect 3 runs diagonally across the former helipad. In many respects the soil here is comparable to control but it contains only 2.9% silt, making it the coarsest textured of the five locations sampled and SAR is elevated (although not problematic) and it has relatively high phosphate content. Compared to control soil pH is also elevated (Table 2.3-2). Despite those differences this area should support early colonising tundra plant species (e.g. fireweed (*Epilobium angustifolium*), birch, willow). To date the area is mostly bare with only 1.4% live ground cover and a little litter (Table 2.3-3). Live ground cover consists of three grasses, two of which may have been seeded sometime in the past.

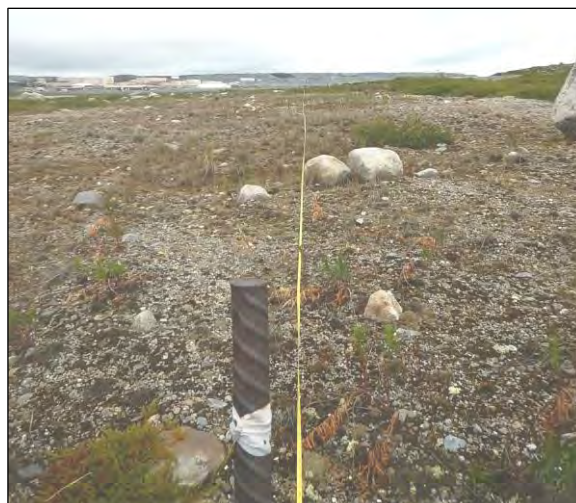
Photo 2.4-1: View along Old Camp Road in 2008 and 2019.

Two small pullouts along Old Camp Road were seeded with native grass cultivars and fertilized in the summer of 1996. In summer 1997, seed from two native legumes was broadcast on one of those pullouts. When that pullout was first monitored 2002 the plant community was dominated by seeded grasses. Limited amounts of fireweed and mosses were also present, but the legumes failed to establish. Litter provided the majority of the total ground cover which, at the time, was 22.3%. No lichen was observed. Since then total ground cover has increased to 76.9% in 2019 and appears to have stabilized. That change is mostly due to growth of mosses and lichen that, together, amounted to 69.7% in 2019. Over that same time cover by seeded grasses declined and 2 indigenous plant species now provide the majority of vascular plant cover. As observed elsewhere on coarse textured, nutrient poor substrates around the mine site seeded species do well when fertilized but die off as those nutrient supplies diminish and over time native species establish.

View along Old Camp Road in 2019

Plant community development on Old Camp Road provides a proxy for other roads on the mine site and continued, periodic, monitoring of it is recommended.

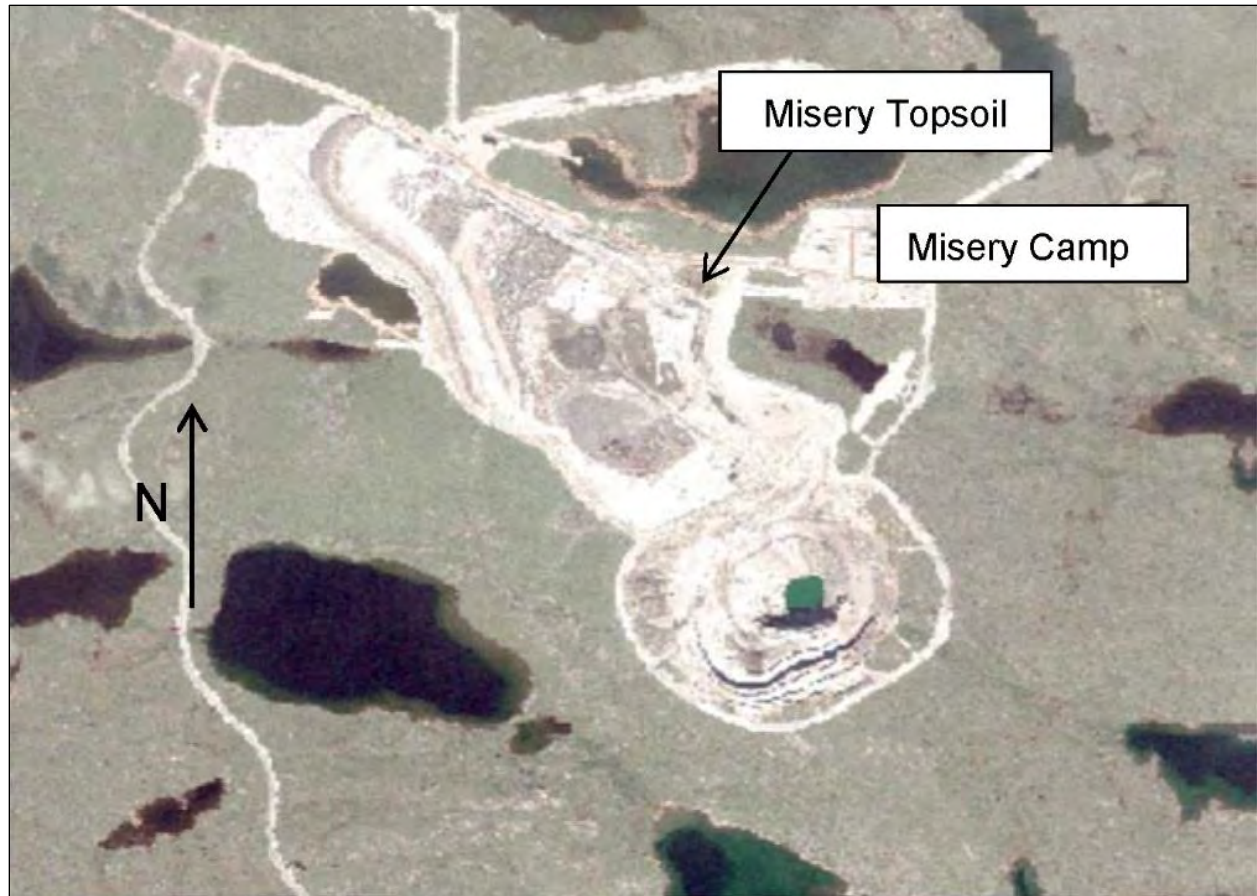
Figure 2.5-1: Misery Topsoil Stockpile Location

The Misery topsoil stockpile was built in 1999 with surface soil salvaged during development of infrastructure associated with Misery Pit. It is located along the western side of the Misery waste rock storage area (WRSA; Figure 2.5-1). It was not left in a free dump state but was levelled and recontoured. To help maintain biological processes it was seeded with native grass cultivars and fertilized in 2002 (Photo 2.5-1). Martens (2013) reported that in 2012 a thick sward of grasses and litter covered the stockpile to such an extent that establishment of indigenous native species was inhibited. In 2015 the stockpile was partially covered with free dumped surface material salvaged from the Lynx Pit and Misery crusher pad while those areas were being developed (Photo 2.5-1). That new material was seeded in 2016. Since then the stockpile has been levelled and the southeasterly 2/3 to 3/4 of it appear to have been capped with 1.5 to 2 m of highly compacted mineral material. Native vegetation is establishing on the remaining, exposed portion of the stockpile and no seeding is currently planned in that area. The motivation behind the apparent capping of the topsoil is unknown.

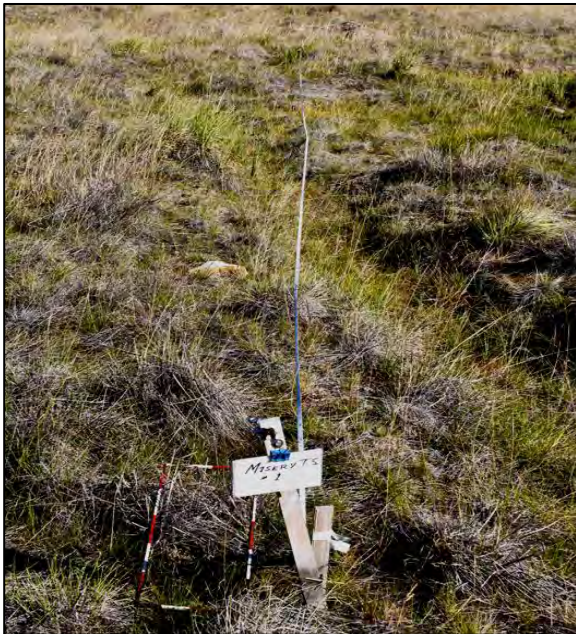
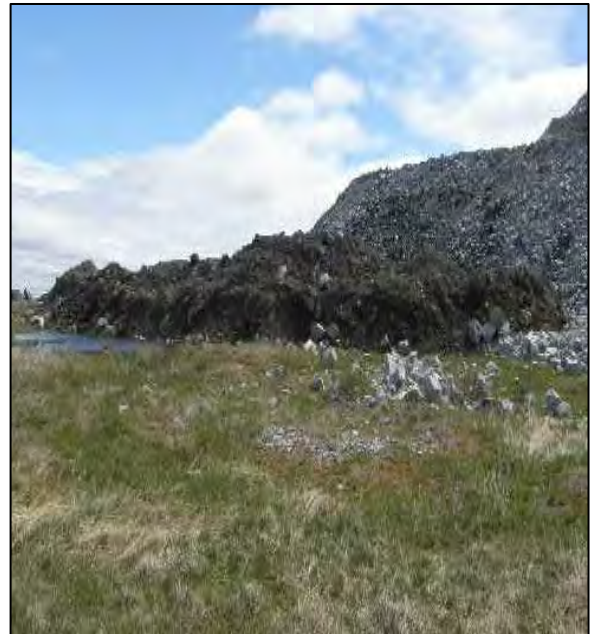
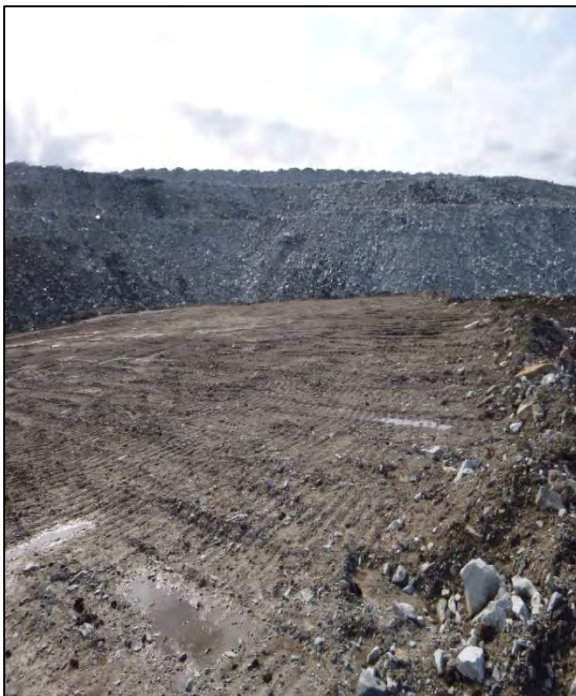
Photo 2.5-1: Misery Topsoil Stockpile site photos.

Native vegetation has begun to establish on the uncapped portion of the Misery topsoil stockpile despite the short interval since it was levelled. Four indigenous plant species were recorded along the transect (Table 2.5-1) and nine additional species were observed growing nearby (Photo 2.5-2). Total live plant cover was 11.1%, comprised of 5% vascular and 6.1% non-vascular plants (mosses). Litter is also accumulating and contributed 9.3% of the 20.4% total ground cover measured. No vegetation was observed growing on the compacted southeasterly portion of the stockpile.

Misery Topsoil in 2012 showing vigorous grass growth.

Misery Topsoil Stockpile in 2016 with material salvaged and added in 2015 in the background.

Levelled and compacted portion of the Misery Topsoil Stockpile in 2019.

The Misery topsoil stockpile was originally constructed in 1999 with surface material salvaged during development of infrastructure associated with Misery pit. It was levelled then seeded and fertilised in 2002 and a thick cover of native grass cultivars and litter subsequently developed (Martens 2005, 2009, 2011, 2013). Free dumped material salvaged from Lynx Pit and the Misery crusher pad was added to the stockpile in 2015, partially covering the original pile. That new material was seeded in 2016. When the site was revisited for monitoring in 2019 it was found to have been levelled and the majority buried under 1.5 to 2 m of highly compacted mineral material, possibly till. The remaining uncovered portion was found to support a developing native plant community and should be monitored again in 2020.

Topsoil is a valuable future resource at the Ekati mine site and every effort should be made to conserve and store it in as healthy condition as possible. Working the soil with large, heavy machinery (e.g., D-10 dozer) results in serious compaction which ultimately disrupts natural biological processes both on and within it and will render it a far less viable growth medium when the time comes to deploy it. Burying topsoil is even less desirable. Buried or heavily compacted material is also more difficult to retrieve from the stockpile and spread. Observations of other topsoil stockpiles on the mine site that were left in the free dump state and now support relatively diverse native plant communities (e.g., Beartooth) indicate that that is the better handling option. Using low ground pressure machinery (e.g. LGP D-6 dozer) is preferred whenever topsoil must be handled.
