**MUSWELLBROOK COAL COMPANY**

**ANNUAL ENVIRONMENTAL  
MANAGEMENT REPORT**

Name of Mine: **Muswellbrook Coal**

AEMR Commencement Date: **1 January 2019**  
AEMR End Date: **31 December 2019**

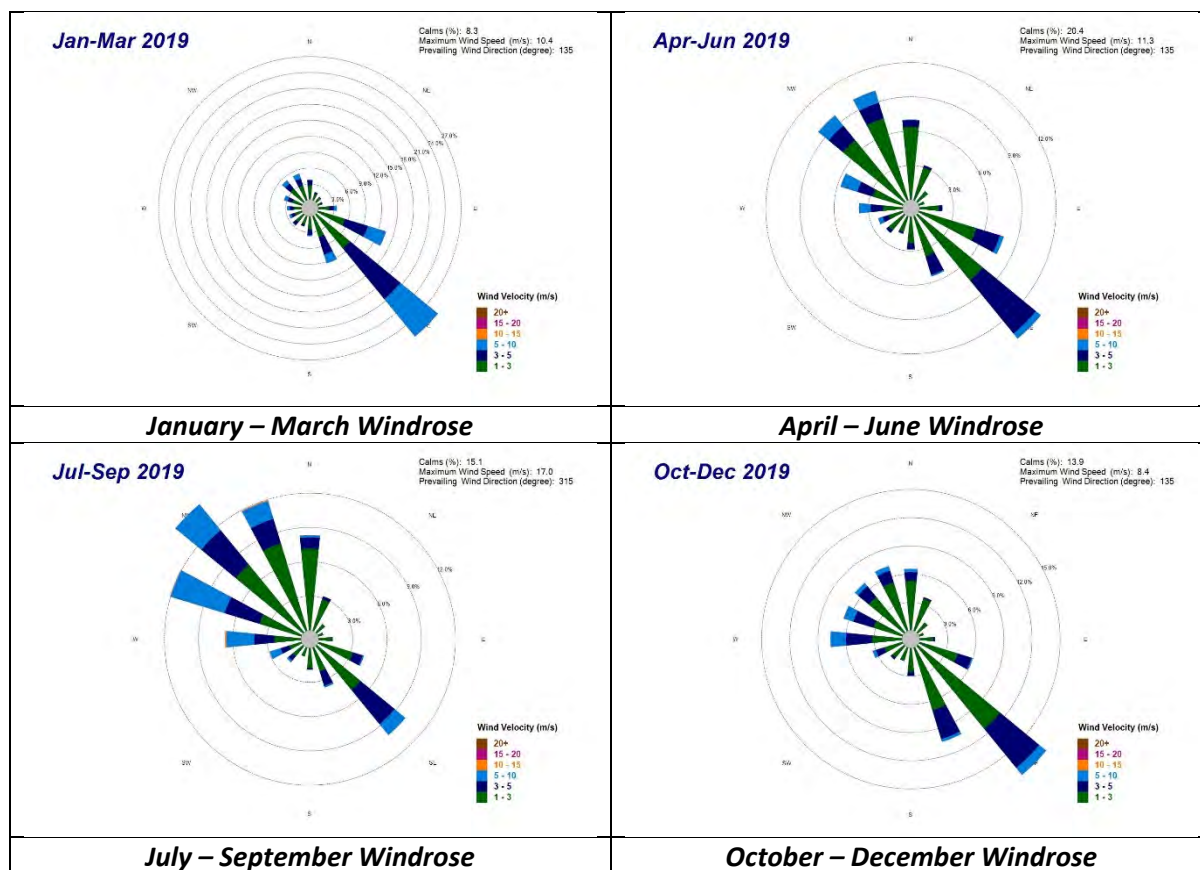
Figure 2: Quarterly Windroses

Quarterly wind roses are provided in **Figure 2**. These results are generally consistent with the predominant wind patterns in the Hunter Valley.

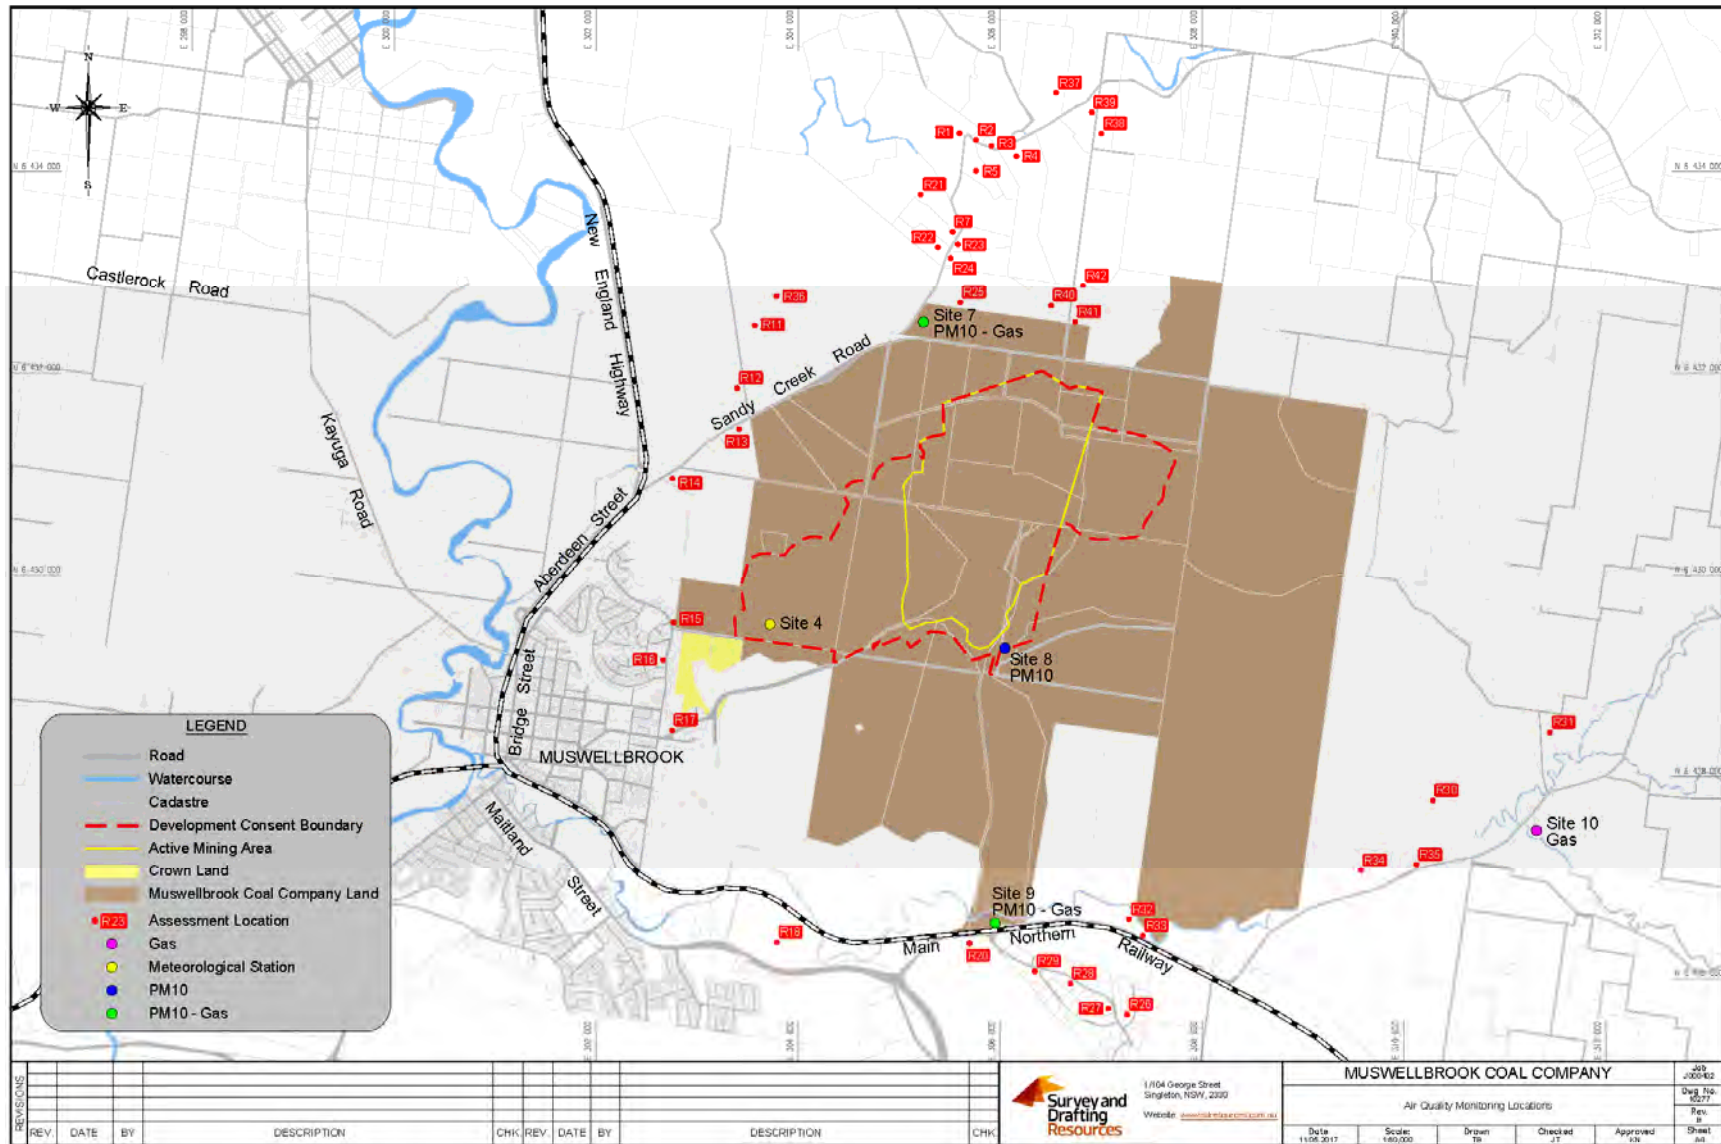
Figure 5: Air Quality Monitoring Locations

The air quality monitoring sites are displayed in **Figure 5**.

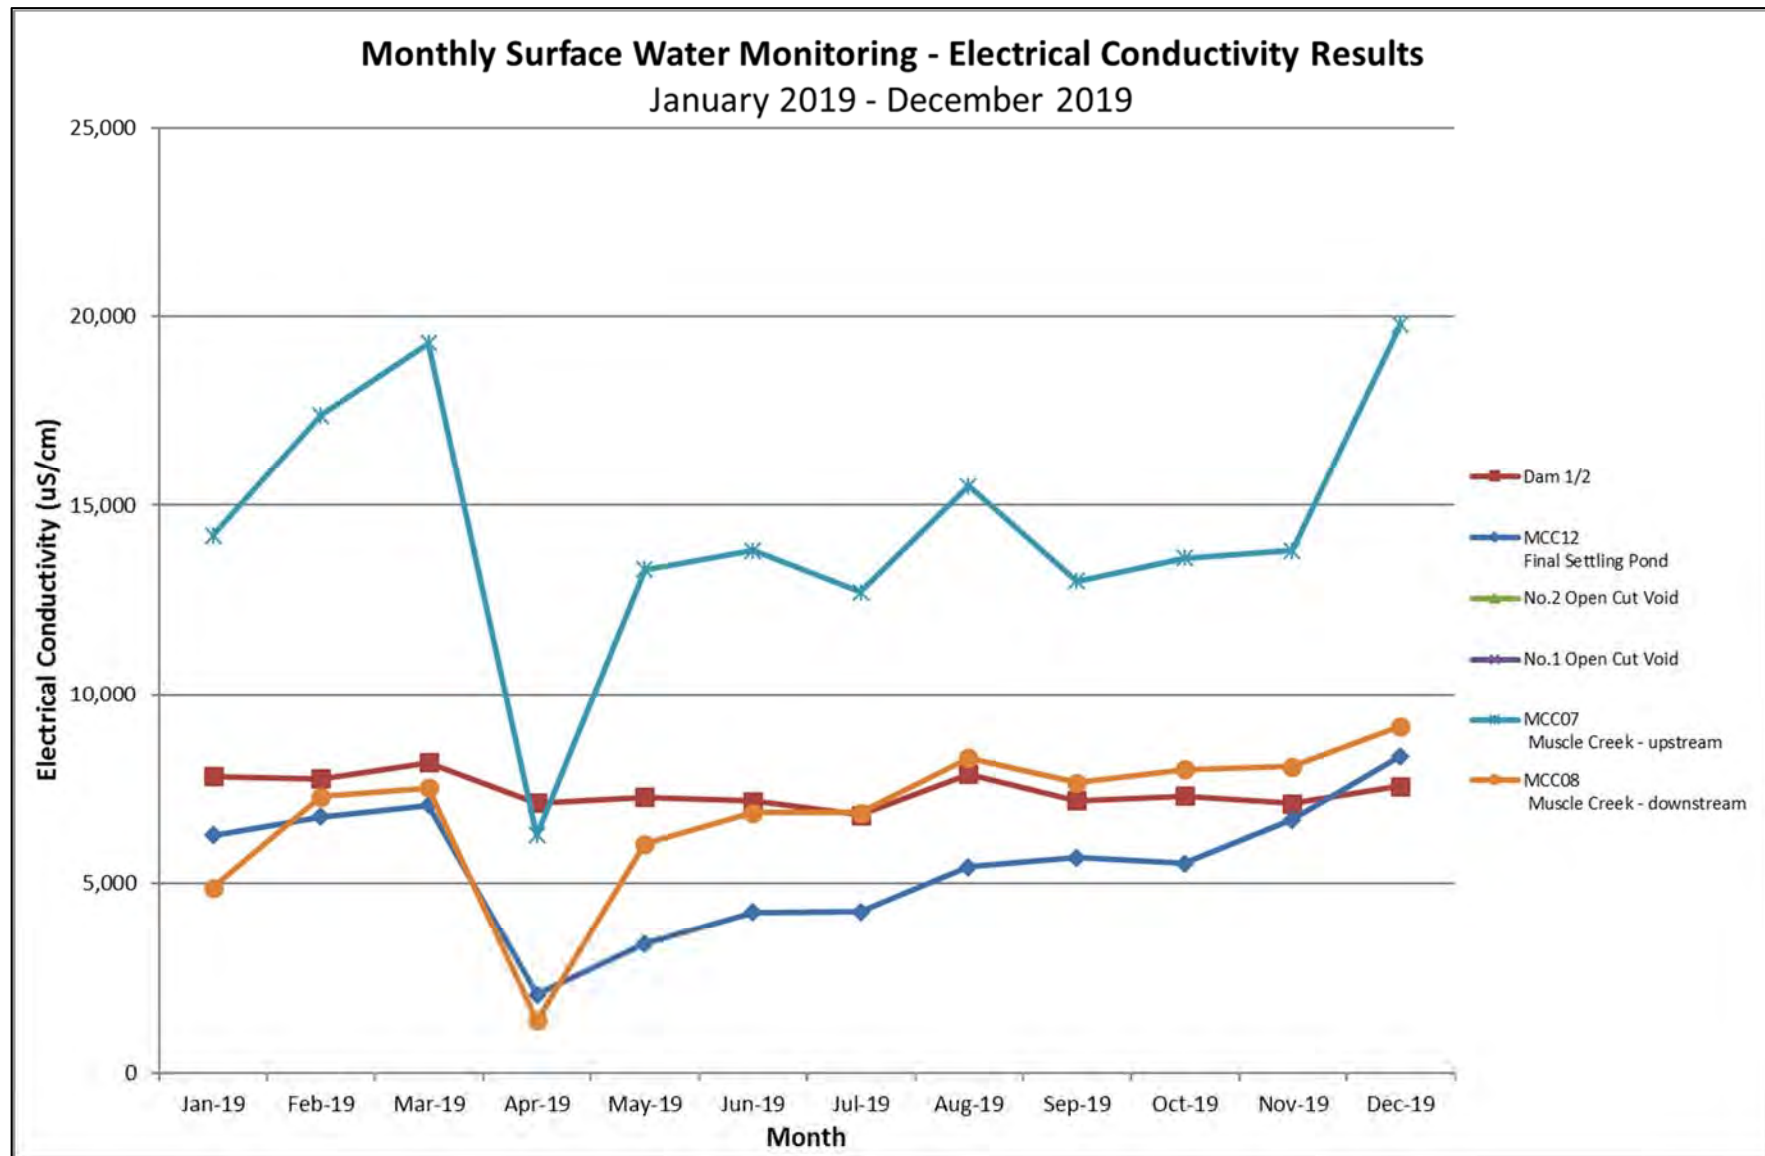
Figure 11: Monthly Surface Water Results – Electrical Conductivity

The surface water pH, Electrical Conductivity (EC) and Total Suspended Solids (TSS) results are shown graphically in **Figure 10** to **Figure 15**. The data and the annual comprehensive surface water monitoring results are provided in **Appendix 2**.

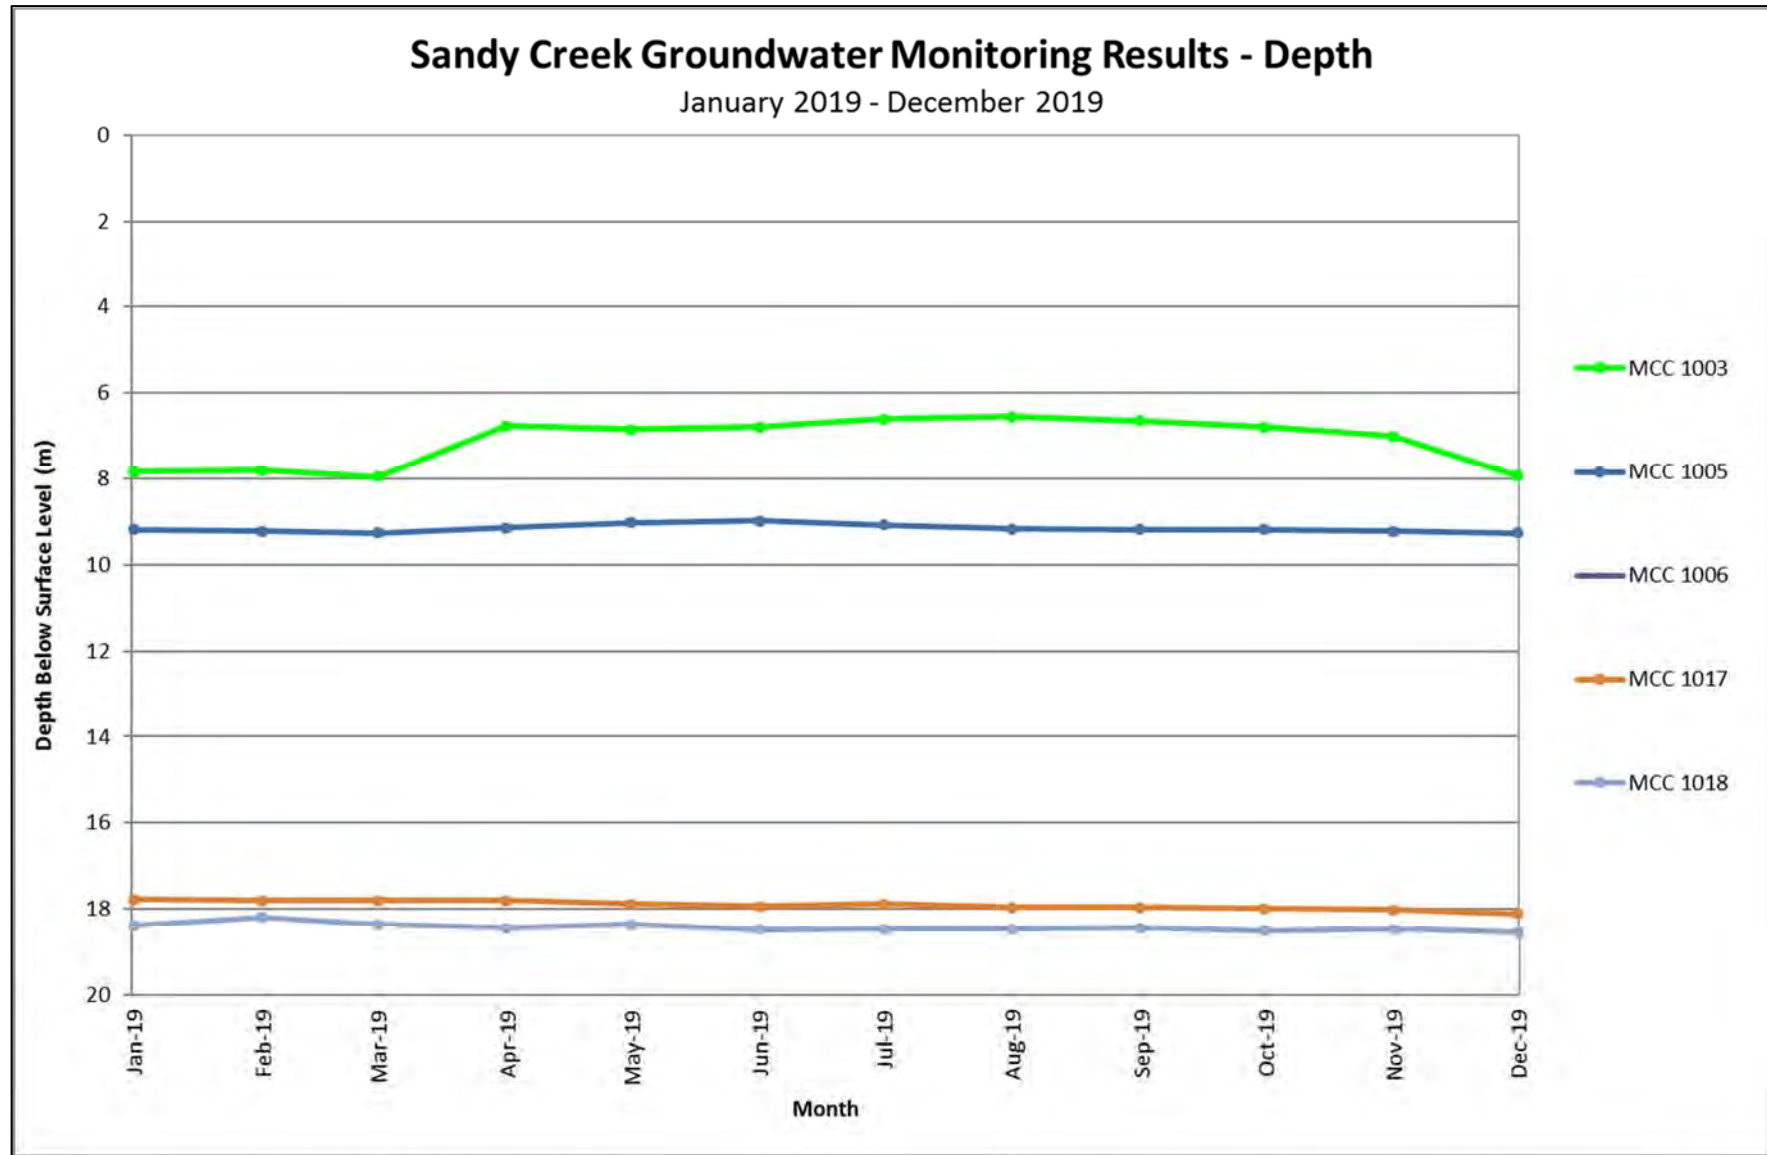
Figure 19: Sandy Creek Groundwater Depth

The alluvial and hard rock aquifers in the Sandy Creek area are a significant lateral distance from the open cut footprint and no impacts have been determined. Ground water depths and quality results are presented in **Figure 19** to **Figure 21**. The data and the annual comprehensive groundwater monitoring results are provided in **Appendix 2**.

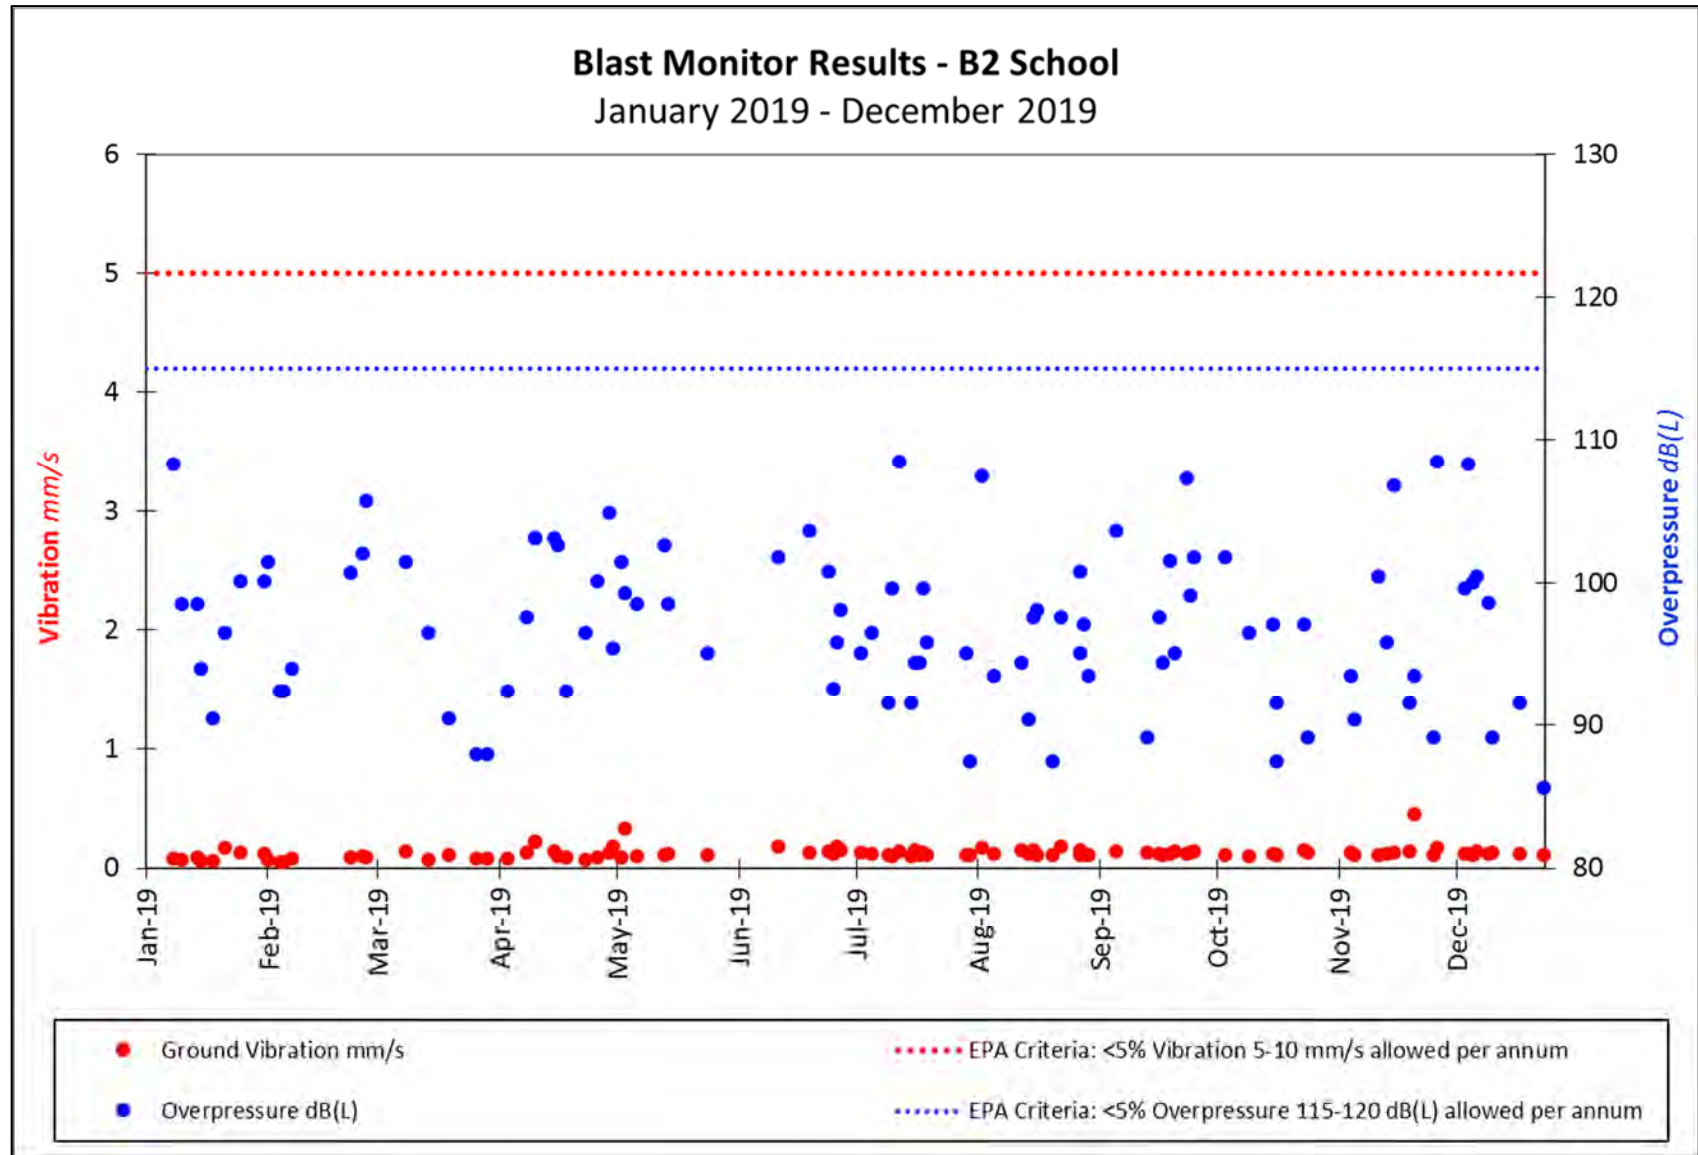
Figure 25: School Blast Monitoring Results

A summary of blast monitoring results is displayed in **Figure 24** to **Figure 27**. Blast data for all monitors is shown in **Appendix 3**.

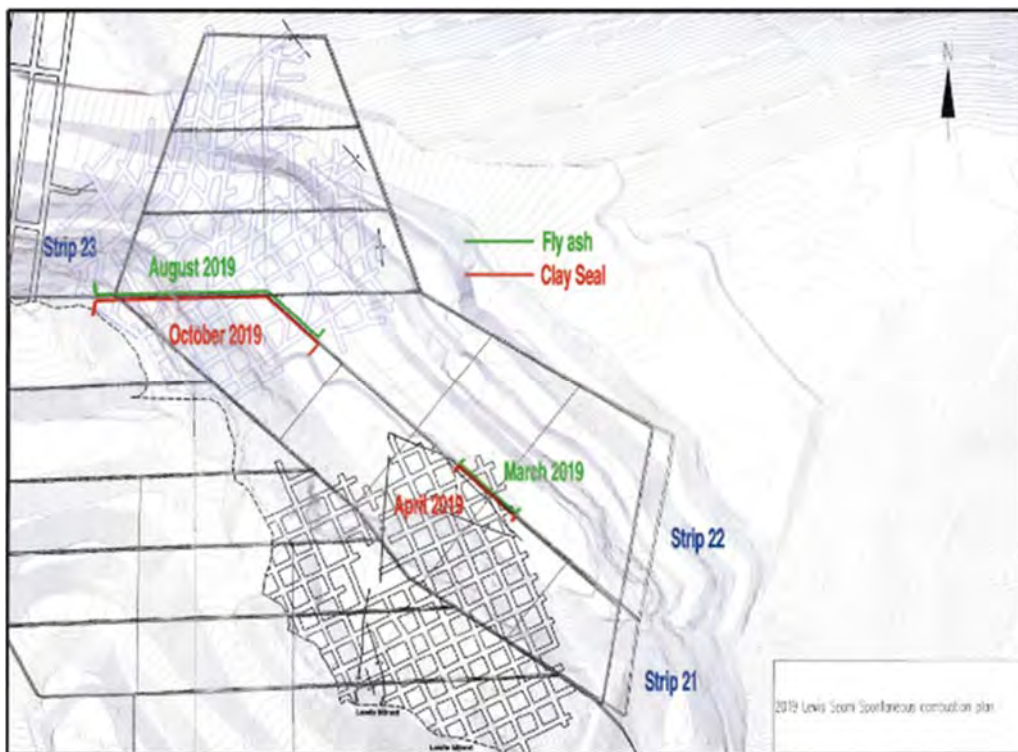
Figure 29: Proposed sealing in Lower Lewis Workings

The planned fly ash and clay sealing activities for this reporting period are shown in **Figure 29** to **Figure 30**.

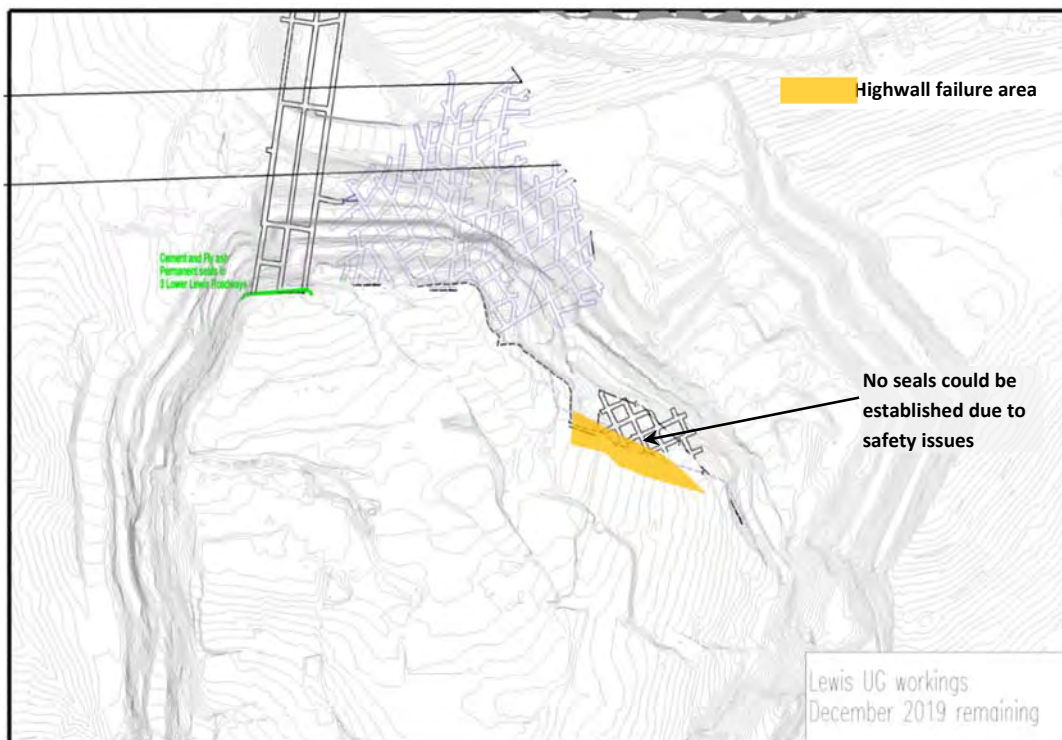
**Figure 31: Actual sealing in Lower Lewis workings**

The actual fly ash and clay sealing activities for this reporting period are shown in **Figure 31** to **Figure 32**.#

The reasons why not all of the proposed activities were undertaken include:

- A highwall failure preventing access to parts of the Lower Lewis workings. This lack of access was due to serious safety concerns with working in this area.
- No sealing was able to be conducted on the eastern end of the Muswellbrook and St Heliers workings due to stability issues with the wall.

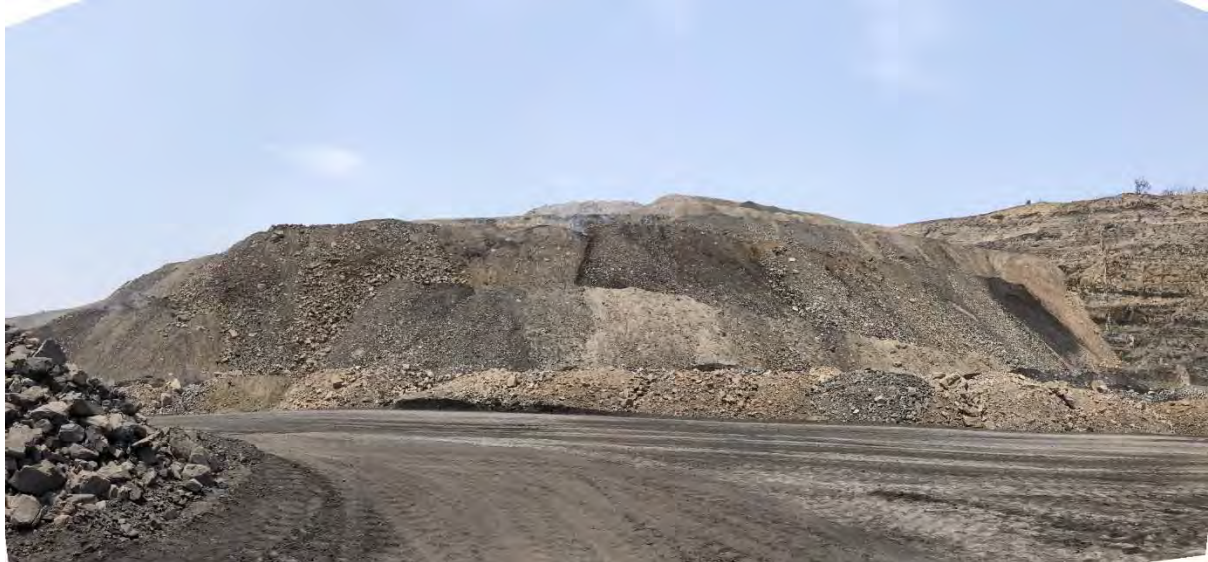
- Good control and management of spontaneous combustion in dumps was achieved (see **Figure 33** and **Figure 34**).

**Figure 33: Photo of Spontaneous Combustion Management on Western Side of OC1 dumps**

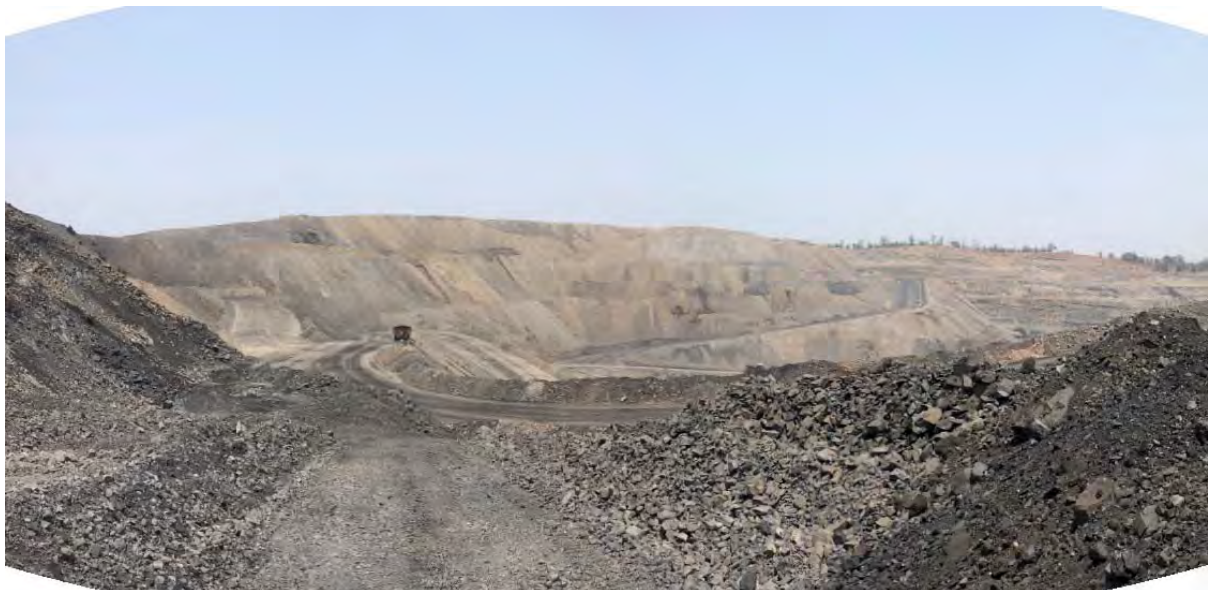
**Figure 34: Photo of Spontaneous Combustion Management on Eastern Side of OC1 dumps**

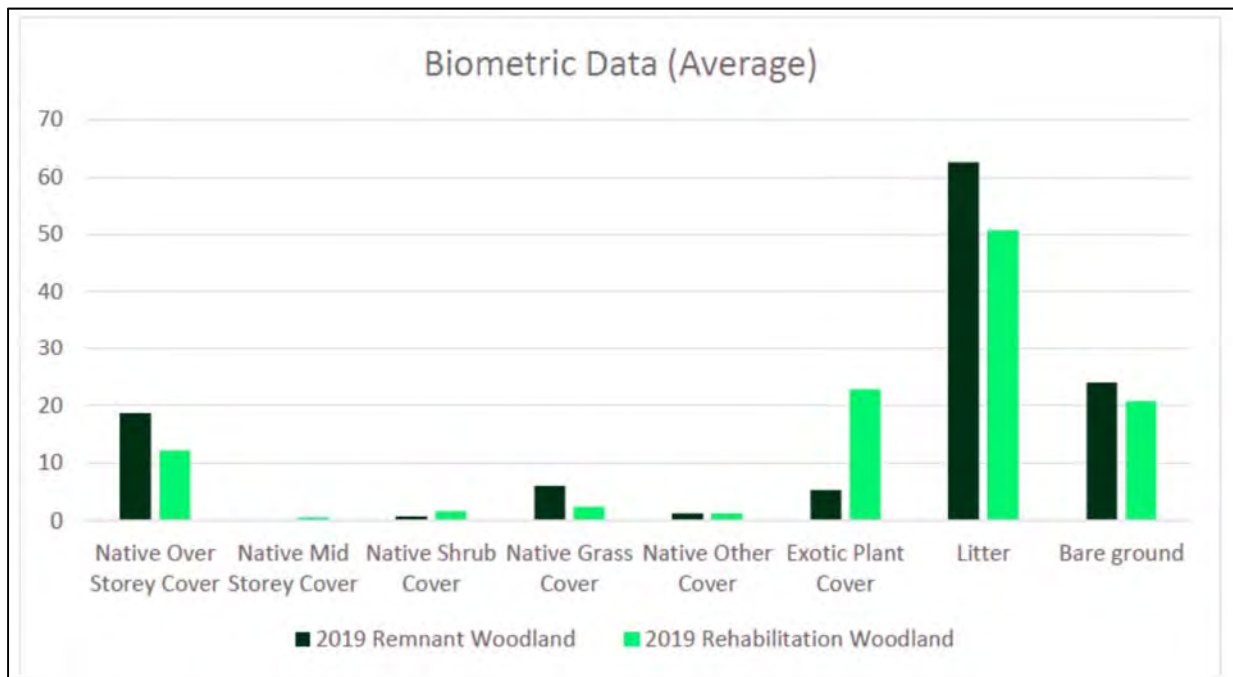
**Figure 43: Biometric Data Averages**

Average percentage of native over-storey, mid-storey cover, and native grass, shrub and native other cover was measured for rehabilitation and remnant woodland sites (**Figure 43**). Exotic plant cover, litter and bare ground was also recorded and provides a comparison between remnant and rehabilitation woodland sites.

The remnant woodland sites contained a greater proportion of native species in general, with a slightly higher proportion in over-storey and grass cover, equal amounts of native other cover and slightly less in native shrub cover. Foliage cover within the over-storey at rehabilitation woodland sites is comparable to remnant woodland sites with rehabilitation woodland sites being 14.4% and remnant woodland sites being 18.7%. Exotic ground cover at rehabilitation woodland sites was five times higher than that found at remnant woodland sites. Both litter cover and bare ground cover were comparable between rehabilitation and remnant woodland sites.

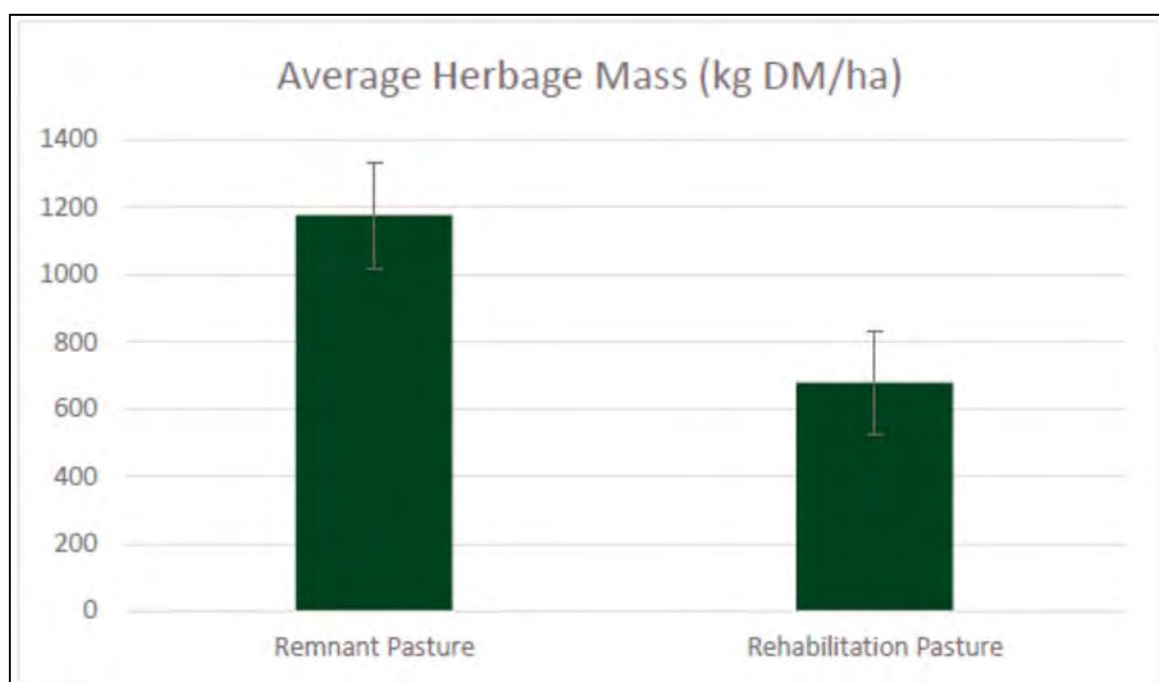
**Figure 44: Average Herbage Mass (kg DM/ha) between Remnant and Rehabilitation Pasture Sites**

Remnant pasture herbage mass for 2019 is presented in **Table 45**. Data collected for rehabilitation pasture sites is presented in **Table 46**. A comparison of the remnant and rehabilitation pasture sites is shown in **Figure 44**.

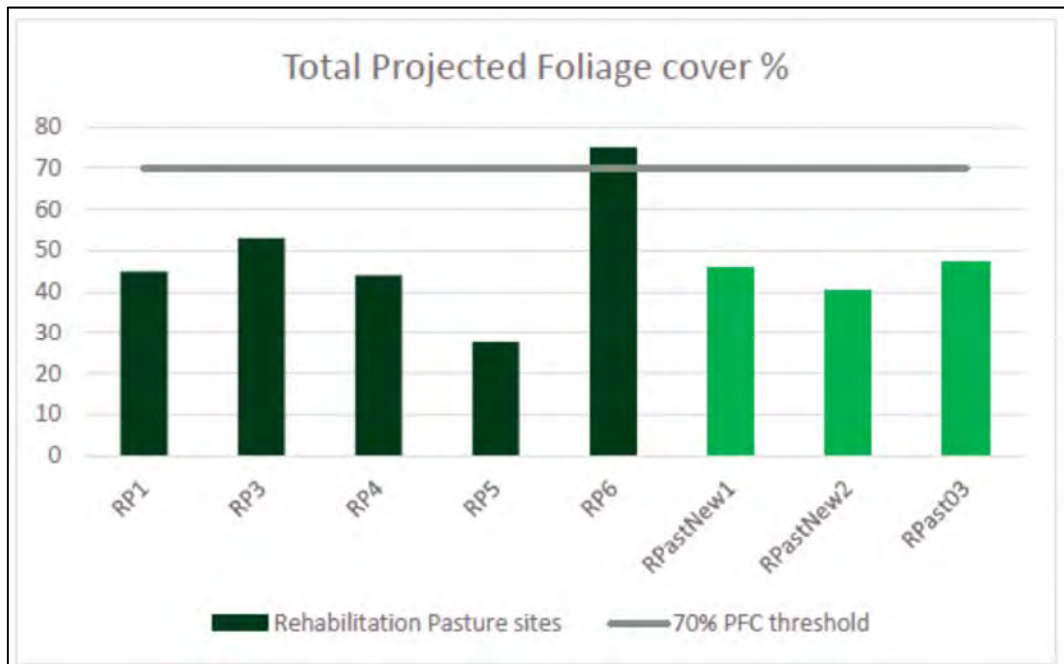
**Figure 47: Total Projected Foliage Cover at Rehabilitation Pasture Sites**

Percentage Foliage Cover (PFC) at each of the rehabilitation pasture sites has been calculated and is presented in **Figure 47**.

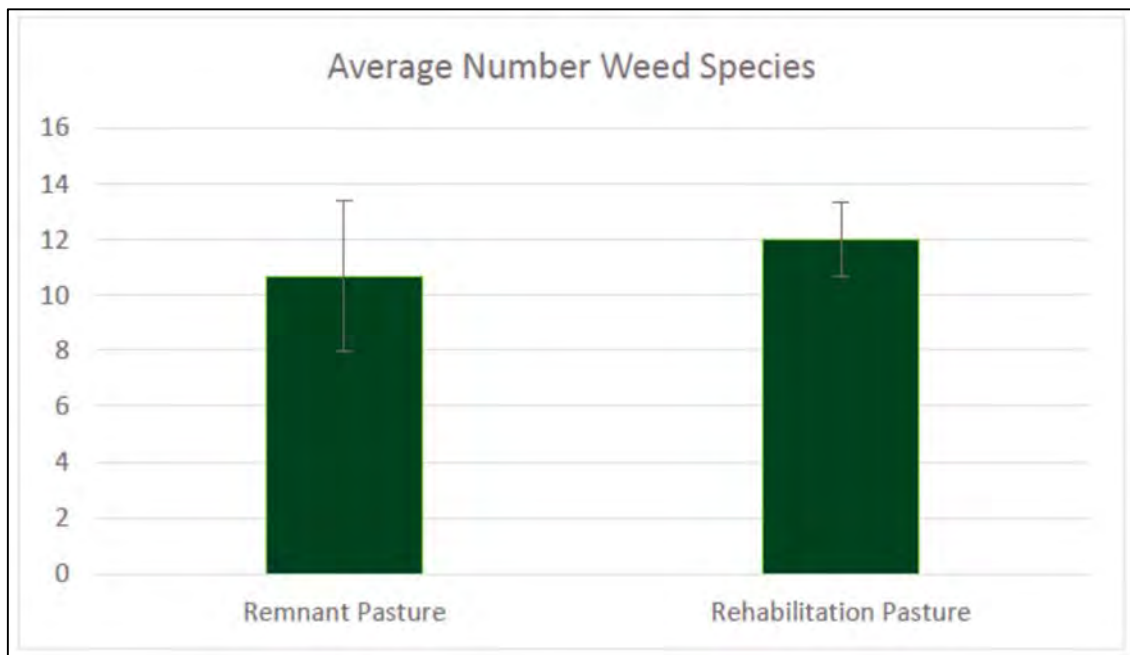
**Figure 48: Comparison Between Remnant and Rehabilitation Pasture Sites for Average Weed Species Richness**

The average number of weed species has been compared between remnant and rehabilitation pasture sites (**Figure 48**). The average weed species present at both remnant and rehabilitation pasture sites was very similar with remnant pasture sites comprising 11 weed species and rehabilitation pasture sites comprising 12 species. This is a decrease in weed species when compared to the previous reporting period.

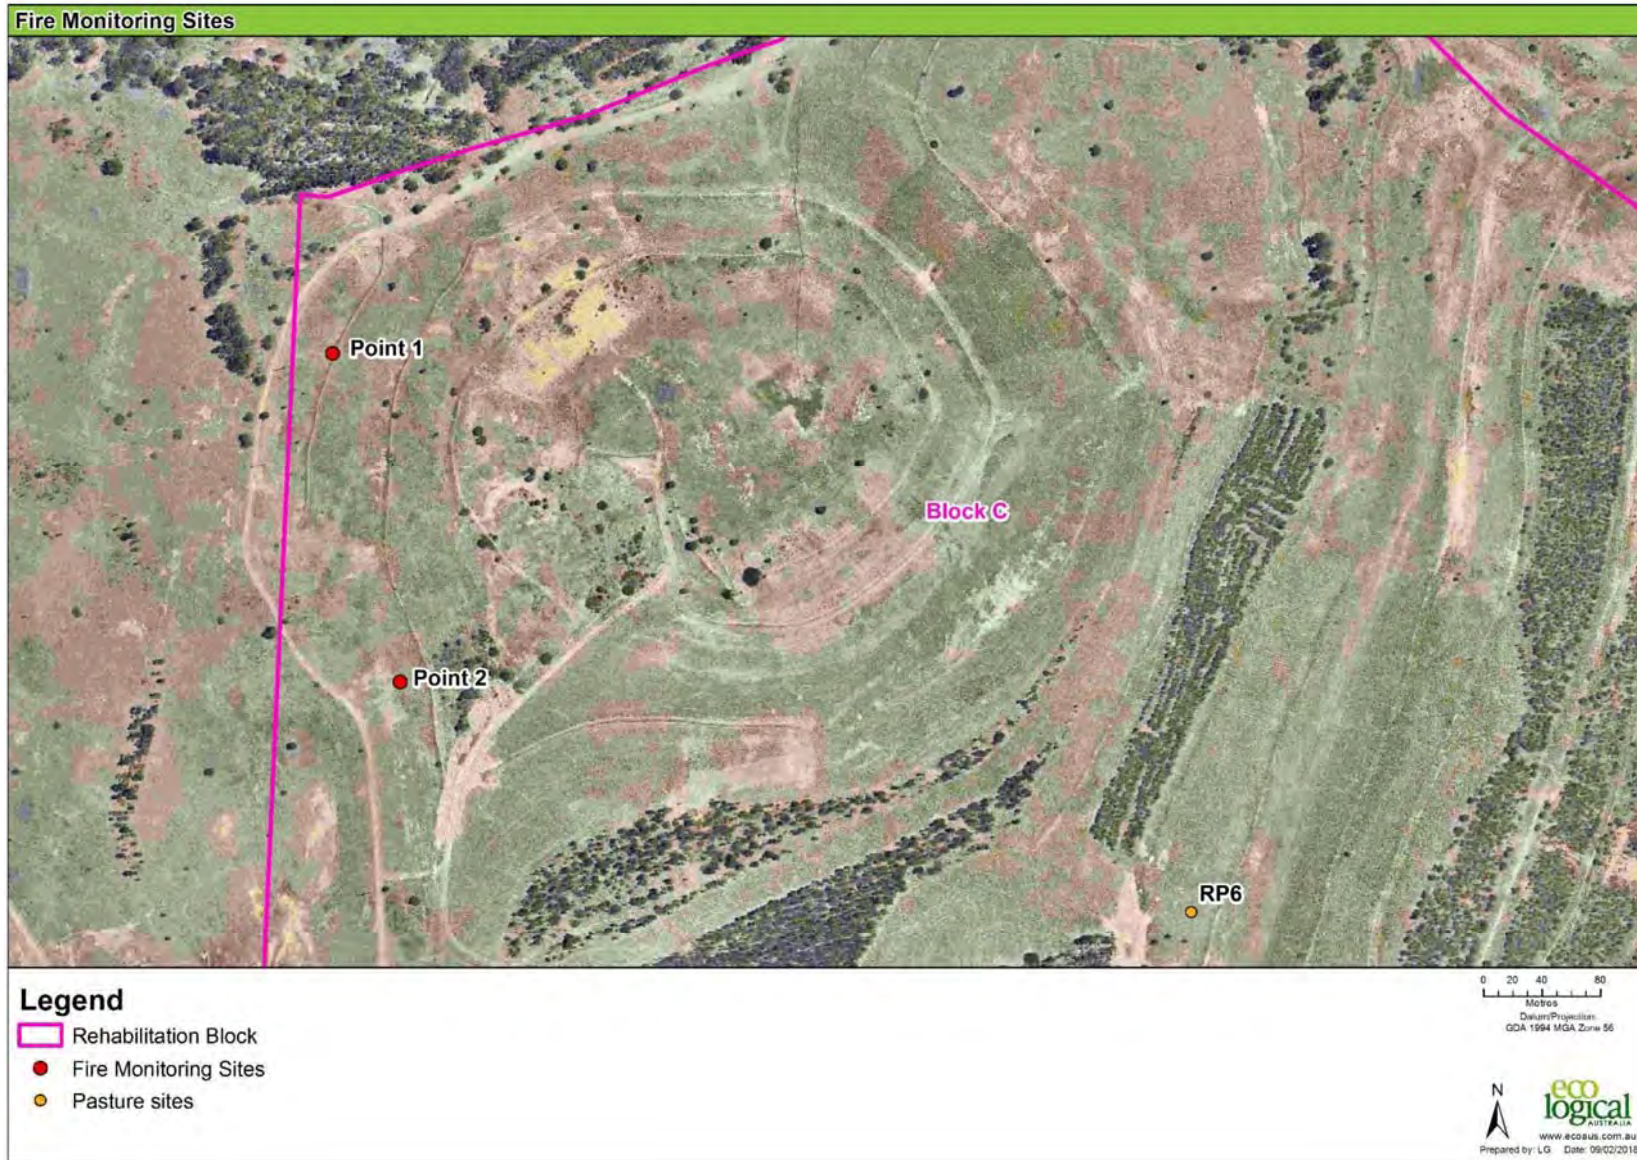
Figure 52: Fire Affected Monitoring Sites

An unplanned fire occurred on the 14 December 2015 within the western and south-western section of Block C. Two monitoring points have been set up to monitor the area in order to document the resilience of rehabilitation to impacts of fire (**Figure 52**).
