NBC COLLIERY GLISA AND PAARDEPLAATS MINING PROJECT

Phase 1 – Heritage Impact Assessment

Issue Date: 19 May 2021
Revision No.: 2.0
PGS Project No.: 524HIA
CI Group project No: 19.0001

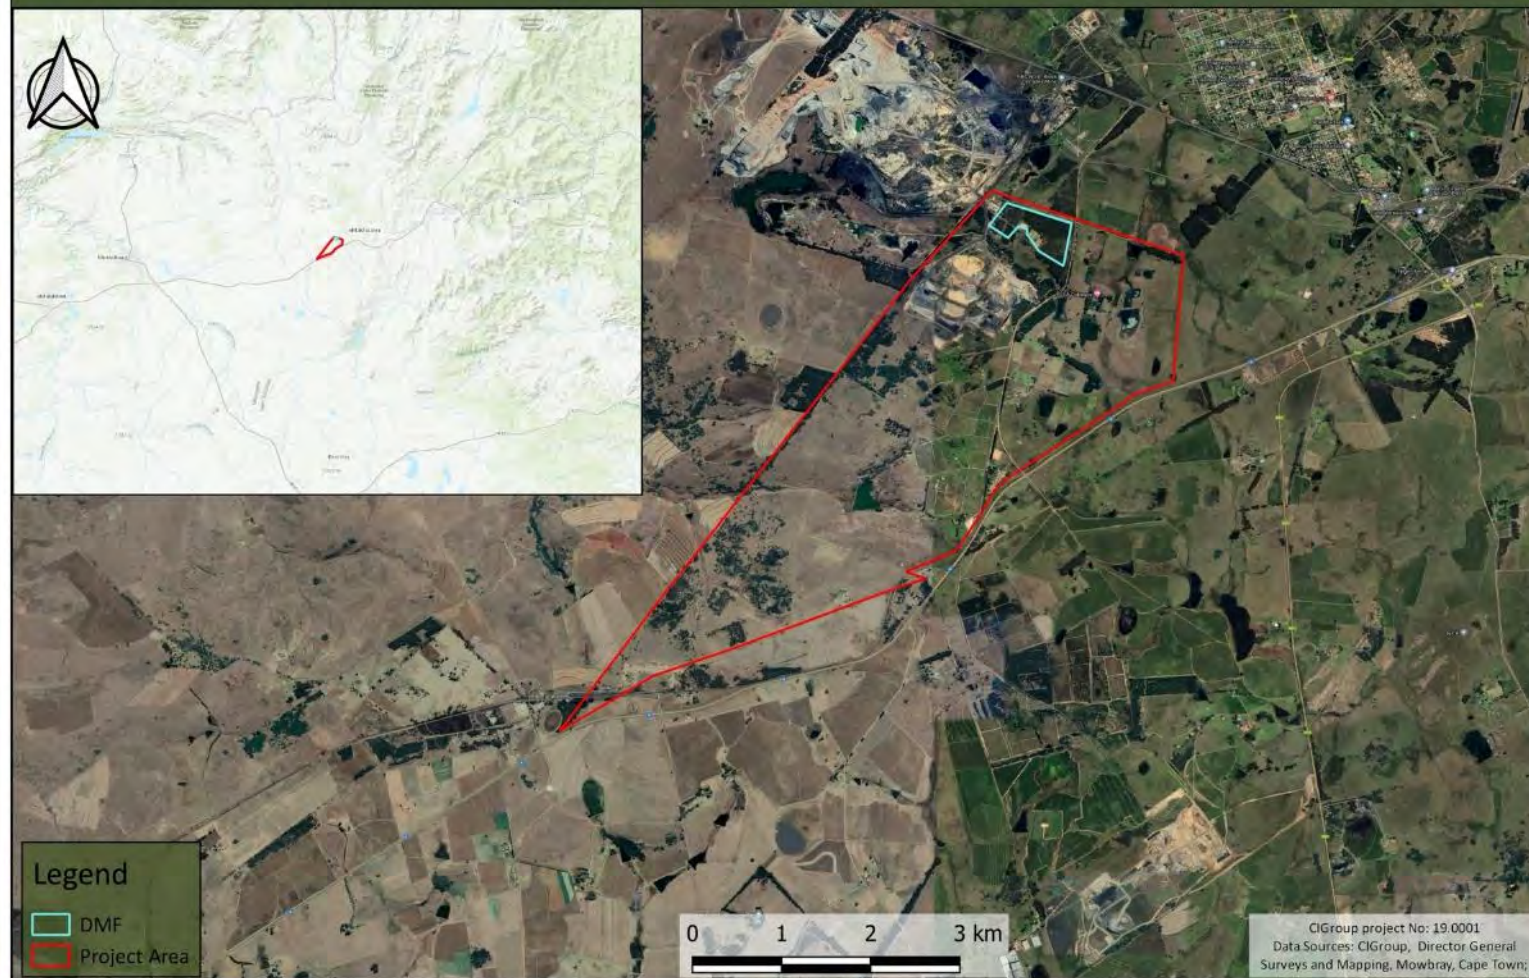
Figure 4 - Locality plan depicting the study area within its surroundings. The position of the proposed DMF area is shown in blue.

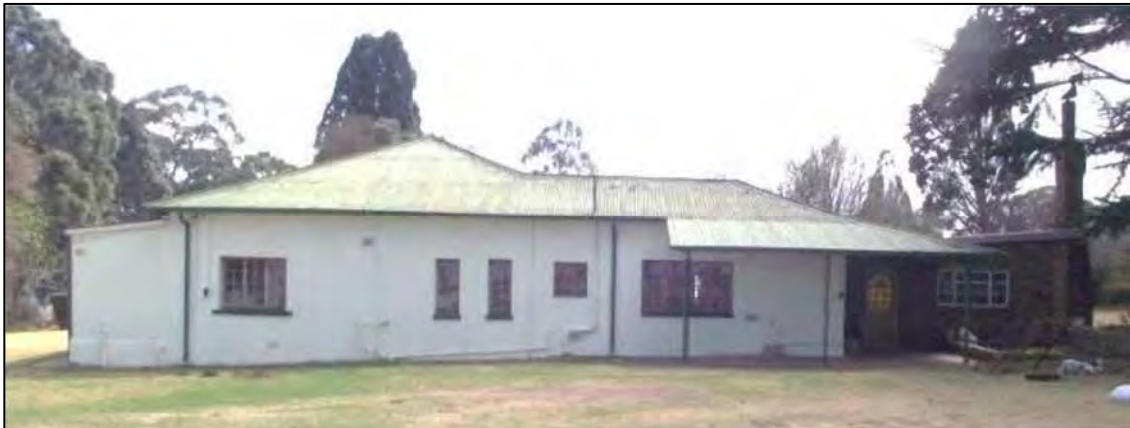
Figure 24 – The main farmhouse building as recorded in 2012 (Photo: Kitto & Fourie, 2012).

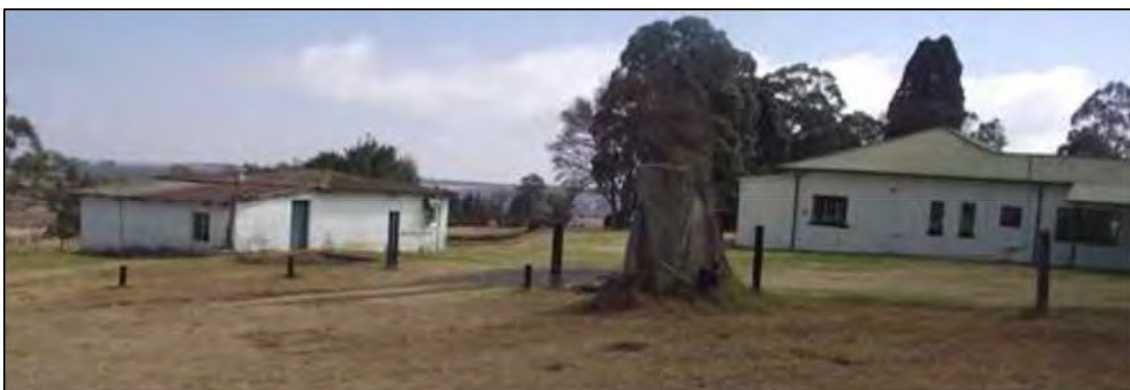
Figure 25 – The main house and storeroom/shed as recorded in 2012 (Photo: Kitto & Fourie, 2012).

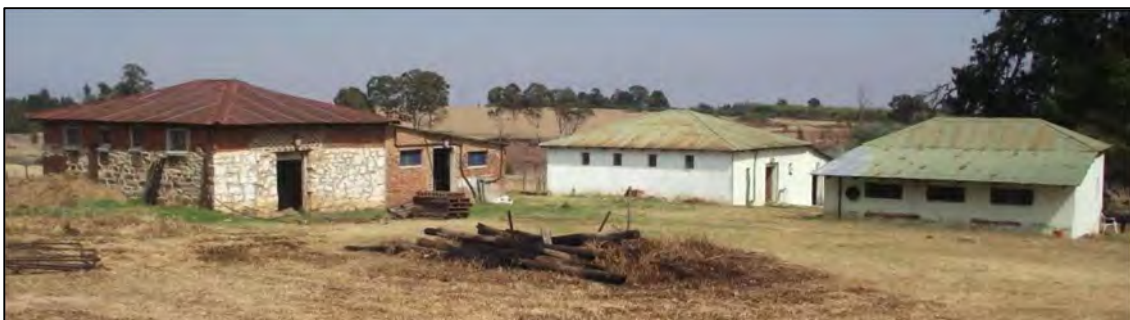
A pigsty was situated next to the cattle shed. The original structure is built with stone and mortar, but later extensions to raise the walls and additions are brick-built. The additions were most probably used as stables for horses. The building has a low pitched corrugated iron roof and external electrical and water systems. The building has no window or door frames and cement lintels were used for the window and door openings. The structure has a cement floor.

Figure 26 - Pigsty and two sheds/storerooms as recorded in 2012 (Photo: Kitto & Fourie, 2012)

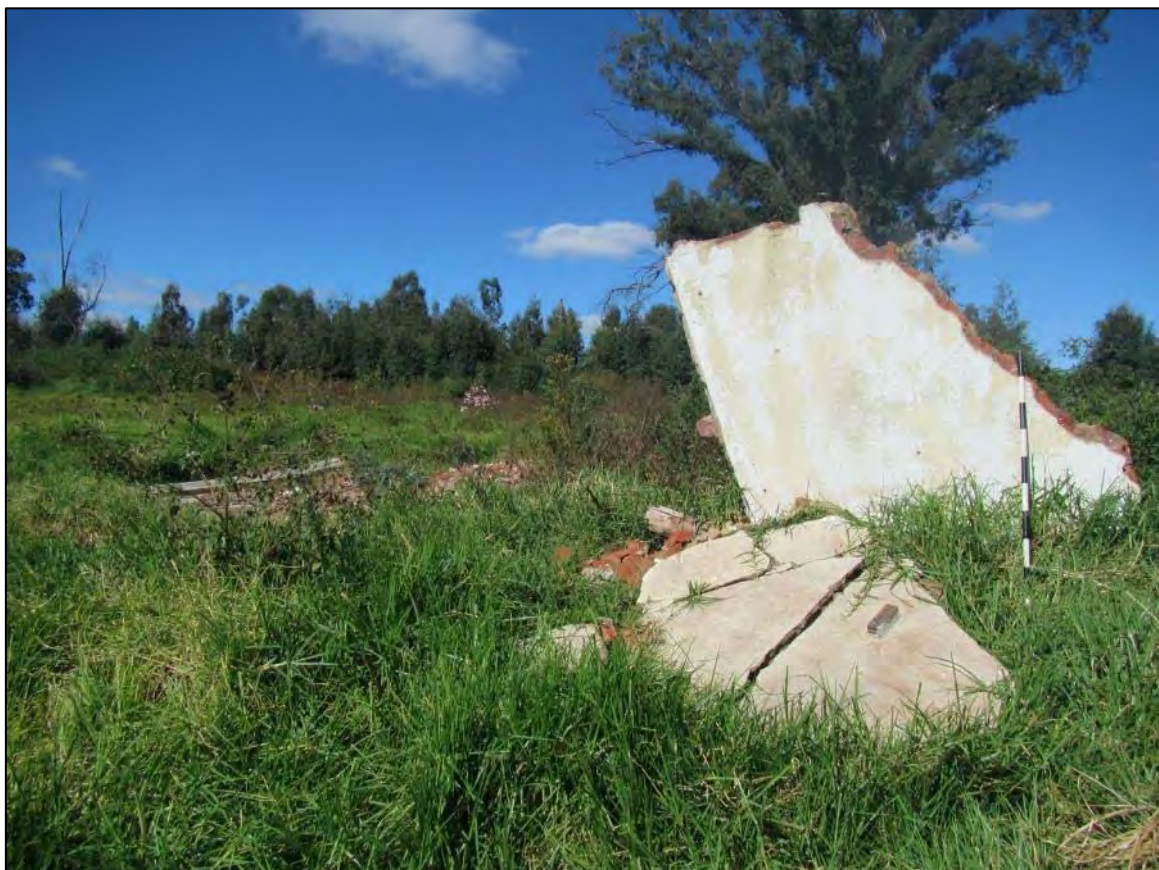
Currently, the structures that were identified at site PP 01 in 2012 have been demolished. Only the ruins of the foundations remain. The site is overgrown and abandoned.

Figure 27 - General view of site PP 01 as recorded during the 2021 fieldwork.

See Chapter 7 for impact assessment calculations and Chapter 8 for required mitigation measures

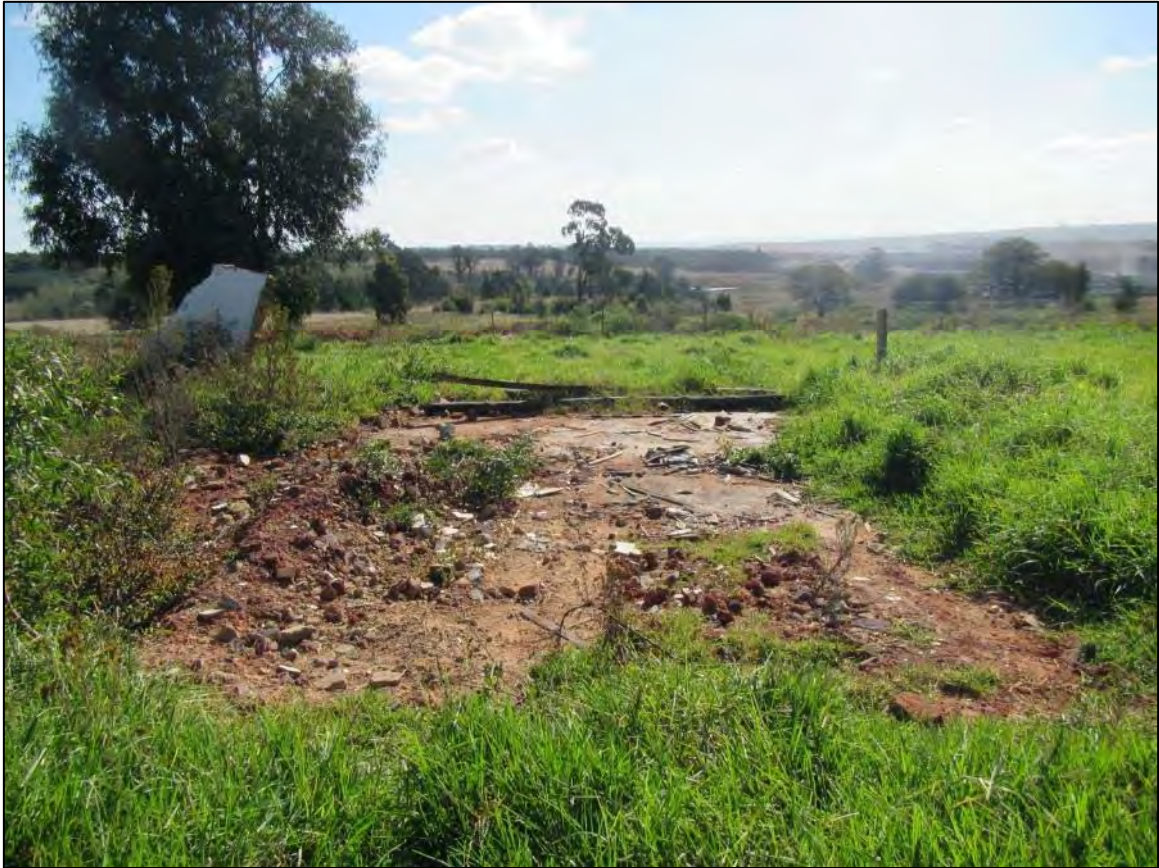
Figure 28 – Another view of site PP 01 as recorded during the 2021 fieldwork.

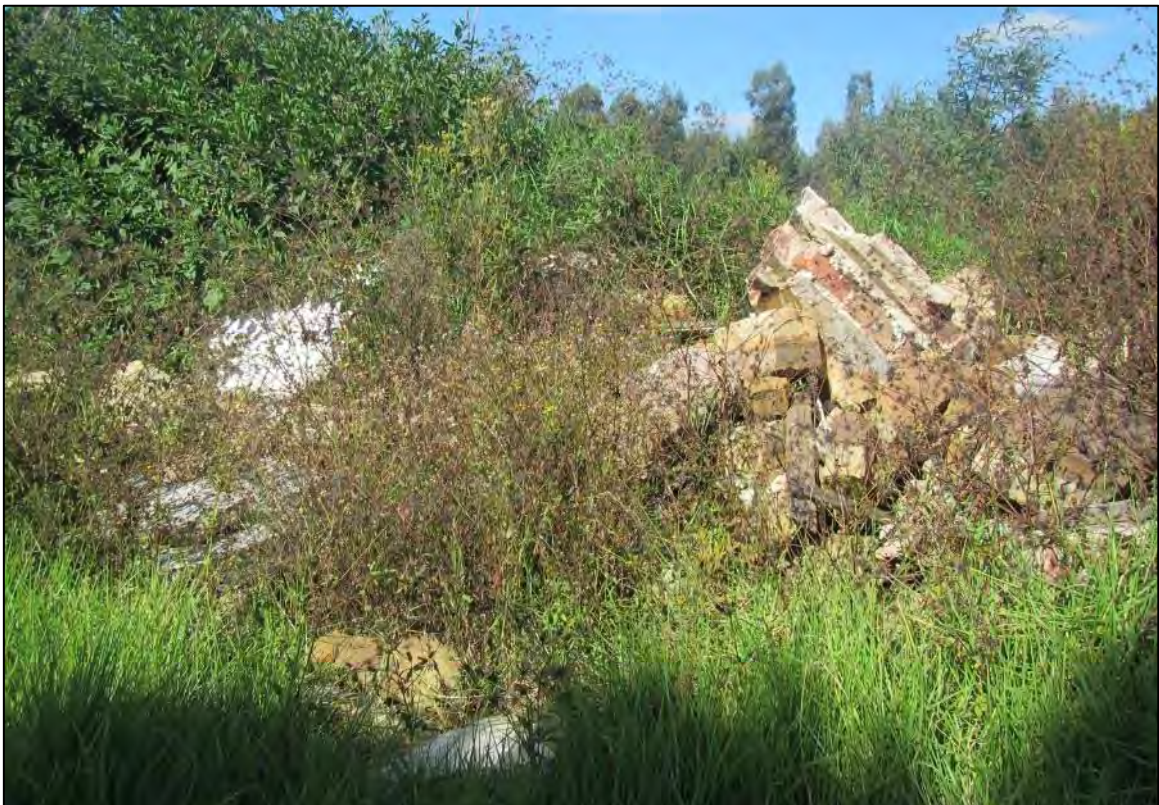
Figure 29 - View of building rubble from the demolished remains of structures from site PP 01.

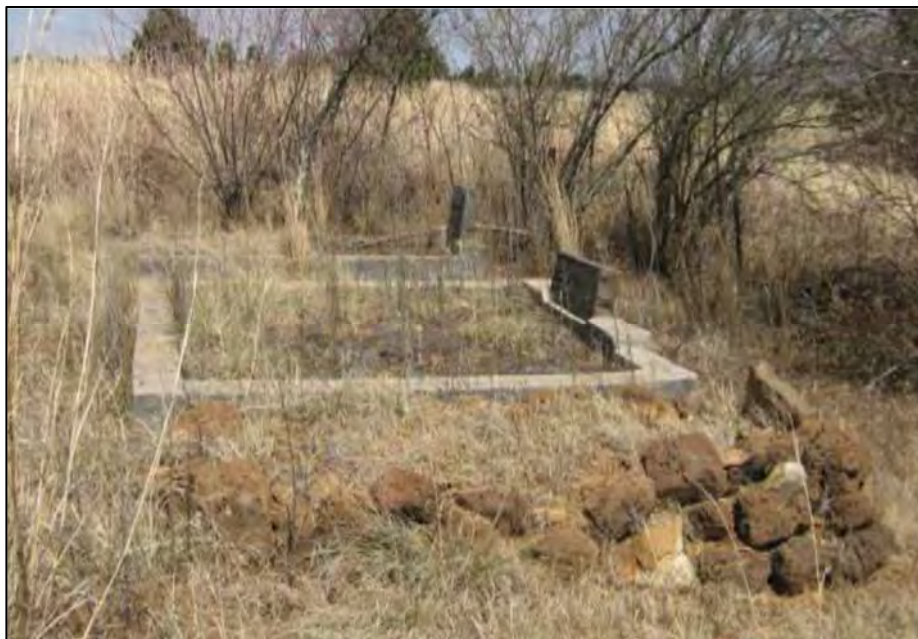
A cluster of four informal graves was identified at this location. The graves are situated in between a gravel road and a fence. The graves are placed next to each other along the fence and are orientated from west to east. One grave has a rectangular-shaped cement outline as a dressing, with an inscribed granite headstone. This seems to be a double child's grave, as the headstone has two inscriptions painted on. Another grave is a double adult grave with a square-shaped cement outline, which is filled with a layer of gravel. It also has an inscribed granite headstone. The fourth grave has an informal, elongated oval-shaped mound of packed rocks as a dressing. It does not have an inscribed headstone. The graves are overgrown with vegetation, but it was evident that the graves had been cleared regularly as the vegetation was not overwhelming. The headstone inscriptions date the graves from the late 1960's and the 1970's and all the names on the graves are of the Mtweni family.

Figure 30 – General view of the cemetery as recorded in 2012 (Photo: Kitto & Fourie, 2012).

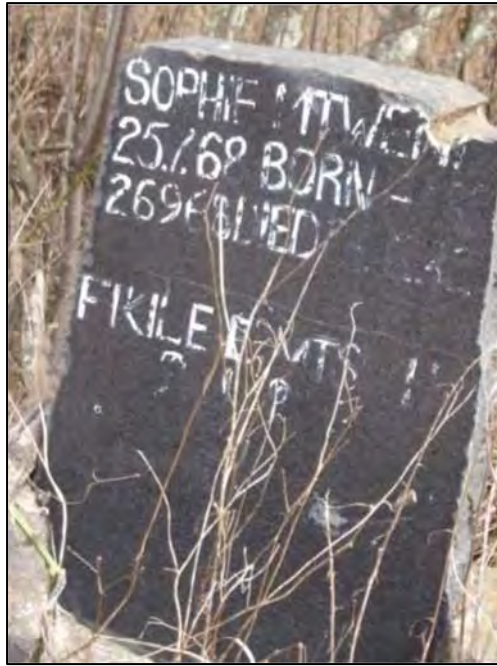
Figure 31 - Inscription on the double child's grave as recorded in 2012 (Photo: Kitto & Fourie, 2012).

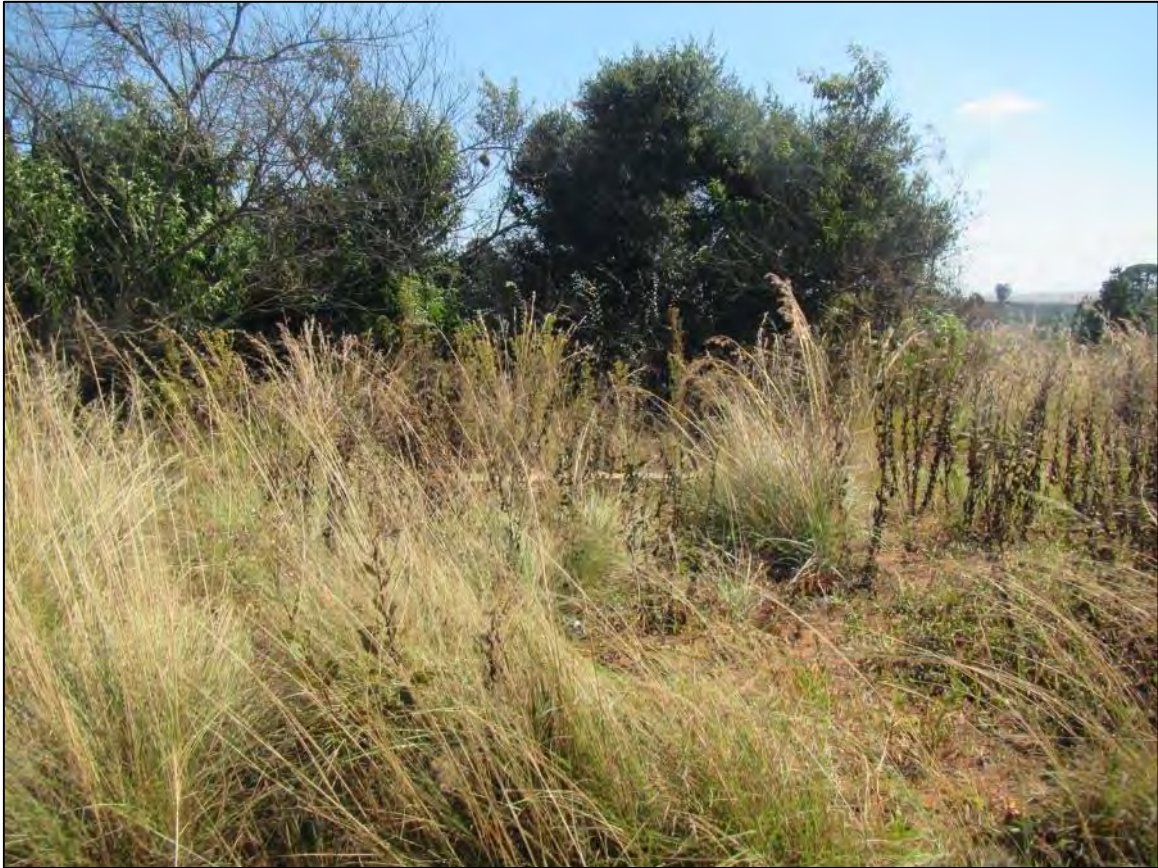
Figure 32 - General view of the cemetery at PP 02 as recorded during the 2021 fieldwork.

See Chapter 7 for impact assessment calculations and Chapter 8 for required mitigation measures.

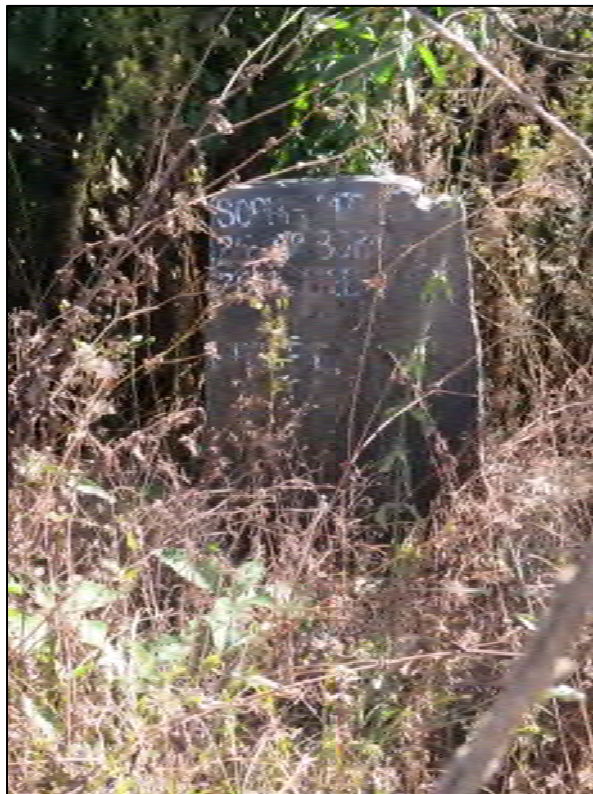
Figure 33 – Closer view of the headstone on the double grave.

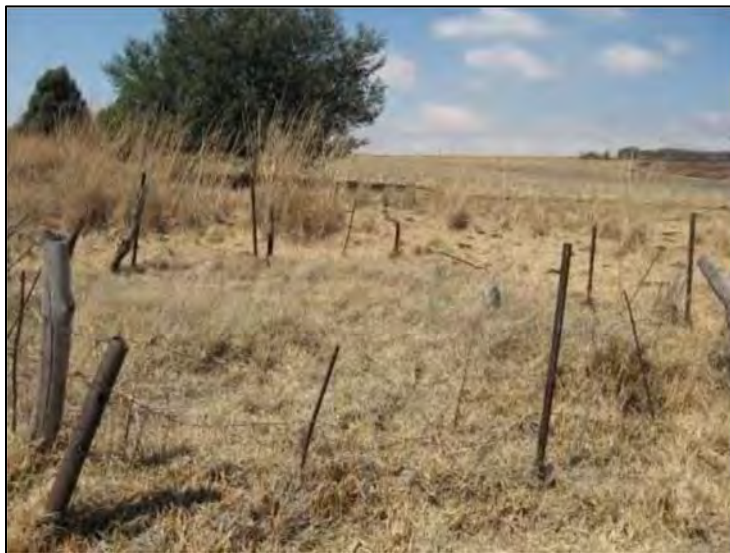
Two informal graves were identified at this location. The graves are crudely fenced and are placed next to each other and orientated from west to east. The graves have large oval-shaped outlines of packed rock as dressings. A flat rock serves as the head stone for one grave. A plastic bottle and ceramic cup were placed on the graves as grave goods. The graves are not maintained and are overgrown with grass and other vegetation. The graves belong to the Maseko family, but their age was not known (local informant - Lina). The Maseko family apparently lives on the farm in the farmworkers houses located behind the farmstead (PP 001). Such graves are treated as being of 60 years or older unless evidence is obtained to the contrary.

Figure 34 – The two Maseko graves as recorded in 2012 (Photo: Kitto & Fourie, 2012).

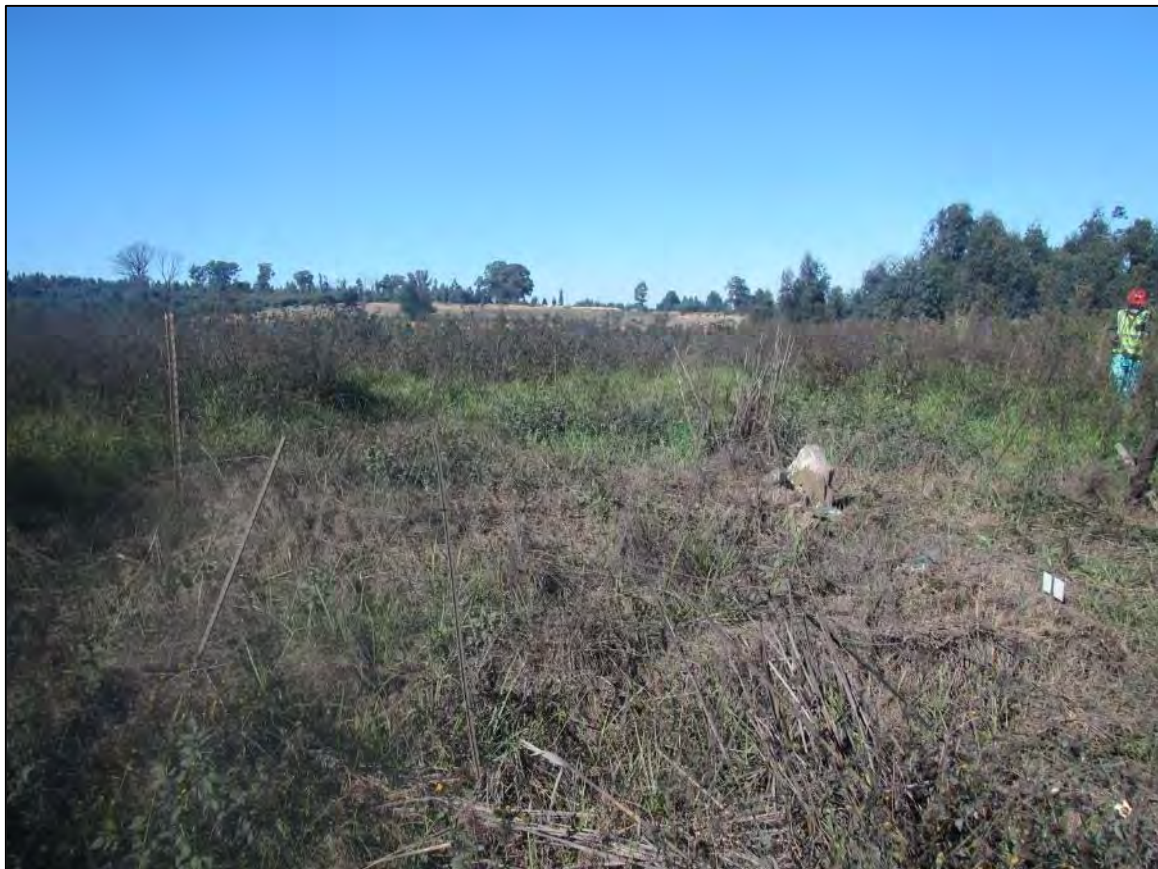
Figure 35 - General view of site PP 03 as recorded during the 2021 fieldwork.

See Chapter 7 for impact assessment calculations and Chapter 8 for required mitigation measures.

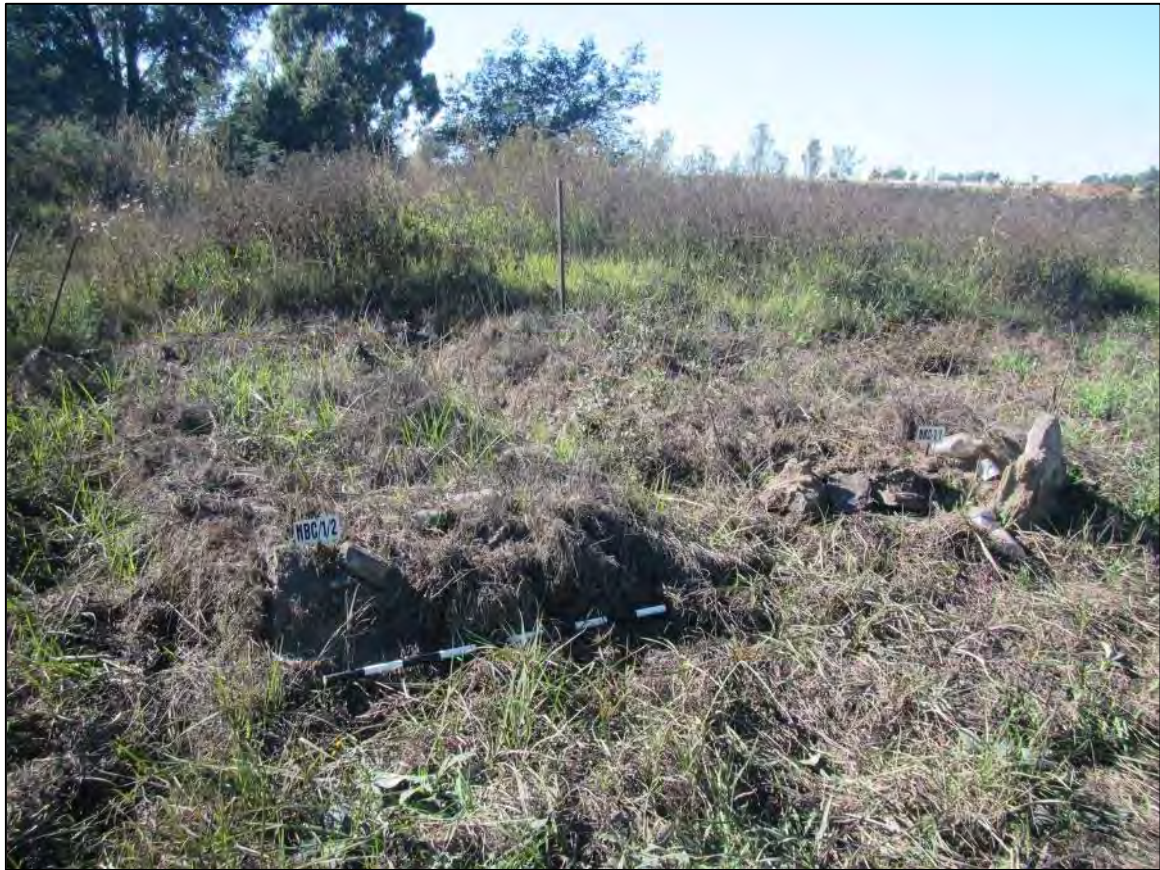
Figure 36 - The two Maseko family graves as recorded in 2021. The scale is in 10cm increments.

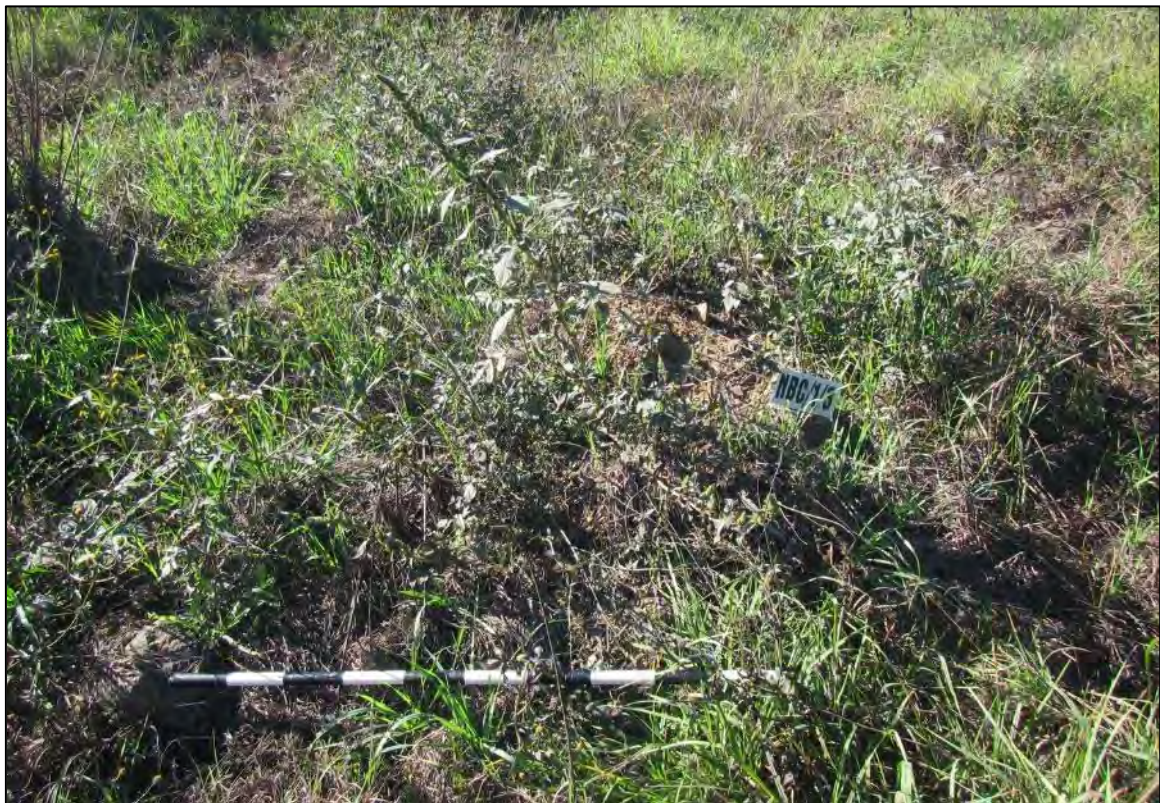
Figure 37 - The third grave belonging to an unknown individual. The scale is in 10cm increments.

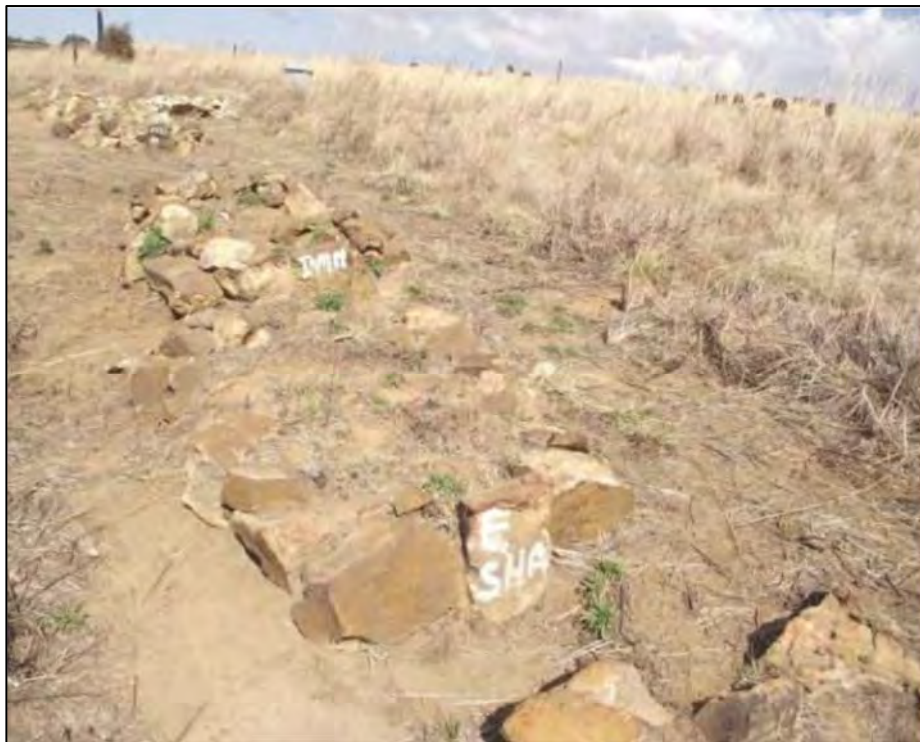
An informal cemetery with approximately 81 graves was identified at this location. The cemetery is not fenced and is located in the open veld. The graves are placed in 5 unequal lines next to each other. The graves are placed along the boundary fence of the property and they are orientated from west to east. Most of the graves have informal oval or rectangular shaped mounds or outlines of packed rocks as dressings. Some of the graves had been cleaned recently, but most of them are overgrown with grass and other vegetation. A number of graves have granite inscribed headstones and one grave has a formal granite dressing with an inscribed granite headstone.

Figure 38 – General view of the cemetery at PP 04 as recorded in 2012 (Photo: Kitto & Fourie, 2012).

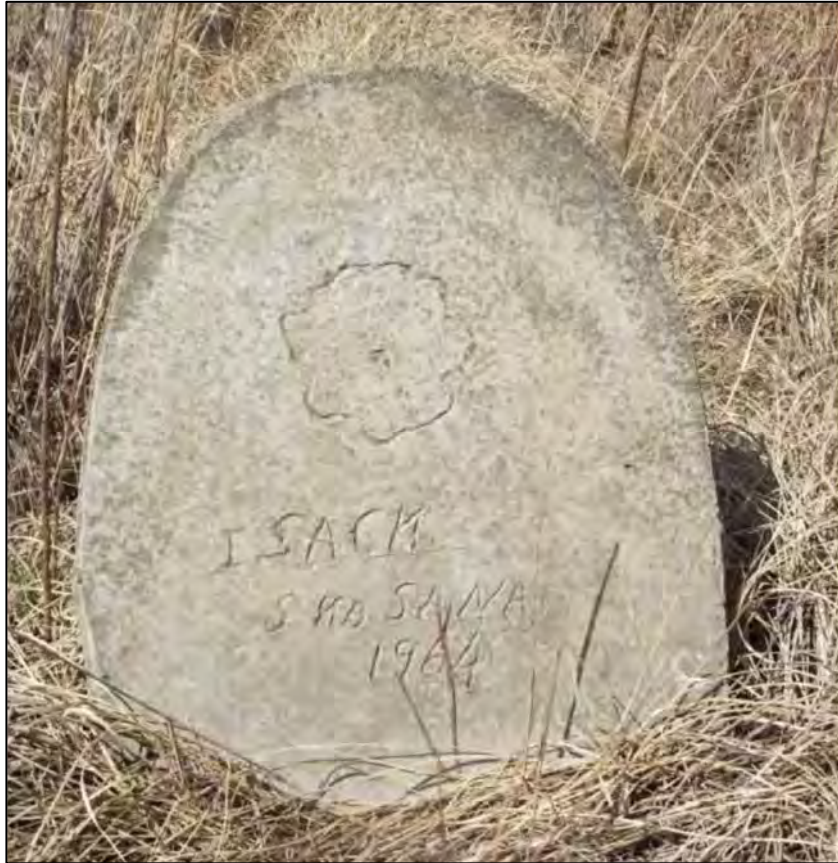
Figure 39 - Close-up view of the headstone on one of the graves (Photo: Kitto & Fourie, 2012).

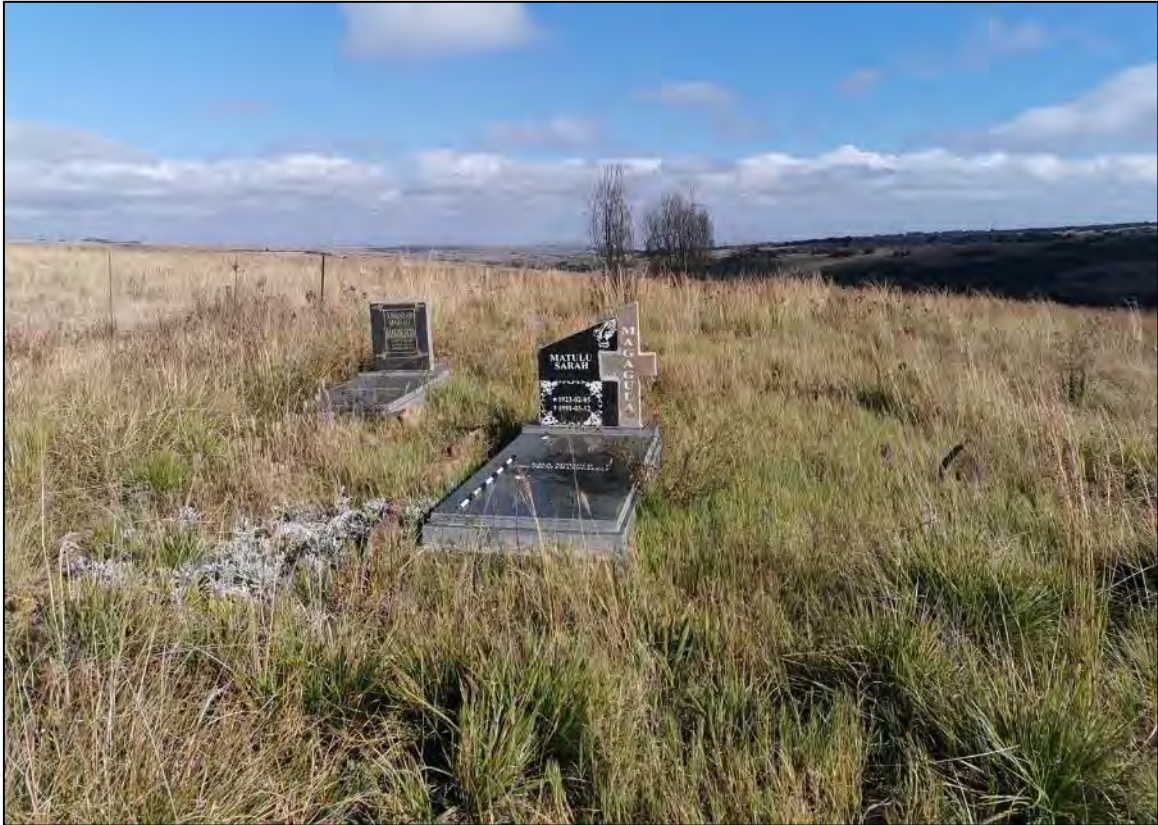
Figure 40 - General view of some of the graves at PP 04 as recorded during the 2021 fieldwork.

See Chapter 7 for impact assessment calculations and Chapter 8 for required mitigation measures.

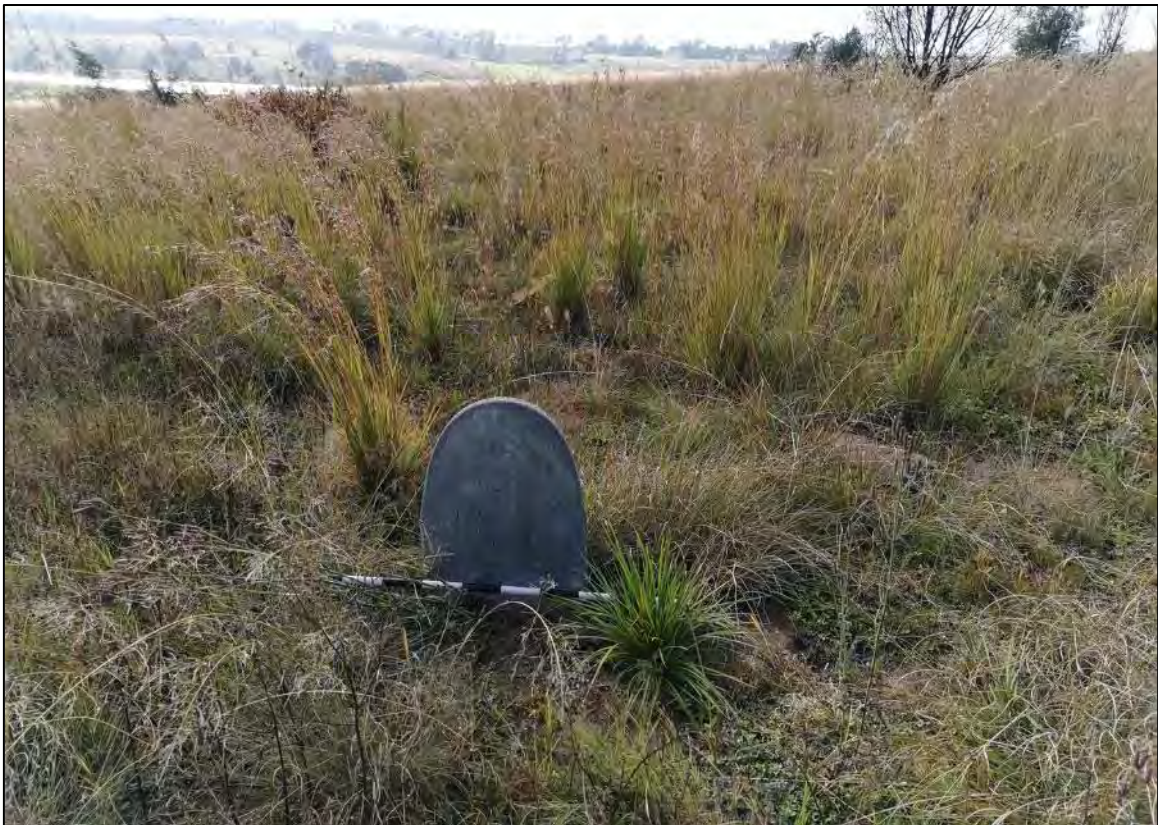
Figure 41 - View of one of the graves with a cement headstone from site PP 04. This photograph was also taken during the 2021 fieldwork. The scale is in 10cm increments.

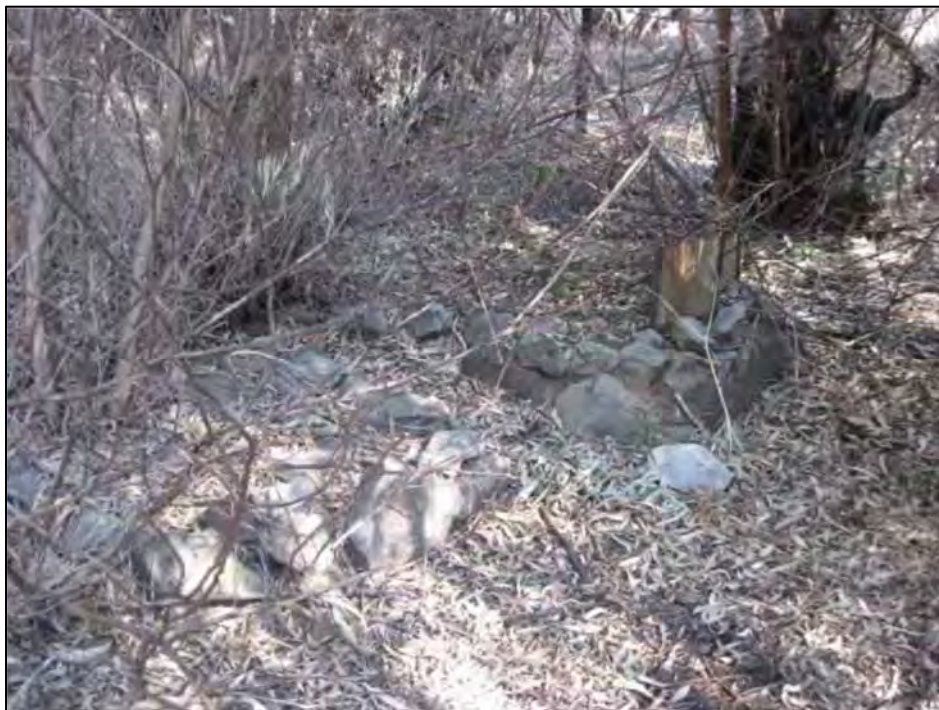
Another informal cemetery with approximately 40 graves was identified at this location. The cemetery is not fenced and is located amongst a plantation of blue-gum trees. The graves are placed in 5 unequal lines next to each other. The graves are also placed along the boundary fence of the property and they are orientated from west to east. Most of the graves have informal oval or rectangular shaped mounds or outlines of packed rocks as dressings. Most of the graves are overgrown with grass and other vegetation. Some graves have inscribed granite headstones and some graves have painted metal markers as headstones. Most of the graves have grave goods placed on the dressings.

Figure 42 - View of some of the graves from PP 05 as recorded in 2012 (Photo: Kitto & Fourie, 2012).

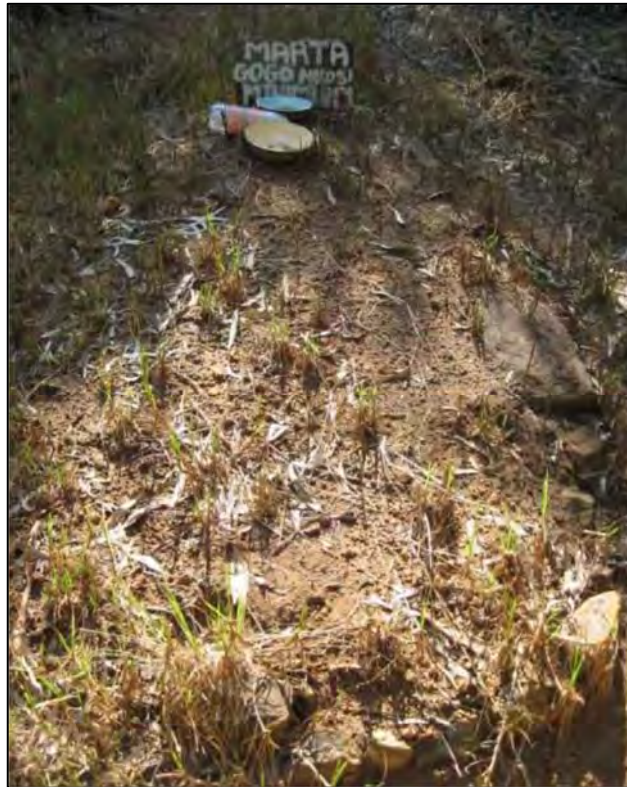
Figure 43 - Grave with marker and grave goods as recorded in 2012 (Photo: Kitto & Fourie, 2012).

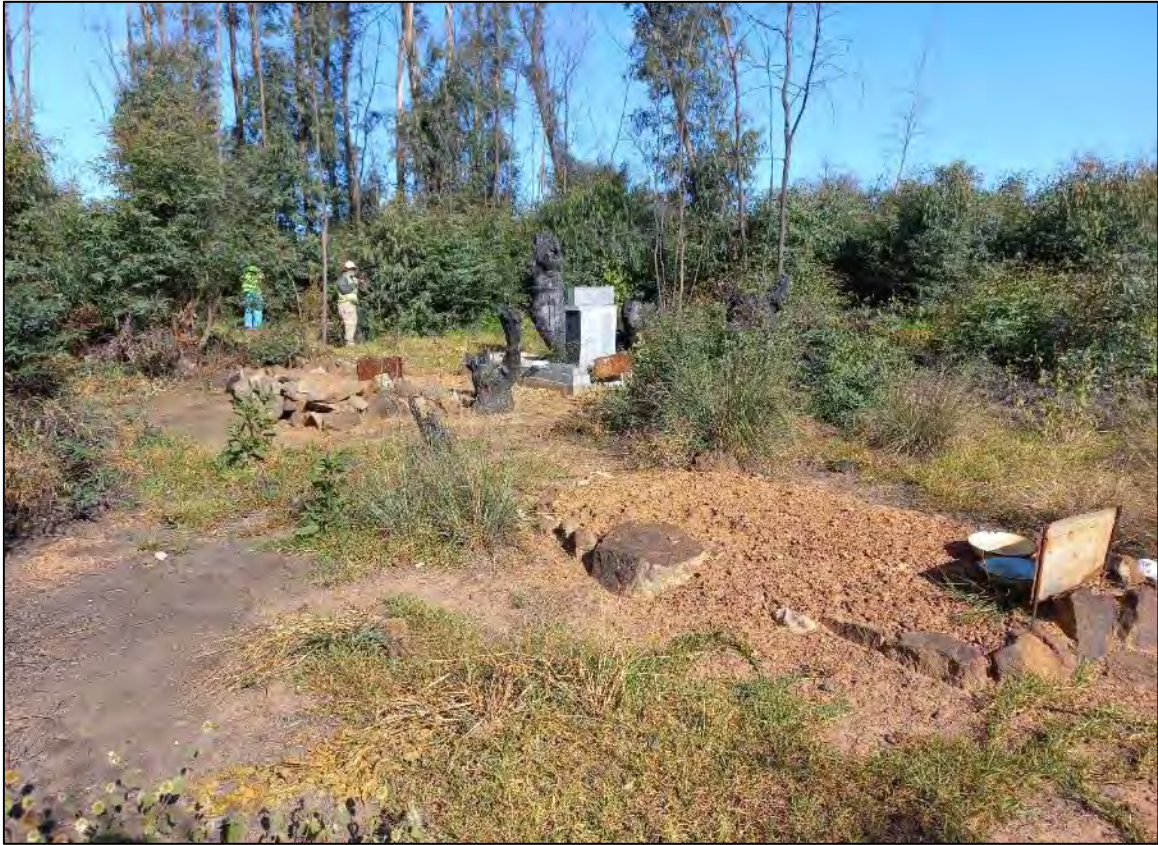
Figure 44 - General view of the cemetery at site PP 05 as recorded during the 2021 fieldwork.

See Chapter 7 for impact assessment calculations and Chapter 8 for required mitigation measures

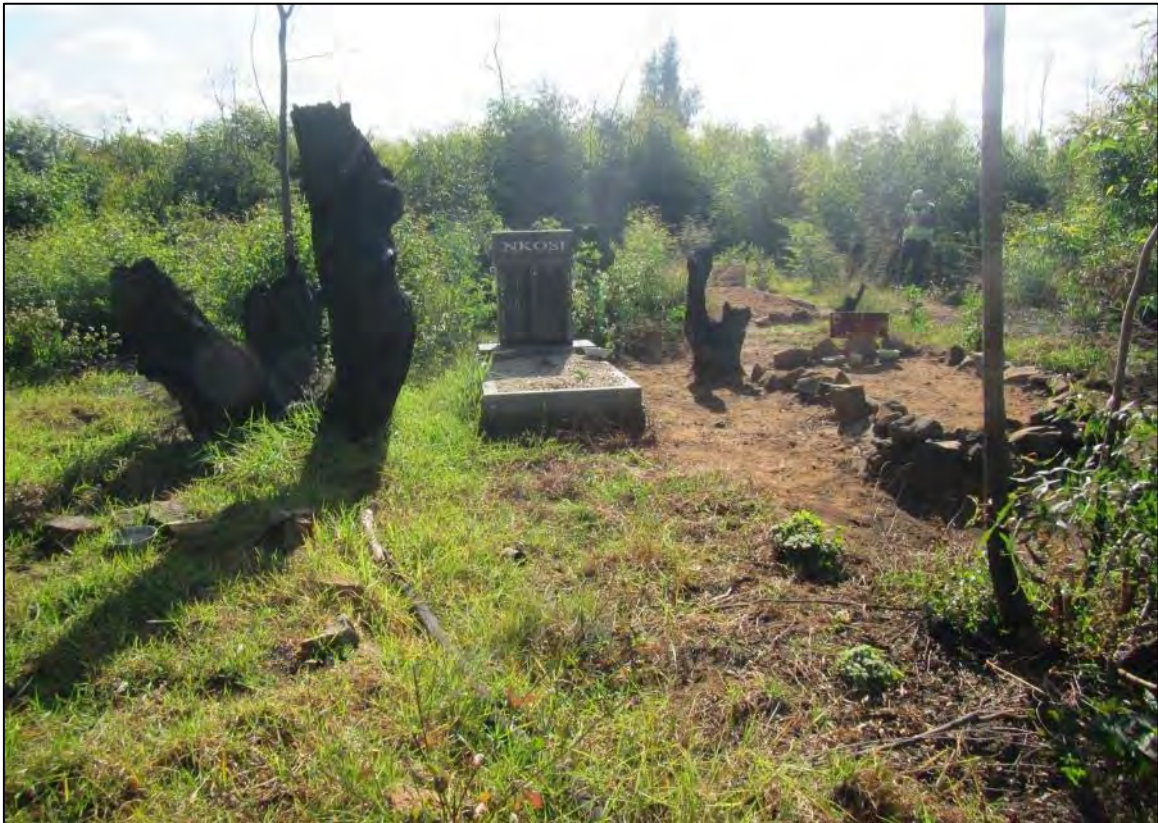
Figure 45 – Another general view of the cemetery at PP 05 as recorded during the 2021 fieldwork.

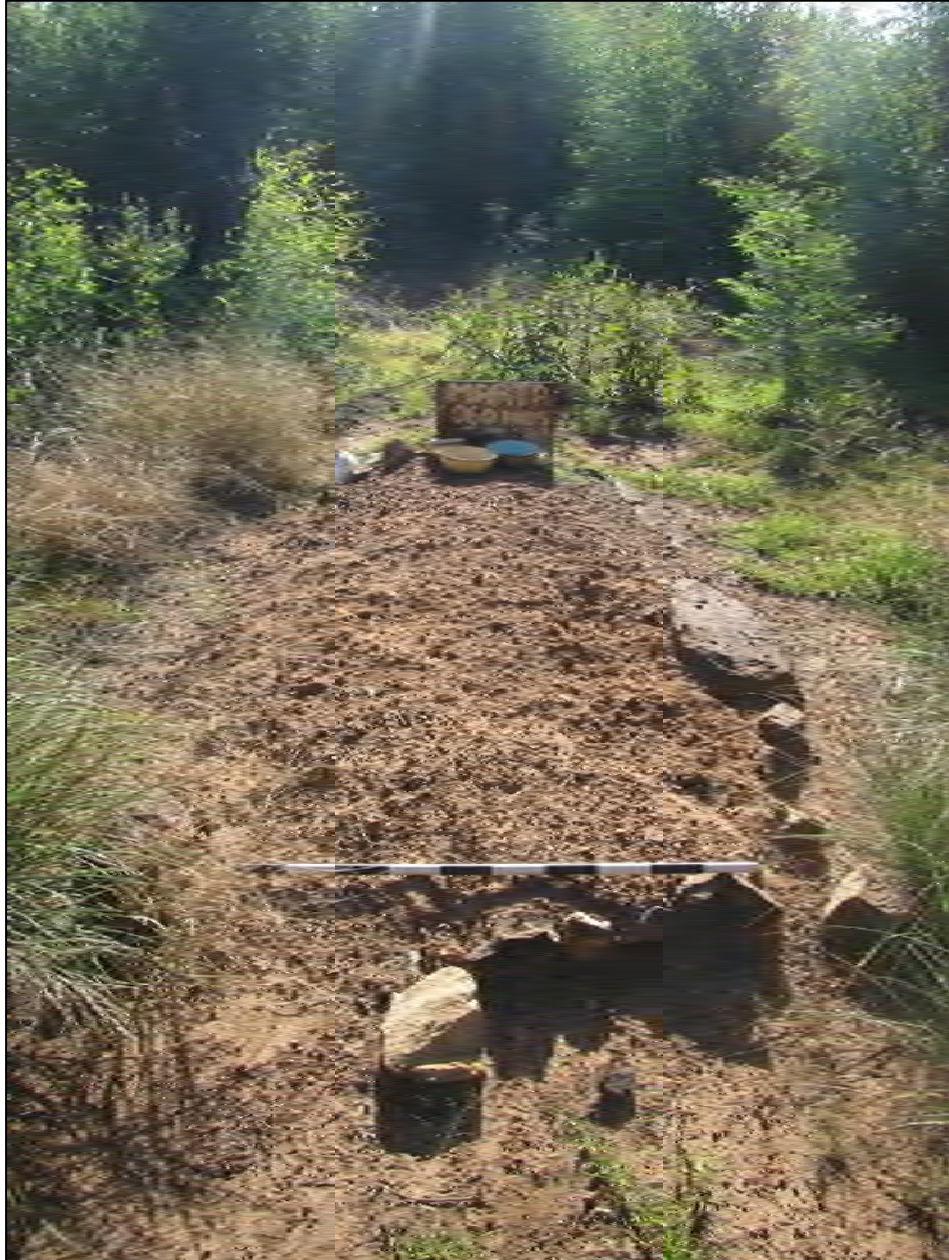
Figure 46 – Closer view of one of the graves from site PP 05. This is the same grave as the one shown on the photograph that was taken in 2012. The scale is in 10cm increments.

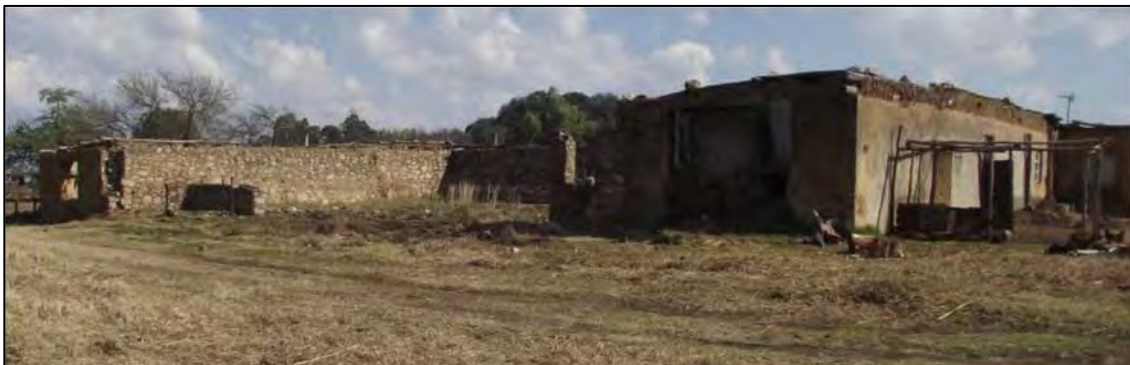
The remains of an old cattle kraal were identified at this location. The structure was built with stone and mortar and measures approximately 20m x 25m in size. The walls of the kraal are thick and measure approximately 0.75m thick and 2.2m high. The kraal has a storeroom attached to one side and feeding troughs are placed along another wall. The storeroom is a later addition and is brick-built with a sloping corrugated iron roof. Three families had used parts of the old kraal structure to build their own homesteads. These families were working on the farm. The age of the kraal is not known.

Figure 47 - View of the kraal with dwelling additions as recorded in 2012 (Photo: Kitto & Fourie, 2012).

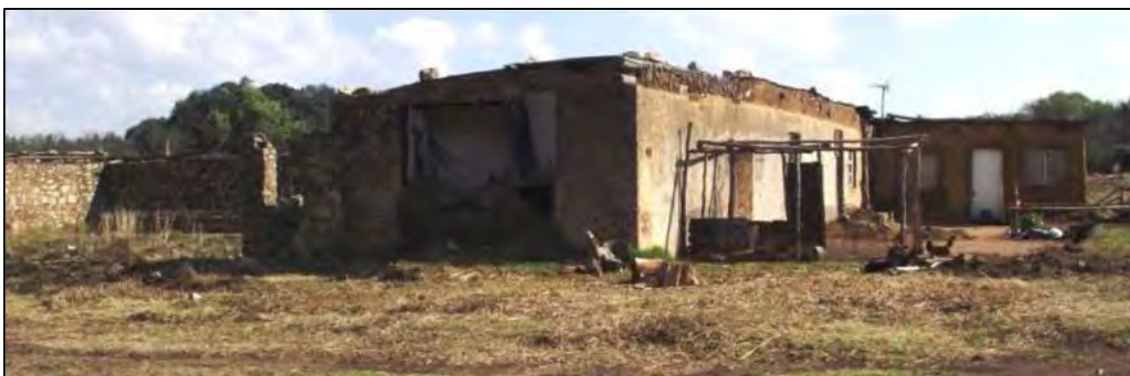
Figure 48 - Close-up view of a dwelling addition as recorded in 2012 (Photo: Kitto & Fourie, 2012).

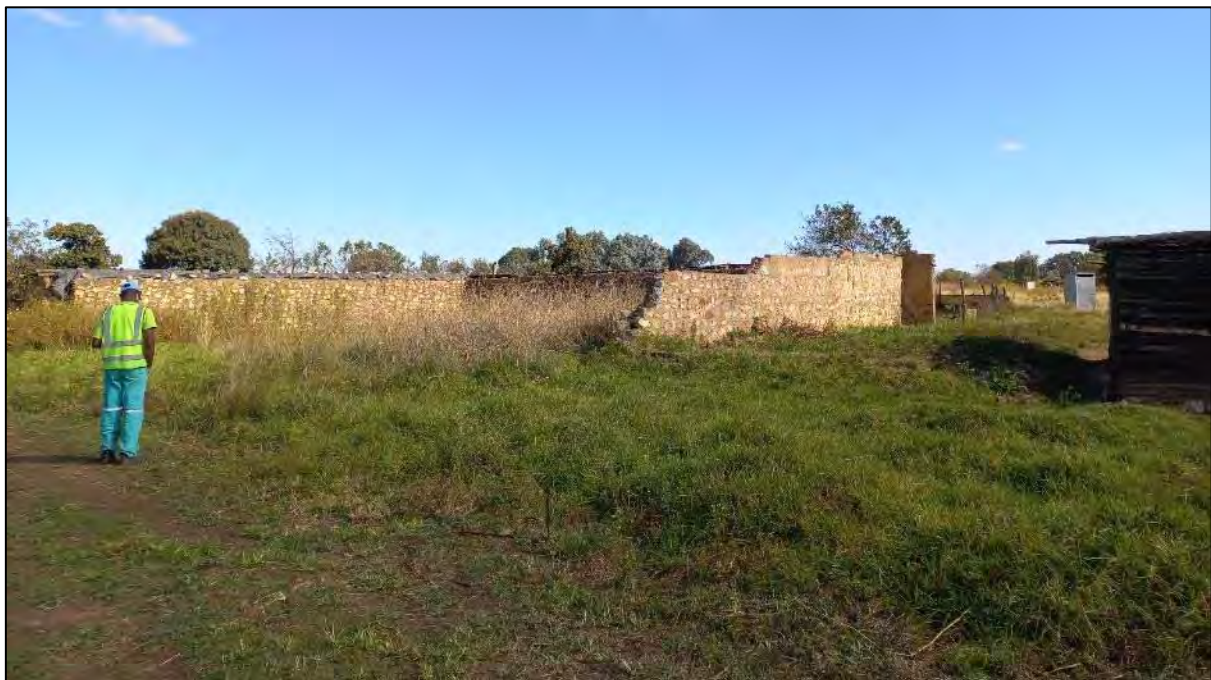
Figure 49 - General view of site PP 06 as recorded during 2021 fieldwork.

See Chapter 7 for impact assessment calculations and Chapter 8 for required mitigation measures
