NBC COLLIERY GLISA AND PAARDEPLAATS MINING PROJECT

Phase 1 – Heritage Impact Assessment

Issue Date: 19 May 2021
Revision No.: 2.0
PGS Project No.: 524HIA
CI Group project No: 19.0001

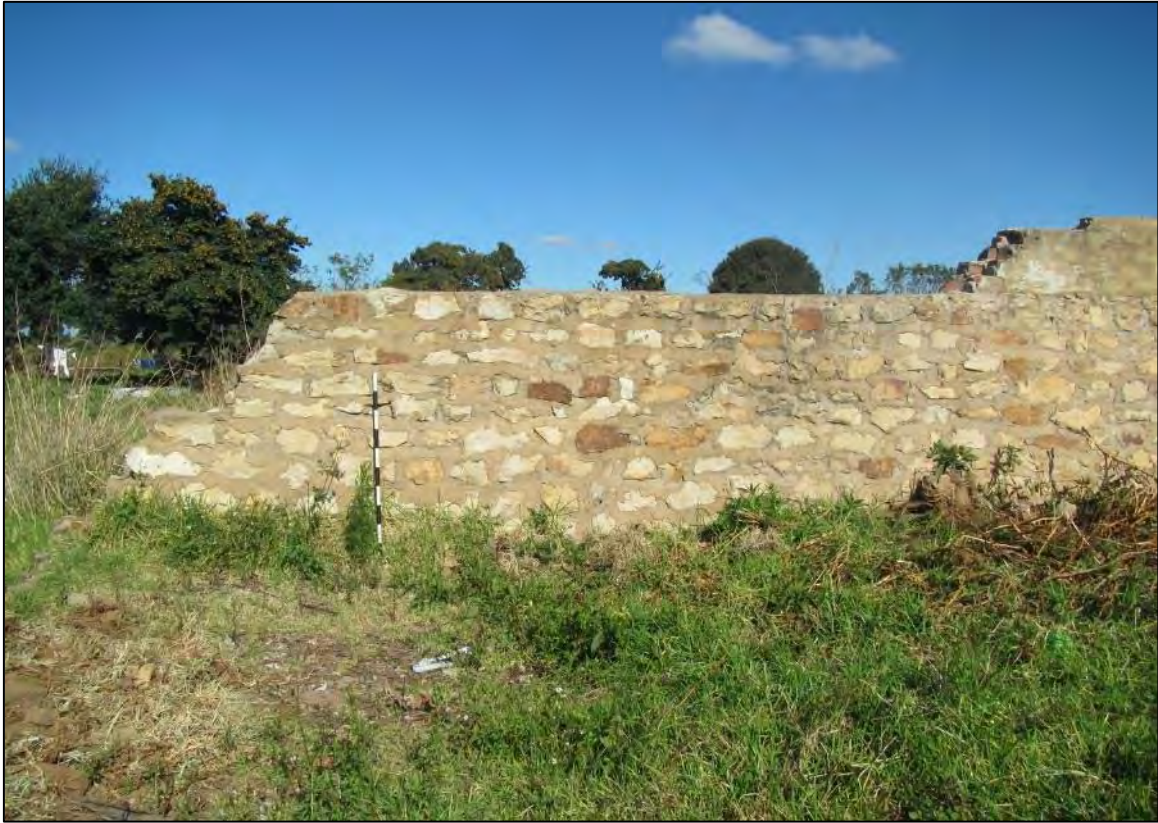
Figure 50 – Closer view of a section of walling from the kraal. The scale is in 10cm increments.

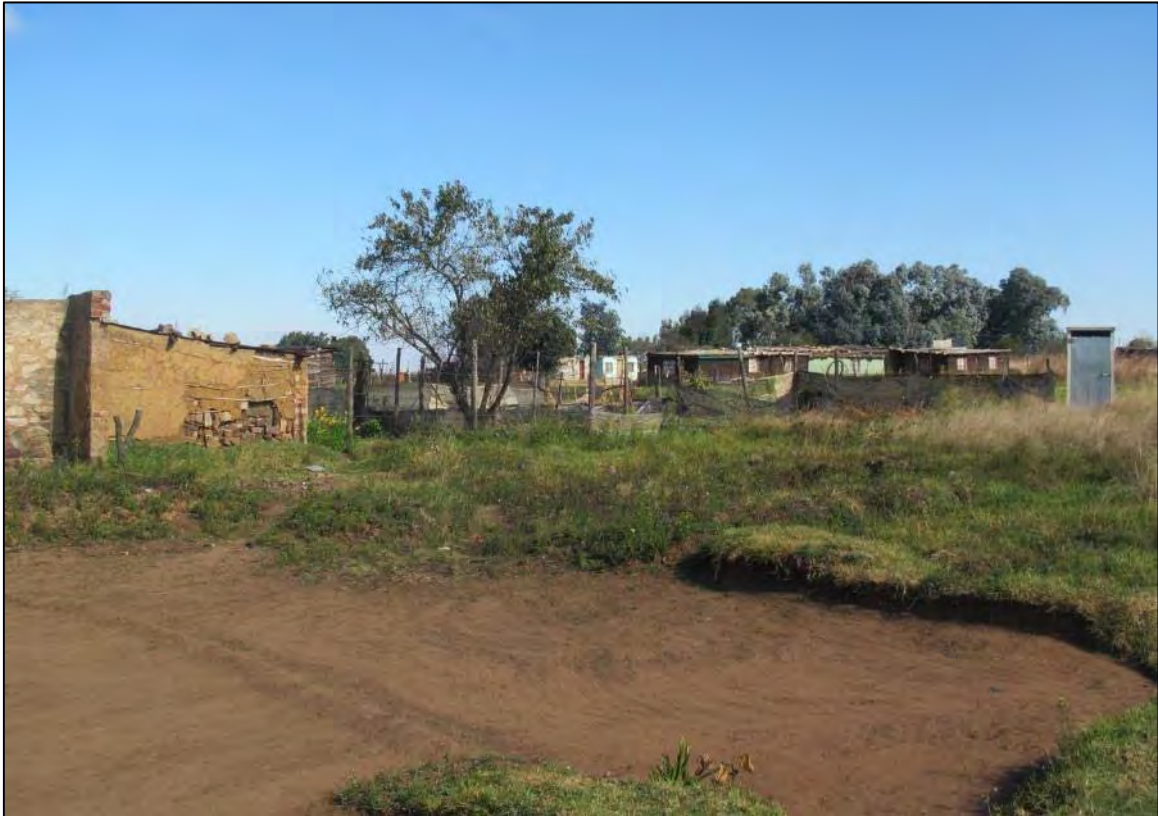
Figure 51 - View of some of the dwellings associated with the kraal.

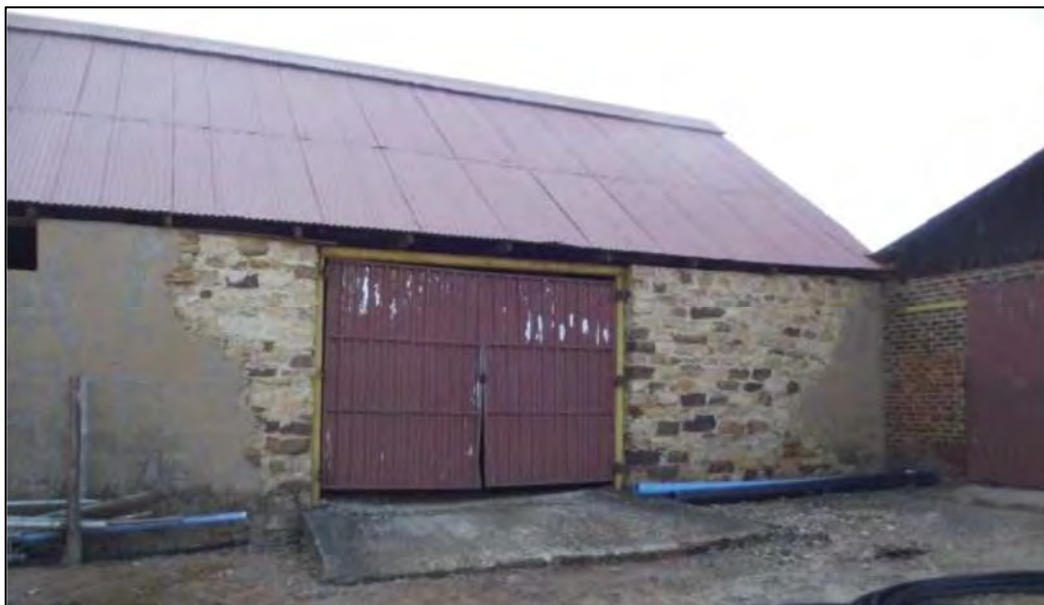
A large storeroom or shed was identified at this location. The storeroom measures approximately 20m x 12m in size and has a high pitched corrugated iron roof. It has large metal doors with metal door frames. These are most likely a later addition. The high windows have wooden frames and are open. The building also has an external electrical system. It has a cement floor and the building is still in use. A small, square sandstone-built structure is situated next to the larger storeroom. This structure measures approximately 5m x 5m in size and also has a pitched corrugated iron roof. It is built with sandstone blocks and mortar and is in a rather weathered state. It does not have a door or door frame and a wooden lintel is used in the door opening. It has wooden window frames. The building has a dirt floor and does not have any water or electrical systems. The age of these buildings is not known.

Figure 52 – General view of the large storeroom as recorded in 2012 (Photo: Kitto & Fourie, 2012).

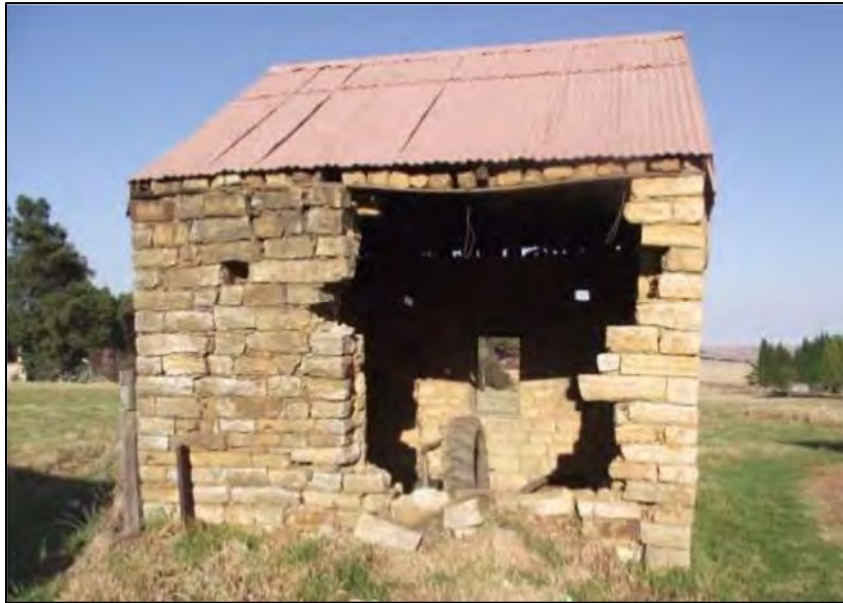
Figure 53 – The dilapidated square structure as recorded in 2012. This building was constructed of sandstone (Photo: Kitto & Fourie, 2012).

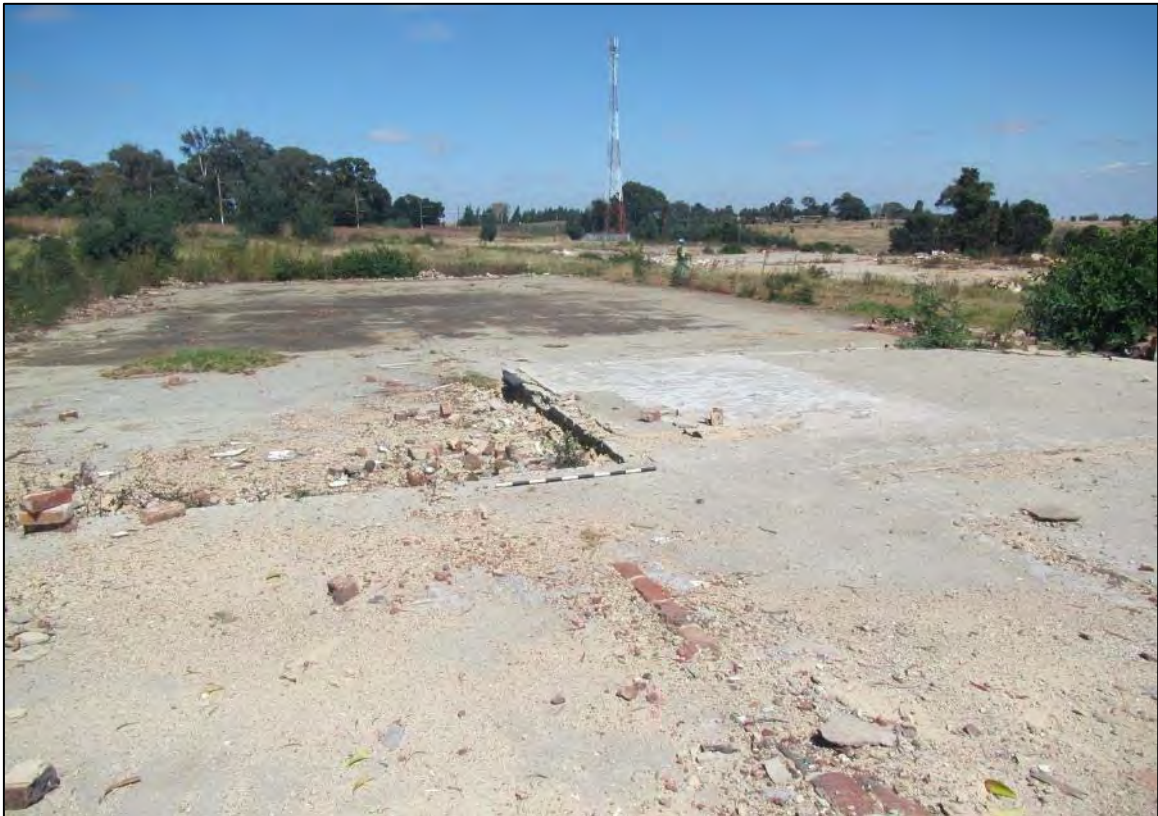
All the structures and buildings that were located at site PP 07 have been demolished. Only the remains of the foundations are visible on site.

Figure 54 - General view of site PP 07 as recorded during the 2021 fieldwork.

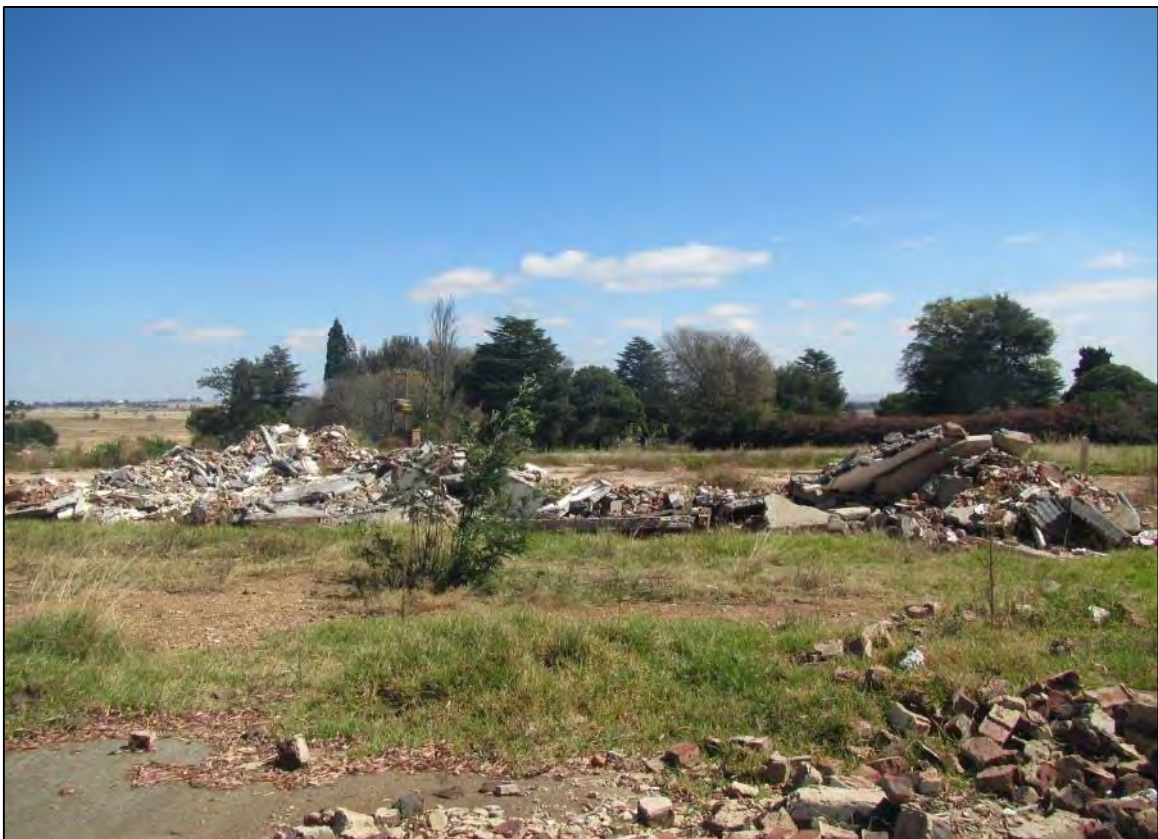
Figure 55 - General view of the demolished remains observed at site PP 07.

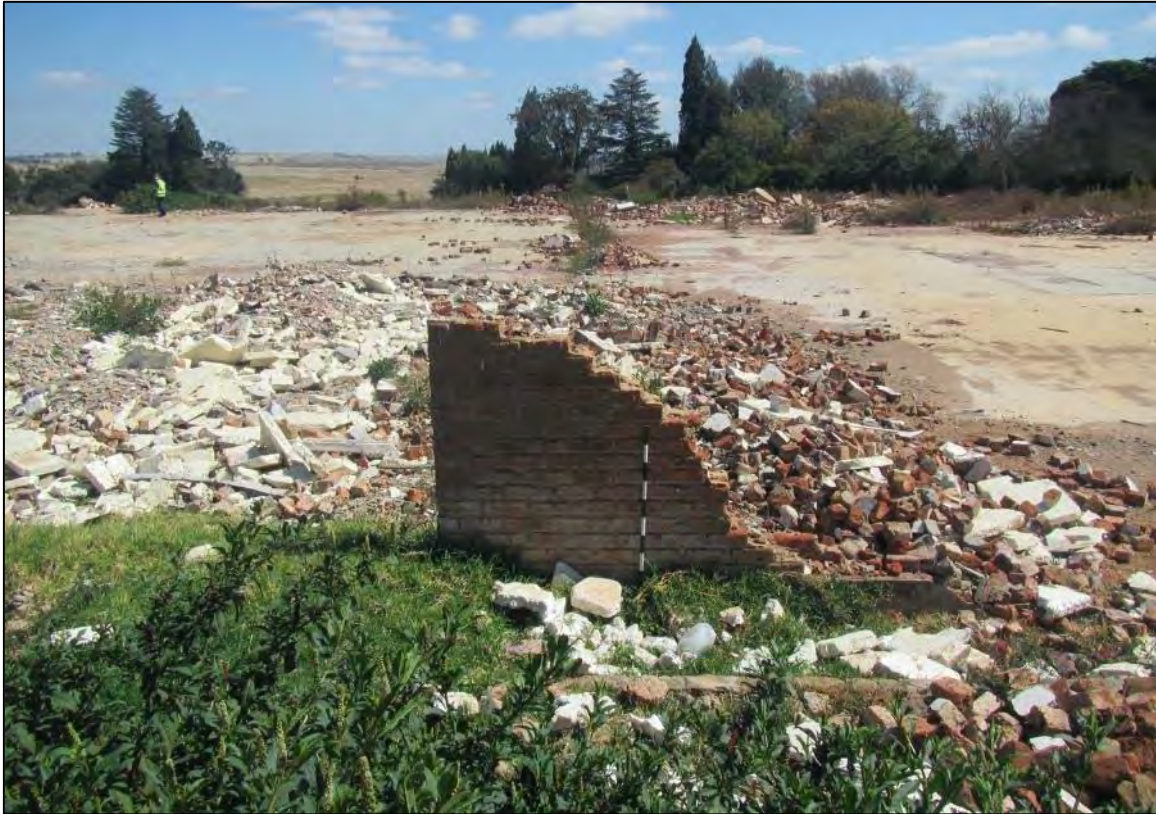
Figure 56 – Another view of the state of site PP 07 as recorded during the 2021 fieldwork. The scale is in 10cm increments.

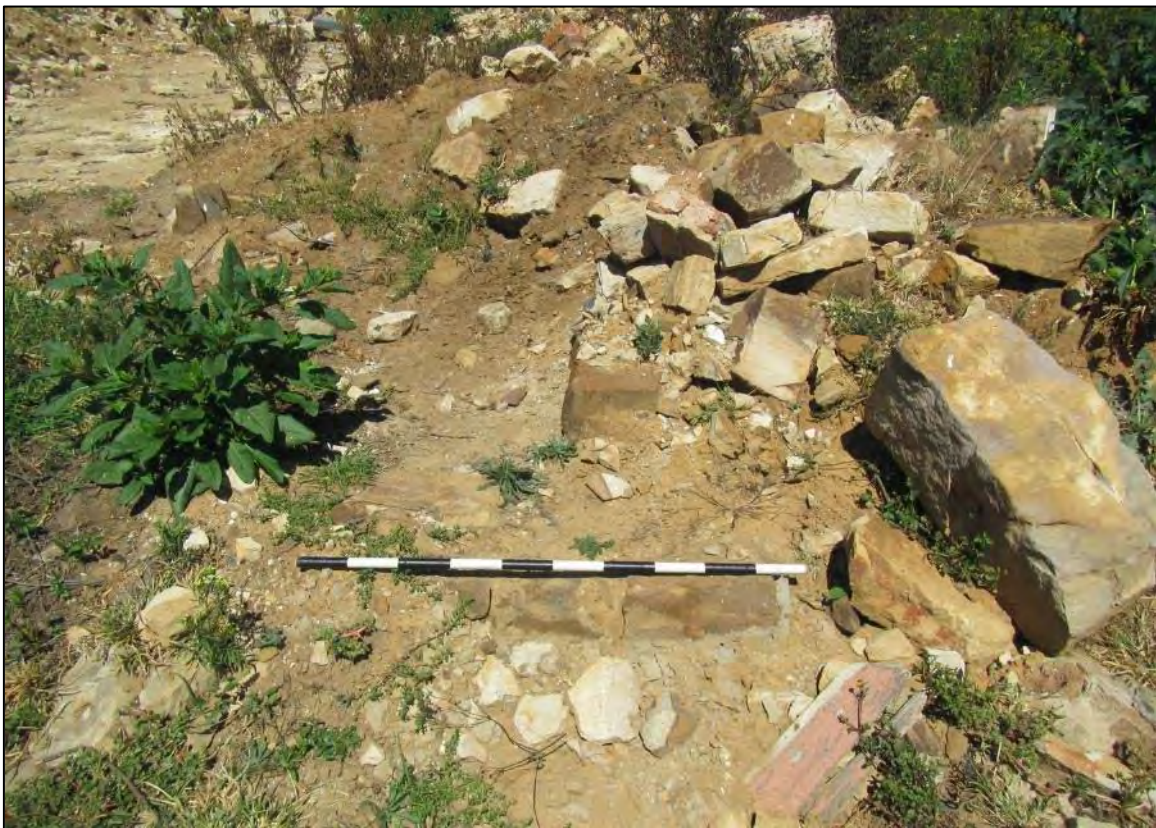
Figure 57 - Remains of the sandstone-built structure as recorded during the 2021 fieldwork at site PP 07. The scale is in 10cm increments.

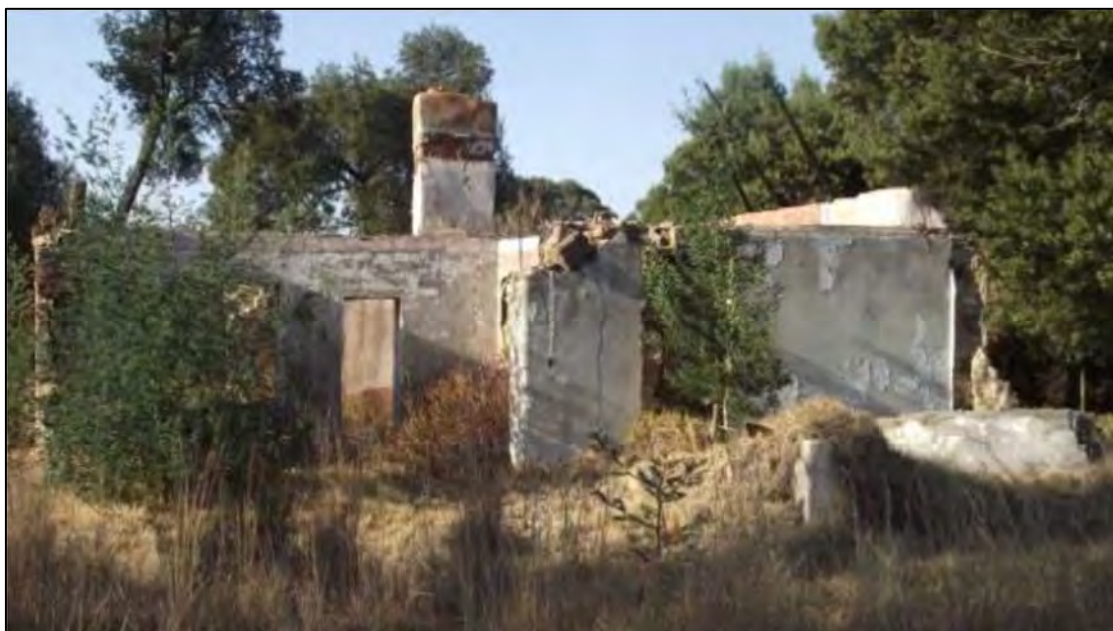
The remains of a farmhouse and its associated buildings were identified at this location. The remains of the multi-roomed farm house measure approximately 20m x 20m in size. The building was constructed with sandstone blocks and mortar and later additions are brick-built. The walls of the building are thick and are mostly constructed with sandstone blocks and mortar. Some other sections had been constructed or repaired with mud-bricks. Most of the building is plastered with cement and is painted over. A wrought iron fireplace with red tile surround was still in situ, which could date the building to approximately the 1910s to 1930s [Edwardian period,

Figure 58 – General view of the farmhouse as recorded in 2012 (Photo: Kitto & Fourie, 2012).

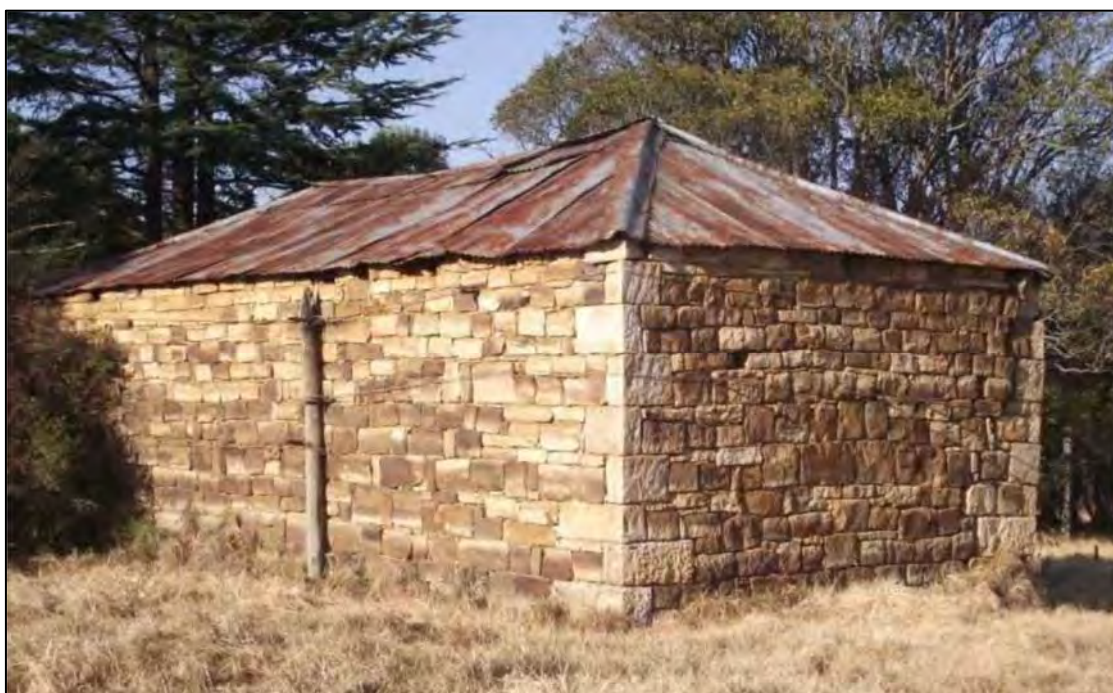
A water reservoir is situated approximately 30m from the main house. Another sandstone building is situated approximately 40m on the other side of the farmhouse. This building was constructed with sandstone blocks and mortar and has a pitched corrugated iron roof. This structure measures approximately 5m x 10m in size and is in a semi-dilapidated state. This structure probably served as a storeroom or garage for the main building.

Figure 59 – The sandstone storeroom as recorded during 2012 (Photo: Kitto & Fourie, 2012).

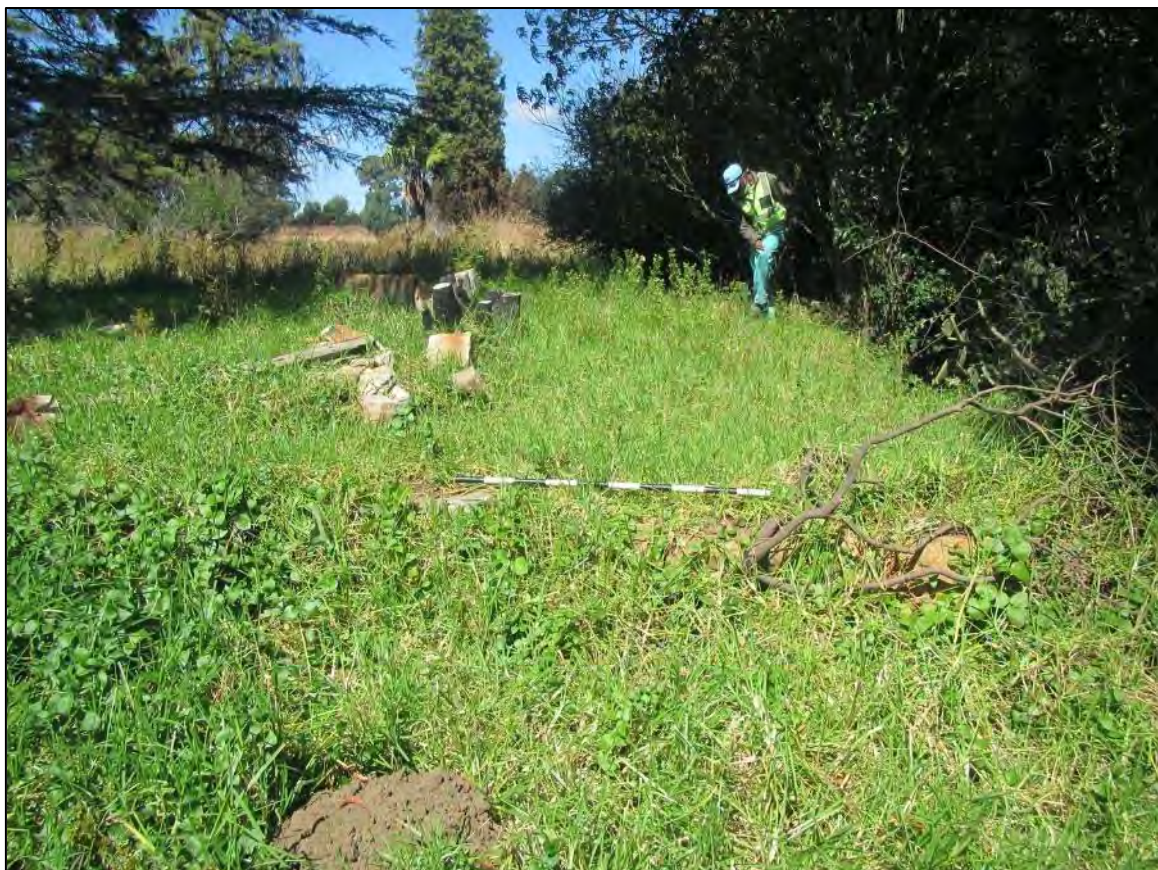
The structures that were identified in 2012 have all been demolished. Only the remains of the structures and foundations were found during the 2021 fieldwork.

Figure 60 - View of the foundation of a structure as seen during 2021. The scale is in 10cm increments.

See Chapter 7 for impact assessment calculations and Chapter 8 for required mitigation measures

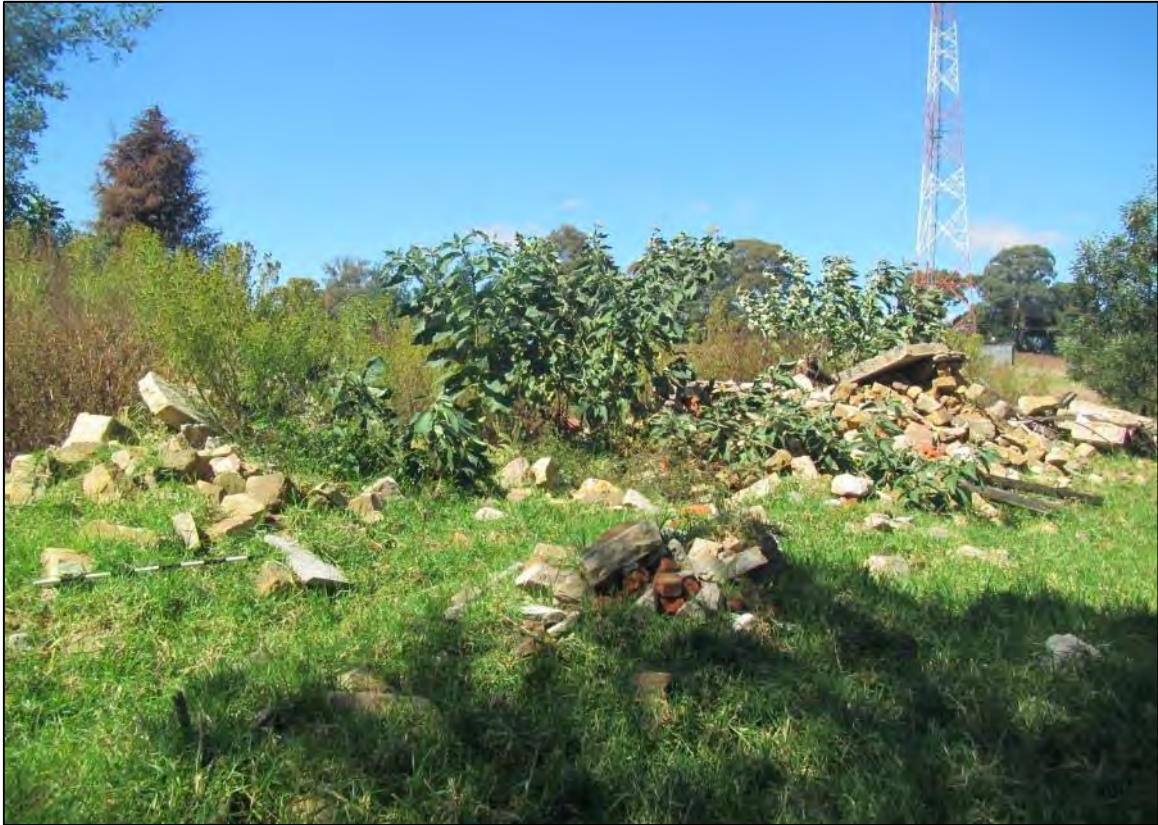
Figure 61 – Building rubble from a demolished structure at site PP 08. The scale is in 10cm increments.

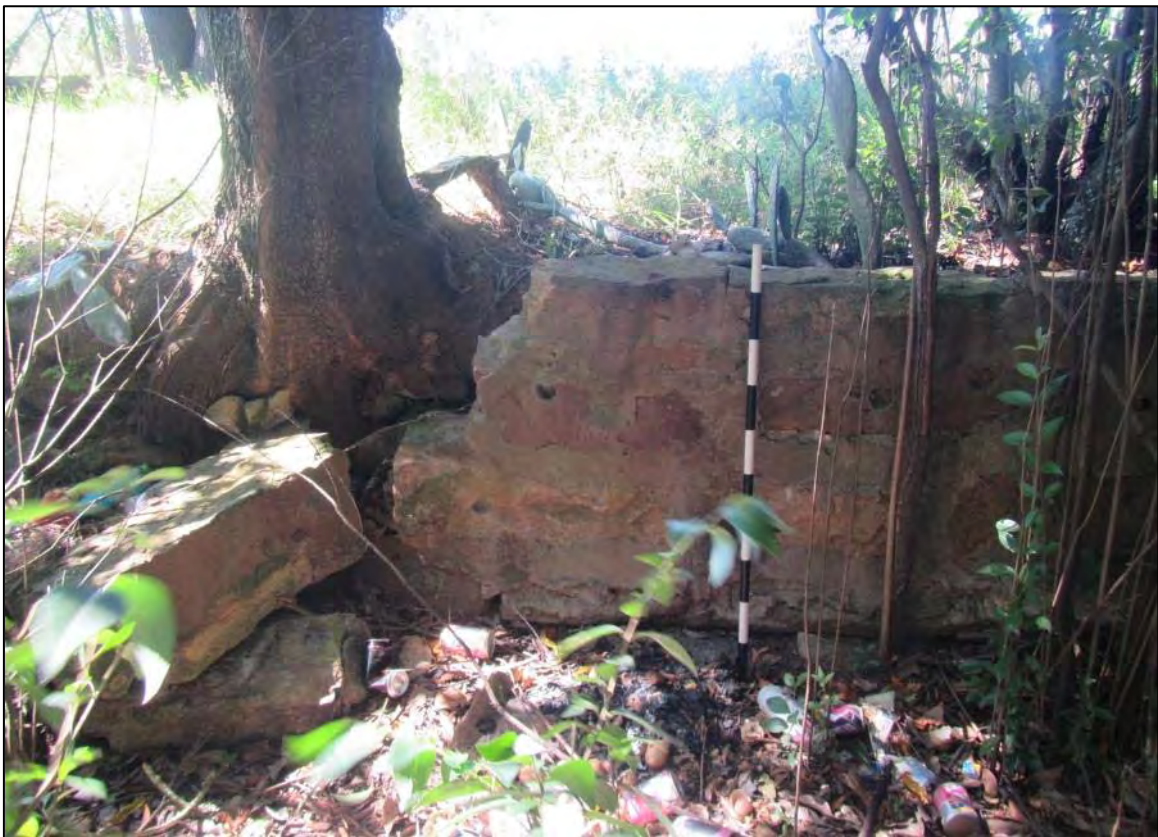
Figure 62 – More structural remains observed at site PP 08. The scale is in 10cm increments.

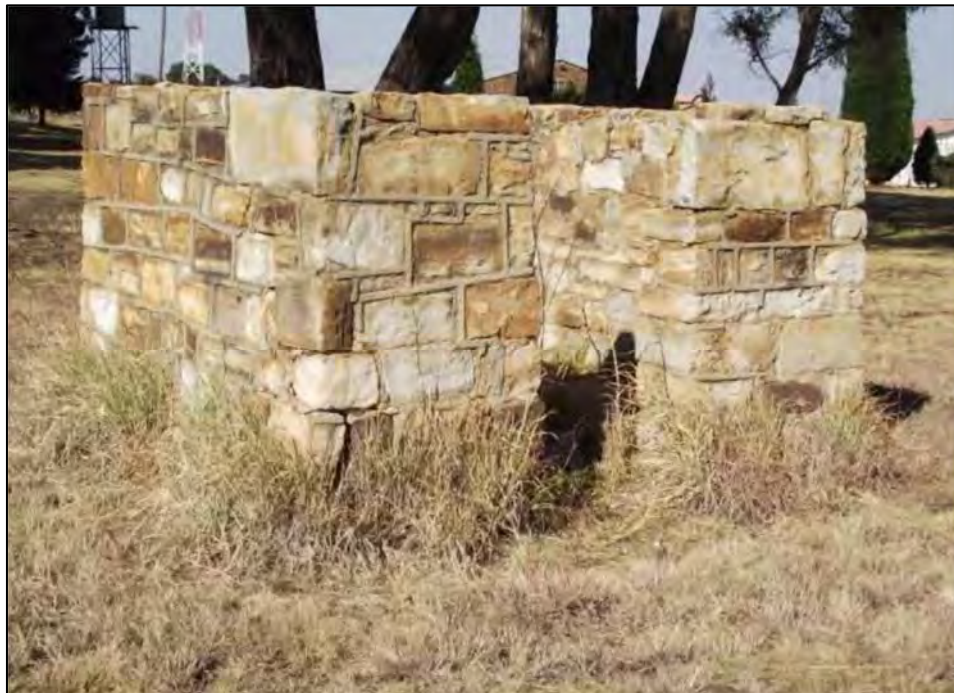
The remains of a small, square structure were identified at this location. The structure is built with sandstone blocks and cement and measures approximately 4m x 4m in size. The structure has no roof and has only one entrance with no windows. It also has a gravel floor. The function and age of this structure is unknown.

Figure 63 - Square sandstone structure as recorded in 2012 (Photo: Kitto & Fourie, 2012).

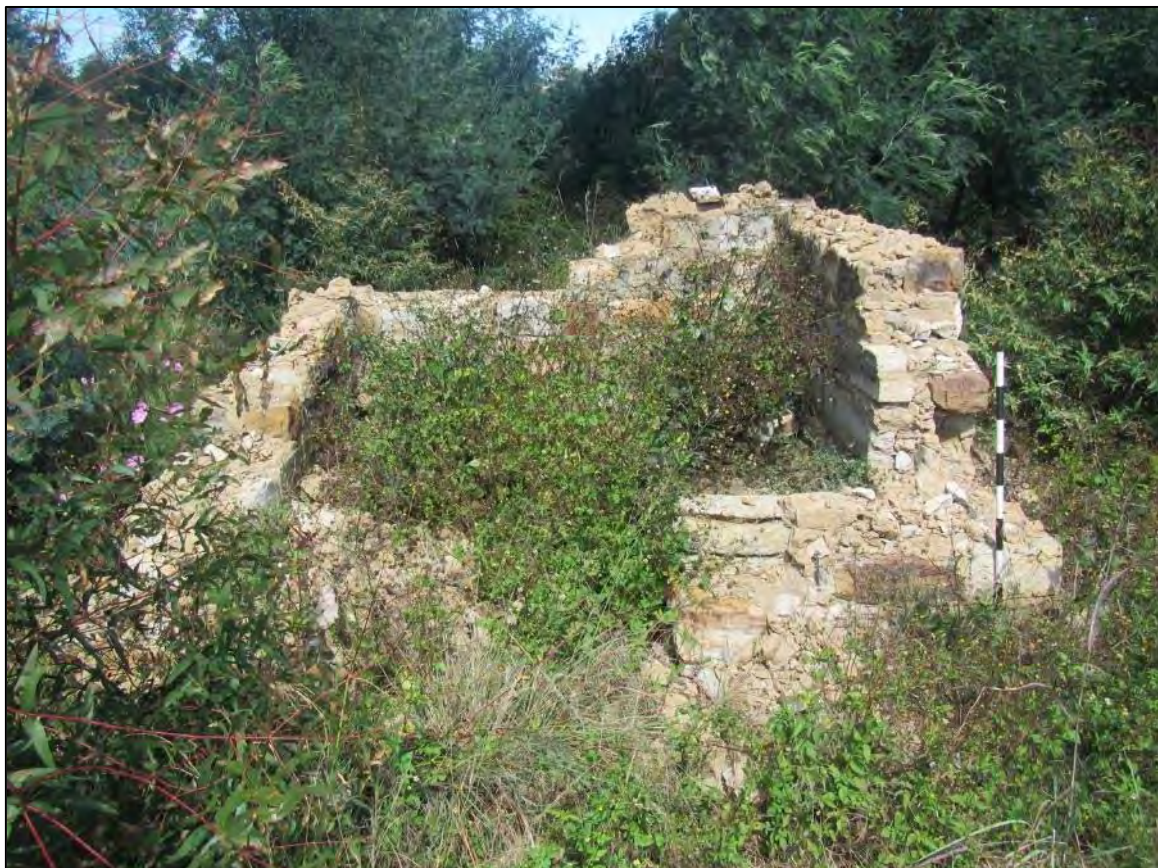
Figure 64 - View of the front of the structure as recorded in 2021. This view of the structure shows the same façade as the one that was taken in 2012 above. A comparison of the two photographs clearly show the level of deterioration at the site. The scale is in 10cm increments.

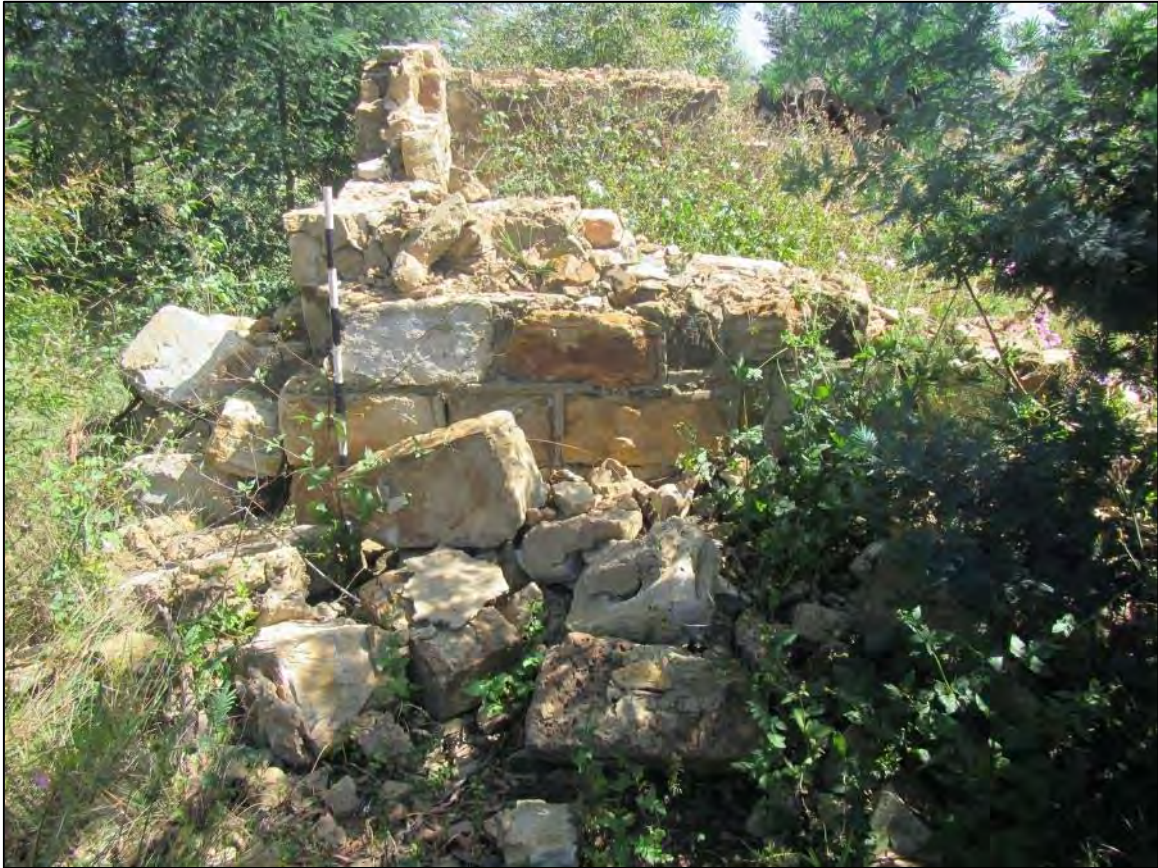
The remains of the same square structure were identified during the 2021 fieldwork. However, the condition of the structure has deteriorated significantly in the nine years since the previous assessment

Figure 65 – Another view of the structure as recorded in 2021. The scale is in 10cm increments.

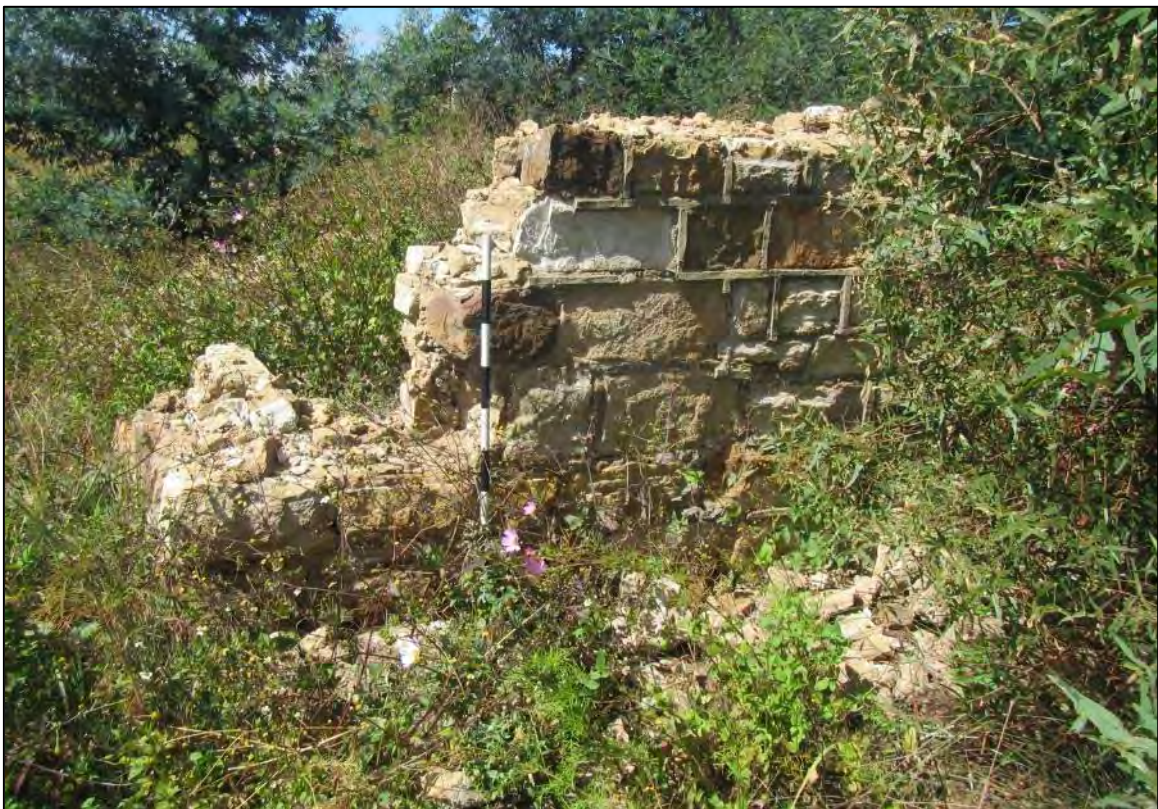
Figure 66 – Another view of the structure as recorded in 2021. The scale is in 10cm increments.

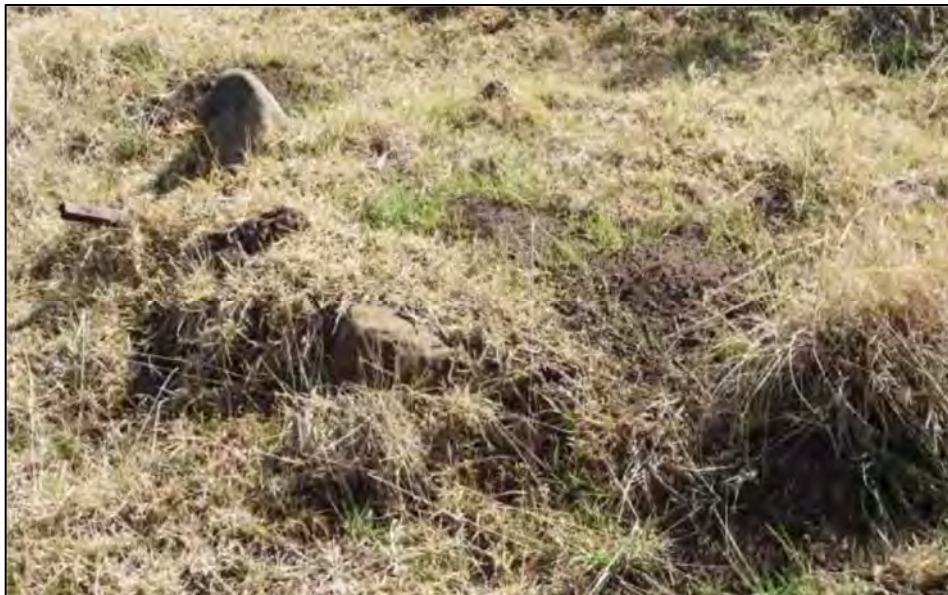
A single, informal grave was identified at this location. The grave is situated approximately 40m from a farmstead, which has been identified as site PP 011 (below). The grave has an oval-shaped outline of packed rocks as dressing and is orientated from west to east. A single rock is placed upright at the western end to serve as a headstone. The grave is not maintained and is overgrown with grass and other vegetation. The age of the grave is not known.

Figure 67 – General view of the grave at site PP 010 as recorded during the fieldwork undertaken in 2012 (Photo: Kitto & Fourie, 2012).

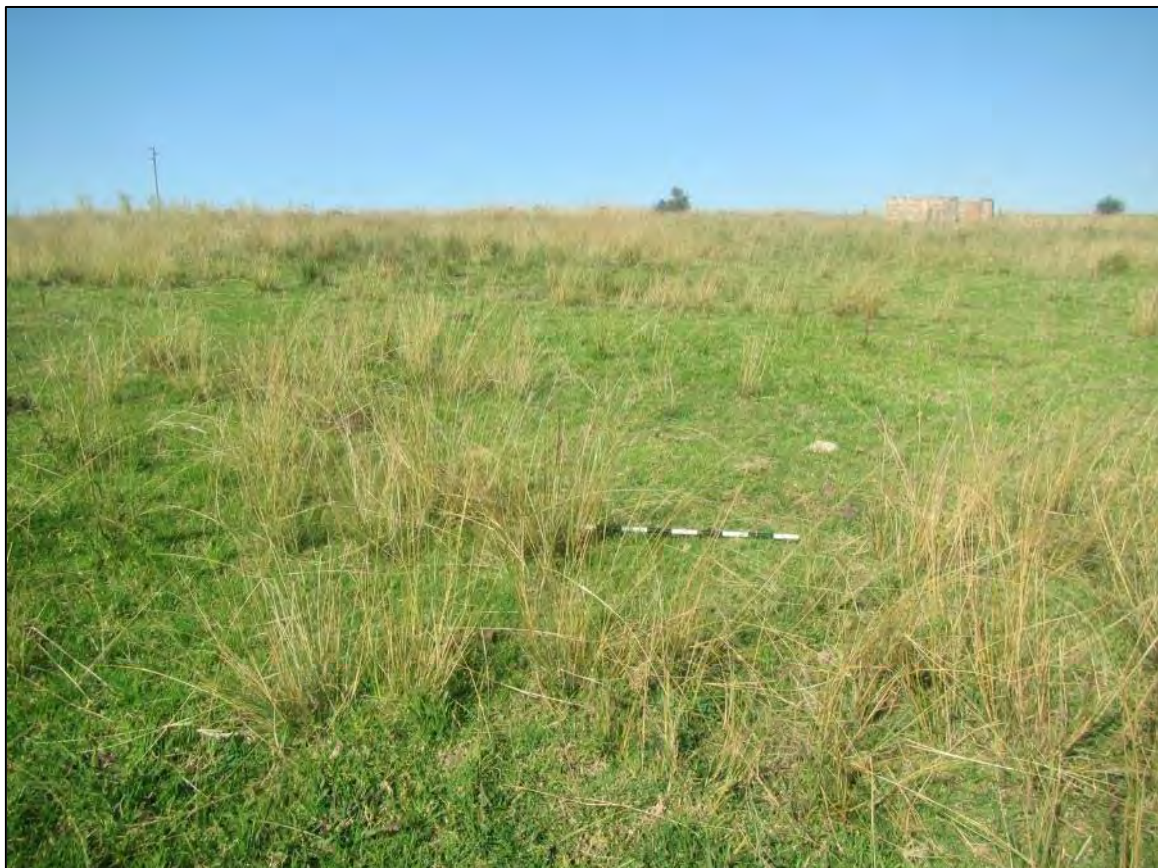
The general area of where the grave was identified in 2012 was walked through by the fieldwork team from PGS. Despite the intensive walkthrough undertaken, no surface features as those observed during the 2012 fieldwork could be found. Several single stones, that could possibly be grave markers, were

Figure 68 - General view of the area where the grave was recorded during the 2012 fieldwork. The scale is in 10cm increments.

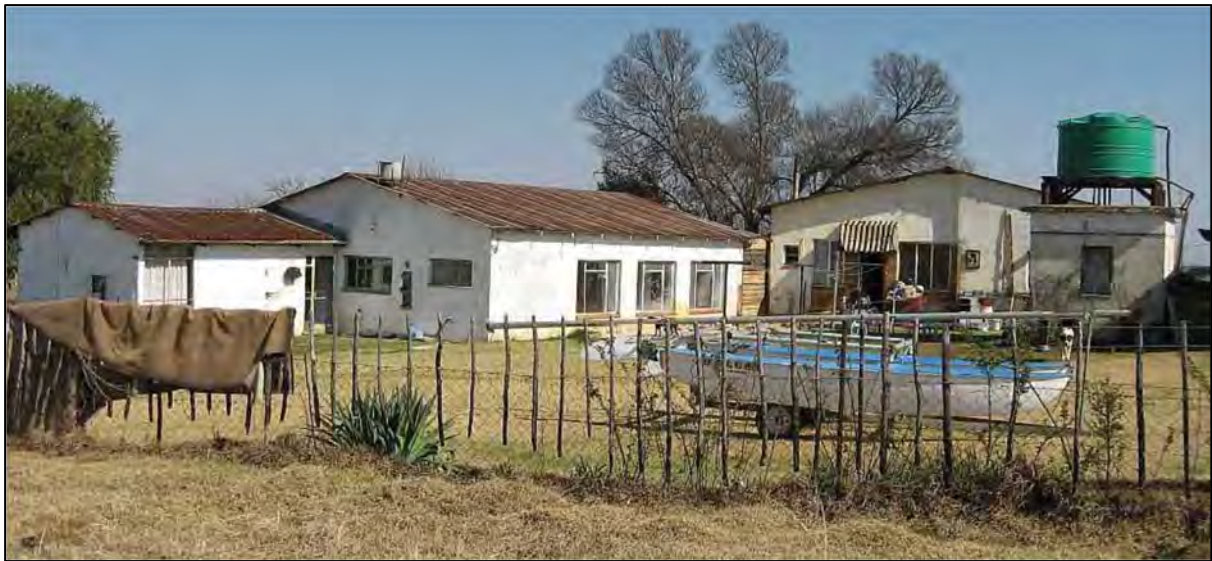
Figure 69 – The farmstead at site PP 10 as recorded in 2012 (Photo: Kitto & Fourie, 2012).

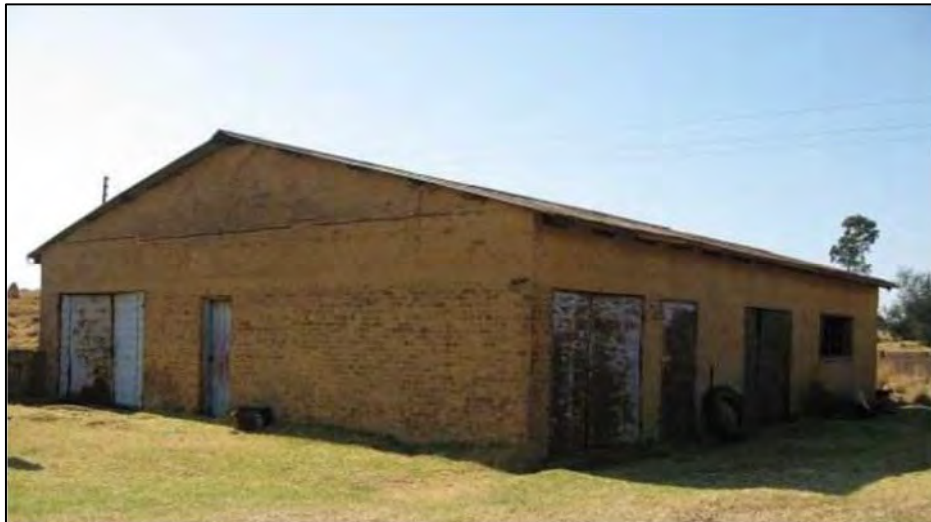
Figure 70 - Brick shed as recorded in 2012 (Photo: Kitto & Fourie, 2012).

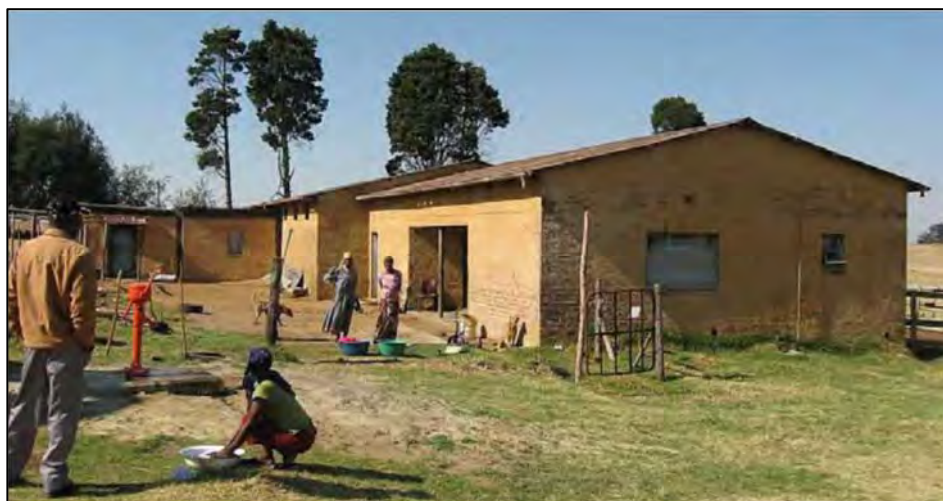
Figure 71 – Farm worker houses as recorded in 2012 (Photo: Kitto & Fourie, 2012).

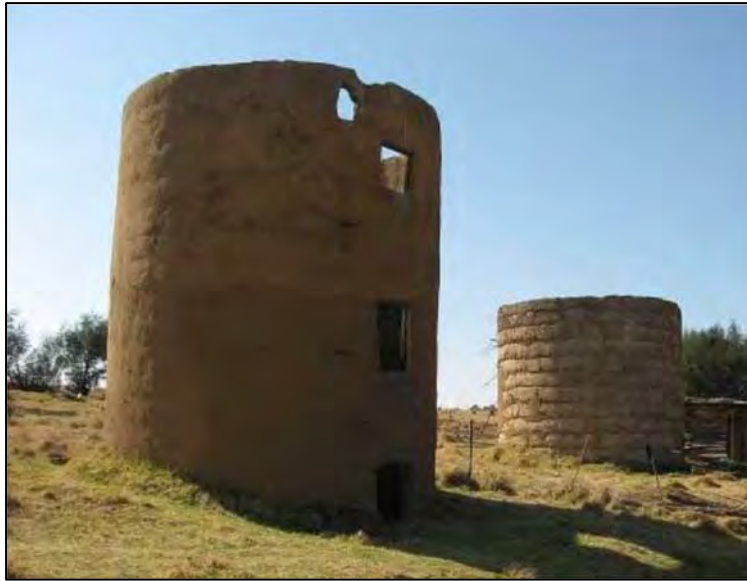
Figure 72 – The two silos from site PP 10 as recorded in 2012 (Photo: Kitto & Fourie, 2012).

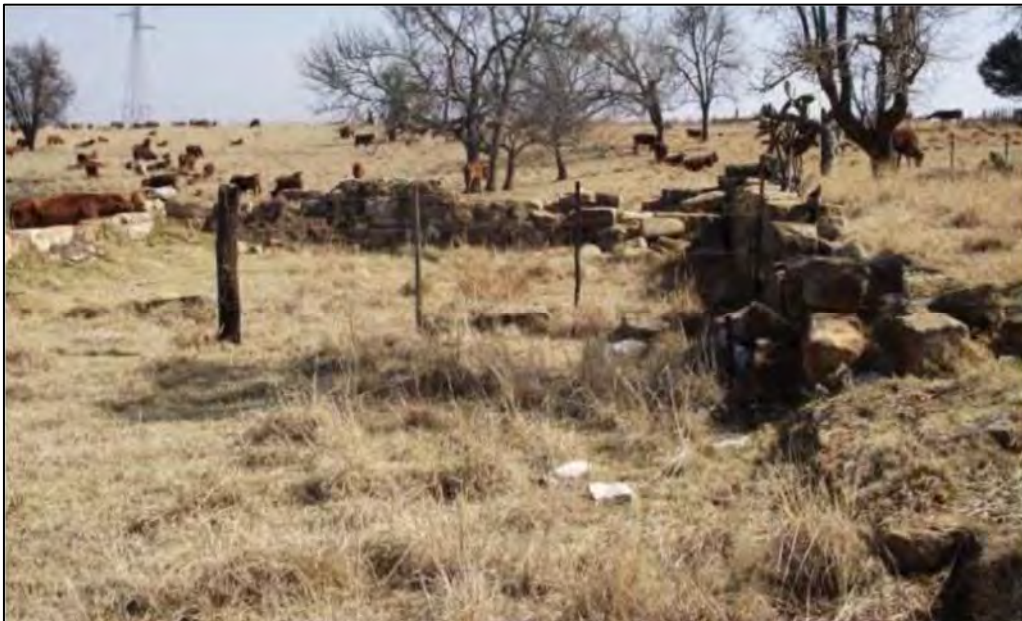
The remains of a cattle kraal were also identified near the houses. The kraal was built with sandstone blocks and mortar and measures approximately 25m x 8m in size. The kraal is in a ruined state and the walls had been replaced by fencing.

Figure 73 - Remains of the cattle kraal as recorded in 2012 (Photo: Kitto & Fourie, 2012).

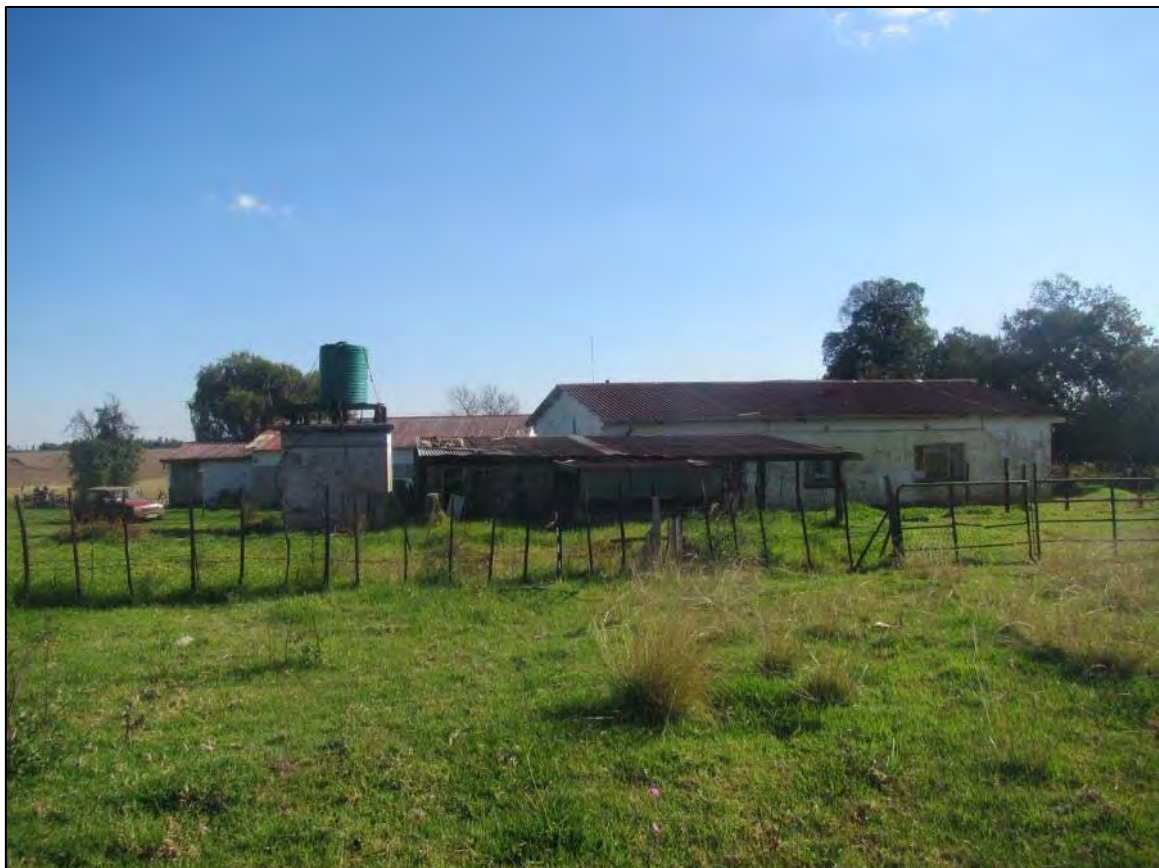
The farmstead was visited during the current fieldwork. The main farmhouse appears to be a bit dilapidated from the building that was recorded in 2012. However, all the other structures are still intact and appear to be in a similar condition as when they were identified in 2012. The site is currently occupied by the Joubert family.

Figure 74 - View of the main farm house as recorded during the recent fieldwork.

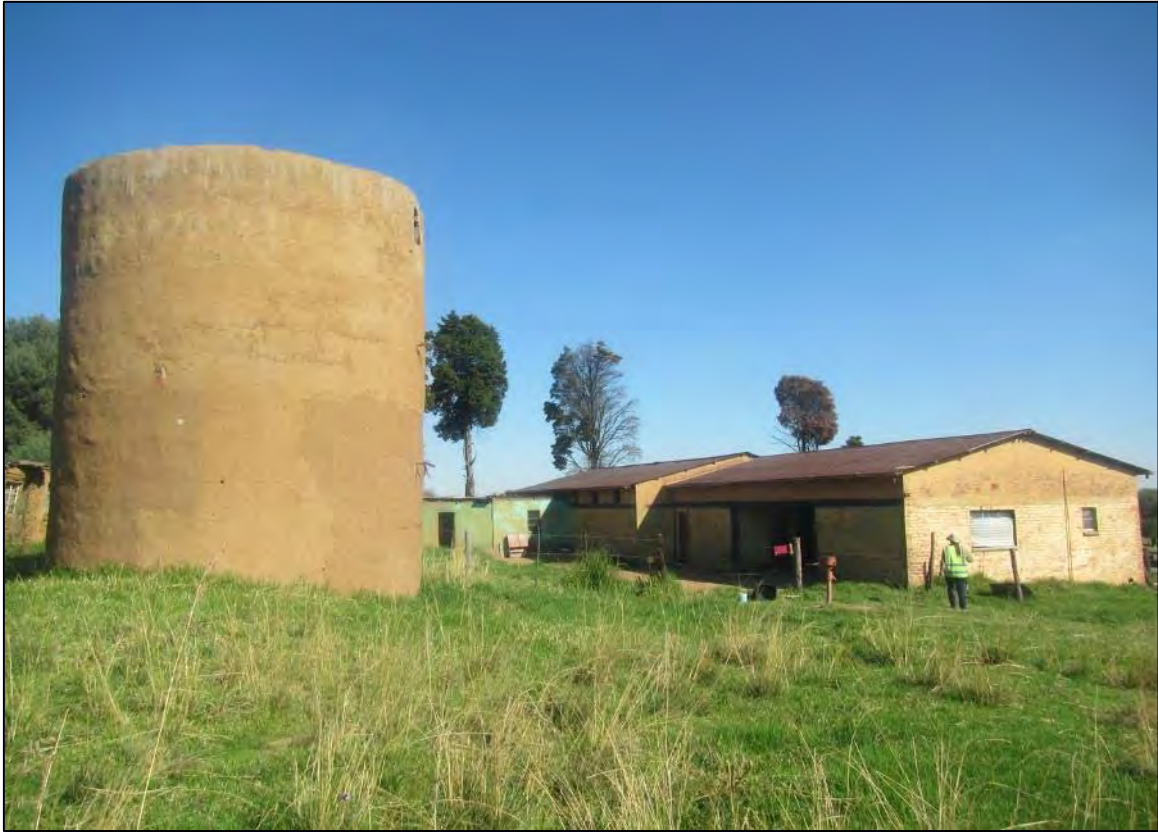
Figure 75 - View of the silo, storeroom and farm labourer houses.
