NBC COLLIERY GLISA AND PAARDEPLAATS MINING PROJECT

Phase 1 – Heritage Impact Assessment

Issue Date: 19 May 2021
Revision No.: 2.0
PGS Project No.: 524HIA
CI Group project No: 19.0001

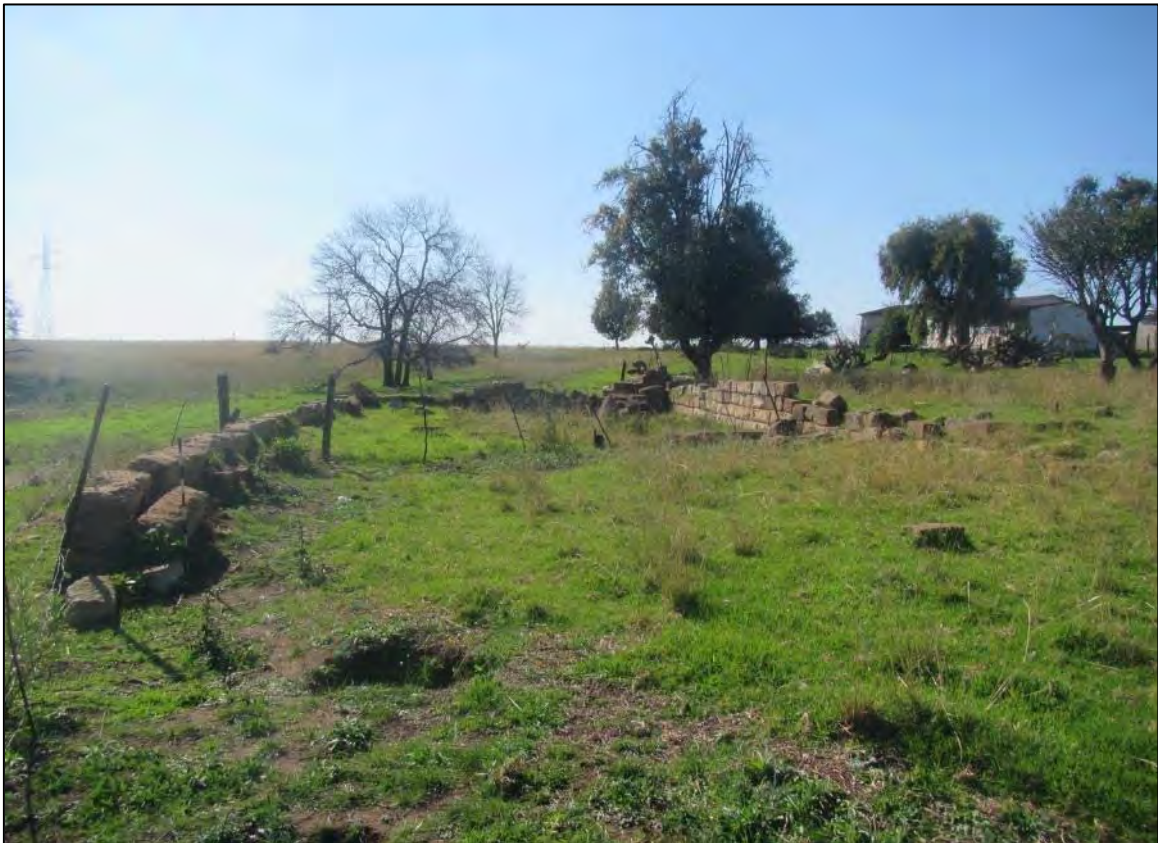
Figure 76 - General view of the stone kraal. The scale is in 10 cm increments.

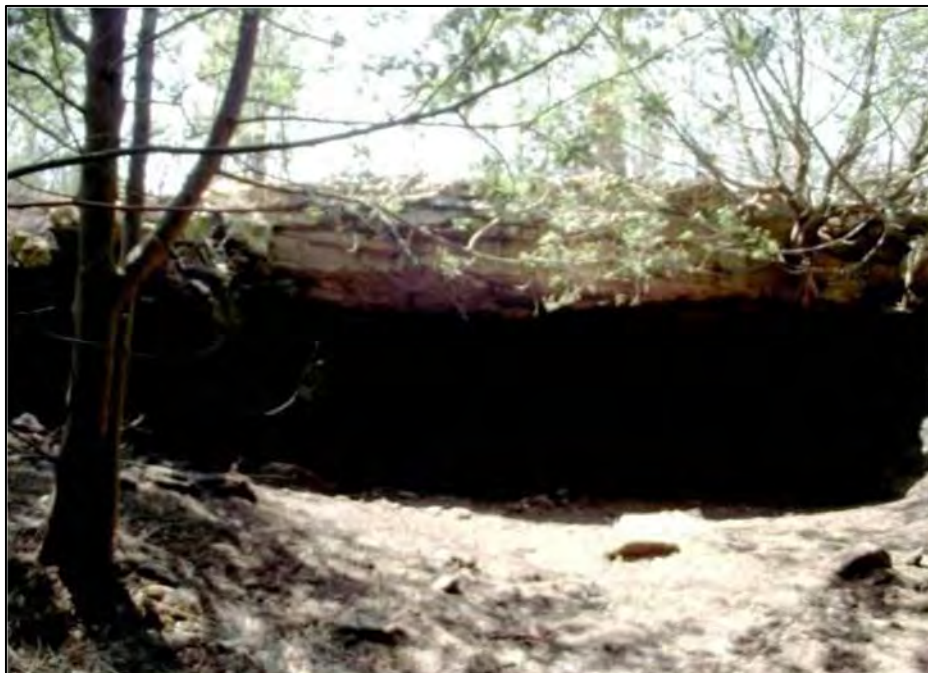
An abandoned coal mine shaft was identified at this location. The shaft measures approximately 2m x 5m and extends approximately 25m into the side of the hill. A second tunnel/shaft extended from the main shaft and its roof had collapsed at the end of this shaft/tunnel. Most of the shaft is flooded with water. Wooden supports to keep the roof of the shaft from collapsing are still in place. A ventilation hole had been dug in the roof which is visible on the surface of the rock outcrop. The age of this abandoned mine is not known. However, it is likely that it dates to over 100 years. Van der Merwe's book on the town of Belfast states that coal mining occurred in this area in historical times and was associated with Sammy Marks (1952).

Figure 77 – The entrance to the old mine shaft as recorded in 2012 (Photo: Kitto & Fourie, 2012).

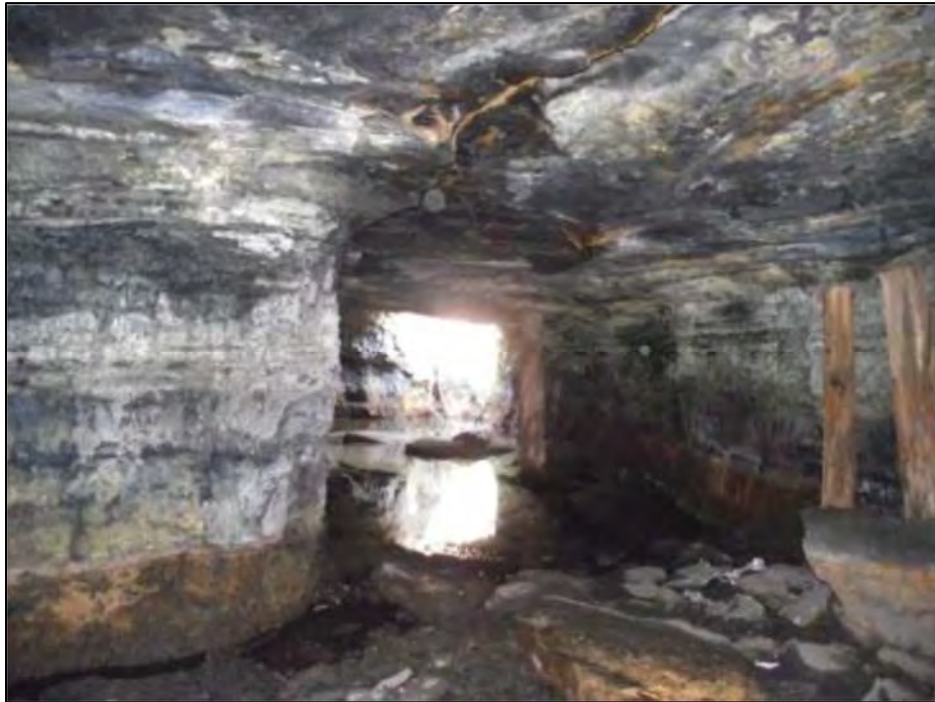
Figure 78 - Interior view of mine shaft as recorded in 2012 (Photo: Kitto & Fourie, 2012).

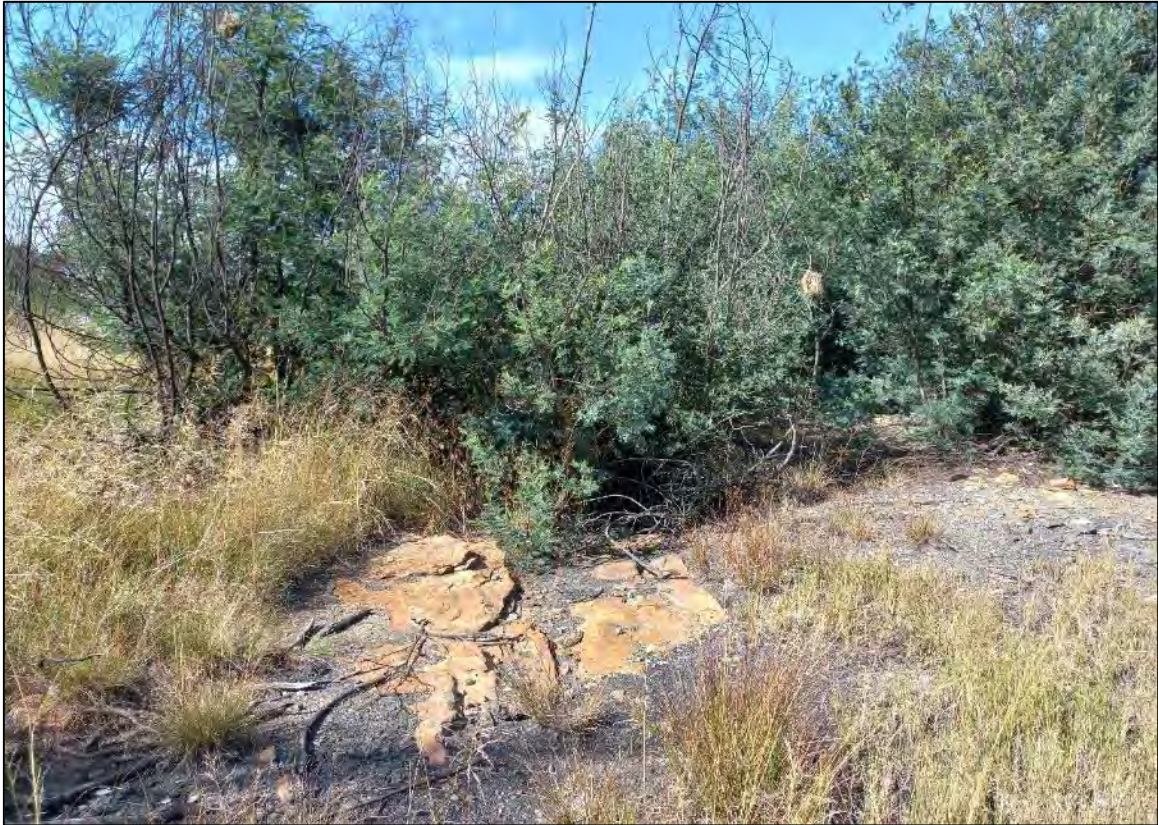
Figure 79 – General view of the site and shaft entrance as recorded in 2012.

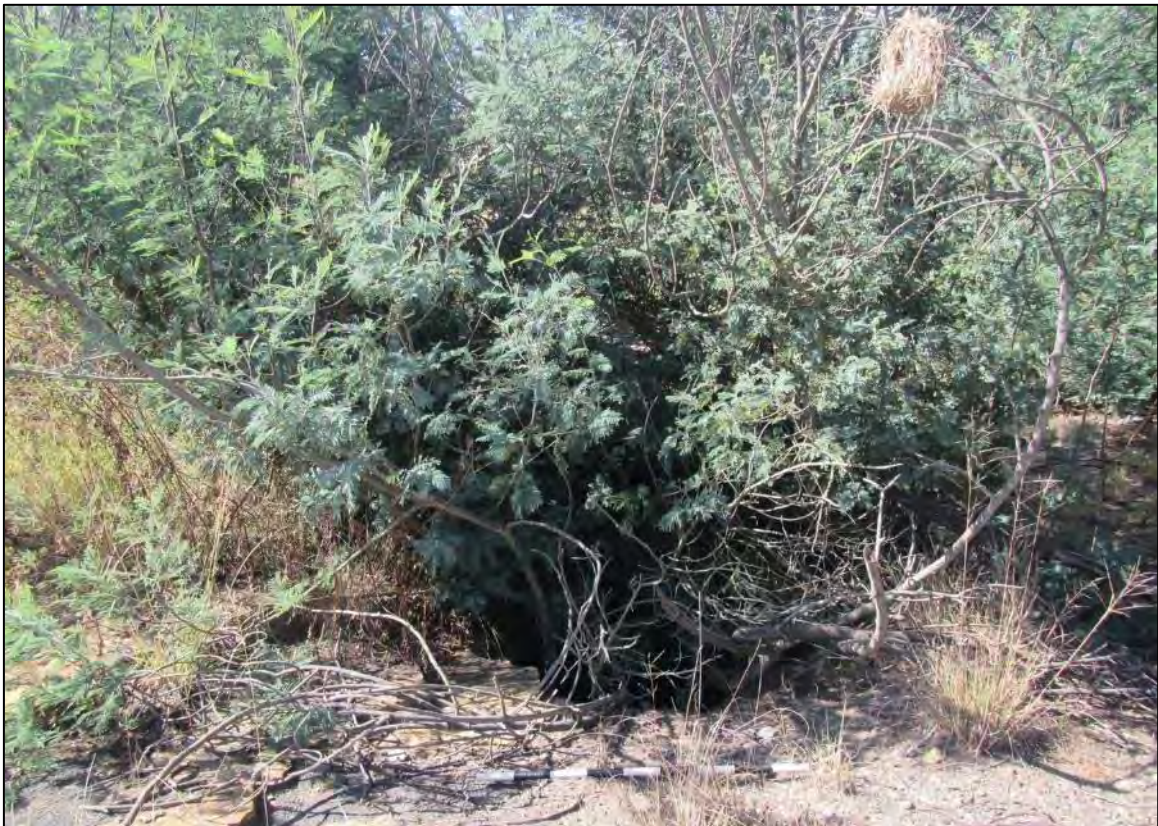
Figure 80 – Closer view of the entrance to the shaft as recorded during the recent fieldwork. As can be seen, the shaft entrance is completely overgrown. The scale is in 10cm increments.

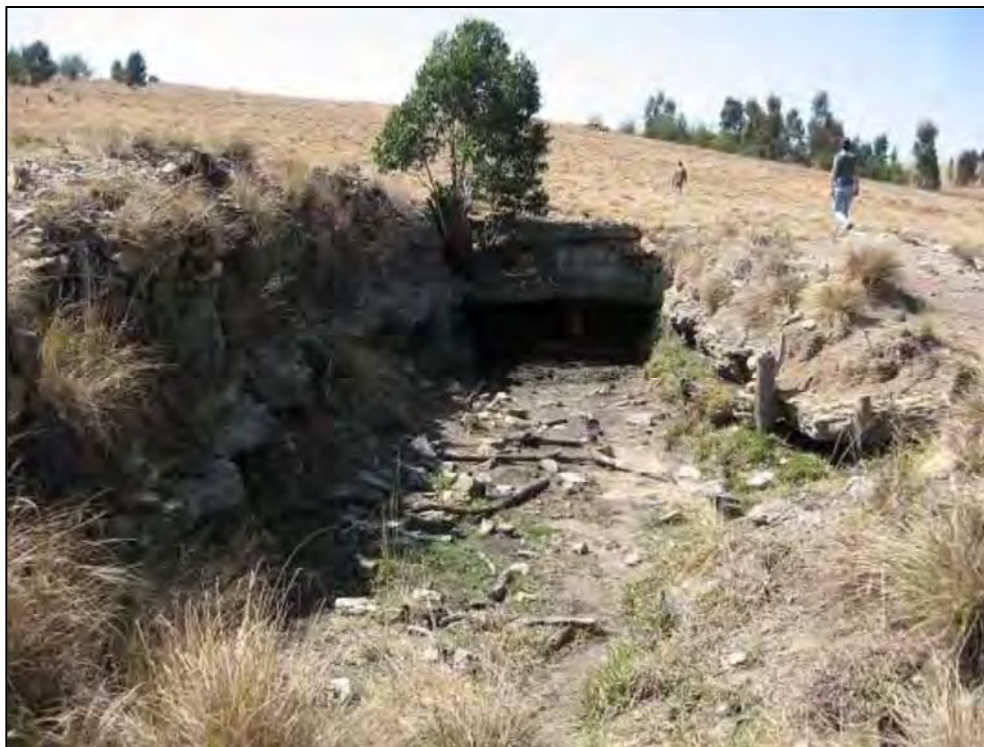
Figure 81 - General view of mine shaft at site PP 13 as recorded in 2012 (Photo: Kitto & Fourie, 2012).

The shaft appears to be in the same condition as when it was identified in 2012.

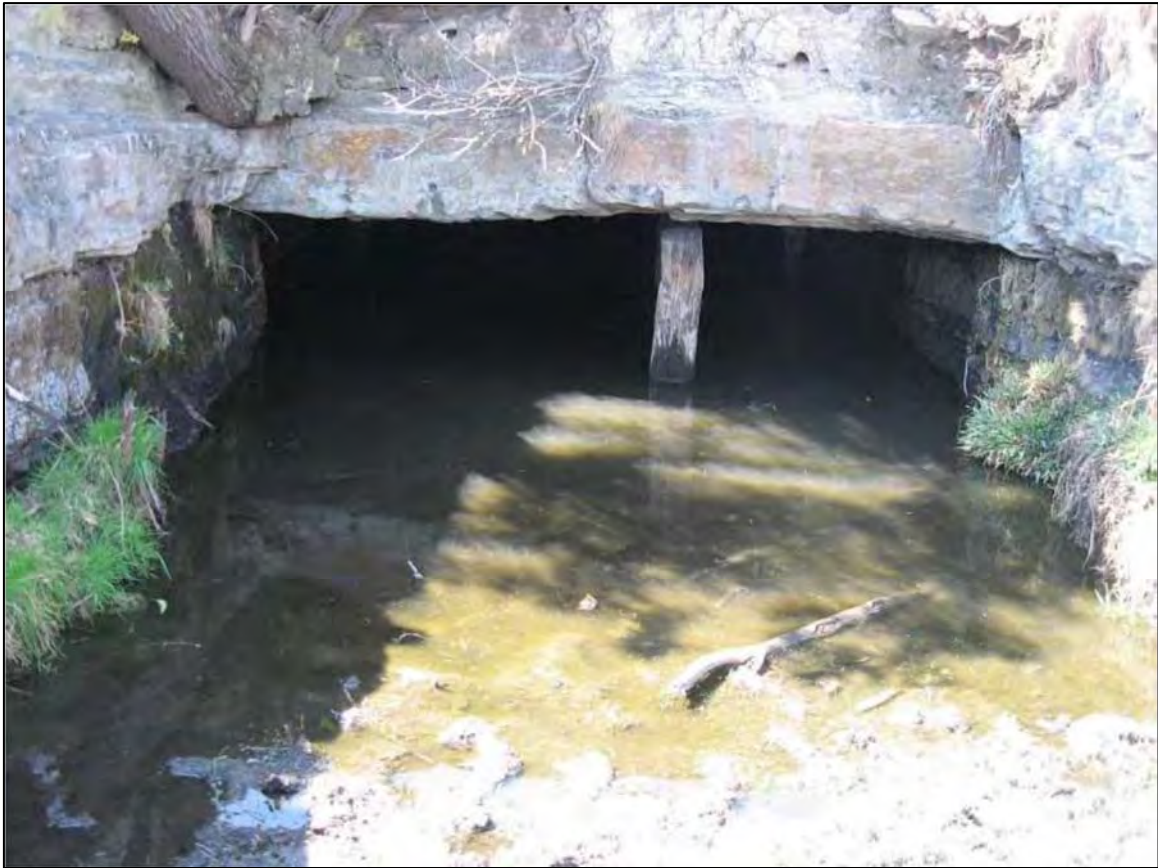
Another abandoned mine shaft was identified at this location. The shaft also measures approximately 2m x 5m and extends approximately 25m into the side of the hill. Most of the shaft is flooded with water. Wooden supports to keep the roof of the shaft from collapsing are still in place. The age of this abandoned mine was not known. However, as noted above, it probably dates to the historical period. The coal spoil heap is also still present close to the entrance of the shaft

Figure 82 - Close-up view oof the shaft entrance as recorded in 2012 (Photo: Kitto & Fourie, 2012).

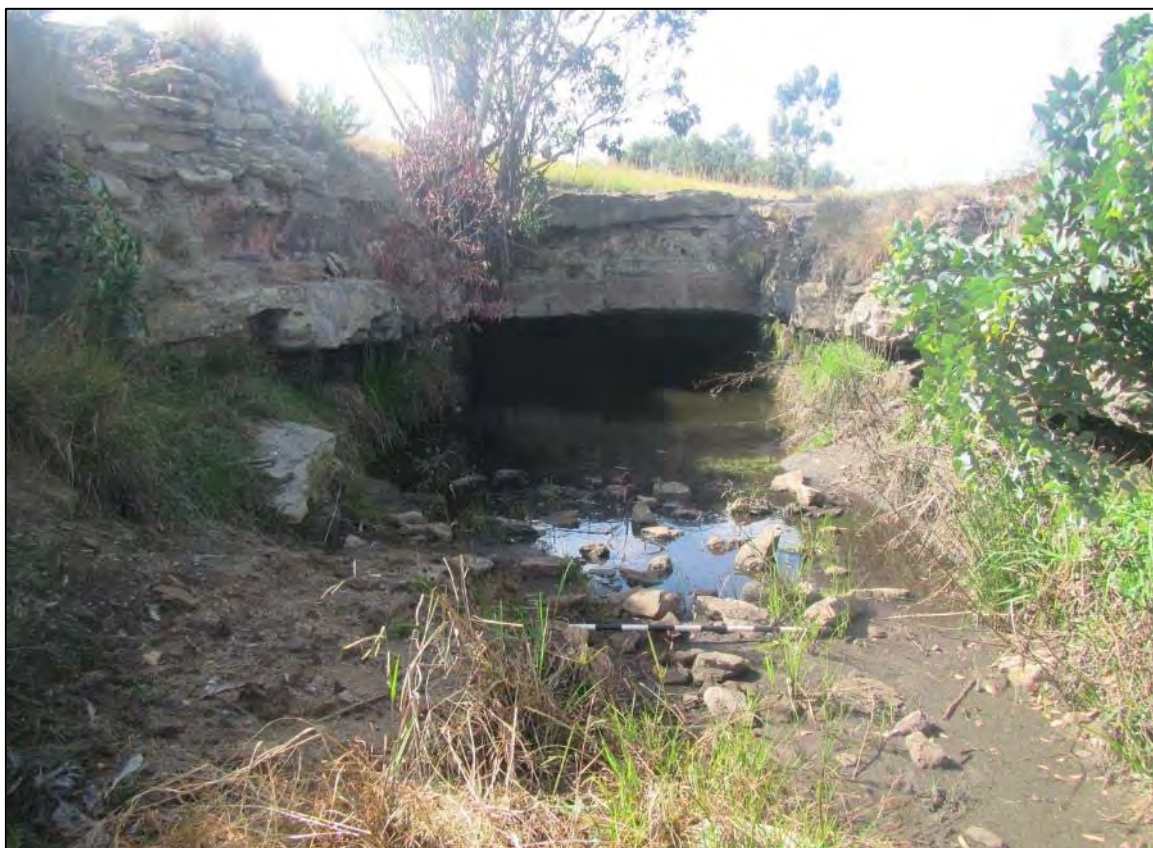
Figure 83 – General view of the shaft entrance at PP 13 as recorded during the recent fieldwork. The scale is in 10cm increments.

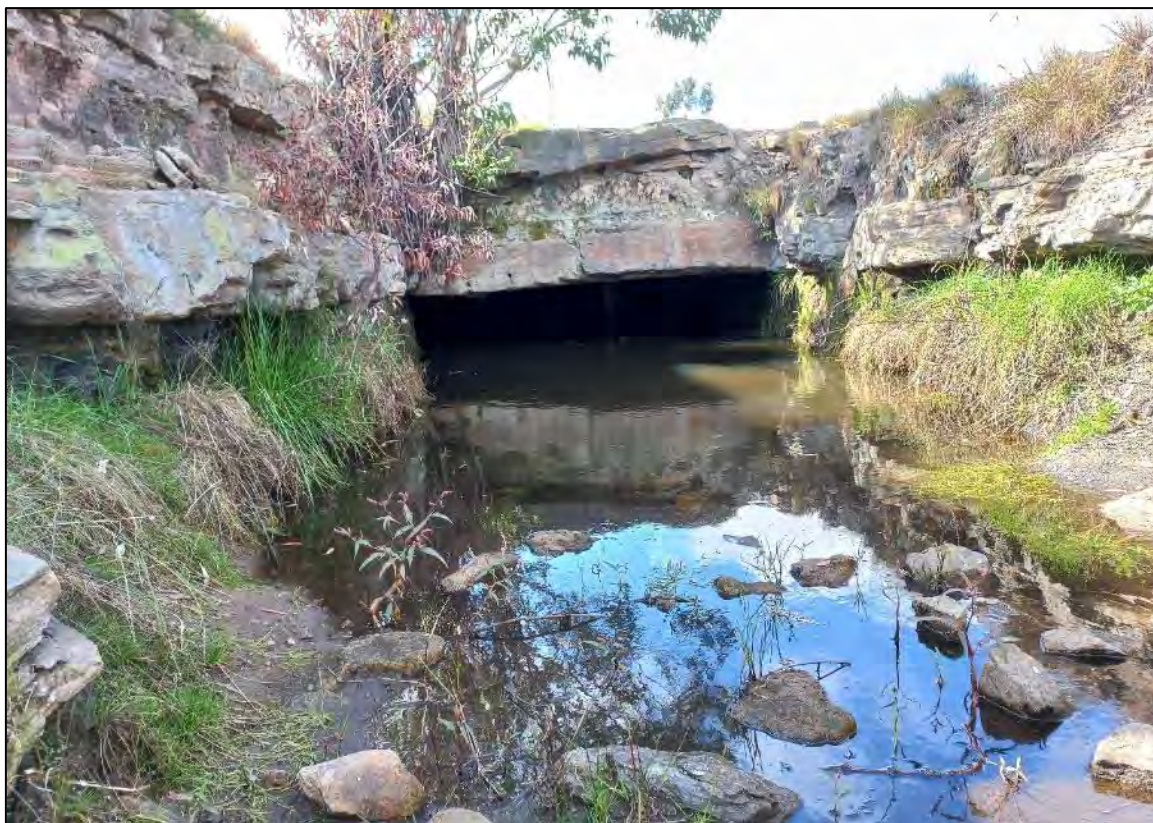
Figure 84 – Closer view of the shaft entrance at PP 13 as recorded during the recent fieldwork.

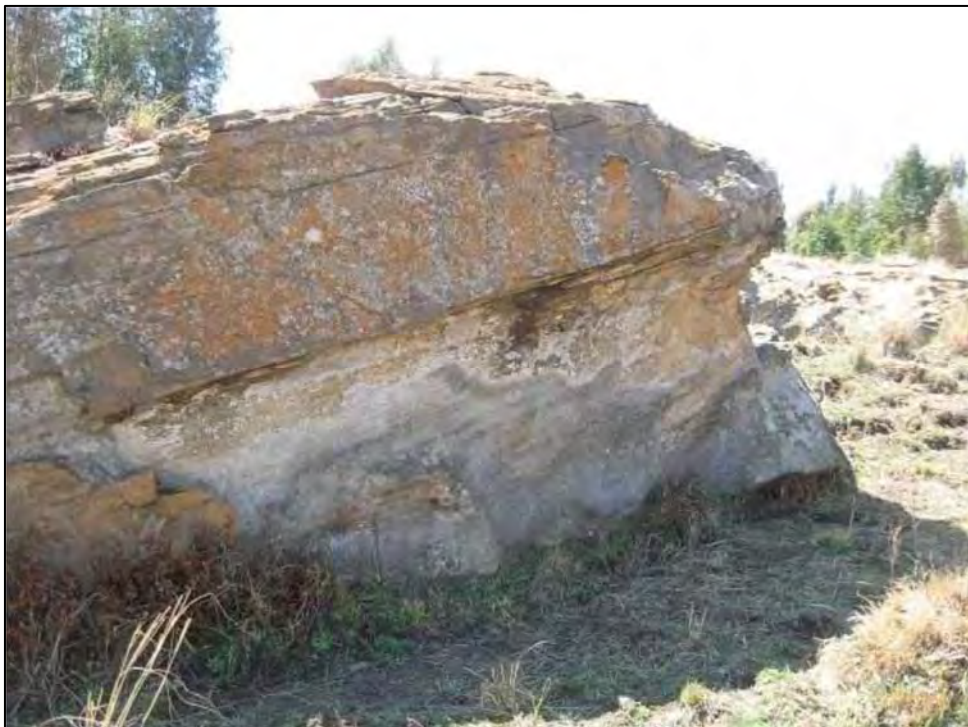
A possible rock art site was identified at this location. The position of the panel is situated on the southern side of an exposed rock bank which formed a slight overhang. Two extremely faded figures were identified. These figures were red in colour, but could not be identified clearly. The figures measure approximately 20cm in size. The rock face is also deteriorating. No archaeological deposit was identified at the foot of the rock face.

Figure 85 – General view of the rock outcrop with possible rock art as recorded in 2012 (Photo: Kitto & Fourie, 2012).

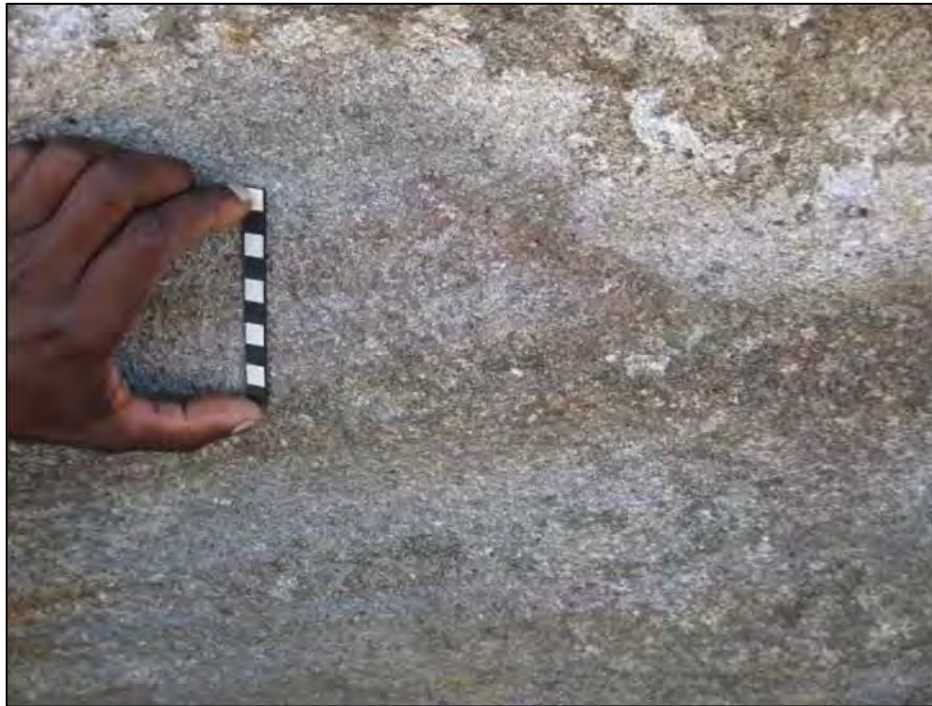
Figure 86 – Closer view of the possible rock art as recorded in 2012 (Photo: Kitto & Fourie, 2012).

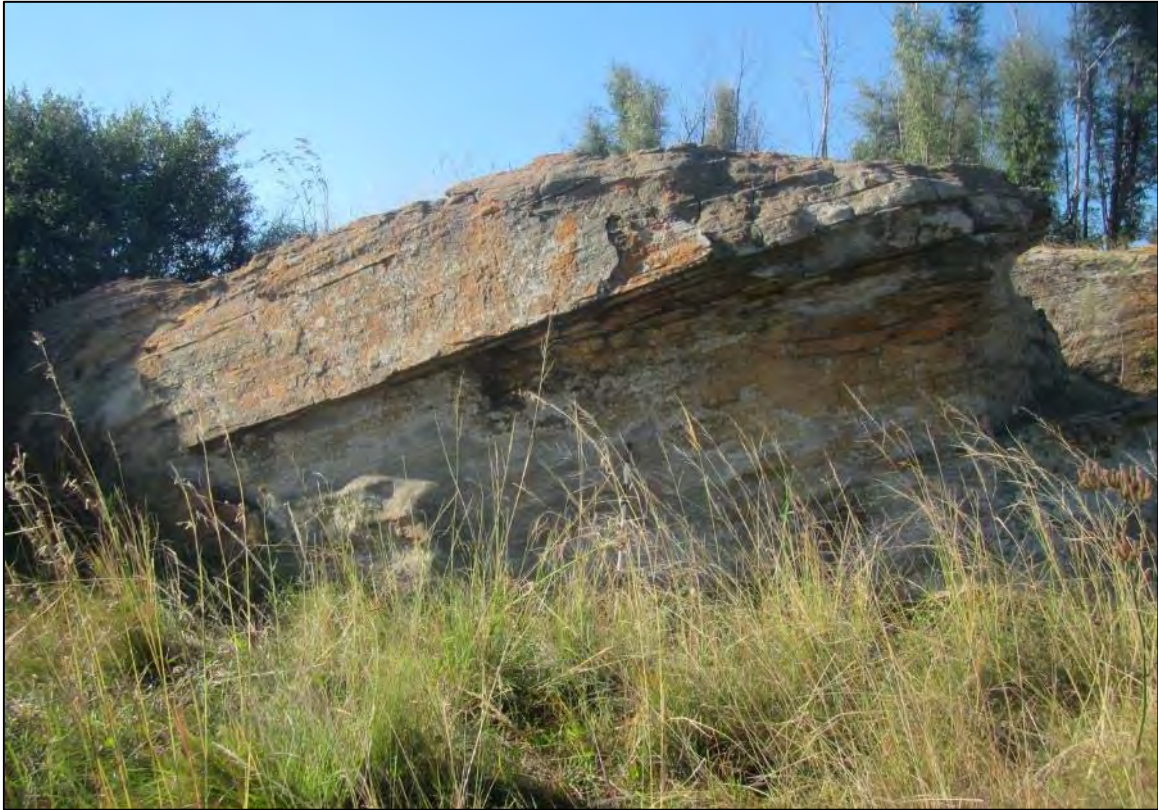
During the 2012 study, the site was assessed to be of **Provincial Significance (Grade 2)**. Due to the deterioration that has evidently occurred over the last nine years, the current significance of the site is deemed to be of **Medium to High Significance (GP. A)**.

Figure 87 - General view of the exposed rock at site PP 14 as recorded during the recent fieldwork.

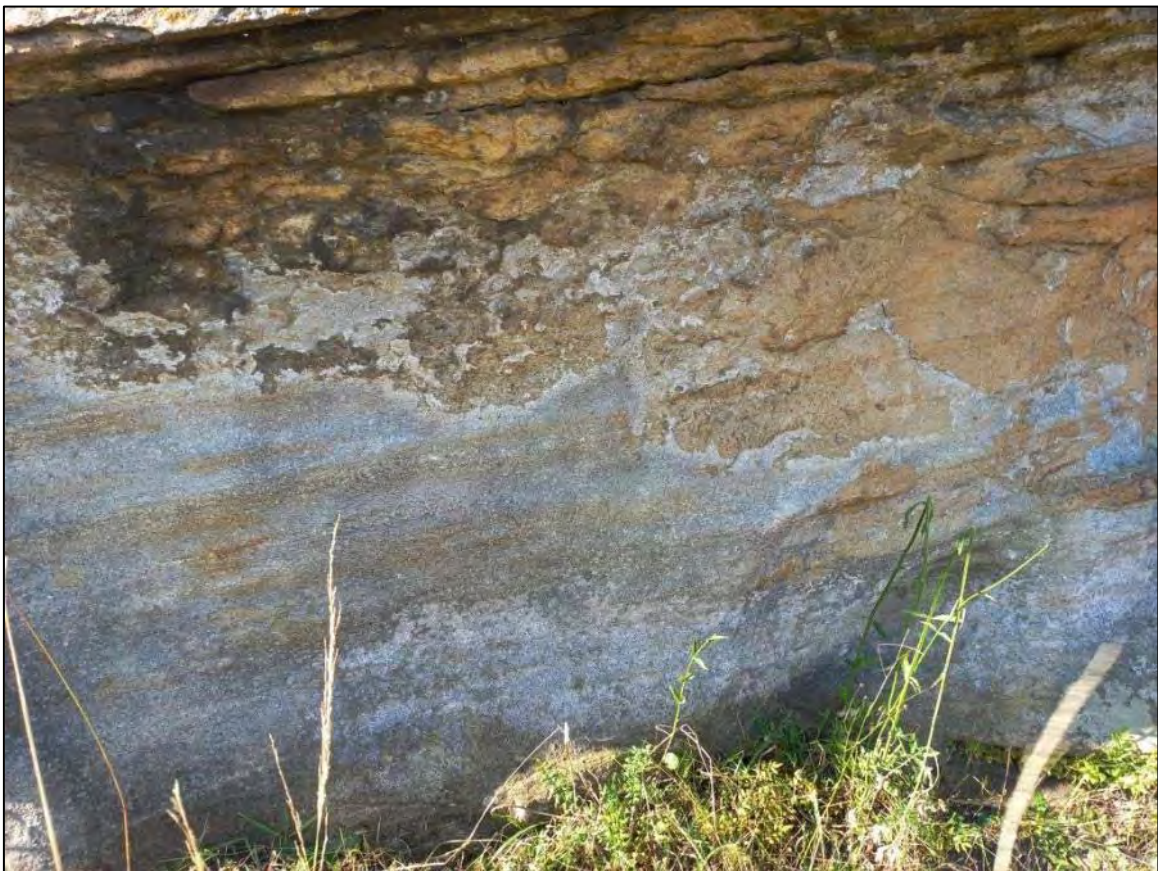
Figure 88 - Closer view of the side of the boulder shows no distinctive or visible rock art

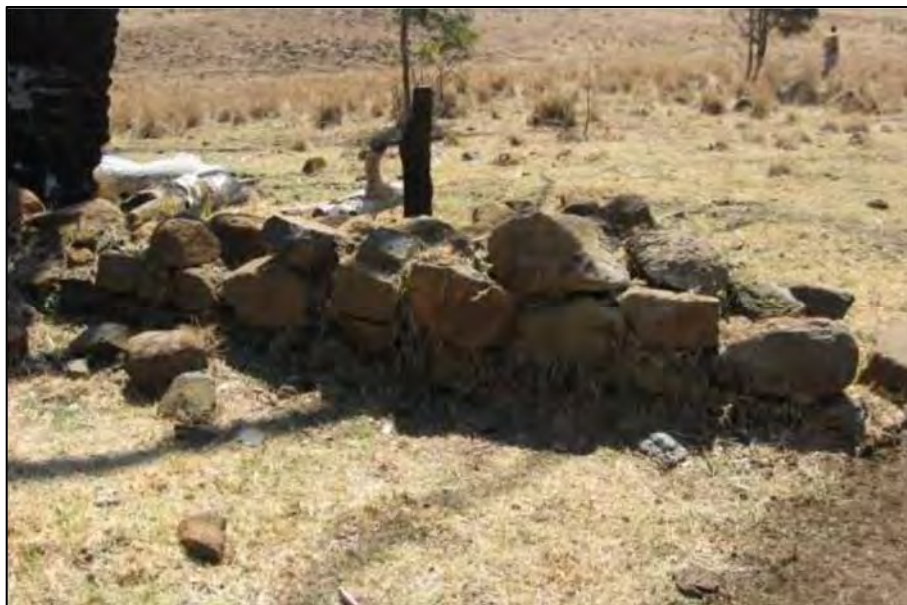
The ruined stone walled cattle kraal was situated approximately 35m to the west of the homestead. The kraal measures approximately 10m x 10m in size and the walls measure approximately 0.5m wide and 0.75m high.

Figure 89 - Remains of the cattle kraal as recorded in 2012 (Photo: Kitto & Fourie, 2012).

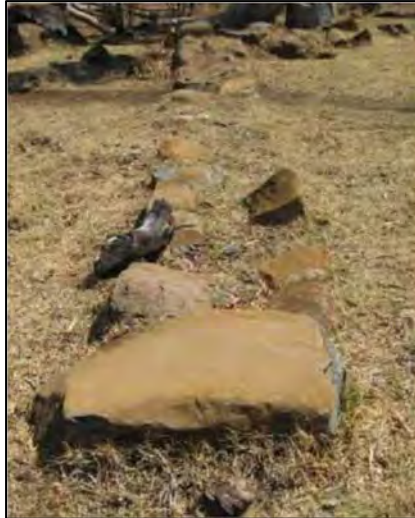
Figure 90 – Close-up view along a section of the wall of the cattle kraal (Photo: Kitto & Fourie, 2012).

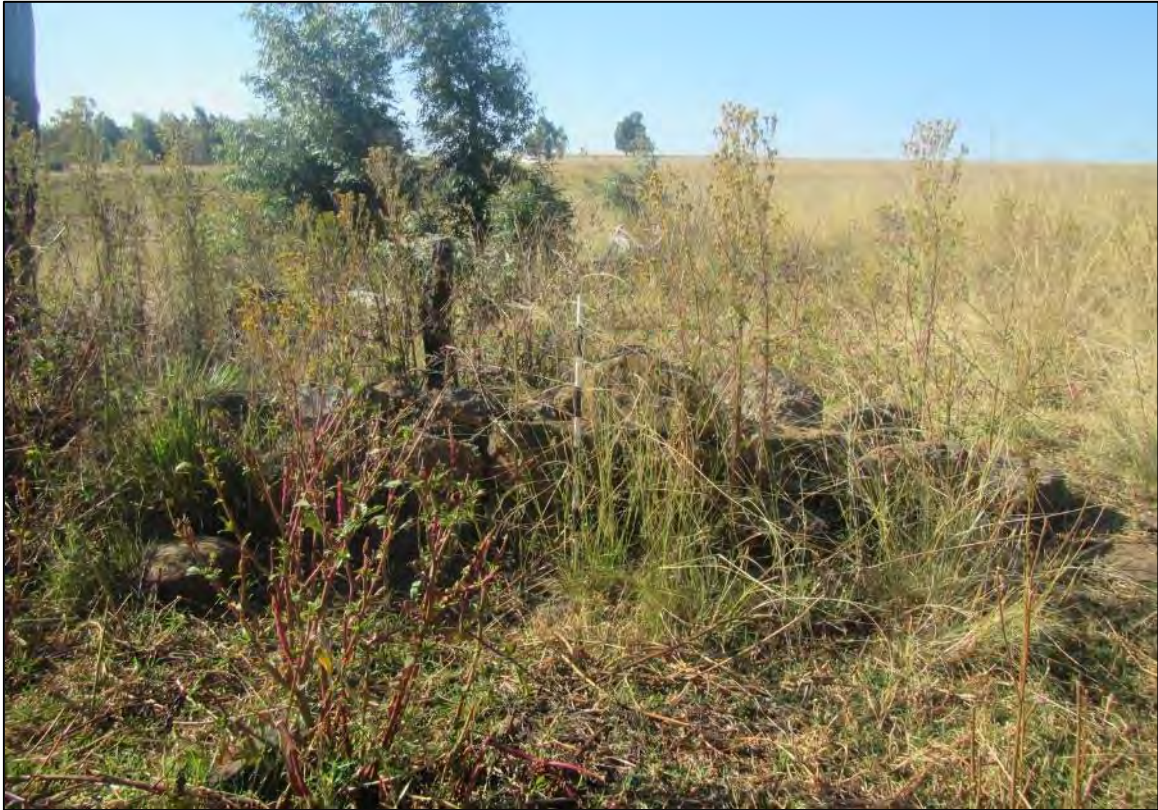
Figure 91 - View of the stone kraal as recorded during the 2021 fieldwork. The site is currently overgrown and it appears as if sections of its walls have collapsed since the 2012 fieldwork. The scale is in 10cm increments.

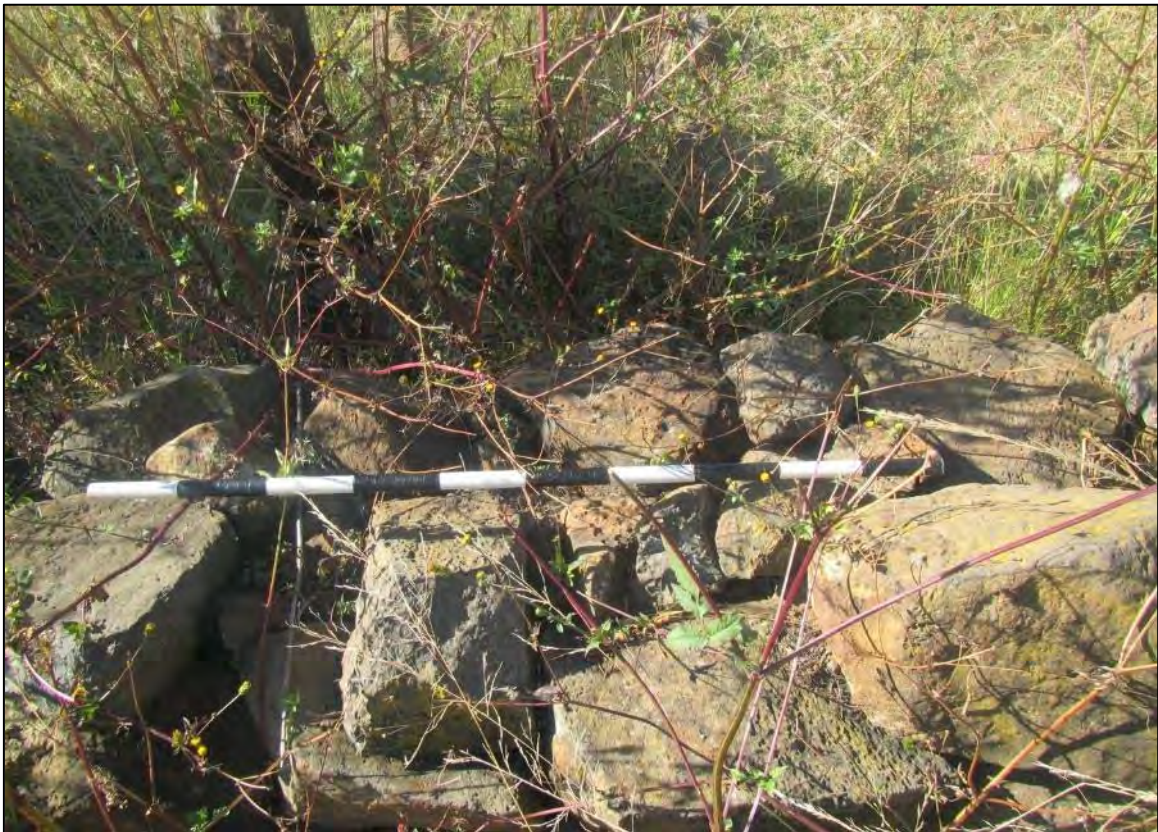
Figure 92 - Closer view of a section of walling from the kraal. The scale is in 10cm increments.

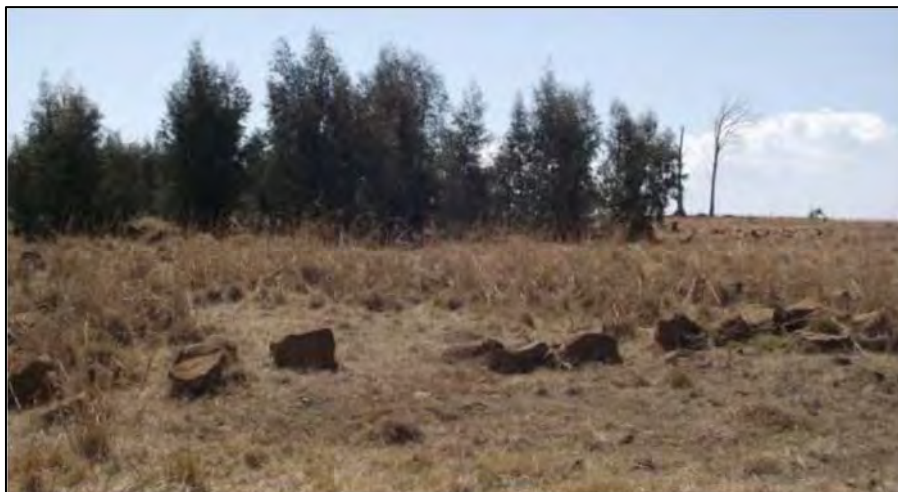
The ruin of a stone-walled cattle kraal is situated approximately 30m to the east of the homestead. The kraal measures approximately 10m x 12m in size but the walls had been robbed and the size of the walls could not be determined. Two informal graves were also identified next to the kraal. They are placed next to each other and are orientated from west to east. The graves have oval-shaped mounds of packed rocks as dressing. The graves have no headstones and their age could not be determined.

Figure 93 – The remains of kraal walling as recorded in 2012 (Photo: Kitto & Fourie, 2012).

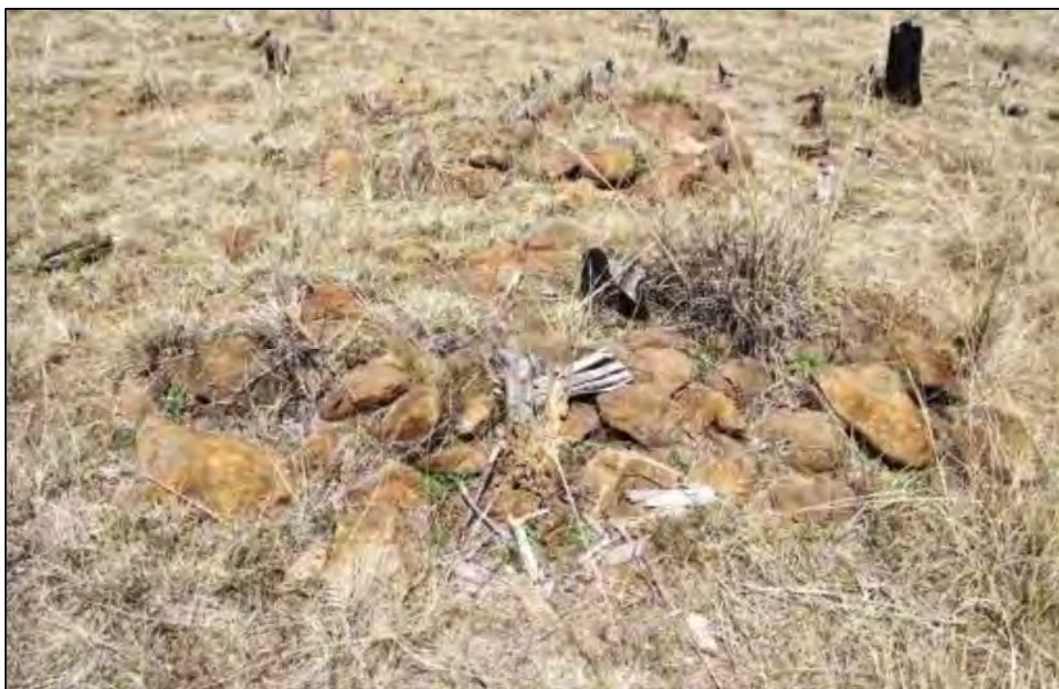
Figure 94 – General view of the two graves as recorded in 2012 (Photo: Kitto & Fourie, 2012).

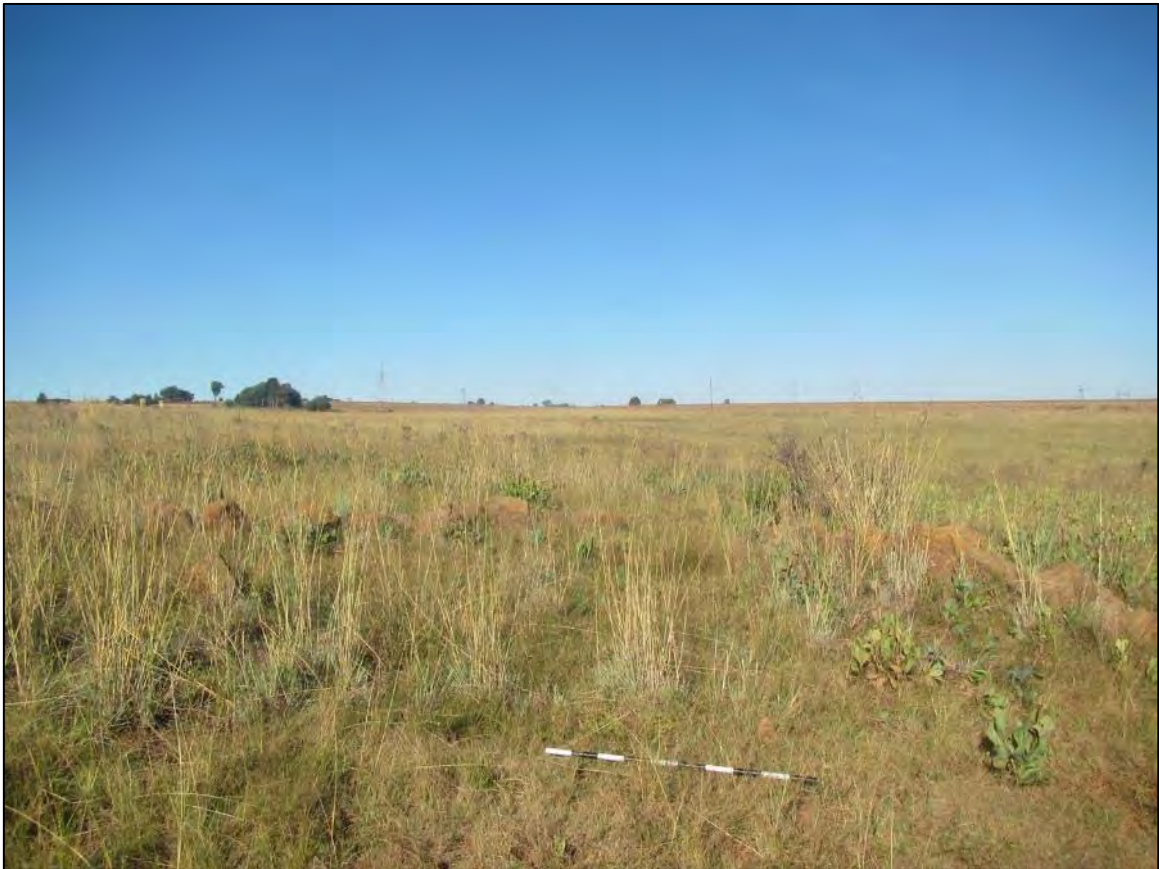
Figure 95 - General view of the site as recorded in 2021. The scale is in 10cm increments.

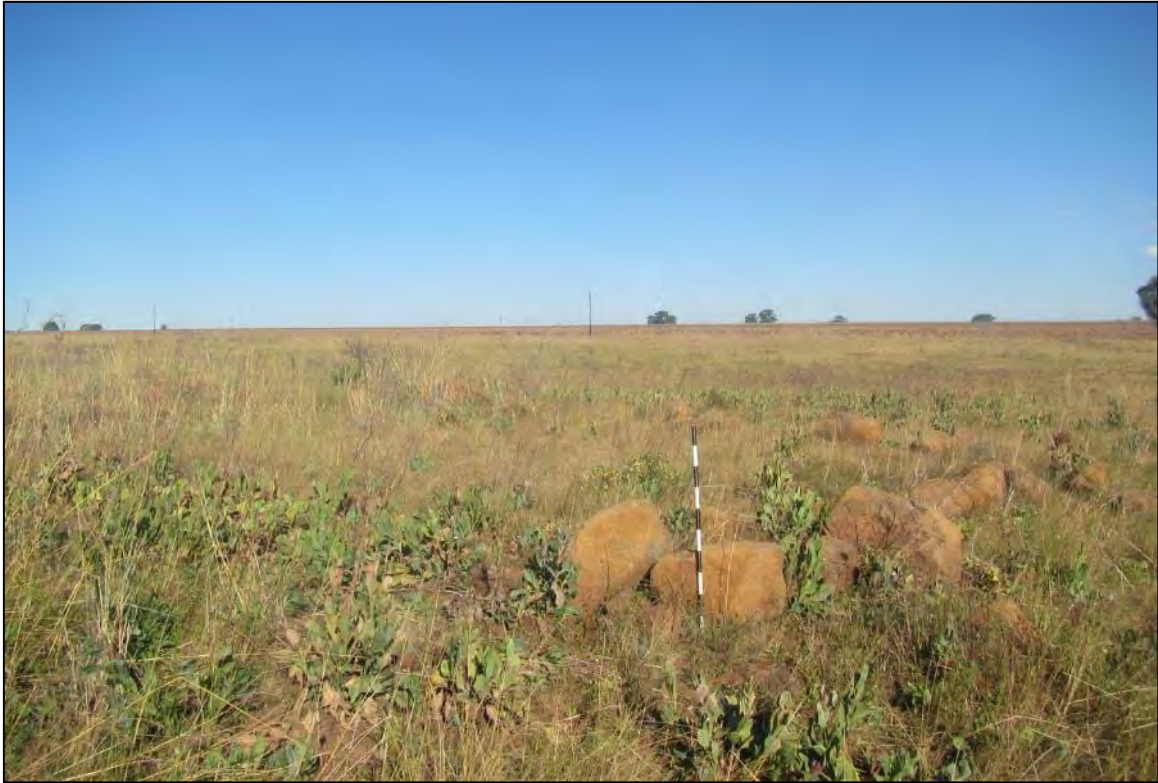
Figure 96 - View of the stone wall observed at the site during the 2021 fieldwork. The scale is in 10cm increments.

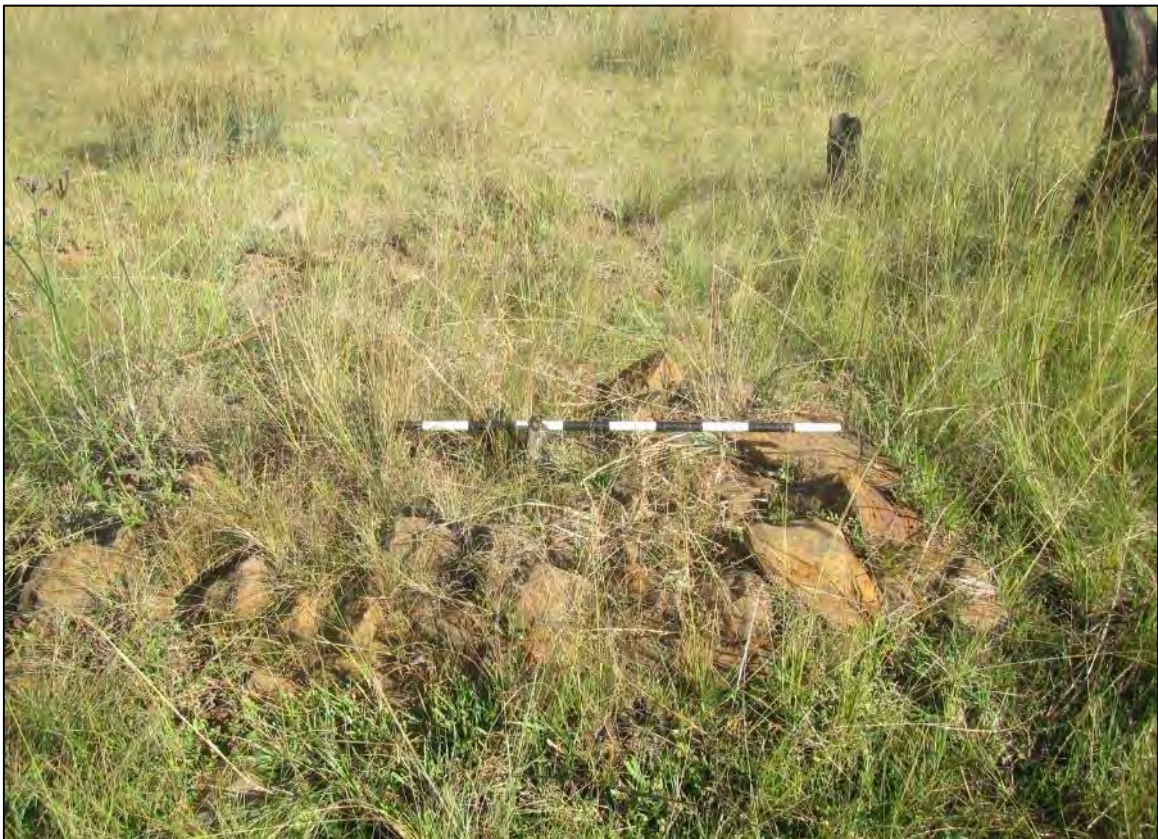
Figure 97 - View of the two graves as recorded during the 2021 fieldwork. The scale is in 10cm increments.

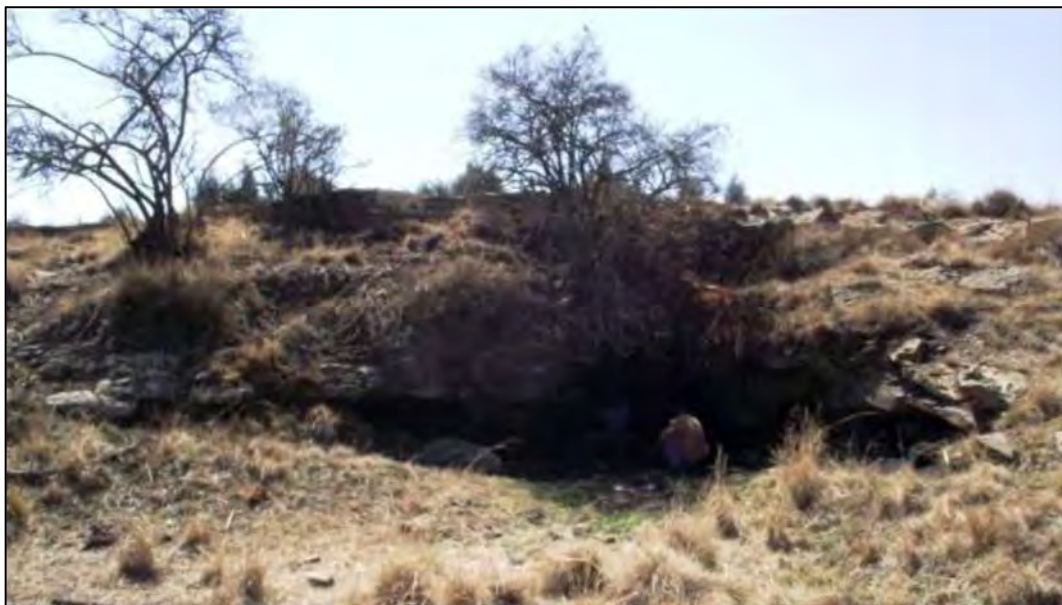
An abandoned coal mine shaft was identified at this location. The shaft measures approximately 2m x 4m and extends approximately 15m into the side of the hill. Most of the shaft is flooded with water. The age of this abandoned mine is not known but it is likely to be of historical date (as discussed above).

Figure 98 – Entrance to the mine shaft at site PP17 as recorded in 2012 (Photo: Kitto & Fourie, 2012).

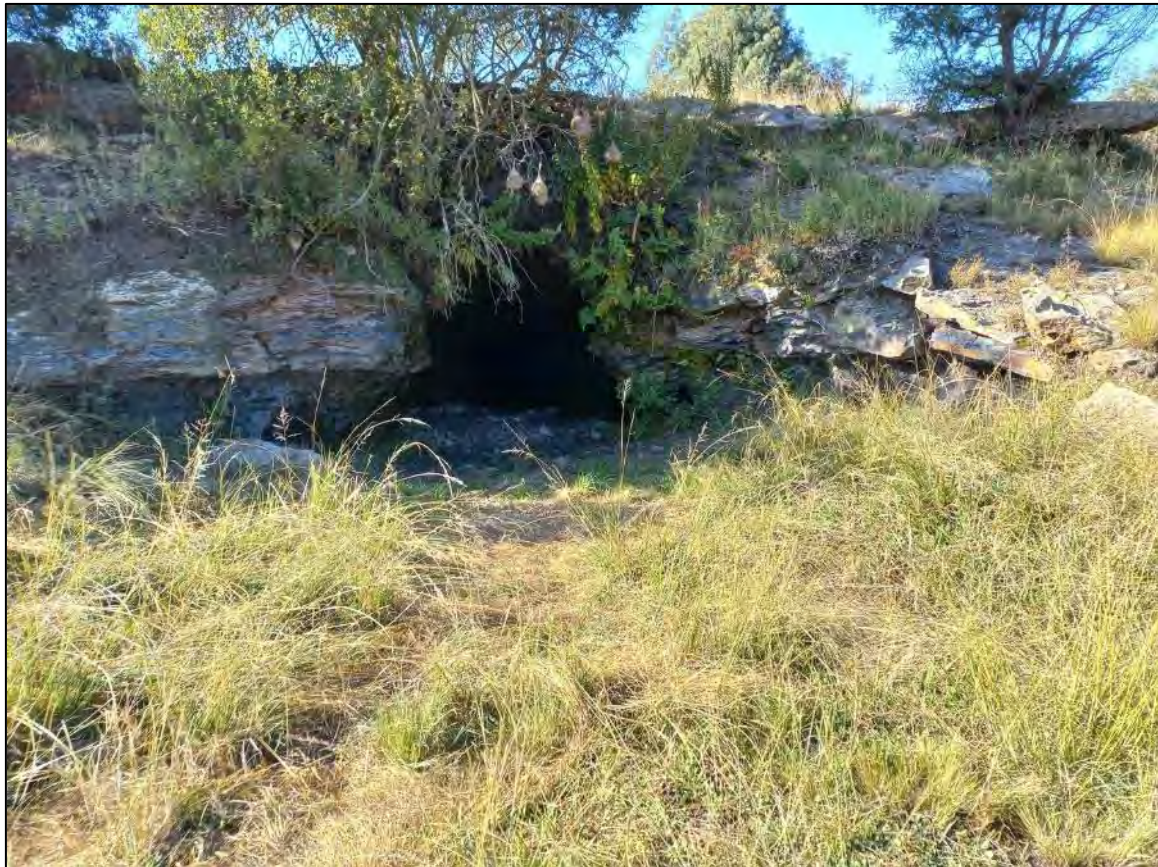
The site was visited during the recent fieldwork. The mine shaft appears to be relatively intact and in a similar condition as when it was recorded in 2012. The shaft is still flooded with water.

Figure 99 – General view of site PP 17 as recorded during the recent fieldwork. The entrance to the mine shaft can be seen below the weaver-nests hanging from the tree.

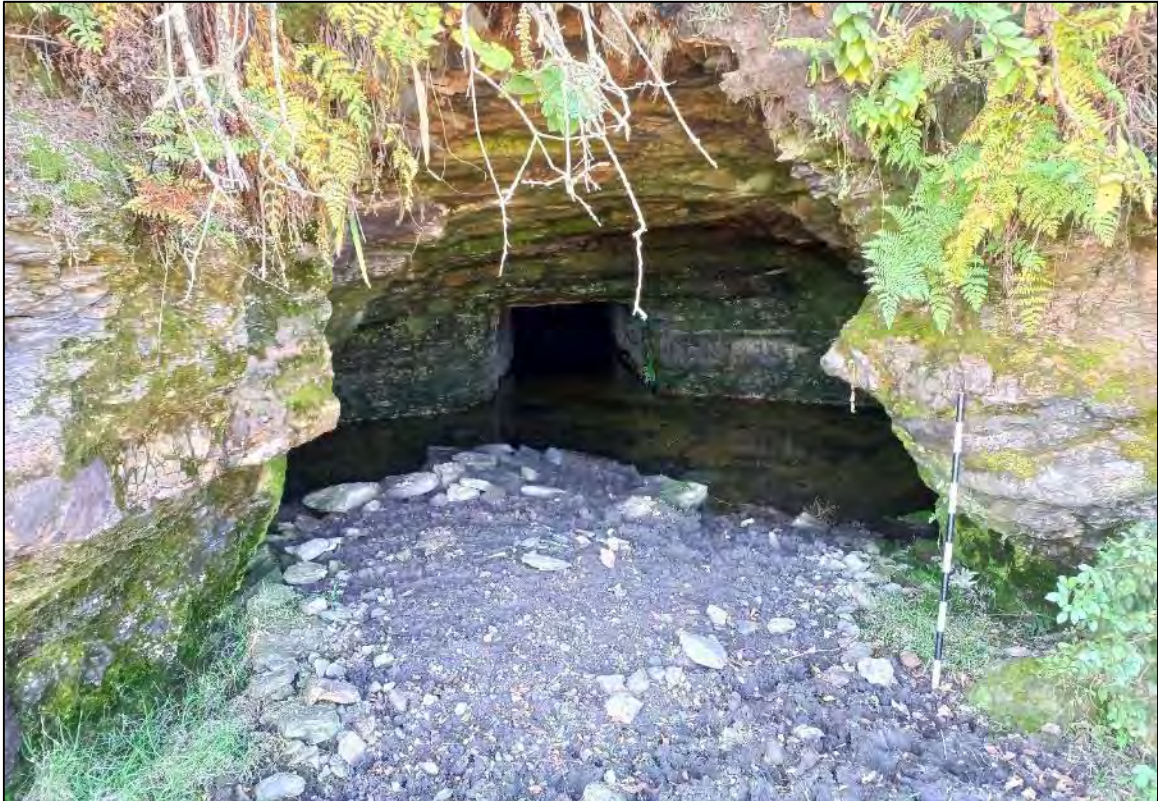
Figure 100 – General view of the entrance to the shaft at site PP 17 as recorded during the recent fieldwork. The scale is in 10cm increments.

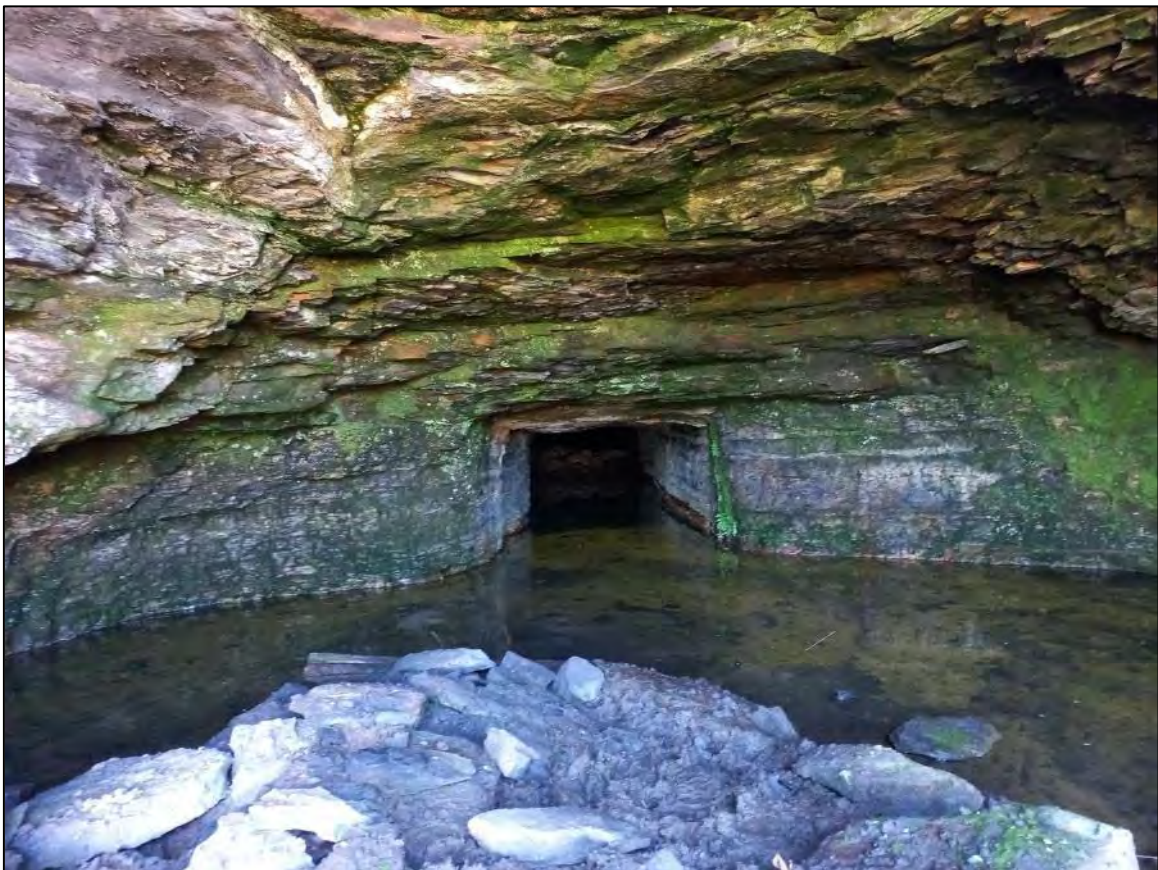
Figure 101 - Interior view of the shaft as recorded during the recent fieldwork.
