NBC COLLIERY GLISA AND PAARDEPLAATS MINING PROJECT

Phase 1 – Heritage Impact Assessment

Issue Date: 19 May 2021
Revision No.: 2.0
PGS Project No.: 524HIA
CI Group project No: 19.0001

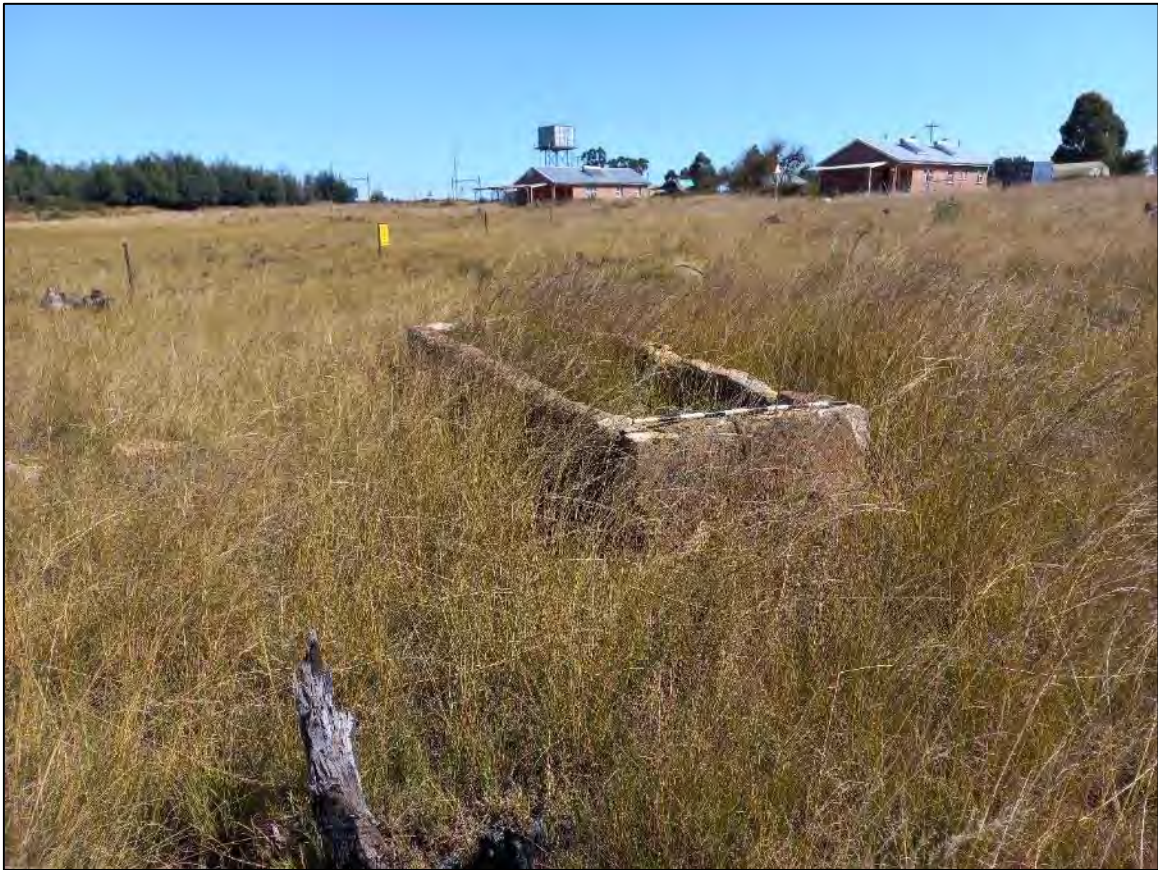
The site was visited during the recent fieldwork. The trough appears to be in the same condition as when it was recorded in 2012. The site is overgrown with vegetation and it would appear that the trough is not currently used.

Figure 102 - General view of the animal drinking trough at site PP 18 as recorded during the recent fieldwork. The scale is in 10cm increments.

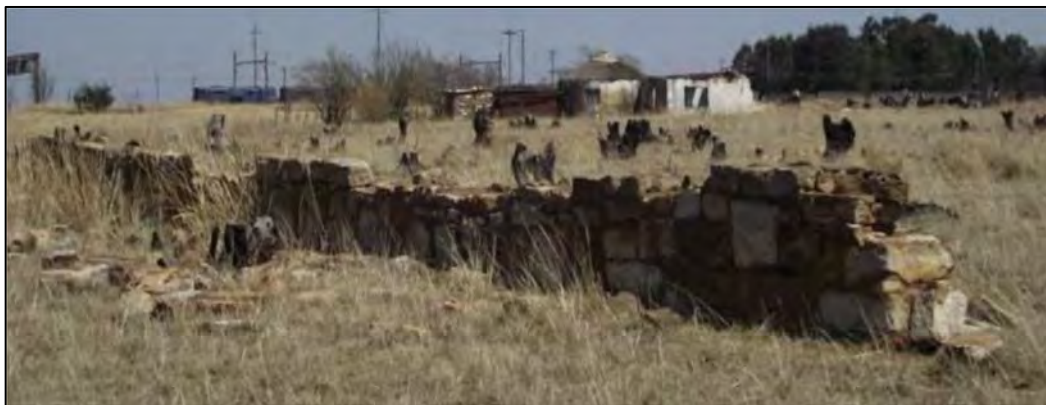
A ruined stone-walled cattle kraal was identified at this location. The kraal measures approximately 20m x 10m in size and the walls measure approximately 0.5m wide and 1m high. Most of the sandstone blocks used in the walls of the kraal have been robbed (used somewhere else) and the original kraal is in a very dilapidated state.

Figure 103 - Remains of stone kraal as recorded in 2012 (Photo: Kitto & Fourie, 2012).

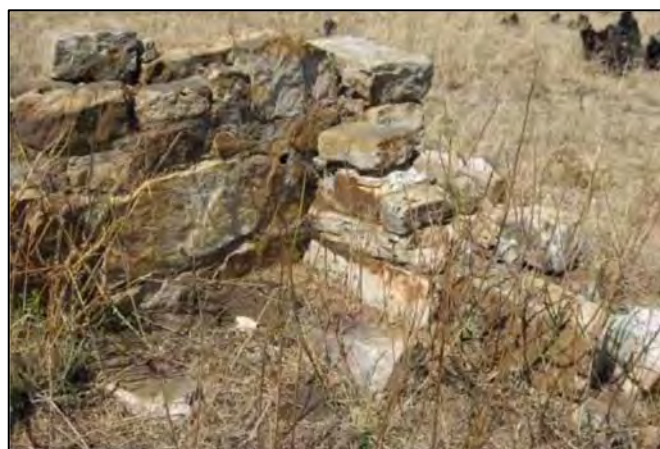
Figure 104 - Close-up view of a section of walling from the kraal (Photo: Kitto & Fourie, 2012).

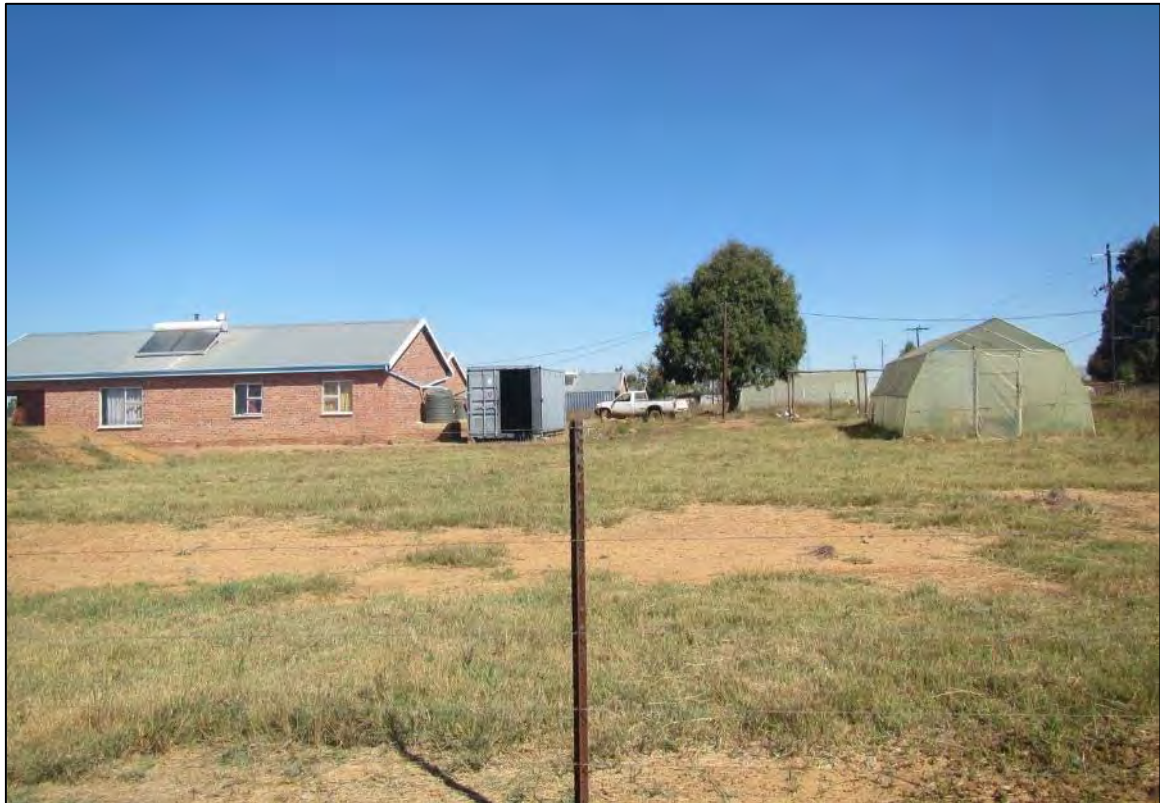
Figure 105 - General view of PP 19 as recording during the recent fieldwork. The kraal is no longer located on-site, as the area has since been used for the site of the Phumulani Agri-Village.

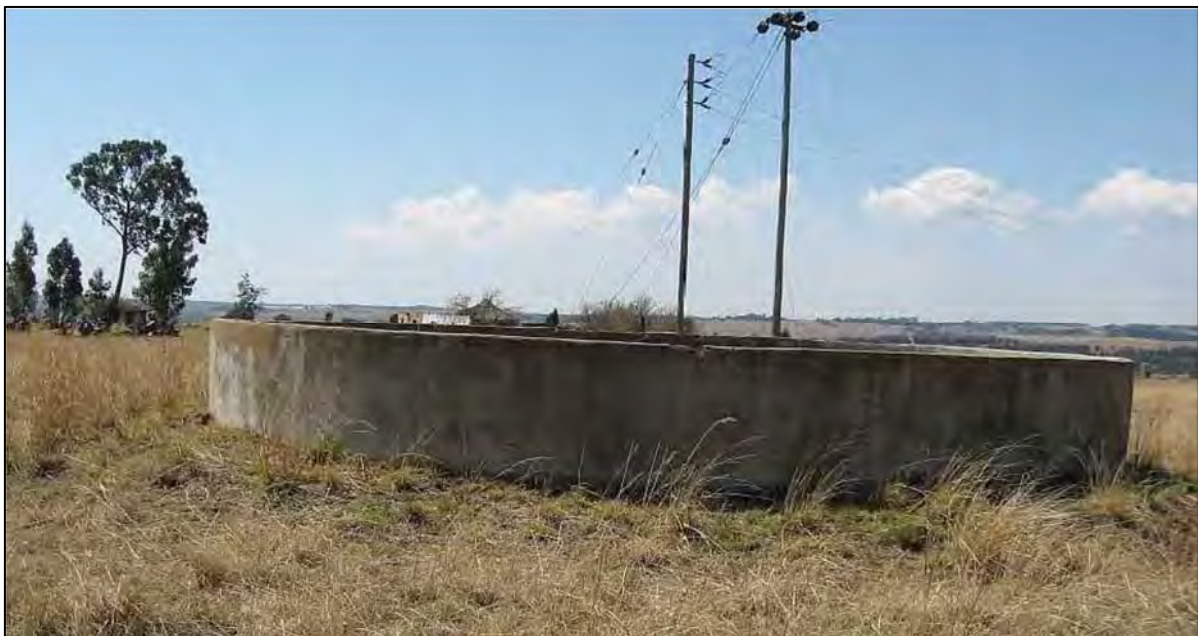
Figure 107 – General view of the brick and cement dam as recorded during the fieldwork undertaken in 2012 (Photo: Kitto & Fourie, 2012).

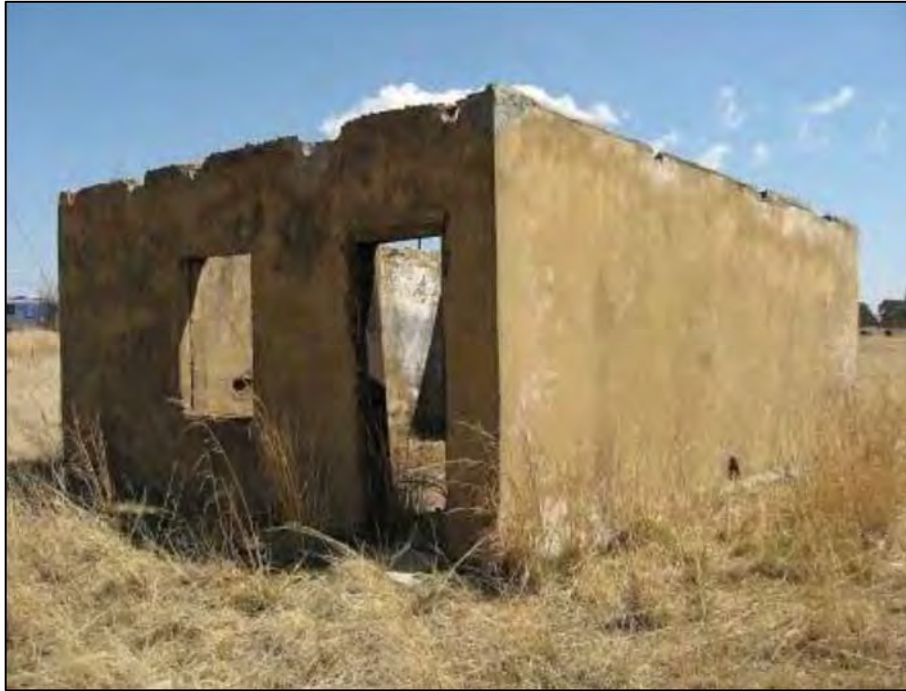
A 6m x 6m square brick-built building is situated next to the cement dam. The building is plastered and has a wooden door frame. The building's roof, windows and doors had been removed.

Figure 108 - Brick structure as recorded during the fieldwork undertaken in 2012 (Photo: Kitto & Fourie, 2012).

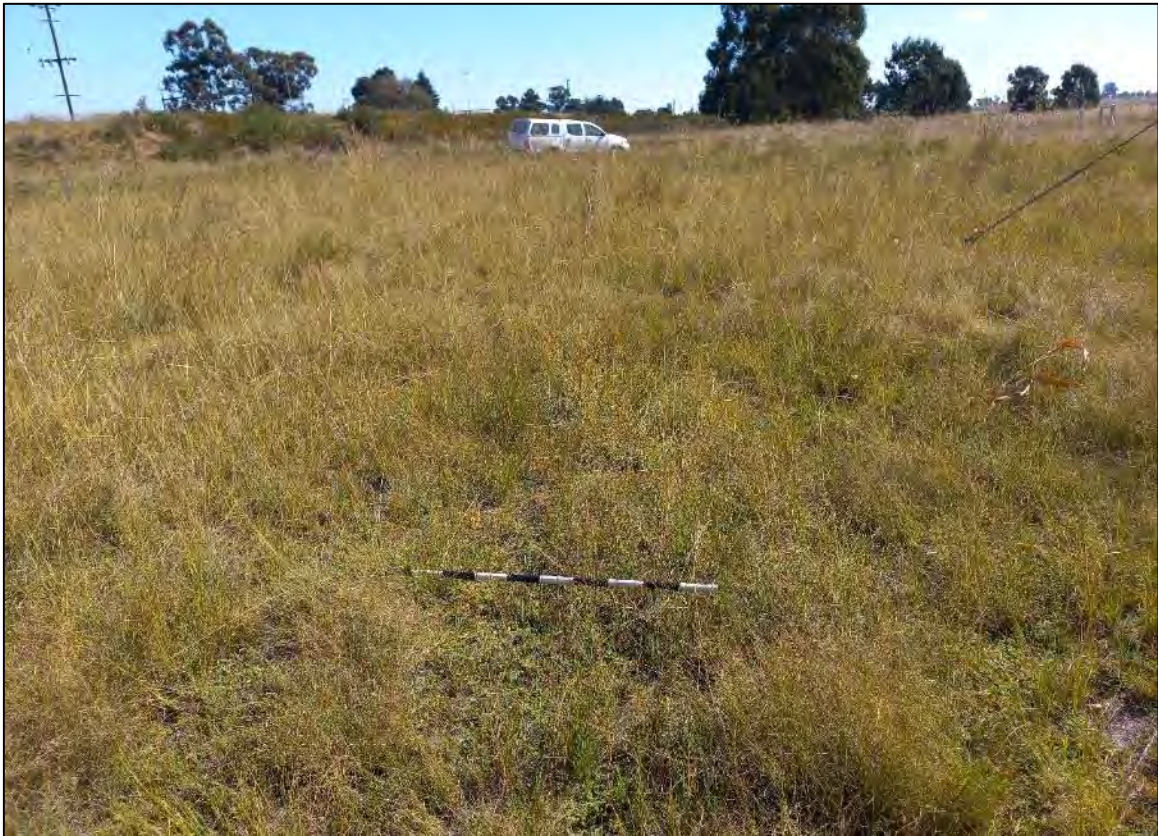
Figure 109 - General view of the site as recorded in 2021. As can be seen from this image, no evidence for the dam or associated structure could be found. The scale is in 10cm increments

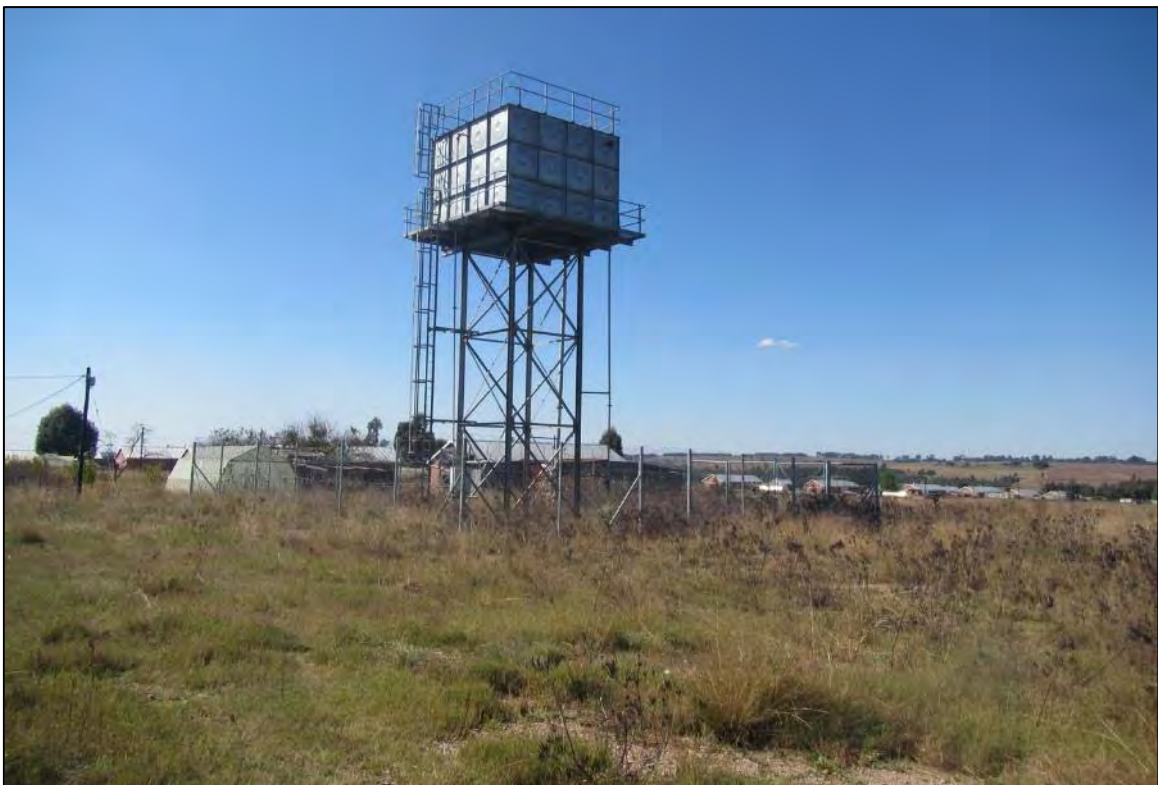
During the recent fieldwork undertaken in 2021, the site was also visited. No evidence for the structures that were recorded in 2012 could be observed during the recent fieldwork. It would appear that the structures were most likely demolished during the construction of the Phumulani Agri-village. A newer steel reservoir is located close to the original position of the cement dam.

Figure 110 – The new steel reservoir that was built near site PP 20. This steel reservoir is associated with the Phumulani Agri-Village.

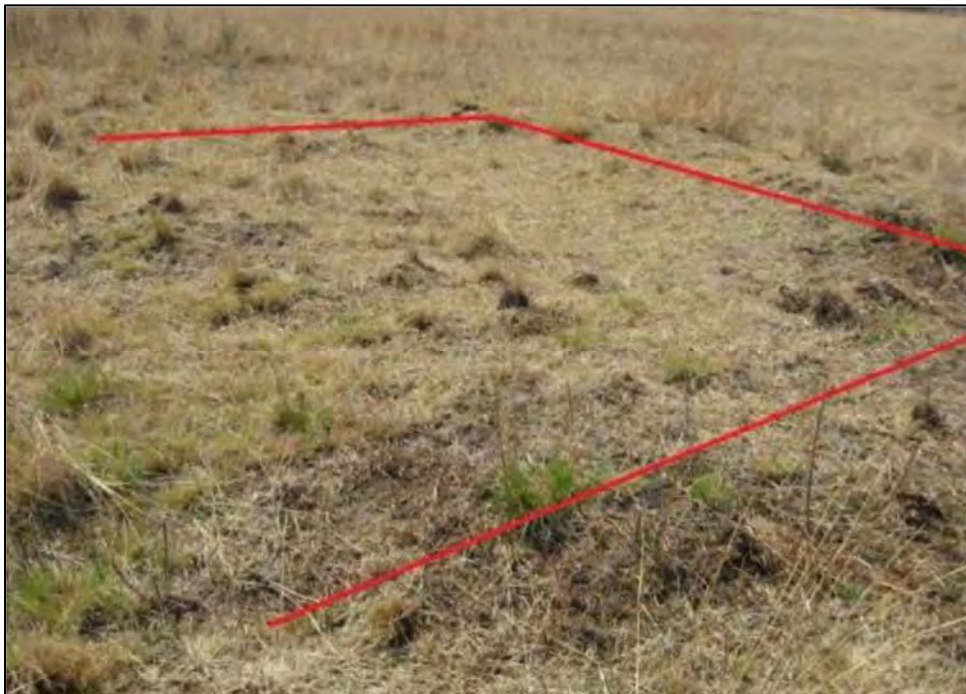
The remains of a mud-brick homestead were identified at this location. The remains of the mud-brick homestead consist of the foundations of one rectangular structure, which measure approximately 7m x 4m in size, and a multi-roomed I-shaped structure, which measures 8m x 12. A further circular structure measures approximately 4m in diameter. This structure was most probably the cooking hut. Rocks were used in the foundations to support the mud-brick walls of the structures. A lower grinding stone was also identified with the remains of the structures. Several modern metal artefacts such as wire, corrugated iron and cans were found scattered around the site.

Figure 111 - Foundations of rectangular structure as recorded in 2012 (Photo: Kitto & Fourie, 2012).

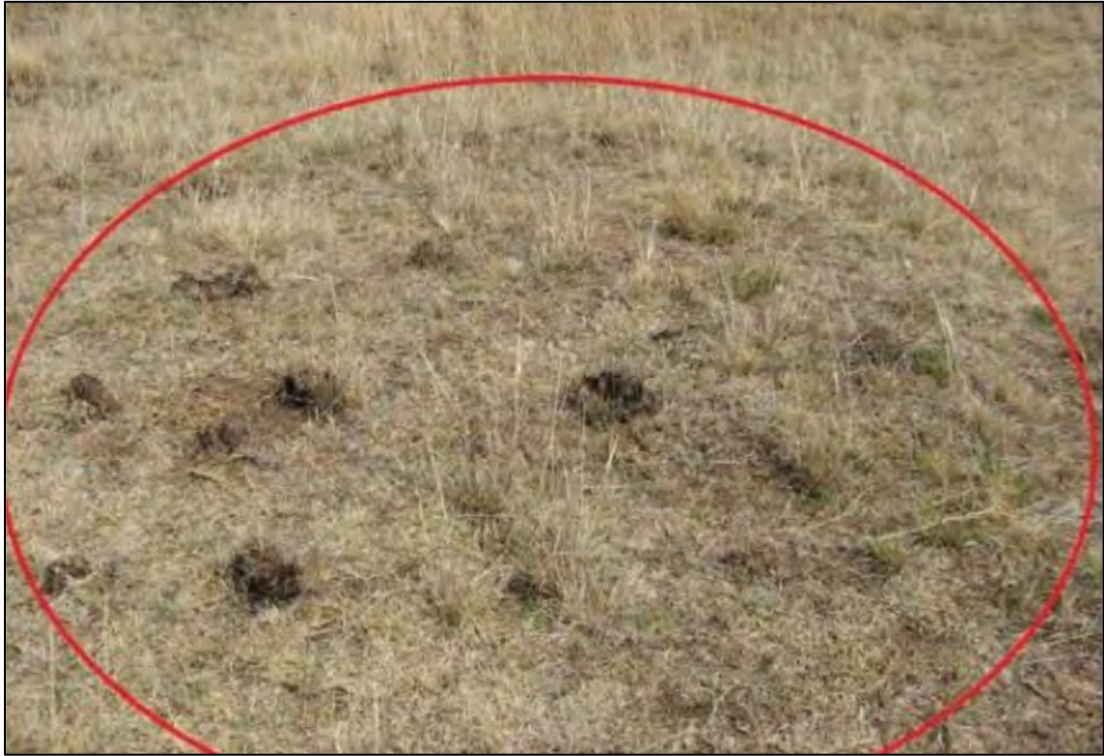
Figure 112 - Remains of circular structure as recorded in 2012 (Photo: Kitto & Fourie, 2012).

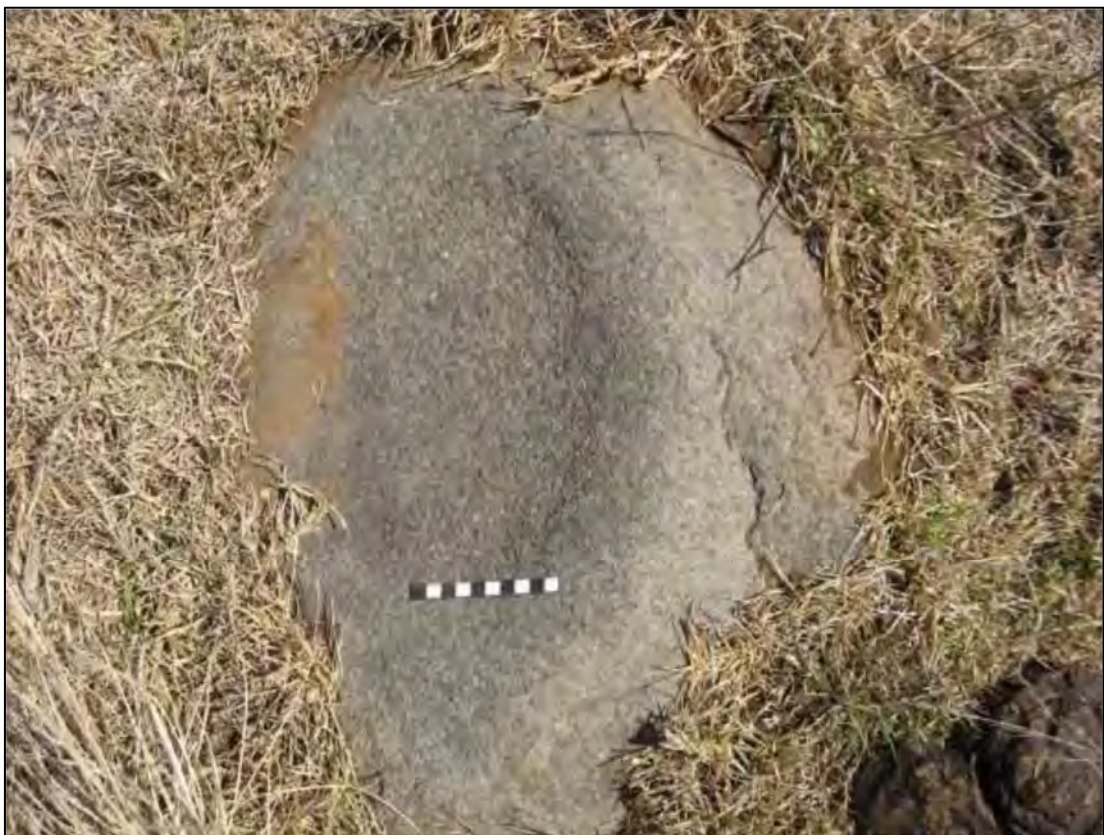
Figure 113 - Lower grinding stone as recorded in 2012 (Photo: Kitto & Fourie, 2012).

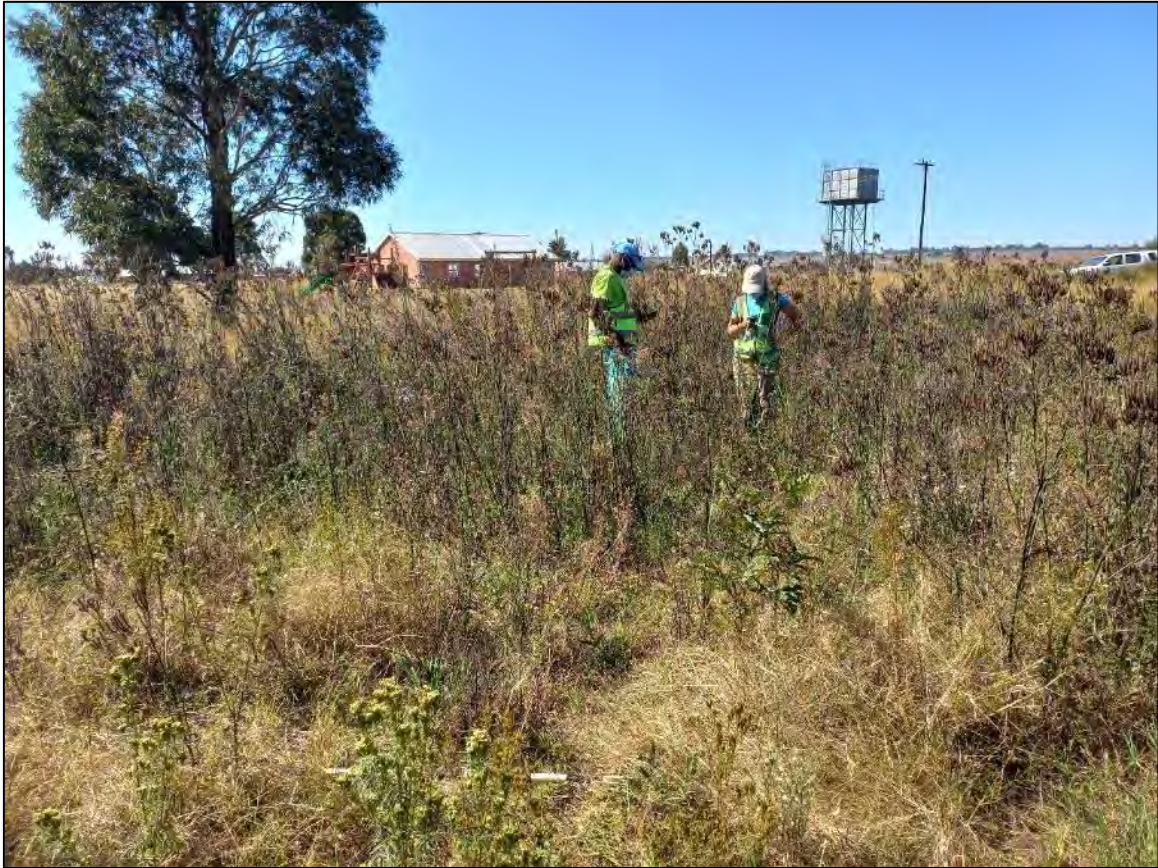
Figure 114 - General view of the site as recorded during the recent site visit. Note the dense vegetation found across the surface of the site, which may explain why the remains of the structures could not be found.

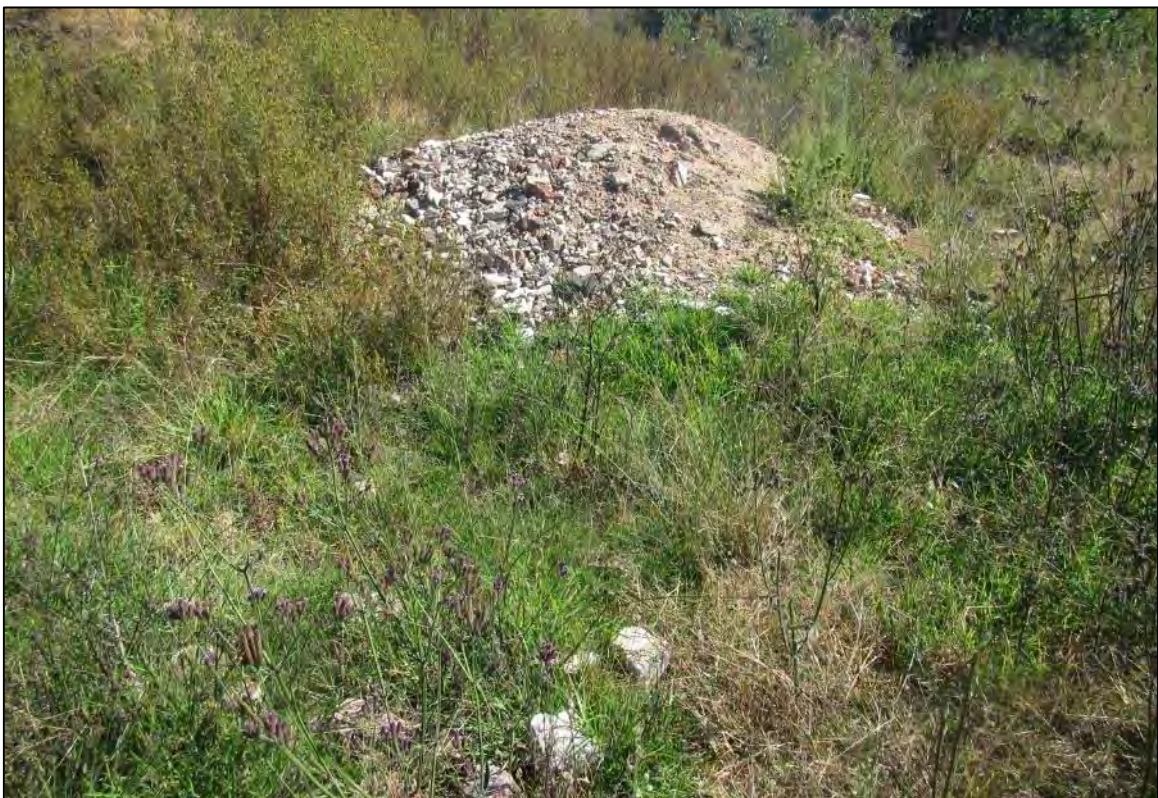
Figure 115 – Evidence for illegal dumping activities was noticed around the site.

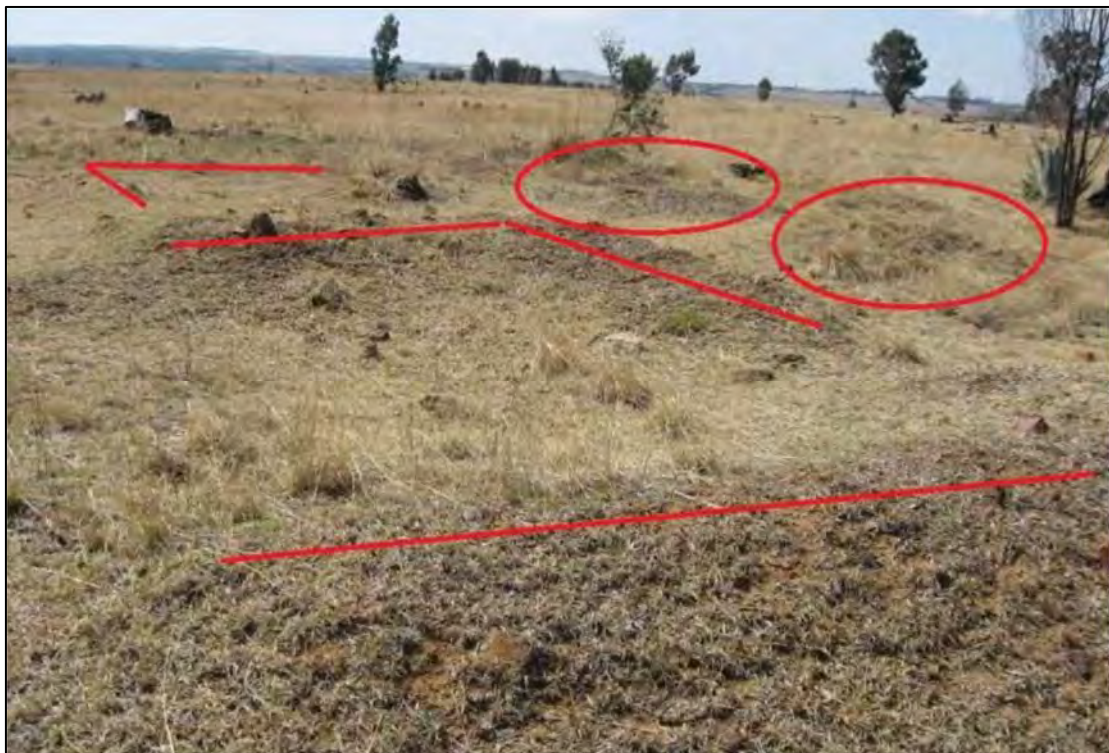
The remains of a mud-brick homestead were identified at this location. The remains of the mud-brick homestead consist of the foundations of one rectangular multi-roomed structure, which measures approximately 10m x 15m in size; two rectangular-shaped structures, which measure 4m x 6m each; and a square room, which measures 4m x 4m. There was also a circular structure, which measures approximately 4m in diameter. This structure was most probably the cooking hut. The structures are arranged in an open square which formed a central Lapa area. Rocks were used in the foundations to support the mud-brick walls of the structures. Several modern metal artefacts such as wire, corrugated iron and cans were found scattered around the site.

Figure 116 - Foundations of a multi-roomed structure recorded in 2012 (Photo: Kitto & Fourie, 2012).

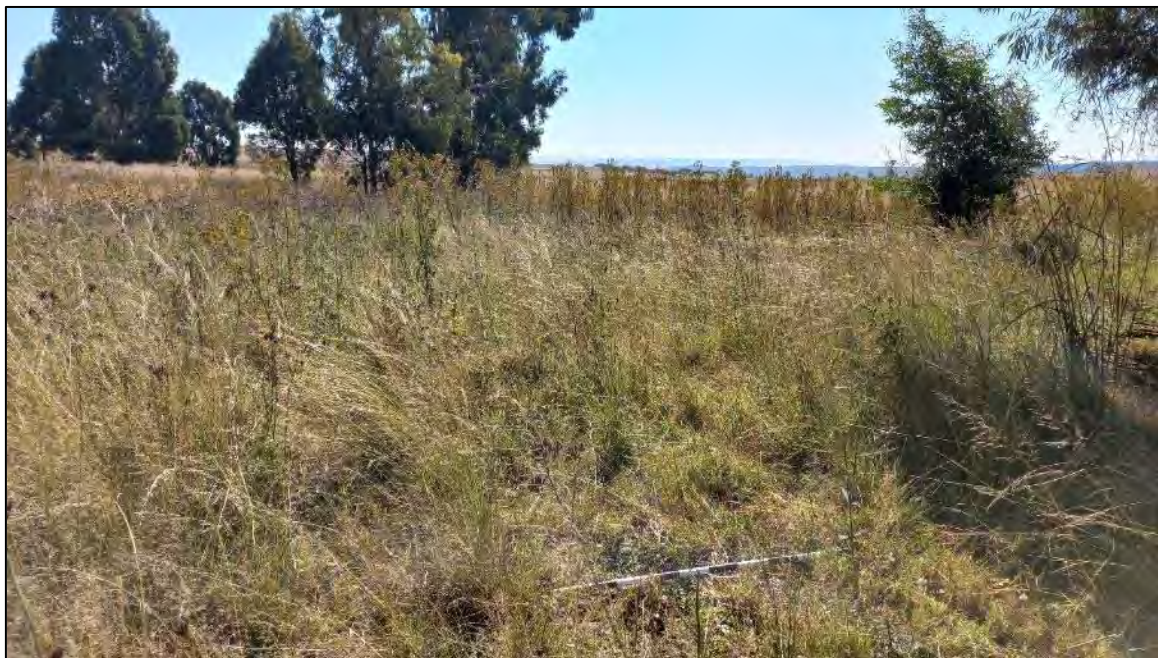
The site was visited during the recent fieldwork. A small section of the remains of the foundation of the mud-brick homestead could be identified. The outlines of the structure were barely visible underneath the grassy vegetation. No other cultural material including remains were observed at the site.

Figure 117 - General view of site PP 22 as recorded during the recent site visit. The remains of the mudbrick homestead could barely be seen in the dense vegetation. The scale is in 10cm increments.
6.2.23 PP 23

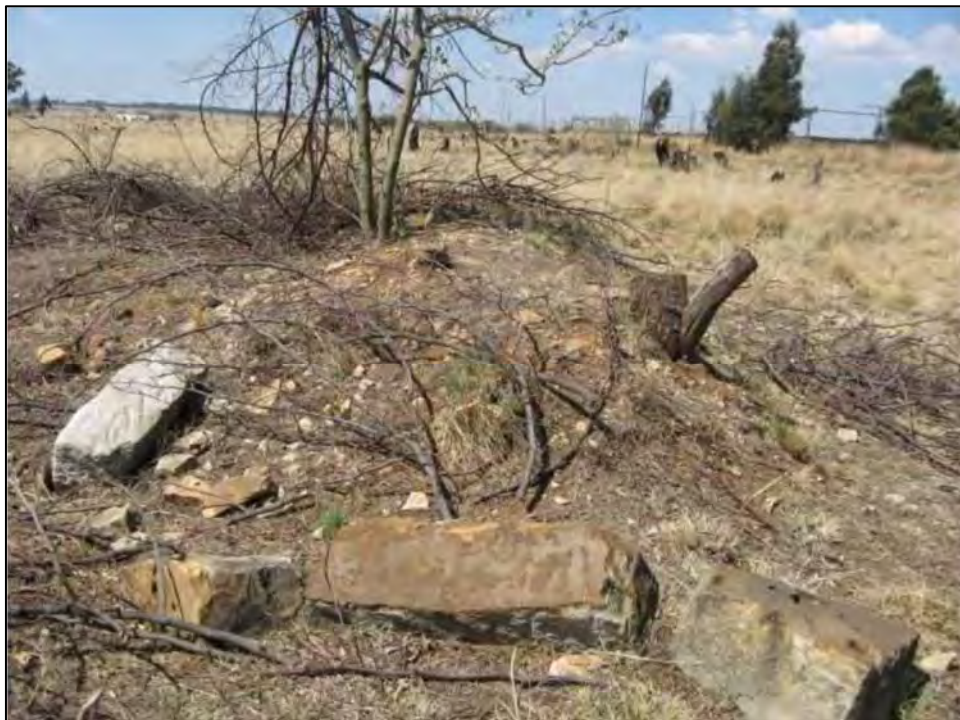
Figure 118 – General view of the site as recorded in 2012. The poorly preserved state of the structure can be seen (Photo: Kitto & Fourie, 2012).

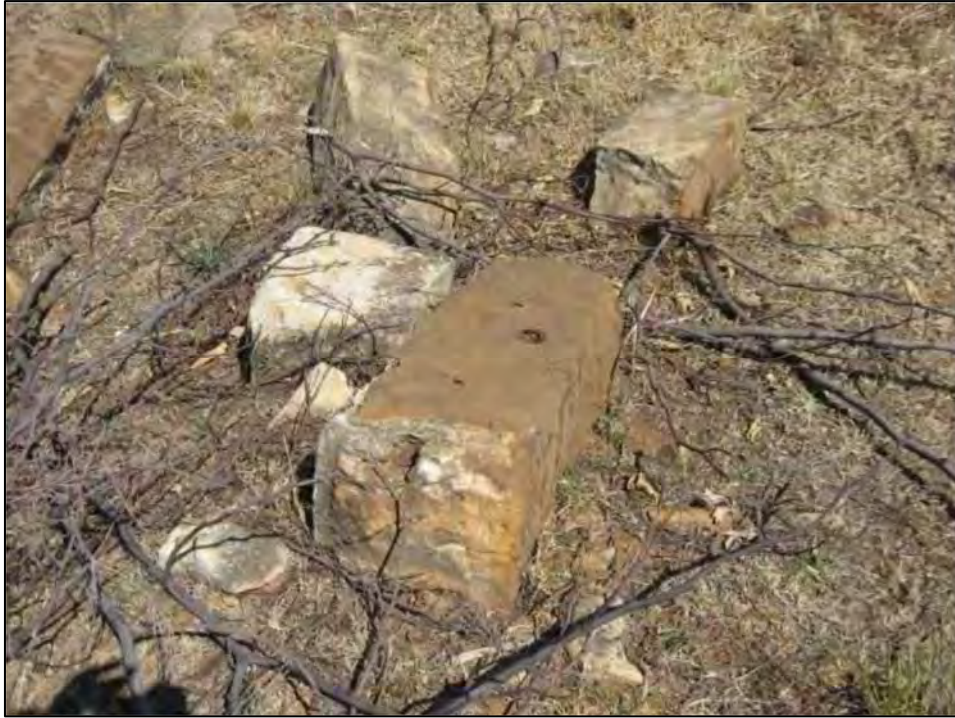
The remains of an old sandstone building were identified at this location. Most of the remains of the building had been removed and only the sandstone blocks which formed the foundations of the building are left. Several bricks were also found scattered across the site. There were no other features such as windows, doors or any floors to identify the structure with. These remains are most probably parts of an old farmhouse, which were broken down and removed from this site in the past. The structure measures approximately 18m x 20m in size. The exact function and age of this structure are not known.

Figure 119 – Another photograph of the site that was taken in 2012. A few of the sandstone blocks can be seen (Photo: Kitto & Fourie, 2012).

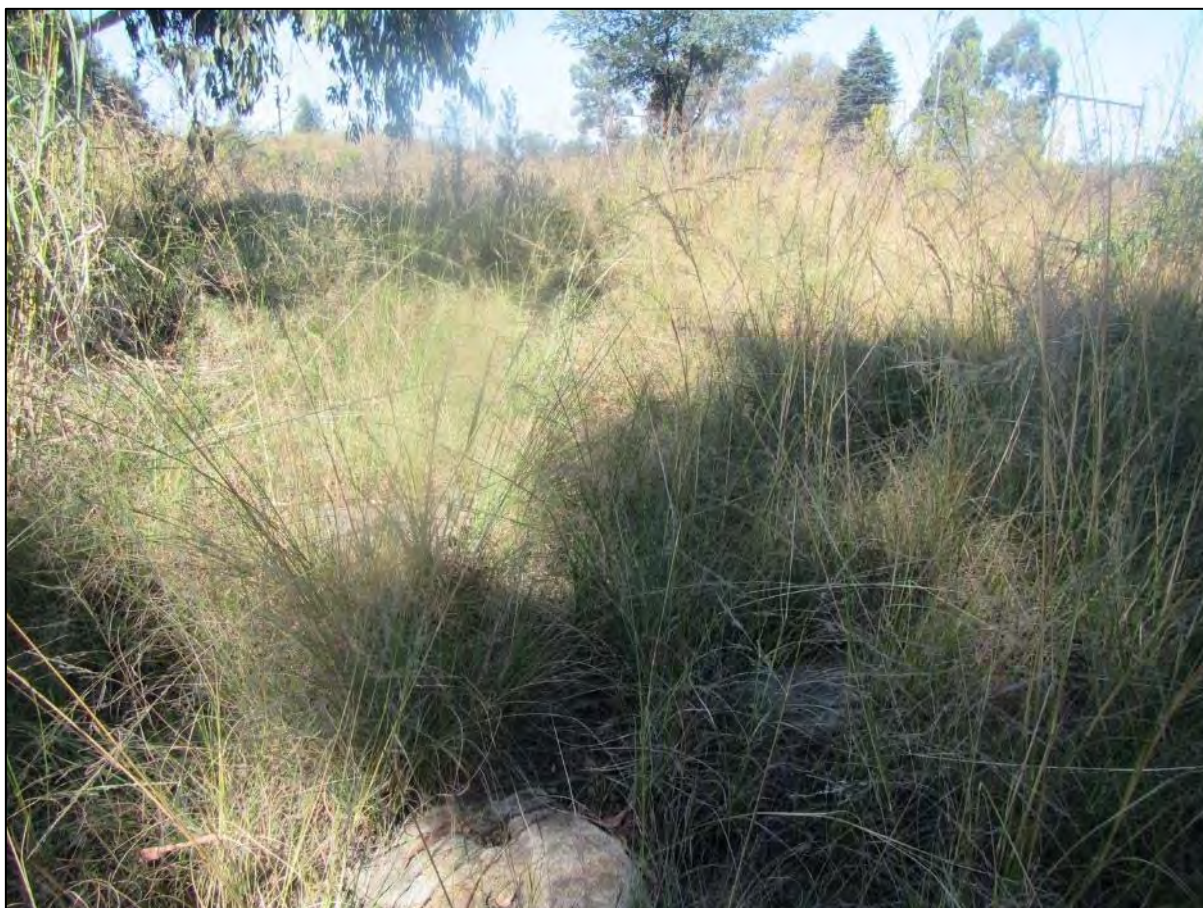
The site was visited during the recent fieldwork. The scattered remains of an old sandstone building were identified at this location. Most of the remains of the building had been removed and only the sandstone blocks which formed the foundations of the building were left. The site is overgrown.

Figure 120 - General view of site PP 23 as recorded during the recent fieldwork. The dense vegetation covering the surface of the site can be seen.

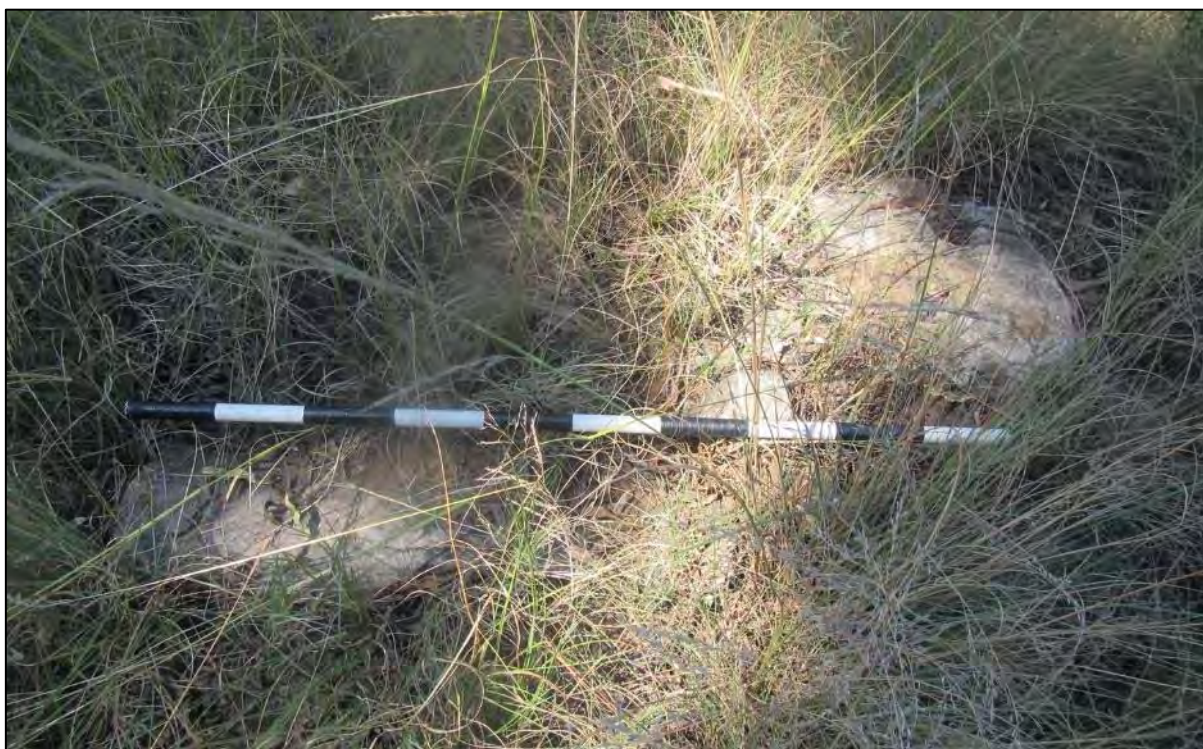
Figure 121 - Only the scattered remains of the sandstone blocks of the structure were observed on site. The site is poorly preserved and overgrown. The scale is in 10cm increments.

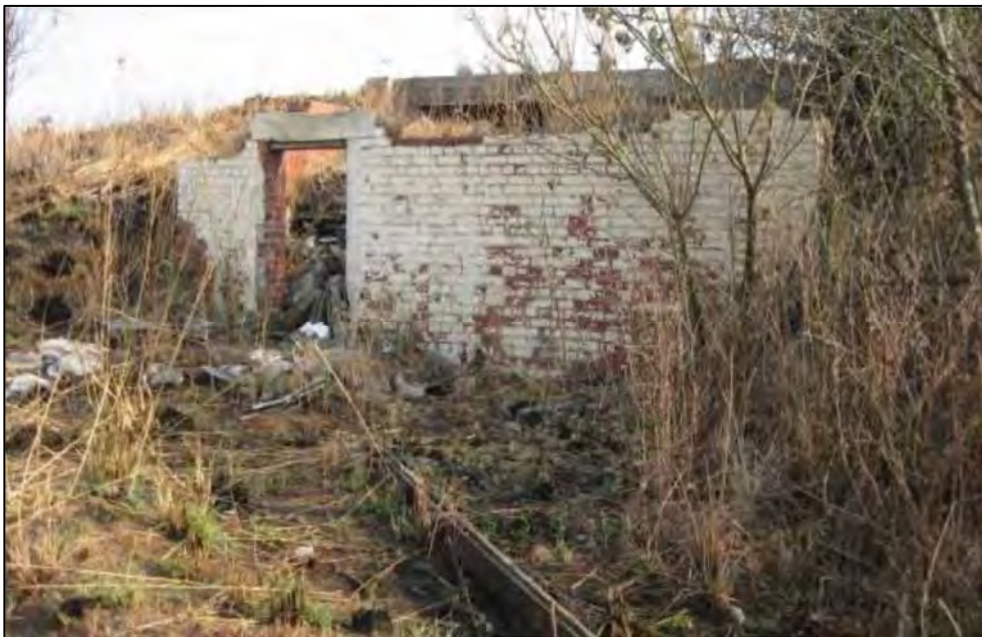
The ruined remains of the Sunbury Railway Station were identified at this location. The structure is constructed of red brick that was plastered and painted. The structure has been stripped of its roof, doors, windows and all other features. Only a few of its walls remain. The structure is in ruins and is overgrown with vegetation. The age of the station is not known.

Figure 122 - Remains of the building at the Sunbury Railway Station as recorded in 2012 (Photo: Kitto & Fourie, 2012).

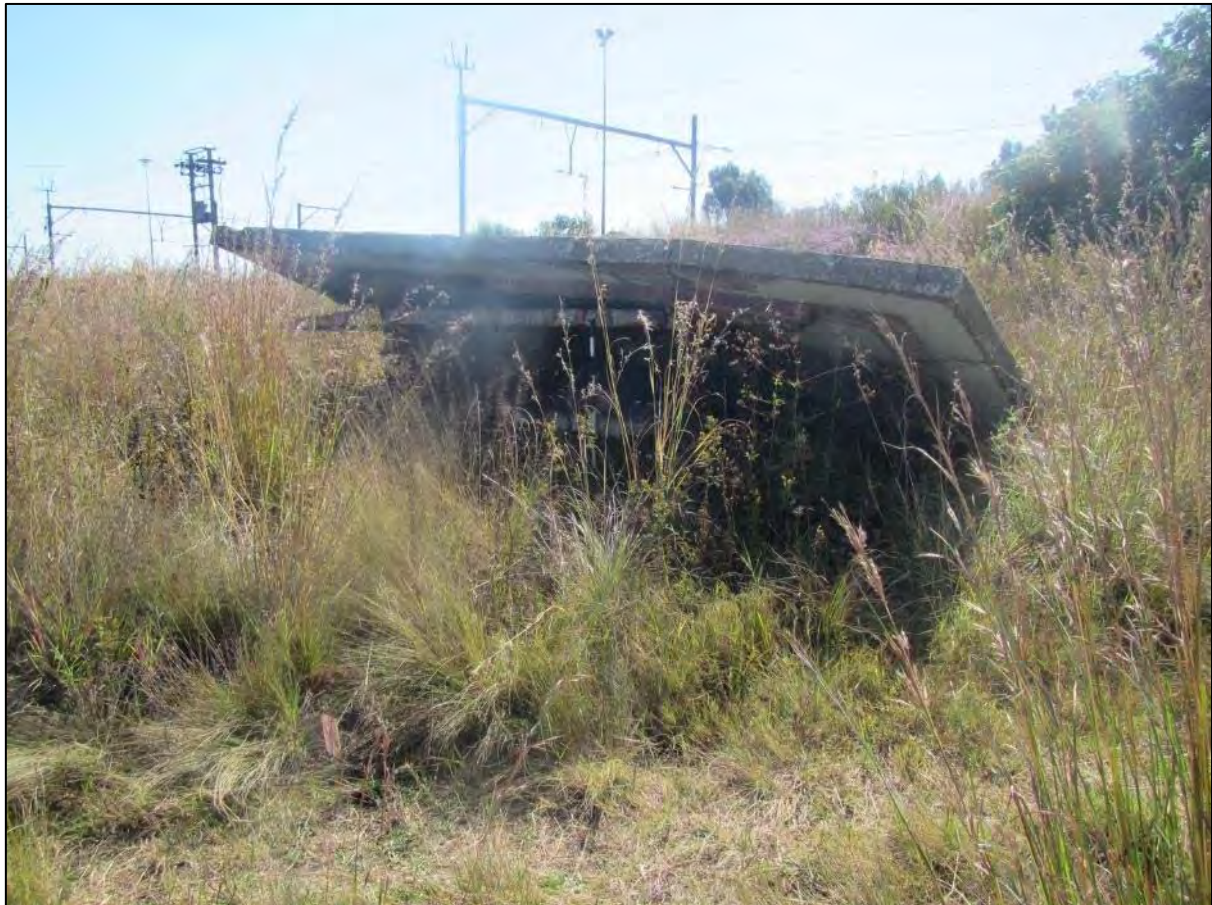
Figure 123 - The collapsed remains of the building associated with the Sunbury Railway Station as recorded during the recent fieldwork.

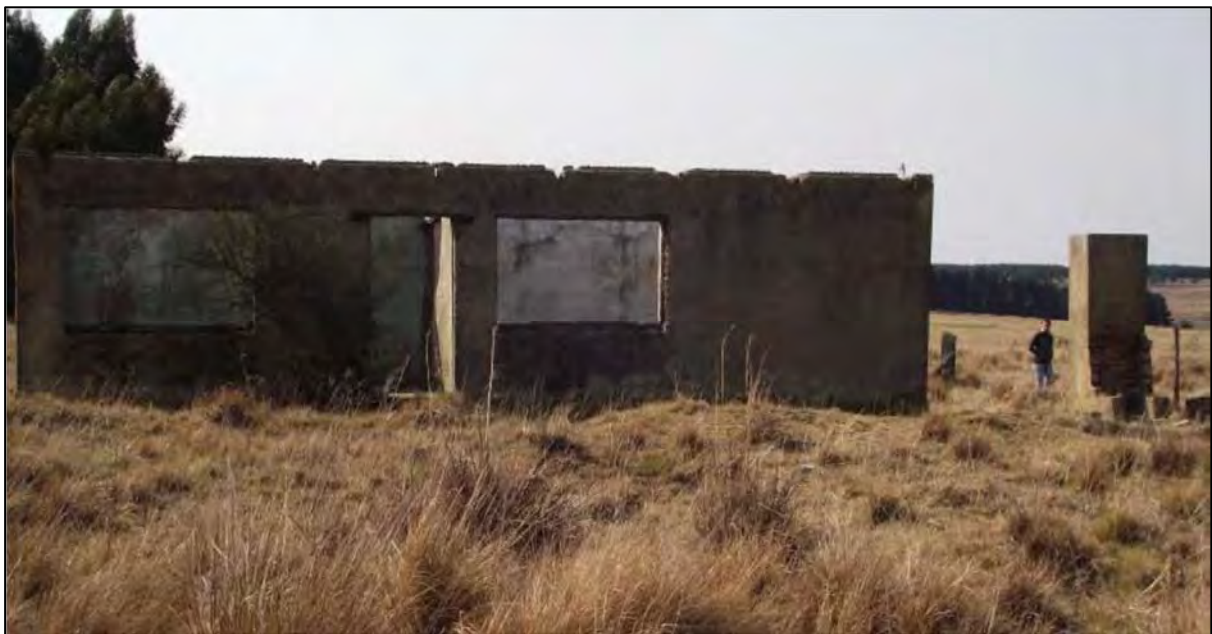
The remains of farm labourer quarters were identified at this location. The structure is brick-built and plastered and measures approximately 10m x 5m in size. The roof, doors, windows and frames have been removed from the building. The building consisted of two rooms and a bathroom. A warm water system (donkey) is situated next to the bathroom of the building. A midden was also identified approximately 20m from the structure.

Figure 124 - Ruins of farmworker dwelling and “donkey” structure as recorded during the fieldwork undertaken in 2012 (Photo: Kitto & Fourie, 2012).

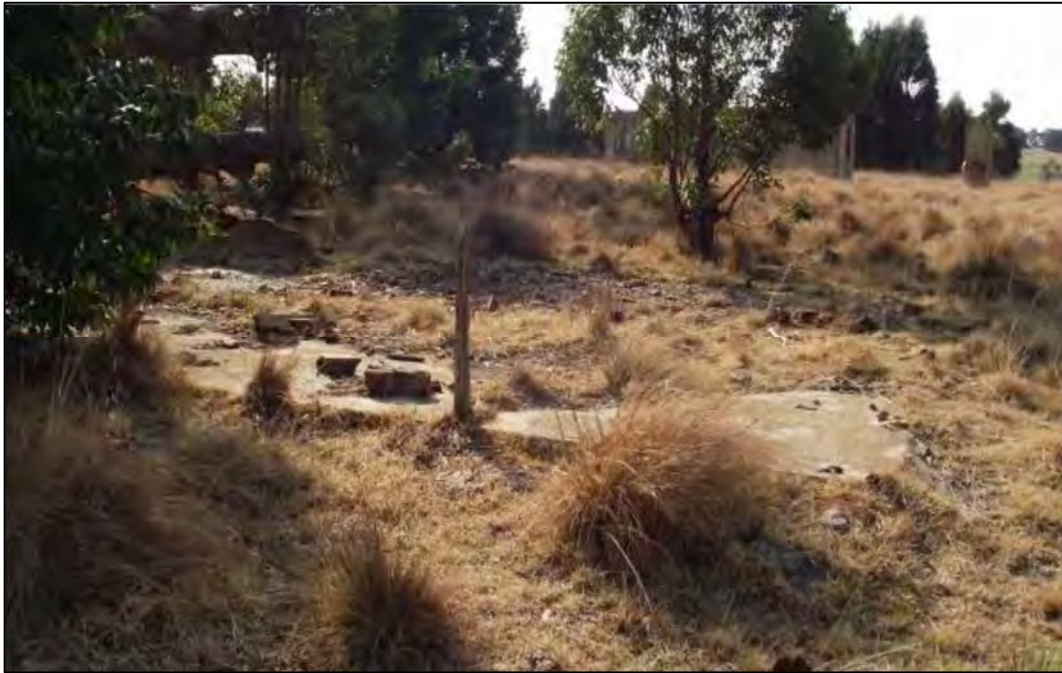
The remains of a cattle or pig shed were also identified approximately 50m to the west of the labourer quarters. A brick and cement drinking trough was identified near the remains of the cattle/pig shed.

Figure 125 - Remains of shed as recorded in 2012 (Photo: Kitto & Fourie, 2012).

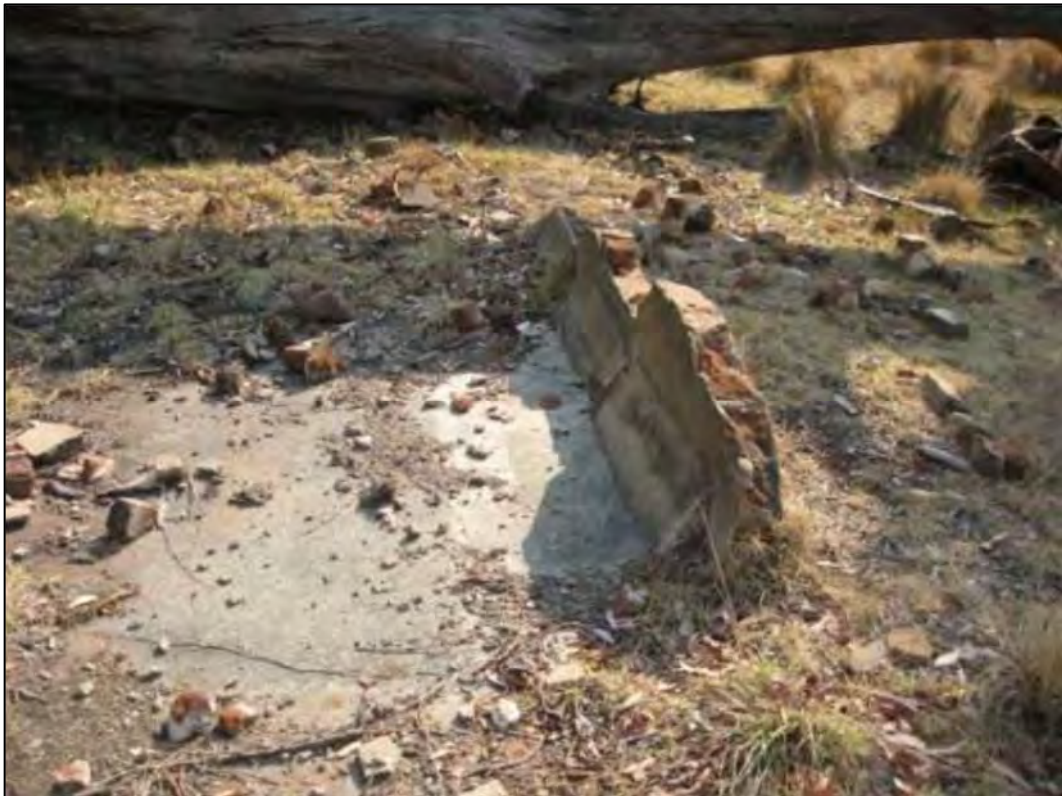
Figure 126 - Close-up view of a section of walling from the shed. This photograph was also taken during the site visit of 2012 (Photo: Kitto & Fourie, 2012).

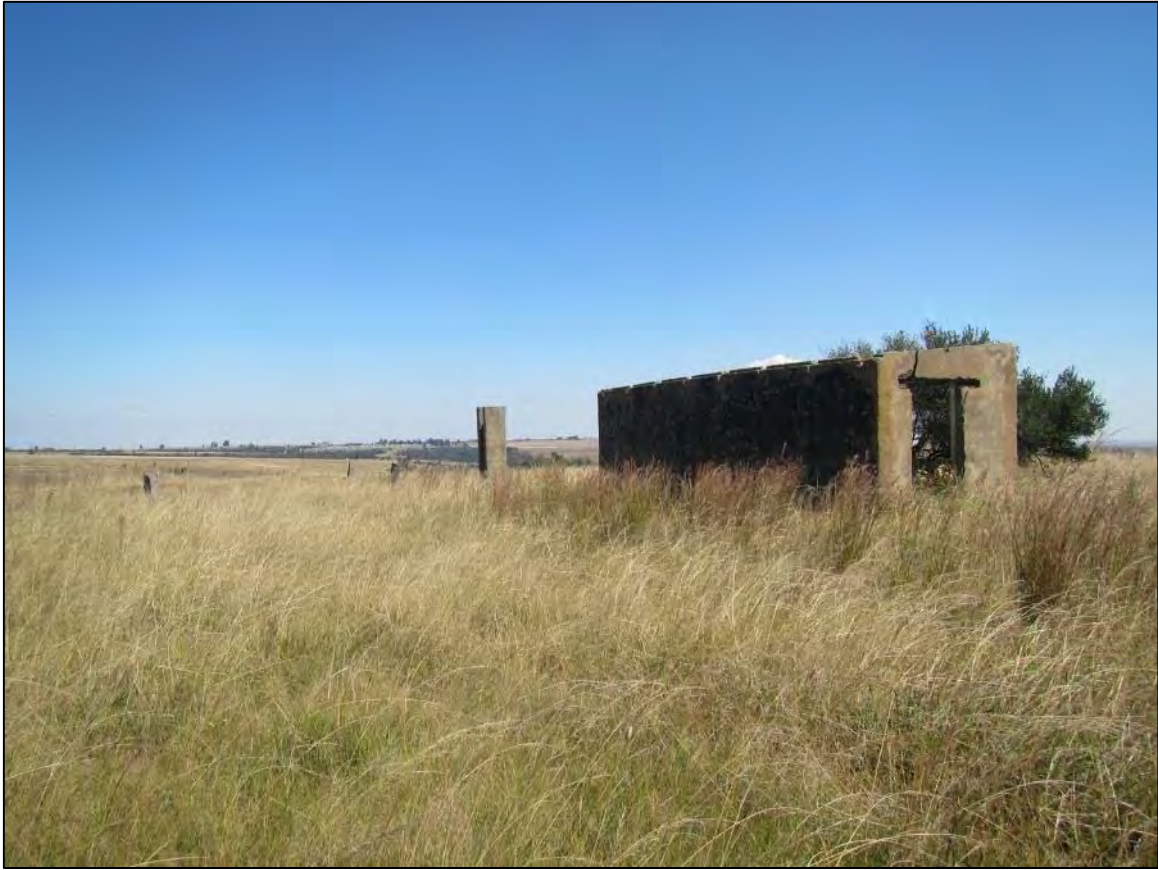
During the site visit undertaken recently, the remains of collapsed dwellings were observed. A single animal drinking trough was also found near the houses.

Figure 127 - General view of site PP 25 as recorded during the recent site visit.
