NBC COLLIERY GLISA AND PAARDEPLAATS MINING PROJECT

Phase 1 – Heritage Impact Assessment

Issue Date: 19 May 2021
Revision No.: 2.0
PGS Project No.: 524HIA
CI Group project No: 19.0001

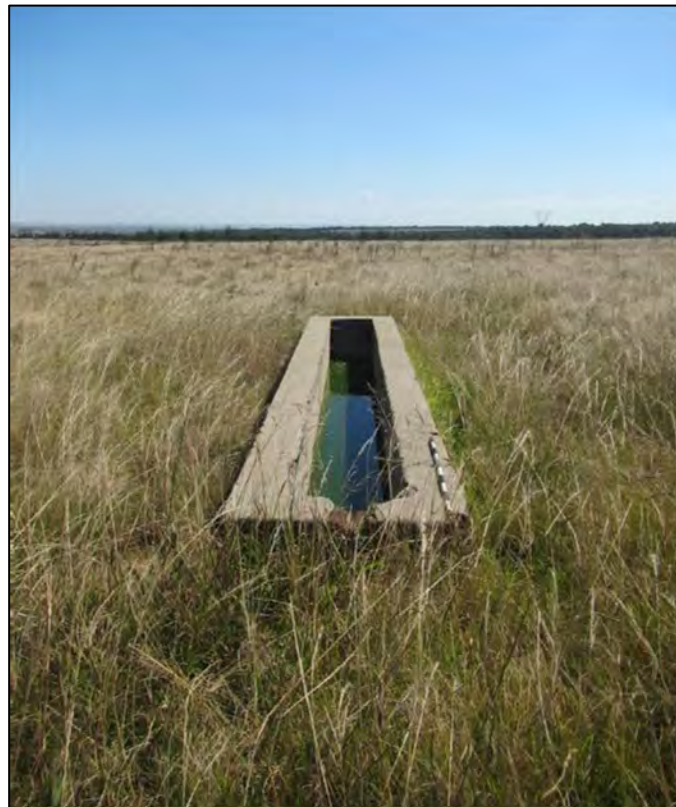
Figure 128 - The drinking trough was also observed during the recent fieldwork.

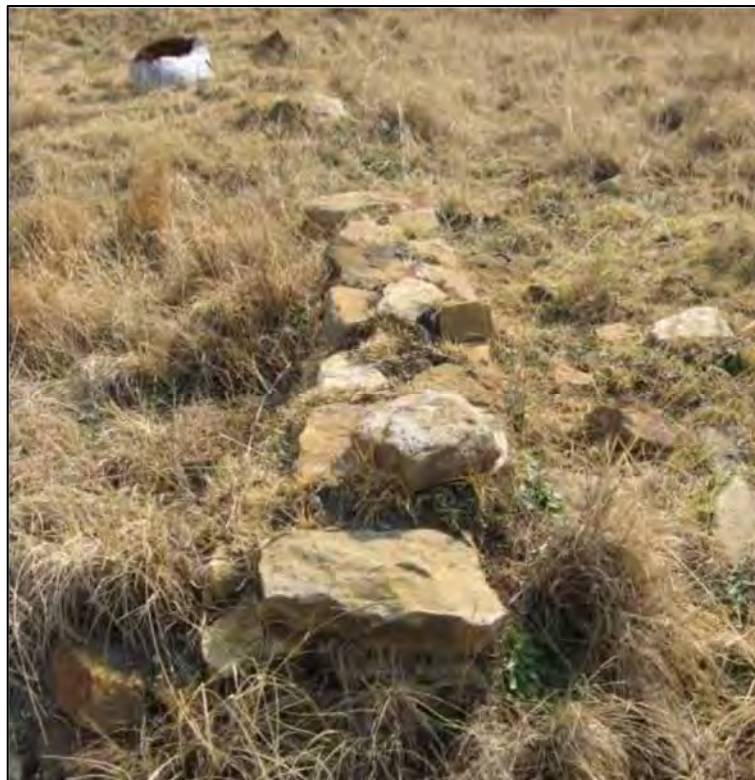
The remains of a mud-brick homestead were identified at this location. The mud-brick homestead consists of the foundations of two square structures, which measure approximately 4m x 4m in size each, and a multi-roomed rectangular structure, which measures 8m x 15m. Another circular structure measures approximately 4m in diameter. This structure was most probably the cooking hut. Rocks were used in the foundations to support the mud-brick walls of the structures. Several modern metal artefacts such as wire, corrugated iron and cans were found scattered around the site.

Figure 129 - Foundation of the homestead as recorded in 2012 (Photo: Kitto & Fourie, 2012).

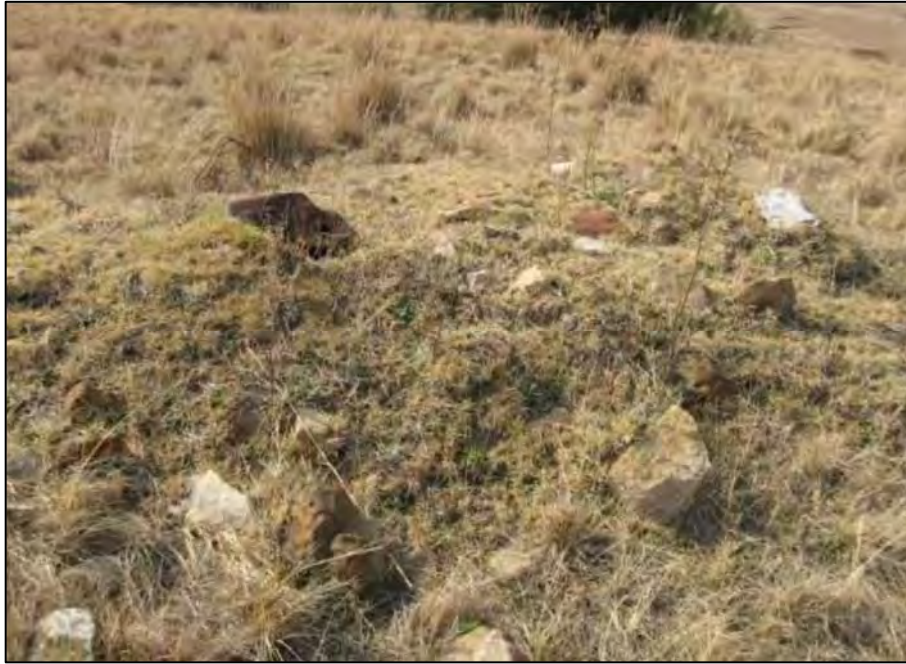
Figure 130 - Remains of a circular structure recorded in 2012 (Photo: Kitto & Fourie, 2012).

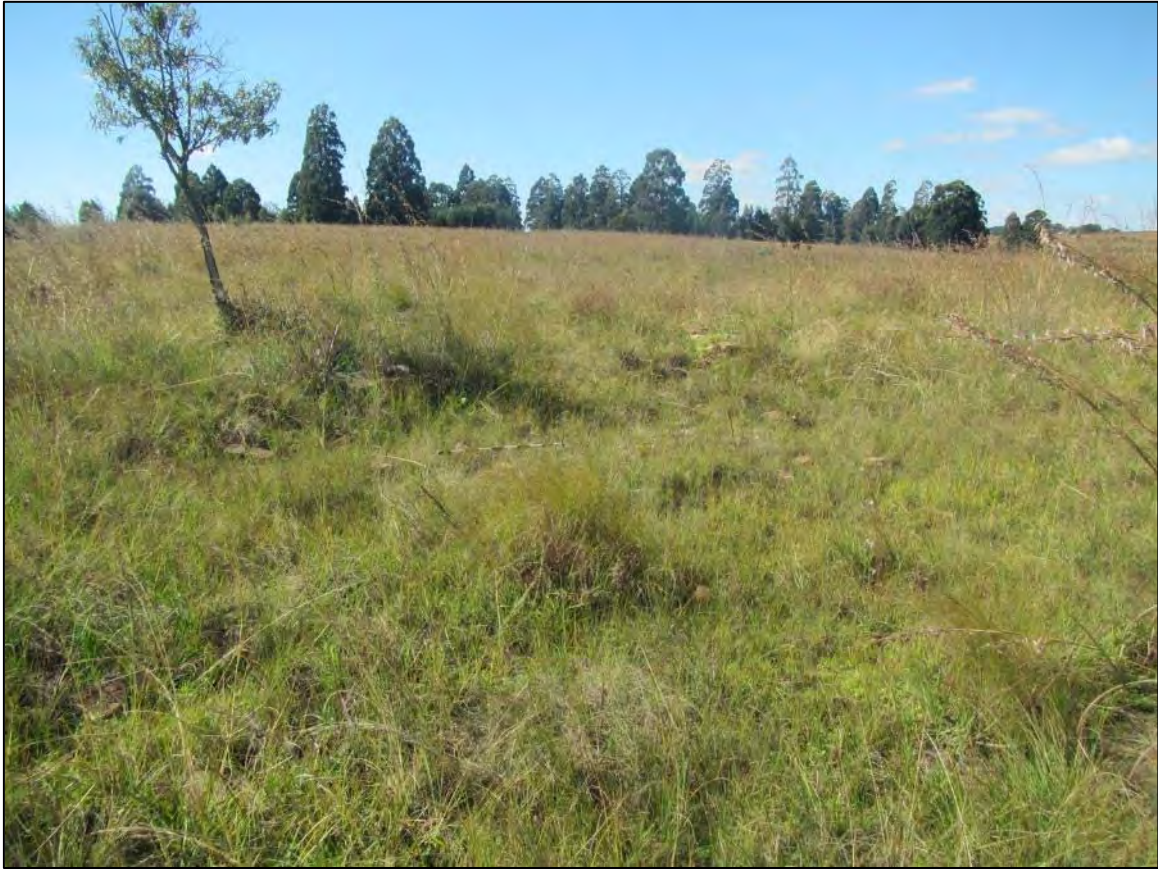
During the site visit undertaken recently, the site was found to consist of the remains of a barely visible foundation of a mudbrick house. The site was found to be very overgrown.

Figure 131 - General view of the site as recorded during the recent fieldwork.

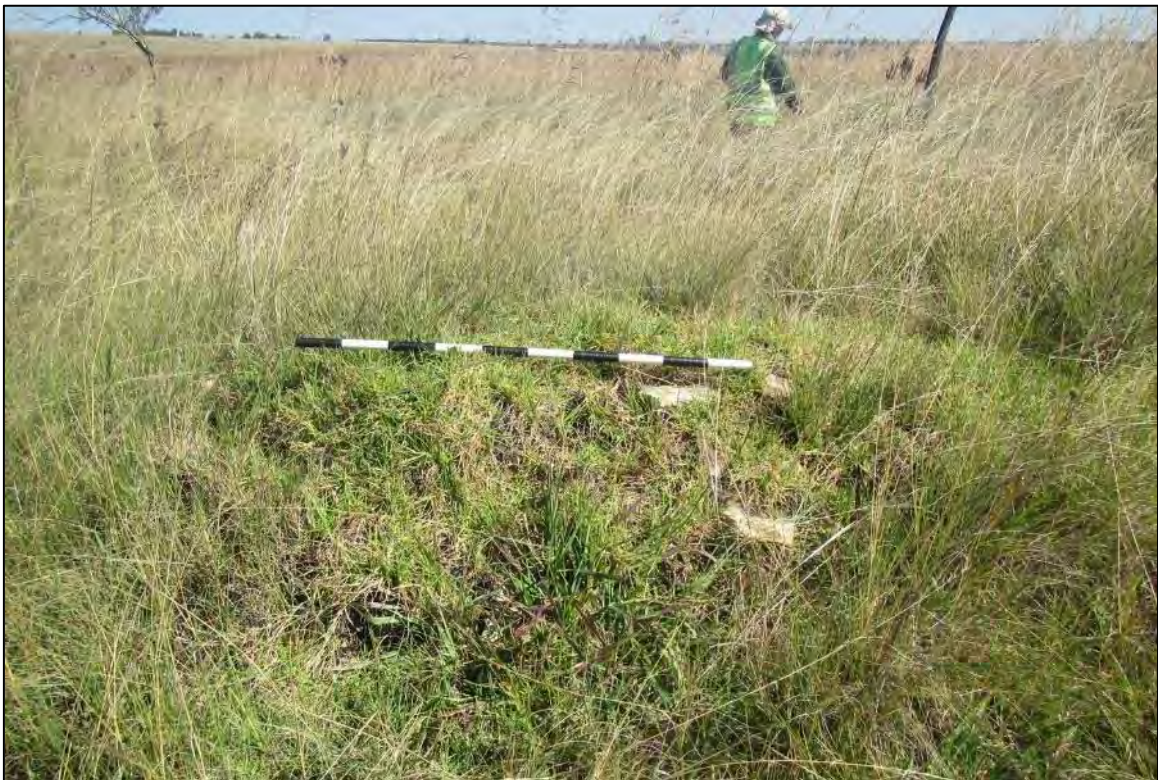
Figure 132 – Another view of the site that was recorded during the recent visit. This image depicts an elevated soil heap containing scattered bricks and stones. The scale is in 10cm increments.

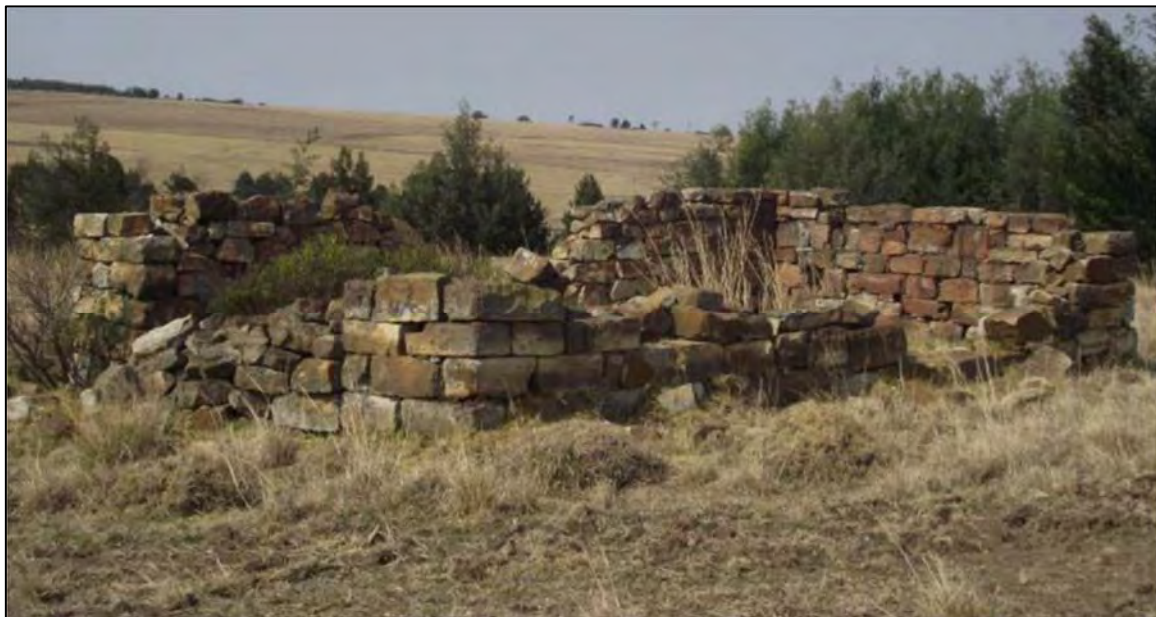
The remains of a sandstone building were identified at this location. The structure measures approximately 12m x 5m and is constructed with sandstone blocks without mortar or cement. The original entrance to the structure has been filled up with other sandstone blocks. The walls of this structure measure approximately 0.5m wide and approximately 2m high. The structure was most probably a shed or a storeroom.

Figure 133 - Ruin of the sandstone building as recorded during the fieldwork undertaken in 2012 (Photo: Kitto & Fourie, 2012).

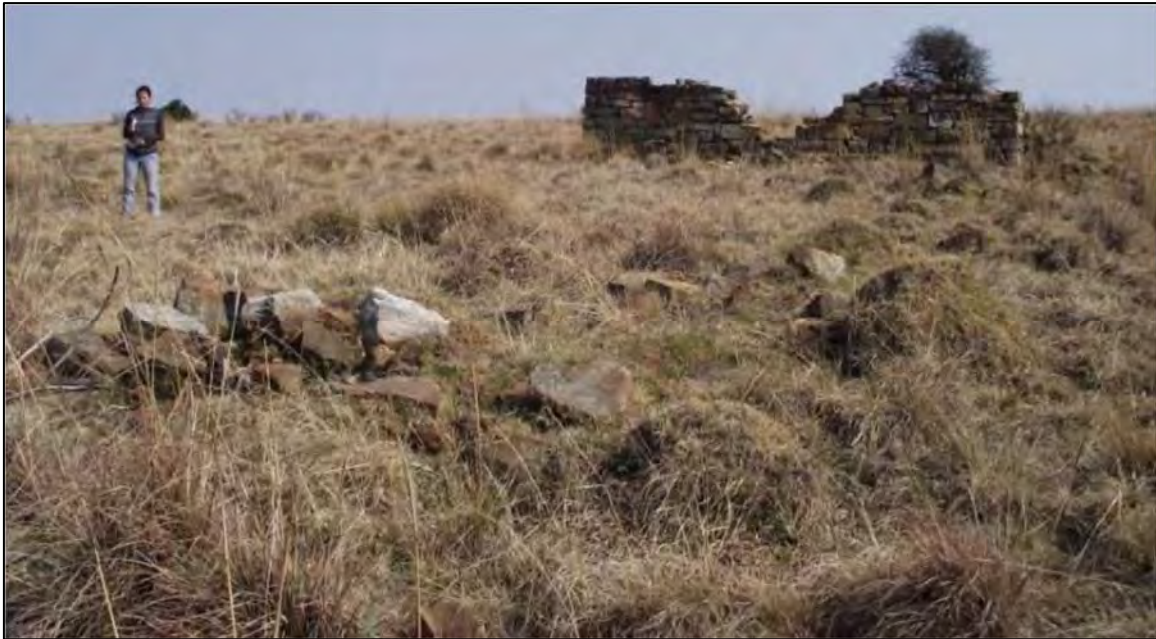
The remains of a stone-walled kraal were identified next to the sandstone structure. Most of the walling for the kraal has been removed and only some sandstone blocks from the foundations are left. The kraal measures approximately 10m x 25m.

Figure 134 – Another view of the site as recorded in 2012. This image depicts the remains of walls associated with the building (Photo: Kitto & Fourie, 2012).

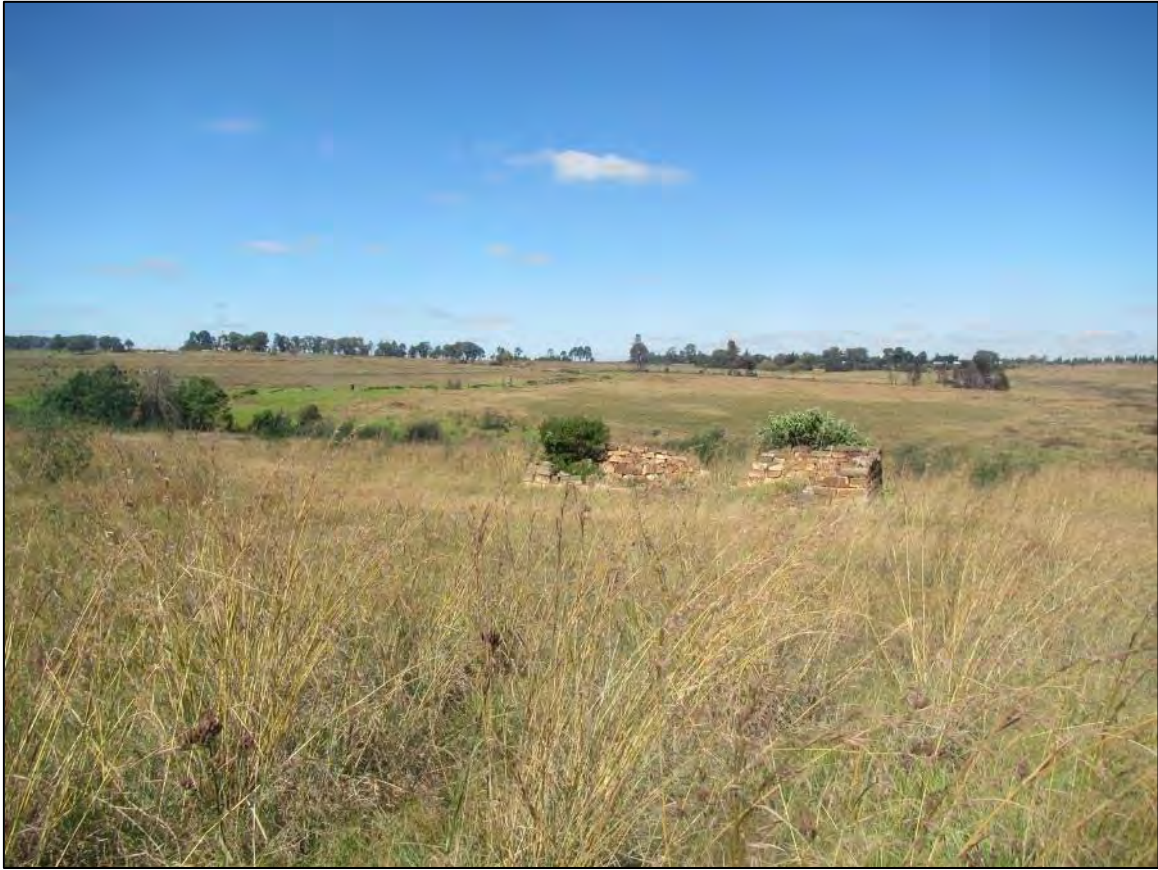
During the site visit undertaken recently, the site was found to consist of a collapsed sandstone building and wall. The site is abandoned and poorly preserved. This said, the site appears to be in a similar condition as what was recorded in 2012.

During the 2012 study, the site was assessed to be of **Medium Significance** or **Generally Protected B (GP. B)**. Due to the fact that the site has not deteriorated significantly, the current significance of the site would be the same.

Figure 135 - General view of the site as recorded during the recent fieldwork. The sandstone building can clearly be seen.

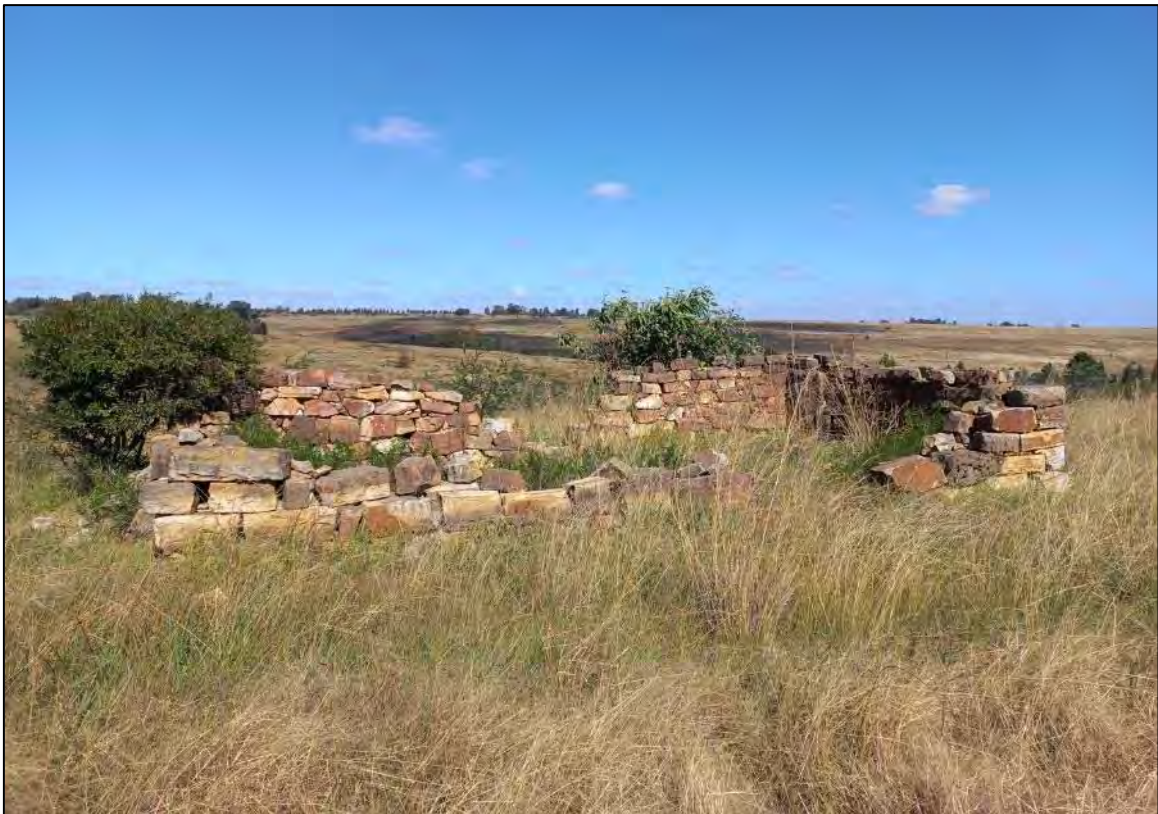
Figure 136 – Closer view of the sandstone building as recorded during the recent fieldwork.

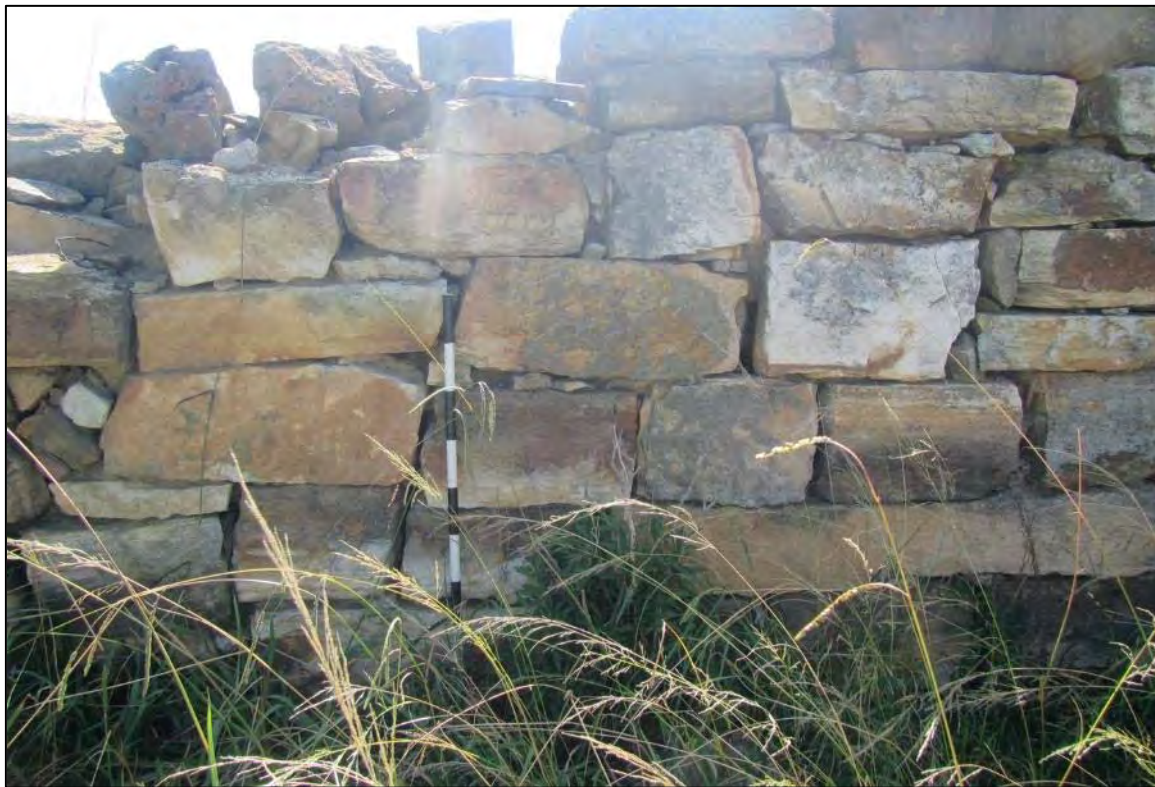
Figure 137 – Side view of a section of walling from the building. The scale is in 10cm increments.

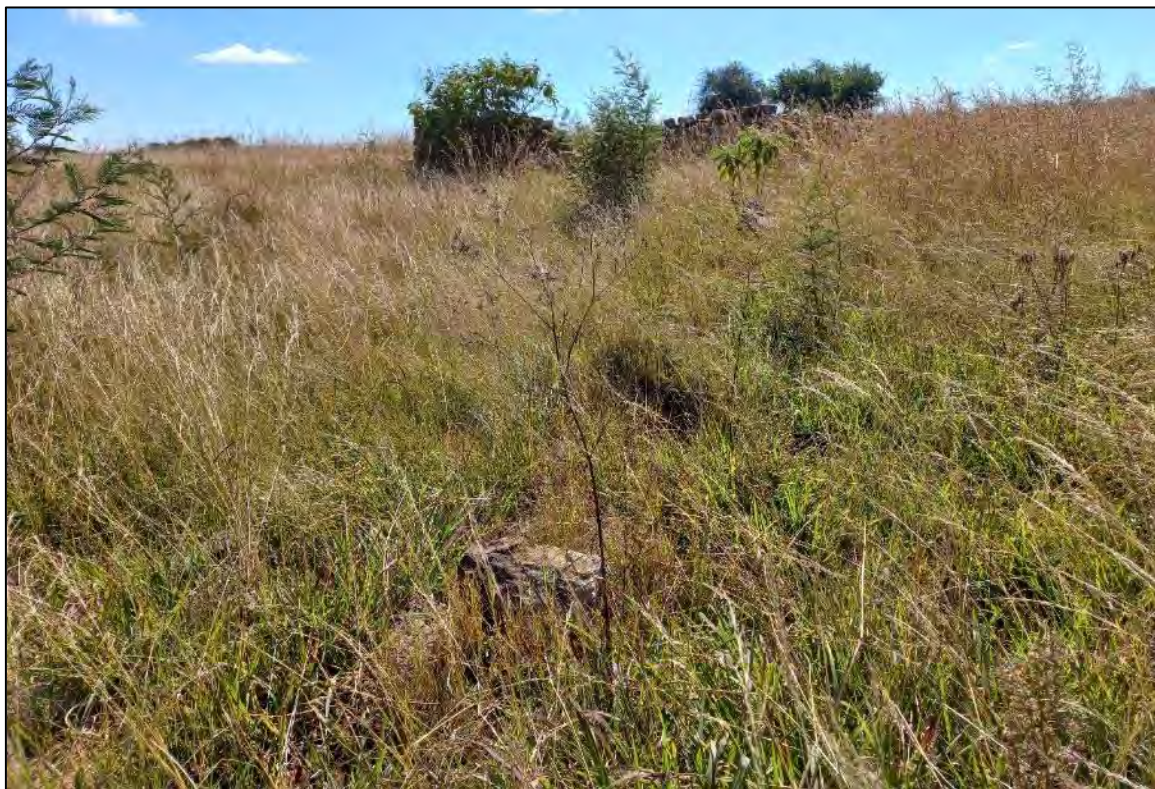
Figure 138 – A section of the stone wall associated with the sandstone building (visible in the back) can be seen in the foreground.

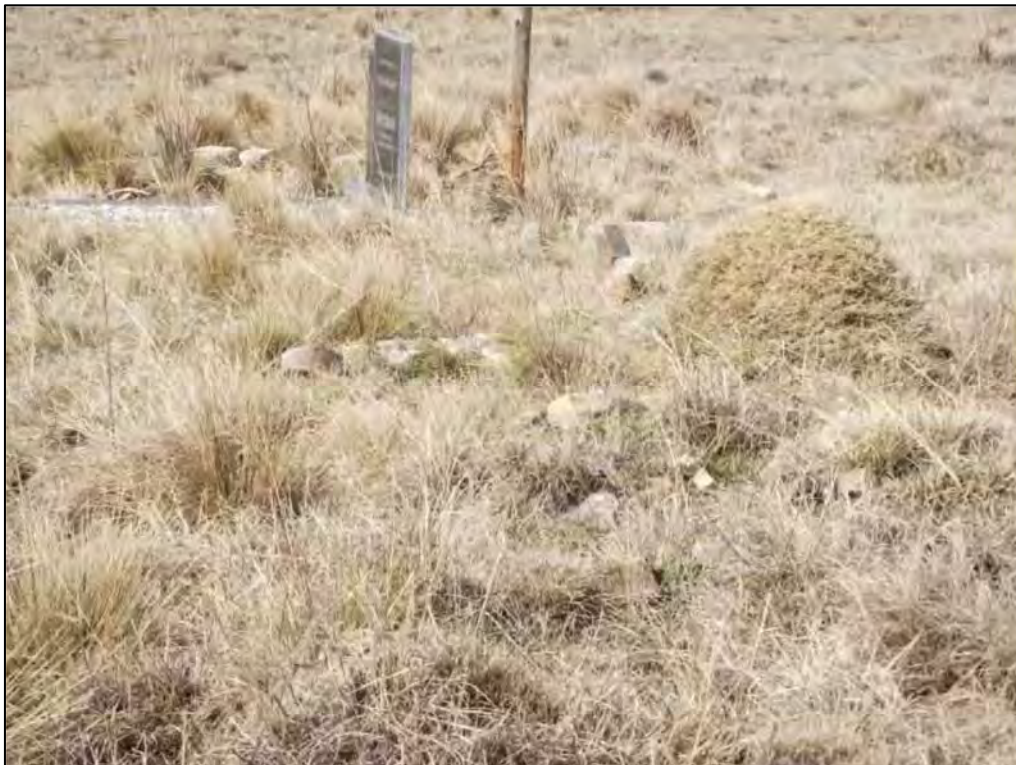
A small informal cemetery with eight graves was identified at this location. The cemetery is fenced and is situated in the open veld. The graves are placed in one line next to each other and all are orientated from west to east. Seven of the graves have informal, oval-shaped outlines of packed rocks which are filled with soil. Rocks are placed upright at the western ends to serve as headstones. One grave has a formal granite dressing and an inscribed granite headstone. This grave dates from the early 1960's and belongs to the Skhosana family. Most of the graves are overgrown with grass and other vegetation. No grave goods were found with these graves.

Figure 139 – General view of the cemetery as recorded in 2012 (Photo: Kitto & Fourie, 2012).

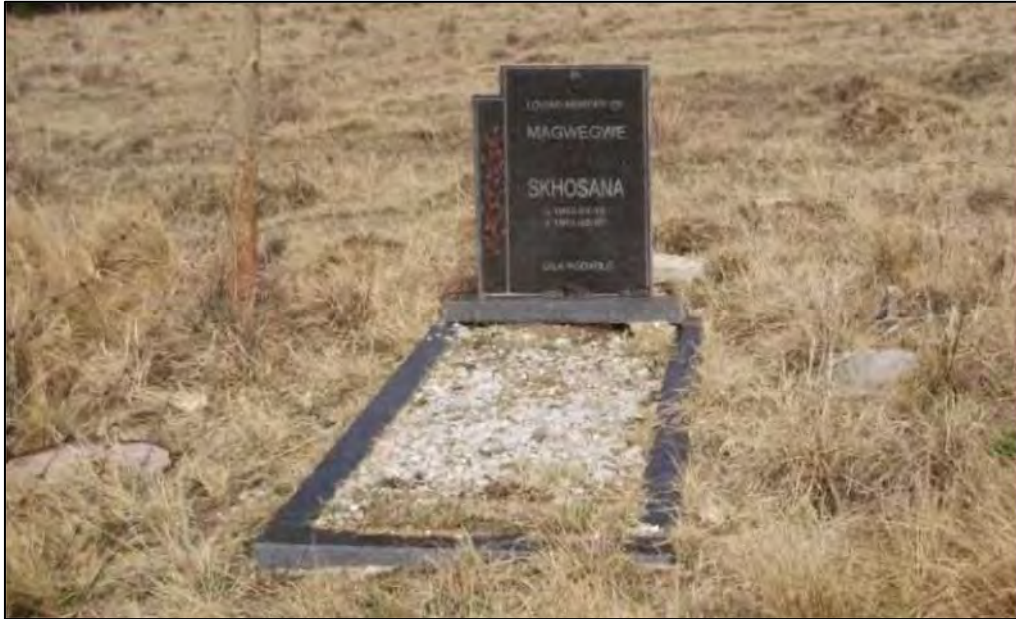
Figure 140 - Close-up view of one of the graves from site PP 28 as recorded in 2012 (Photo: Kitto & Fourie, 2012).

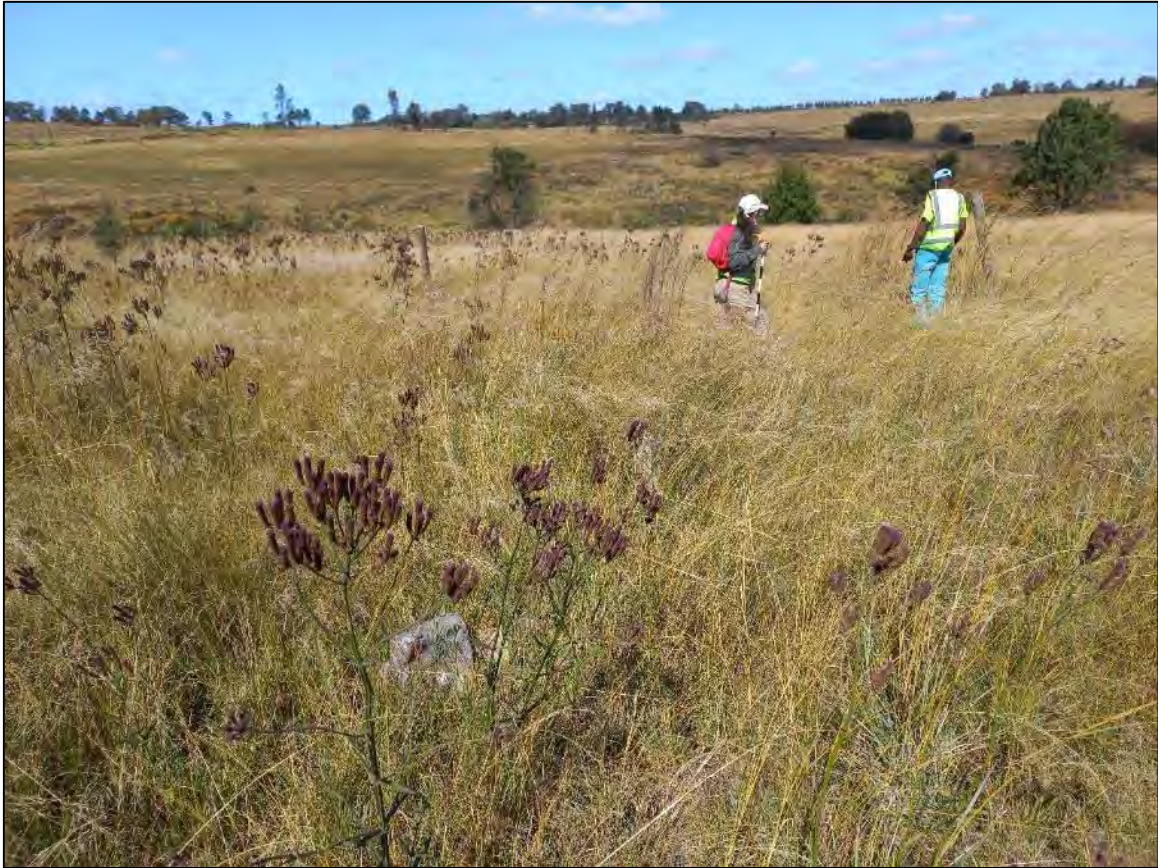
All eight graves were observed during the site visit undertaken recently. One of the graves contained a headstone, which is in a poor state of preservation and has fallen over. The graves are overgrown but clearly visible.

Figure 141 - General view of the site as recorded during the recent site visit. The dense vegetation can still be seen.

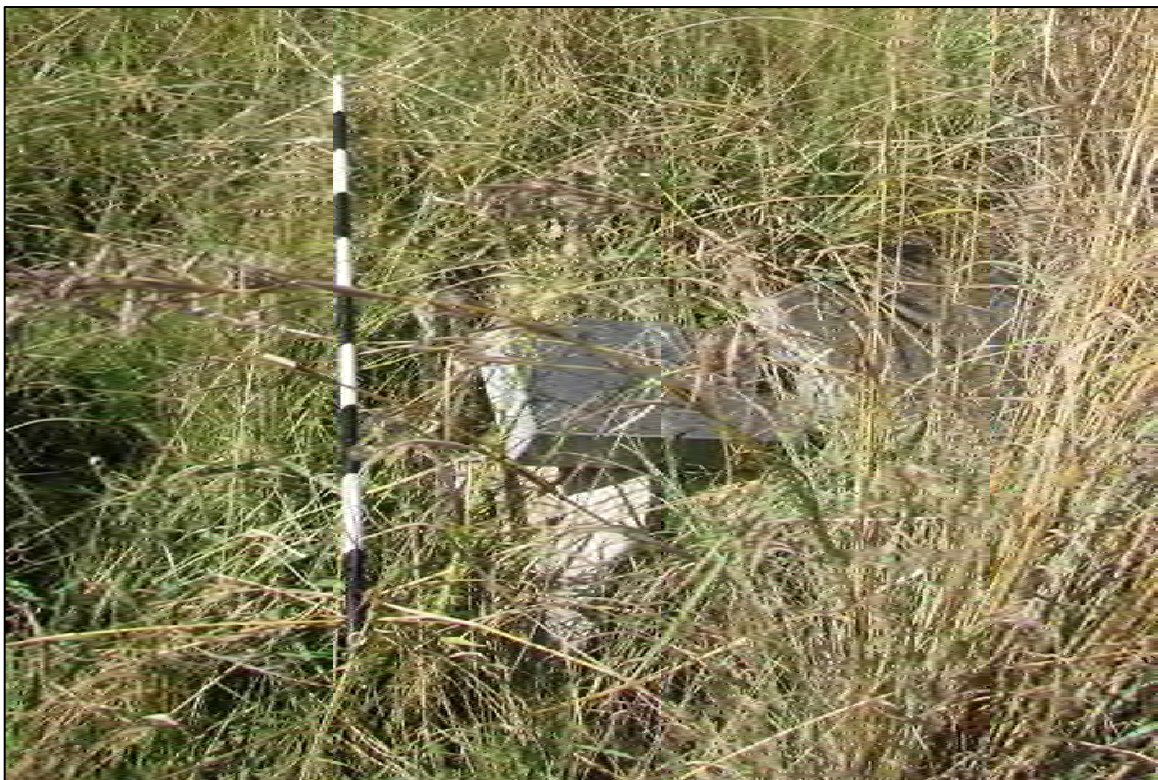
Figure 142 - View of the headstone on the grave of Magwegwe Skhosana, which has fallen over. The scale is in 10cm increments.

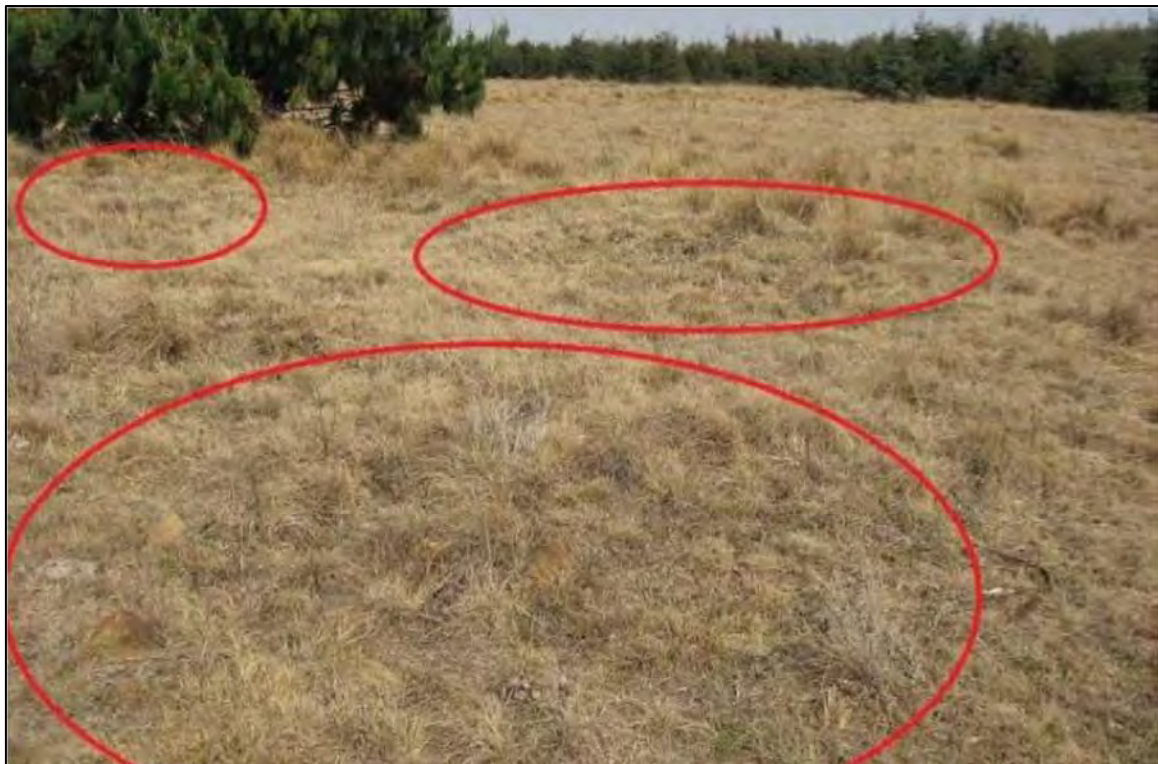
The remains of an extended mud-brick settlement were identified at this location. The remains of this mud-brick settlement cover an area of approximately 200m x 200 and consist of at least nine different homesteads or structures that formed part of the larger settlement. Most of the structures are ruined and were very difficult to identify. The numbers, sizes and shapes of these structures of this settlement are not clearly identifiable. Rocks were used in the foundations to support the mud-brick walls of the structures. Several modern metal artefacts such as wire, corrugated iron and cans were found scattered around the site.

Figure 143 - General view of some of the foundation remains as recorded in 2012 (Photo: Kitto & Fourie, 2012).

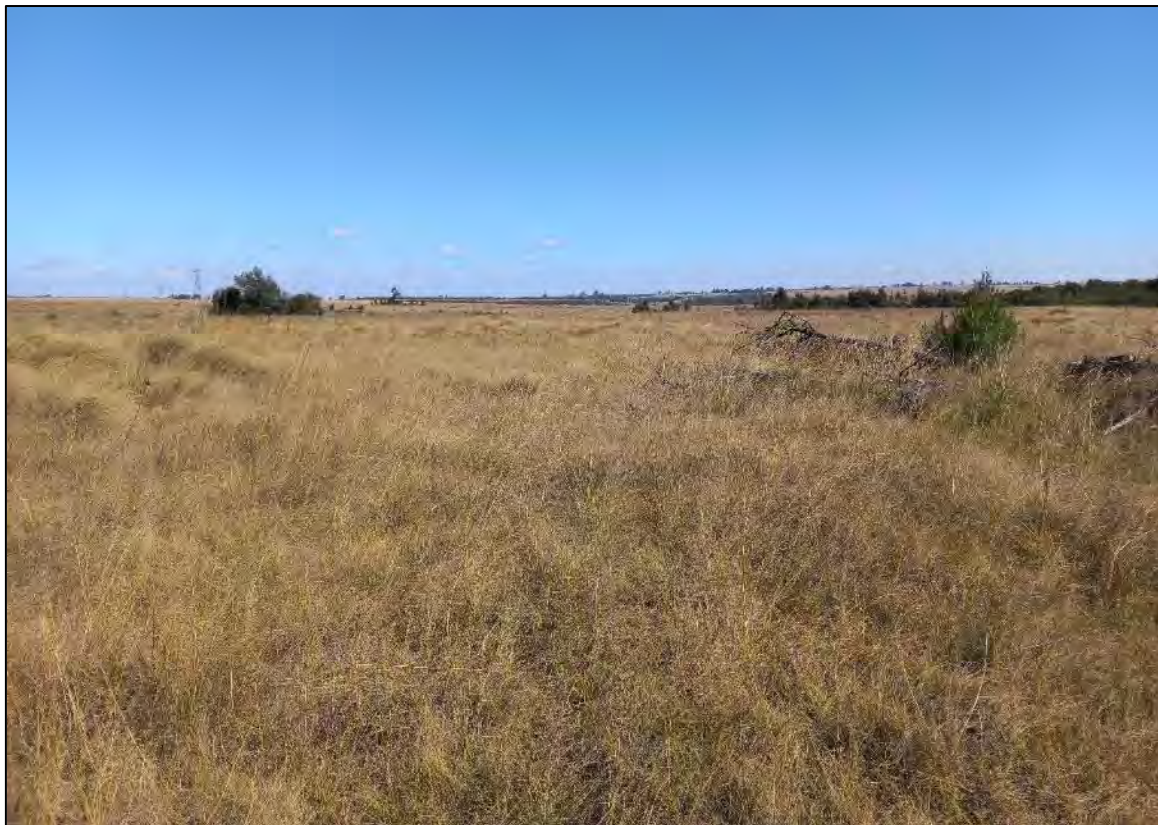
The site was visited during the recent fieldwork. It was found to consist of the foundation remains of several mudbrick homesteads spread across the site. Only the raised foundations are visible on the surface. The site is overgrown. No other cultural remains were found.

Figure 144 - General view of site PP 29 as recorded during the recent fieldwork.

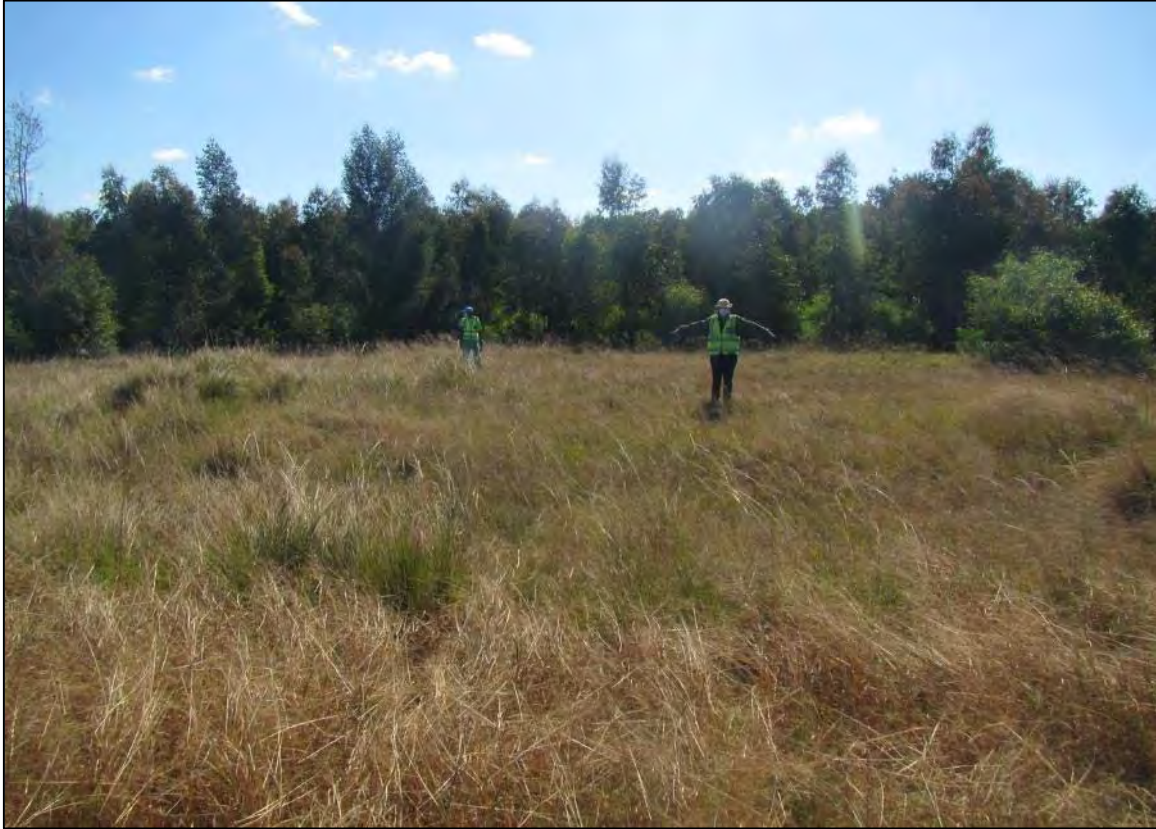
Figure 145 - View of the remains of the foundations of two mudbrick homesteads. The scale is not visible due to the dense grass covering the surface of the site.

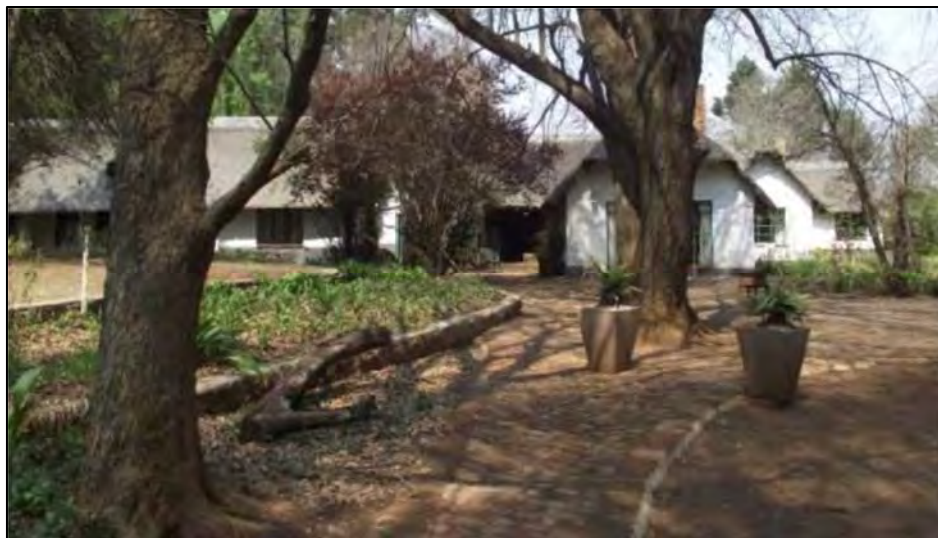
Figure 146 – General view of the farmhouse as recorded in 2012 (Photo: Kitto & Fourie, 2012).

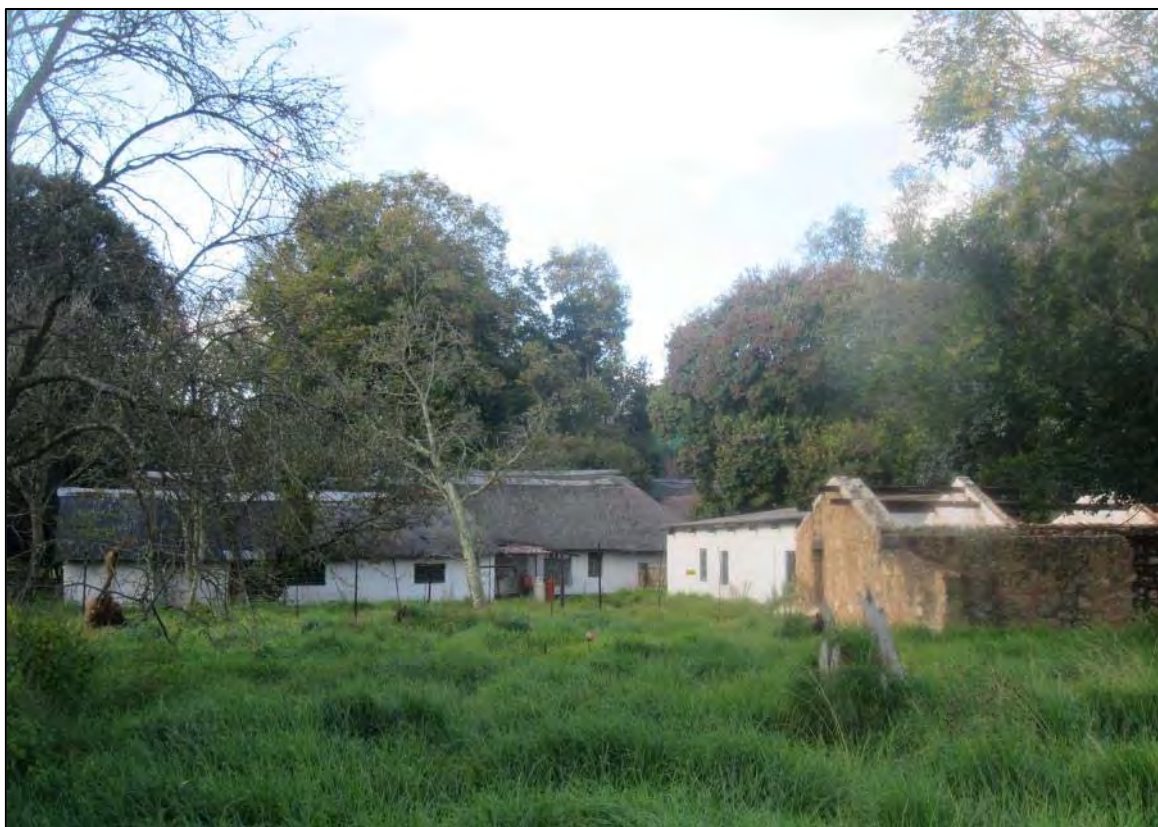
The site was visited during the recent fieldwork. It was found to consist of the remains of an abandoned farmstead with several buildings and a stone kraal. It appears as if the site has been abandoned for some period as the site is overgrown with vegetation.

Figure 152 - General view of the farmstead at site PP 30 as recorded during the recent visit to the site. The thatched-roof farmhouse can be seen in the background on the left.

During the 2012 study, the site was assessed to be of **Medium Significance** or **Generally Protected B (GP. B)**. Although the site has deteriorated, the current significance would remain the same.

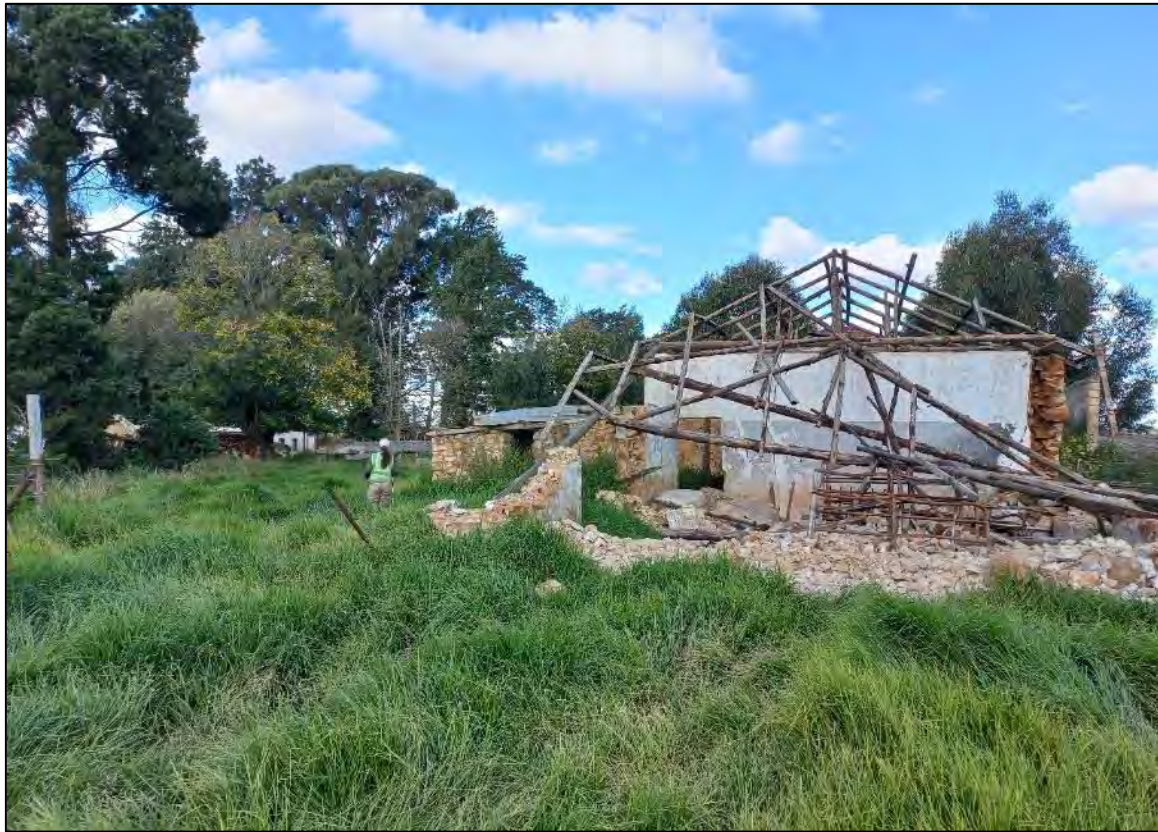
Figure 153 - View of the stone building with collapsed roof. The scale is in 10cm increments.

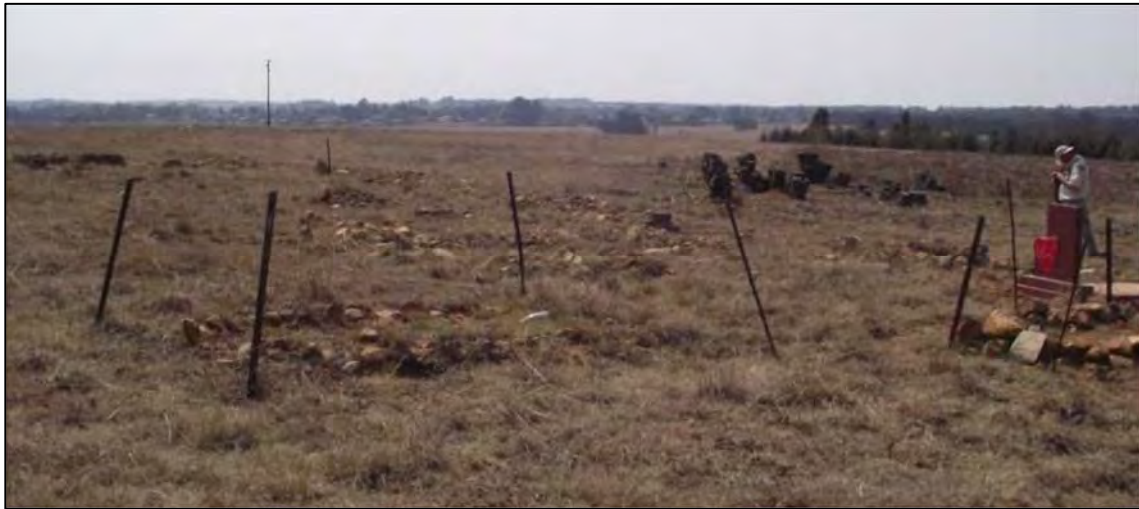
An informal cemetery with approximately 39 graves was identified at this location. The cemetery is not fenced and is located in a ploughed and planted field. The graves are placed in 3 unequal lines next to each other aligned east-west. Most of the graves have informal oval or rectangular shaped mounds or outlines of packed rocks as dressings. One grave has a formal granite dressing and an inscribed granite headstone. Some of the graves had been cleaned recently, but most of them are overgrown with grass and other vegetation. Some graves have granite inscribed headstones. According to local residents, the graves are farmworker graves. Some families still live on the farm and others live in the settlement of Siyathuthuka.

Figure 154 - View of the cemetery at site PP 31 as recorded in 2012 (Photo: Kitto & Fourie, 2012).

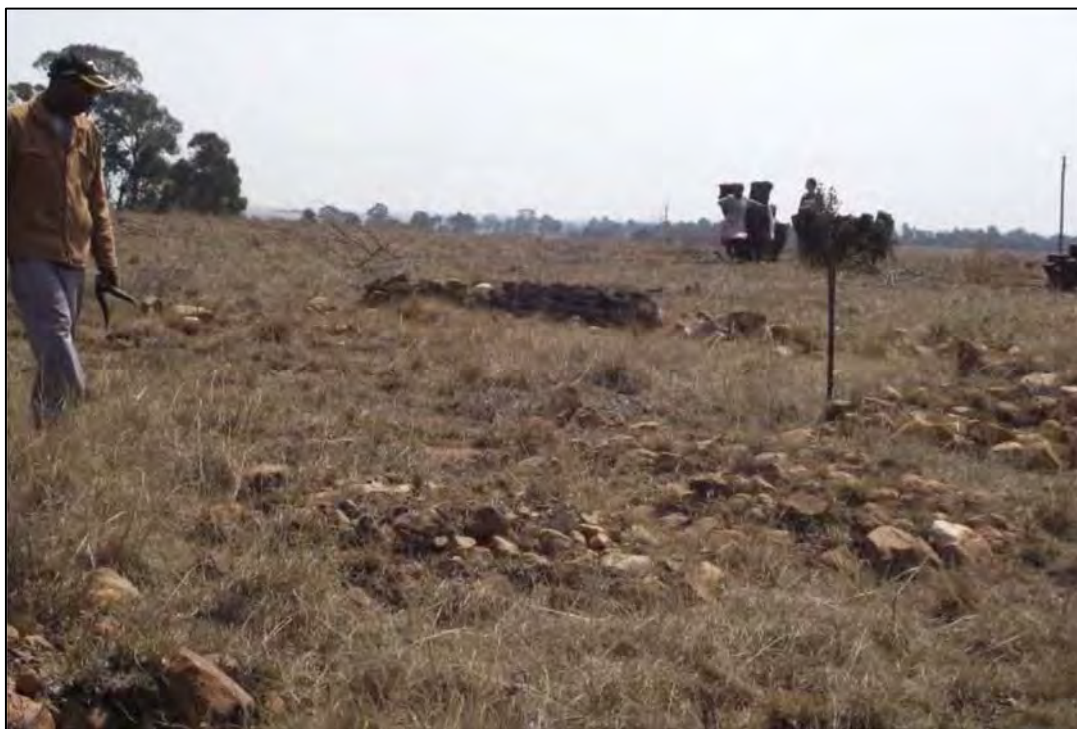
Figure 155 – Another view of the cemetery as recorded in 2012 (Photo: Kitto & Fourie, 2012).

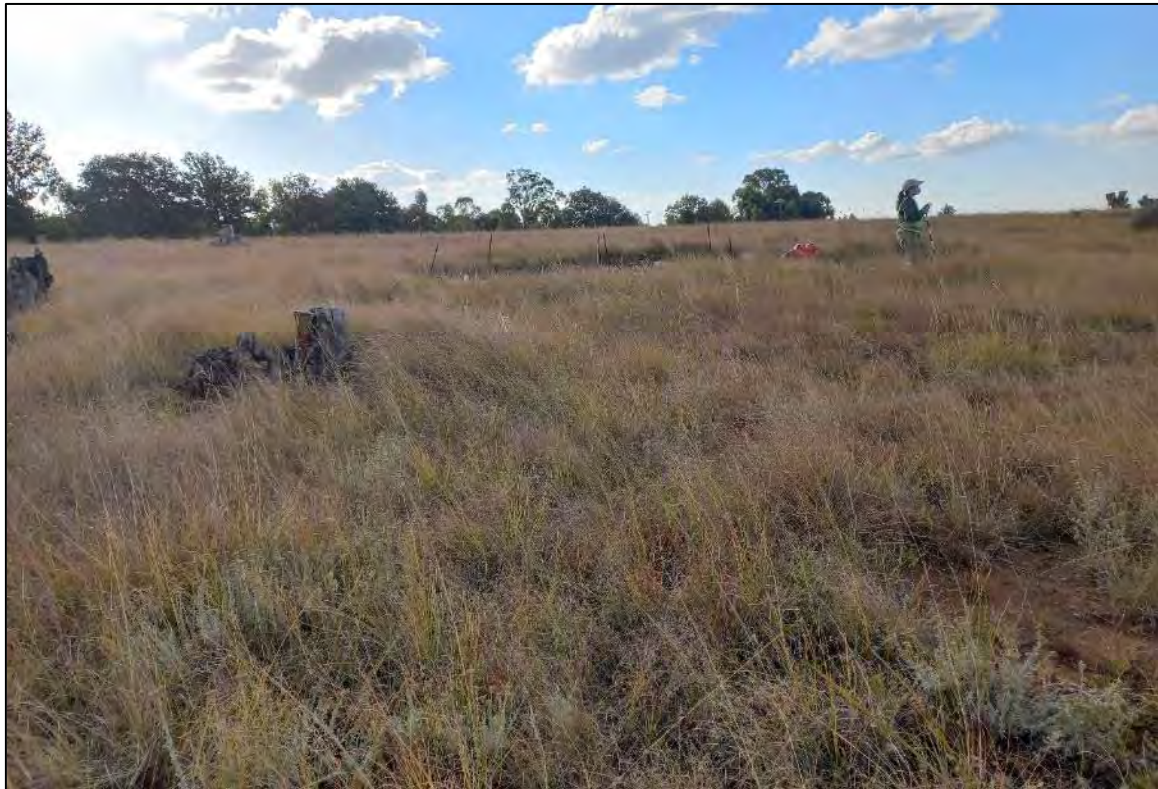
The site was visited during the recent fieldwork. It was found to consist of a cemetery containing a total of approximately 40 graves located in an agricultural field. Many of the graves have stone-lined dressings whereas some graves have formal dressings and inscribed headstones. The graves are clearly visibly. The cemetery is not fenced.

Figure 156 - General view of the cemetery at site PP 31 as recorded during the recent site visit.

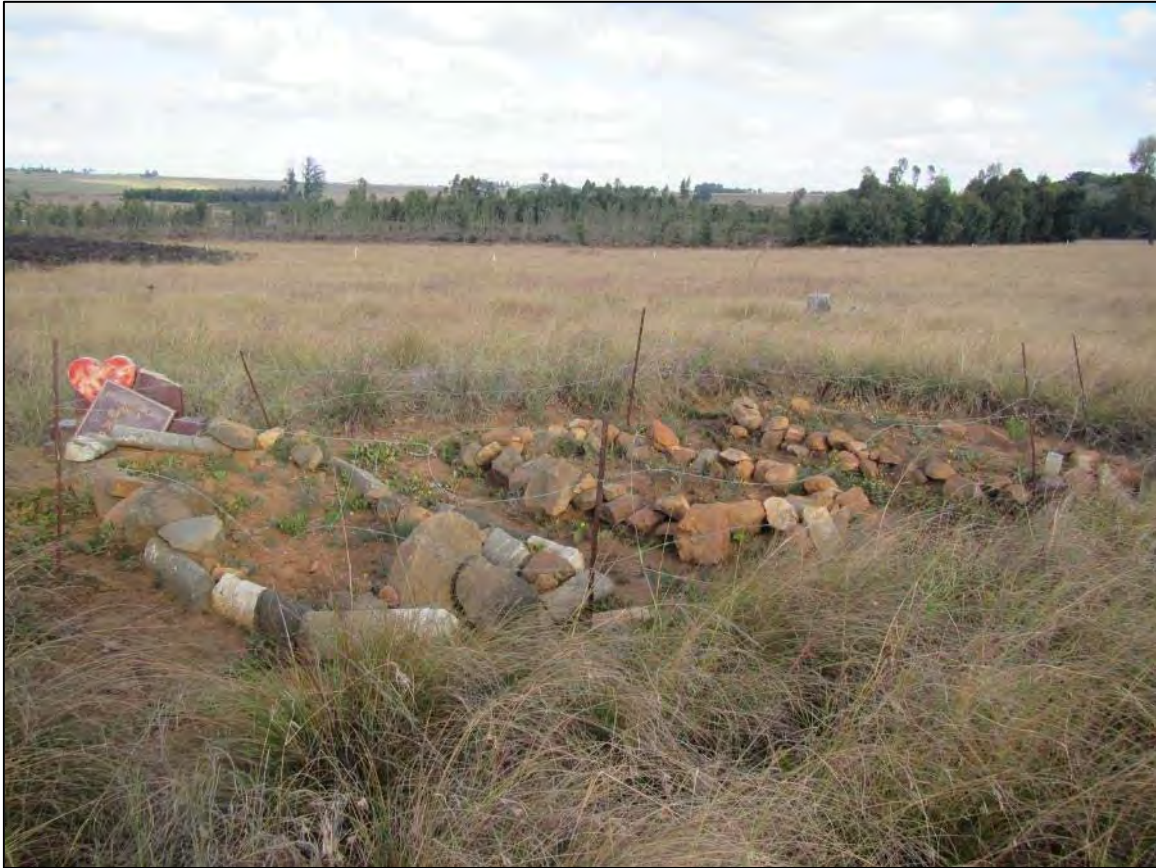
Figure 157 - View of some of the graves consisting of formal dressings, headstones and packed graves. Not the small fence surrounds three stone-lined graves.
