NBC COLLIERY GLISA AND PAARDEPLAATS MINING PROJECT

Phase 1 – Heritage Impact Assessment

Issue Date: 19 May 2021
Revision No.: 2.0
PGS Project No.: 524HIA
CI Group project No: 19.0001

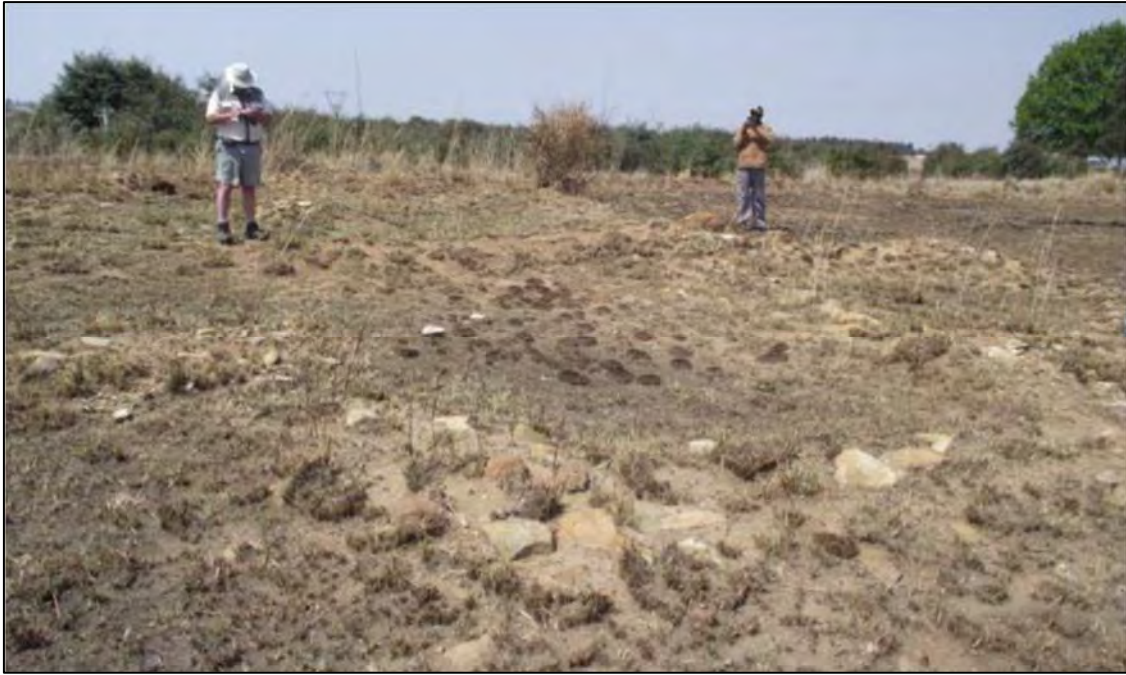
The remains of another mud-brick homestead were identified at this location. The remains of the mud-brick homestead consist of the foundations of four square structures, which each measure approximately 4m x 4m in size, and a circular structure that measured approximately 4m in diameter. This structure was most probably the cooking hut. The structures are all placed around a central Lapa area. Rocks were used in the foundations to support the mud-brick walls of the structures. Several modern metal artefacts such as wire, corrugated iron and cans were found scattered around the site.

Figure 158 – General view of site PP 32 as recorded during the fieldwork undertaken in 2012. The foundation remains of the homestead can be seen on this photograph (Photo: Kitto & Fourie, 2012).

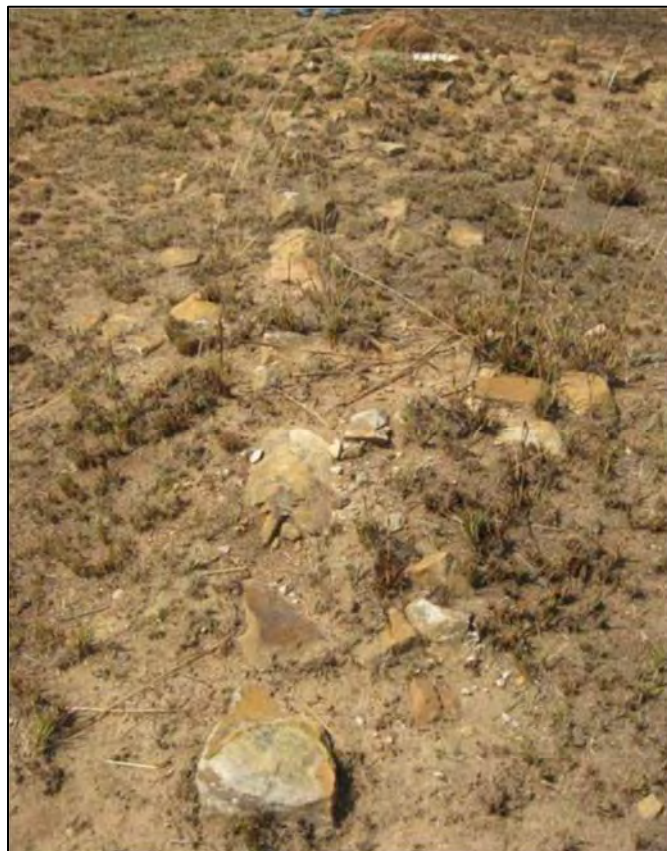
Figure 159 - Close-up view of one of the wall foundations. This photograph was also taken during the 2012 fieldwork (Photo: Kitto & Fourie, 2012).

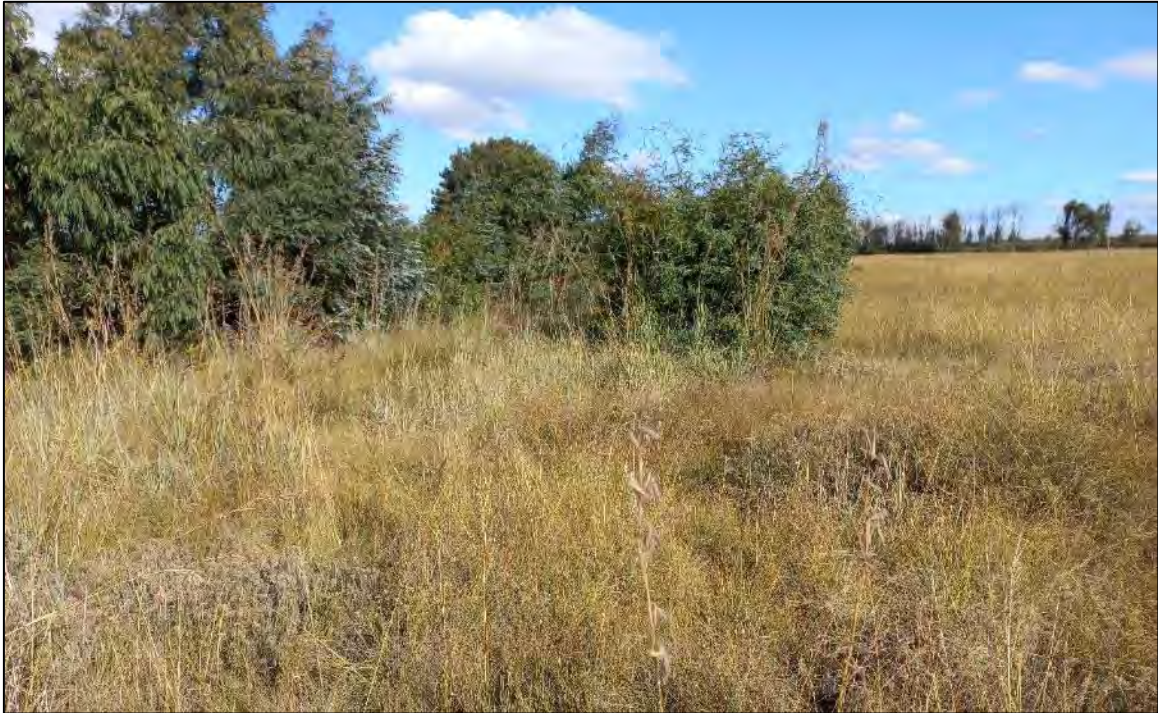
Figure 160 - General view of site PP 32 as recorded during the recent fieldwork. Note the dense vegetation found at the site.

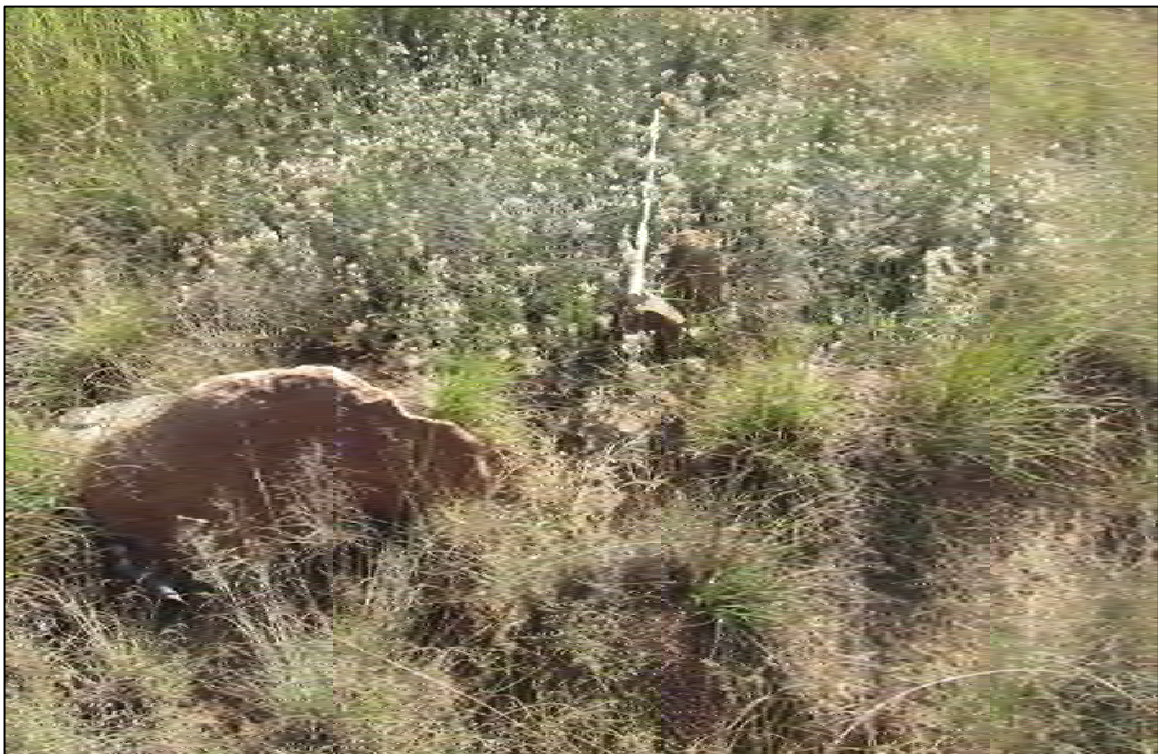
Figure 161 - View of some of the stone foundations observed at the site.

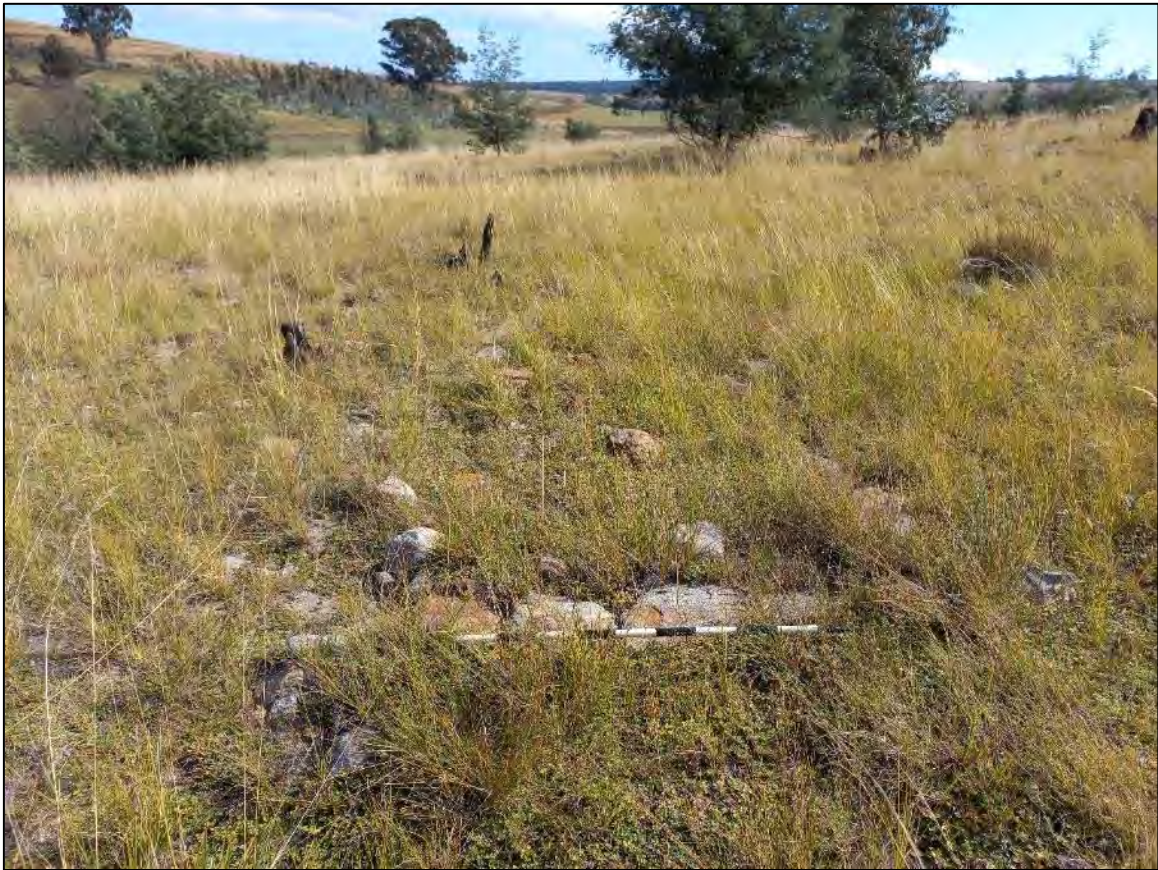
Figure 162 - General view of the stone foundations of a ming structure found at site PP 33. The scale is in 10cm increments.

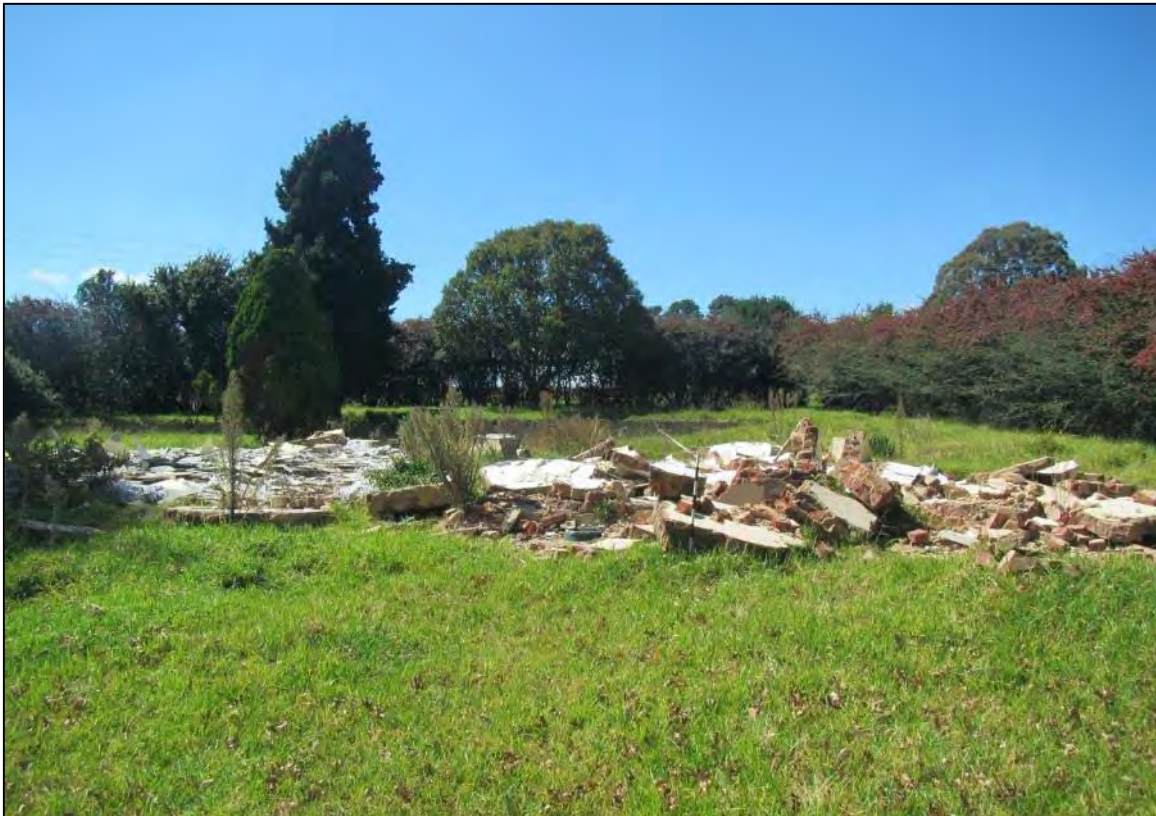
Figure 163 - General view of the demolished structure at PP 34.

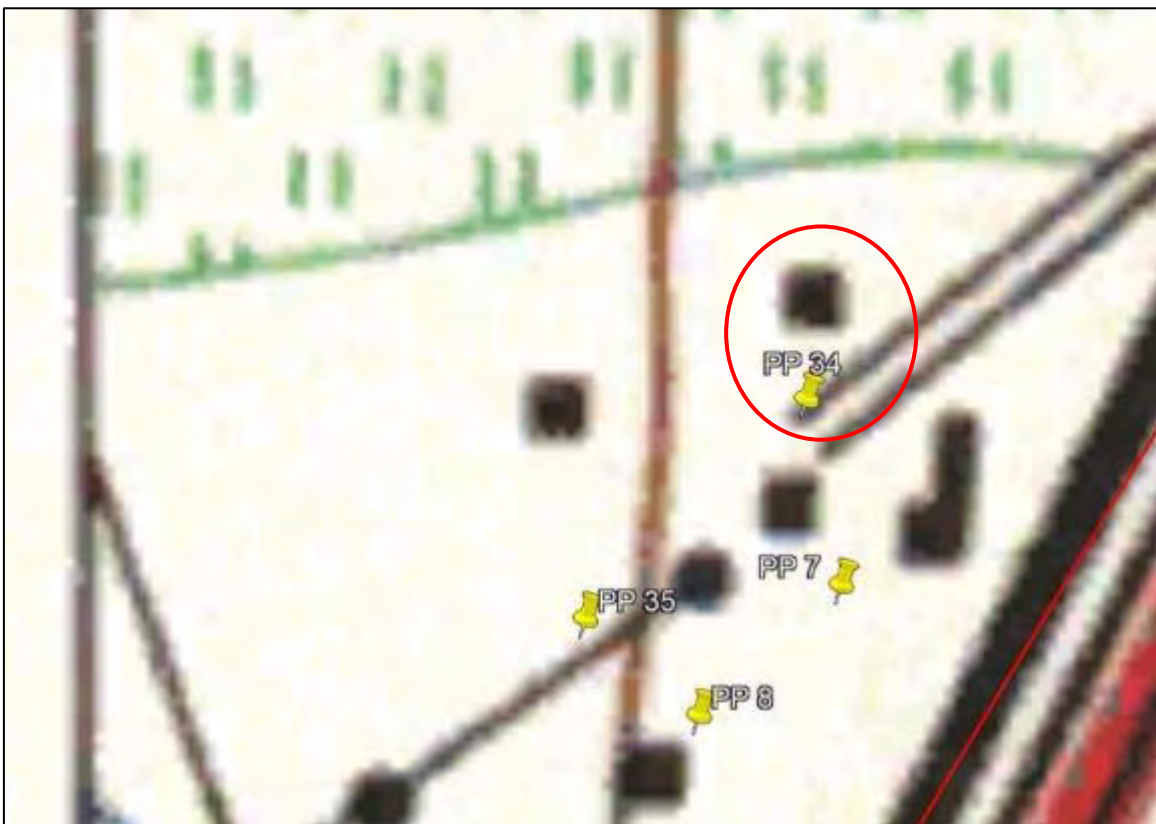
Figure 164 - View of the building (red polygon) depicted on the Second Edition of the 2530CA (Belfast) Topographical Map in proximity to the position of the demolished structure at site PP 34. This map was compiled in 1989.

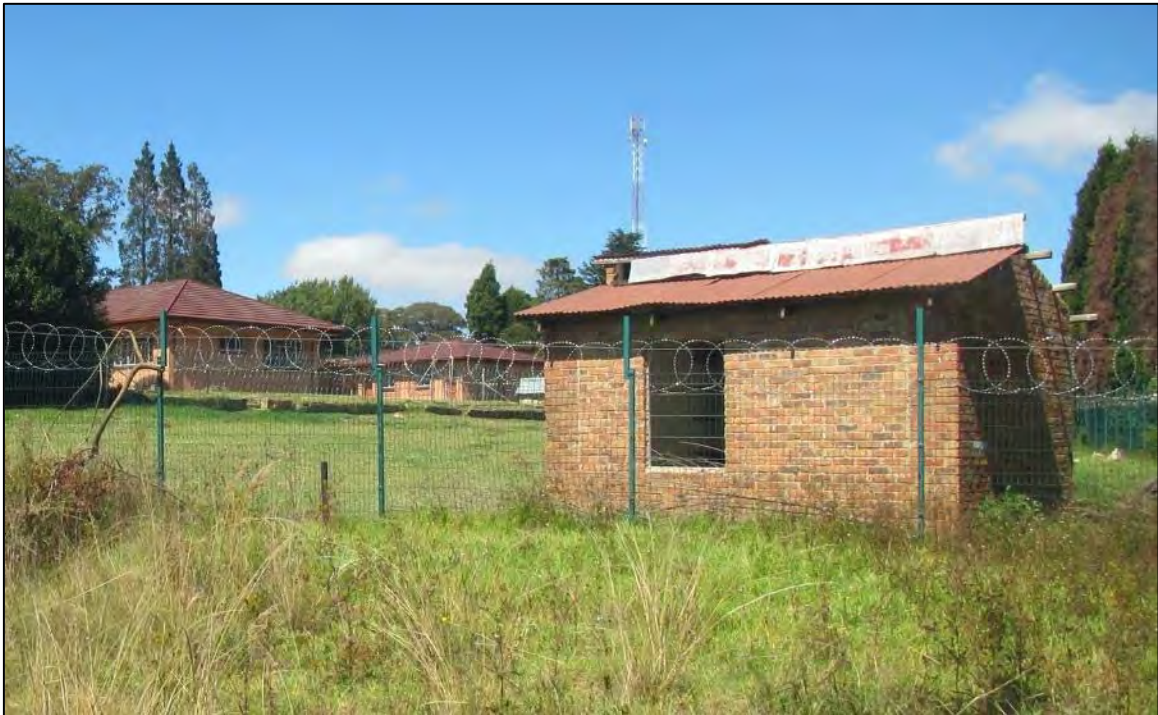
Figure 165 - General view of the two brick houses (visible in the background) with an associated smaller brick building in the foreground.

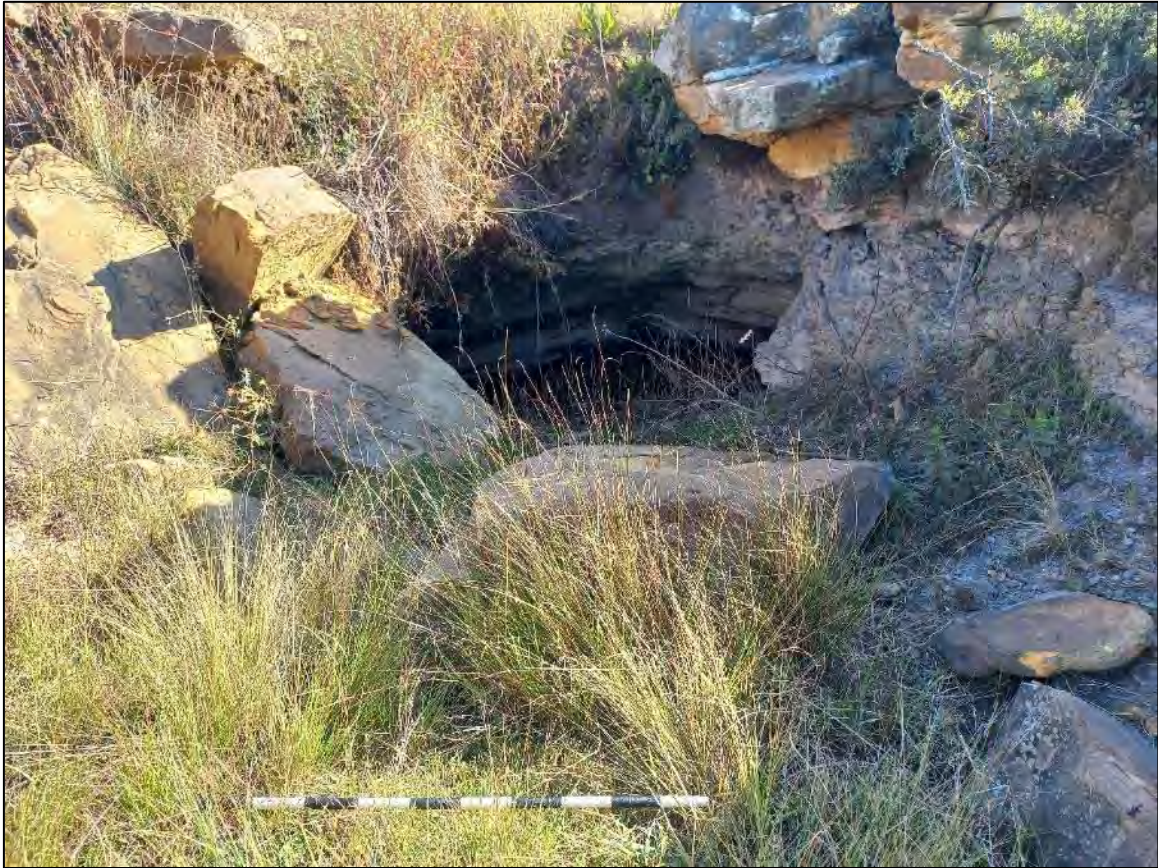
Figure 167 - View of the entrance to the abandoned coal mine shaft at PP 36. The scale is in 10cm increments.

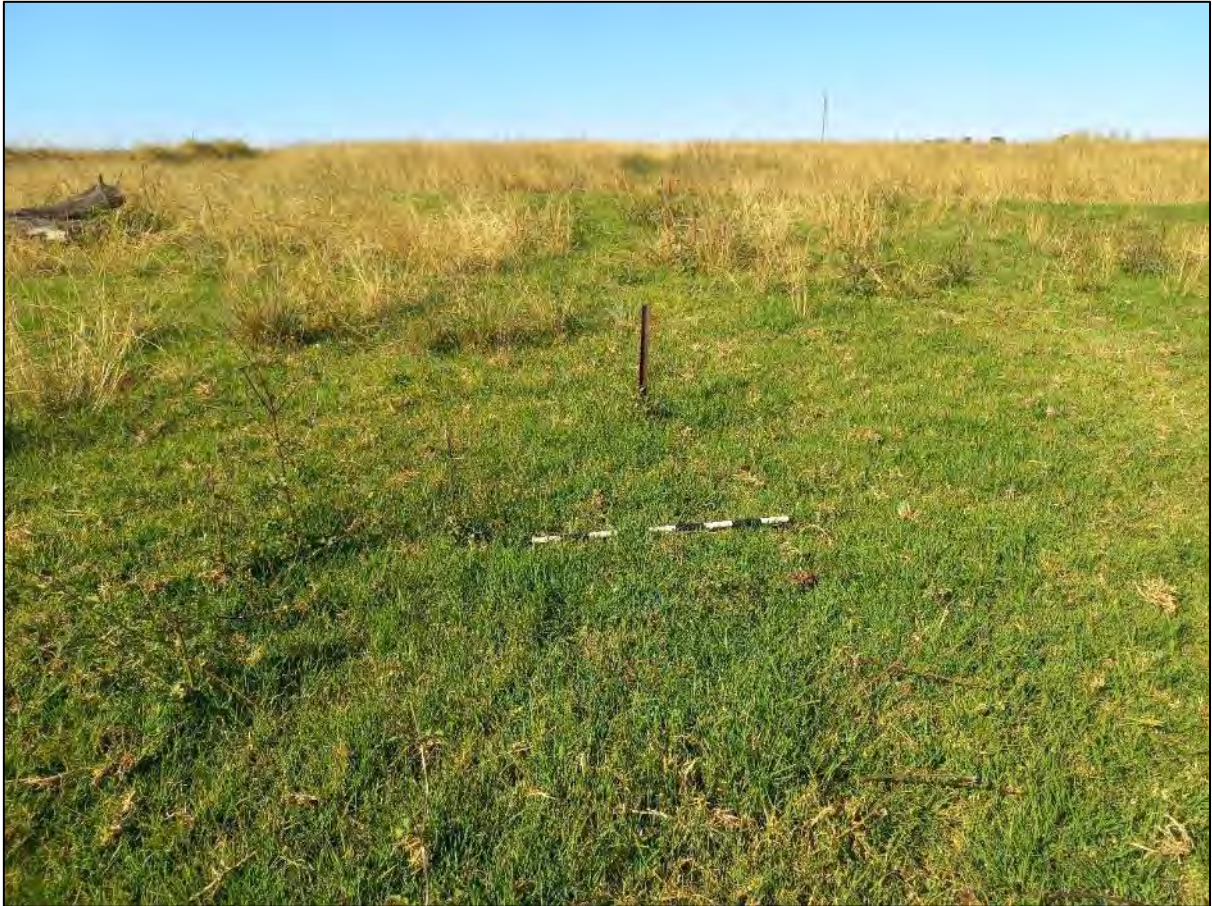
Figure 168 - General view of the single grave at site PP 37. The metal rod marking the position of the grave can be seen. The scale is in 10cm increments.

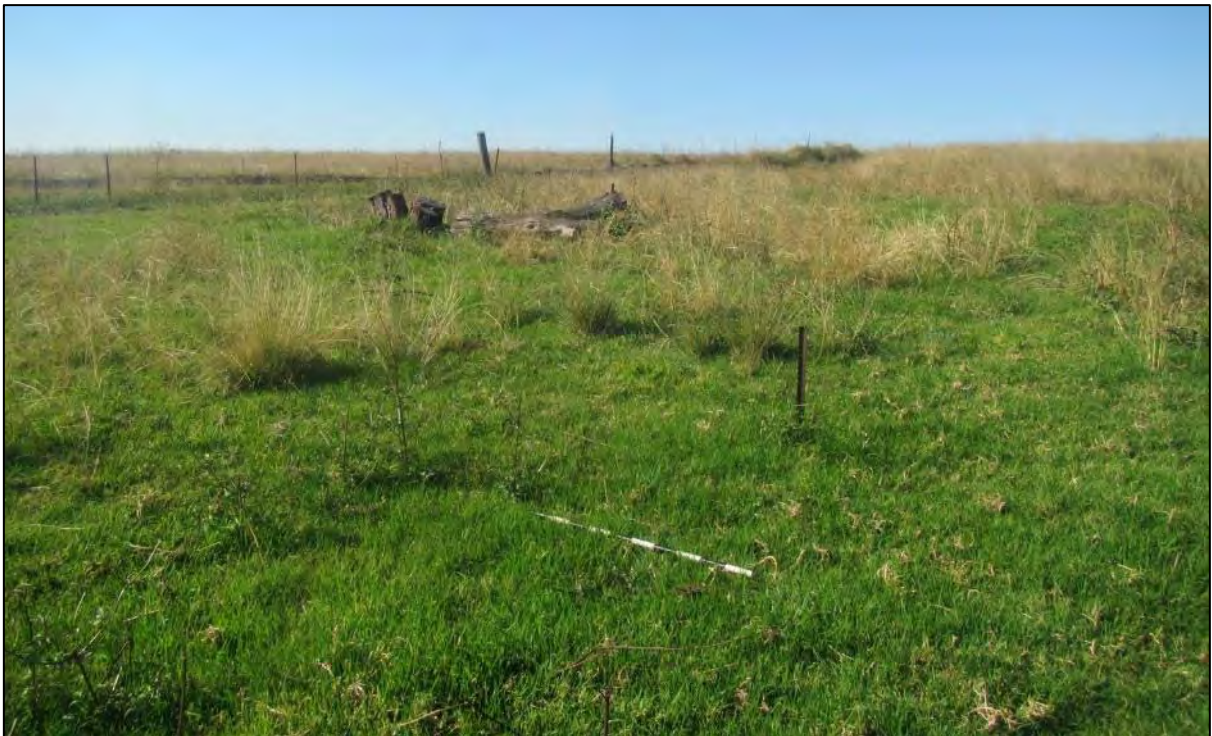
Figure 169 - Another view of the single grave at site PP 37. The metal rod marking the position of the grave can again be seen. The scale is in 10cm increments.

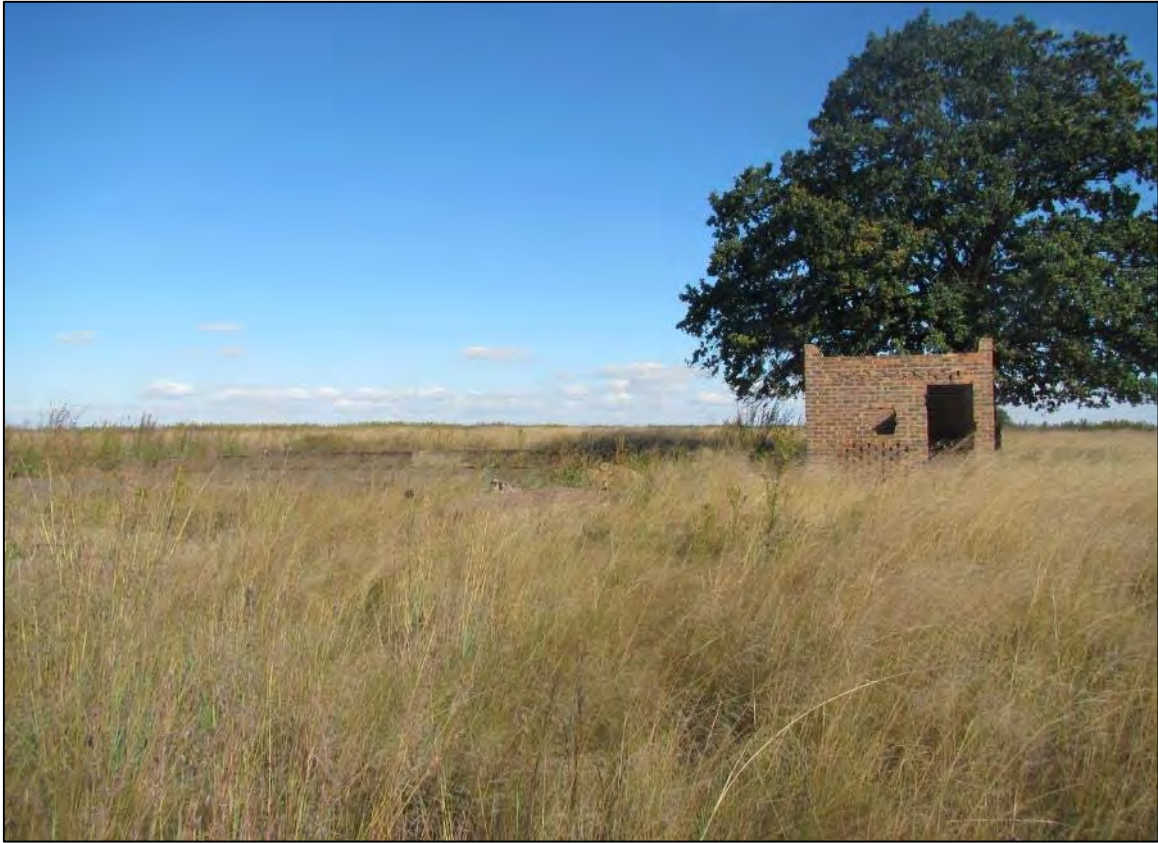
Figure 170 - General view of site PP 38.

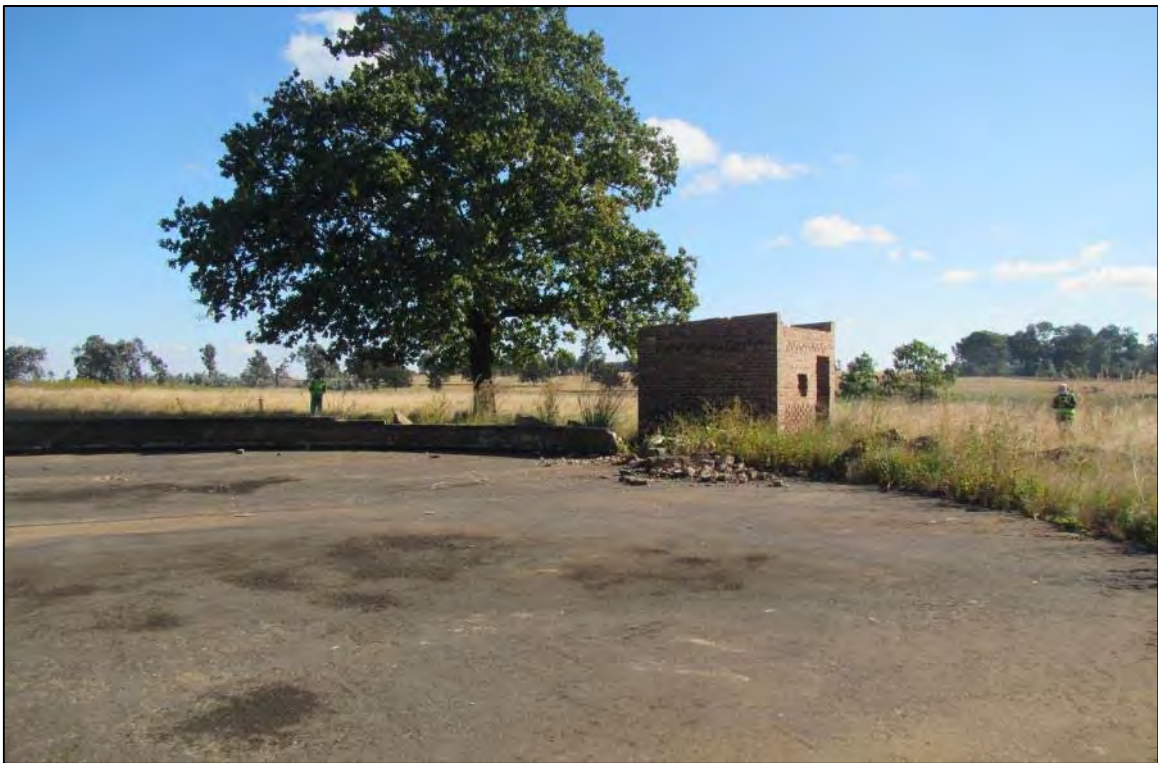
Figure 171 – Another view of the site showing a section of the reservoir in the foreground with the brick building in the back.

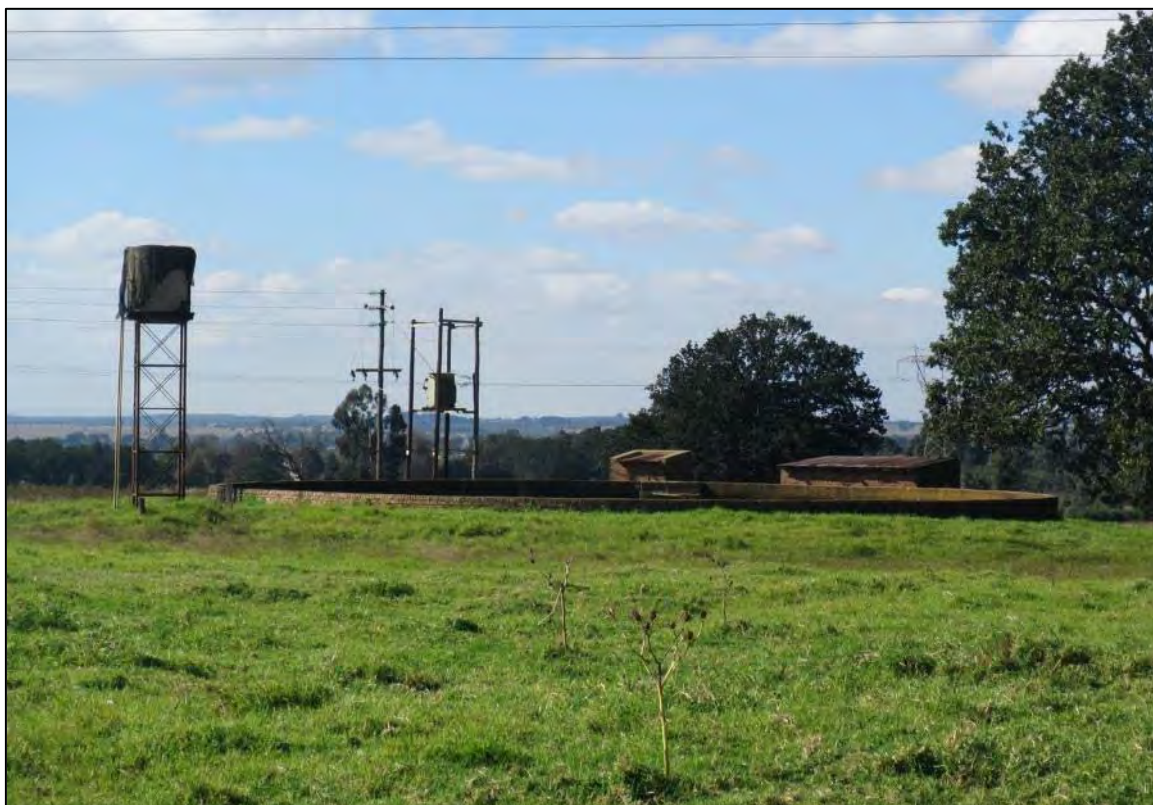
Figure 172 - General view of the reservoir and buildings at site PP 39.

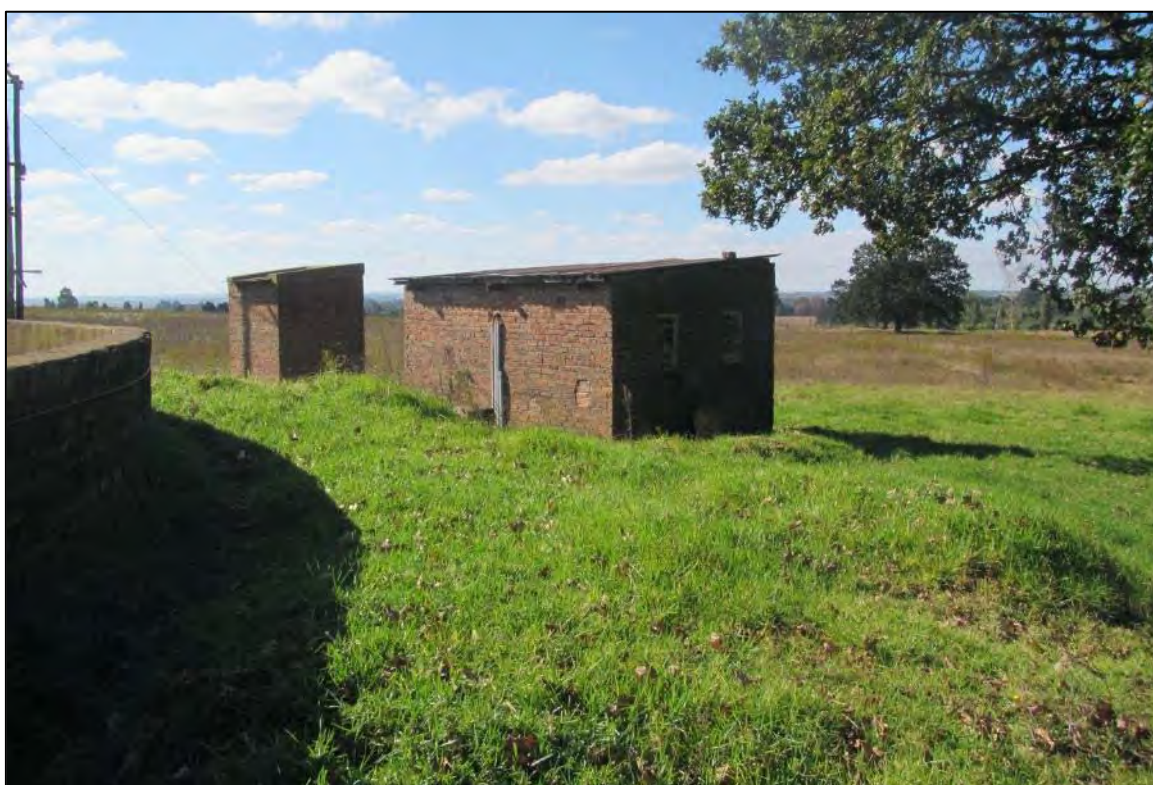
Figure 173 – A section of the reservoir is visible on the left, with the two associated brick structures located in the back.

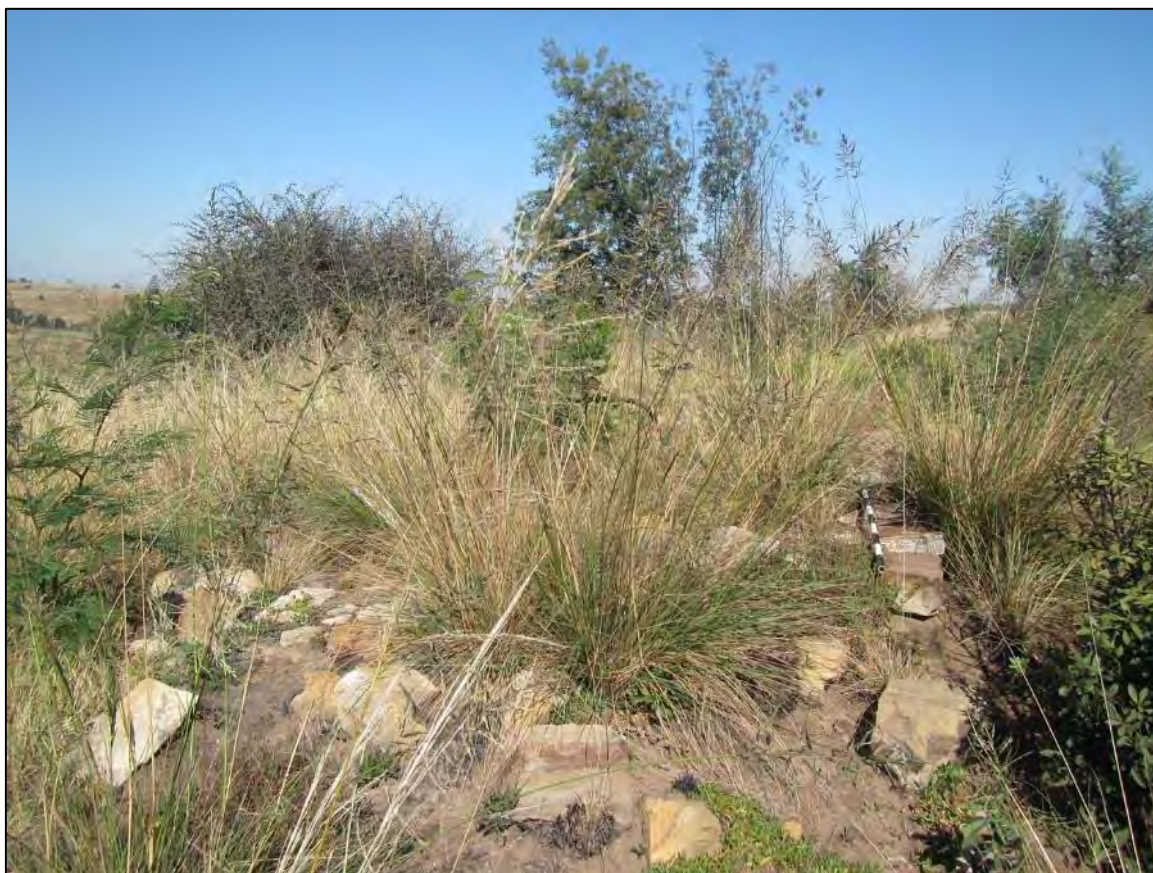
Figure 174 – General view of the stone foundations of a rectangular structure. The scale is in 10cm increments.

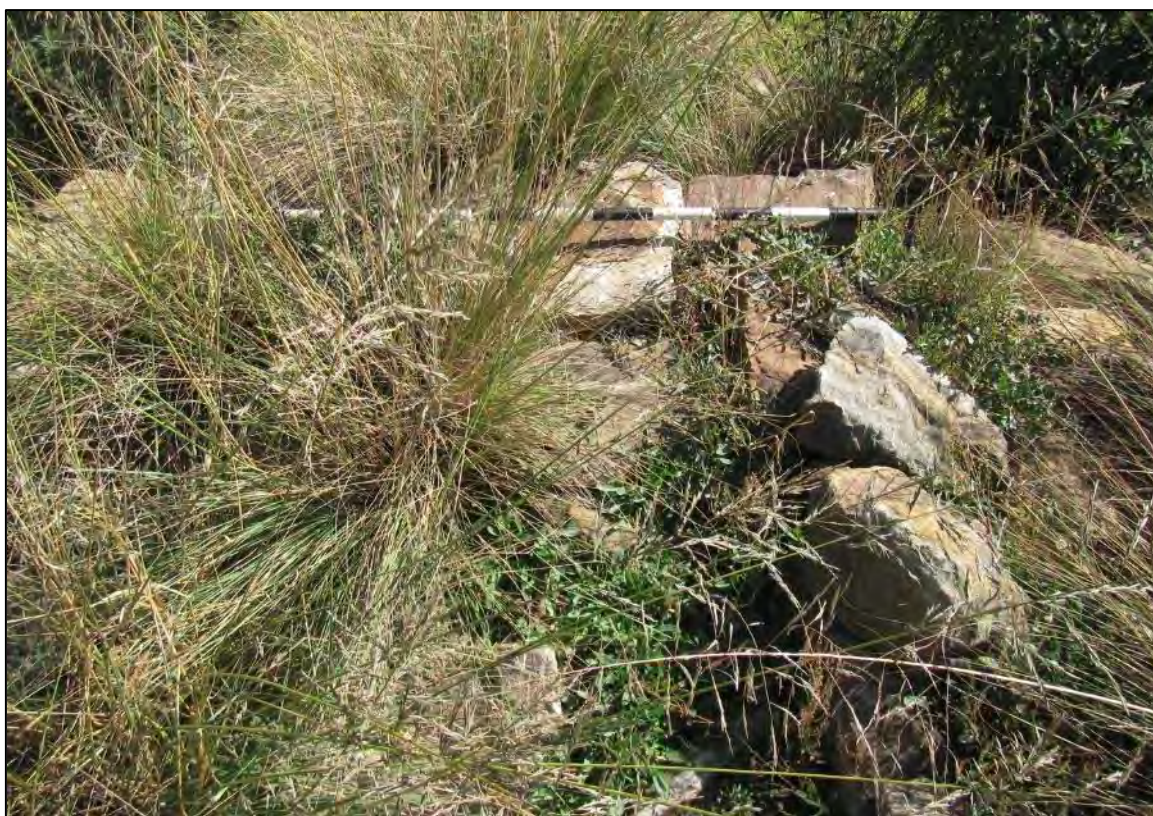
Figure 175 - Closer view of a section of the foundations at site PP 40.

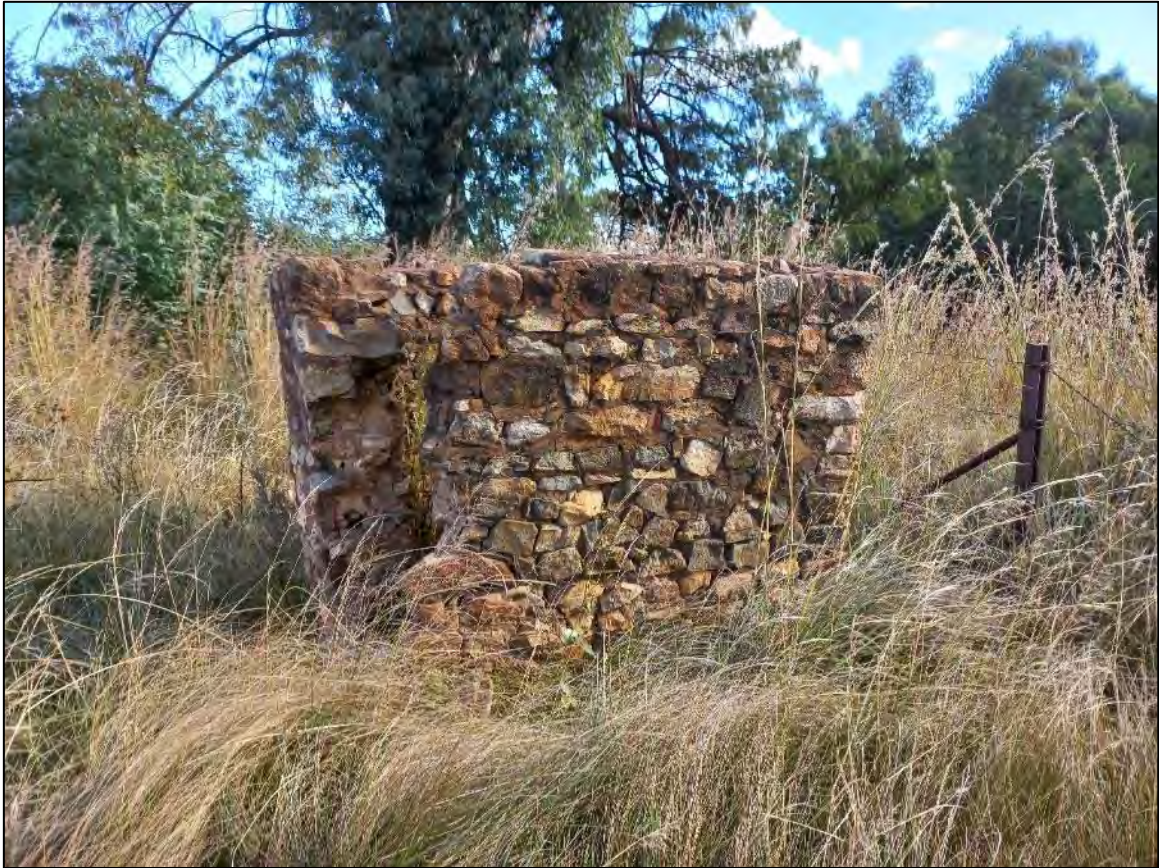
The remains of a small, square structure were identified at this location. The structure was built with stone and cement and measures approximately 4m x 4m in size. It has no roof and has only one entrance with no windows. The function and age of this structure are unknown. A section of one wall has broken away.

Figure 176 – General view of the stone structure at site PP 41.

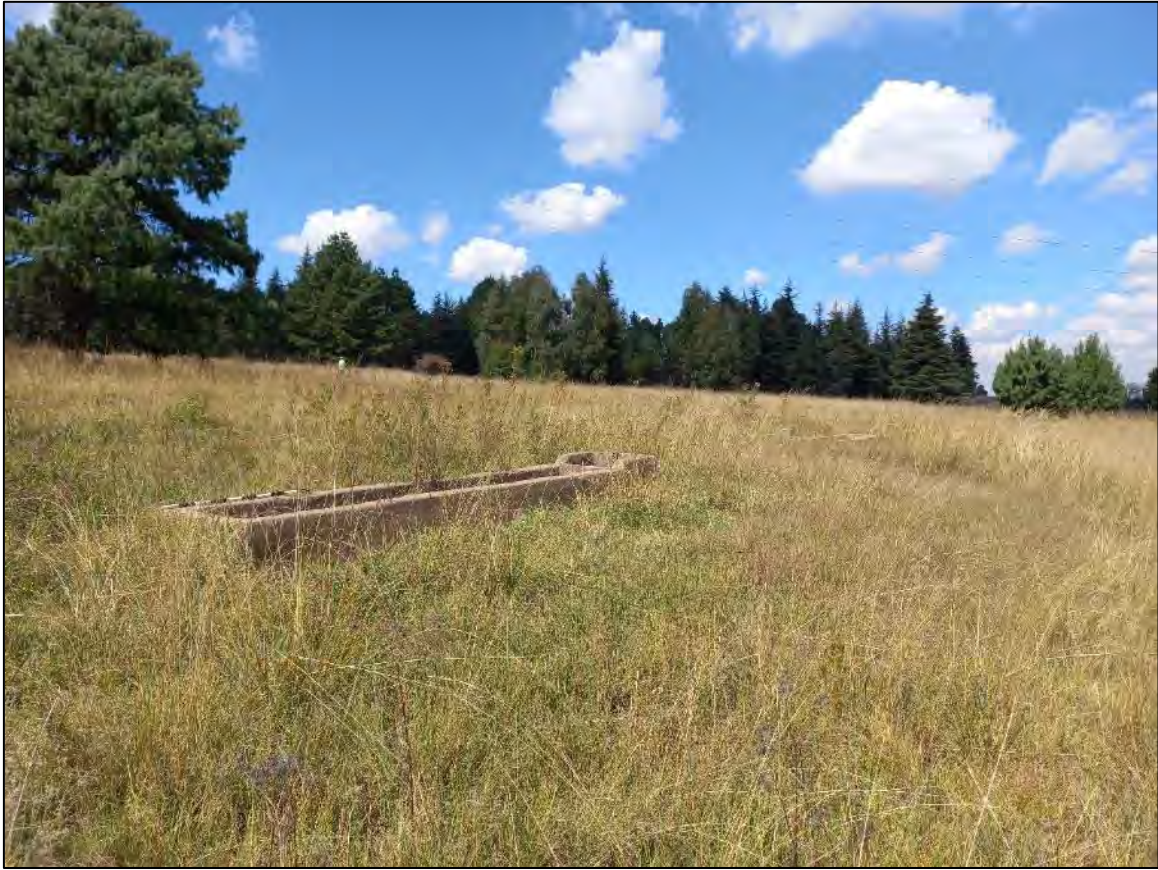
Figure 177 - View of the animal drinking trough. The scale is in 10cm increments.

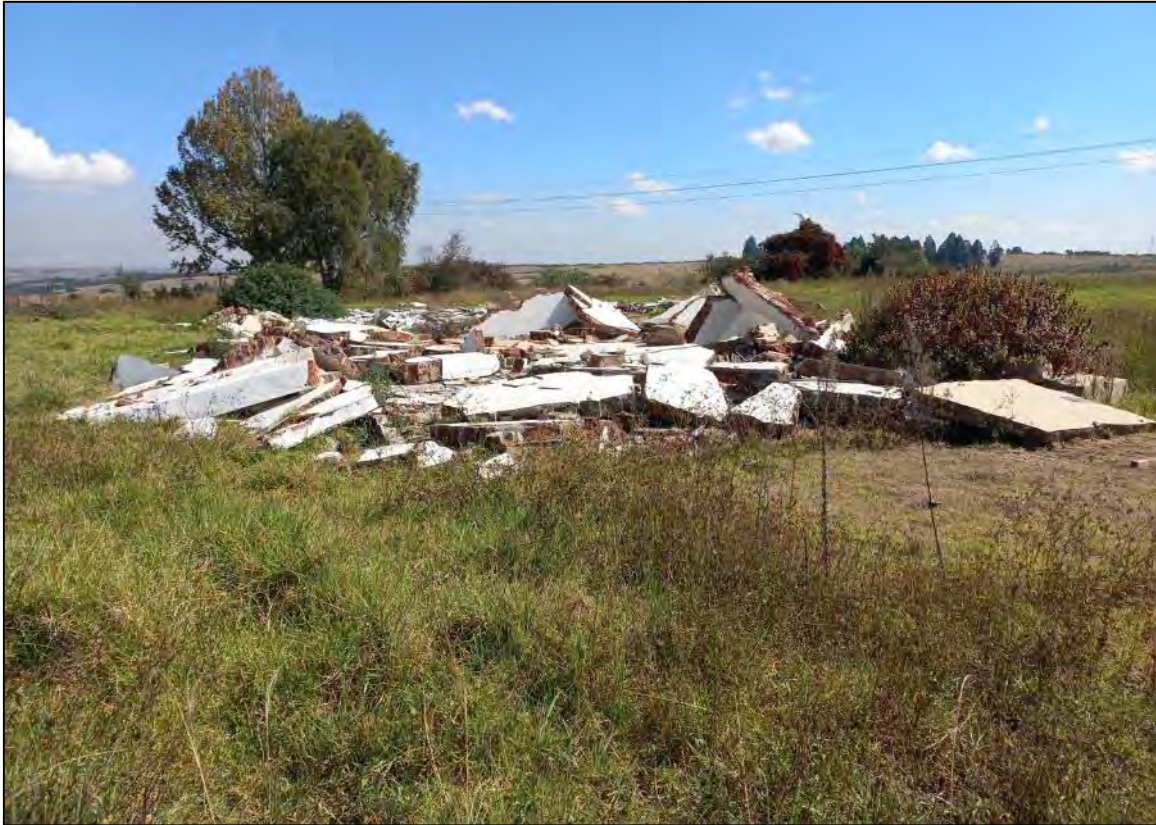
The site consists of the remains of a demolished brick and plaster structure. The collapsed walls and foundations of the structure were found on site.

Figure 178 - General view of the demolished structure at site PP 43.

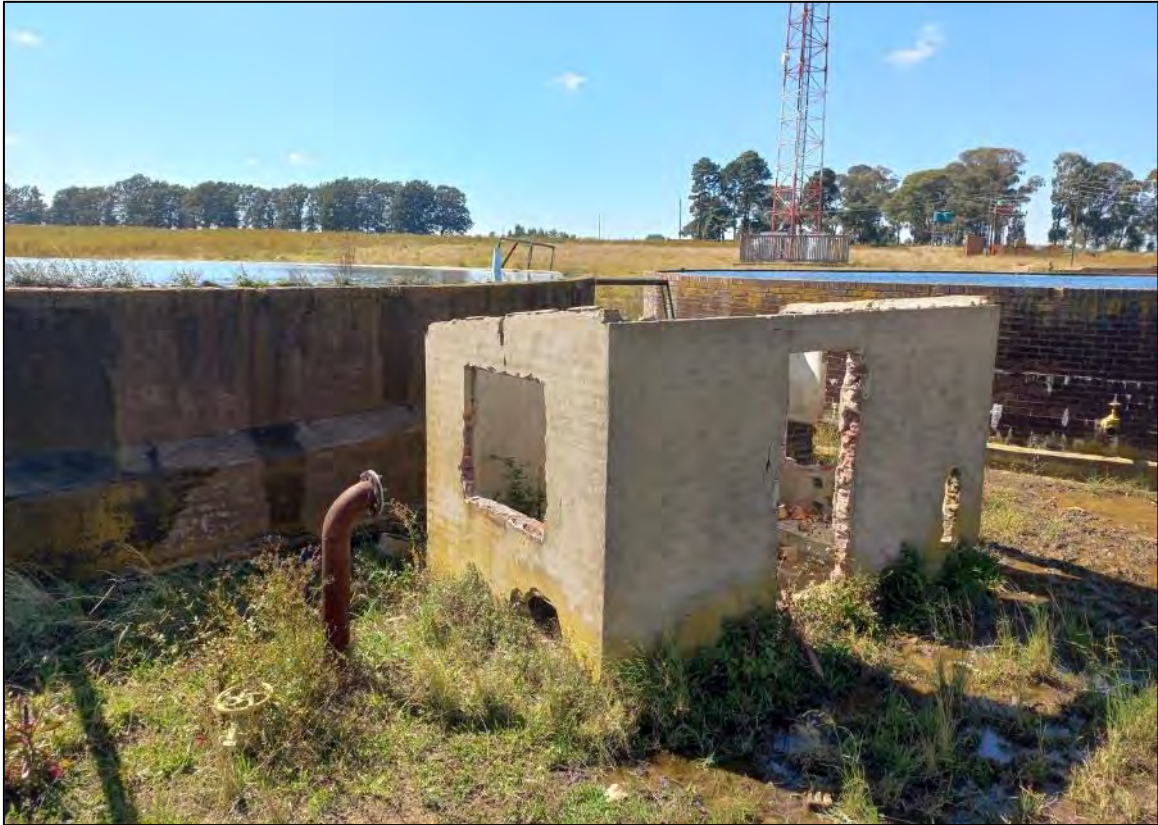
Figure 180 - General view of the site showing sections of the two reservoirs in the back with one of the associated brick buildings visible in the foreground.

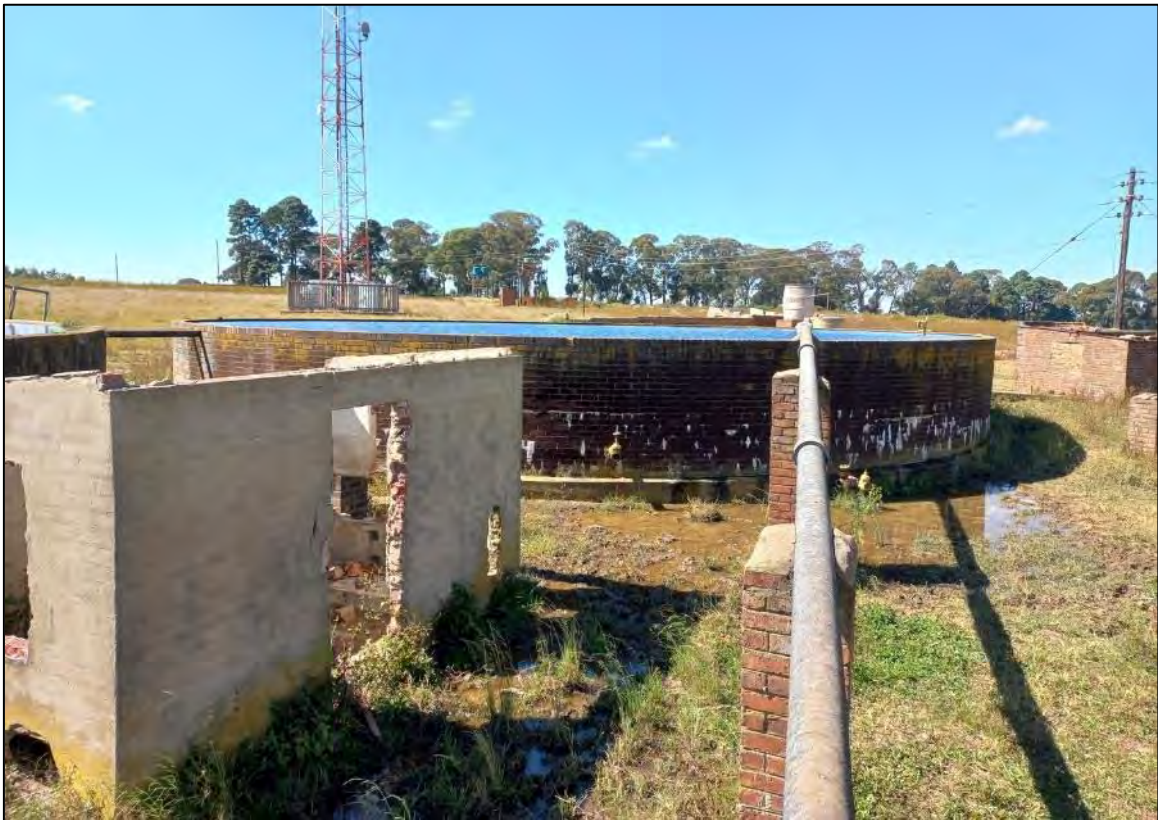
Figure 181 – Another view of the site showing a reservoir and its associated buildings and structures.
6.2.45 PP 45

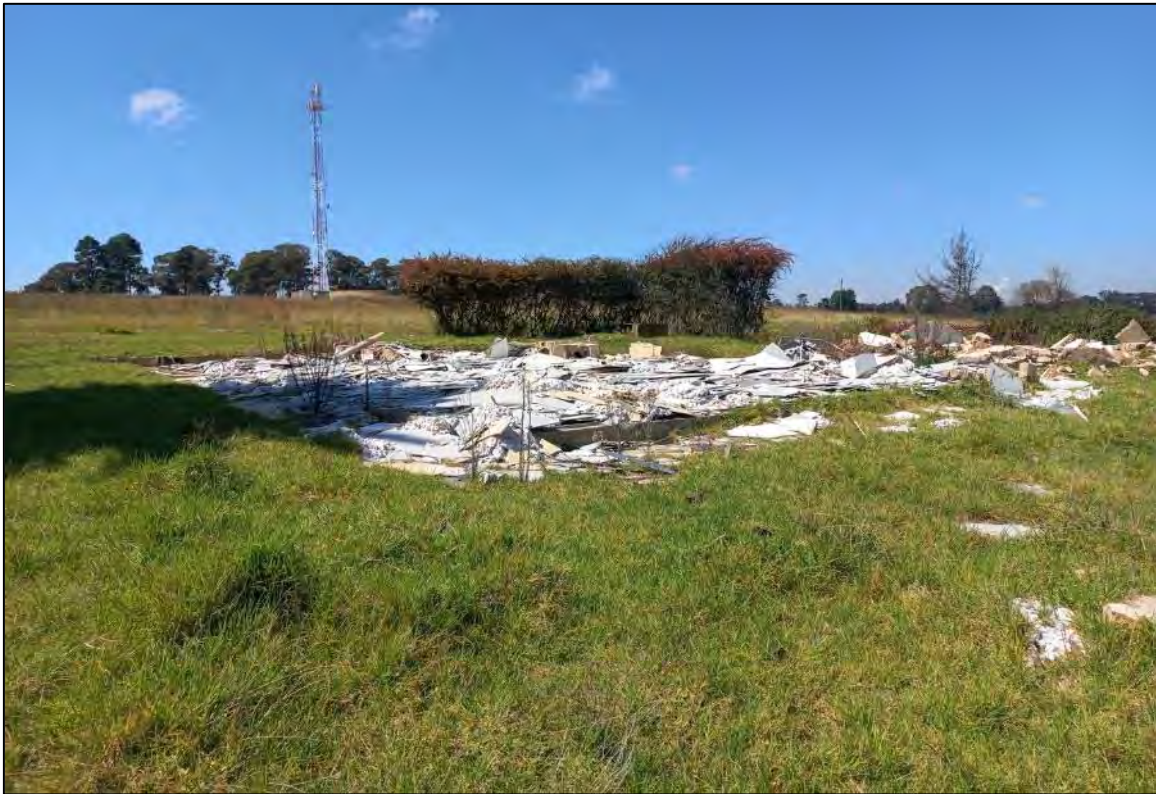
Figure 182 - General view of the demolished structure at site PP 45.

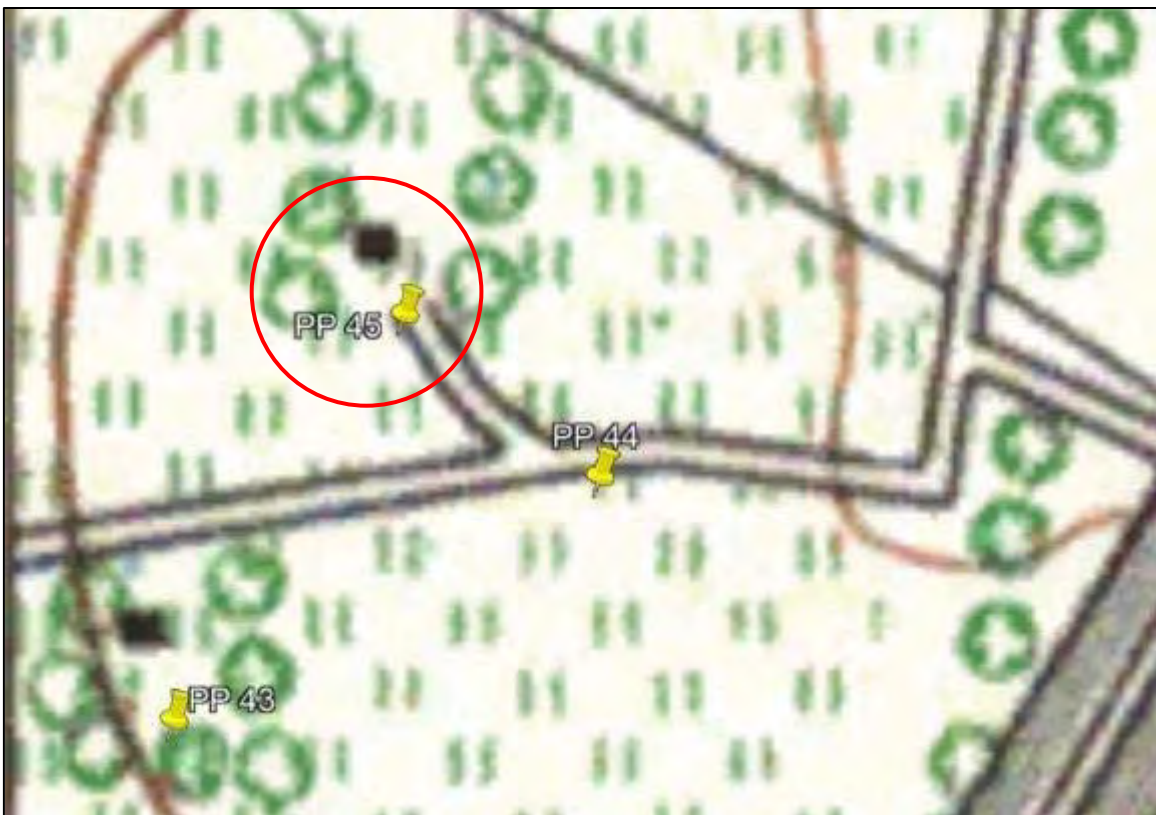
Figure 183 - View of the building (red polygon) depicted on the Second Edition of the 2530CA (Belfast) Topographical Map in proximity to the position of the demolished structure at site PP 45. This map was compiled in 1989.
