NBC COLLIERY GLISA AND PAARDEPLAATS MINING PROJECT

Phase 1 – Heritage Impact Assessment

Issue Date: 19 May 2021
Revision No.: 2.0
PGS Project No.: 524HIA
CI Group project No: 19.0001

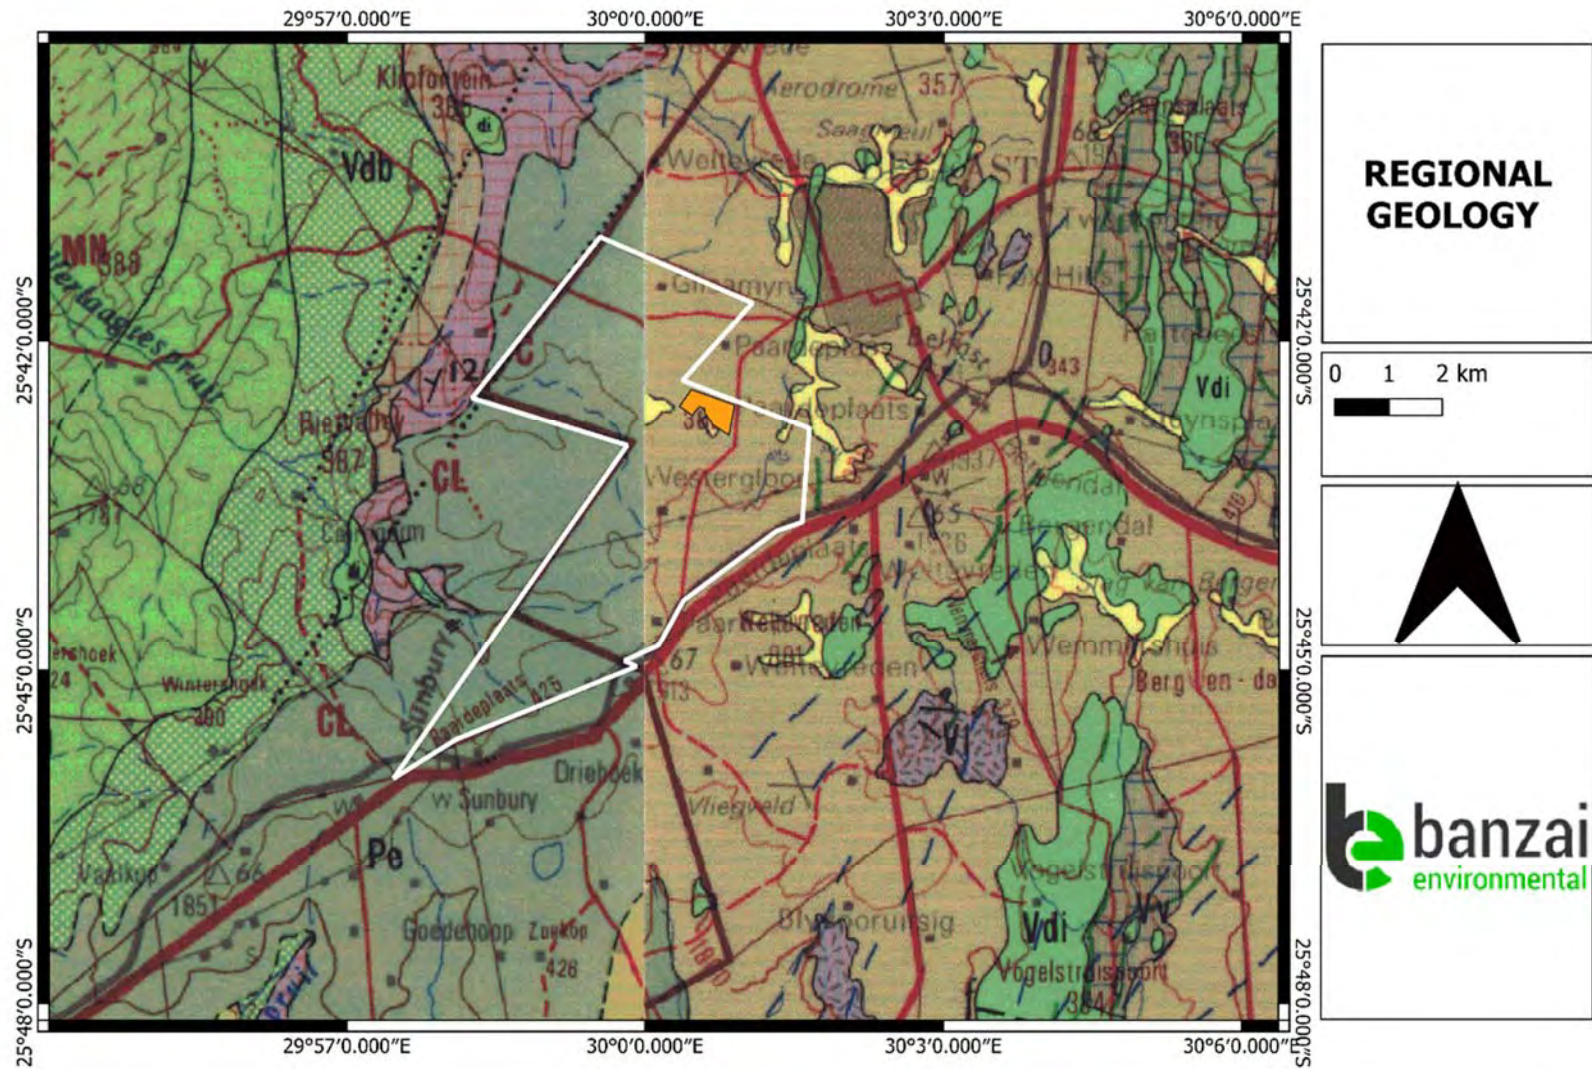
Figure 184 - Extract of the 2528 (Pretoria) and 2530 (Baberton) Geological Map (Council of Geoscience) indicating the surface geology of the proposed development in white and orange (Butler, 2021:12).

Most of the coal mined in South Africa originates in the Permian Vryheid Formation (refer **Figure 184** below).

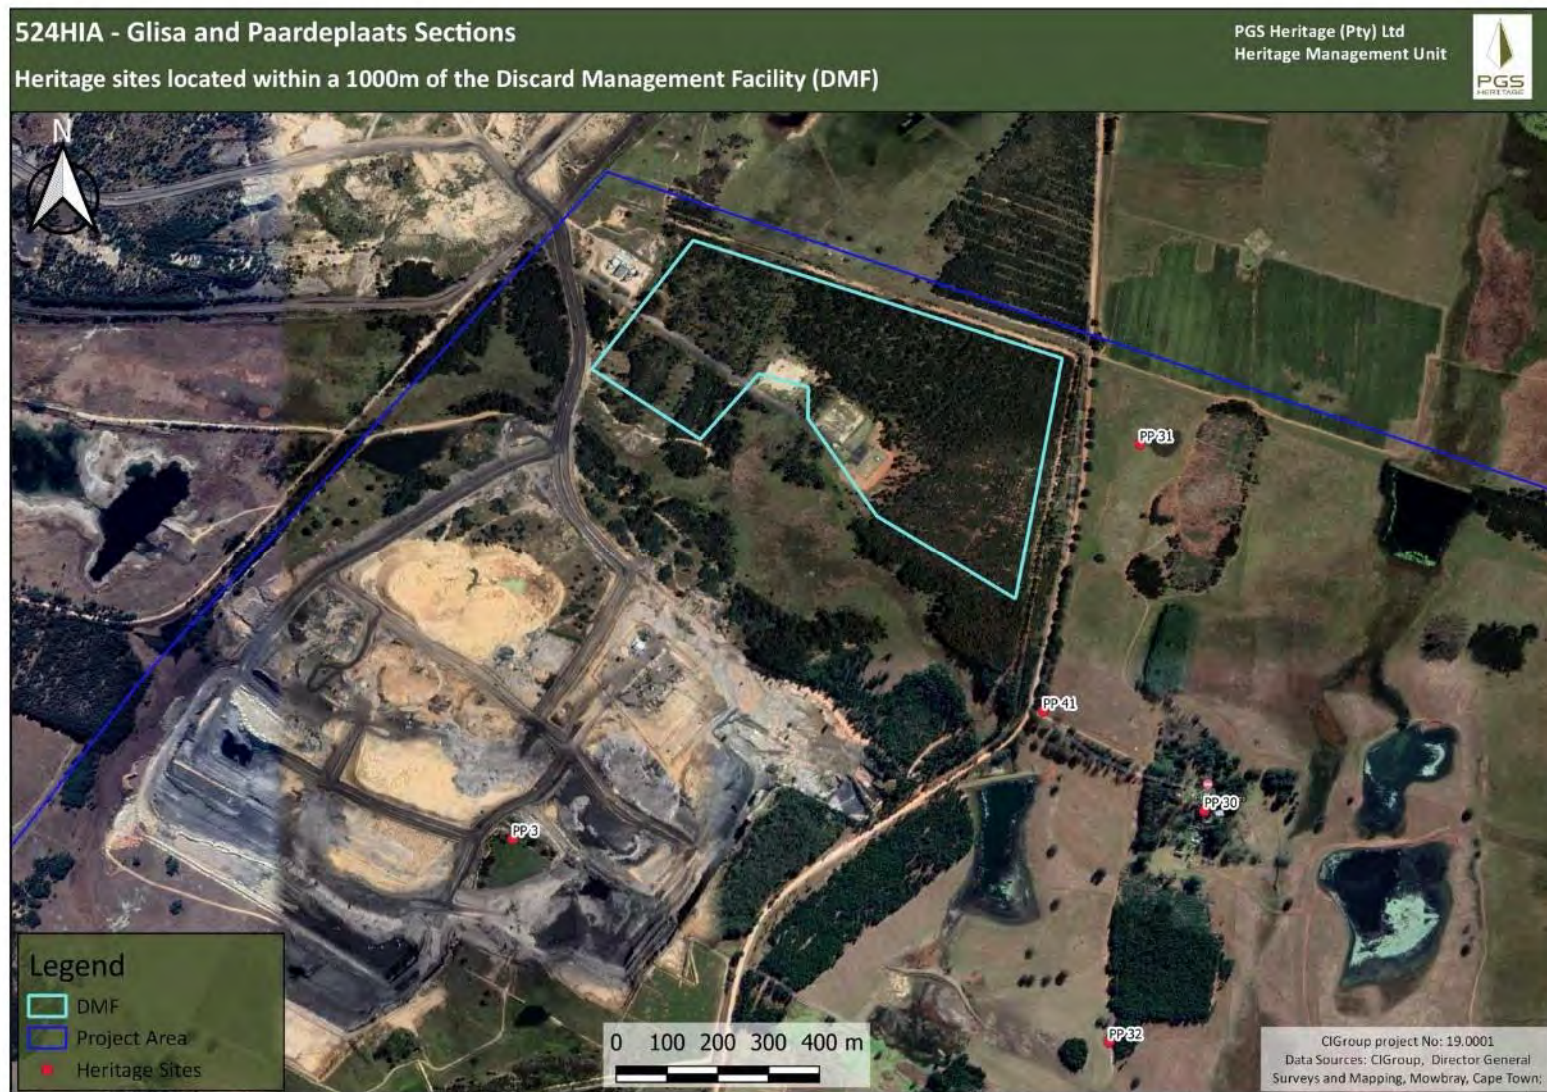
Figure 189 – This image provides an overlay of the identified heritage sites over the proposed development footprint area of the DMF. As can be seen, none of the identified heritage sites are located within, or in close proximity to, this development footprint.

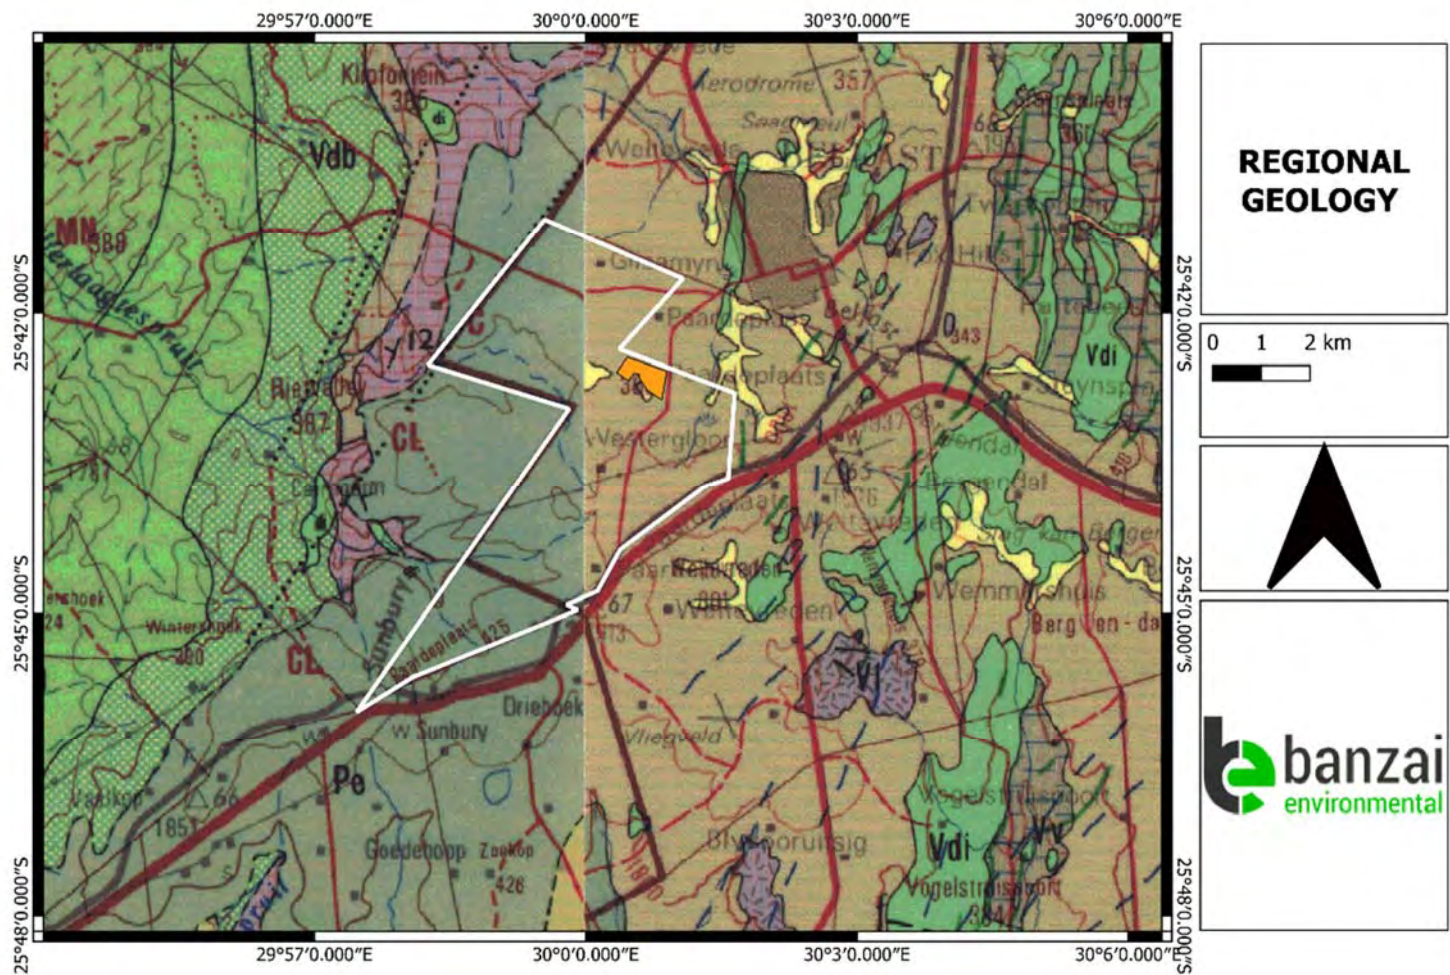
Figure 4: Extract of the 2528 (Pretoria) and 2530 (Baberton) Geological Map (Council of Geoscience) indicating the surface geology of the proposed development in white and orange.

The proposed Glisa EMP and IWUL Consolidated Project near Emakhazeni, in Mpumalanga is depicted on the 1: 250 000 2528 Pretoria (1978) and 2530 Baberton (1986) Geological Map (Council for Geosciences, Pretoria) (Figure 4). The area is underlain by rocks of the Transvaal Supergroup (Rooiberg and Pretoria Groups) that is overlain by the Vryheid Formation (Ecca Group, Karoo Supergroup). Isolated areas are mantled by Quaternary alluvium (Figure 4).
