Paraburdoo Closure Plan

2019

Mineral Field 47 – West Pilbara

Version 2.0

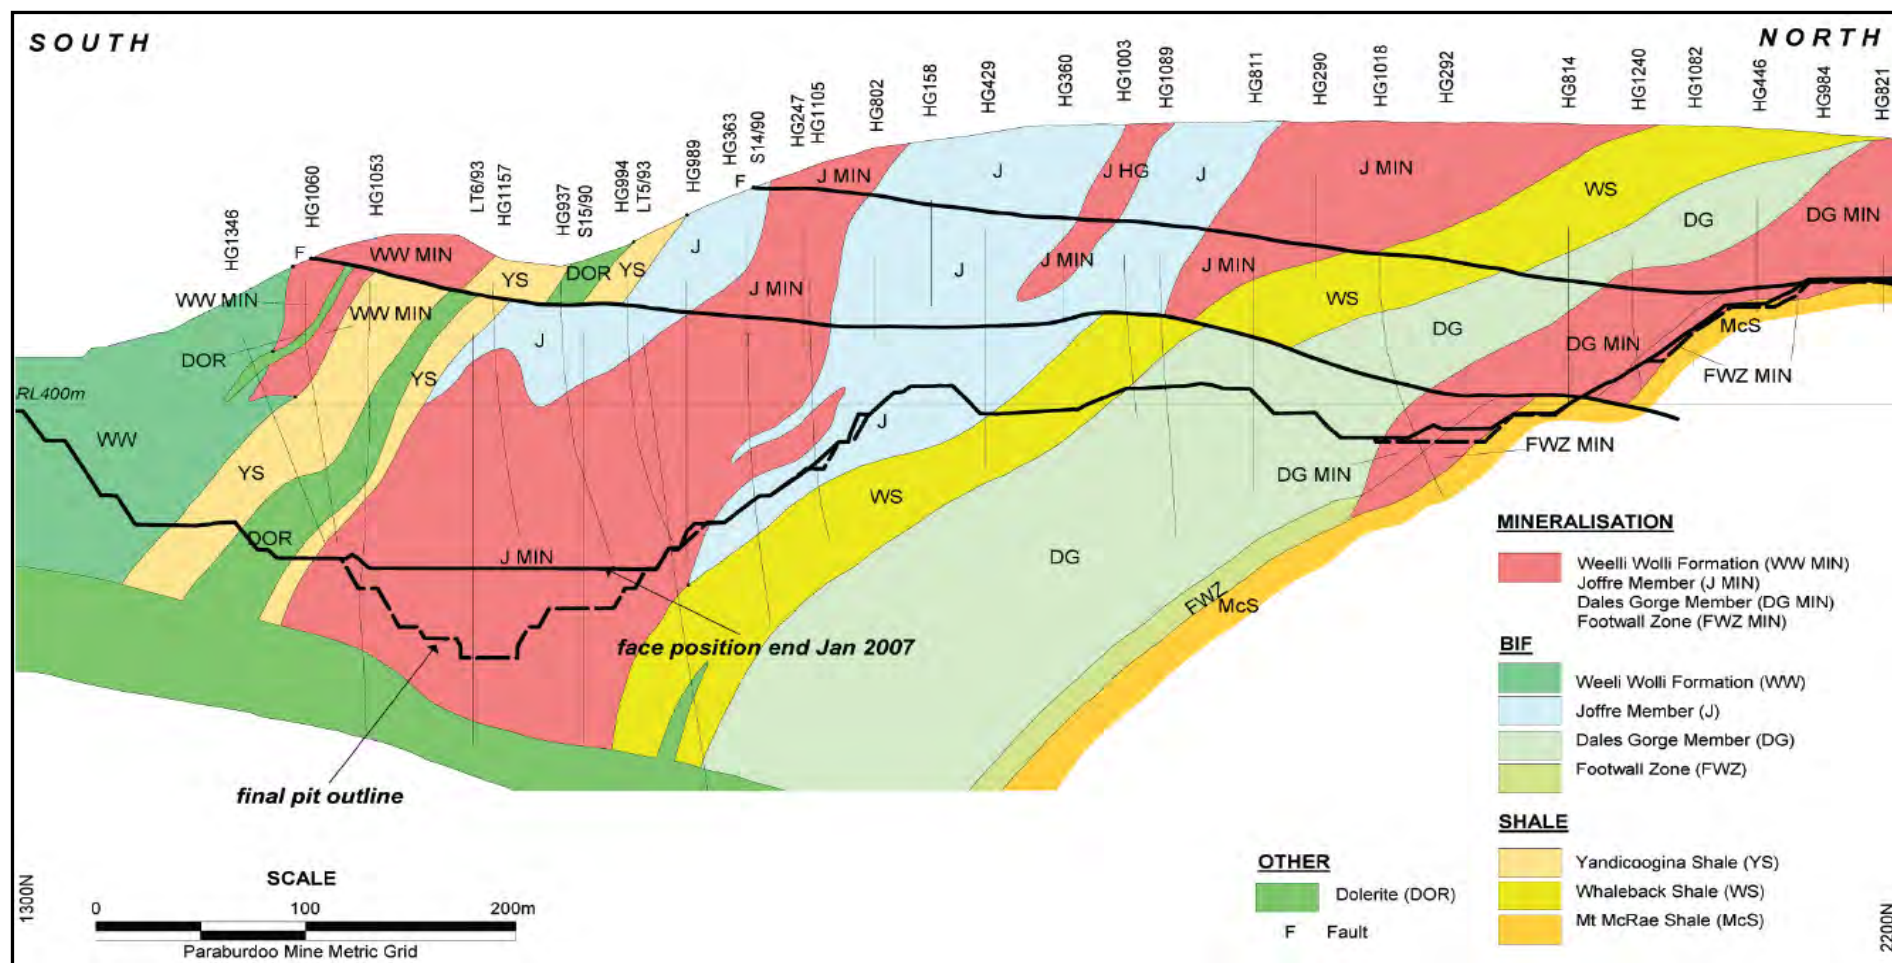
Figure 12: Cross-section of Paraburdoo 4 East deposit showing Brockman Iron hosted mineralisation (looking west)

Paraburdoo lies within the Hamersley Iron Province on the southern margin of the Hamersley Basin. The mine deposits lay along the east-west aligned Paraburdoo Range which is the eroded south-dipping limb of the Bellary Anticline. The geological setting is structurally complex and includes folding, low to high angle faulting and dolerite intrusions. Both the Brockman and Marra Mamba Iron formations are present as two loosely sub-parallel south-dipping ridges. The Brockman Iron Formation features seven ore lenses from 18E through to 27W that extend over a strike distance of 14 km. The Marra Mamba hosted mineralisation is confined to the 5W, NLC and 18E deposits. These deposits are all located within 7 km of the Paraburdoo Mine infrastructure.

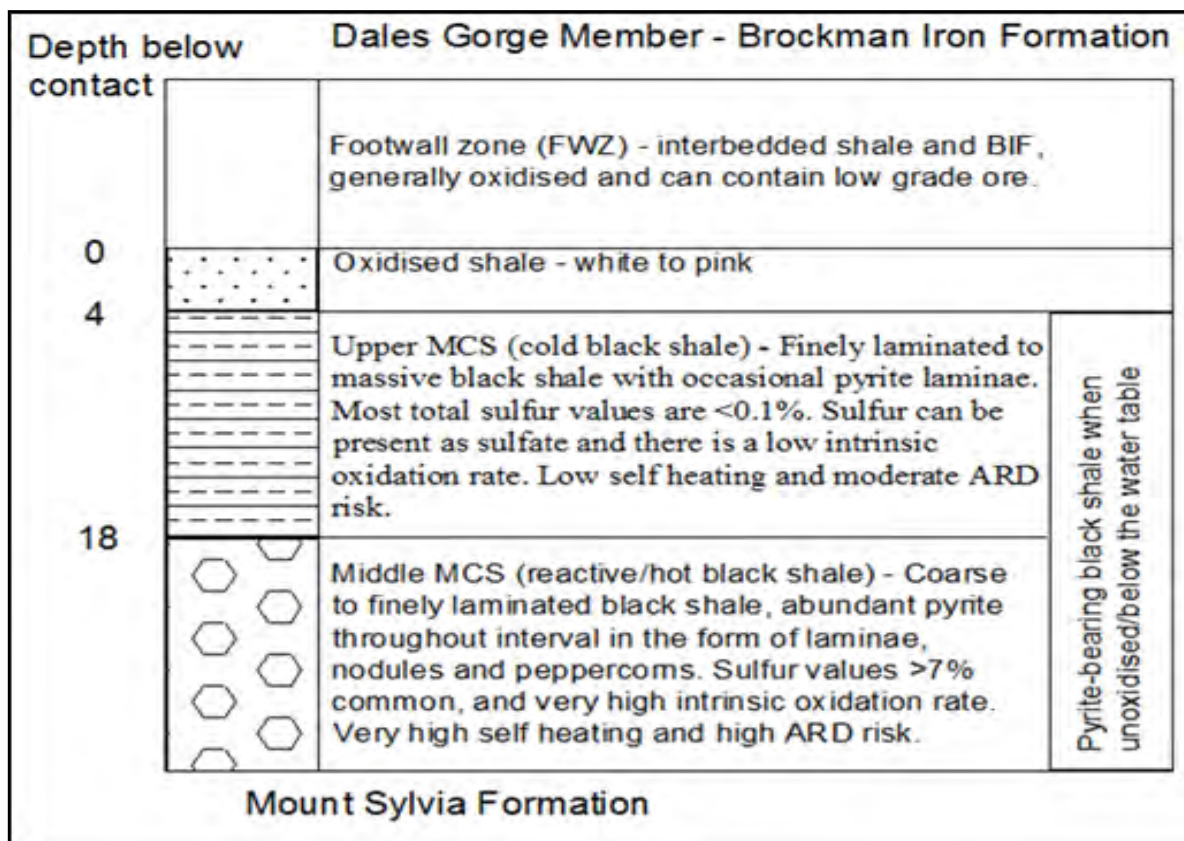
Figure 13: Typical stratigraphy of Mount McRae Shale at Paraburdoo. Depth below contact (meters)

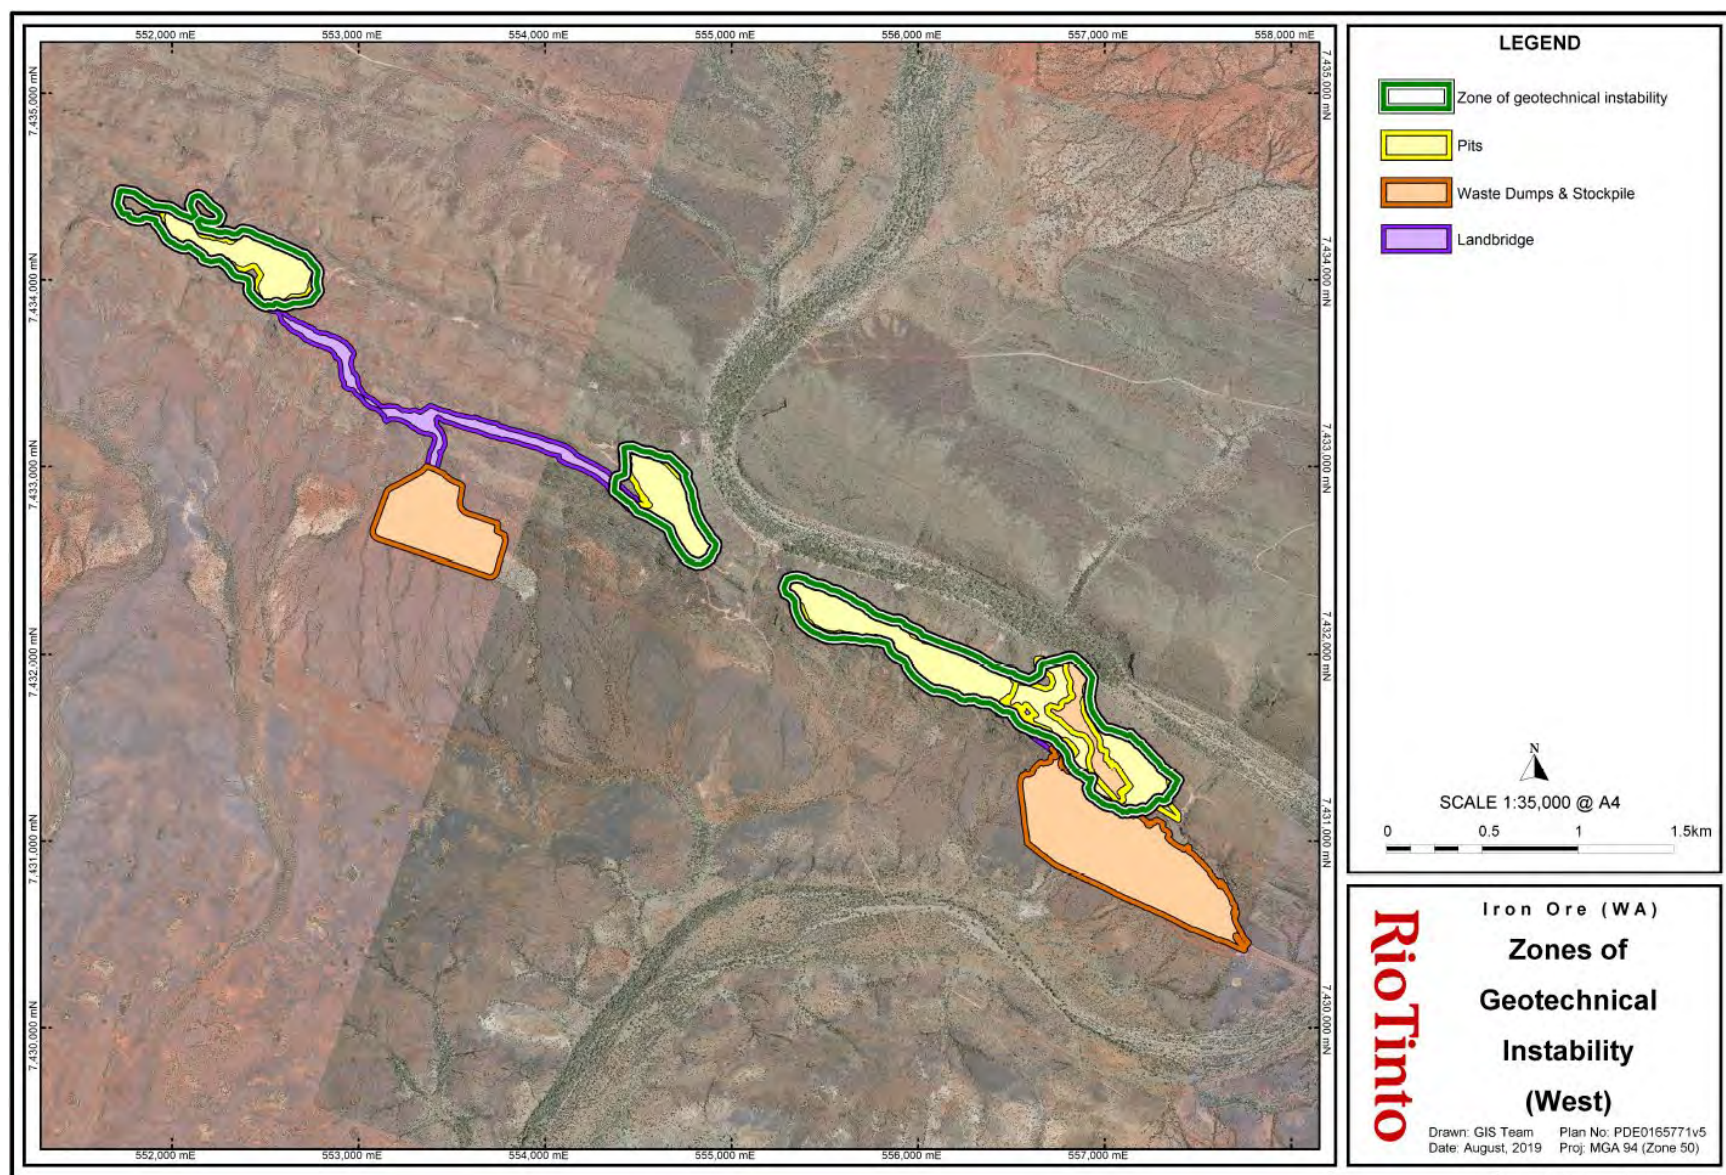
Figure 14: Zones of geotechnical instability around pits (27W, 20W, 14-16W and 11W)

Preliminary zones of geotechnical instability have been identified around all pits covered within the scope of this closure plan and are shown in Figure 14 and Figure 15. It should be noted that these images are based on conceptual pit and backfill waste dump designs, and will be refined as closure approaches. In particular, the zones of pits near Seven Mile and Pirraburdu Creeks will require further refinement as pits located on creek lines (11W, 4W, NLC and 4EE) will be partially backfilled (or at the minimum have appropriate bunding) to prevent any possible creek interception, and as such the zone of instability will change.

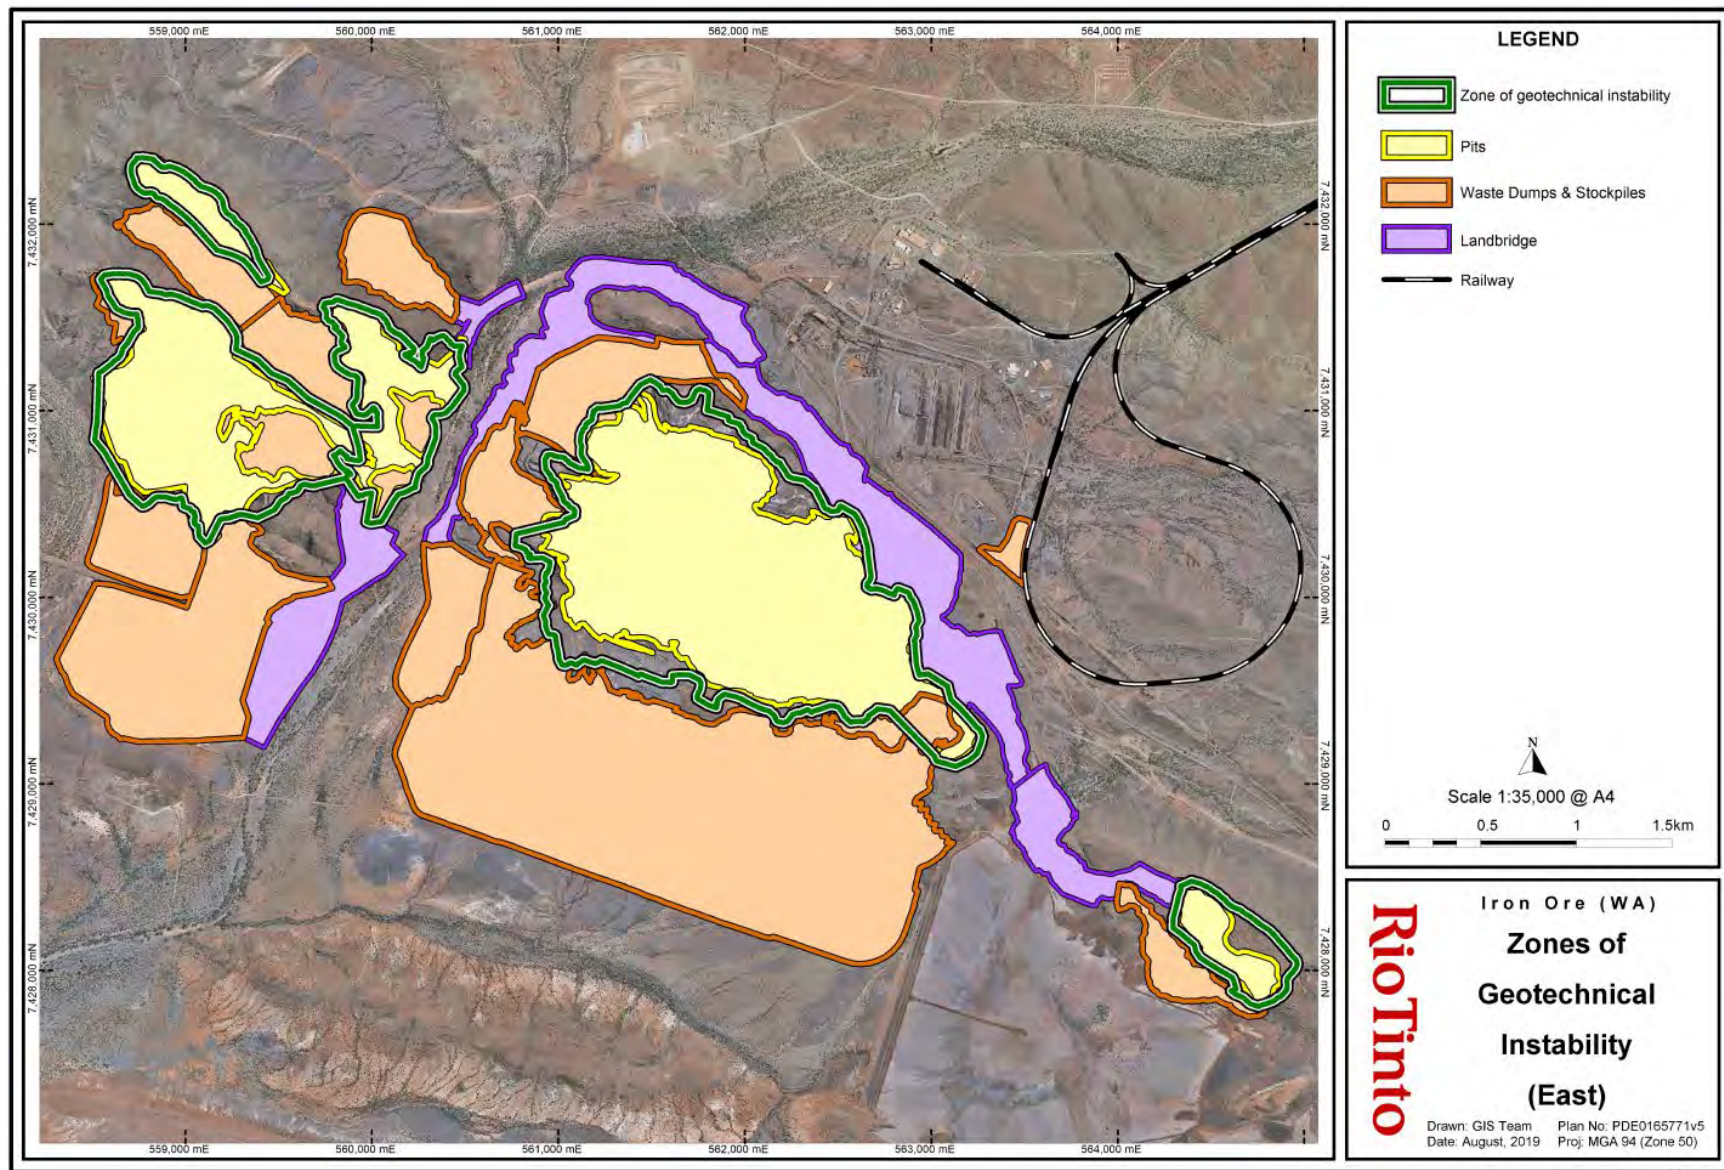
Figure 15: Zones of geotechnical instability around pits (18E, 4EE, NLC, 4W and 5W)

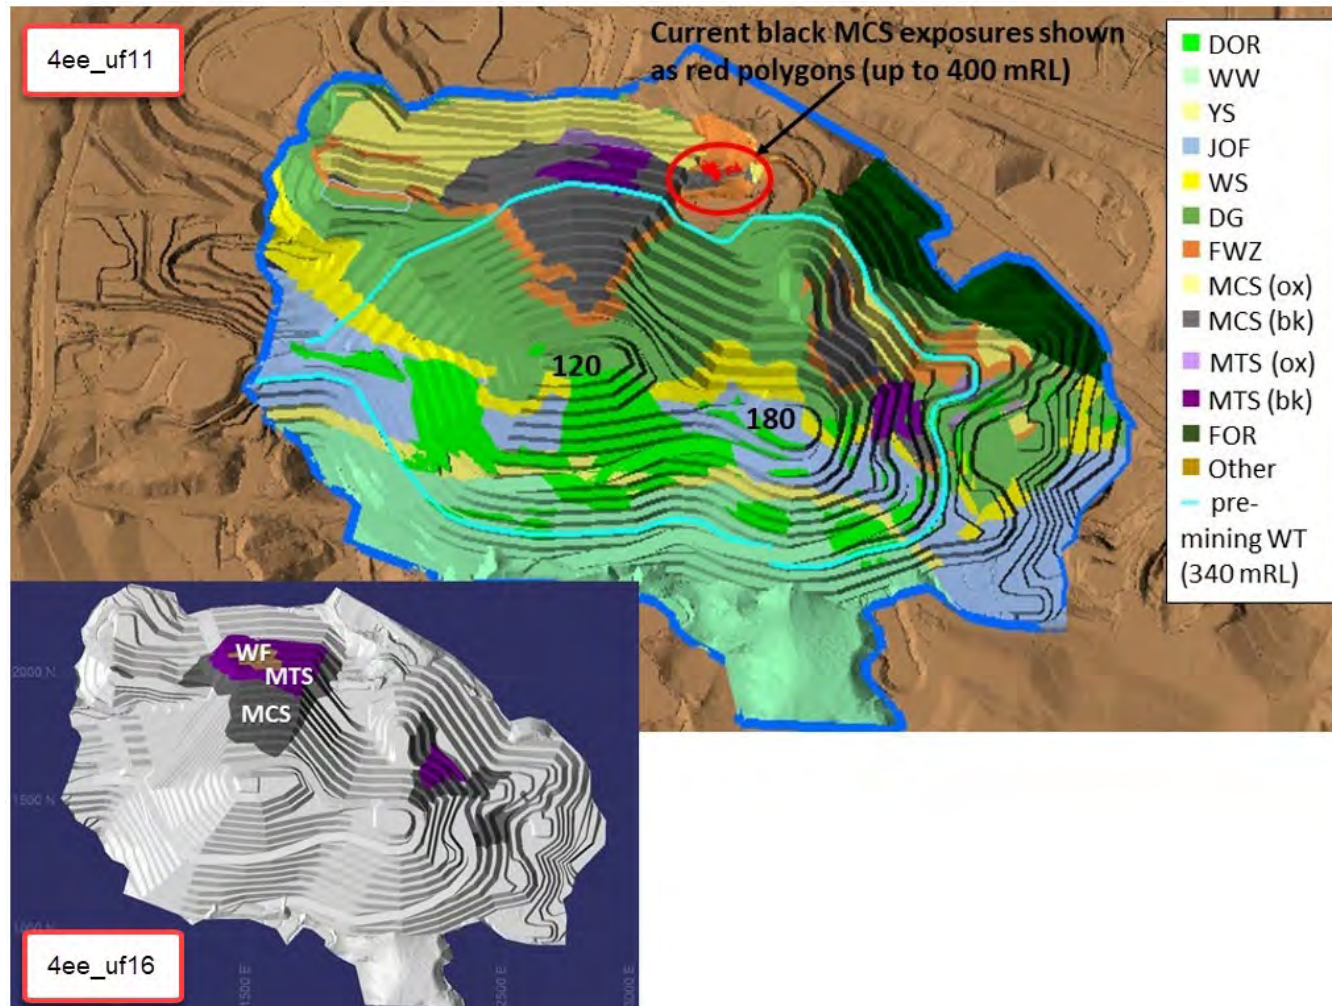
Figure 16: Modelled lithology exposures on the proposed 4EE final pit shell (4ee_uf11) and updated MCS (black), MTS (purple) and WF (brown) exposures modelled against the 4ee_uf16 pit shell¹¹

¹¹ Pit floor levels (mRL) have been labelled. The pit wall intersection of the pre-mining water table at 340 mRL has also been indicated

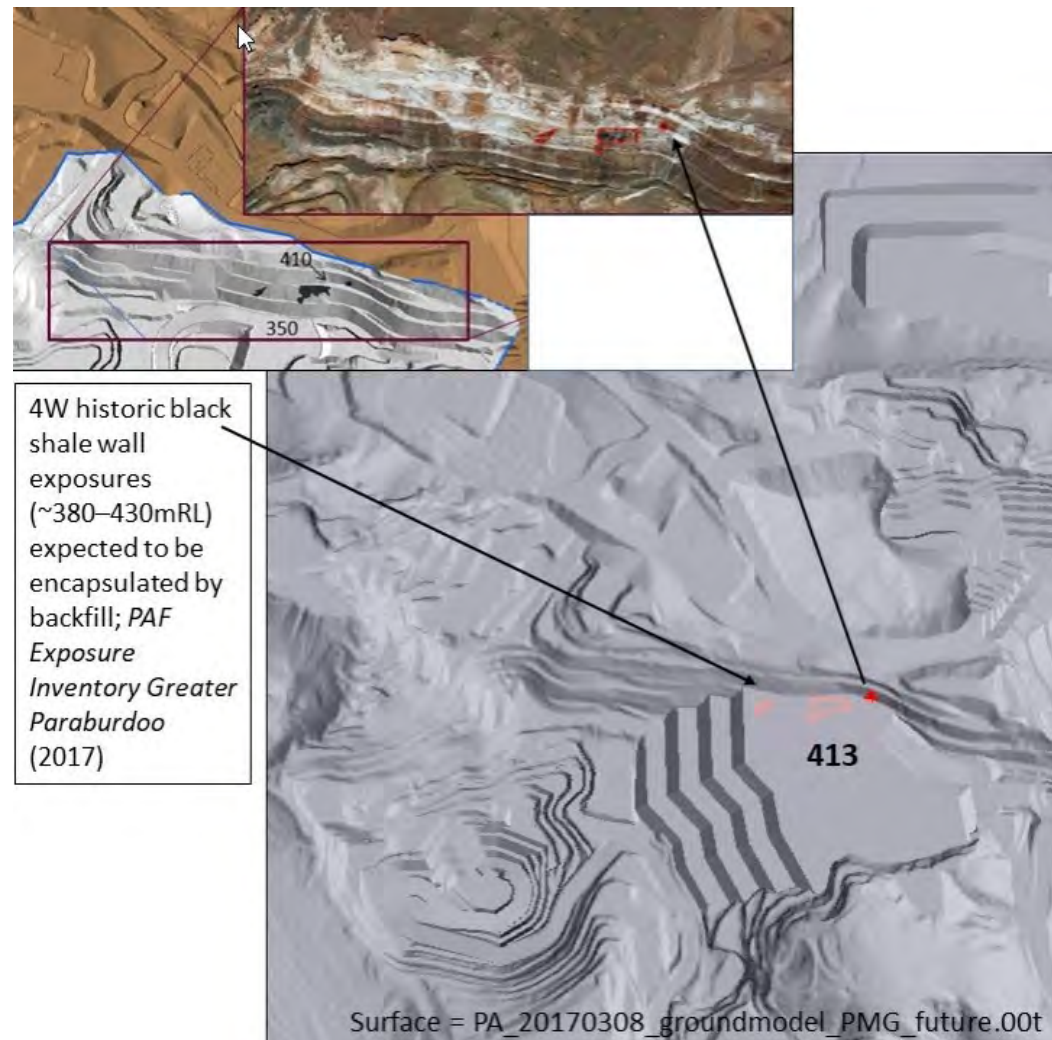
Figure 17: 4 West pit showing exposures of black shale on the final pit shell.¹²

¹² Please note details of tailings deposition have not been finalised and as such heights have been excluded from the image

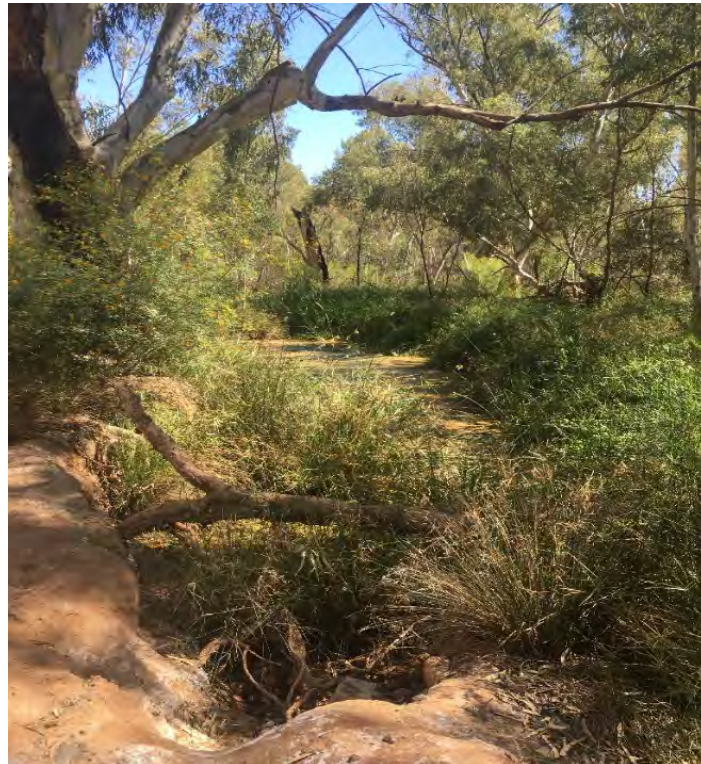
Figure 20: Ratty Springs. Photo taken December 2003

Ratty Springs is a culturally significant water feature located where the Pirraburdu Creek crosses the Paraburdoo Range (Figure 20). Deep groundwater rises from the Fortescue group, supporting the shallow alluvial aquifer. As the creek line narrows and passes through the Paraburdoo Range, the impermeable Marra Mamba bedrock rock forms a barrier to flow and groundwater is subsequently expressed at surface (Figure 21). Ongoing monitoring of water quality and wetting extent at Ratty Springs has found that there is an annual wetting and drying of pools fed by the Spring associated with rainfall.

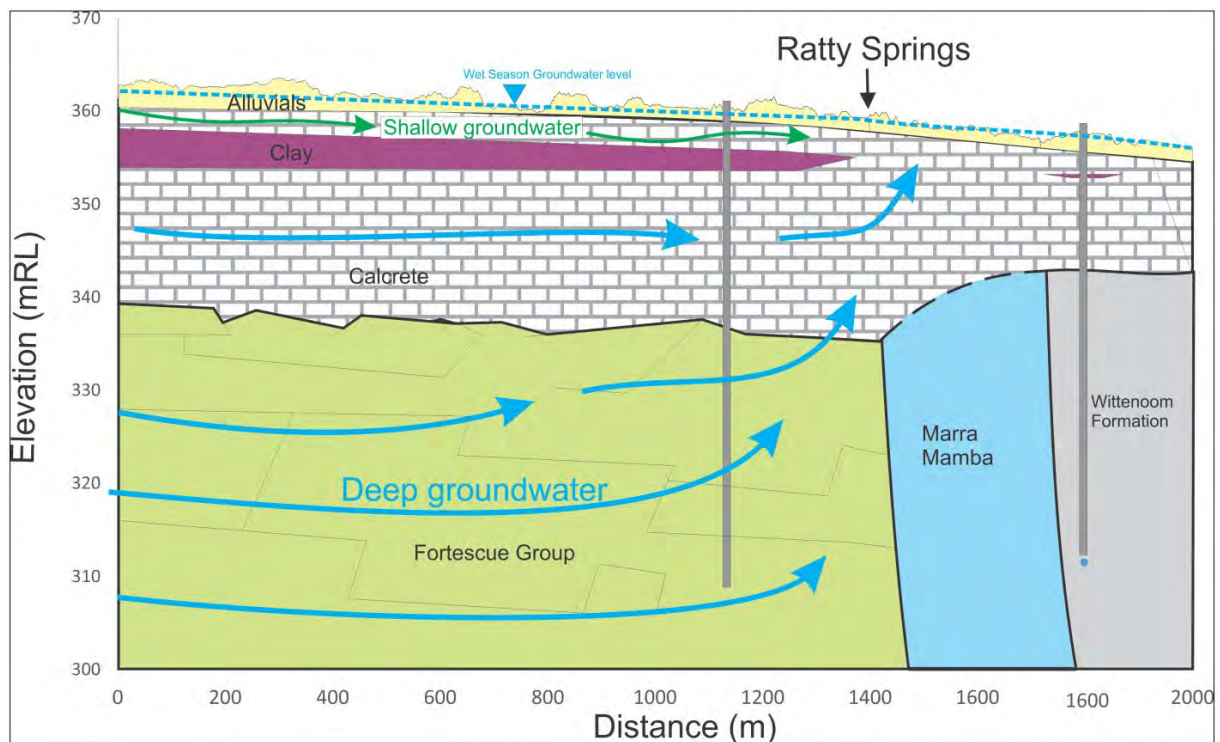
Figure 21: Ratty Springs hydrogeological conceptual cross section

During the wet season increased recharge into the shallow alluvial aquifer results in water table rise and an increase in pool size. During the dry season increased evapotranspiration results in the lowering of groundwater level in the shallow aquifer and the pool may become completely dry. The nearest pit is the proposed 20W (above water table), located approximately 600 m south or downstream of the Springs. The nearest below water table pit is 4W, located 4.5 km south east. Dewatering of the 4W and 4E pit has not impacted the Springs to date, and it is predicted dewatering of the proposed 4EE pit won't result in any new impacts to the area.

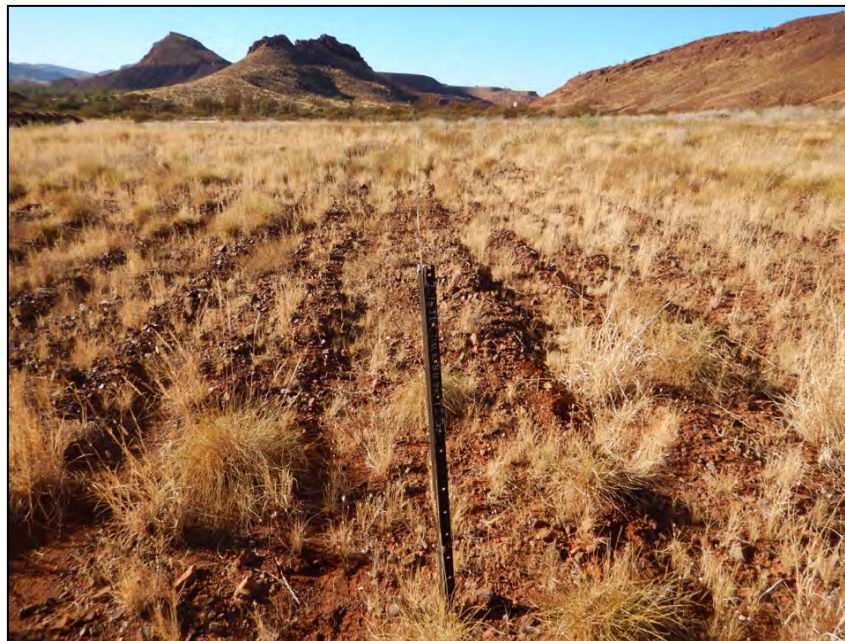
Figure 27: Paraburdoo Truck Training rehabilitation area showing establishment of *Spinifex*

parameters within the range recorded from the reference sites. Floristically the Truck Training Ground recorded a composition similar to the reference sites and species richness was high. Whilst perennial cover had not increased substantially since 2015, the cover of *Spinifex* increased three-fold between 2016 and 2017, as shown in Figure 27. Varied strata consisting of *Spinifex*, overstorey shrubs and trees had also developed. In terms of surface stability both areas were flat and appeared stable. The Old Airstrip recorded no erosion in 2017 and the rip lines were still evident. A single erosion gully was noted on one transect of the Truck Training Ground and four weed species were noted in the area.

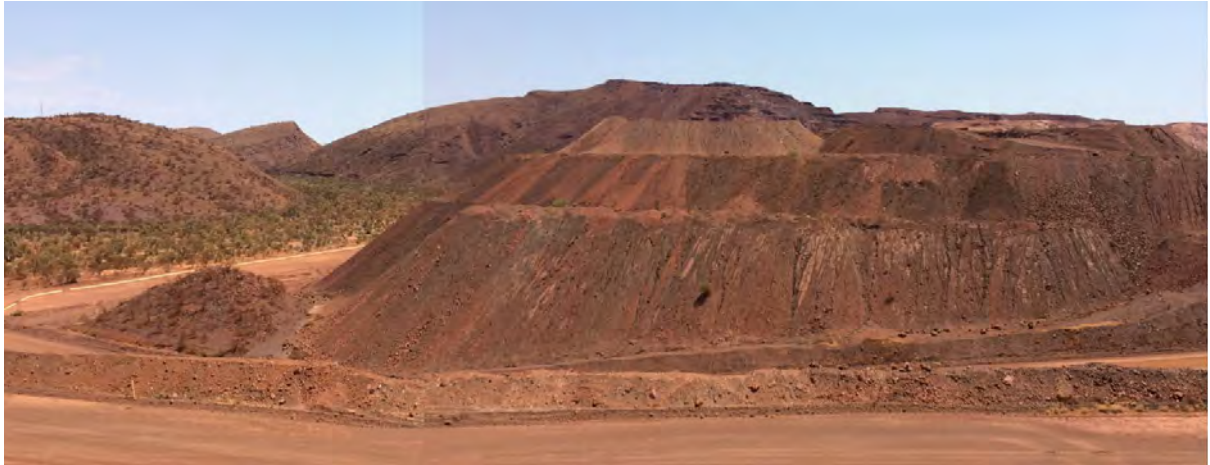
Figure 28: The 4W WD02- pre-rehabilitation earthworks

In contrast the 4 West waste dump 02 (4W WD02; also called 4WN) and 4 West Road (4WR) areas are examples of how rehabilitation techniques have improved over time. These areas were rehabilitated in 2015, and as part of the design process characterisation of waste material types to identify their erodibility was undertaken. The batters were pushed down to 20 linear degrees, with 20 m lift heights and 10 m wide berms back sloping at 6 degrees. As the toe of the 4W 02 waste dump is adjacent to the Pirraburdu Creek rock armoured bund was installed at this location to provide erosion protection from flood events. Topsoil was spread on the surface to a depth of 100 mm and the area was deep ripped on the contour. A native seed mix was machine seeded at this time. Figure 28, Figure 29 and Figure 30 depict the progression of rehabilitation works on the rehabilitation area. Despite the use of best practice rehabilitation techniques, a large rainfall event occurred in January 2016 and produced 89 mm of rainfall in one day. This event facilitated the development of gully erosion and may have compromised the early establishment of vegetation by burying and washing away seed, reducing the success of the rehabilitation. However this rainfall event confirmed the design and construction of the berms were effective in their purpose of holding runoff (Figure 31). Future rehabilitation monitoring will determine if erosion features are stabilising or if remedial works are required.

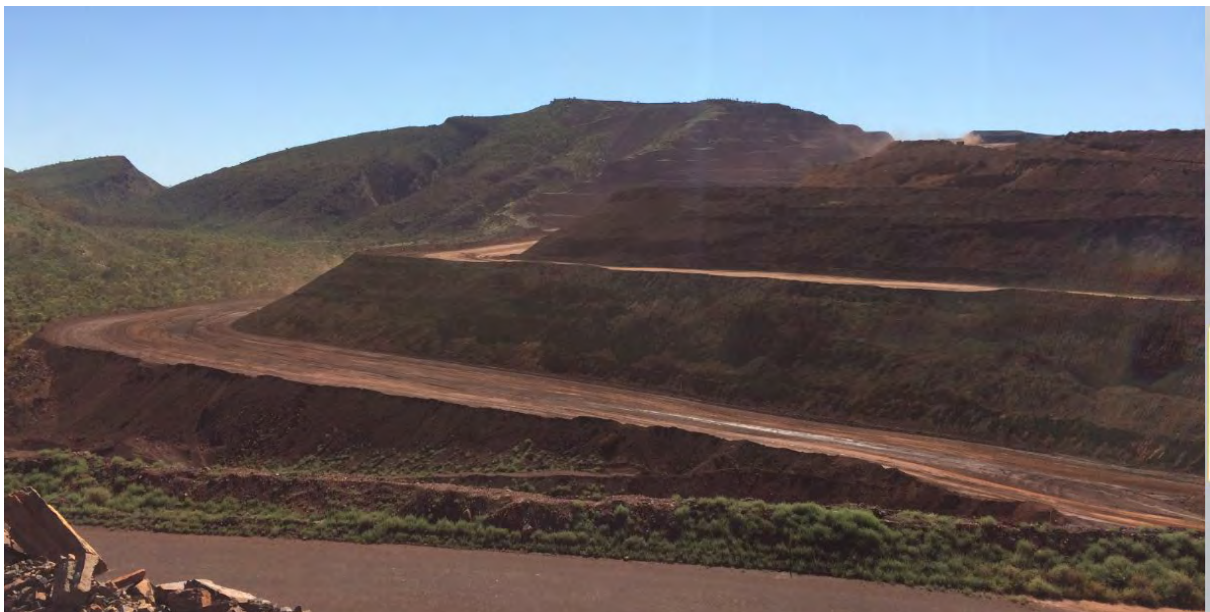
Figure 29: The 4W WD02- during rehabilitation earthworks

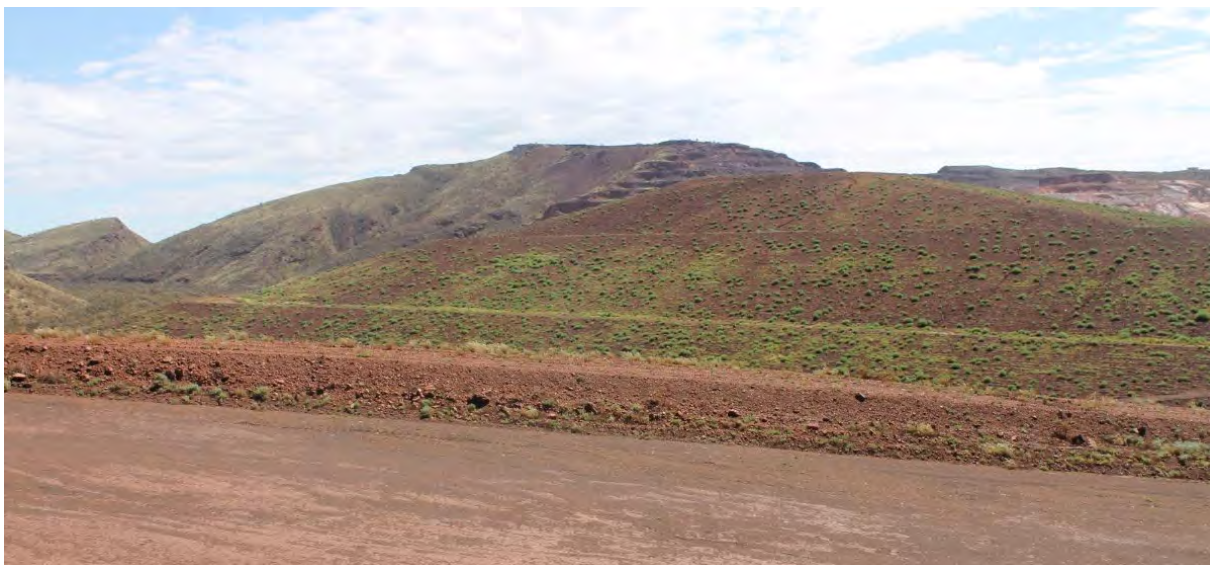
Figure 30: The 4W WD02- post rehabilitation earthworks

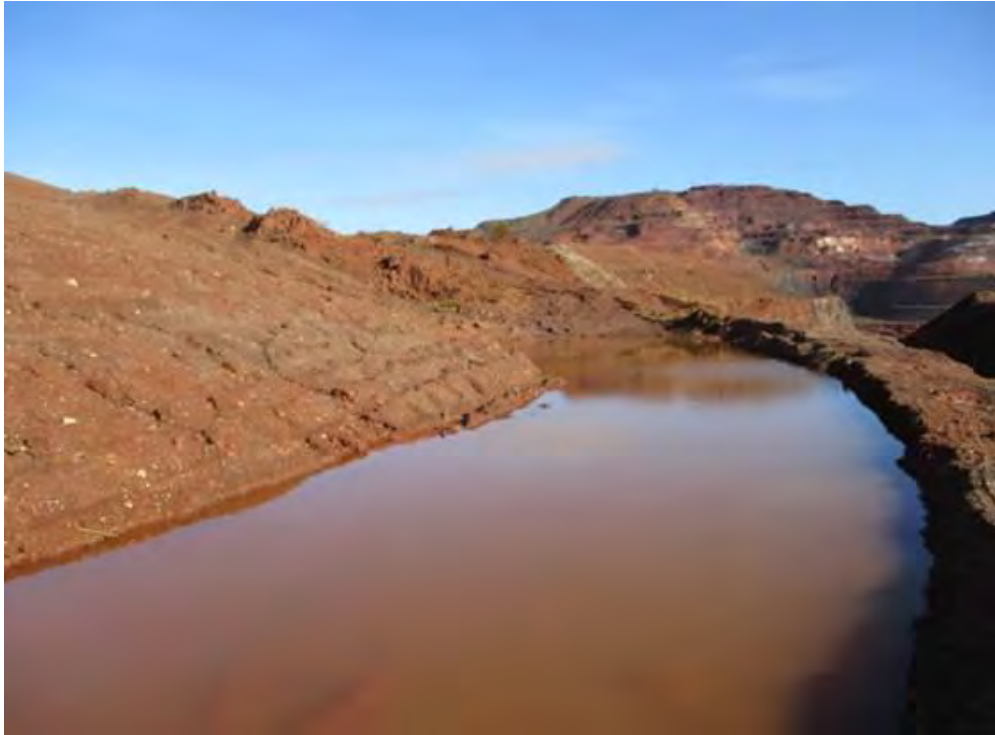
Figure 31: 4W WD02- showing water ponding in berms

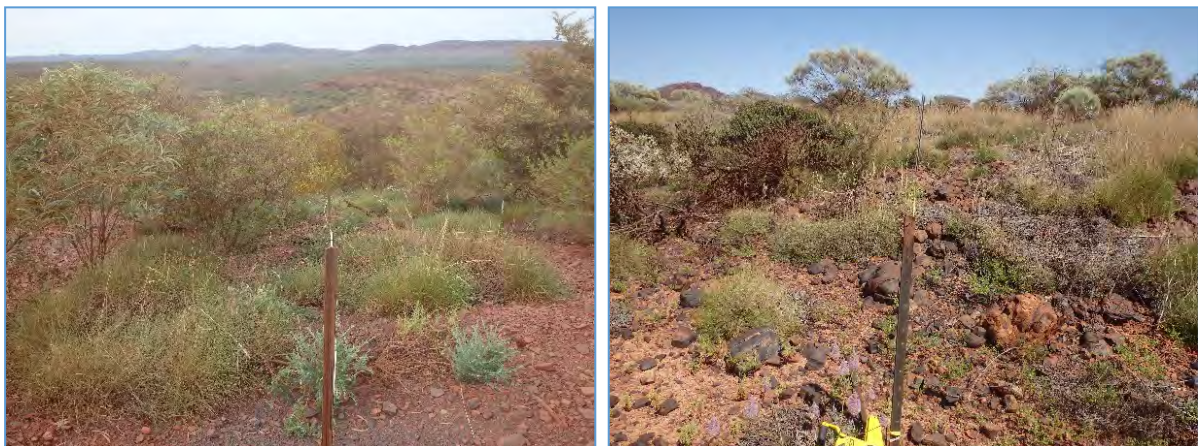
Figure 32: Channar East 3 waste dump rehabilitation (left) and reference site (right) monitoring transect

Rehabilitation of the Channar East 3 waste dump (CHE3), located at the adjacent Channar mine site, was completed in 2007, and included topsoiling and seeding. Monitoring was last undertaken in 2016 and results indicate the rehabilitation areas are performing well with native plant species richness, plant density, spinifex density and plant cover all within, or above, the range found in the reference sites (Figure 32). The rehabilitation at this site is likely to become similar to the reference sites in terms of floristic structure, density and composition. Erosion monitoring of the CHE3 waste dump identified two gullies and these have been scheduled for future monitoring.

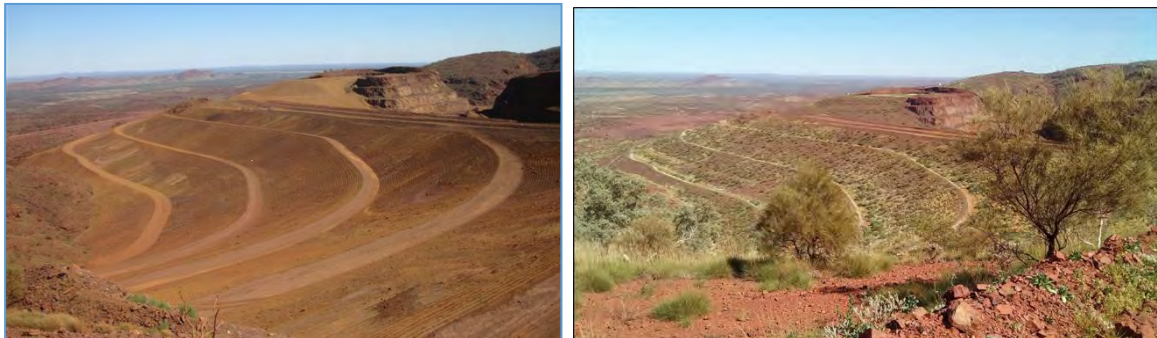
Figure 33: Channar 84E5 WD dump rehabilitation in 2011 (left) and in 2018 (right)

Rehabilitation of the Channar 84 East 5 waste dump (84E5 WD) occurred in 2011 and is a good example of a rehabilitation area performing well without topsoil application (Figure 33). The success of the rehabilitation area is largely due to improved earthworks practices and quality control. During earthworks the lifts were completed in a top to bottom sequence and the final surface was finished to a high specification before moving to the next area. This ensured that the final surfaces were very close to the design and all windrows were finished and in place with each lift. Topsoil was unavailable so ripping was completed after all surfaces were re-profiled. Ripping was via a winged tyne and the dozer undertaking the ripping had machine guidance GPS installed to ensure accuracy. The most recent rehabilitation monitoring assessment undertaken in 2016 suggests rehabilitation has developed well. Plant species richness, density and cover were generally found to be within the range of the reference sites. Minor erosion features were present in some areas, however they do not threaten overall landform stability. Some weeds, predominantly Buffel Grass and Kapok Bush, were present but only at low densities.

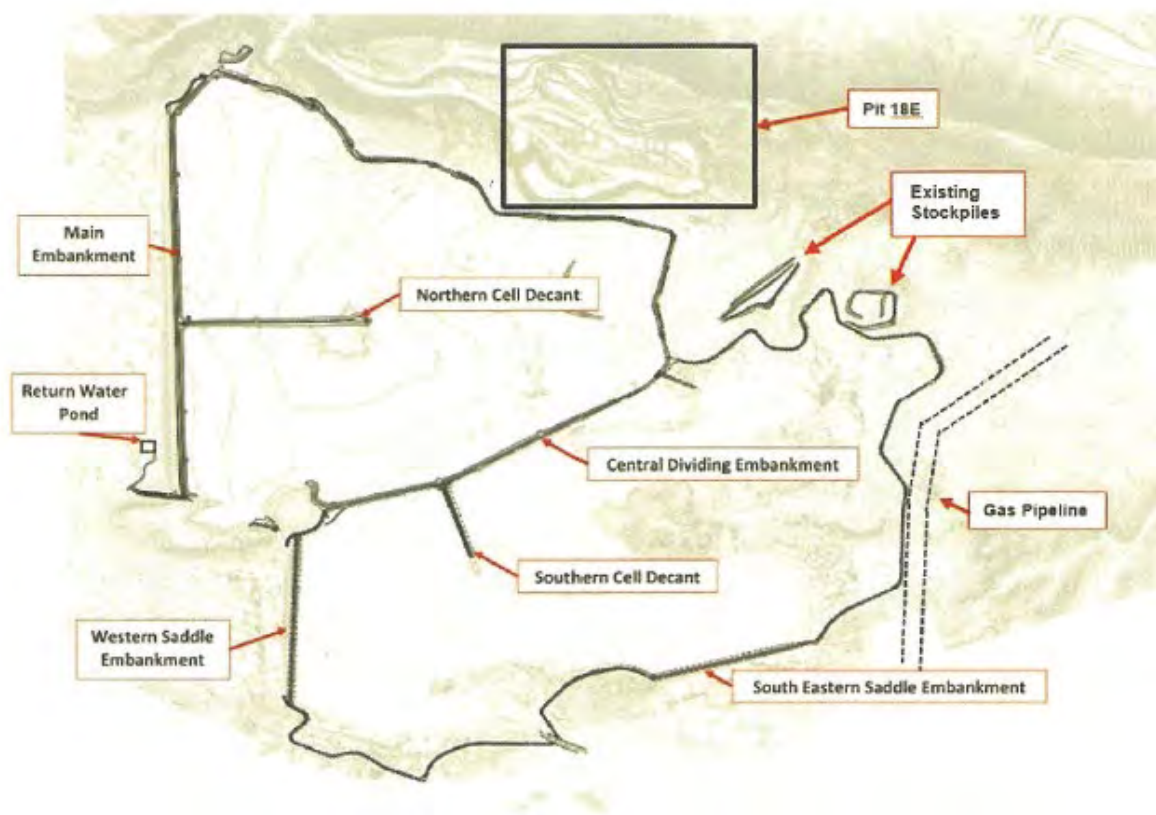
Figure 34: Paraburdoo Tailings Storage Facility

Year	Construction Phase
1995	Main Embankment Constructed to RL 358 m
1997	Main Embankment raised to RL 362 m Western Saddle raised to RL 369 m
2000	Northern/Southern Cell created with central southern embankment constructed to RL 369 m
2002	Main Embankment Upstream Raise to RL 369 m
2007	Decant causeway constructed to RL 369 m
2009	South Eastern Saddle Embankment constructed to RL 369 m
2014	Main & Central Embankment and decant causeway raised to RL 371 m
2017	Central, Western and South East Embankments raised to RL 371 m

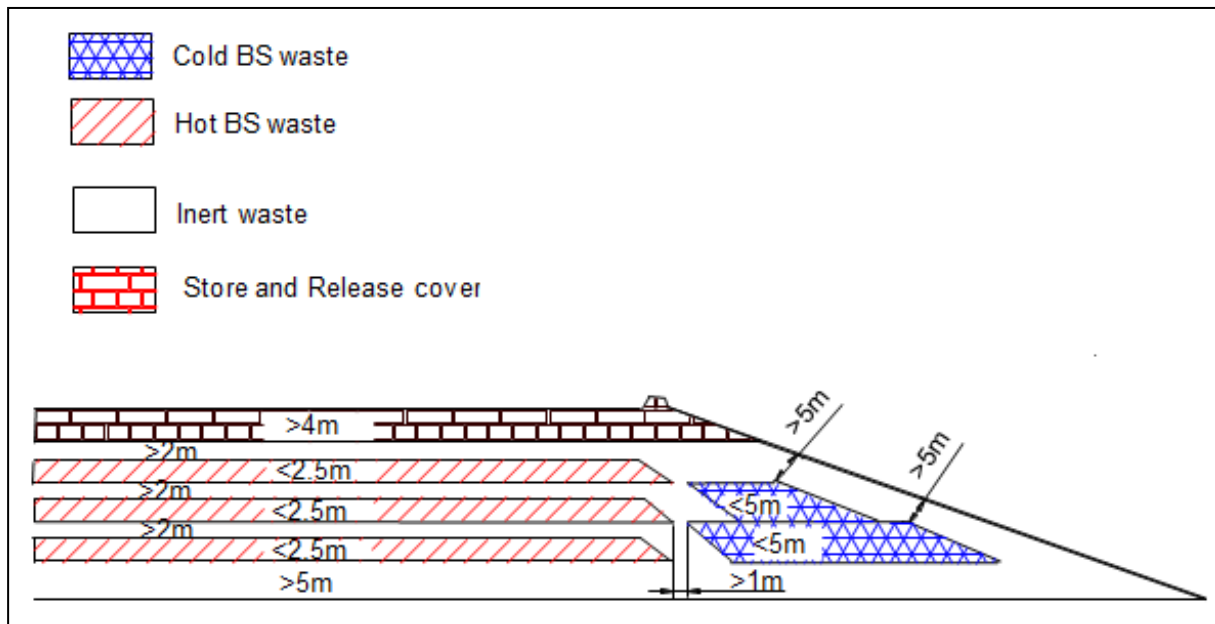
Figure 35: Standard external dump design for PAF encapsulation. It should be noted cold black shale can also be placed where hot black shale waste is stored

Where the storage of PAF waste material in pits (backfill) is not possible, PAF material will be encapsulated in waste rock dumps on top of the original ground surface. More stringent design criteria are required for external PAF waste dumps than for in-pit disposal because of the risk of erosion exposing encapsulated sulfidic material and the greater likelihood of convective transport of oxygen through the side slopes of the dump. As shown in Figure 35, hot black shale will not be stored under waste dump slopes.

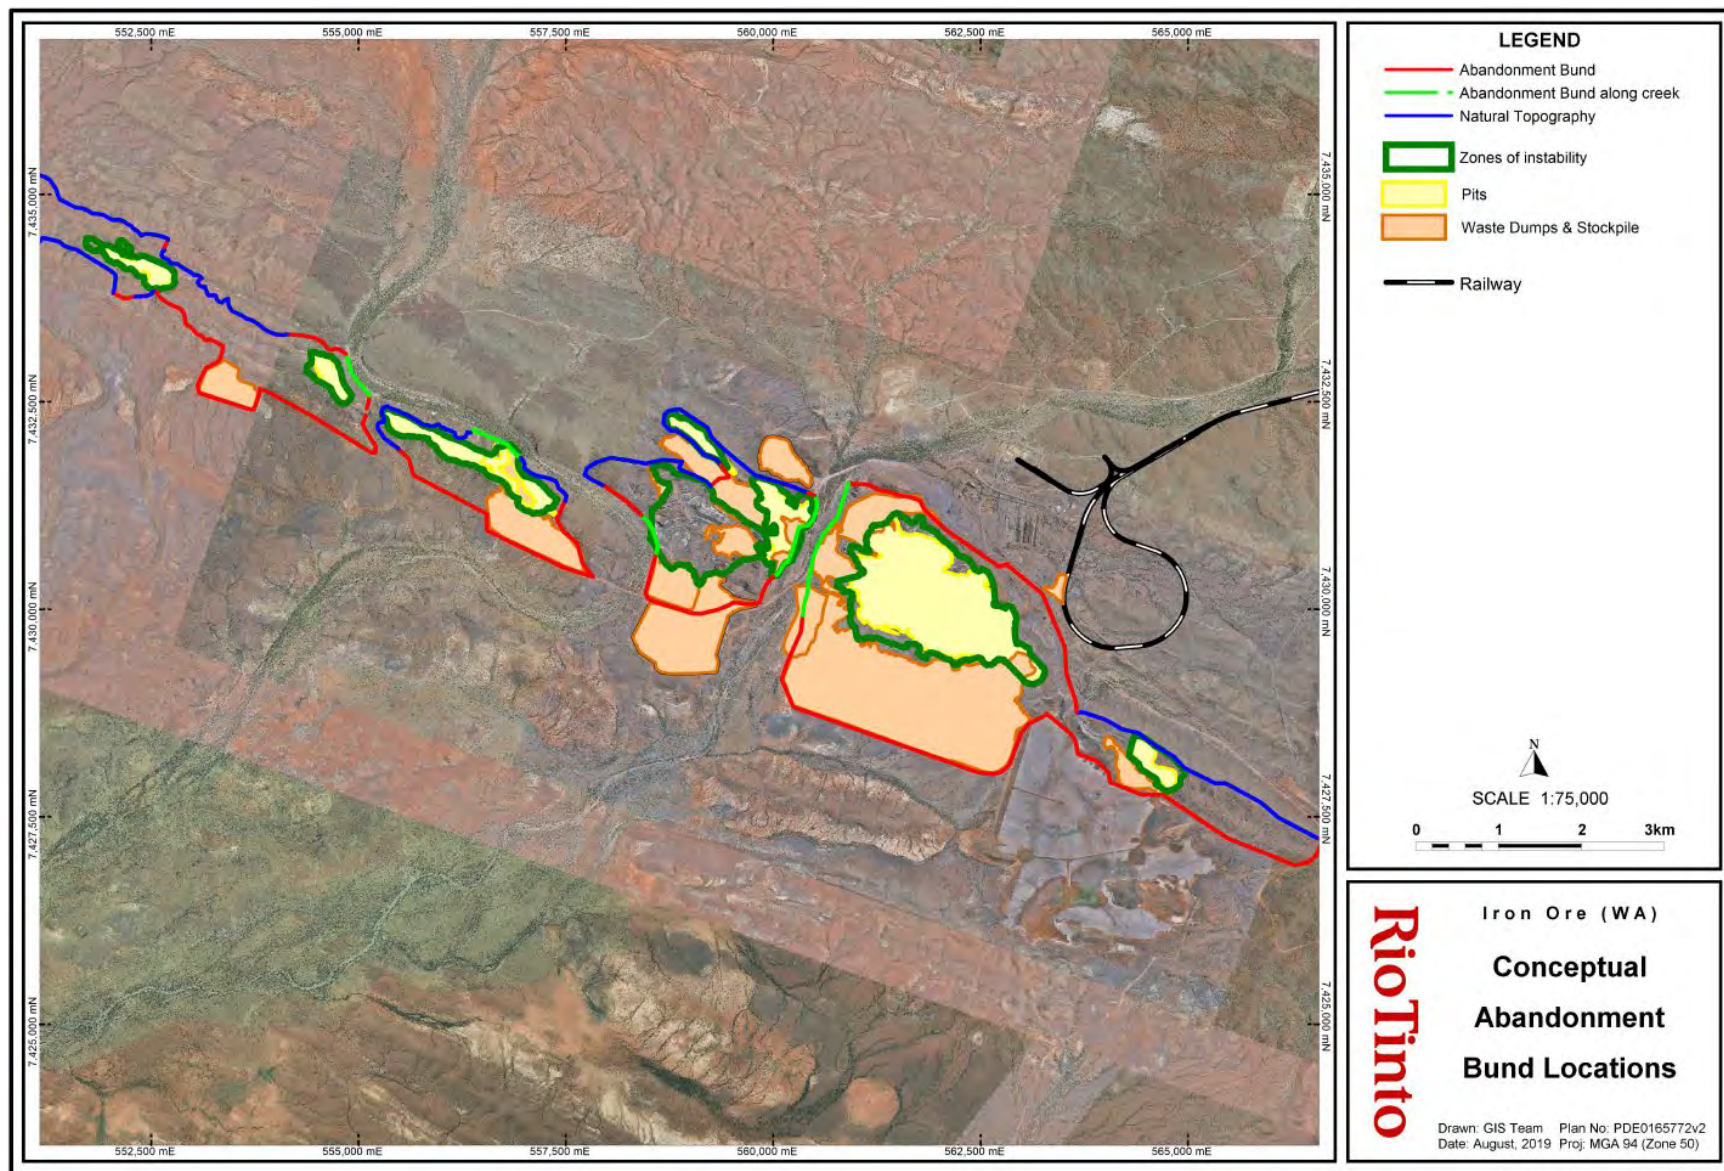
Figure 36: Conceptual abandonment bund locations

- in accordance with the DMIRS guideline Safety Bund Walls Around Abandoned Open Pit Mines unless an alternative design is approved by the DMIRS;
- outside of the zone of instability around pit walls;
- with consideration of the implications for local drainage; and
- fully around pit edges unless agreement is reached with the DMIRS that the risk of inadvertent access is sufficiently low in specific areas (e.g. due to natural topography, or due to the presence of barriers in other locations).

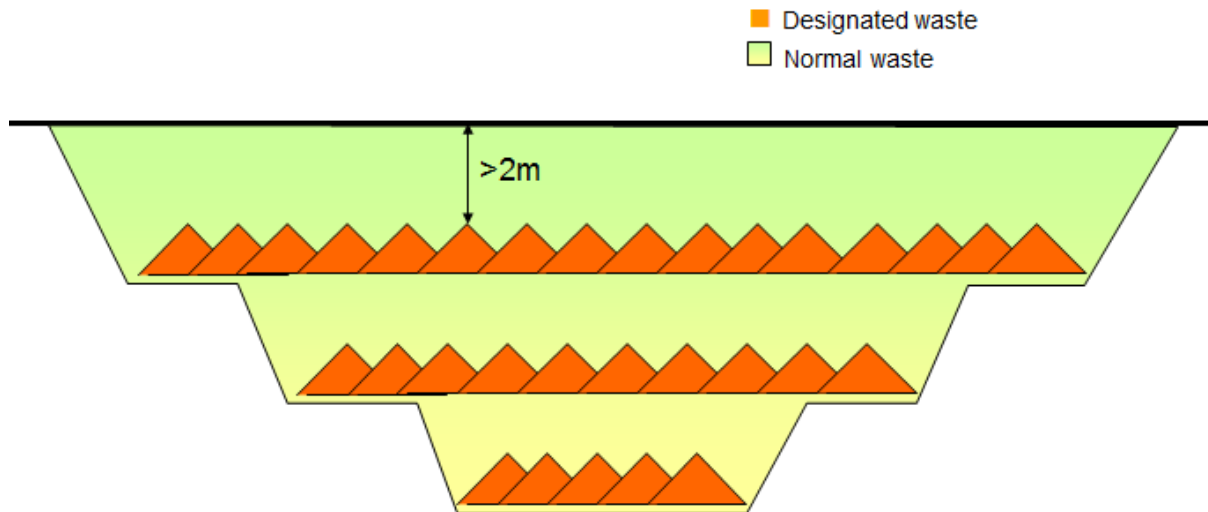
Figure 37: Typical in-pit dump design for fibrous mineral encapsulation

Should fibres be excavated during mining, fibrous material would be stored in the designated fibrous in-pit waste dump 4W_WD03. It is possible the ‘designated fibrous’ classification of 4W_WD03 will be downgraded in the future should fibres not be encountered and disposed of within it.

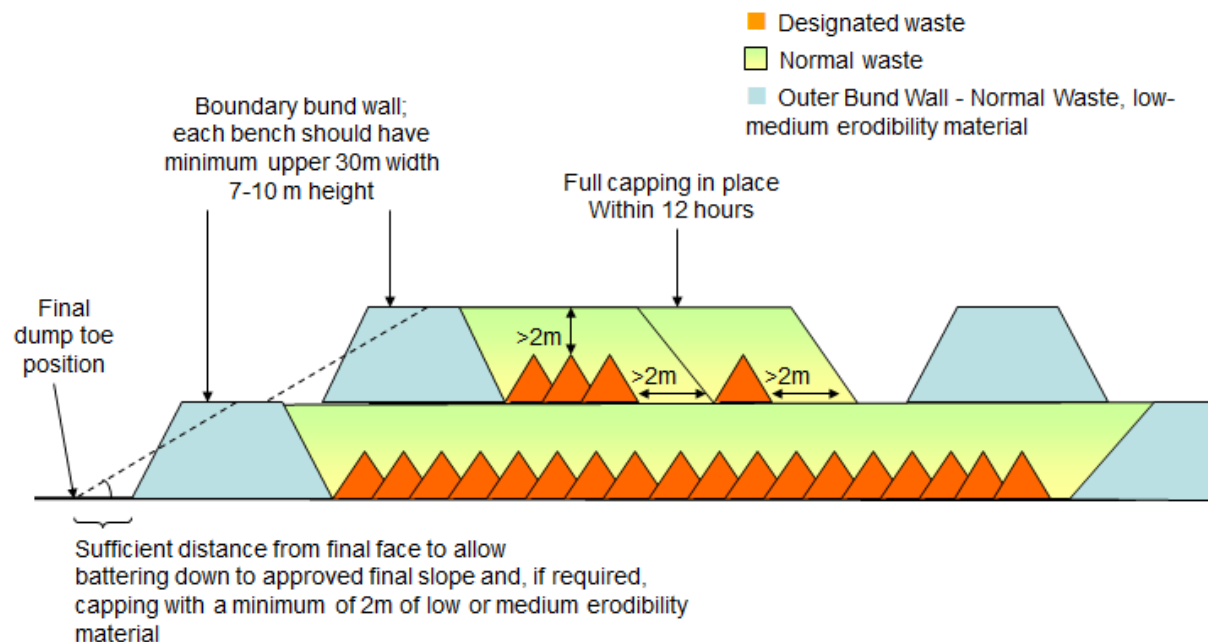
Figure 38: Typical external dump design for fibrous mineral encapsulation
