Paraburdoo Closure Plan

2019

Mineral Field 47 – West Pilbara

Version 2.0

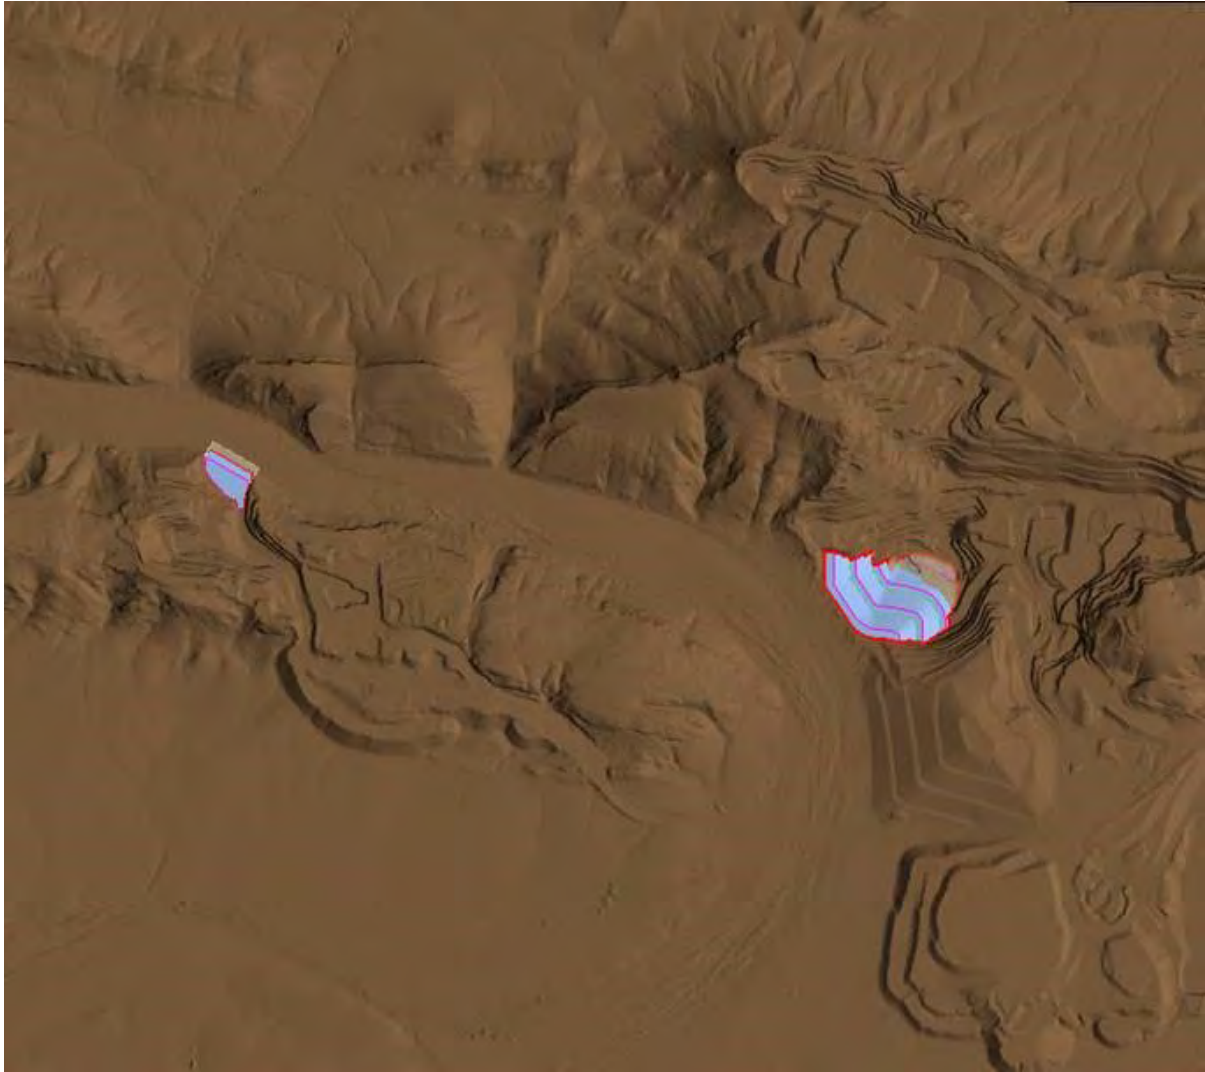
Figure 40: Conceptual partial backfill closure designs for pits 11W and 4W to prevent creek interception

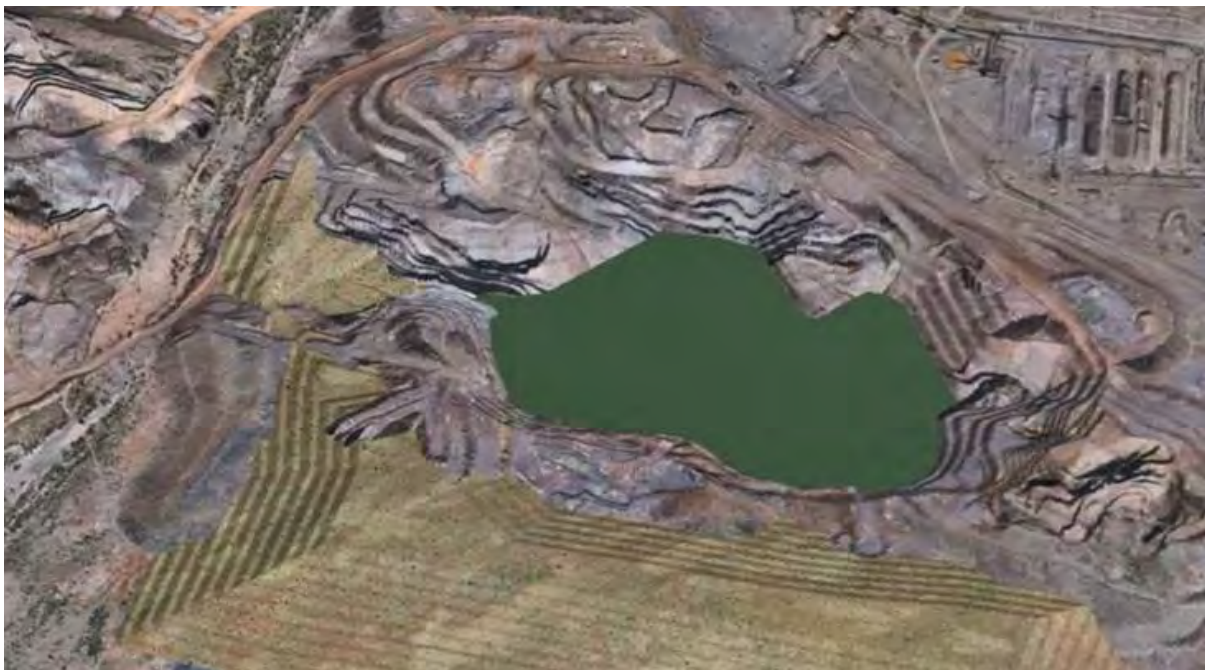
Figure 41: Conceptual backfill closure design for the 4E pit to the west of the 4EE pit and surrounding mine landforms

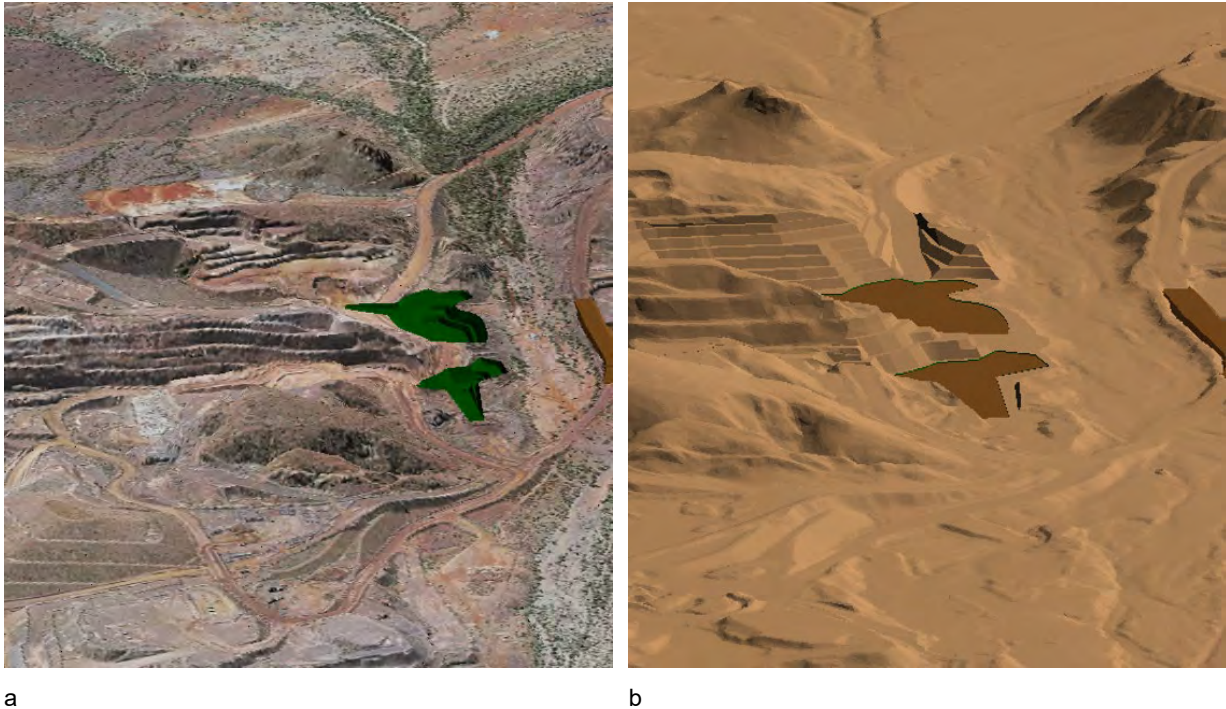
Figure 42: Conceptual partial backfill closure designs for NLC pit (a: post-mining pit shell, b: partially backfilled pit)

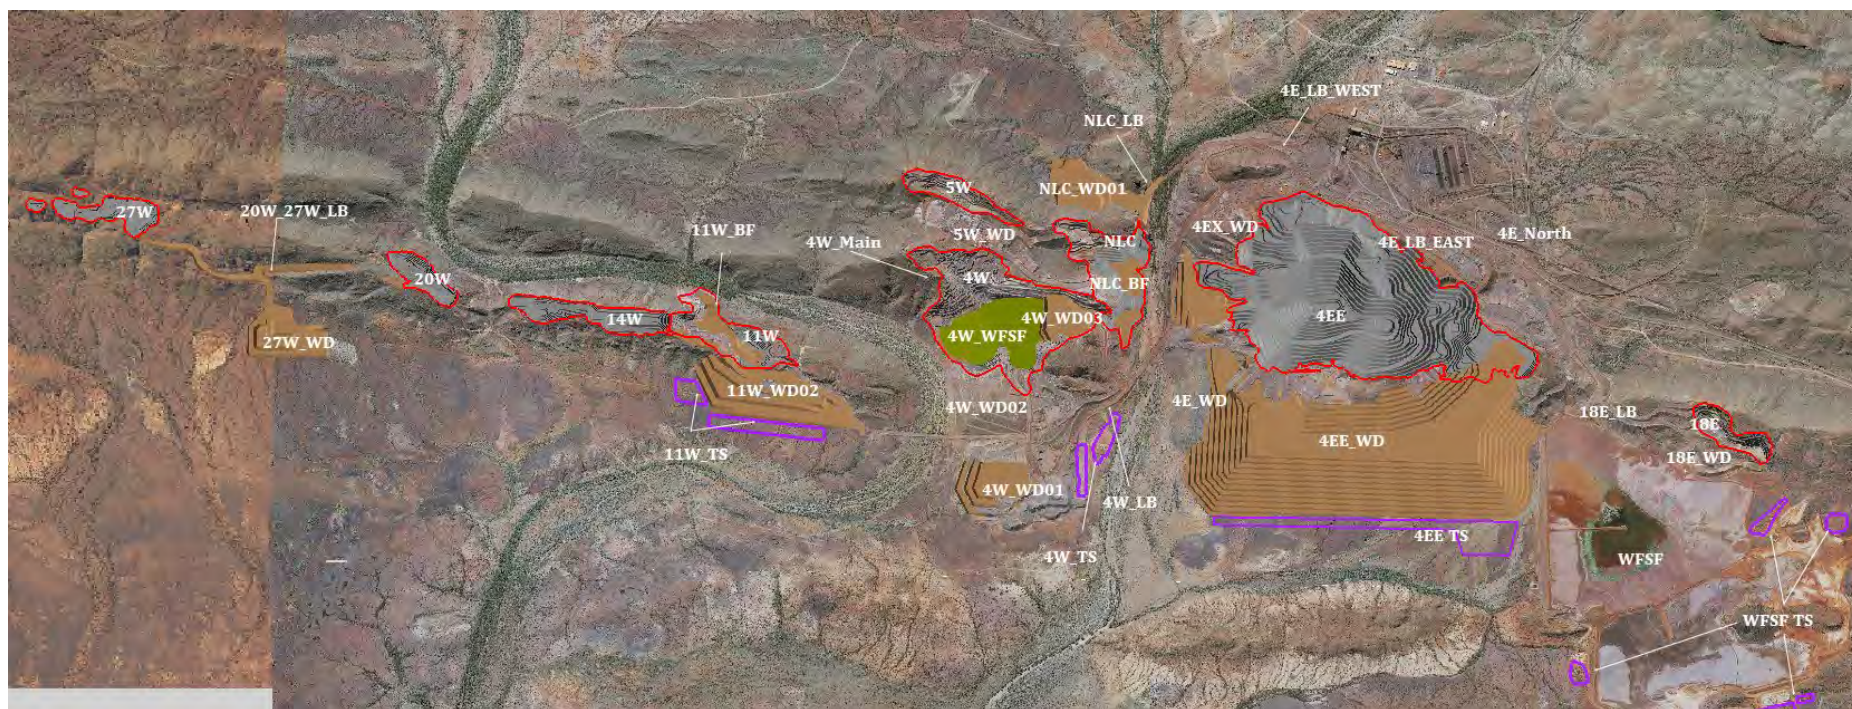
Figure 44: Conceptual layout of the site at completion of mining

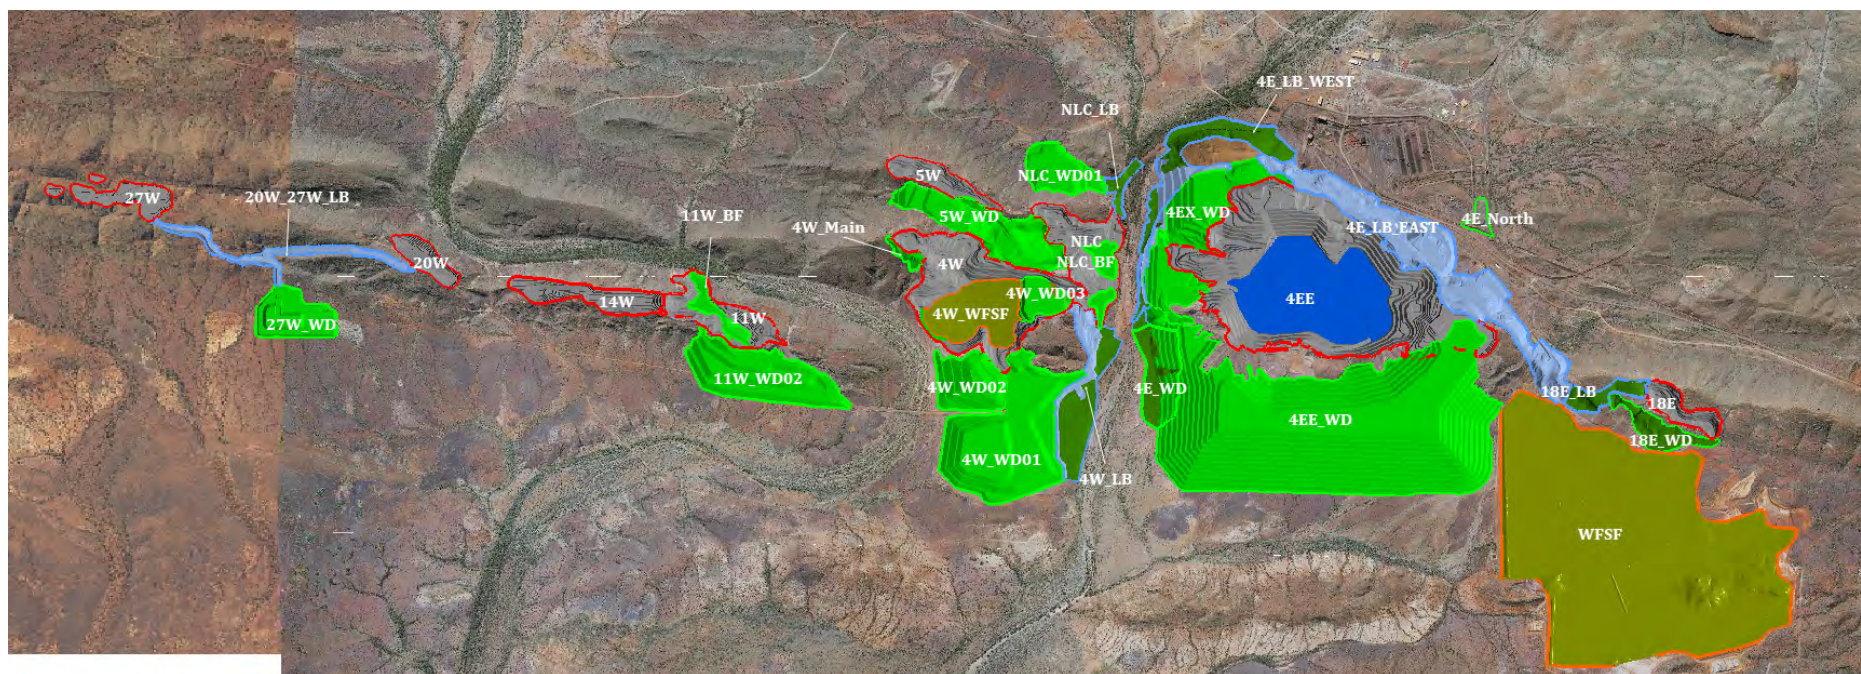
Figure 45: Conceptual layout of the site at completion of rehabilitation activities (reshaping and backfill)

The post-closure landform is the final expected landform at the completion of the closure measures outlined in Table 24. A conceptual image of landforms for Paraburdoo is presented in Figure 45.

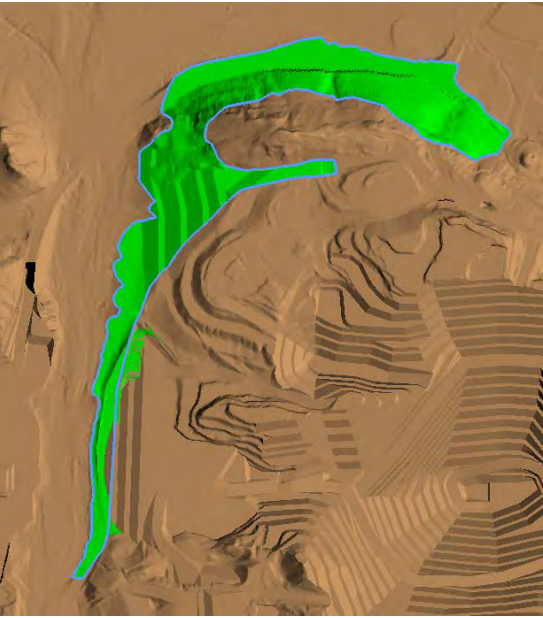
4E East Landbridge

Waste volume	16,511,544 m³	
Erodibility ranking	Medium	
	Low	54%
	Medium	30%
	High	16%
Classification	Inert <input checked="" type="checkbox"/>	Capping required at closure:
	PAF <input type="checkbox"/>	-
	Fibrous minerals <input type="checkbox"/>	-
	WFSF <input type="checkbox"/>	-
Overall height (m)	97	
Topsoil required (m³)	159,700
