# RAVENSWORTH OPEN CUT

## Ravenstworth Operations Annual Review 2020

**Number:** RAVOC-1007099517-67

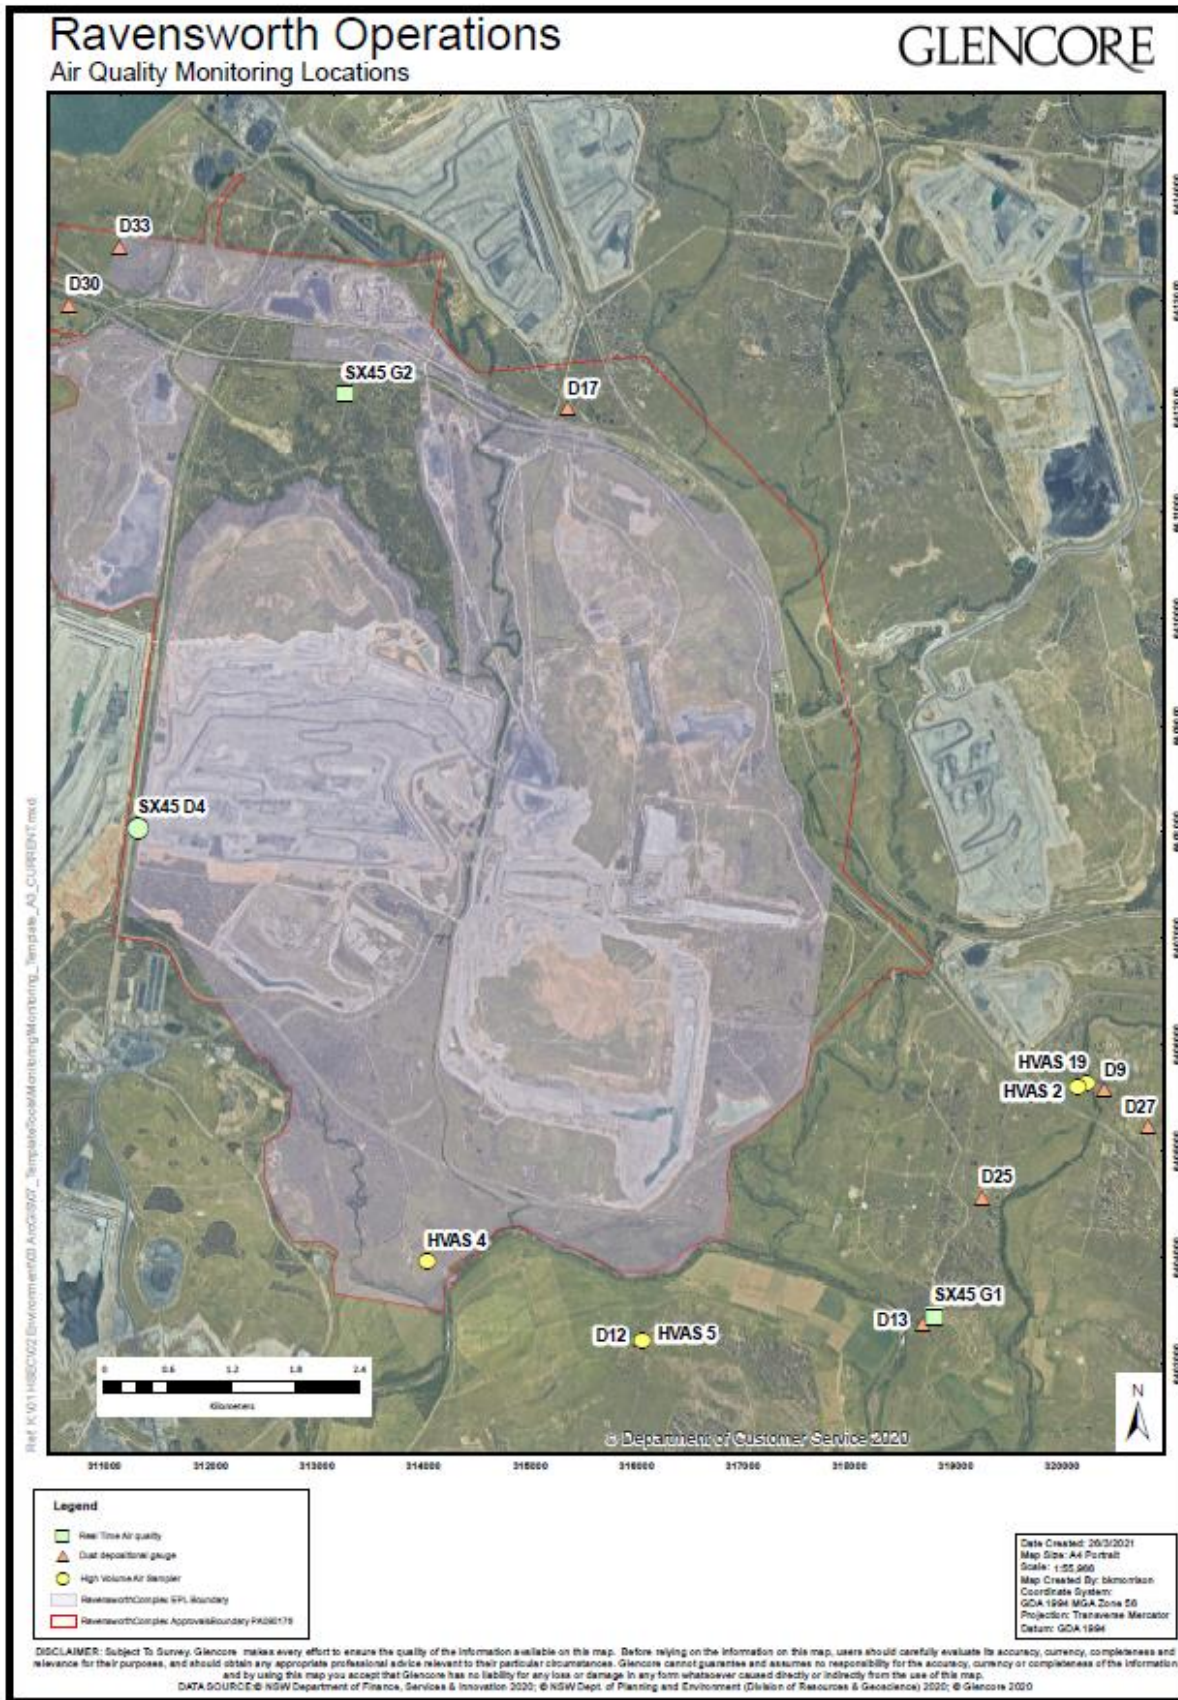
Figure 6-10 - Air Quality Monitoring Locations

Dust monitoring is undertaken to ensure compliance with Schedule 3, Conditions 20-24 of PA 09\_0176. The Ravensworth Complex operates two Tapered Element Oscillating Microbalance (TEOM) units, located to the south east of Narama on private property (TEOM G1) and to the north-west on Ravensworth owned land (TEOM G2). The location of these TEOM units is shown on *Figure 6.10*. TEOM G1 (EPA Point 9) and TEOM G2 (EPA Point 10) is monitored in accordance with Ravensworth's EPL 2652.

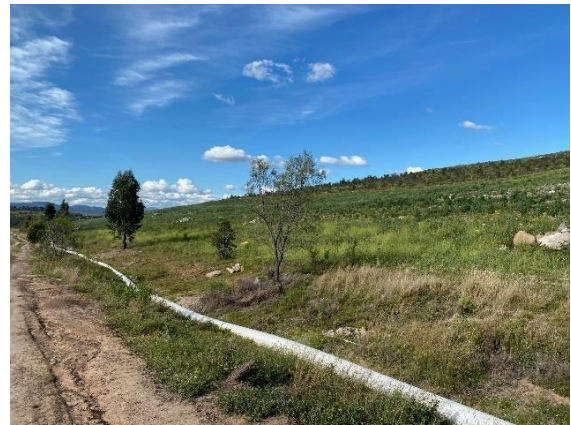
Photo 1 – Habitat tree installed on Eastern Emplacement Area geomorphic landform

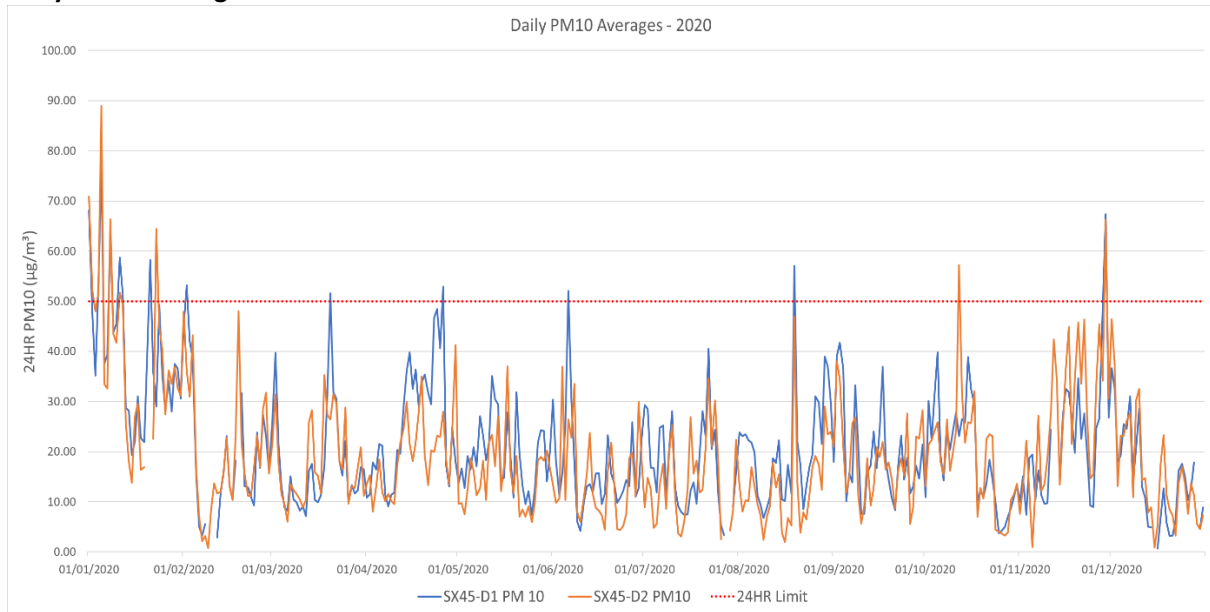
## Daily PM10 Averages

The G1 and G2 24 hour average PM<sub>10</sub> data for 2020 is provided in **Appendix D**. Data gaps during 2020 were attributed to storms, power outages and repairs, resulting in invalid data.

**PM<sub>10</sub> 24 hr Exceedances above 50 µg/m<sup>3</sup> during 2020**

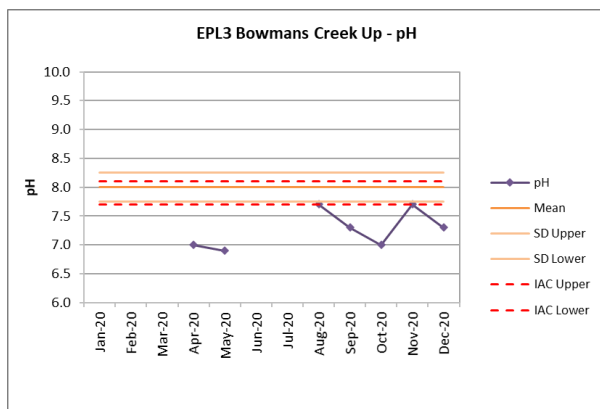
**Chart A3.1 EPL3 Upstream pH**

2020 monthly water quality monitoring results for pH, TSS, EC and TDS are shown for the following waterways in the charts below; Bowmans Creek **Charts A3.1 to A3.8**, Bayswater Creek **Charts A3.9 to A3.24**, Emu Creek **Charts A3.25 to A.28**, Davis Creek **Charts A3.29 to A3.36** and Pikes Creek **Charts A3.37 to A3.48**. The mean and standard deviation values shown on these charts are based on historical monitoring data from 2007 to 2018 which is the same data that the groundwater pH and EC IAC values presented in **Table A1.2** were based on.
