Perilya Broken Hill Limited

Broken Hill North Mine

2019/2020 Annual Review

September 2020

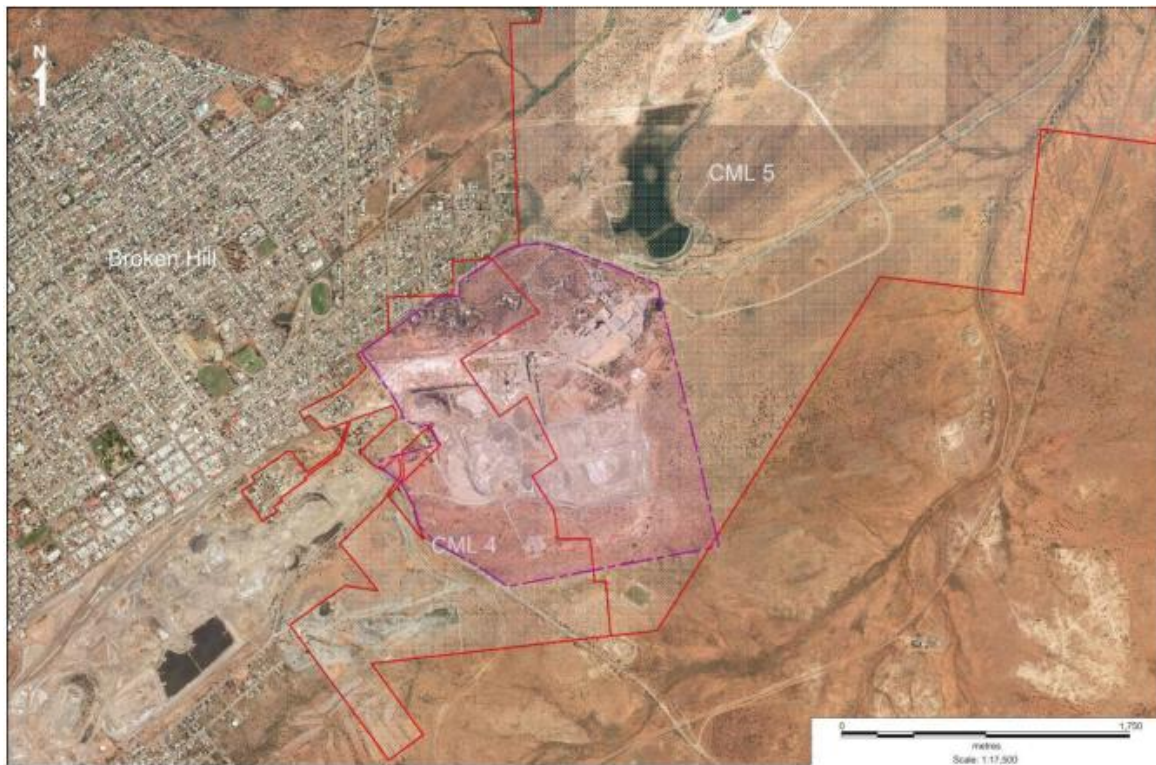
Figure 3 - SDD 7538 Approved North Mine Layout

Broken Hill North Mine (North Mine) Operation is located on the eastern edge of Broken Hill in the Far West region of New South Wales (Figure 1) and lies within a 162 ha area covered by Consolidated Mining Lease (CML) 4 and CML 5 (Figure 2). The current Development Consent (SSD 7538) Modification 2 authorises the operation until 18th August 2043. The Mining Operation Plan (MOP 2018) amendment 1 November 2018 issued for a 3 year period from 1st March 2018 to 28th February 2021. Figure 3 includes the approved mine layout for SDD 7538 and Figure 4 shows the approved limit of mining areas.

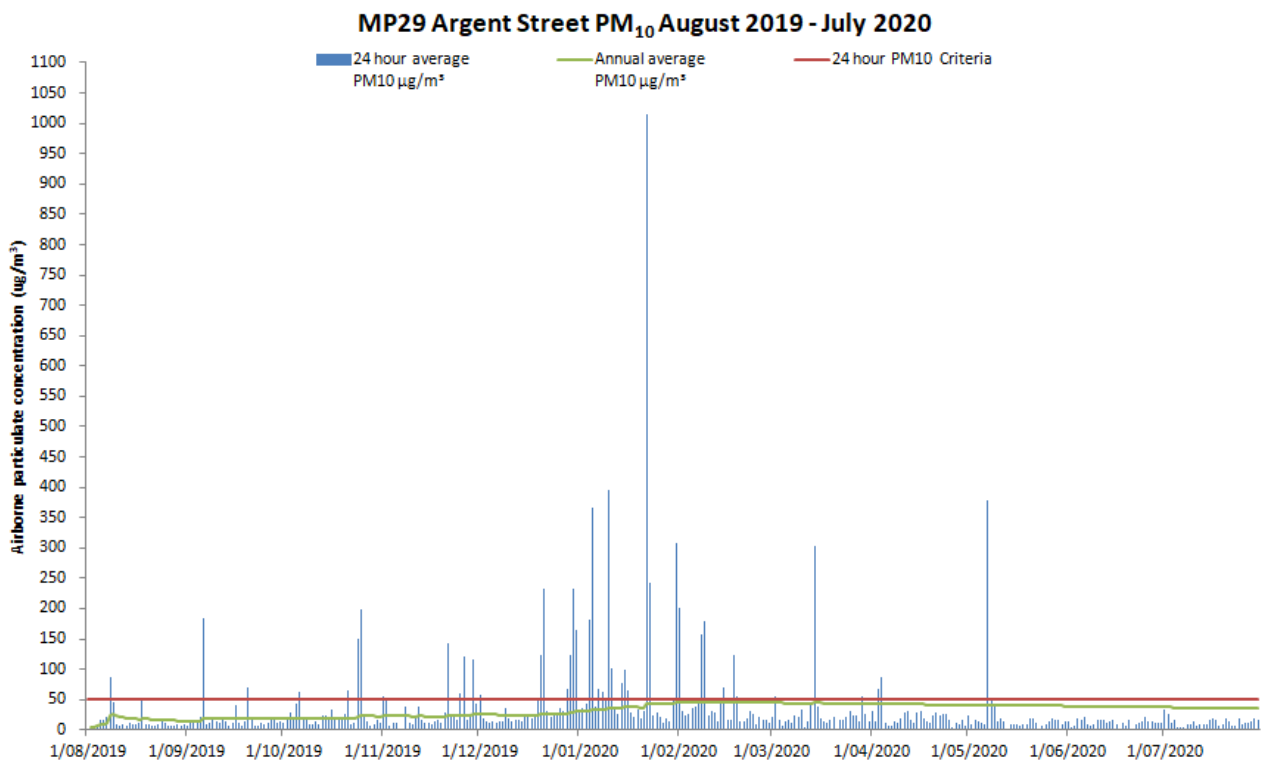
Figure 5 - Argent Street (MP29) PM₁₀ summary for August 2019 - July 2020

Continuous PM₁₀ results for the reporting period at MP29 Argent Street and MP31 Menindee Road including running annual average for the reporting period are provide in Figure 5 and Figure 6.

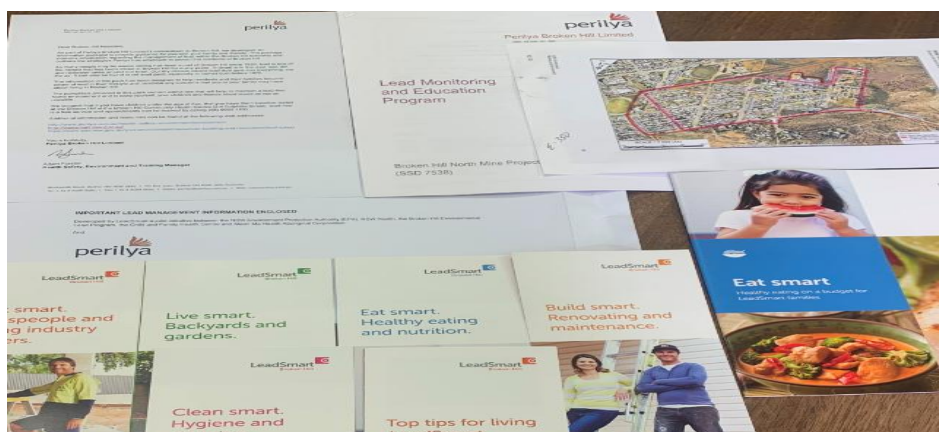
Figure 9 - Lead awareness package mail out

Following approval of North Mine Lead Monitoring and Education Program Revision E on 5th November 2019, Newsletter information packages were arranged for delivered by 22nd December to District 5a residence. The lead awareness packages included a copy of program and living with lead pamphlets from LeadSmart Broken Hill as per Figure 9.

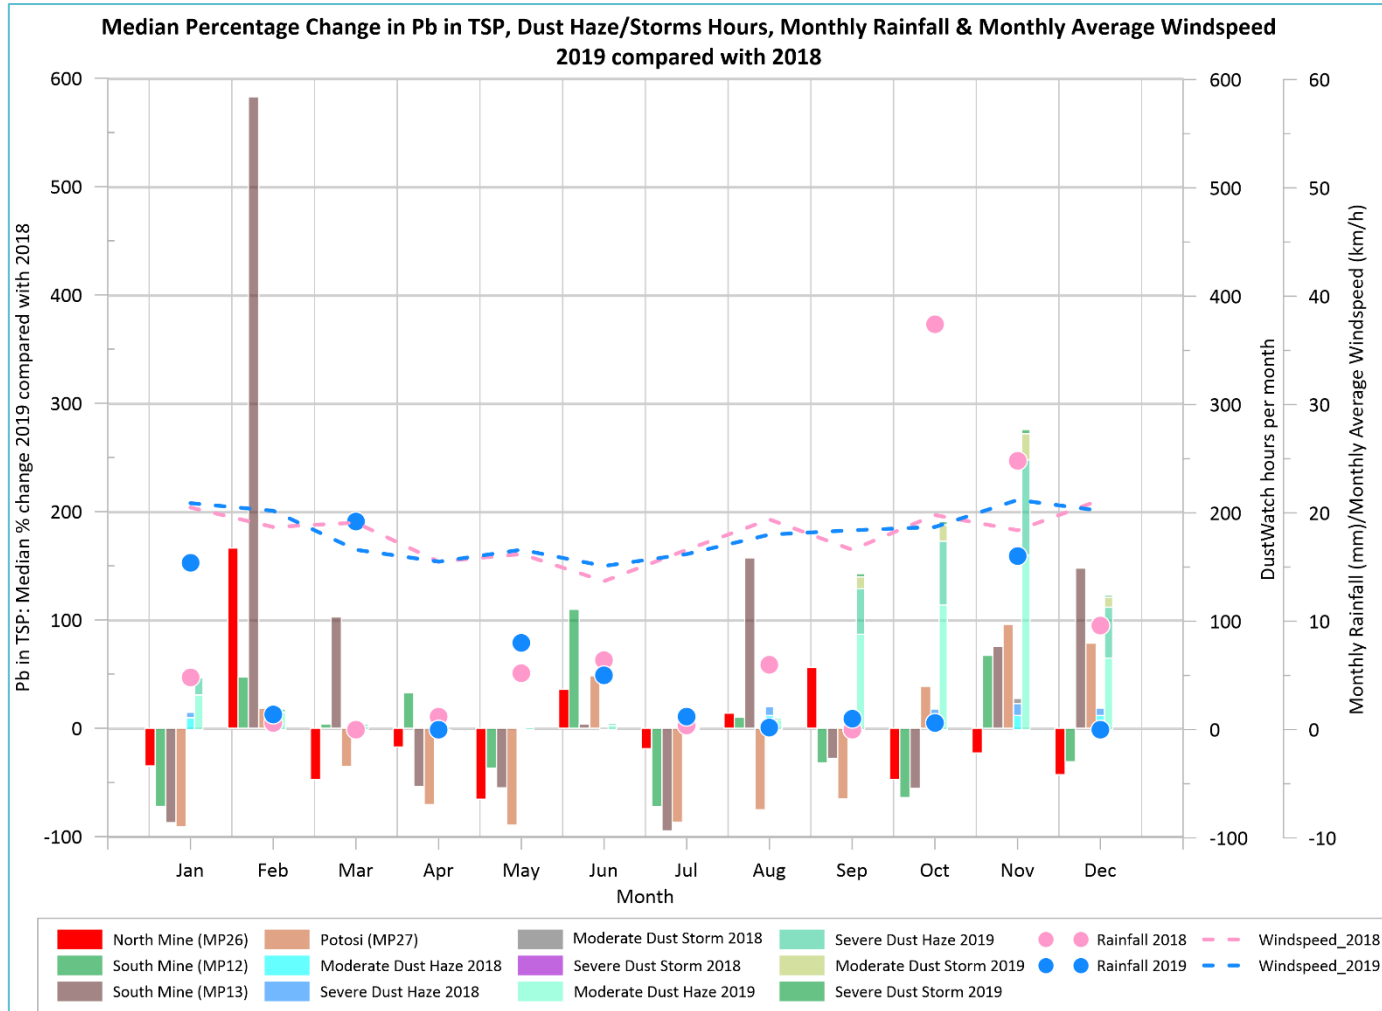
Figure 12 Median Percentage Change in Pb in TSP Compared with DustWatch hours, Monthly Rainfall and Monthly Average Windspeed: 2019 compared with 2018

The average and median percentage change in the Pb in TSP levels are presented along with the meteorological data (monthly DustWatch hours, monthly total rainfall and monthly average windspeed) in **Figure 11** and **Figure 12**.
