2021 Annual Review

**BULGA
COAL**

GLENCORE

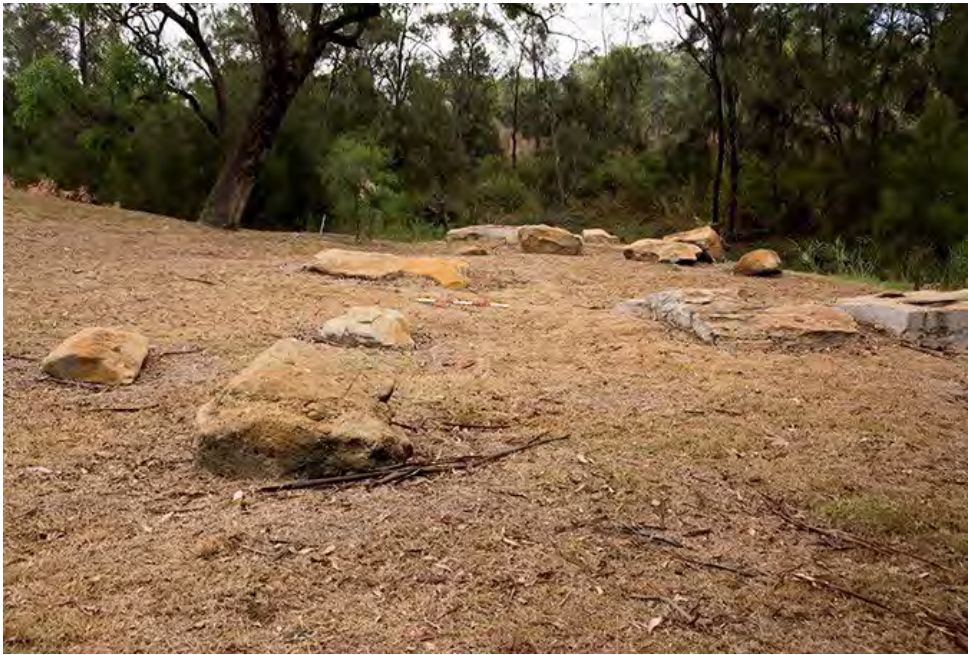
Photo 3 LCGCA Photographic Monitoring – 2017 view from Photo Point 3

There has been no discernible weathering of the areas surrounding the grooves since the relocation occurred. In 2019 some exfoliation of small portions of the rock from the edge of the slab was noticed. These portions did not appear to have worsened in the intervening years.

Photographic monitoring of the Loders Creek Grinding Grooves Conservation Area (LCGGCA) occurs annually, and the site is monitored once a year as part of the Quarterly Monitoring Program. In March 2021, the four fixed photo points were photographed to monitor the condition of the Loders Creek Grinding Grooves. There are 5 main groups of grooves within the site (Groups A to E). The site was originally photographed in September 2015 following the relocation, and annually between 2017 and 2021. **Photo 3, Photo 4, Photo 5, Photo 6 and Photo 7** present the 2017 to 2021 condition from Photo Point 3 for comparison. Results are summarised below:

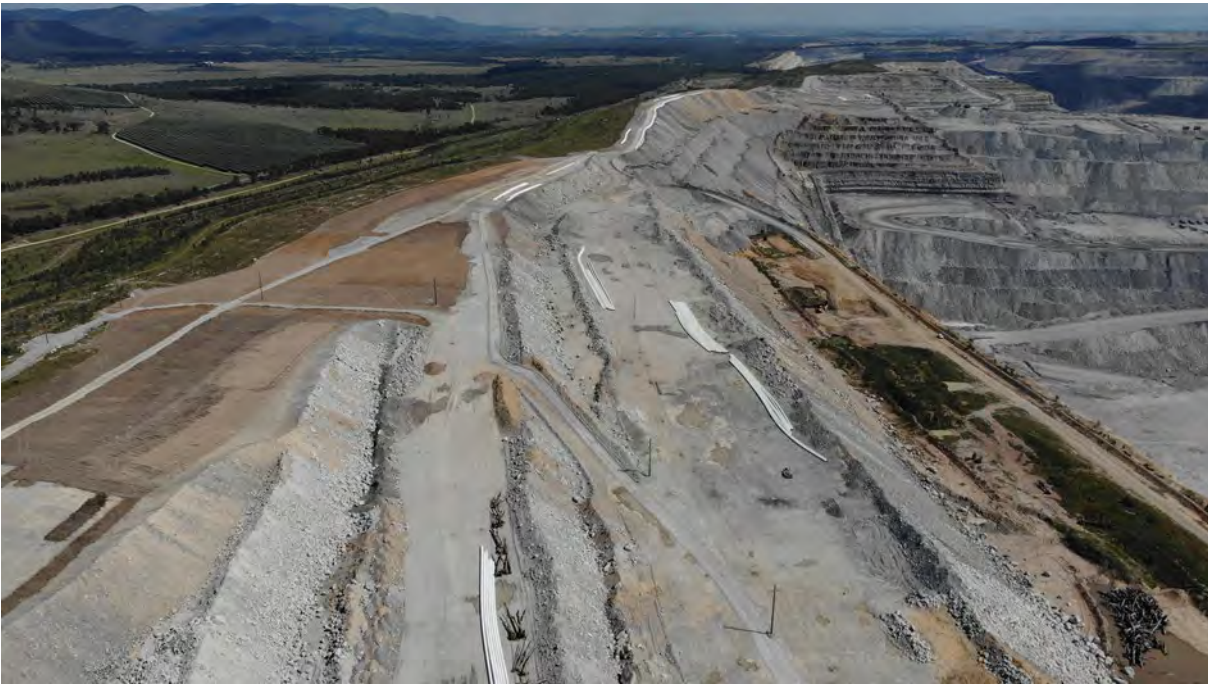
Photo 8 The natural landform design was integrated with the existing landform and drainage on the NVB, photo showing topsoil application in progress following shaping of the final landform.

During 2021, Bulga Open Cut continued to implement a Geomorphic natural landform design, shaping of overburden dumps occurred on both the Eastern Emplacement Area (EEA) and the Noise and Visual Bund (NVB). Bulga Open Cut continued to progressively rehabilitate all available overburden emplacement areas which have reached final landform extents, as shown in Photo 9.

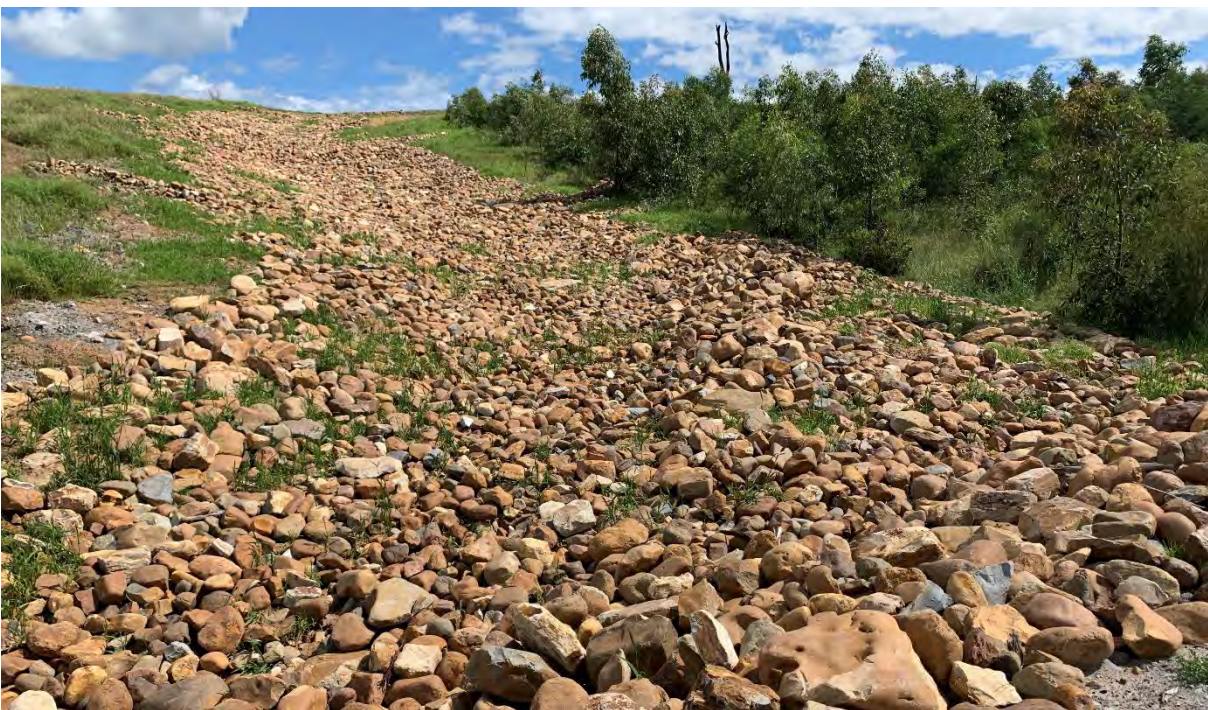
Photo 9 Natural drainage constructed within a geomorphic natural landform.

Natural drainage patterns are included at the conceptual design phase and refined for final construction. An example of a constructed geomorphic drain is shown in **Photo 9**.

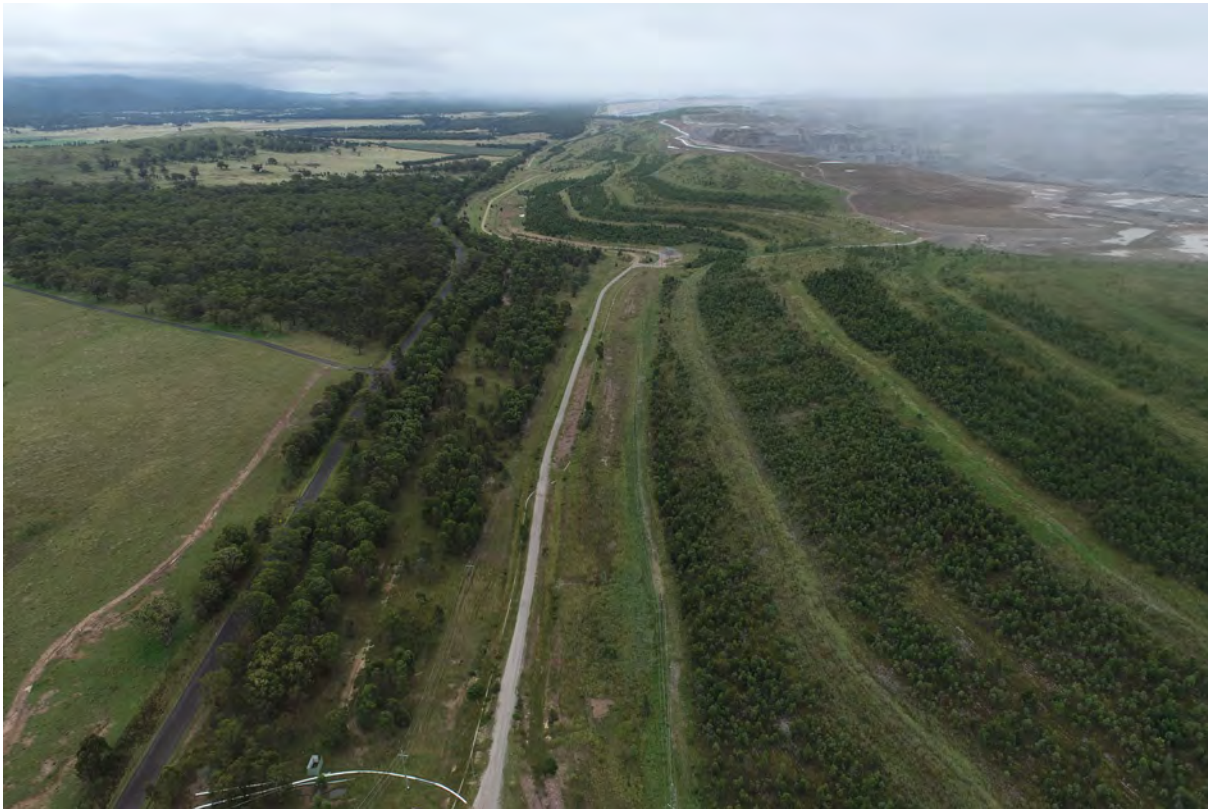
Photo 10 Vegetation establishment on the Noise and Visual Bund (foreground), and completed 2021 rehabilitation (background).

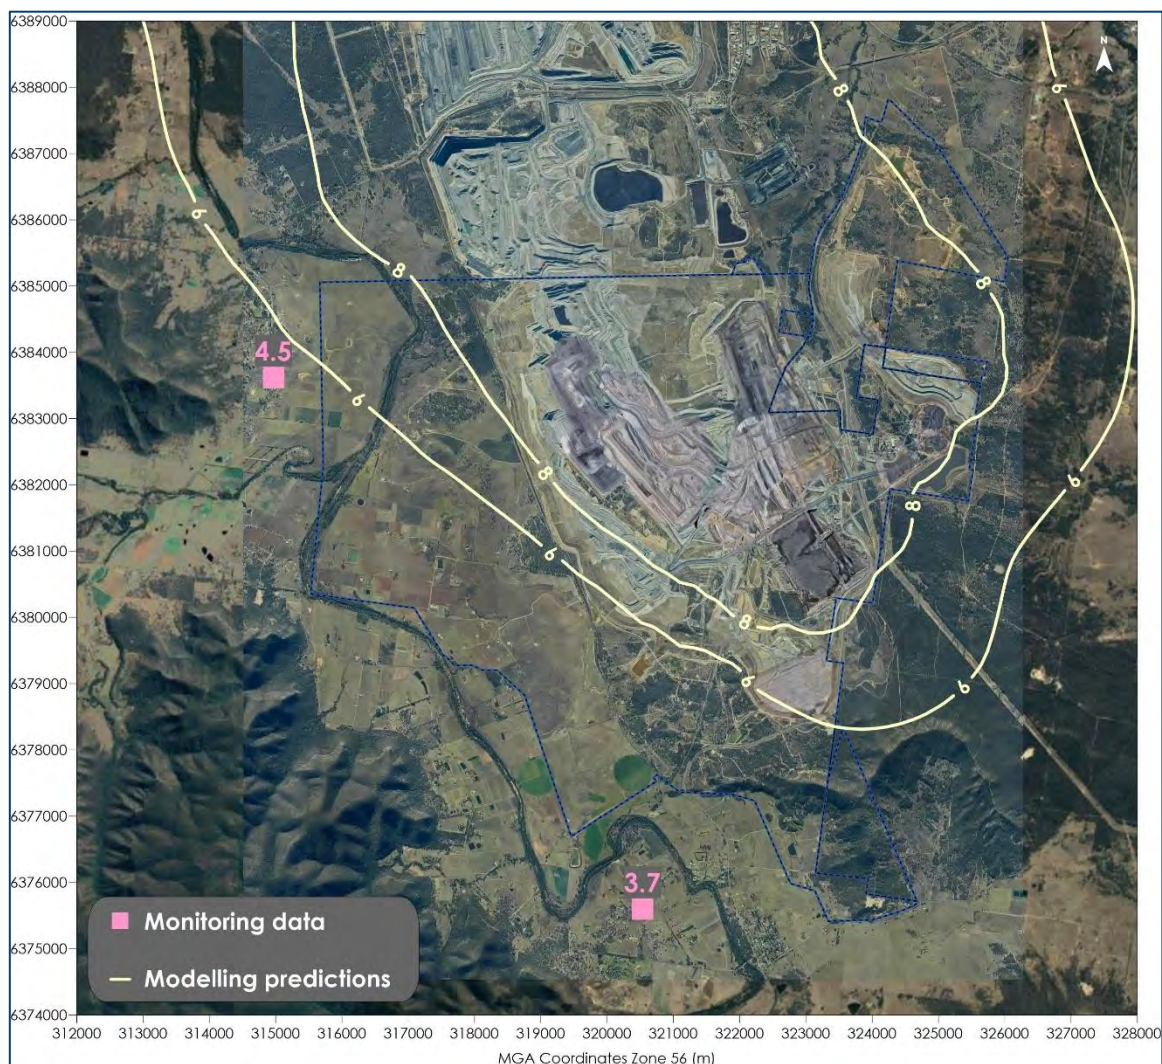
Figure 3-2: 2021 PM_{2.5} annual average monitoring data superimposed over the predicted PM_{2.5} annual average modelling contour (Year 2022 cumulative)

Figure 3-2 presents the measured 2021 annual average $PM_{2.5}$ data superimposed over the dispersion modelling contours reproduced from the *Bulga Coal Complex Modification 3 Air Quality Impact Assessment* (Year 2022) (Jacobs, 2019). The measured and predicted data in the figures include dust levels from Bulga and other sources.

Figure 3-2 indicates that the measured annual average PM_{2.5} levels in 2021 are approximately 1µg/m³ lower than the predicted levels for the Year 2022 modelling scenario.
