Annual Review

Donaldson Coal Mine

1 November 2020 – 31 October 2021

R.W. Corkery & Co. Pty. Limited
Geological & Environmental Consultants
ABN: 31 002 033 712

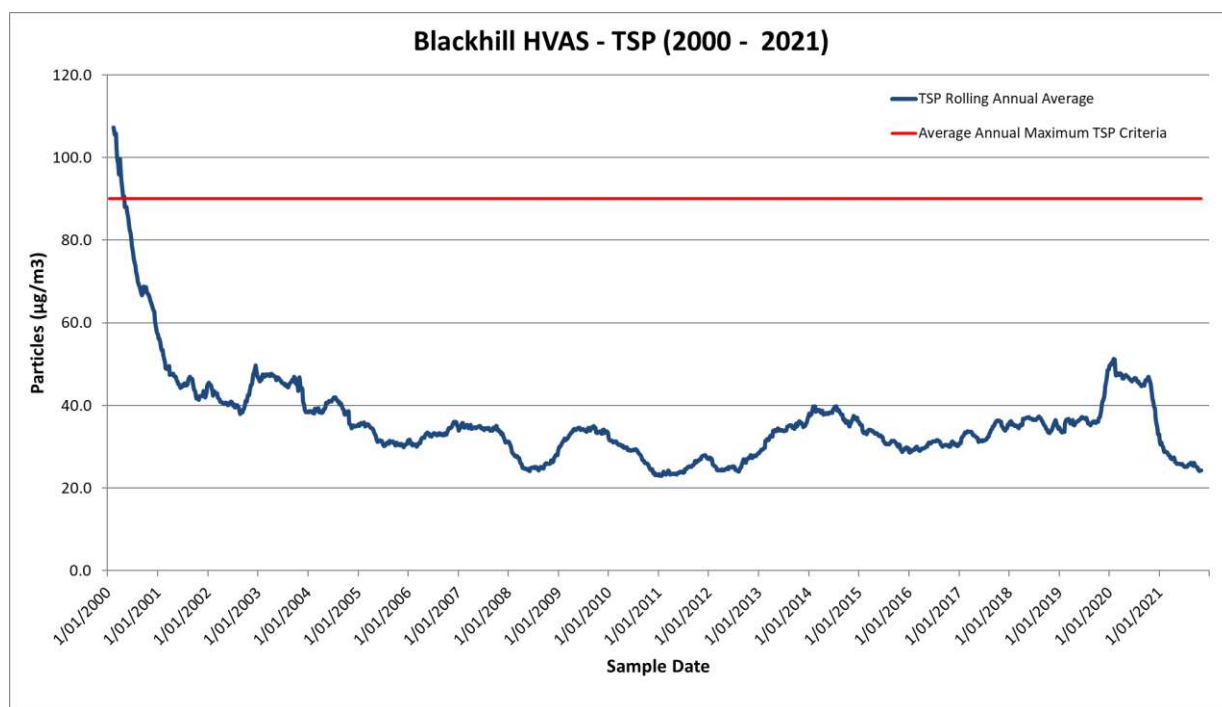
Figure 6.4 **HVAS Results – Annual Average TSP (2000 to 2021)**

Sample Site	No Samples Required	No samples collected and analysed	Maximum TSP Value ($\mu\text{g}/\text{m}^3$)	Minimum TSP Value ($\mu\text{g}/\text{m}^3$)	Annual Average TSP Value ($\mu\text{g}/\text{m}^3$)
Black Hill Public School	61	61	59.0	4.9	22.8

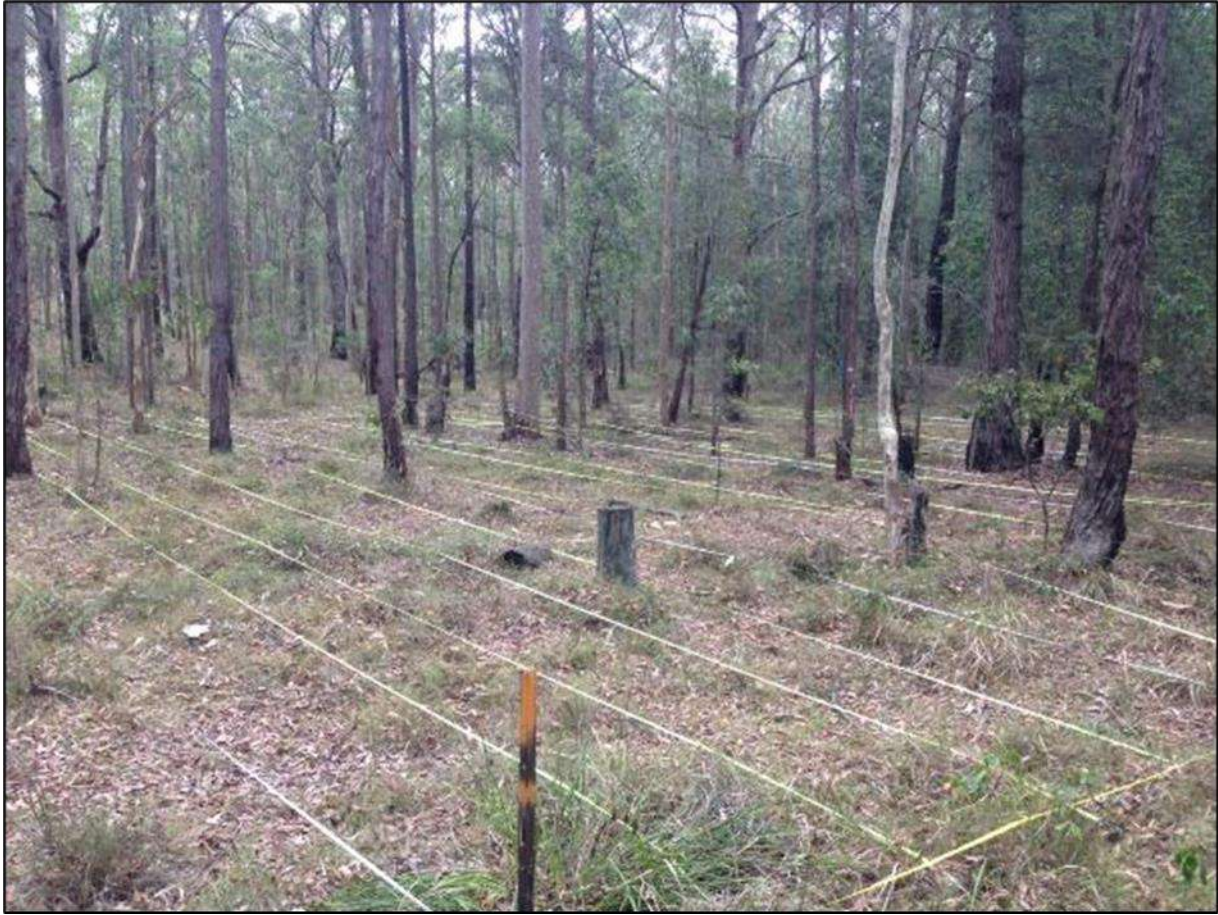
Plate 1: Example of grid layout for collection of biomass measurements (Quadrat 5)

Research has shown that there is a relationship between the growth of one part of an organism and another part that is known as allometric (where a part is a constant exponential function of the whole). The relationship between the basal area of a tree and the height can be used to monitor the development of the trees within the quadrats over time.

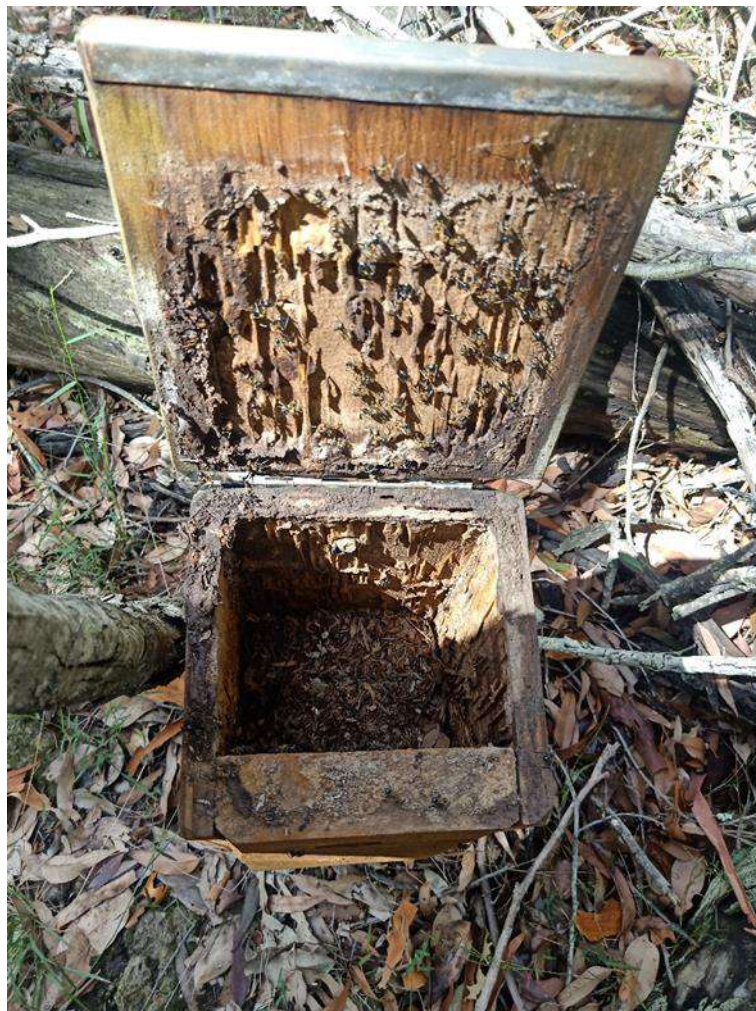
Plate 11: Damaged Terrestrial Nest box.
