Report on the Geotechnical Investigation for the
**RAILWAY BALLOON TRACK LAYOUT AT
UNION MINE**

WSP Africa Building C Knightsbridge 33 Sloane Street Bryanston 2191
Project name	Mortimer Railway Balloon Project
Report title	Report on the Geotechnical Investigation for a Railway Balloon Track Layout at Union Mine, Rustenburg
Report number	NWS20617/G0219 – F0

GaGE Consulting (Pty) Ltd was appointed by WSP, on behalf of their client, Union Mine, to conduct a design-level geotechnical investigation, for a Railway Balloon Track Layout, at Union Mine, Rustenburg, in the North West Province.

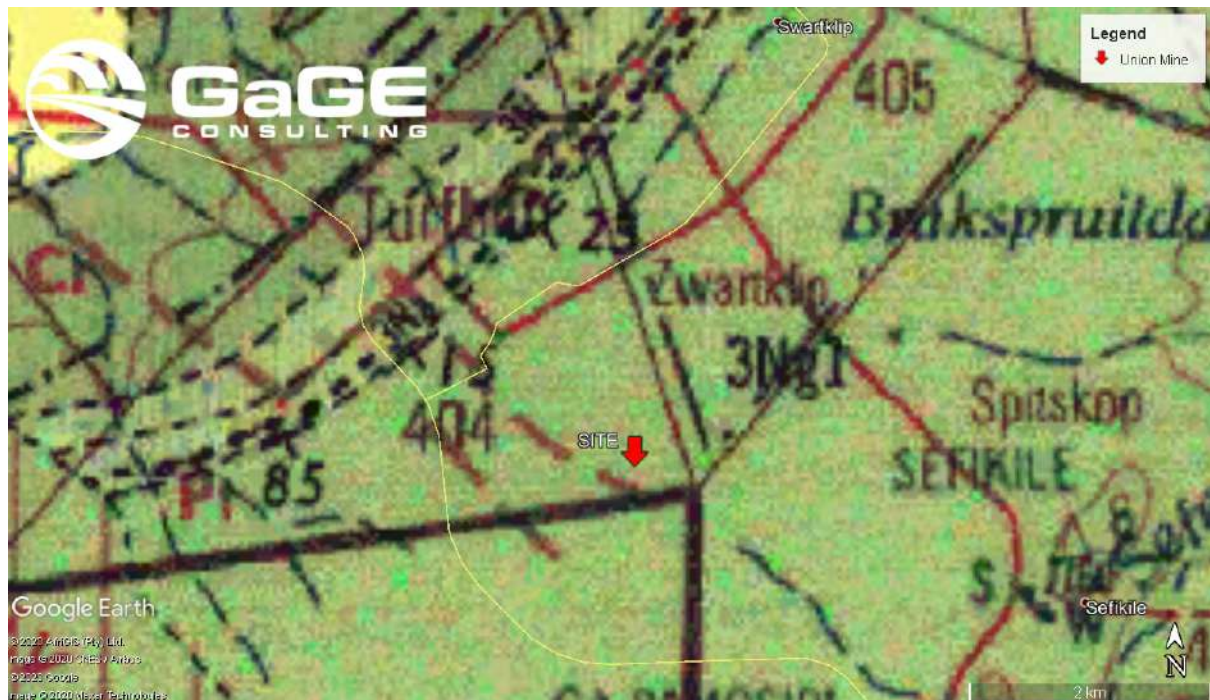
Figure 2-2 Extract from the 1:50 000 geological sheet 2426 Thabazimbi, showing the local geology.

The site and surrounding area are underlain by the Pyramid Formation of the Rustenburg Layered Suite (RLS), on the western limb of the Bushveld Igneous Complex, as shown in Figure 2-2. The suite of mafic sills, which intruded the basal rocks of the Transvaal Supergroup, comprises rocks that range from norites, pyroxenite, harzburgite, gabbro-norite, magnetite and olivine-magnetite rich gabbro-norite, anorthosite and olivine-apatite rich gabbro-norite.

The residual soils developed from the gabbro-norites of the Rustenburg Layered Suite are the most expansive soils in South Africa. This is due to the soils having clay content of over 30% and sometimes as high as 60% with montmorillonite being the major clay mineral (Brink, 1979).

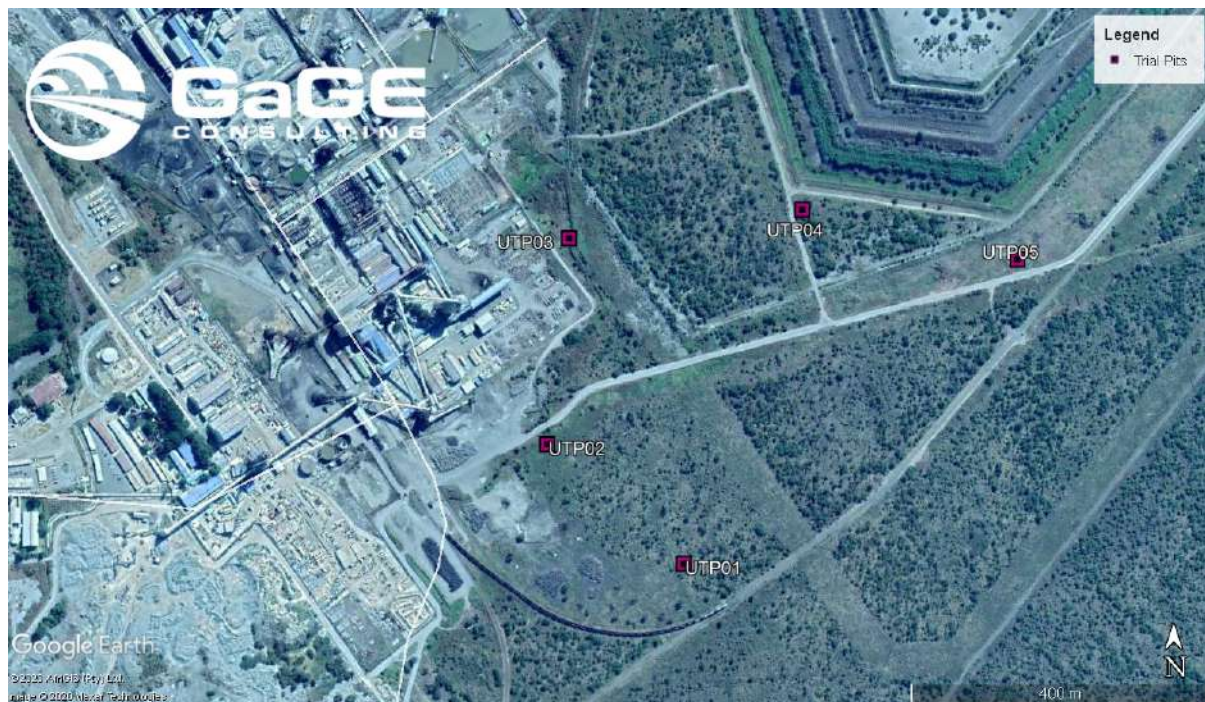
Figure 3-1 Locality of trial pit excavations and DCP locations across the site during geotechnical investigation

The location of the respective trial pits and borehole positions is illustrated in Figure 3 1, and in conjunction with Table 3 1, which summarises their coordinates and final depths. The trial pit logs are included in Appendix A, the associated profiling and logging parameters in Appendix B, and the laboratory results in Appendix C.

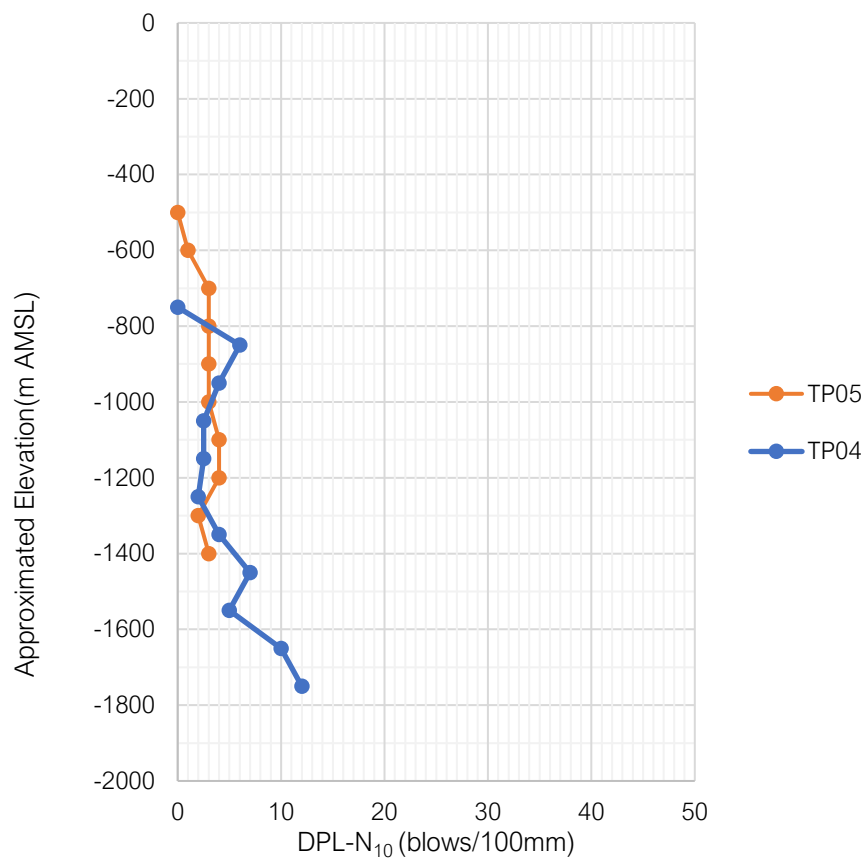
Figure 3-2 DPL-N₁₀ with depth

In situ Dynamic Penetrometer - Light (DPL) tests were conducted. The DPL tests are summarised in Figure 3-2 and generally corresponded to the logged consistency

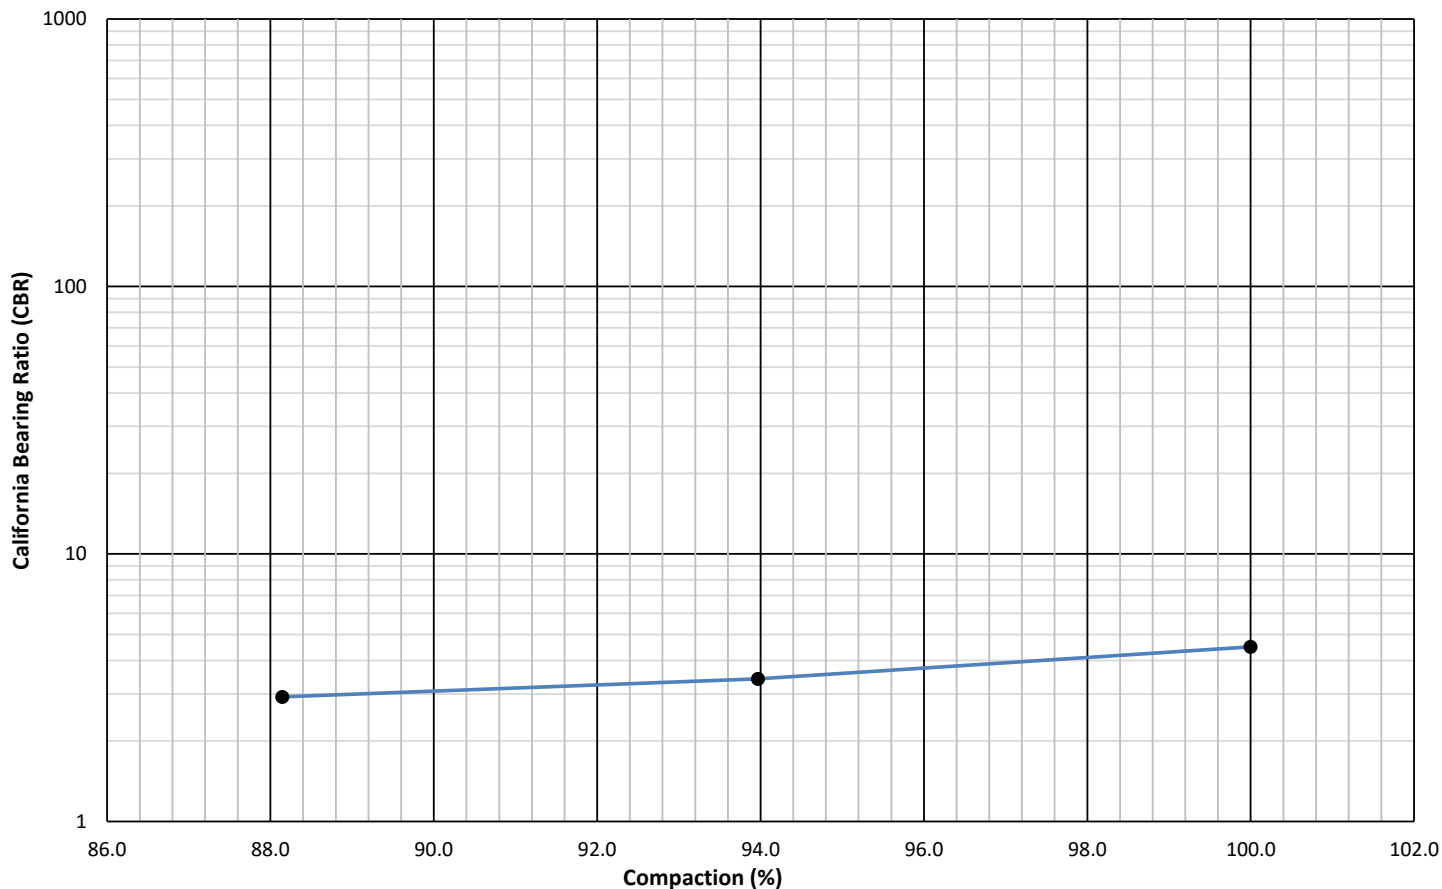
Mod. AASHTO Values		Compaction Data: CBR			Swell	CBR at (mm)			CBR Values	
MDD	OMC	Dry Dens.	MC	Comp.		2.5	5.0	7.5	Compaction (%)	CBR
(kg/m ³)	(%)	(kg/m ³)	(%)	(%)	(%)					
1924	13.1	1923	12.0	100.0	4.7	4	4	5	100	4.5
									98	4.1
									97	3.9
1924	13.1	1807	12.0	94.0	3.6	3	5	5	95	3.6
									93	3.3
1924	13.1	1695	12.0	88.1	3.4	3	3	3	90	3.1

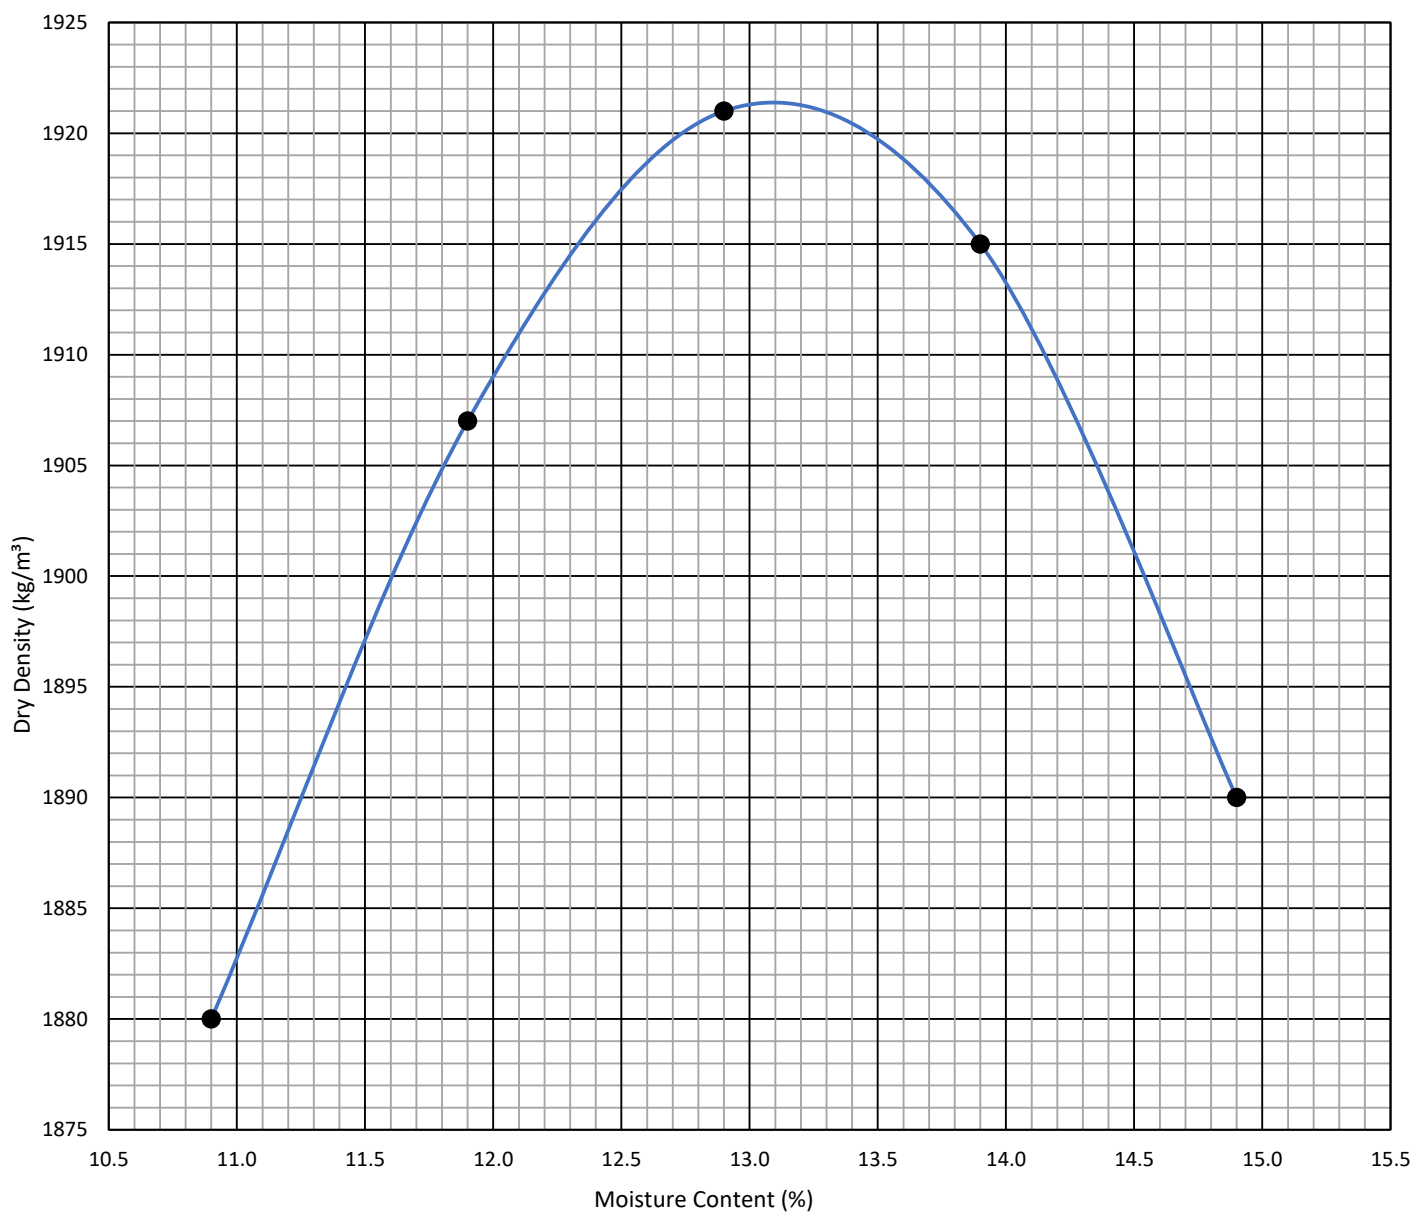
Moisture Content (%):	10.9	11.9	12.9	13.9	14.9			
Dry Density (kg/m ³)	1880	1907	1921	1915	1890

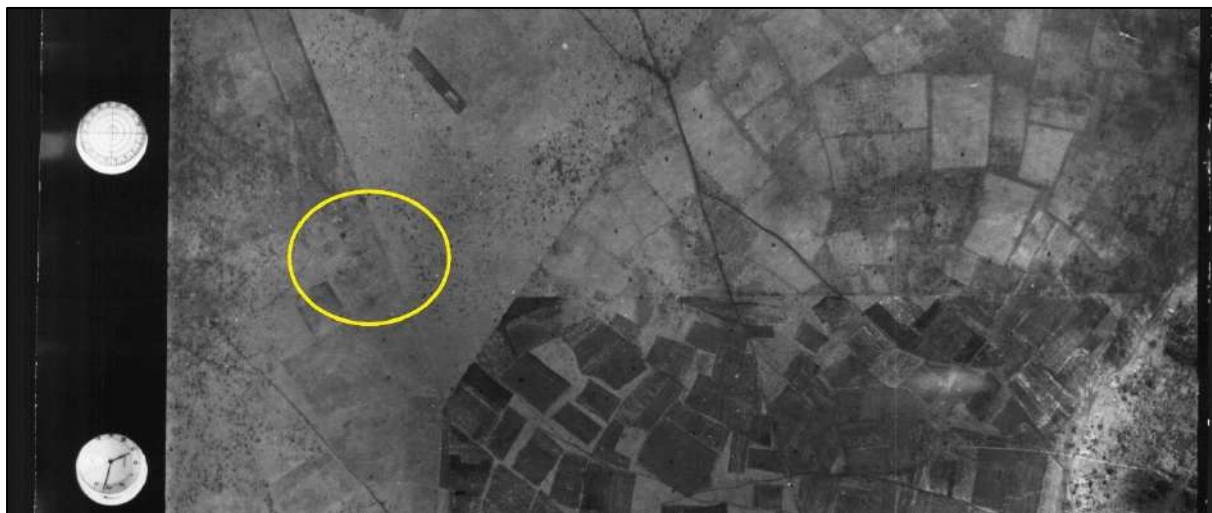
Figure 1: Historical image from June 1949 roughly indicating the location of the currently proposed mine activities.

Historical imagery (June 1949) indicates that prior to the onset of mining activities the study area had a notably lower density of large tree species. It also appears that portions of the study area may have been subjected to some levels of crop cultivation (Figure 1), whilst it is possible that the remaining areas would have also been used for grazing. It must be noted that the low tree density as seen in Figure 1 is indicative of the Dwallboom Thornveld vegetation type as described by Mucina and Rutherford.

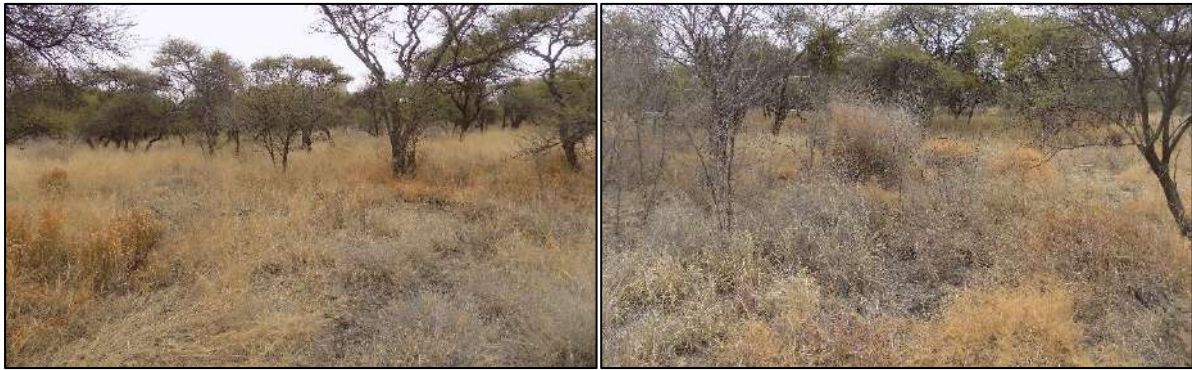
Figure 2: Representative images of the vegetation observed that has not been disturbed within the proposed development footprint areas.

During the field assessment it was evident that the vegetation within the study area as described by Mucina and Rutherford (2006) has subsequently been altered, with a distinct increase in woody species density and signs of woody encroachment in areas (Figure 2). This change in vegetation structure is attributable to the onset of mining activities, as the ecological processes necessary for the maintenance of the vegetation structure as described by Mucina and Rutherford (2006) will have been hindered / ceased, whilst edge effects and habitat disturbance will have stimulated the onset of bush encroachment.

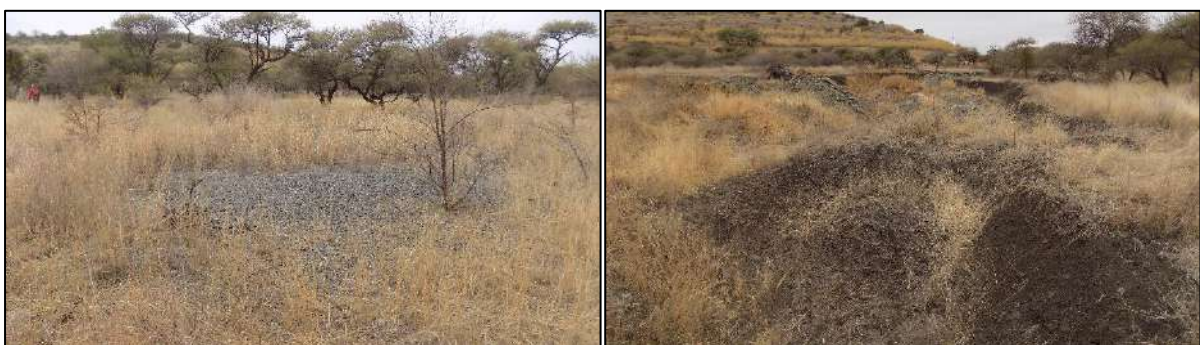
Figure 3: Representative images of the disturbed areas associated with the proposed footprint areas. Historical gravel dumping (left) and recent earth works (right).

Mining associated disturbances, both historical and current, are evident, with old roads and the dumping of waste material (rubble and gravel) being associated with several of the proposed development sites (Figure 3). More recently, within the northern portion of the study area, earth works (excavations) are evident and have led to extensive habitat loss within the FCR Plant 2 footprint (Figure 4). Both the historical and current impacts from earth works and disposal of rubble have impacted upon the habitat associated with the loading pads, the FCR plants and the proposed access road in the north. Within these footprints there are still areas where the habitat has not been anthropogenically disturbed, however, the overall ecological functioning and sensitivity of these areas has evidently decreased. Although several indigenous floral species were still evident within the proposed development sites, it is evident that the lack of suitably managed ecological processes such as controlled burns and grazing/browsing activities has led to a loss of floral species diversity and a noted increase in encroachment species such as *Dichrostachys cinerea* and *Asparagus* sp in many areas. Such encroachment is evidence of either previous disturbances to the area or improper ecological management which favours the proliferation of these species. The herbaceous layer did not appear notably species rich and was dominated by dense clumps of graminoid species such as *Enneapogon cenchroides* and *Panicum maximum*. Other graminoid species such as *Eragrostis* sp, *Eragrostis rigidior*, *Setaria sphacelata* and *Aristida congesta* were observed. The woody layer was dominated by species such as *Vachellia tortilis*, *V. karoo*, *Searsia pyroides*, *Combretum* sp, *Grewia flava* and *D. cinerea*. Graminoid species such as *Panicum maximum* are expected to occur within this region, notably in clumps under *Vachellia* spp, however many of the other graminoid species observed are often associated with areas that have previously undergone some form of ecological disturbance.

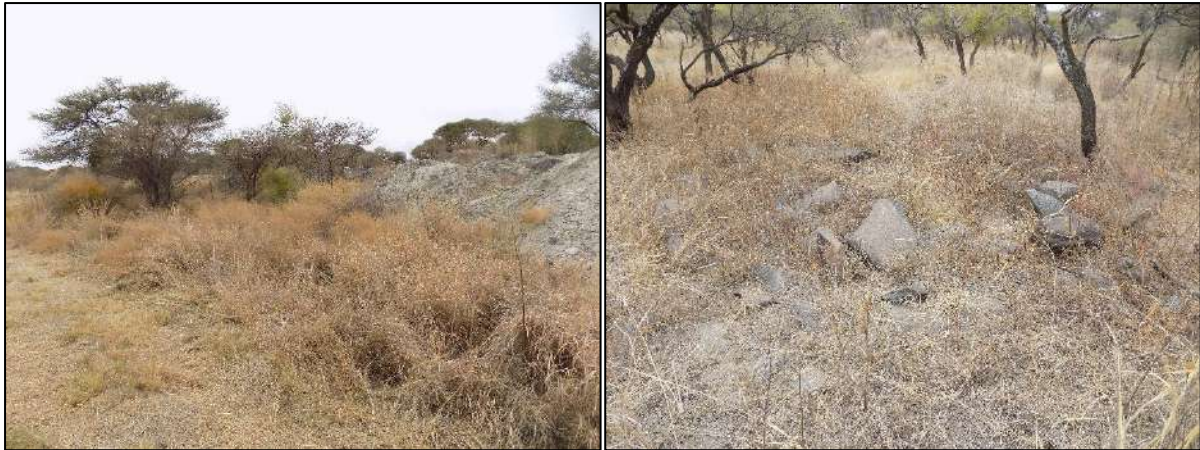
Figure 4: Representative images of the disturbed areas associated with the proposed footprint areas. Relatively recent stockpiling of excavated material (left) along the proposed access road and historical dumping of rubble (right).

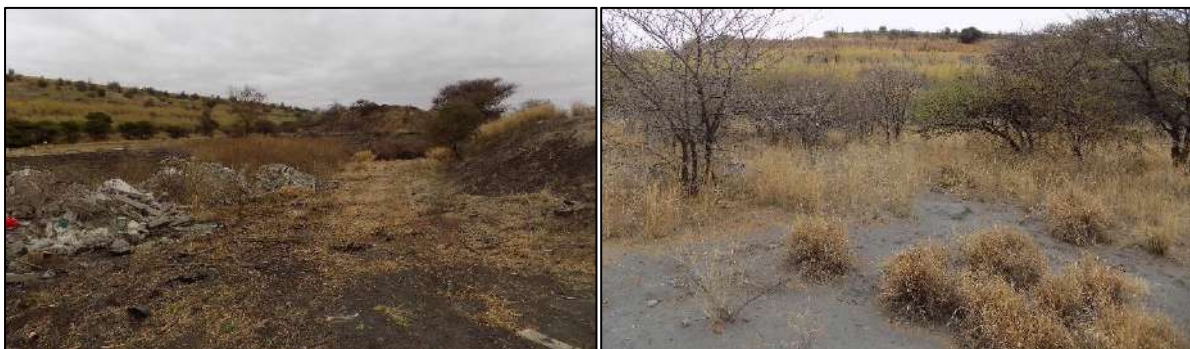
Figure 5: Images of the areas associated with the rail road exit: Dumping of rubble and notable habitat disturbance (left) and the TSF and with evidence of tailings spill into adjacent areas (right)

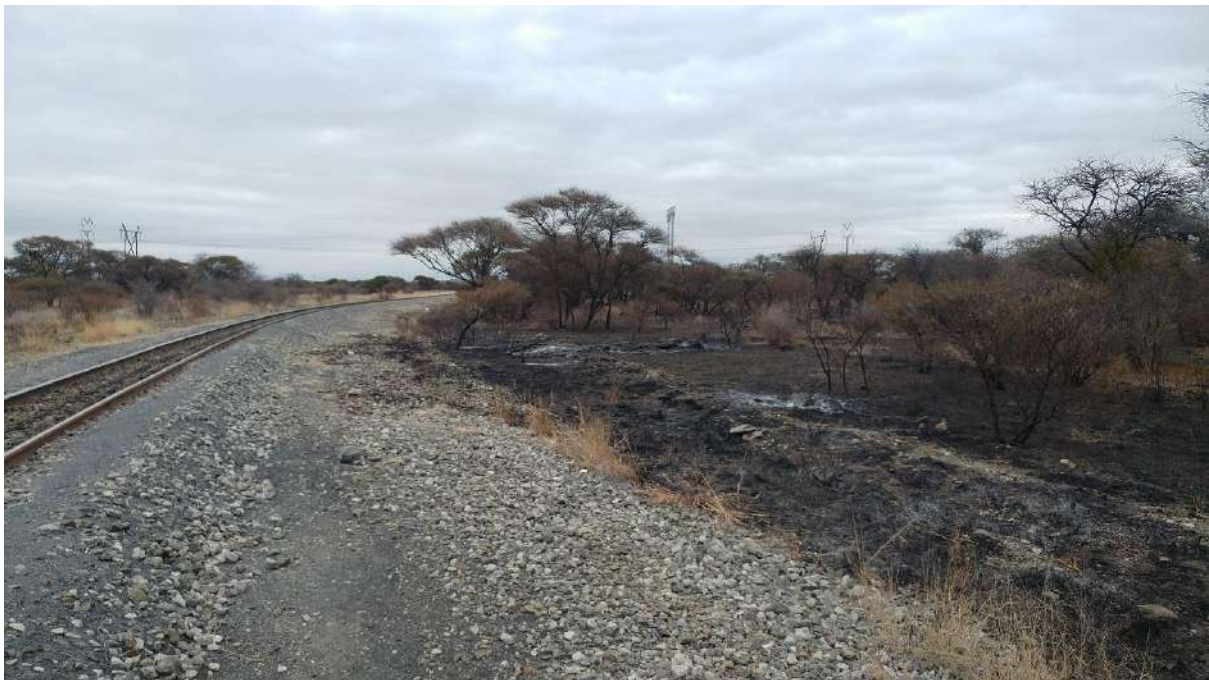
FIGURE 8: RAILWAY TRACK ALONG THE SURVEYD AREA.

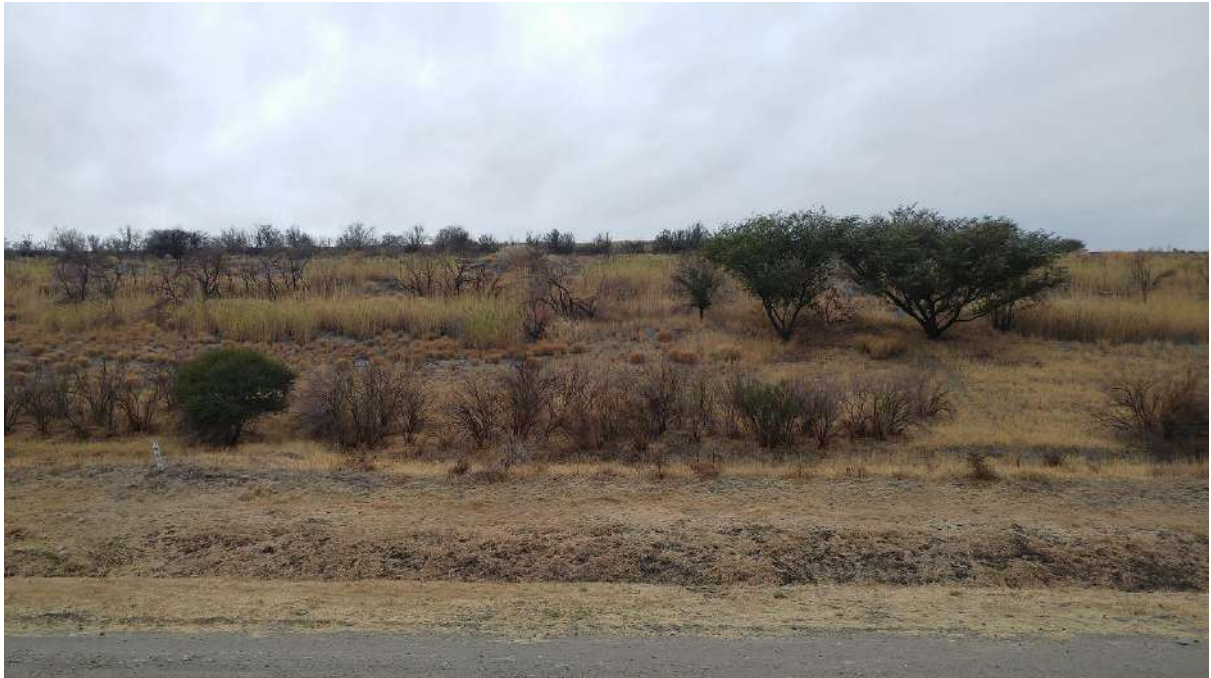
FIGURE 9: SLIMES DAM EAST OF THE PROPOSED AREA.

The surveyed area shows signs of recent human activities in the form of power lines, dirt roads, pipelines, a railway track, slimes dam, earthworks and processing plant all associated with the processes of mining (Figure 5-11). Where the area is less disturbed the vegetation varied in height, in the southern part it was open due to recent bushfires (Figure 12) and denser to the north (Figure 13). The vegetation cover consists of mostly endemic grasses shrubs and trees (Figure 14).

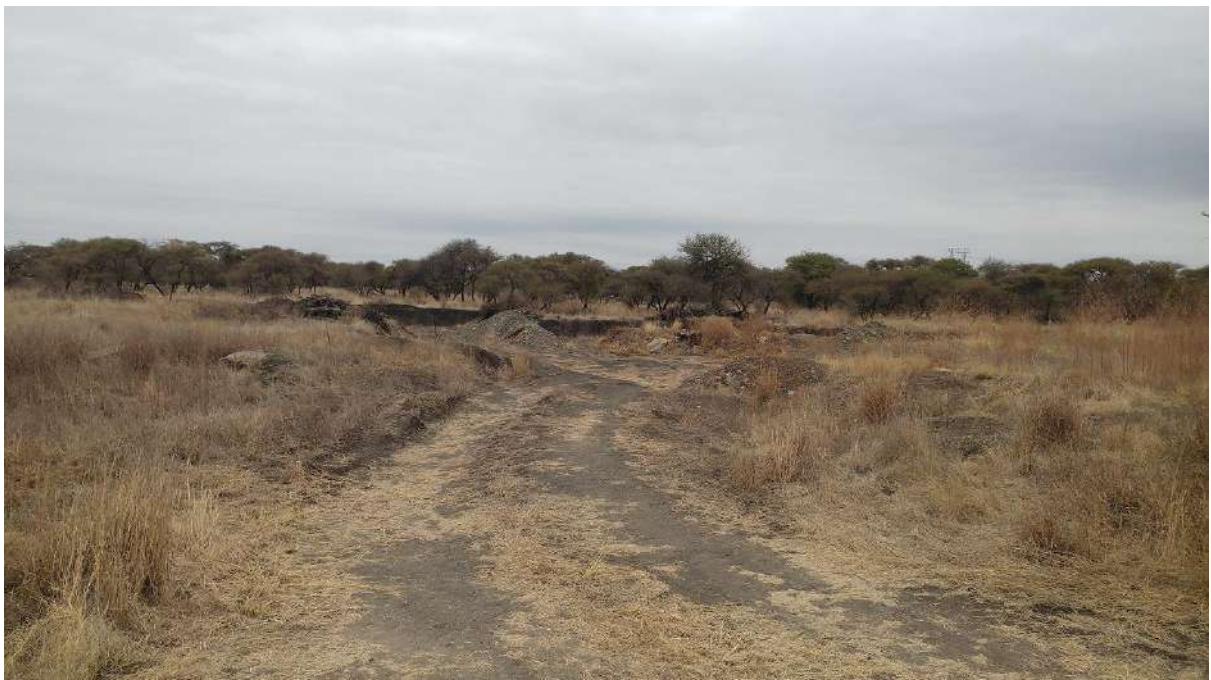
FIGURE 10: EARTHWORKS NORTH IN THE SURVEYED AREA.

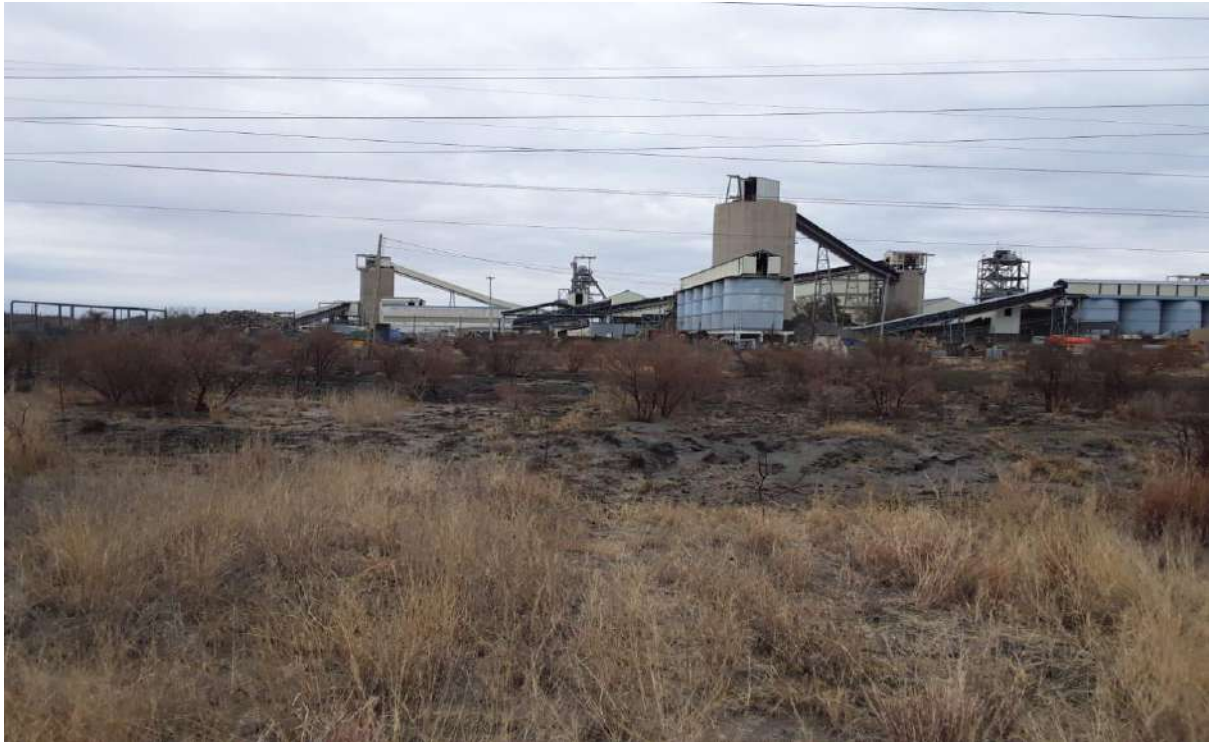
FIGURE 11: PROSSESING PLANT NORTH WEST OF SURVEYED AREA.

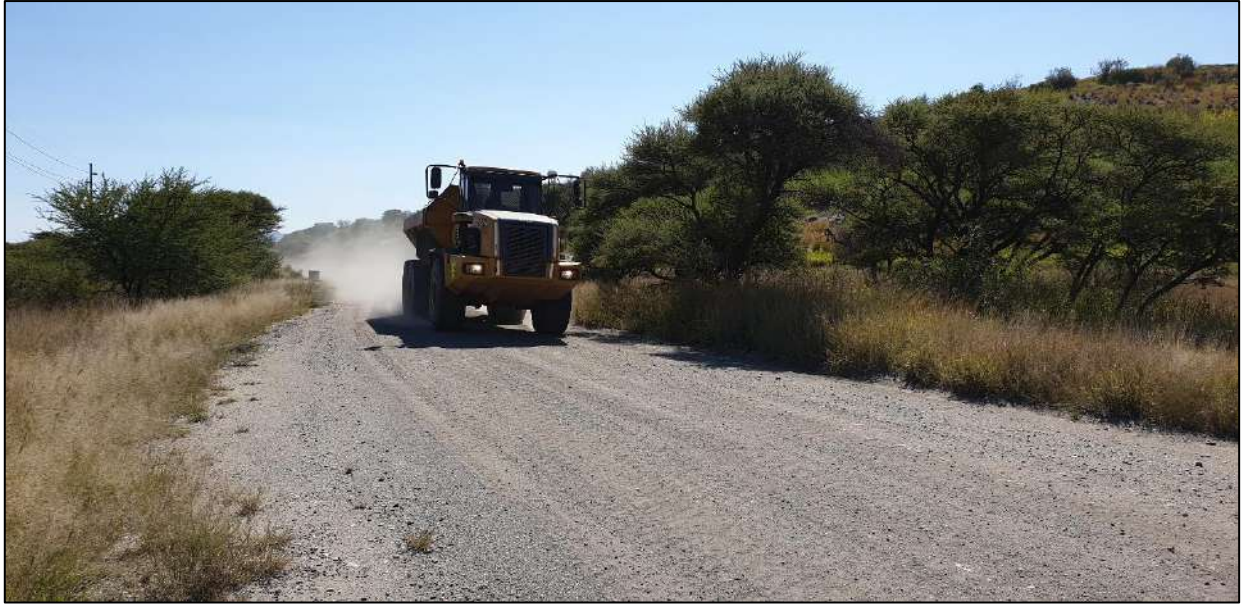
Figure 3: Haul road and vehicles on and surrounding the project area

The soil associated with the (Dwaalboom Thornveld), is described in VegMap (2016) as vertic, black ultramafic clays (which swell when wet and shrink when dry). The clay content of this soil type may result in limited primary production for some plants and therefore the general agricultural land use in this vegetation type is cattle grazing, resulting in a *medium agricultural sensitivity*. As the site it is situated close to industrial processes and moving heavy machinery (Figure 3), grazing is not a compatible land use as animals are likely to be injured.

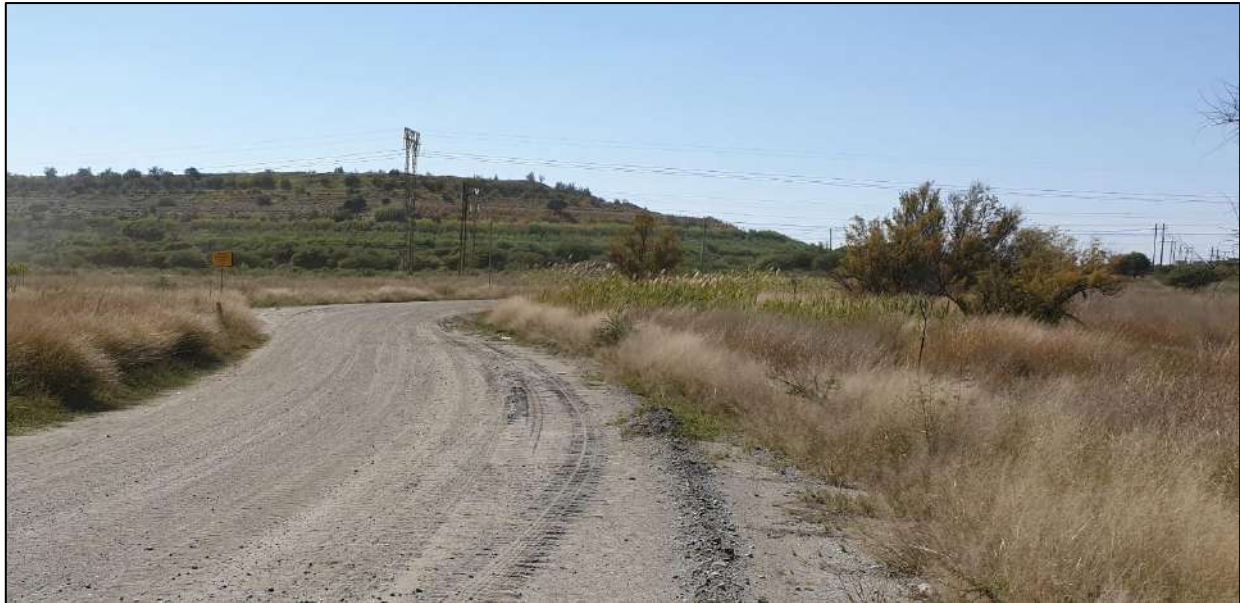
Figure 6: Tailings Storage Facility offering a visual absorption to the north and east of the proposed site (photo facing east)
