United Wambo Joint Venture Annual Review_Post Submission Changes July 2021
United Wambo Open Cut Coal Mine Project Annual Review
GLENCORE
Period: 1 January 2020 to 31 December 2020

Annual Groundwater Review 2020

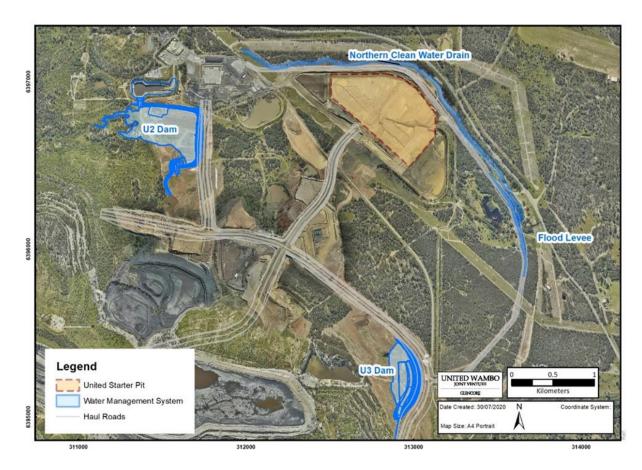
Figure 4 – Water Management Infrastructure

- Two large mine water dams to capture dirty and mine water:
 - U2 Dam, a 390ML dam, has been constructed upstream of the United Open Cut to capture water from the overburden dumps and to protect the pit from water inflow down Redbank Creek; and
 - U3 Dam, a 232ML dam, has been constructed to capture water from the overburden dumps to prevent offsite discharge into Wollombi Brook;
- A clean water drain has been constructed north of the United Open Cut to convey clean water around the mining areas and return it to the downstream environment in Redbank Creek. The drain has been rehabilitated and is currently being monitored prior to release back into Redbank Creek; and
- A flood levee bank has been constructed downstream of the United Open Cut on Redbank Creek.
 The levee has been designed to prevent flood waters from Wollombi Brook entering the pit in a 1 in 1000 year storm event.

Along with these major structures, a significant amount of pumping and pipe infrastructure has also been installed. A new Water Fill Point has been constructed for the United Open Cut.

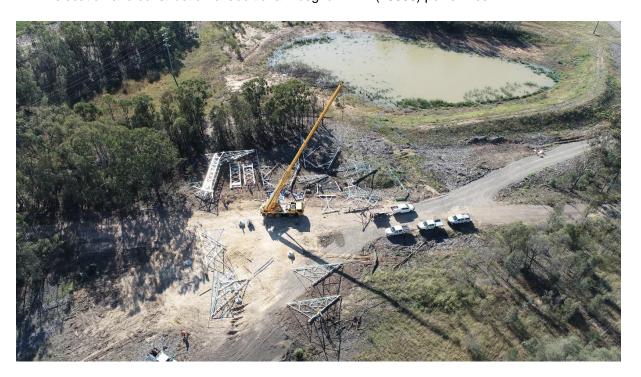
Figure 6 – Construction of a tower for the 330kV relocation

- Relocation of the Liddell to Newcastle 330 kV alignment. Works for this included the clearing of vegetation from the easement, the construction of ten new towers and the stringing of the new towers:
- Relocation of the Ausgrid 66 kV (6011) feeder alignment. These works include the clearing of the easement and construction and stringing of 27 new transmission poles; and
- Relocation and construction of additional Ausgrid 11 kV (48066) powerlines.

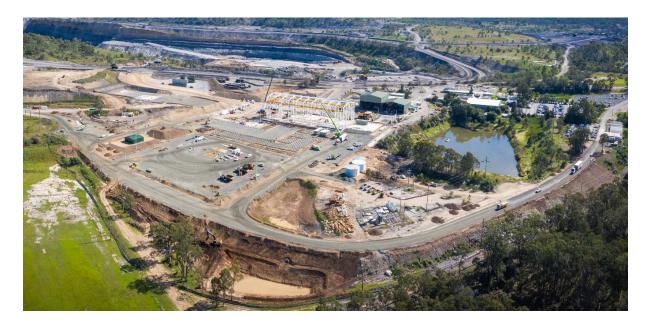
Figure 7 – Construction of the new Mine Infrastructure Area during November 2020

- Bulk Earthworks with ~200,000 m³ of excavation works;
- Construction of new wash facilities for both heavy and light vehicles;
- Construction of new maintenance facilities including a 5 bay workshop;
- New fuels and lubricants dispensing system piped to all new and existing service areas;
- Construction of new offices, bath house and facilities with modular building modules;
- New state of the art sewage and grey water treatment plant; and
- Ancillary facilities including carparks / lighting / access gates / emergency services.

Significant works were undertaken during 2020, including all bulk earthworks and substantial construction of the new infrastructure. The MIA is due to be completed in May 2021.

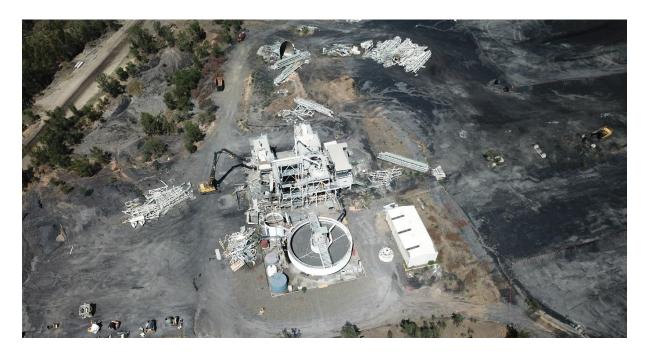
Figure 8 – Demolition of the United Coal Preparation Plant

- United Coal Preparation Plant;
- Thickener Tank;
- · Removal of residual coal from stockpile;
- All conveyors; and
- Crushing Station and Surge Bin.

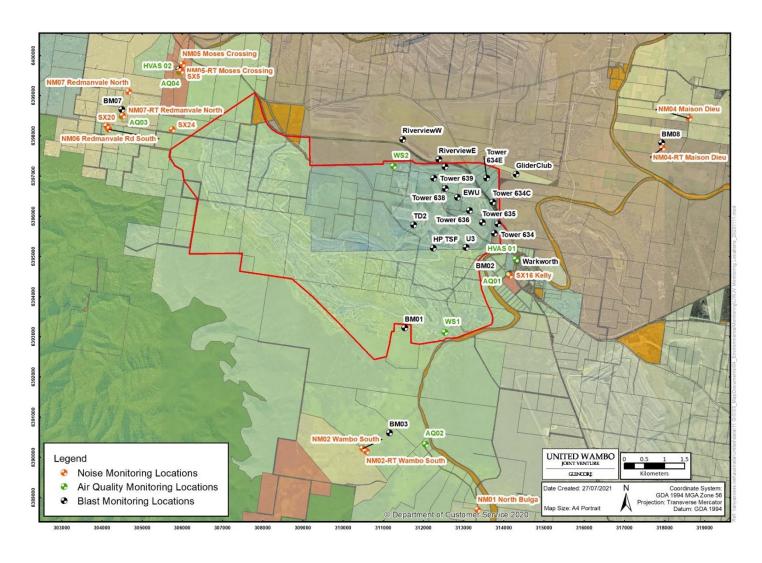
Figure 9 - United Wambo Air Quality, Noise and Blast Monitoring Locations

All monitoring locations for United Wambo are shown in Figure 9 and 10.

Monitoring data was collected at all locations outlined in the SSD 7142 and EPL 3141 consent conditions. The approved monitoring locations BM01, BM02, BM03, BM05, BM07 and BM08 (as shown in **Figure 9** – United Wambo Air Quality, Noise and Blast Monitoring Locations) are reported on in this Annual Review, as committed to in the *Blast Management Plan (Glencore 2020e)*. Summarised monitoring data for these locations are provided in **Table 6-9** to **Table 6-11**.

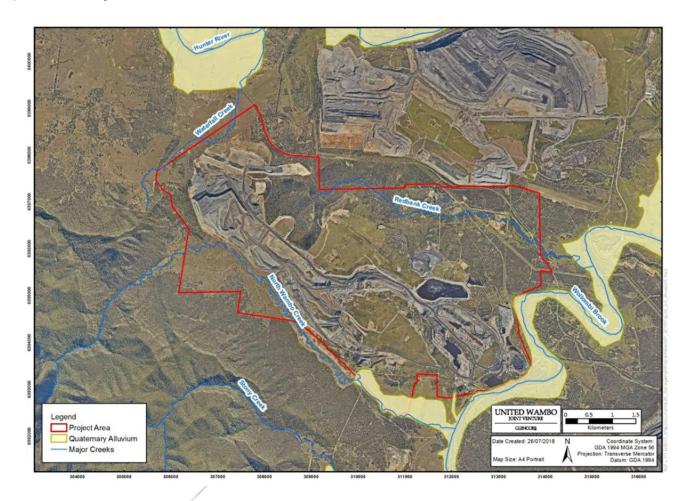
Figure 1 General Location Plan (from UWJV GWMP)

The following section provides a description of the mine operations, groundwater impacts, groundwater licensing and Conditions of Consent related to groundwater at United Wambo. The general site layout is presented in Figure 1

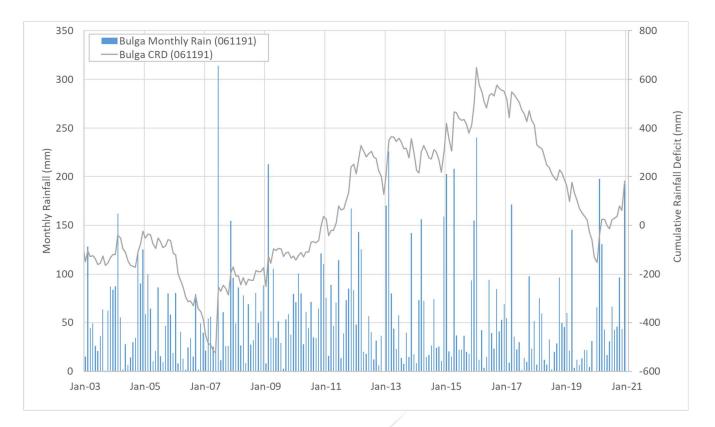
Figure 2 Cumulative Rainfall Deficit

The Bulga Station data was also used to generate a cumulative rainfall deficit (CRD) plot, also known as a Rainfall Residual Mass Curve (RMC), as seen in Figure 2. A CRD plot is provided as a comparative tool to illustrate long term climate trends and their influence on groundwater in the UWJV area. The CRD graphically shows trends in recorded rainfall compared to long-term averages and provides a historical record of relatively wet and dry periods. A rising trend in slope in the CRD graph indicates periods of above average rainfall, whilst a declining slope indicates periods when rainfall is below average. A level slope indicates average rainfall conditions.

The CRD performs an additional service: if rainfall recharge is a significant source of groundwater, the temporal variability in recorded groundwater levels can be expected to mimic the pattern of this curve. That is, natural fluctuations in the groundwater table result from temporal changes in rainfall recharge to groundwater systems. Typically, changes in groundwater elevation reflect the deviation between the long-term monthly (or yearly) average rainfall, and the actual rainfall, illustrated by the rainfall CRD.

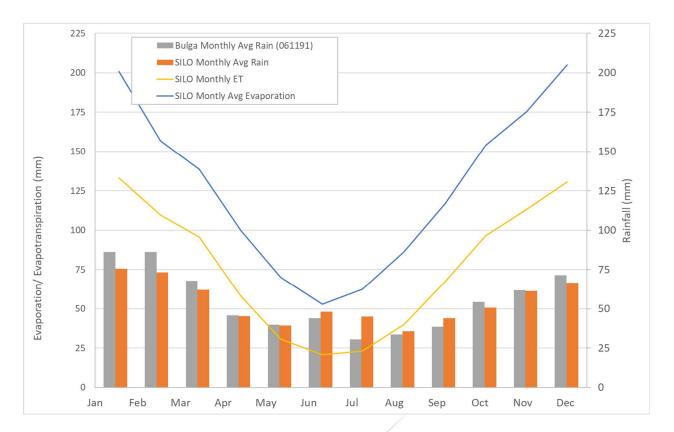
Figure 3 Monthly climate statistics from SILO and Bulga (061191)

SILO data also provides pan evaporation and calculated plant evapotranspiration (using the Penman-Monteith formulation) (see Figure 3). The bimodal plot indicates higher rainfall, evaporation, and evapotranspiration during the summer months. During the mid-year winter months evaporation and evapotranspiration is lowest.
