Miralga Creek

15/04/2021 180-LAH-EN-REP-0001 v2

Environmental Group Site: J03305

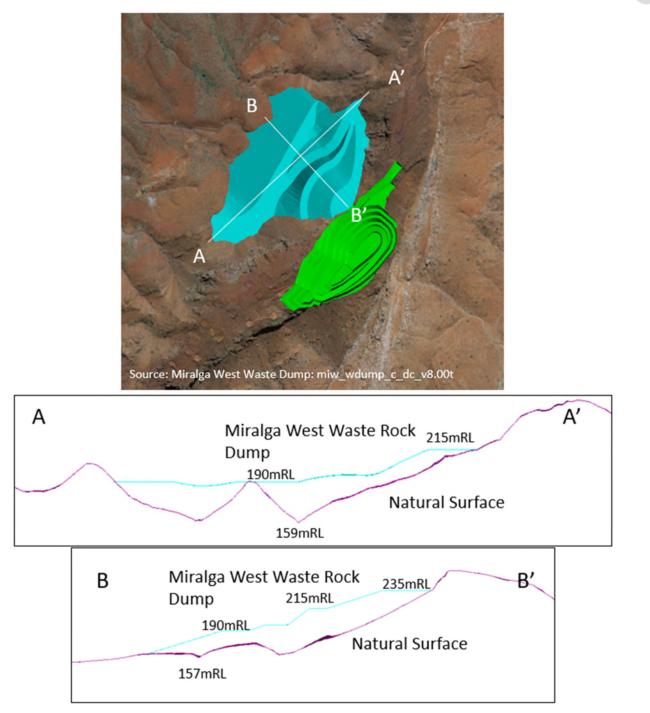
Figure 5-7: Miralga West Waste Rock Dump

Material Characteristics	Dispersive and/or erosive material that is capable of compromising the structure and stability of the activity	Yes	A small proportion of waste stored in this WRD has low erosion stability. This is only 2.1% of the total waste rock volume to be stored within this WRD. Low stability waste rock will not be exposed on final waste rock dump surfaces.

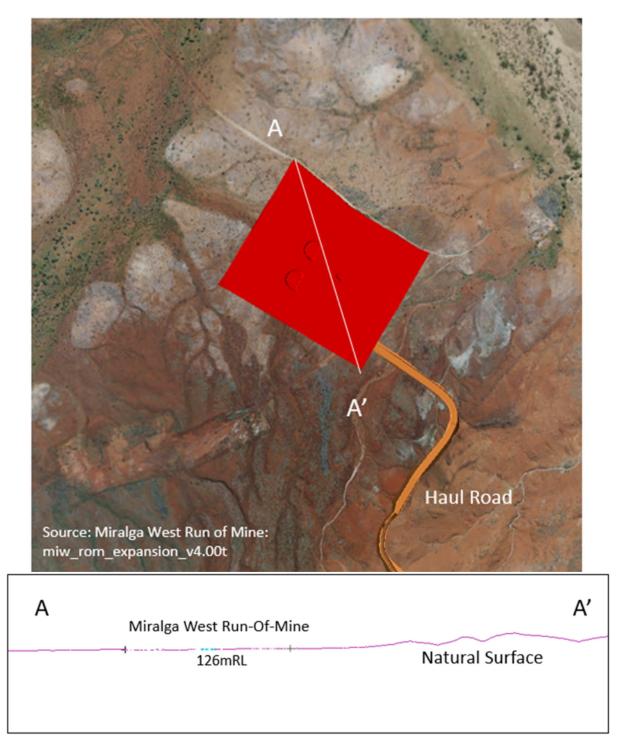
Figure 5-10: Miralga West Run of Mine Pad

Activity Type	Run of mine pad		
Mine Activity Reference	Miralga West ROM, Plant site		
Total Area (ha)	20.34 ha		
Area Per Tenement (ha)	M45/1282: 20.34 ha		
Design Description	The Miralga West ROM pad will be constructed from cut and fill of near surface outcropping material (cut max about 5 m) from the local area. Figure 5-10 is a plan view and schematic cross section of the Miralga East ROM pad from (A) to (A`) with a bearing of 75 degrees. The cross section illustrates the longitudinal design profile as intersected with the natural topography.		
	Fibrous minerals	No	
	Radioactive material	No	
Material Characteristics	Materials capable of generating acid and/or metalliferous drainage, including neutral drainage and saline drainage	No	
	Dispersive and/or erosive material that is capable of compromising the structure and stability of the activity	No

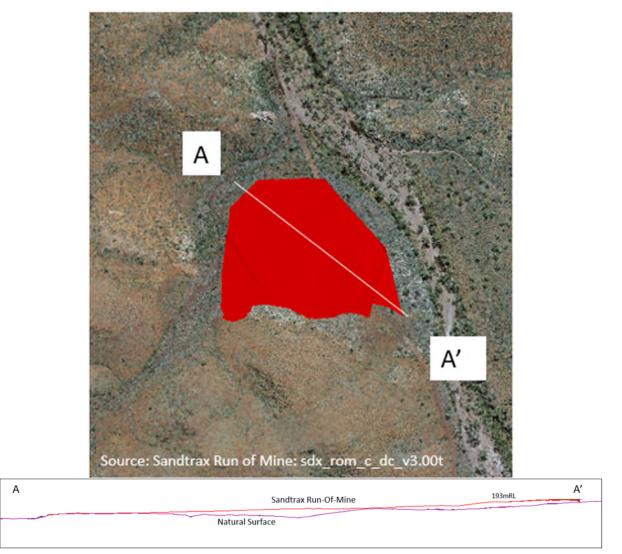
Figure 5-11: Sandtrax Run of Mine Pad

Activity Type	Run of mine pad		
Mine Activity Reference	Sandtrax ROM		
Total Area (ha)	3.21 ha		
Area Per Tenement (ha)	M45/1280: 3.21 ha		
Design Description	The Sandtrax ROM pad will be constructed from cut and fill of near surface outcropping material (cut max about 5 m) from the local area. Figure 5-11 is a plan view and schematic cross section of the Miralga East ROM pad from (A) to (A`) with a bearing of 75 degrees. The cross section illustrates the longitudinal design profile as intersected with the natural topography.		
	Fibrous minerals	No	
	Radioactive material	No	
Material Characteristics	Materials capable of generating acid and/or metalliferous drainage, including neutral drainage and saline drainage	No	
	Dispersive and/or erosive material that is capable of compromising the structure and stability of the activity	No

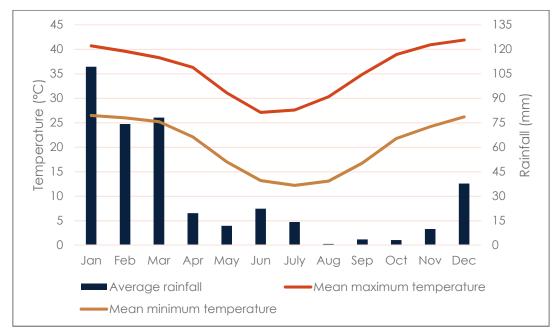
Figure 8-1: Average Monthly Rainfall and Temperatures at Marble Bar (2000 – 2021)

The Project is located 100 km south-east of Port Hedland, along the Marble Bar Road and approximately 40 km (at its nearest point) to Marble Bar. The region has a semi-desert to tropical climate with highly variable, mostly summer rainfall (McKenzie, 2002; Leighton, 2004). The Pilbara climate is significantly influenced by tropical cyclones that develop over the Indian Ocean in Australia's north (Leighton, 2004), with typical average annual rainfall occurring predominantly from January to March. The closest official Bureau of Meteorology weather station in operation is located at Marble Bar, located approximately 40 km south-east of the Project. The average annual rainfall and average monthly minimum and maximum temperatures are provided in Figure 8-1, which also shows the climate data for the Marble Bar weather station, located approximately 33 km north of the Project area (BOM, 2021). The average monthly maximum temperature ranges from 27°C to 42°C, while the average monthly minimum temperature ranges from 12.2°C to 26.5°C. Average monthly rainfall ranges from 0.7 mm to 109.3 mm, while the average annual rainfall is 403.1 mm.

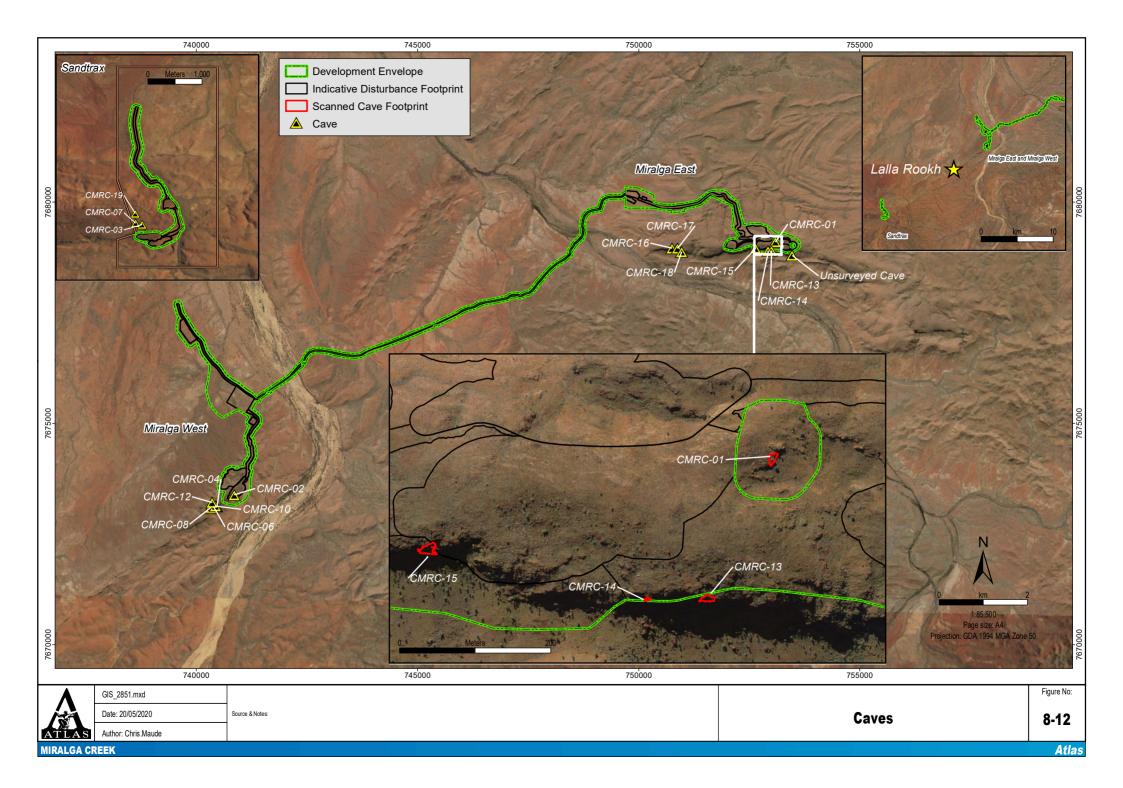
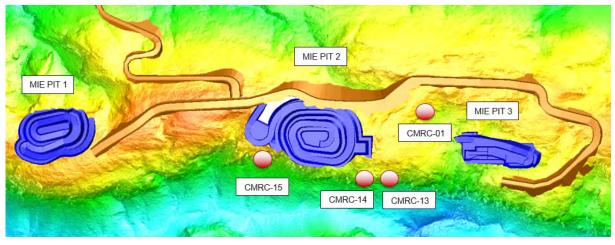
Figure 8-13: Conceptual Layout of Pits, Ramps and Caves at Miralga East

A number of caves at Miralga East have internal chambers extending back into the ridge, close to proposed pits. Figure 8-13 shows the conceptual layout of pits and ramps at Miralga East with respect to Ghost Bat roost caves:

- Category 2 roosts:
 - o CMRC 15
- Category 3 roosts:
 - o CMRC-14
- Category 4 roosts:
 - o CMRC-13
 - o CMRC-01 (technically an overhang rather than a cave).

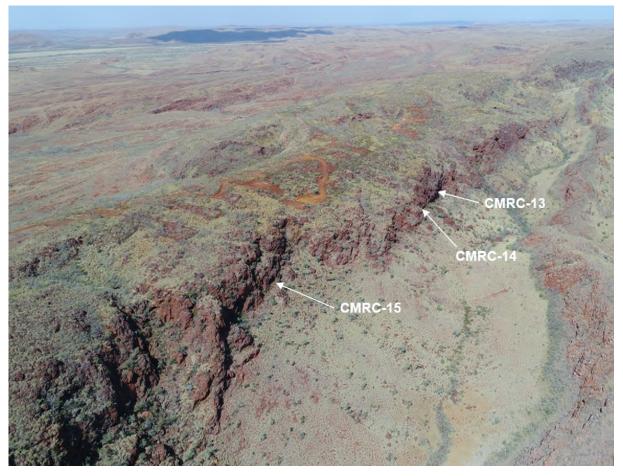
Figure 8-14: Aerial View Looking East Along the Escarpment Showing Locations of Caves at Miralga East

Figure 8-14 shows an aerial view of the ridge. The locations of three caves of particular interest – caves CMRC-13, -14 and -15 – are indicated along the bottom of the southern side of the ridge.

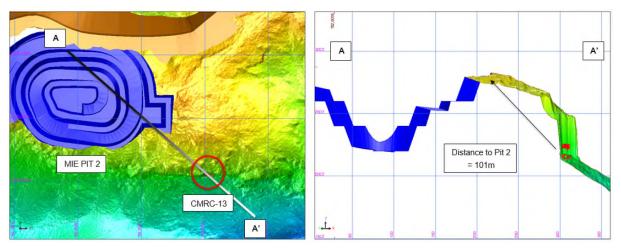
Figure 8-15: Cross-section of Cave CMRC-13 (Category 4) and Miralga East Pit 2

Cave CMRC-13 is a category 4 shallow cave located at the bottom of a ridge line on the opposite face of the ridge to Miralga East pit 2 (Figure 8-15). It is approximately 101 m from the edge of pit 2 and approximately level with the base of the pit.

Pells Sullivan Meynink (PSM) conducted a geotechnical assessment of caves CMRC-13, -14 and -15 (PSM, 2019; Appendix N), followed by a review of the available geological, geotechnical and cave information to qualitatively assess the potential impact of proposed mining activities (primarily drilling and blasting) on the structural integrity of the three caves. The review concluded that (PSM, 2020):

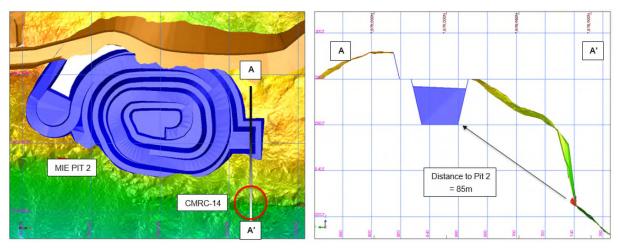
Figure 8-16: Cross-section of Cave CMRC-14 (Category 3) and Miralga East Pit 2

Cave CMRC-14 is a shallow category 3 overhang immediately west of CMRC-13. It is approximately 85 m from the nearest part of the pit shell at Miralga East pit 2 (Figure 8-16).

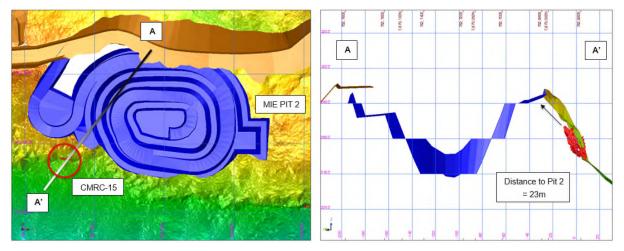
Figure 8-17: Cross-section of Cave CMRC-15 (Category 2) and Miralga East Pit 2

Cave CMRC-15 is a deep, category 2 cave located southwest of Miralga East pit 2. It is approximately 300 m west of caves CMRC-13 and -14, which are further along the base of the same ridge. The cave extends backwards and upwards into the ridge, its internal chamber measuring approximately 16 m from the entrance to the innermost extremity. The rear of the cave is separated from the closest part of Miralga East pit 2 by 23 m (Figure 8-17).

As this was a qualitative review, PSM recommended that the effect of blasting be predicted and evaluated to determine a blasting strategy to mitigate any effects on cave CMRC 15. In consultation with Bob Bullen, Atlas commissioned Blast It Global to model blasting impacts, which are discussed in more detail in Sections 8.5.2.3 and 8.5.2.5.
