# BHP

## Mt Arthur Coal

Annual Review FY20

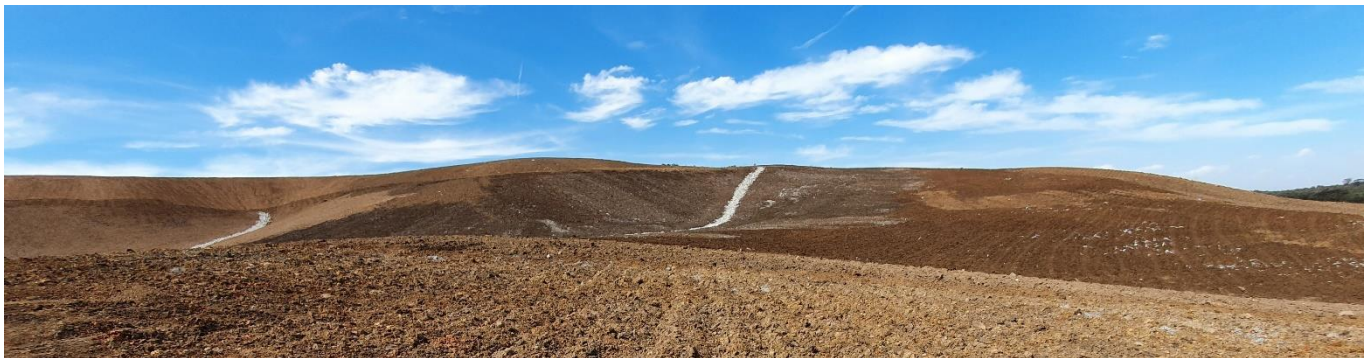
**Figure 6: Rehabilitation at Saddlers Central emplacement using natural landform design**

The final landform design can be seen in Figure 6. Figure 6 shows bulk shaping prior to topsoil placement. Although this geomorphic design has been implemented on other sites within NSW and also worldwide there are many defining characteristics that restrict its use such as space, waste characterisation, rainfall, availability of suitable rock, availability of mulch, final landuse, landform height and steepness of the landform. Mt Arthur Coal has larger higher landforms than other sites in the Hunter Valley, and is also space constrained for emplacement area. The resultant design aligns with industry best practice, but will be monitored over the coming years to ensure further natural landform design incorporates learnings and improvement from the current work.
