# BHP

## Mt Arthur Coal

Annual Review FY21

29 September 2021

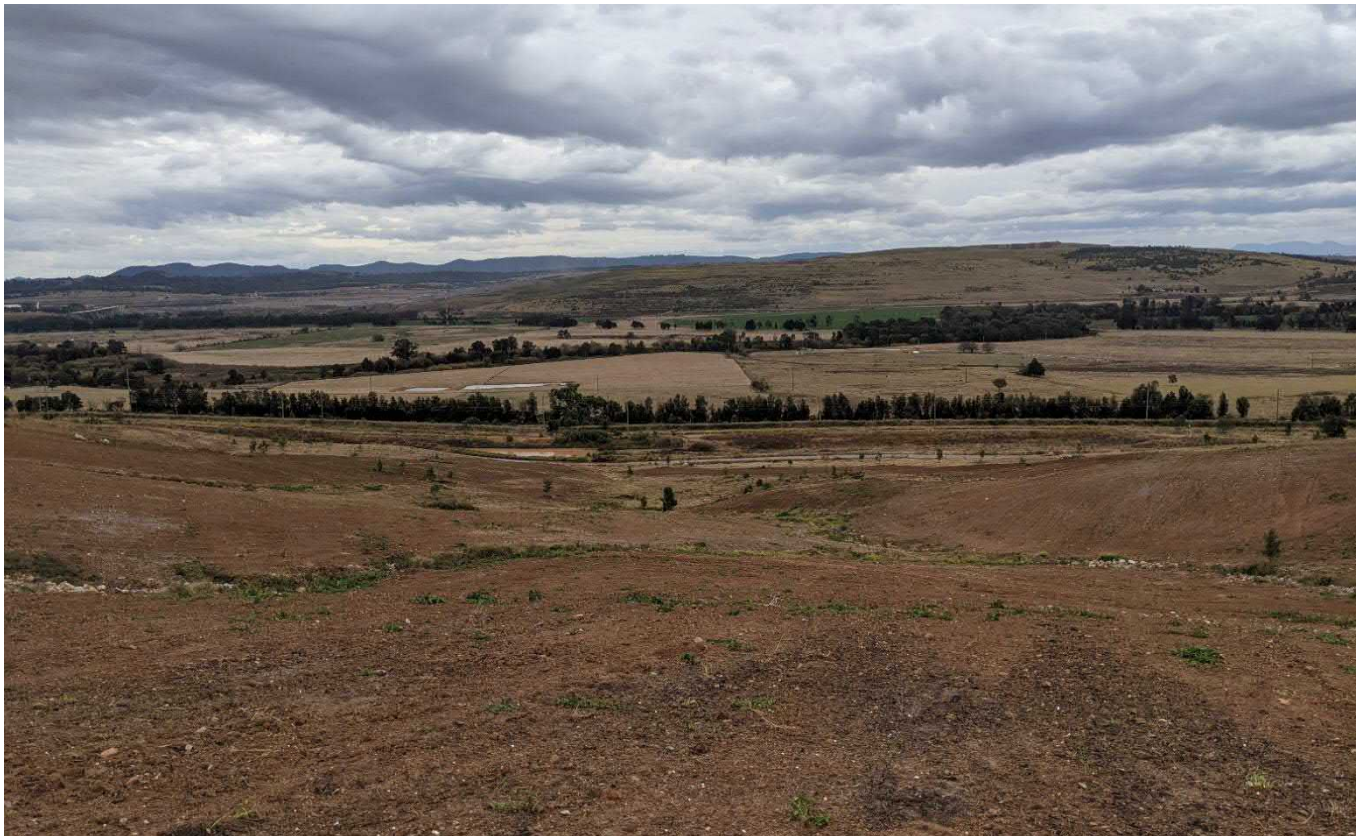
**Figure 8 VD5 following maintenance work looking north**

A trial into temporary stabilisation via the spreading of hay mulch was also conducted in the VD5 northern area. The trial was initially delayed due to the drought impacting availability of hay, however, rain damaged hay was sourced in the reporting period which allowed for initial trials to commence. The trial was focussed in determining the optimal method for spreading hay to gain appropriate coverage.

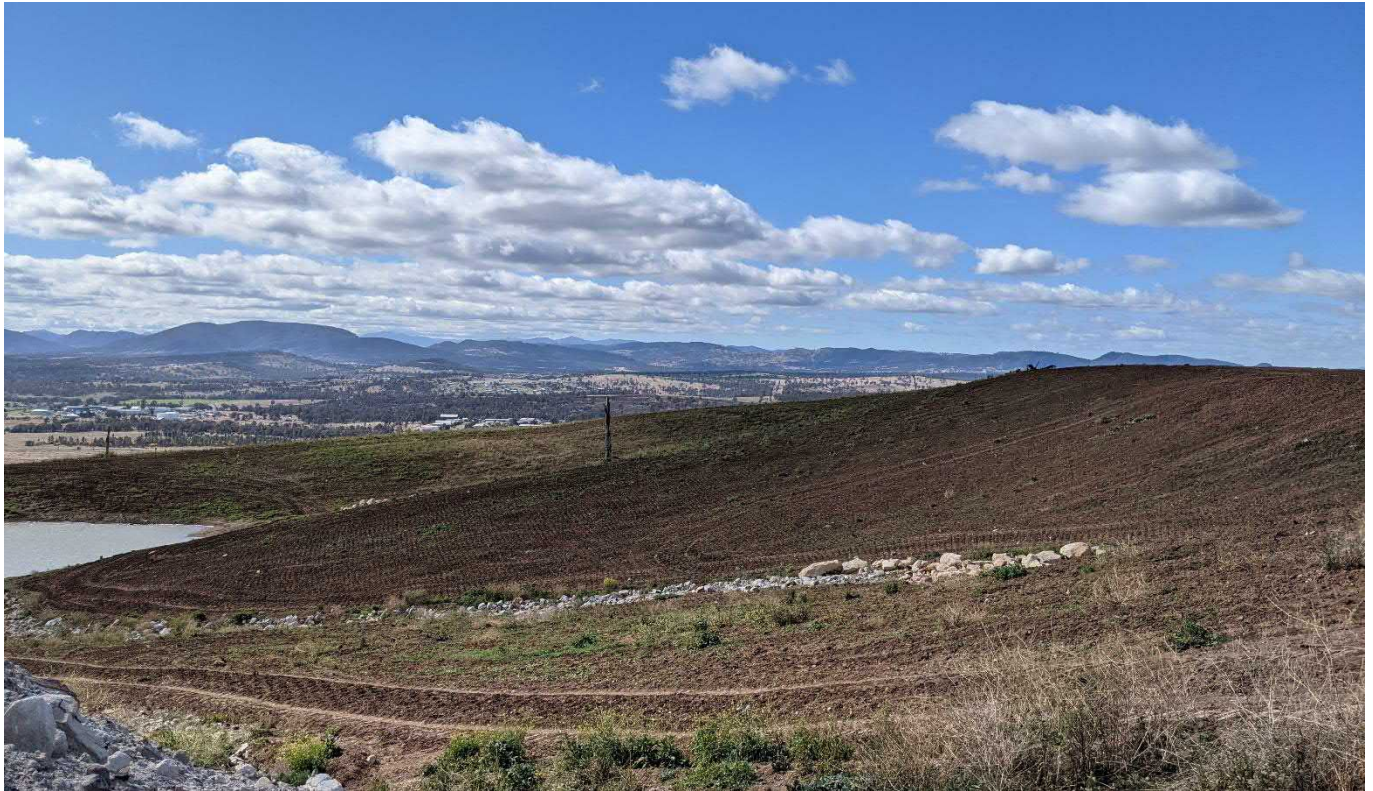
**Figure 9 VD4 following maintenance work looking east**

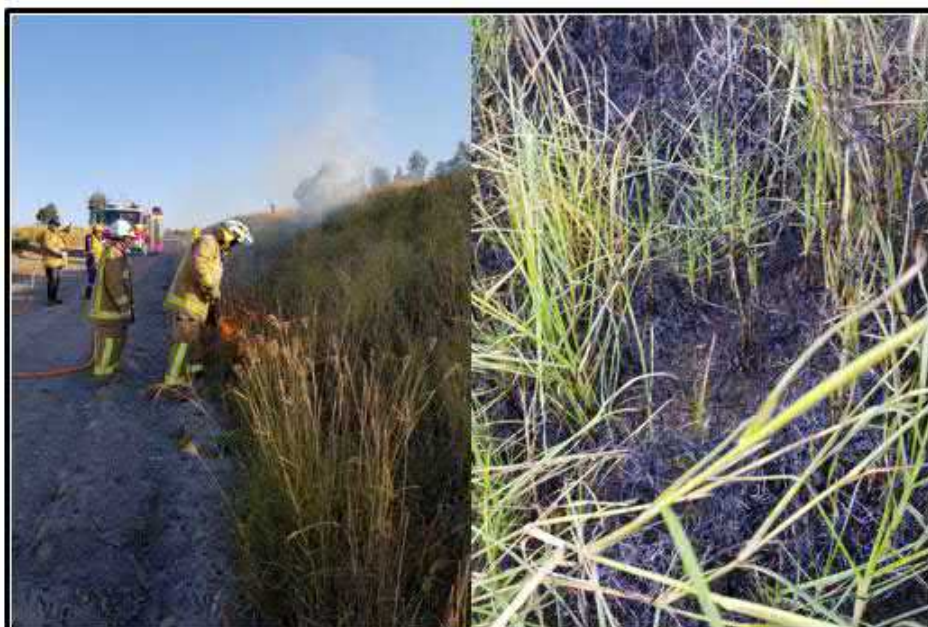
**Figure 10 Controlled burn on VD1 in exotic and depleted grasslands**

A trial into a controlled burn was carried out during the reporting period.

The results indicate that the grass in the area had not cured sufficiently to burn hot enough adequately treat exotic grasses. MAC plans follow up trials will take place in winter 2022 to determine potential of controlled burns in weed management. This will be in conjunction with other weed management practices to determine the most cost effective method for treatment of exotic grasses.

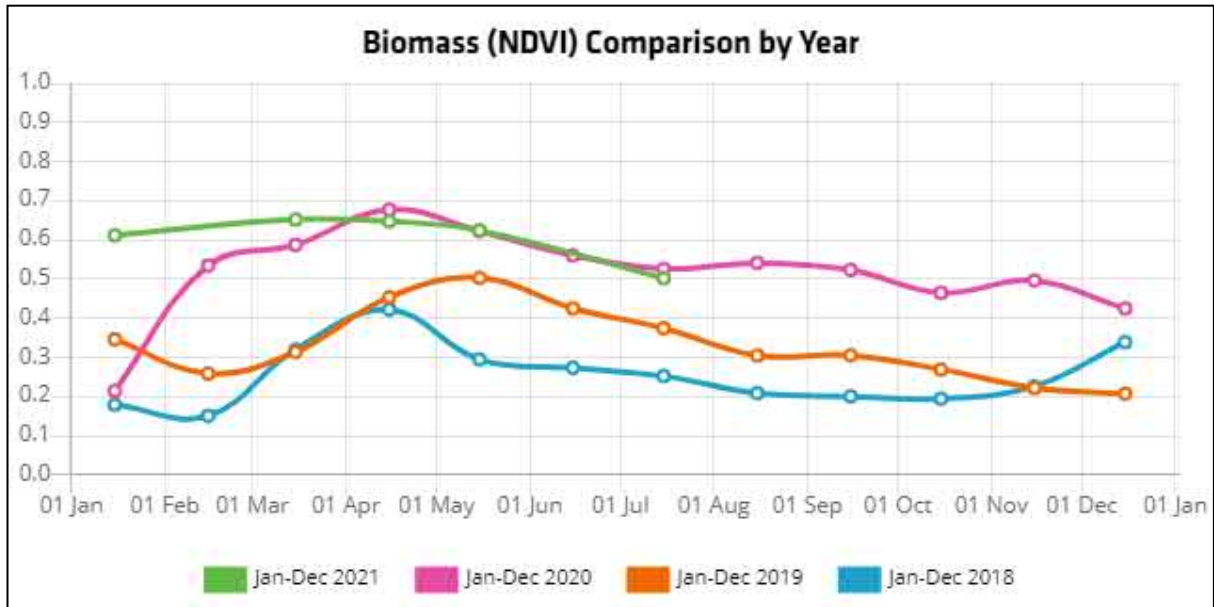
**Figure 11 Biomass (NDVI) time series of VD1**

Vegetation condition is measured using the Normalized Difference Vegetation Index (NDVI). The NDVI is strongly correlated with the condition and abundance of vegetative biomass. The NDVI provides a quantitative measure of relative plant condition. As biophysical properties of vegetation may differ between species (e.g. glaucousness), so too is there variation within the measured response of vegetation indices, and what denotes good or poor health. NDVI measurements are therefore relative to the species under observation. An example of the analysis is presented in Figure 11. The VD1 sequence in Figure 11 shows the impact of drought and increased rainfall from 2019 to 2021.

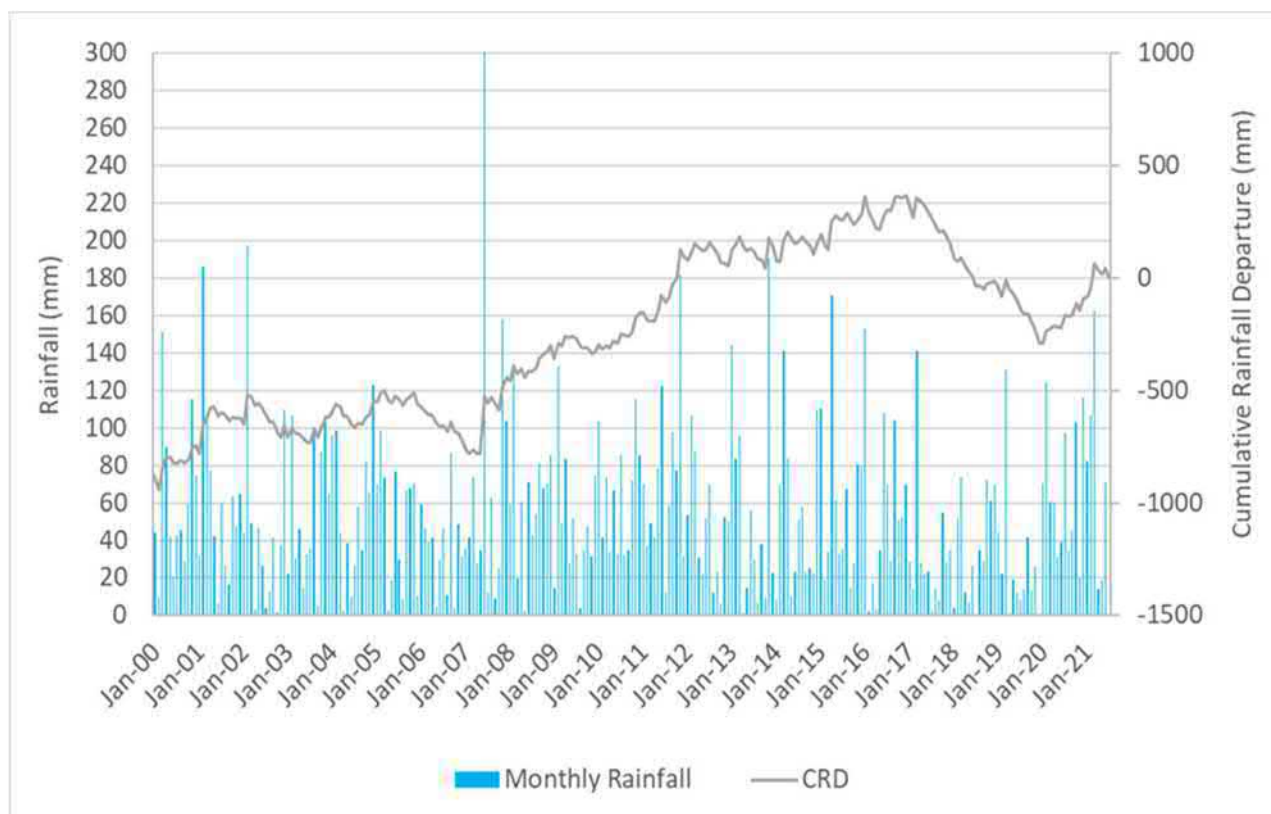
**Figure 2.1** SILO Monthly Rainfall and CRD

**Figure 2.1** shows the CRD and total monthly rainfall. The graph indicates the area has generally experienced a period of relatively average rainfall from 2000 to 2007. Above average rainfall was experienced from 2007 to 2017. From 2017 to 2020 the area experienced below average rainfall and since the start of 2020 the area has experienced above average rainfall.

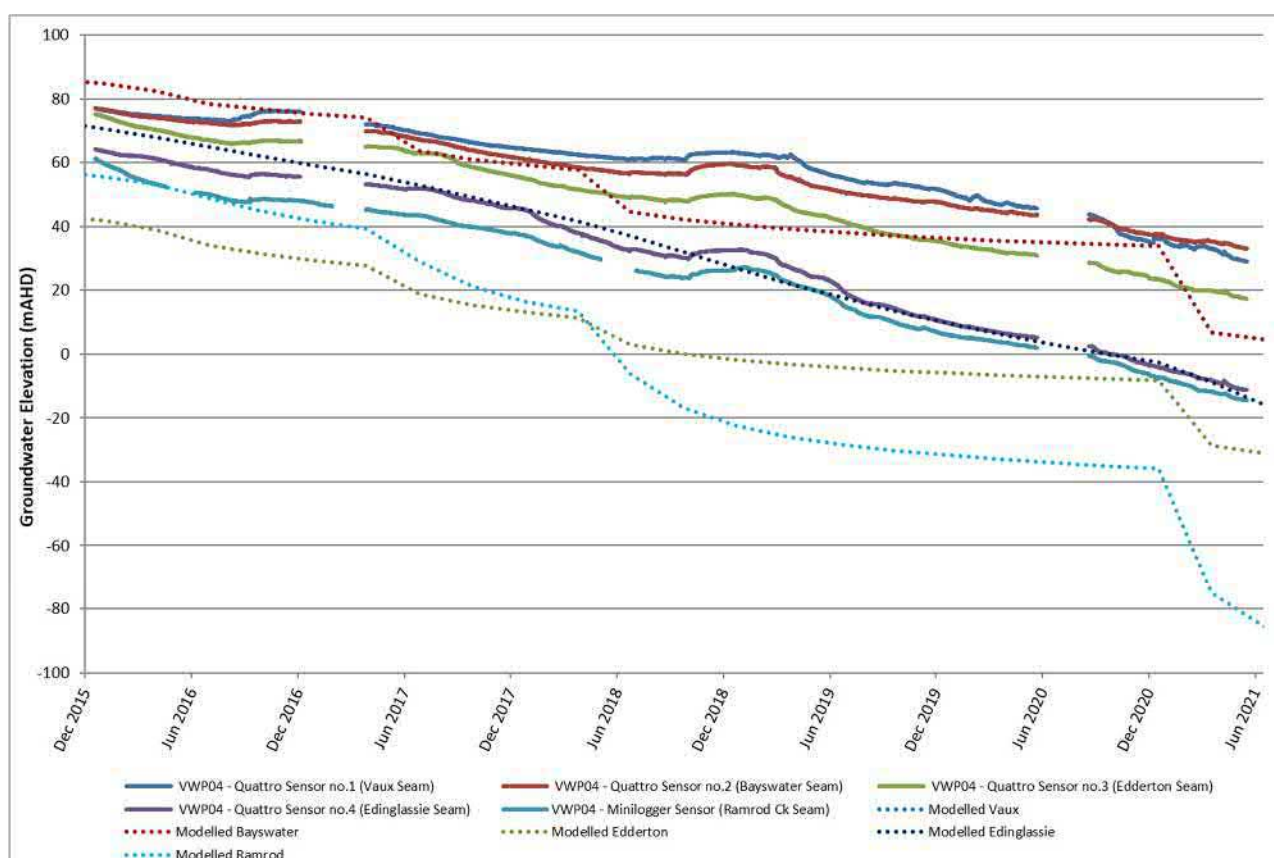
**Figure 4.1 VWP04 Modelled versus Observed Levels**

Bore ID	Screened Lithology	Location	Comment
VWP04	Vaux Seam Bayswater Seam Edderton Seam Edinglassie Seam Ramrod Creek Seam	On site - north of MAC open pit	<p>Levels in the Vaux, Bayswater, Edderton, Edinglassie, and Ramrod Creek Seams exceeded the 2020 trigger levels between October 2020 and June 2021.</p> <p>The continuing declining groundwater level trend represents mining induced depressurisation as predicted for the approved operations by SLR as shown in <b>Figure 4.1</b>.</p> <p>SLR (2020b) predicted continued drawdown in this area with simulated water levels ranging between 4.72 and -85.5 mAHD. The measured water levels ranged from 29 to -14.4 mAHD. The SLR (2020b) model predicted greater drawdown than observed and the trigger levels should be reviewed to align with levels in the latest model predictions.</p>

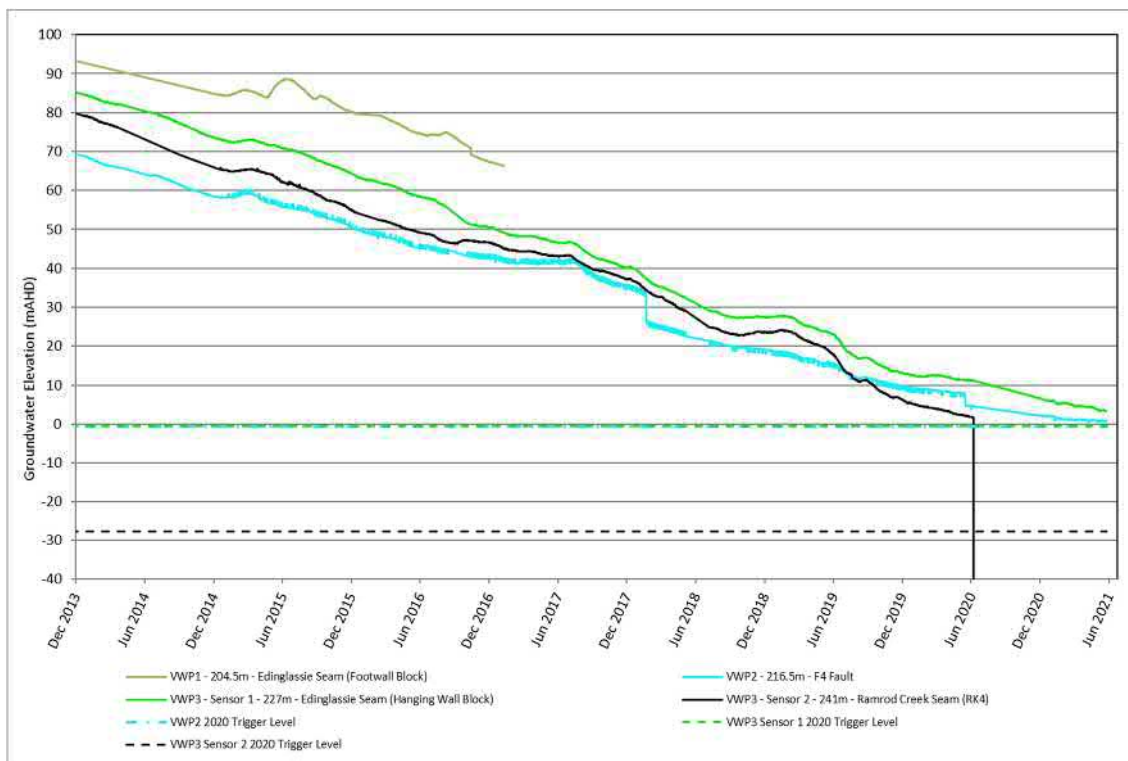
**Figure 7.1** Groundwater levels in Permian Coal Measures Adjacent to the Cut-off Wall

The relatively stable groundwater level trends shown in the alluvial bores indicate that the depressurisation observed in the Permian coal measures does not appear to have impacted on the Hunter River alluvium groundwater levels. Monitoring of the Hunter River alluvium shows no adverse impact from mining activities on alluvial groundwater conditions and beneficial use of groundwater.
