UNITED WAMBO

JOINT VENTURE

2021 Annual Review

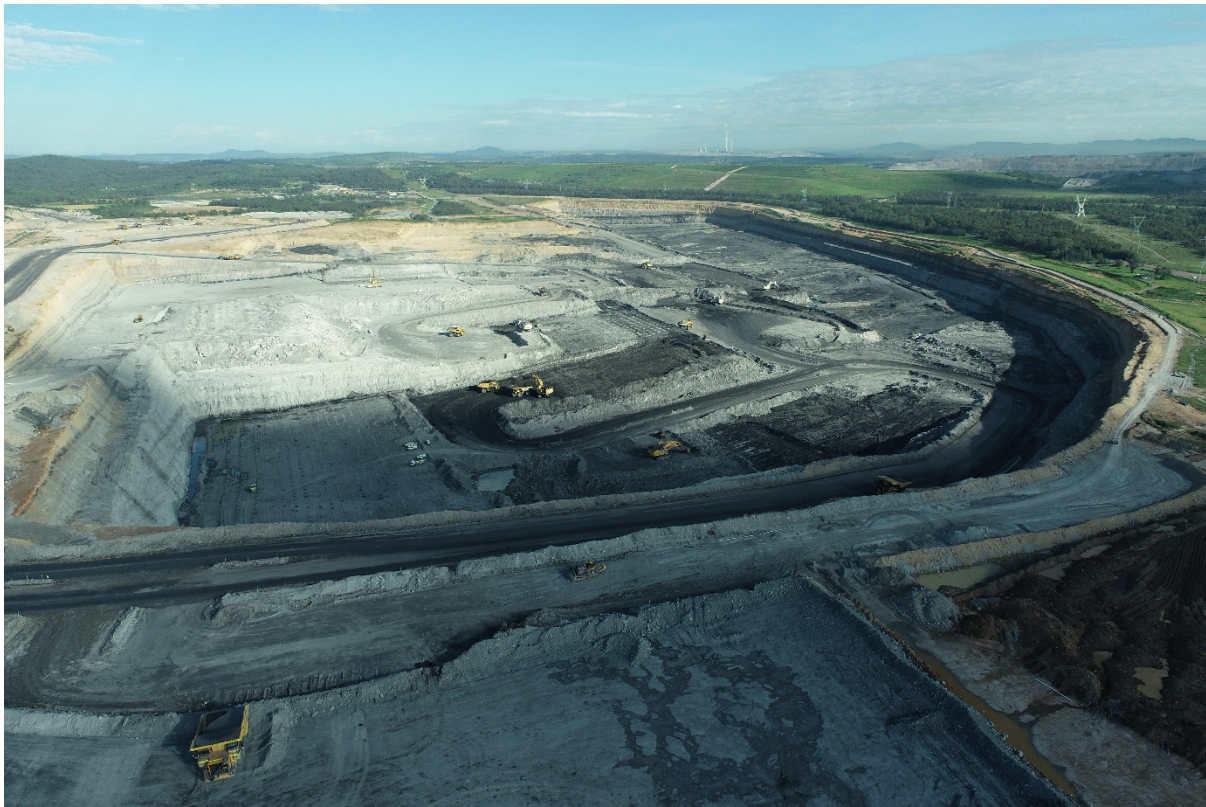
Figure 4-1 United Open Cut operations in December 2021

During 2021, mining operations continued within the United Open Cut, focusing on the main United Open Cut box cut and the continued development of the United Starter Pit. Following the removal of the 330kV powerlines in March 2021, the two mining areas were combined to form one pit. Development of the overburden emplacement areas continued, focused on the areas surrounding the

Wambo Hunter Pit Tailings Dam. The out-of-pit emplacement areas were mostly over previously mined and areas previously rehabilitated by Wambo. Mining also continued within the Wambo Open Cut's Montrose Pit, including the Montrose Ridge area. Overburden from Wambo Open Cut is emplaced in the in-pit emplacement areas. Coal mined from both the United and Wambo open cuts was transported to the main ROM Stockpile.

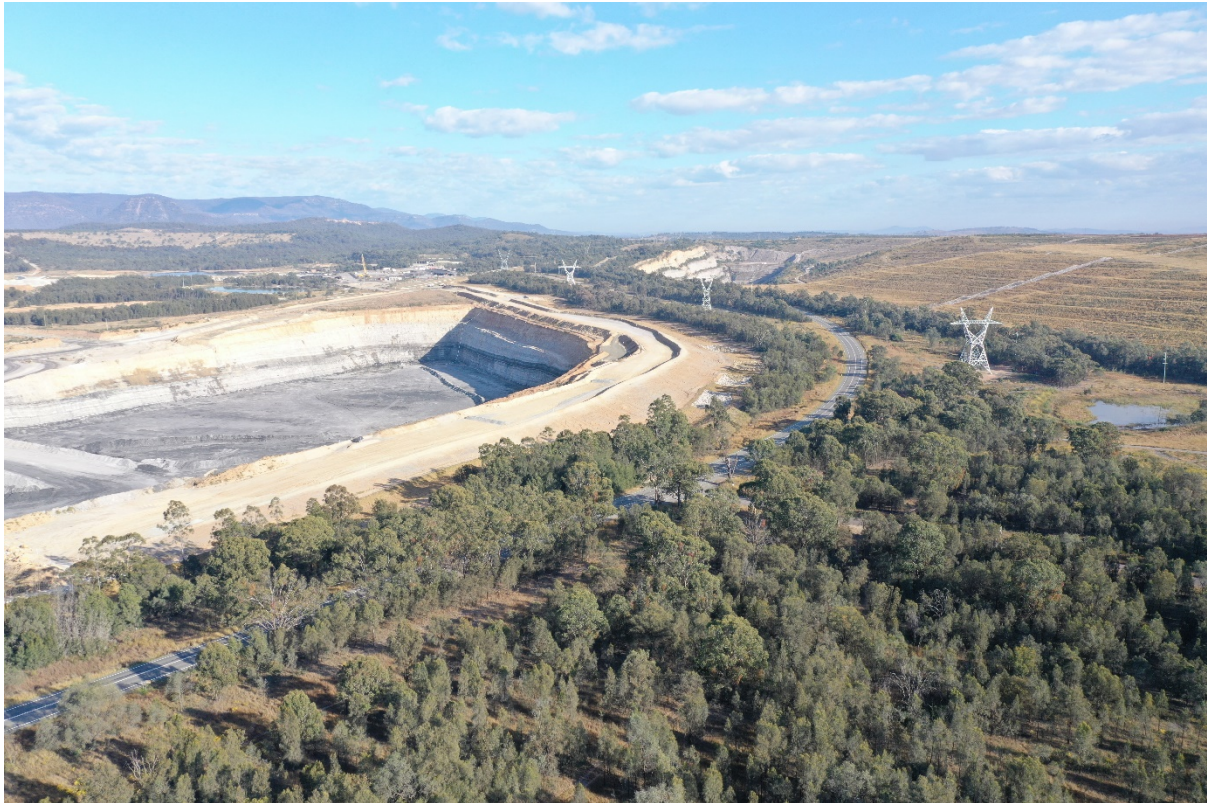
Figure 4-2 New constructed towers for the 330kV relocation

- Relocation of the Liddell to Newcastle 330 kV alignment. Works for this included the construction of ten new towers and the stringing of the new towers during 2020, with the cutover of the power undertaken in March 2021. The existing towers were demolished during April 2021.

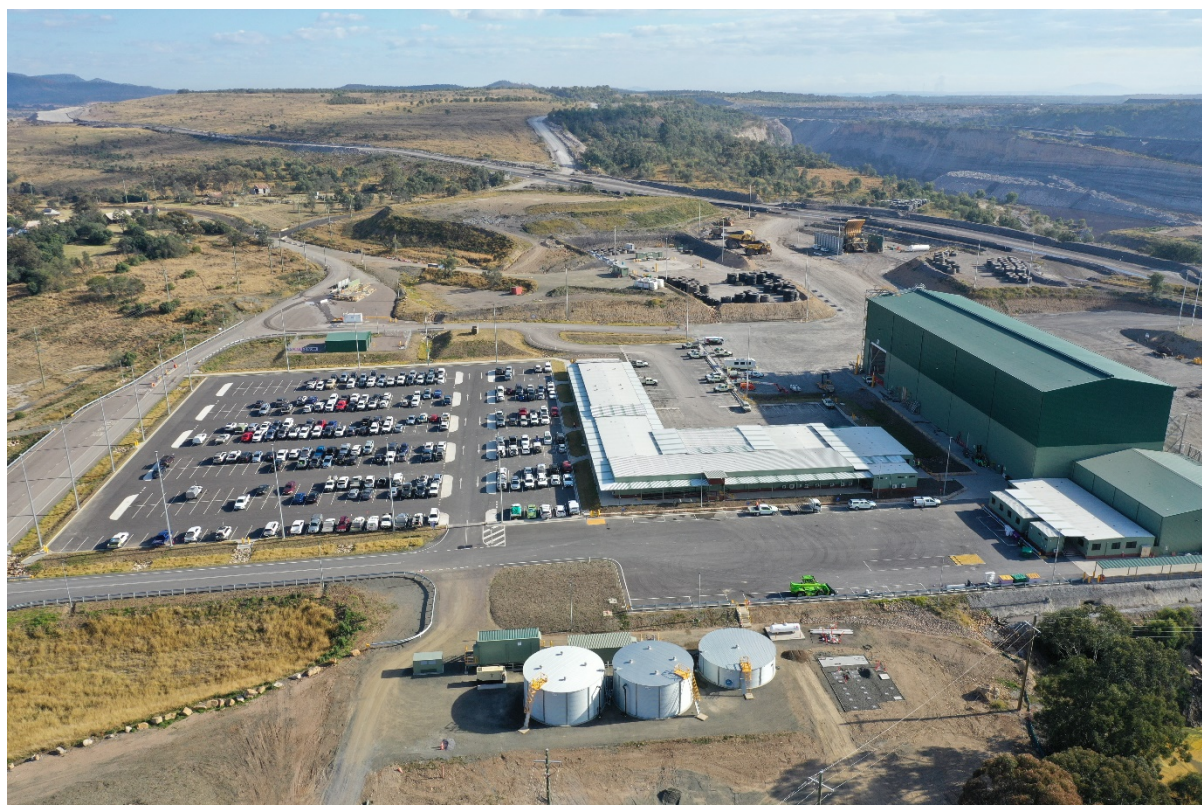
Figure 4-3 Constructed South MIA

- Bulk Earthworks with ~200,000 m³ of excavation works;
- Construction of new wash facilities for both heavy and light vehicles;
- Construction of new maintenance facilities including a 5 bay workshop;
- New fuels and lubricants dispensing system piped to all new and existing service areas;
- Construction of new offices, bath house and facilities with modular building modules;
- New state of the art sewage and grey water treatment plant; and
- Ancillary facilities including carparks / lighting / access gates / emergency services.

The works were completed during 2021, with operations personnel moving into the buildings in August 2021.
