# **WAMBO COAL PTY LTD 2021 ANNUAL REVIEW**

1 January – 31 December 2021

<b>Name of operation</b>	Wambo Coal Mine
<b>Name of operator</b>	Wambo Coal Pty Ltd
<b>Development consent /Project Approval #</b>	DA305-7-2003, DA177-8-2004, EPBC 2003/1138, EPBC 2016/7636, EPBC 2016/7816
<b>Name of holder of development consent</b>	Wambo Coal Pty Ltd
<b>Title/Mining lease #</b>	CL365, CL374, CL397, CCL743, ML1402, ML1572, ML1594, ML 1806, A444, EL7211
<b>Name of holder of mining lease</b>	Wambo Coal Pty Ltd
<b>Water licence #</b>	As per <b>Table 3</b>
<b>Name of holder of water licence</b>	Wambo Coal Pty Ltd
<b>MOP/RMP start date</b>	1 December 2020
<b>MOP/RMP end date</b>	31 December 2023
<b>Annual Review start date</b>	1 January 2021
<b>Annual Review end date</b>	31 December 2021
<p><b>I, Peter Jaeger, certify that this audit report is a true and accurate record of the compliance status of Wambo Coal Mine for the period 1 January 2021 to 31 December 2021 and that I am authorised to make this statement on behalf of Wambo Coal Pty Ltd.</b></p> <p><i>Note:</i></p> <p>a) <i>The Annual Review is an ‘environmental audit’ for the purposes of section 122B(2) of the Environmental Planning and Ass

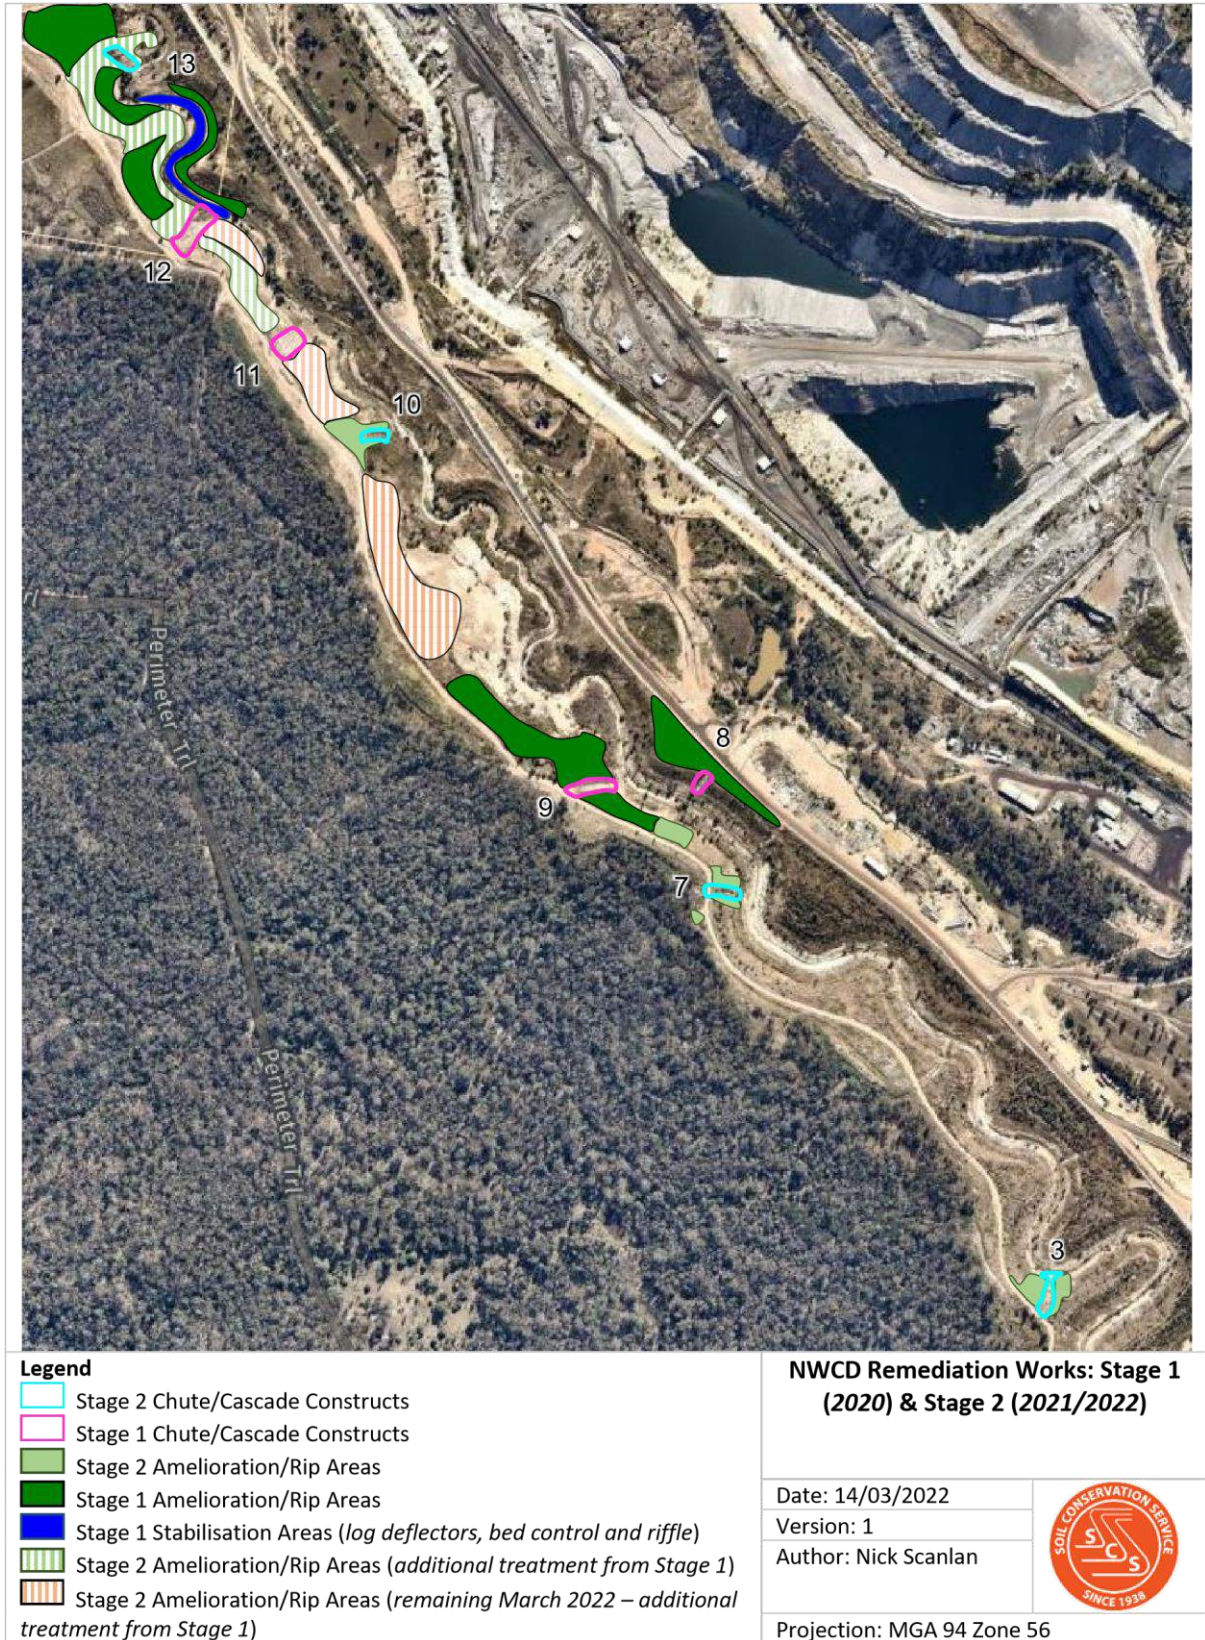
**Figure 7: North Wambo Creek Remediation Works**

- quarterly vegetation monitoring and maintenance in the existing remediation areas;
- amelioration and revegetation;
- re-building of rock chutes; and
- remediation of subsidence impacted areas.

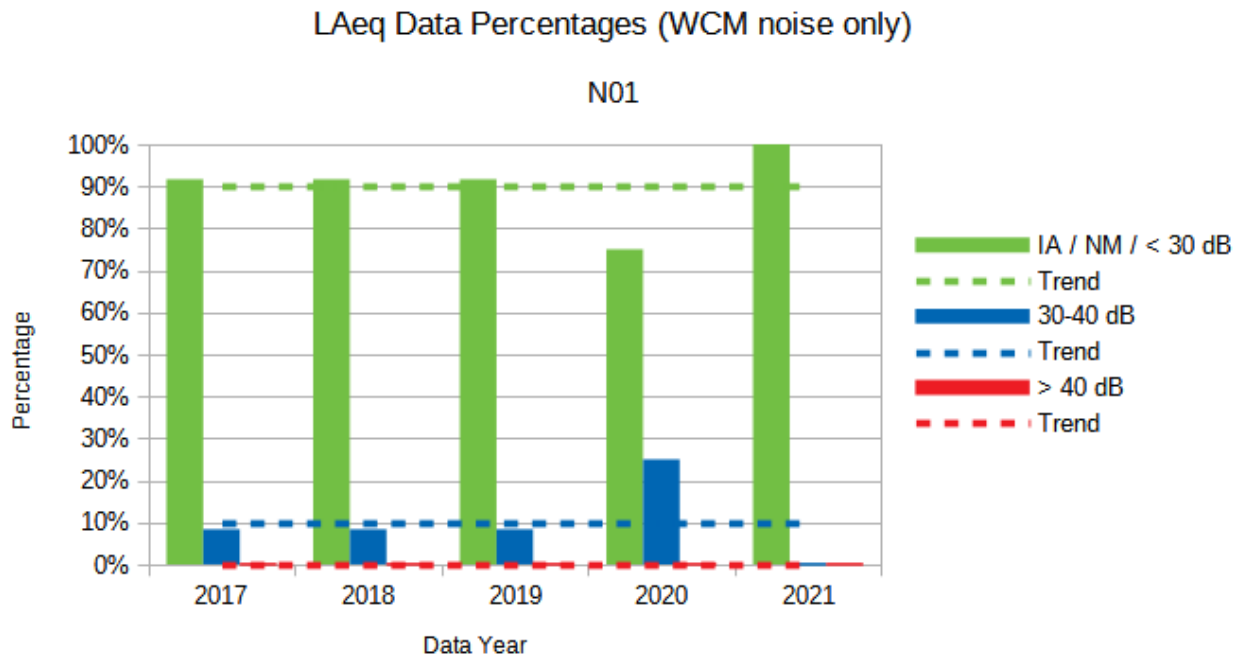
As meteorological conditions and applicability of noise criteria have not been considered in long-term trend analysis, potential exceedances indicated in the following graphs may not have been applicable depending on weather conditions at the time of monitoring.

Figure 2: Attended noise monitoring data, N01

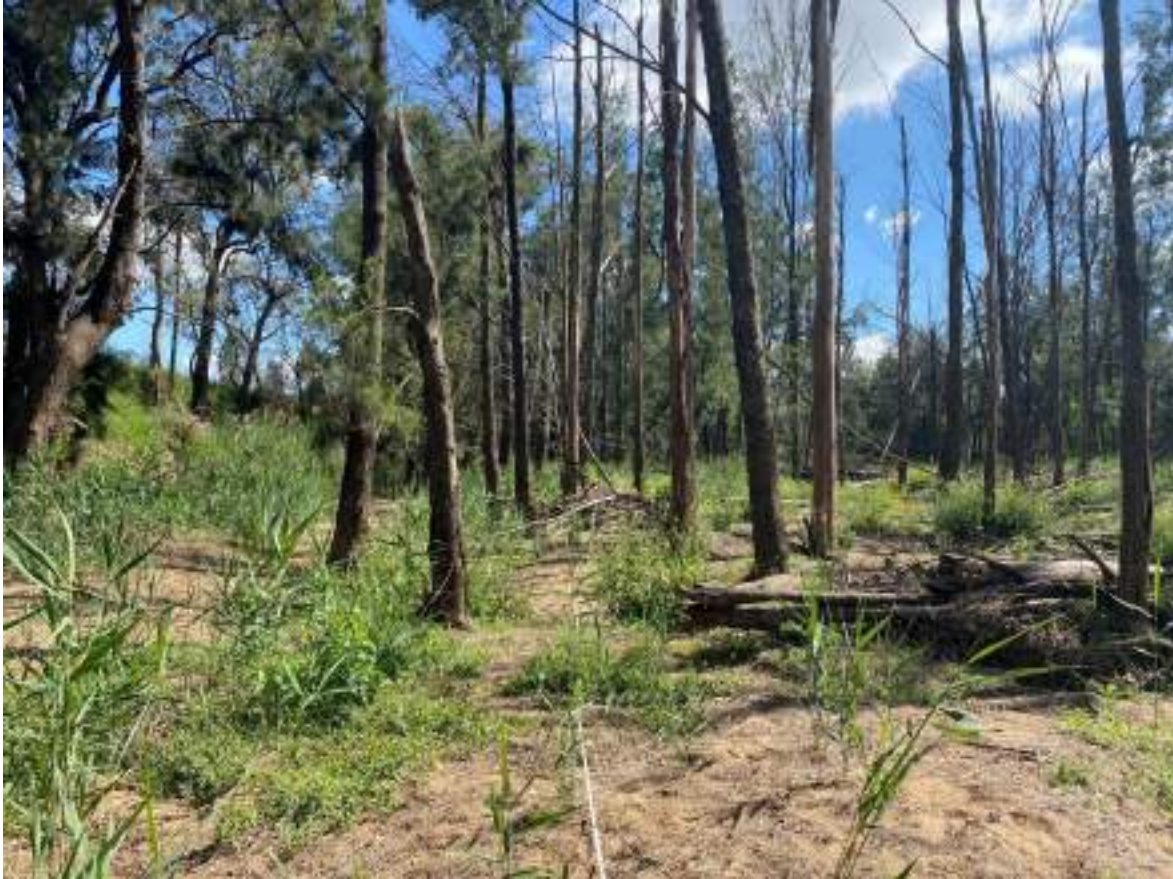
The River Red Gum / River Oak riparian woodland at WCPL is typical of other remaining stands throughout the Hunter Valley, with generally a high cover of weed species and a reduced number of native species (Photograph 1).

**Photograph 1: River Red Gum / River Oak riparian woodland wetland on North Wambo Creek in 2021 (Site V1-A1 within the Wollombi Brook channel)**

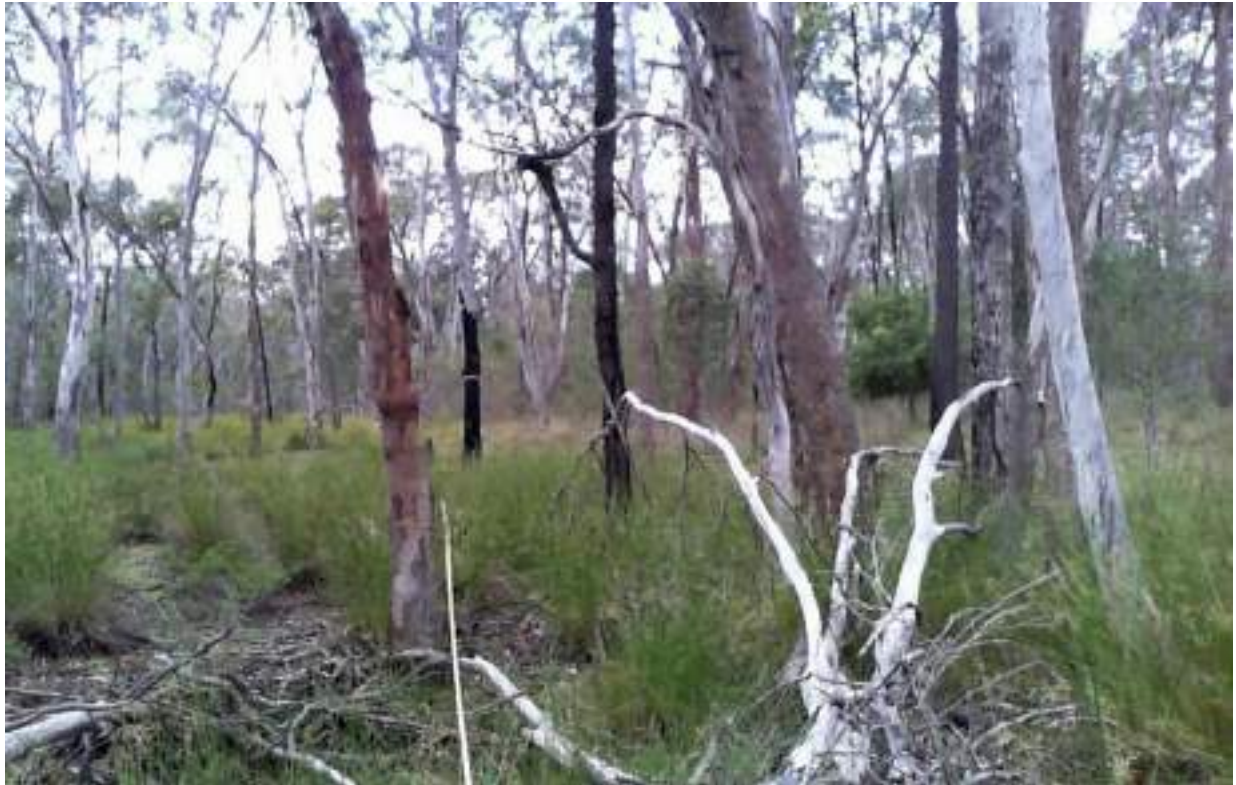
**Photograph 2: Flora monitoring site V3-B1 during 2015**

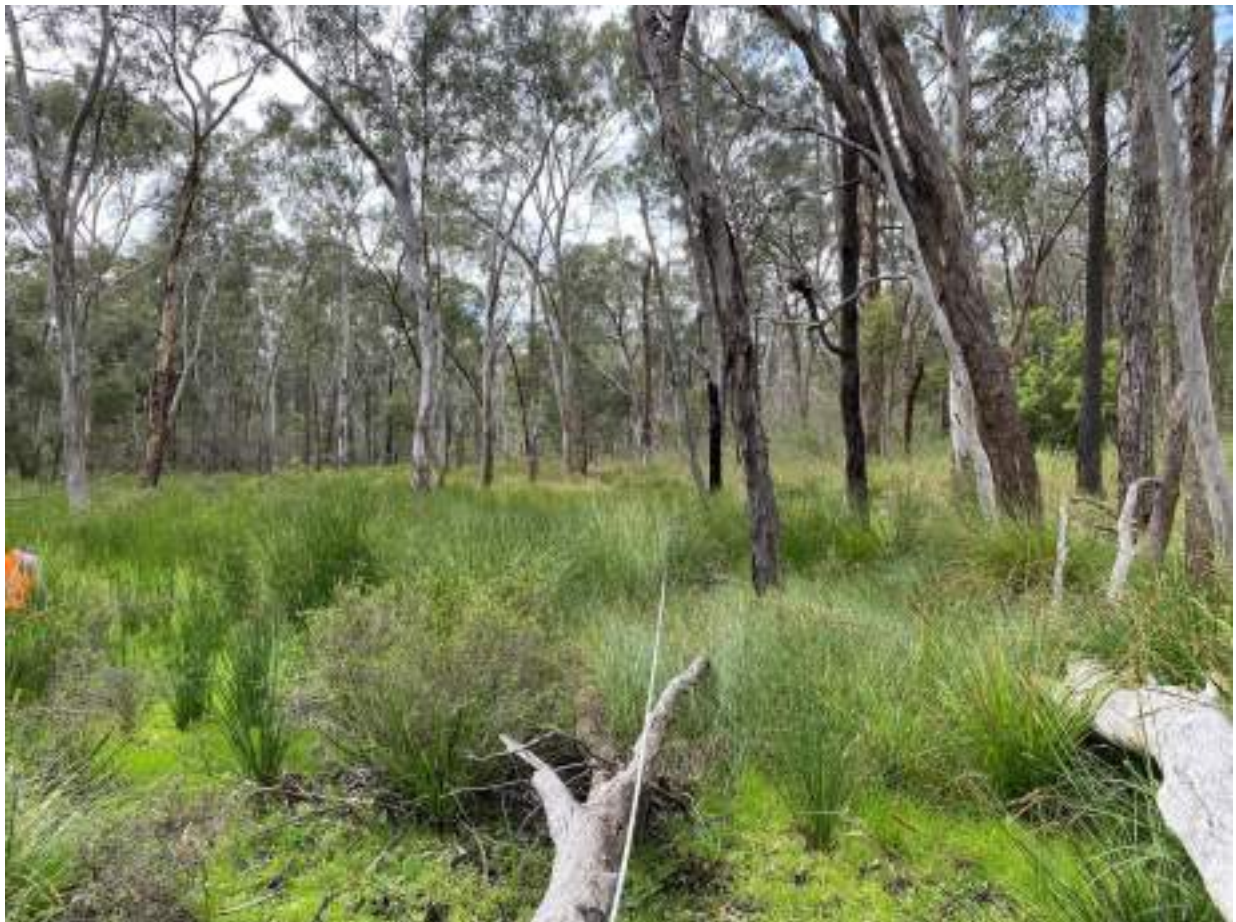
**Photograph 3: Flora monitoring site V3-B1 during 2021**

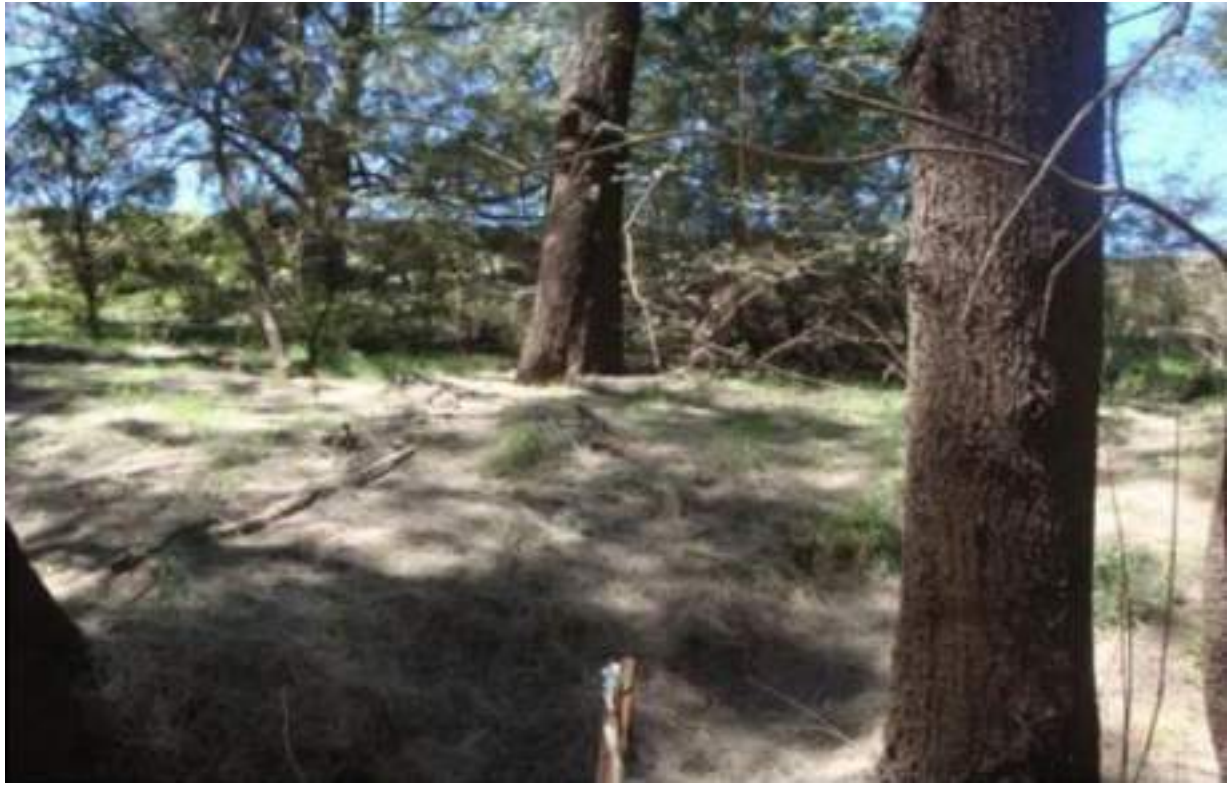
**Photograph 4: Monitoring site A3 during 2013**

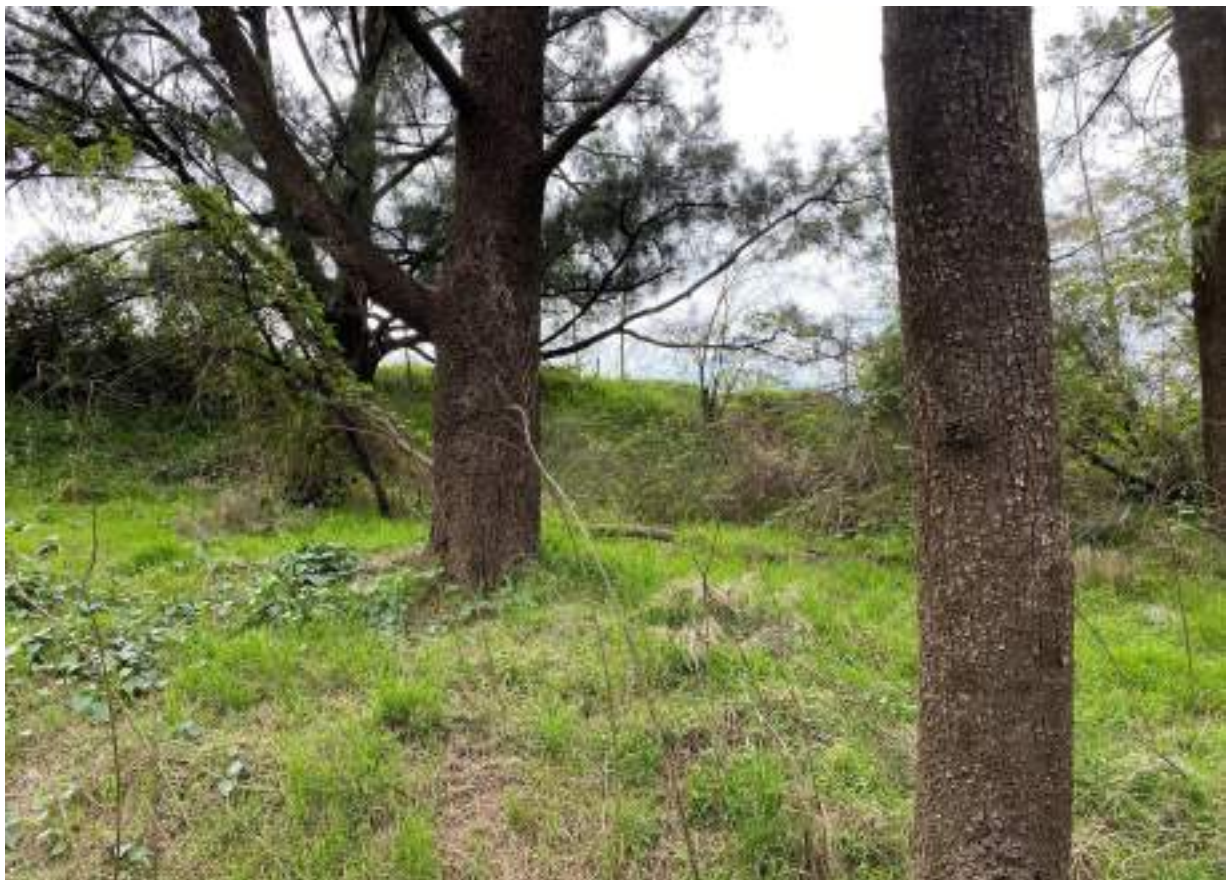
**Photograph 5: Monitoring site A3 during 2021**

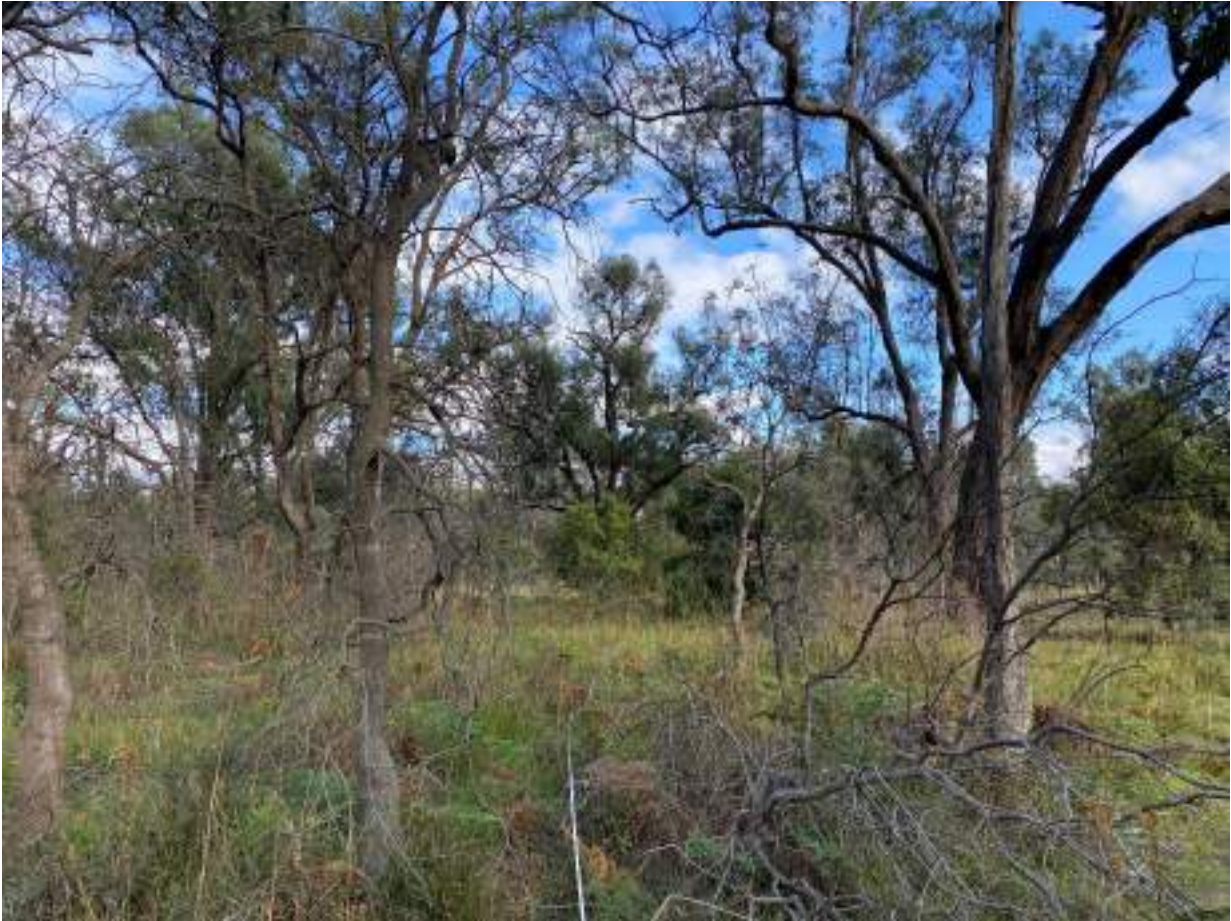
Within WCPL owned land, this community is mostly restricted to the eastern side of Wollombi Brook, primarily within the RWEA area A (Photograph 6). This PCT corresponds to the EPBC Act listed Critically Endangered Ecological Community (CEEC) *Warkworth Sands Woodland of the Sydney Basin Bioregion* and is also listed under the BC Act. This PCT occurs on aeolian sand deposits and is restricted to the Warkworth area.

**Photograph 6: Warkworth Sands Woodland within RWEA A in 2021 (Site V5-B2)**

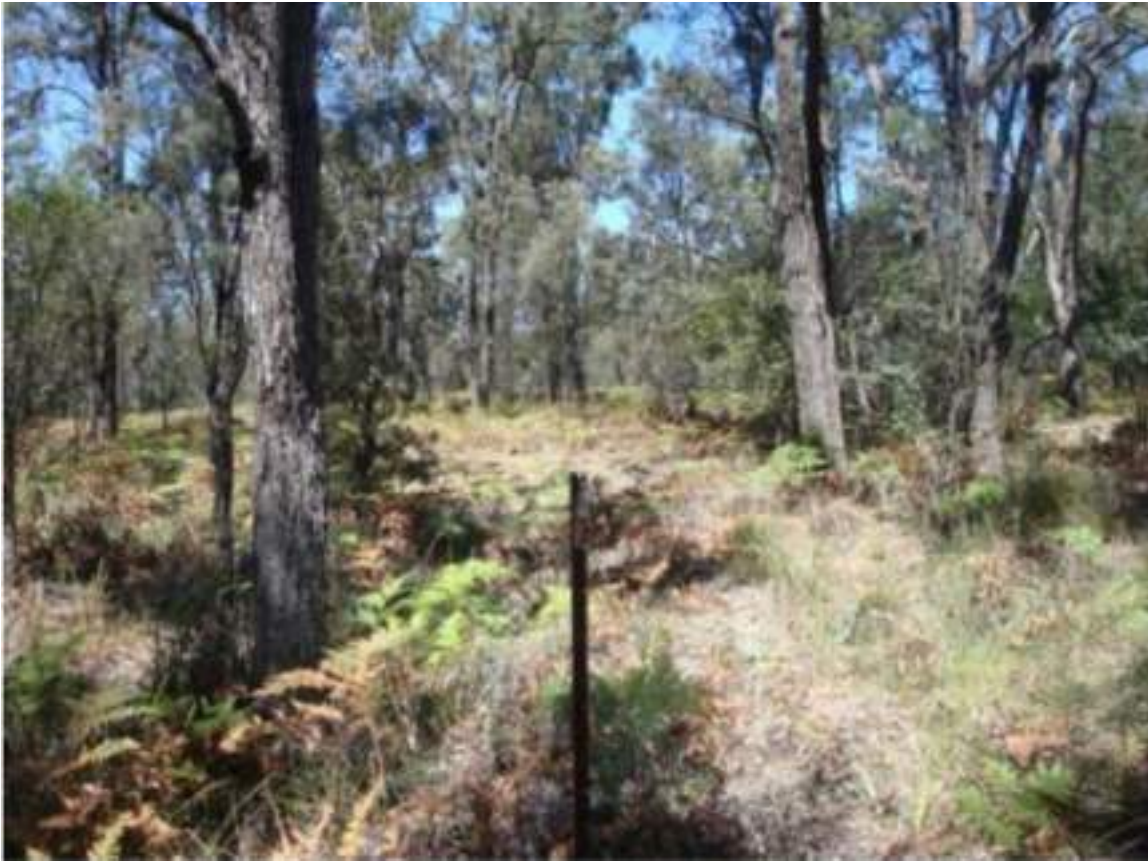
**Photograph 7: Photo monitoring point A2 during 2013**

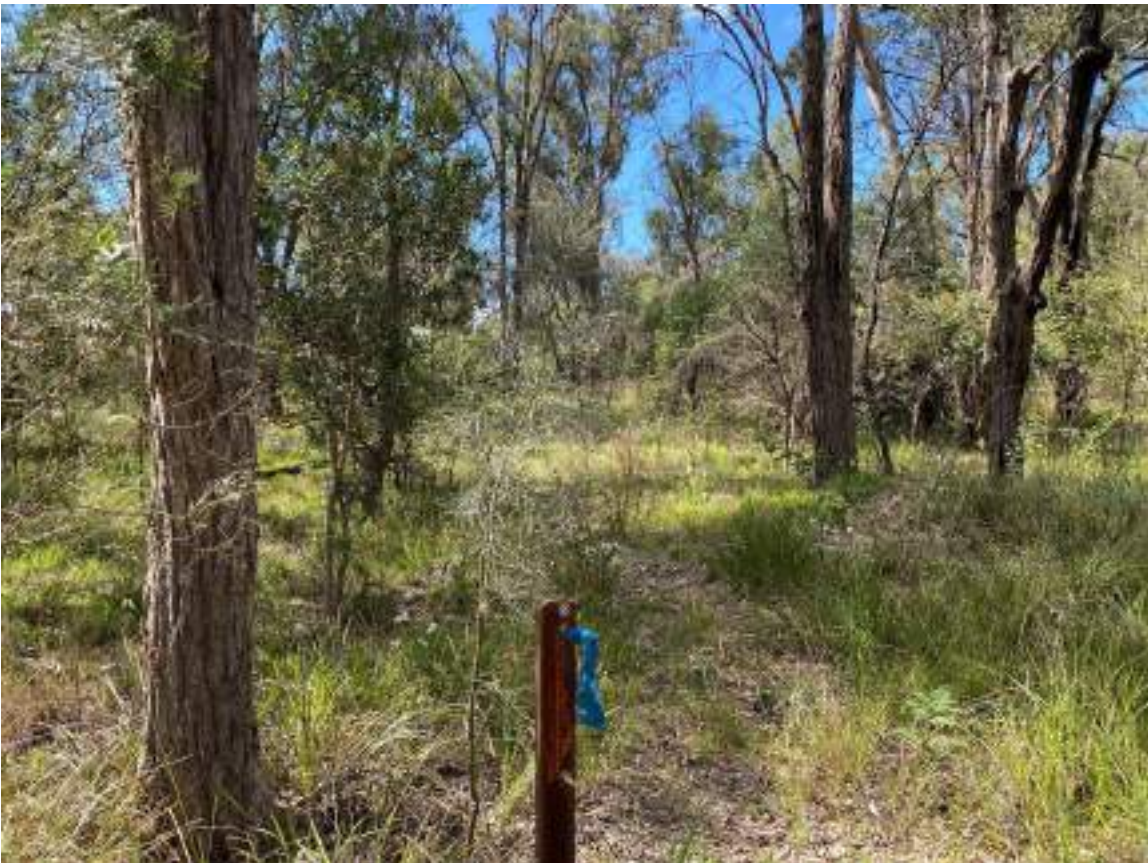
**Photograph 8: Photo monitoring point A2 during 2021**

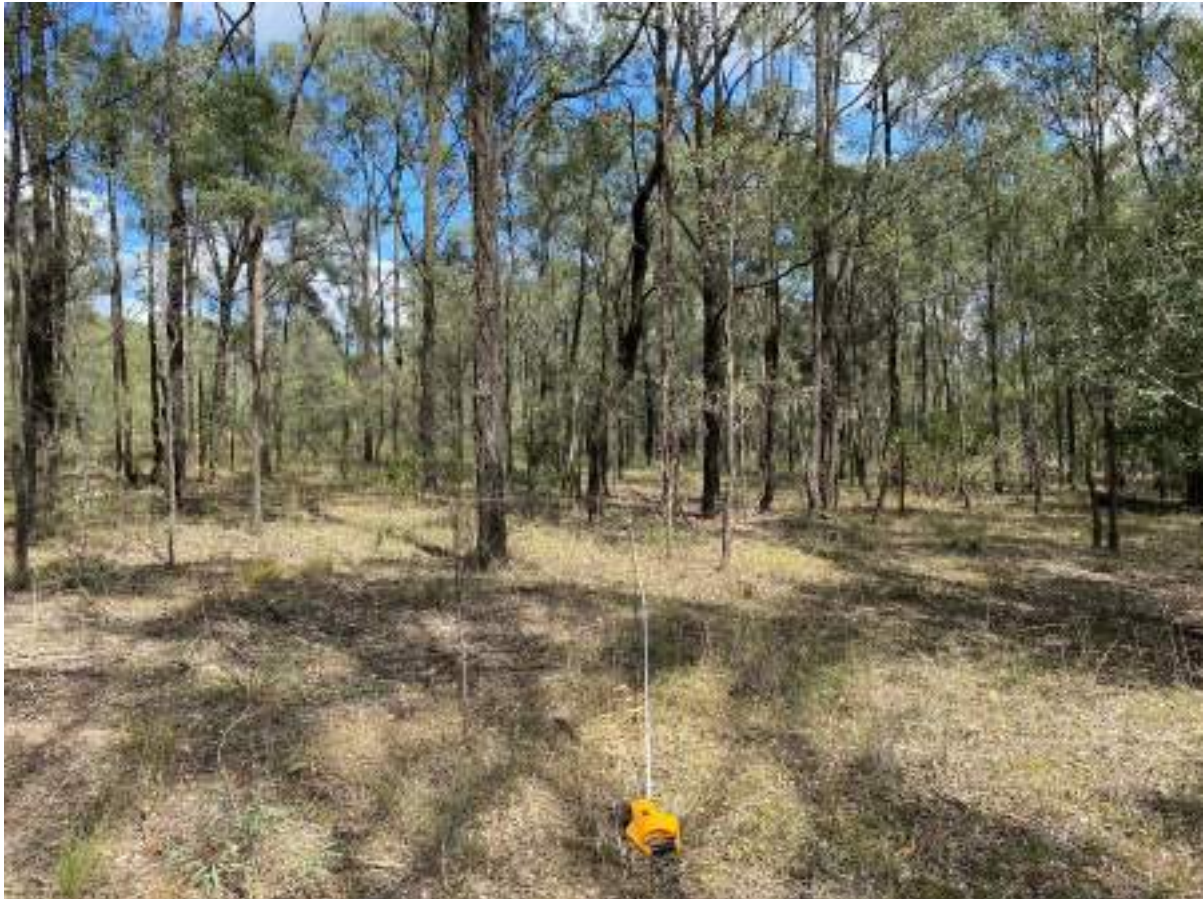
Subsidence cracking is present at four of the eight monitoring plots within this PCT. However, no significant vegetation damage has been observed. Very large cracks are present at site V11-B1 in RWEA C and this plot may not be safe to survey in the future. ELA recommends WCPL inspect this area and undertake remediation of large subsidence cracks if possible.

Photograph 9: Narrow-leaved Ironbark - Bull Oak - Grey Box shrub - grass open forest at WCPL (site V6-A3 in 2021)

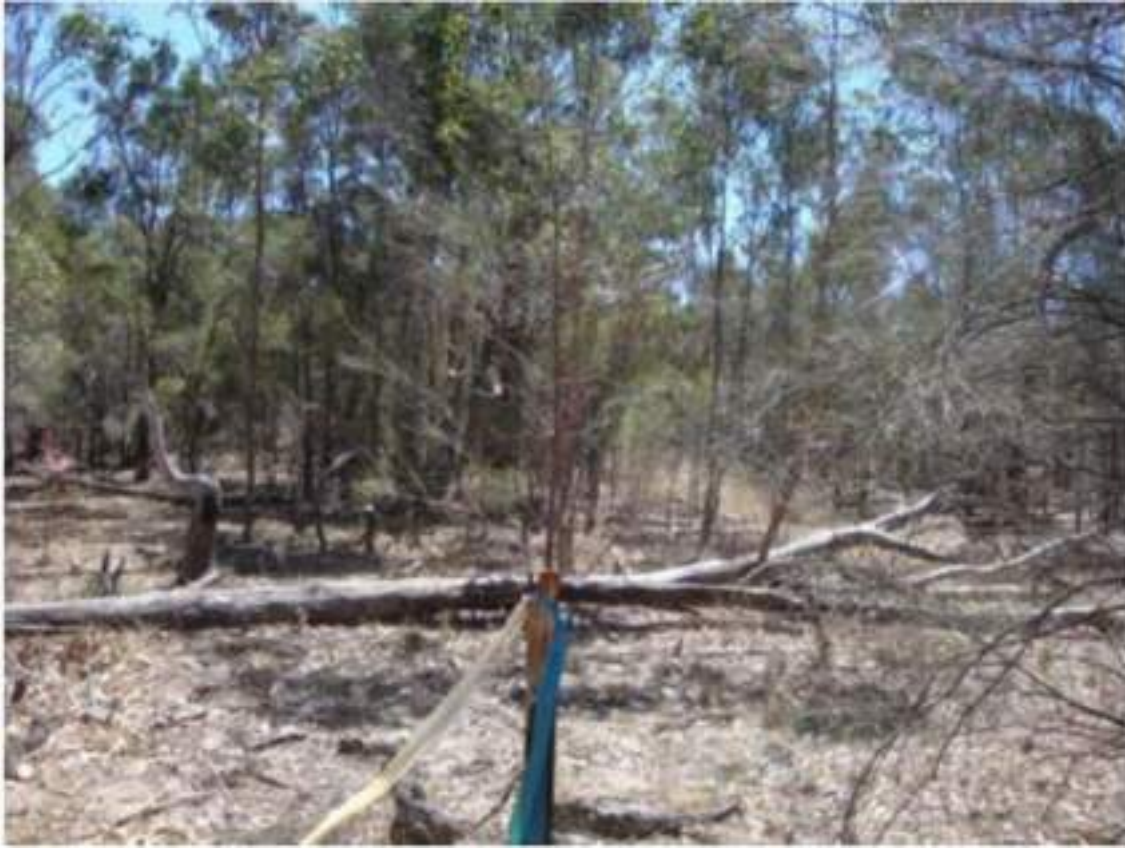
**Photograph 10: Photo-monitoring point A4 during 2013**

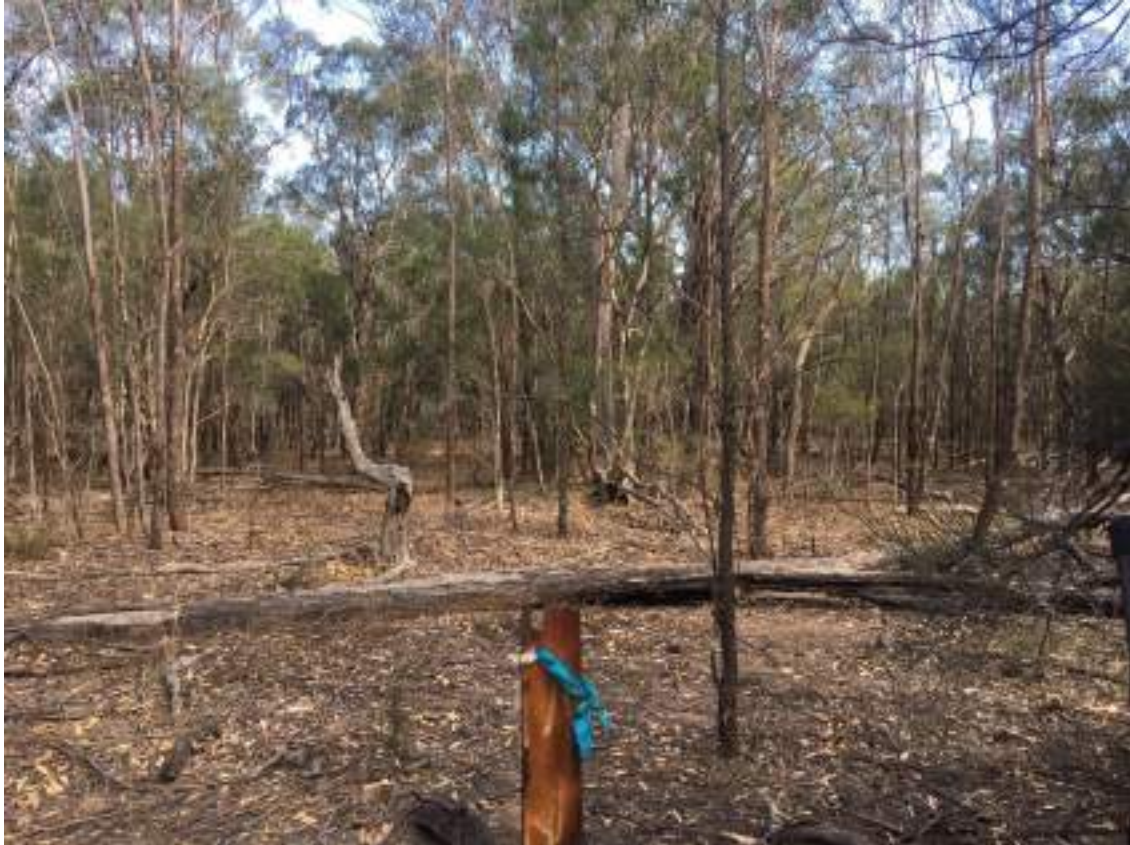
**Photograph 11: Photo-monitoring point A4 during 2021**

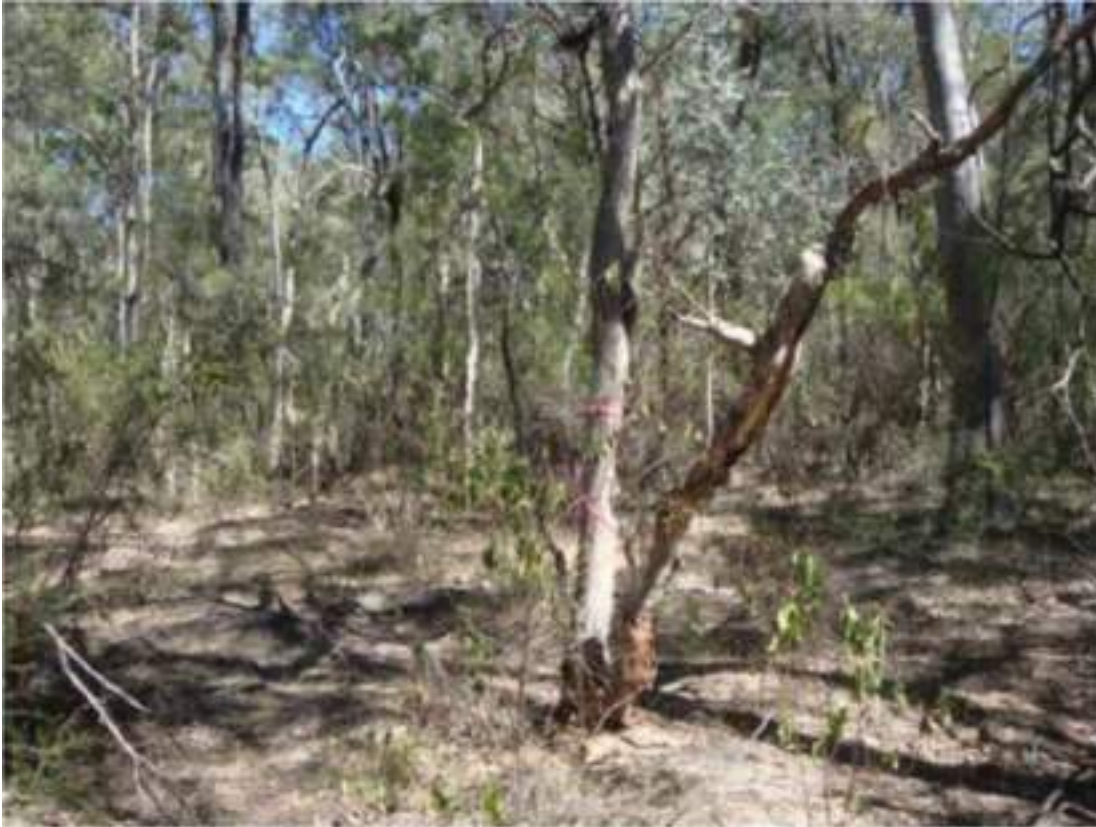
**Photograph 12: Photo-monitoring point B2 during 2013**

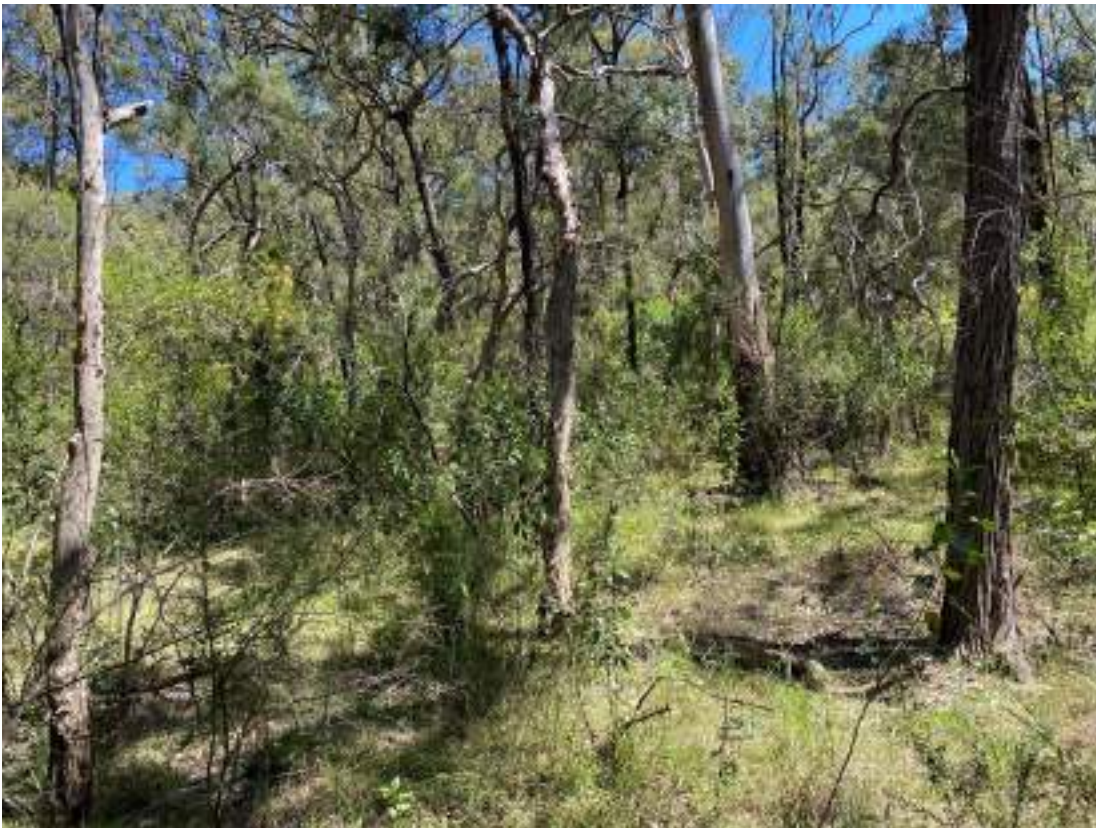
**Photograph 13: Photo-monitoring point B2 during 2021**

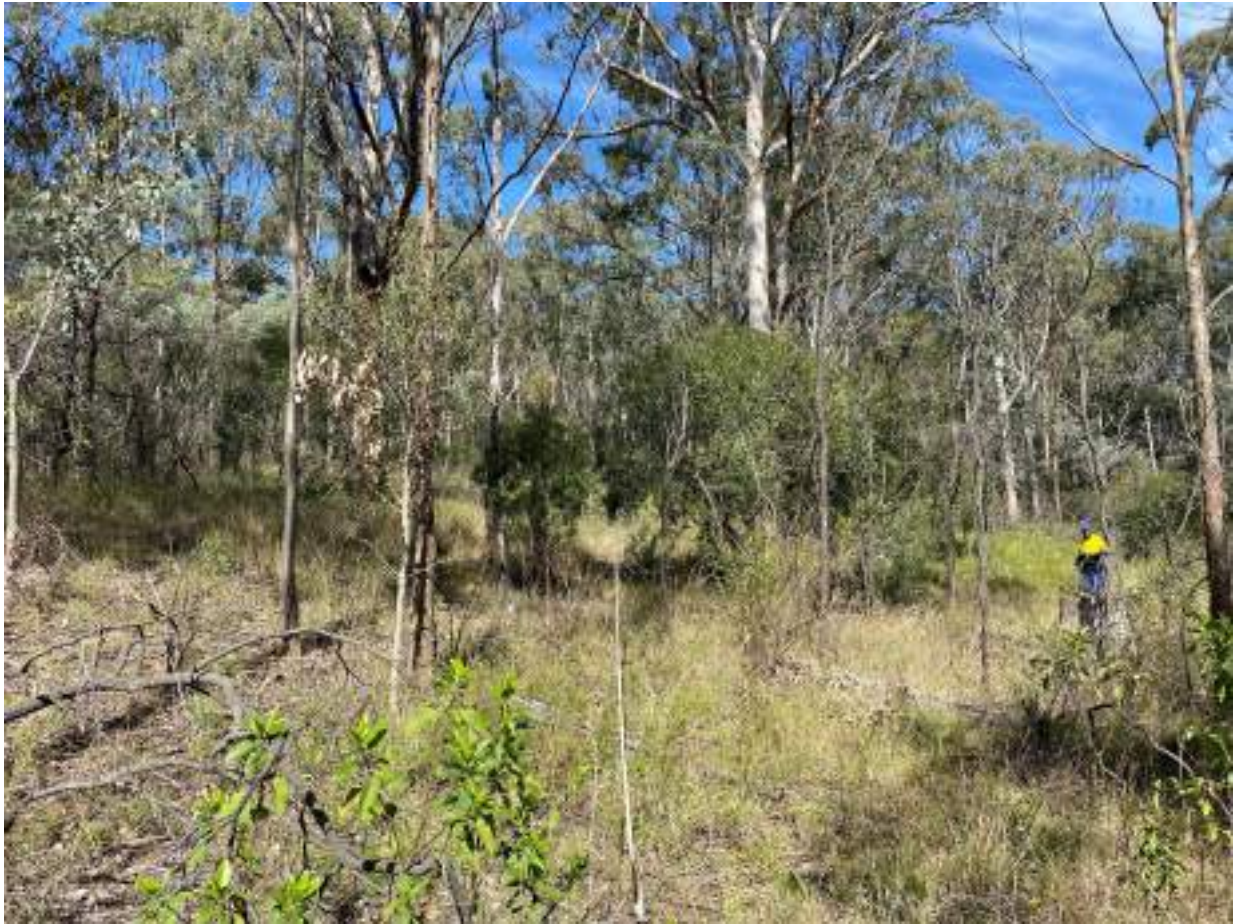
The monitoring sites in this community are located in or near RWEA D. All performance criteria were met in 2021, except for NGCG which was again very high above the target range (Table 9). This not considered a management concern. The average NPS recorded in 2021 was the highest to date (Figure 8), suggesting a number of species have responded to the wetter conditions.

Photograph 14: A typical example of Slaty Box woodland at WCPL during 2021 (Site V10-B3)

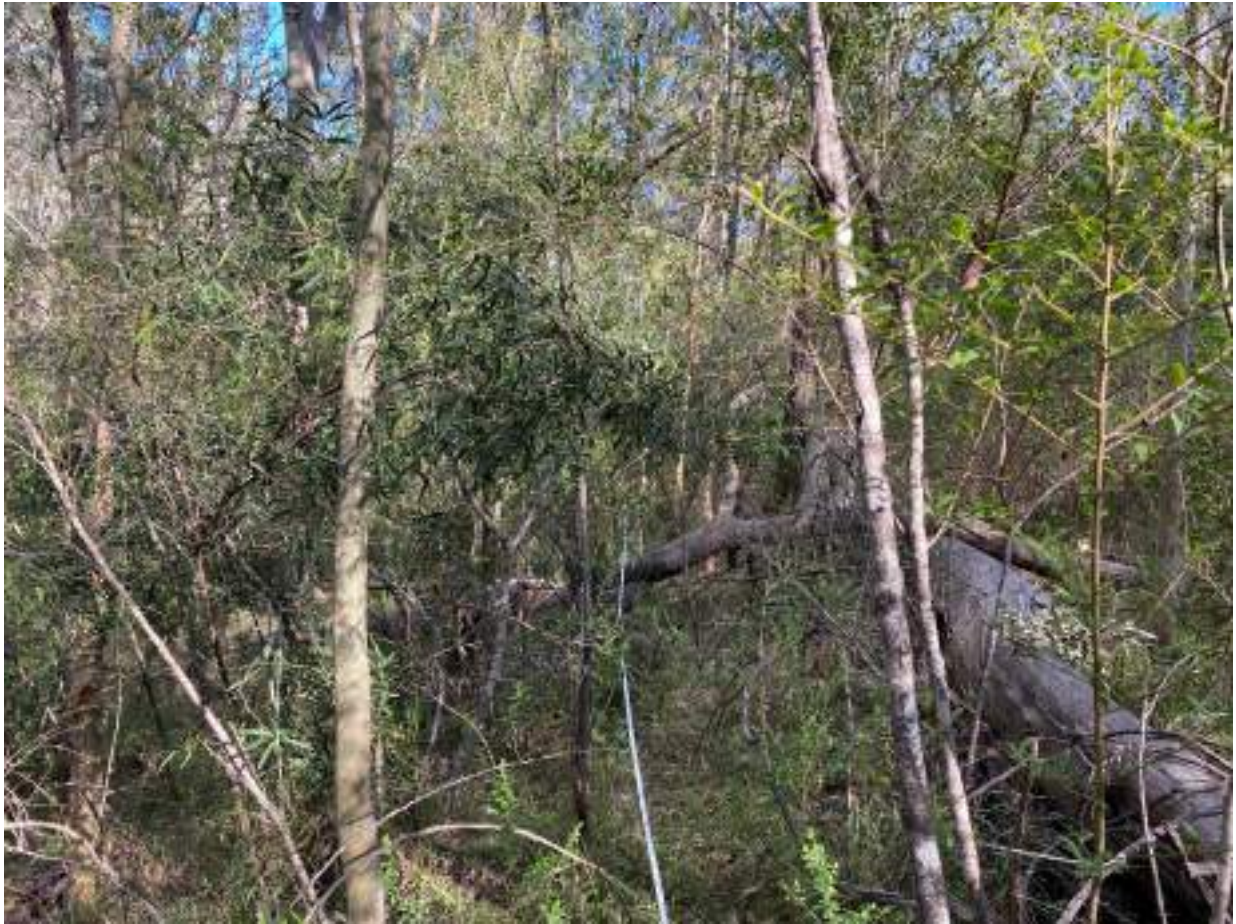
This monitoring site met all performance targets, except NGCG which was very high above the target range (Table 10), though not considered a management concern. Grass cover was previously low with zero recorded for the transect in 2019, as such the high result in 2021 is considered to reflect the upper range of natural fluctuation in relation to environmental conditions. NPS was the highest recorded, showing recovery from the recent dry conditions when the equal lowest NPS was recorded in 2019 (Figure 9). EPC is very low with no species recorded in the floristic plots and no EPC recorded along the biometric transect.

Photograph 15: White Mahogany - Spotted Gum - Grey Myrtle forest at V13-B1 in 2021

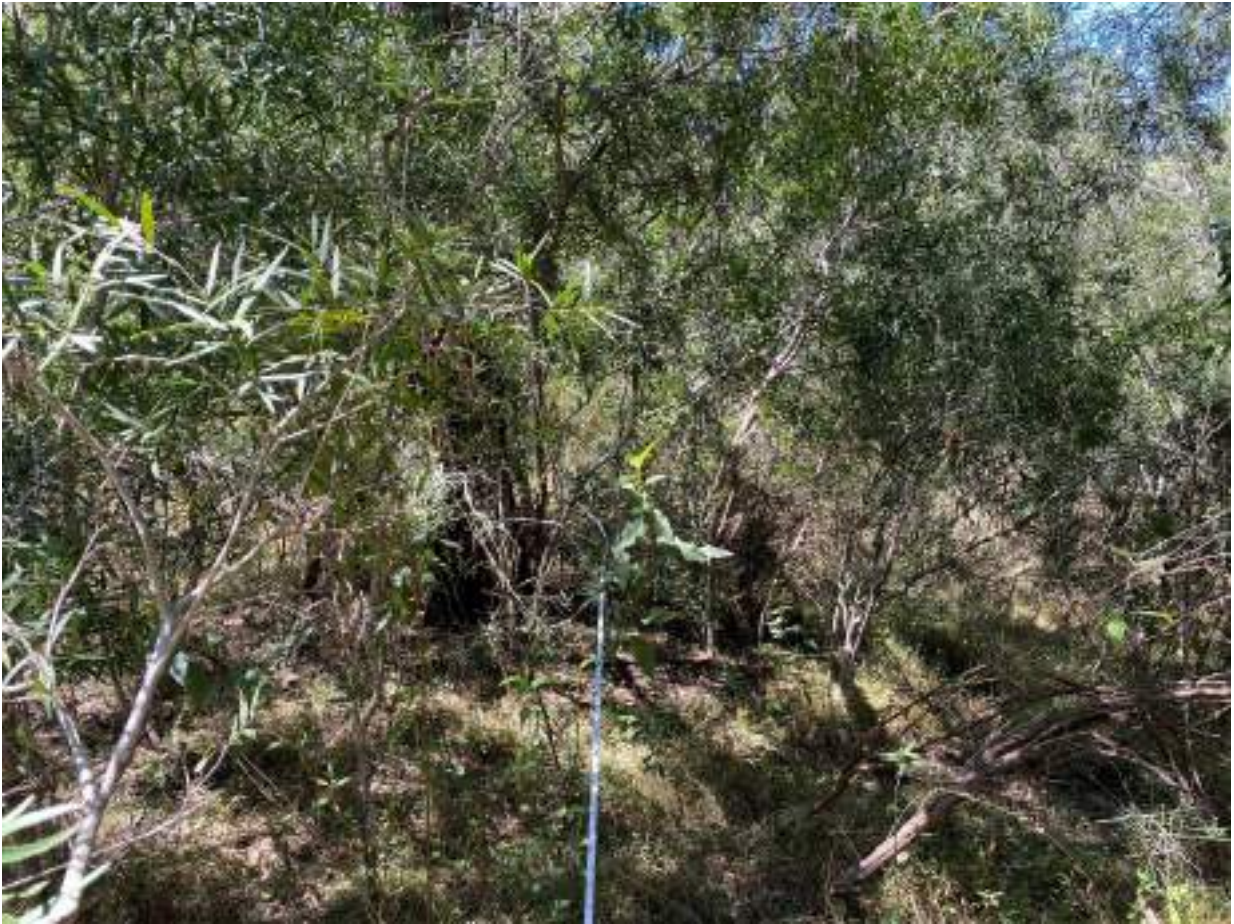
**Photograph 16: Brush Wilga/Native Olive Shrubland at V14-B2 in 2021**

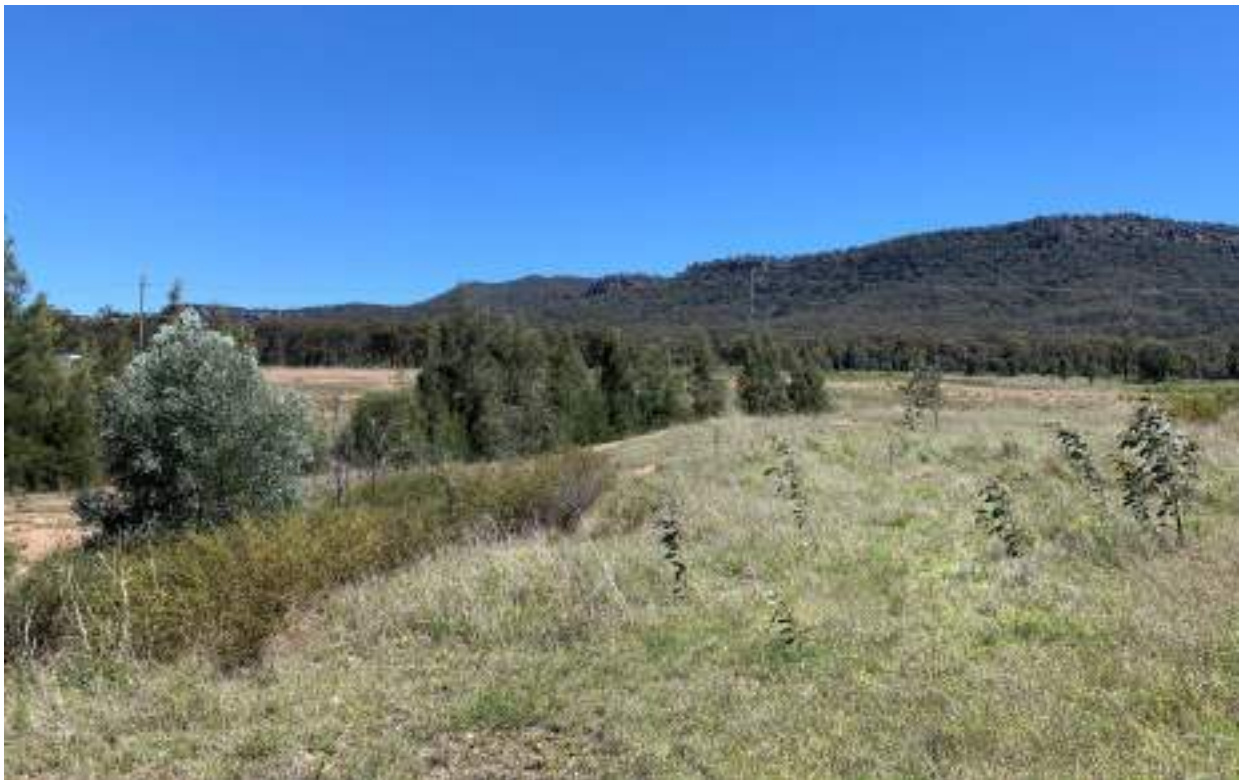
**Photograph 17: North Wambo Creek Diversion during 2021 showing canopy regeneration in near the channel (downstream of site 23R)**

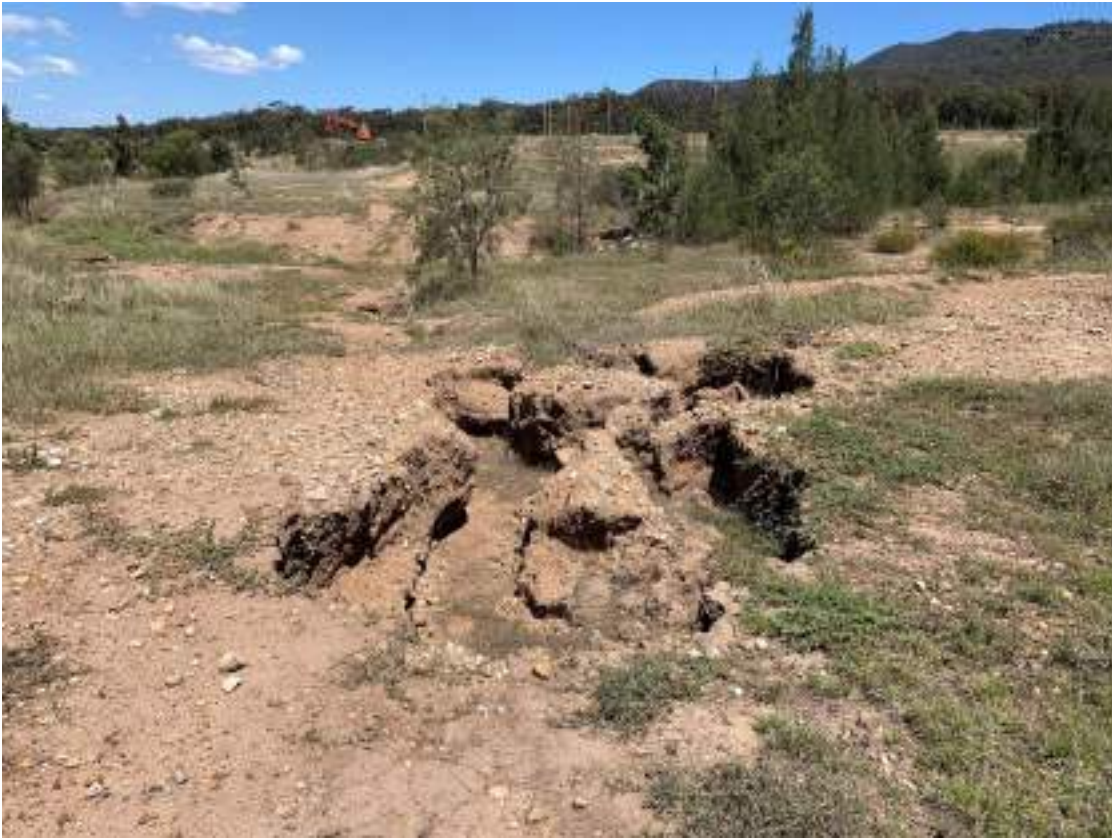
Monitoring sites within the NWCD area are variable in condition (Table 14), with monitoring sites described in Table 15. Most monitoring sites are open pasture areas and generally have low diversity of native plant species and consist of predominantly low grass, primarily *Cynodon dactylon* (Common Couch), with tussocks of *Chloris gayana* (Rhodes Grass) and *Setaria* sp.. Native *Acacia* sp. and *Eucalyptus* sp. saplings, shrubs and small continue to develop in the south of the diversion area as a result of direct seeding works and are present in some transects, particularly sites 25R, 26R and 27R, and some trees are now up to 7 m tall. Natural establishment of *Casuarina cunninghamiana* and *Eucalyptus* sp. in the creek bed, particularly in the north of the creek diversion, also continues (Photograph 17). Erosion was observed in some areas of the creek channel, including gully erosion (Photograph 18).

**Photograph 18: Gully erosion within the North Wambo Creek Diversion (near site 23R) in 2021**
