# **WAMBO COAL PTY LTD 2021 ANNUAL REVIEW**

1 January – 31 December 2021

<b>Name of operation</b>	Wambo Coal Mine
<b>Name of operator</b>	Wambo Coal Pty Ltd
<b>Development consent /Project Approval #</b>	DA305-7-2003, DA177-8-2004, EPBC 2003/1138, EPBC 2016/7636, EPBC 2016/7816
<b>Name of holder of development consent</b>	Wambo Coal Pty Ltd
<b>Title/Mining lease #</b>	CL365, CL374, CL397, CCL743, ML1402, ML1572, ML1594, ML 1806, A444, EL7211
<b>Name of holder of mining lease</b>	Wambo Coal Pty Ltd
<b>Water licence #</b>	As per <b>Table 3</b>
<b>Name of holder of water licence</b>	Wambo Coal Pty Ltd
<b>MOP/RMP start date</b>	1 December 2020
<b>MOP/RMP end date</b>	31 December 2023
<b>Annual Review start date</b>	1 January 2021
<b>Annual Review end date</b>	31 December 2021
<p><b>I, Peter Jaeger, certify that this audit report is a true and accurate record of the compliance status of Wambo Coal Mine for the period 1 January 2021 to 31 December 2021 and that I am authorised to make this statement on behalf of Wambo Coal Pty Ltd.</b></p> <p><i>Note:</i></p> <p>a) <i>The Annual Review is an ‘environmental audit’ for the purposes of section 122B(2) of the Environmental Planning and Ass

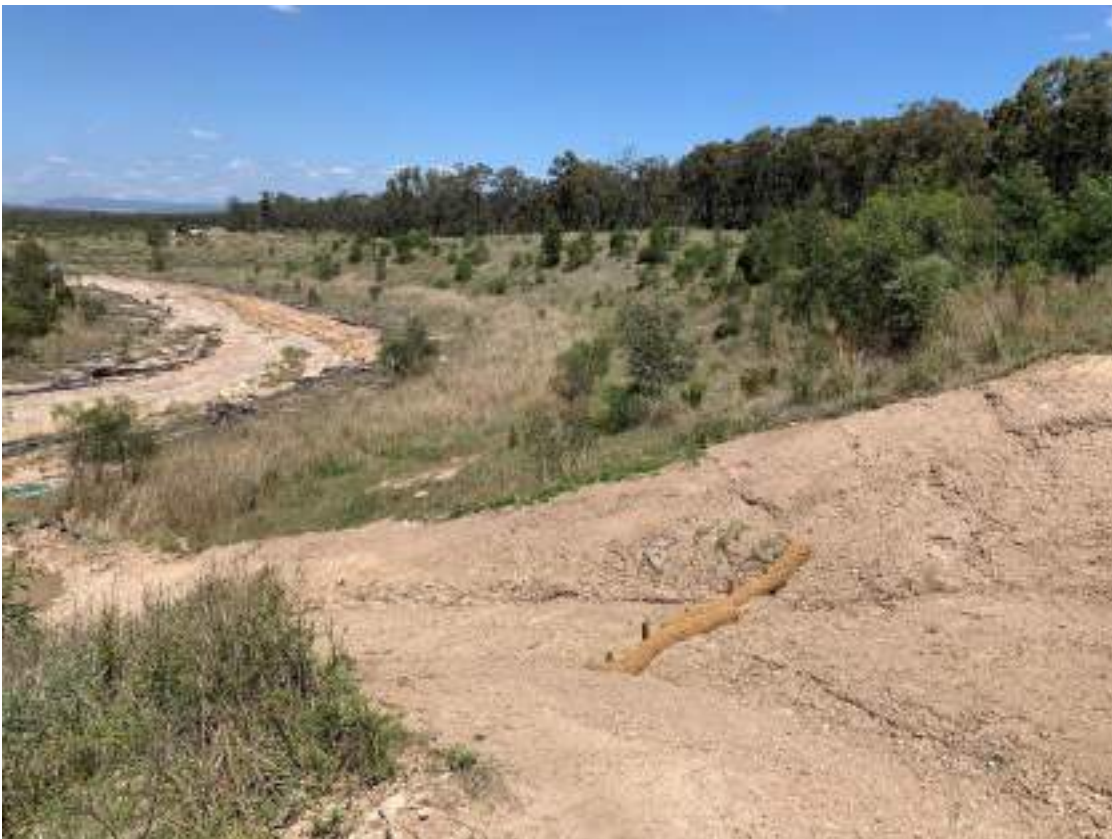
It is important to note that significant soil remediation works have been undertaken at the NWCD during 2020 and 2021 by the NSW Soil Conservation Service (Photograph 19).

**Photograph 19: Example of active landscape management work in the North Wambo Creek Diversion area in 2021**

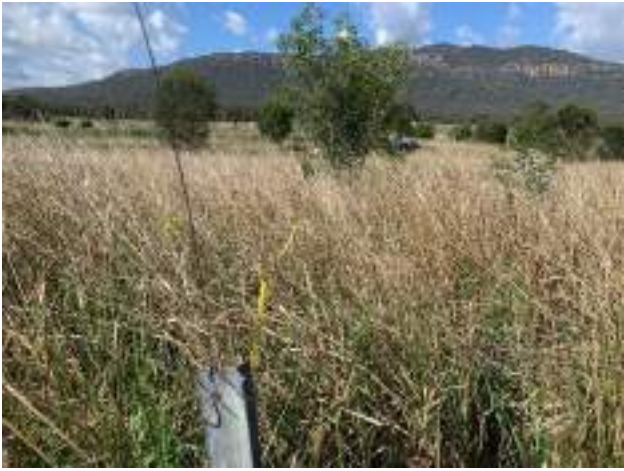
Transect	Notes	Photograph
17R	<p>This transect consists of relatively flat ground covered in pasture with a combination of grassy patches (primarily <i>Cynodon dactylon</i>) and grass tussocks (primarily exotic <i>Chloris gayana</i>), together the entire transect. This is an increase from 2020 when 14% bare soil was recorded. This result is likely a result of two wetter years and the flat nature of this site.</p>

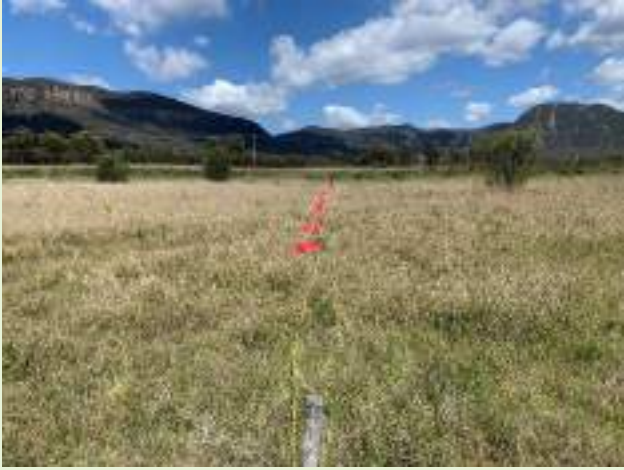
19R	<p>Transect relatively flat and comprised primarily of low grass (<i>Chloris gayana</i>) (55%) and Galenia (6%), dispersed with patches of bare soil (39%). The appearance is similar to the previous year, although a higher proportion of bare ground was recorded in the transect but is not observable in the photo. The bare ground was present as numerous small interpatch areas.</p> <p>Young <i>Eucalyptus</i> and <i>Acacia</i> species continue to develop on creek banks downstream.</p>

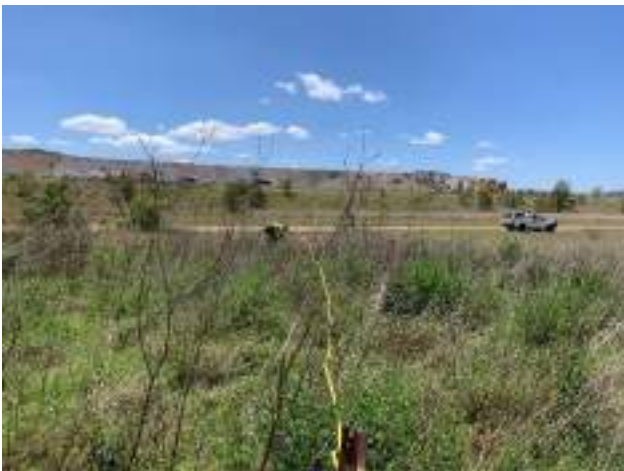
21R	<p>Transect relatively flat grassland dominated by annual exotics and low grass (96%) with bare soil (4%). An increase in annual cover and decrease in bare ground was recorded from the previous year.</p>

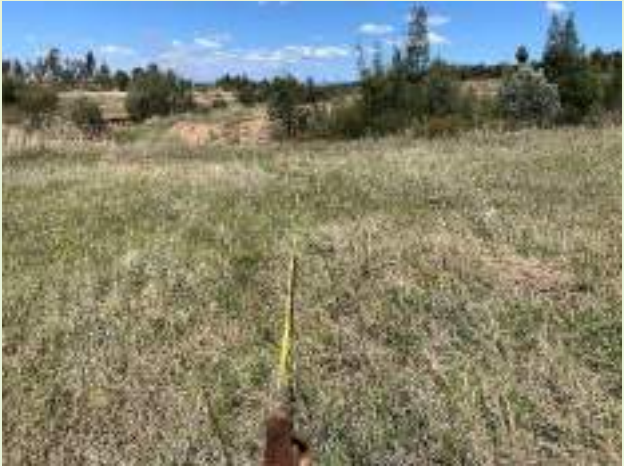
Transect	Notes	Photograph
23R	<p>Low grass occurs over 38% of the transect, similar to recent years, with shrubs also covering 5%. Large bare patches of stony soil occur towards the middle and end of transect where there is a slope (not visible in photo). Bare soil patches cover 57% of the area. Some areas of active erosion including some 30cm deep rills occur in the surrounding area. The creek bank in this area has been undercut and there is slumping on western bank. Regenerating <i>Casuarina cunninghamiana</i> (up to 8m) and some Eucalypts and <i>Acacia</i> sp. are present in and near the channel.</p>

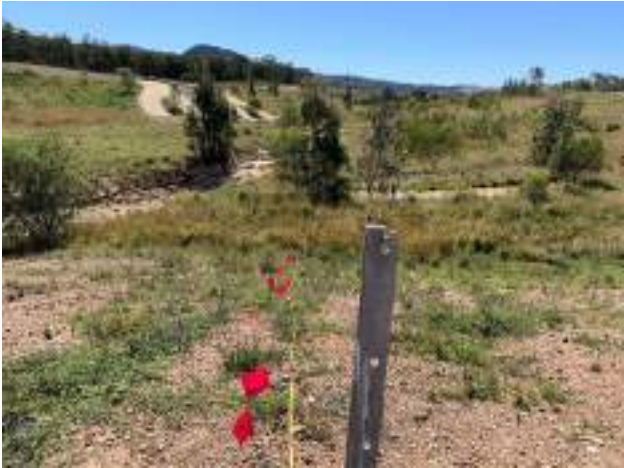
28R	<p>Transect primarily samples the relatively steep eastern creek bank. The majority of this transect was ripped to control <i>Galenia pubescens</i> and erosion prior to the 2017 monitoring.</p> <p>The dominant patches were low grass 49% and tussocks 29%, with tussocks present on the lower slopes and flat at the end of the transect. Bare soil (22%) increased from previous year and the upper slope is unstable and requires works to establish vegetation and limit erosion.</p>

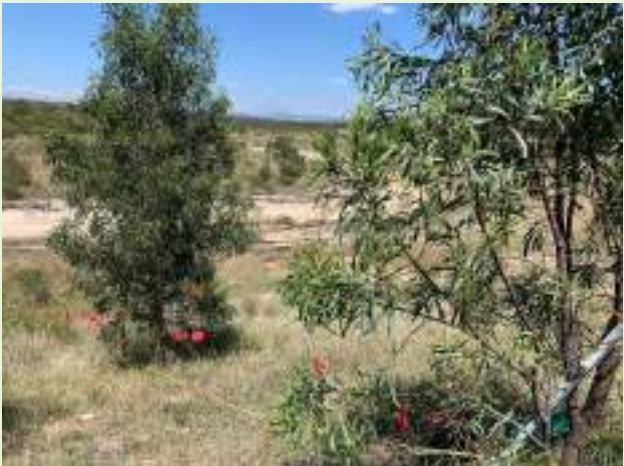
27R	<p>Transect samples the relatively steep western bank of the NWCD. The majority of this transect was ripped to control <i>Galenia pubescens</i> and erosion prior to the 2017 monitoring. Low sparse grasses and logs dominate the flat area adjacent to the creek channel.</p> <p>The transect is dominated by low grass (49%), tussocks (14%) and logs (8%). Bare soil (29%) has decreased from 2019 and 2020, which corresponds to an increase in low grass cover over previous bare soil/woodchips.</p>

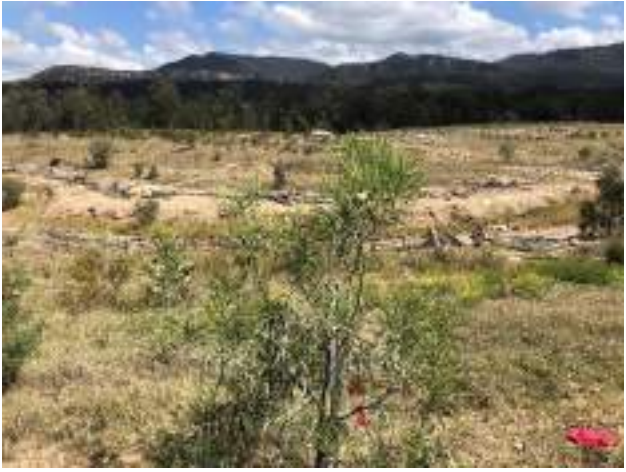
Transect	Notes	Photograph
26R	<p>Transect samples the relatively steep eastern bank to the edge of the creek channel. Low grass (46%) and tussocks (15%) dominated this transect in 2020. Bare soil areas (15%) and logs (19%) make up the remainder. The transect remained similar to previous years, although log patches increased likely due to changes in interpretation by the assessor. <i>Acacia</i> sp. shrubs are continuing to establish on some sections of the bank near this transect.</p>

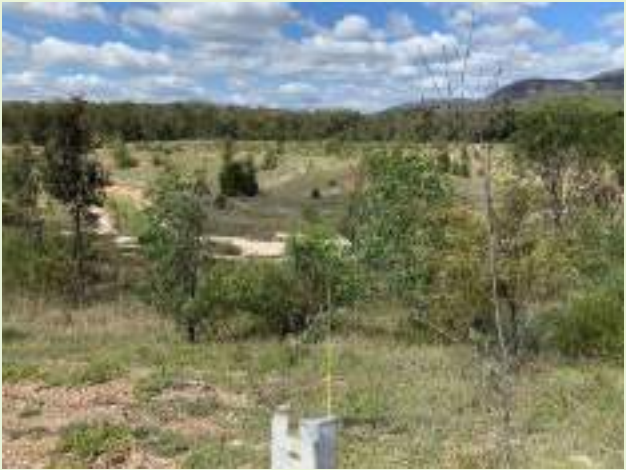
25R	<p>This slope is relatively steep with low grass dominating 58% of the transect and having the highest contribution to soil stability. Shrubs (15%), tussocks (8%) and logs (8%) are also present, with tussocks and logs dominant on the lower bank.</p> <p>Bare soil is most prevalent at the top of transect where some minor erosion is occurring and makes up 11% of the transect, a reduction from the previous year due to an increase in shrubs and tussocks.</p> <p><i>Acacia</i> sp. and Eucalyptus shrubs and small trees are continuing to develop in and near this transect.</p>

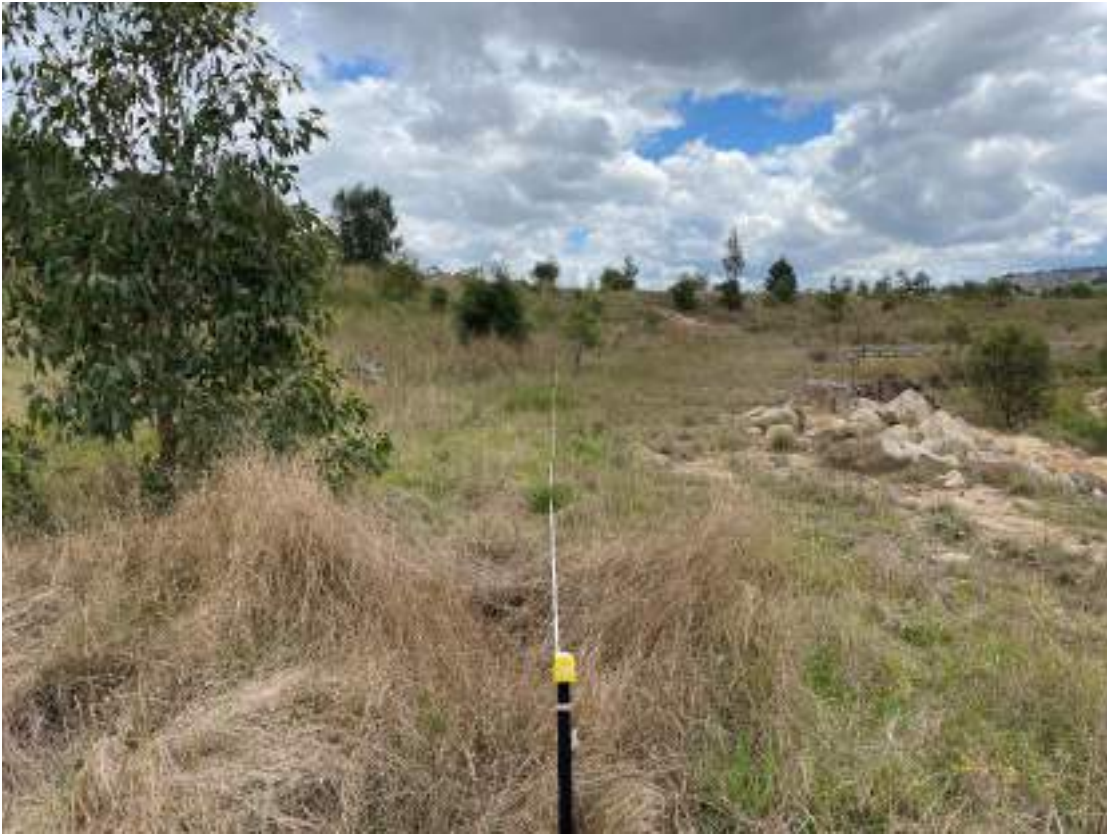
**Photograph 20: NWCD Biometric Plot 1 in 2021**

Plant Community Type (PCT)	Plot Name	NPS	NOS (%)	NMS (%)	NGCG	NGCS	NGCO	EPC	OR	HBT	FL
<b>Target: PCT 42:</b>											
River Red Gum / River Oak riparian woodland	NWCD1	17	0.3	0.1	23.4	0	0	17.1	1	0	75
wetland in the Hunter Valley	NWCD2	21	0.2	0.7	45.8	0.1	0.3	40.2	1	0	2
<b>Average value</b>		19	0.25	0.4	34.6	0.05	0.15	28.65	1	0	38.5
<b>Performance criteria</b>		>20	10-50	10-50	20-60	1-5	5-30	<33	1	-	-

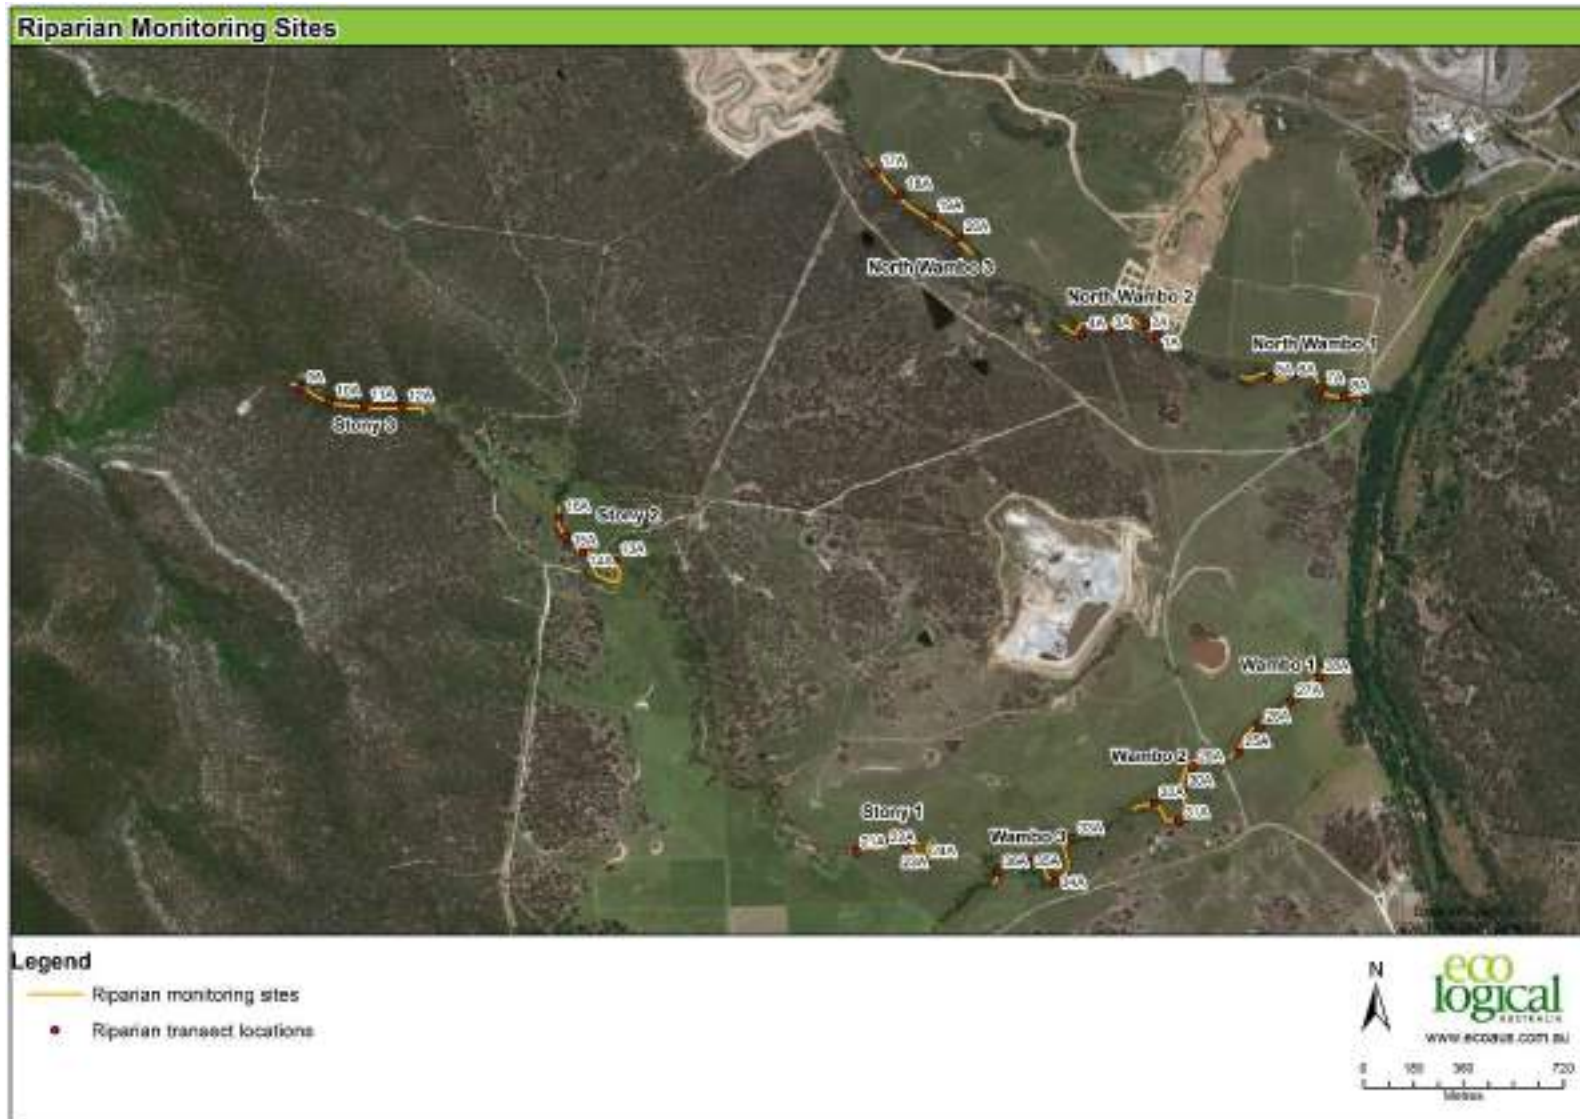
Figure 20: Location of riparian monitoring cross-sections and transects

Methods followed Jansen et. al. (2005) with four 40 m long cross-section transects sampled at each monitoring site (an approximate 500 m length of riparian zone). Three monitoring sites were measured along each creek. The location of monitoring sites and transects is illustrated in Error! Reference source not found. with photographs presented in **Volume 2**.

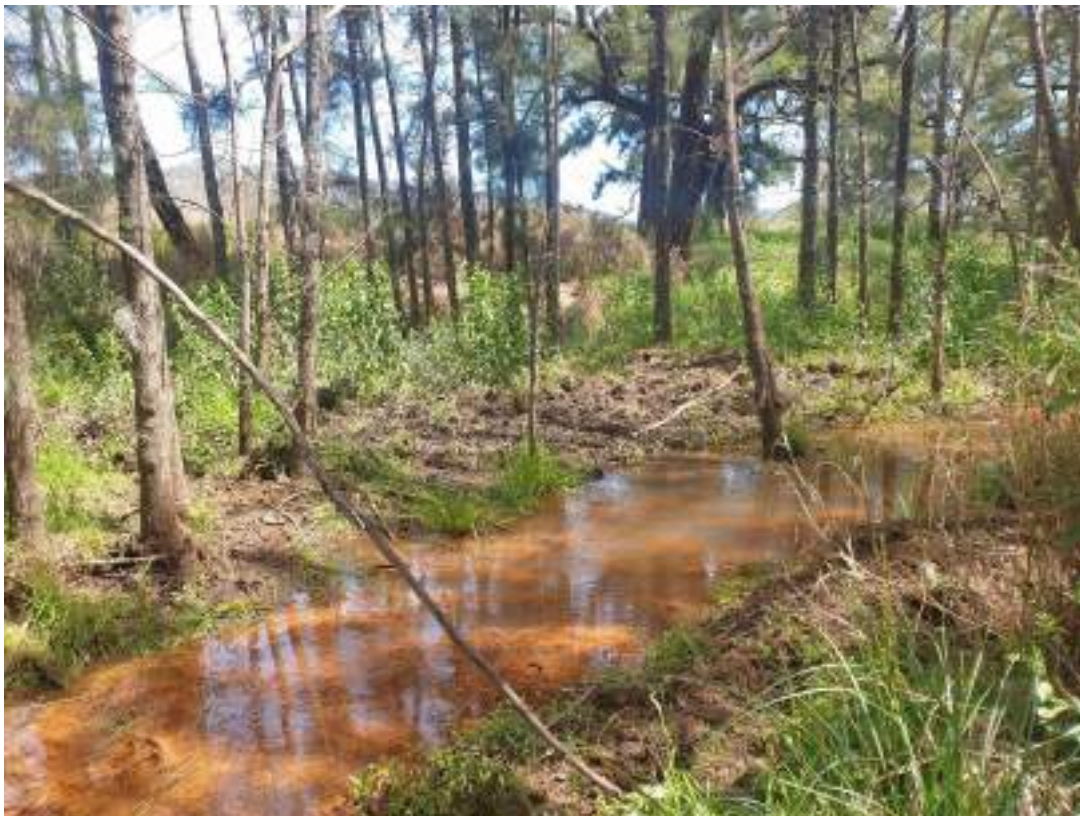
No evidence of recent cattle grazing was recorded in this area. Grazing pressure reduces the ground cover and destabilises the soils leaving these areas more prone to erosion. In previous years cattle grazing had impacted riparian condition scores along South Wambo Creek.

**Photograph 22 Evidence of pig disturbance within site 3 of South Wambo Creek from in October 2021.**

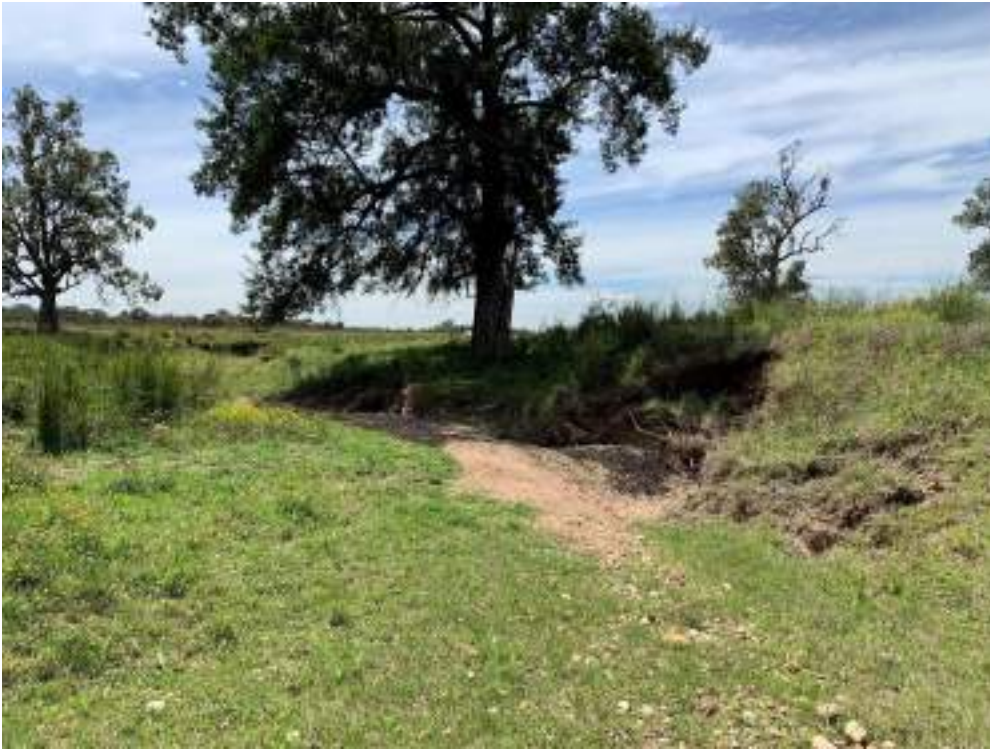
It is unclear whether cattle have been excluded from the lower reaches of Stony Creek at Stony Creek 1. No evidence of recent cattle grazing was recorded, however there was no fencing that would prevent cattle accessing the riparian area. In previous years cattle grazing had impacted riparian condition scores along lower reaches of Stony Creek.

**Photograph 23 Stony Creek 1 predominately cleared vegetation**

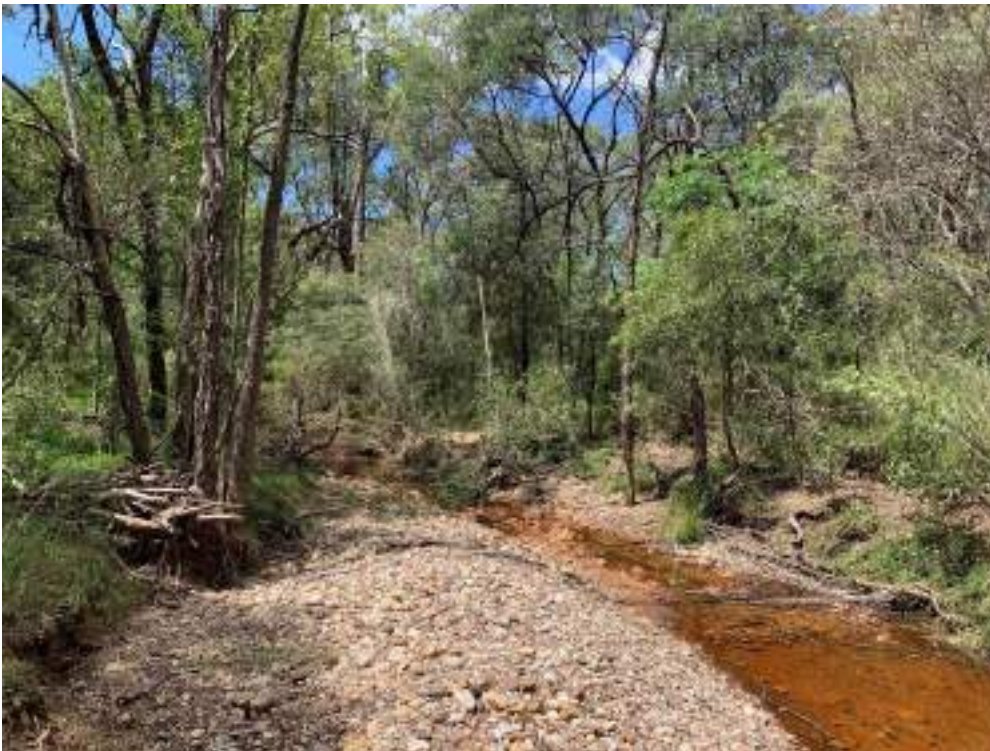
Stony Creek 1 (Photograph 23) and the heavily forested upper reaches observed at Stony Creek 3 (Photograph 24).

**Photograph 24 Stony Creek 3 heavily forested vegetation**

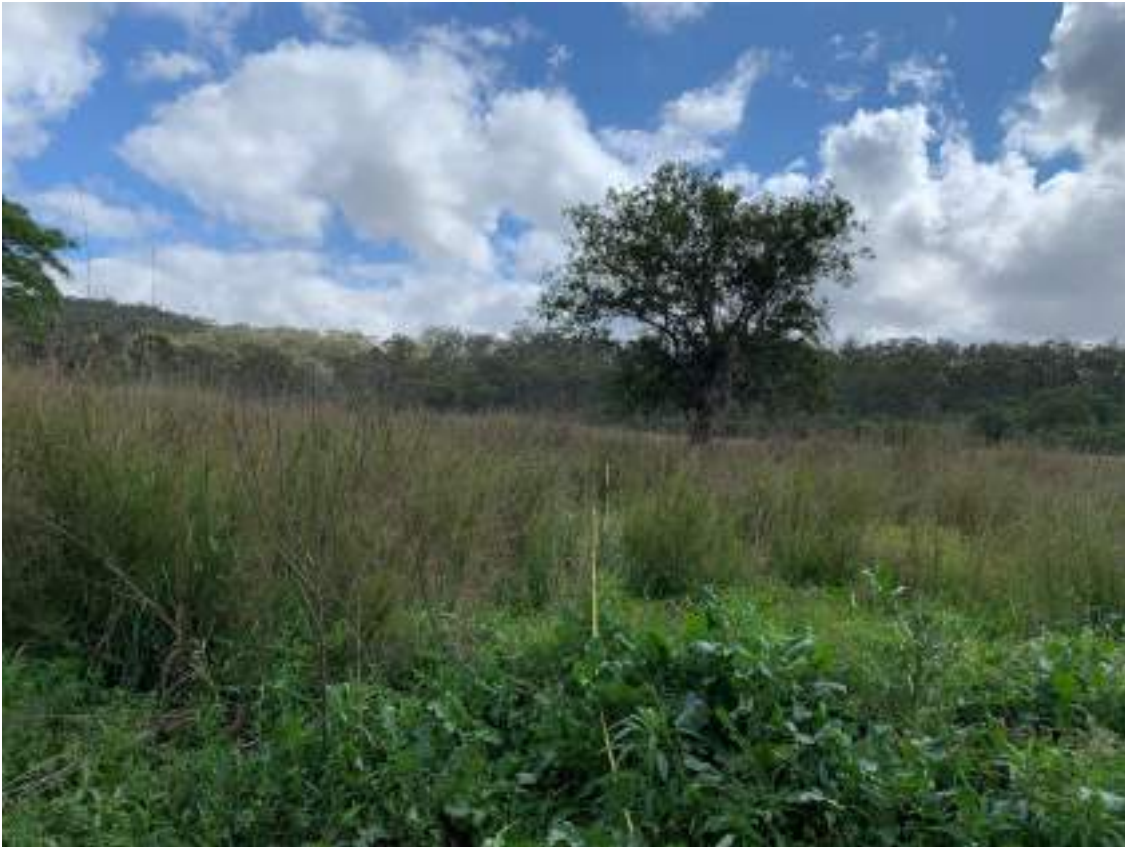
**Photograph 25: Transect 14 at stony Creek 2 in 2021 showing high ground cover following higher rainfall**

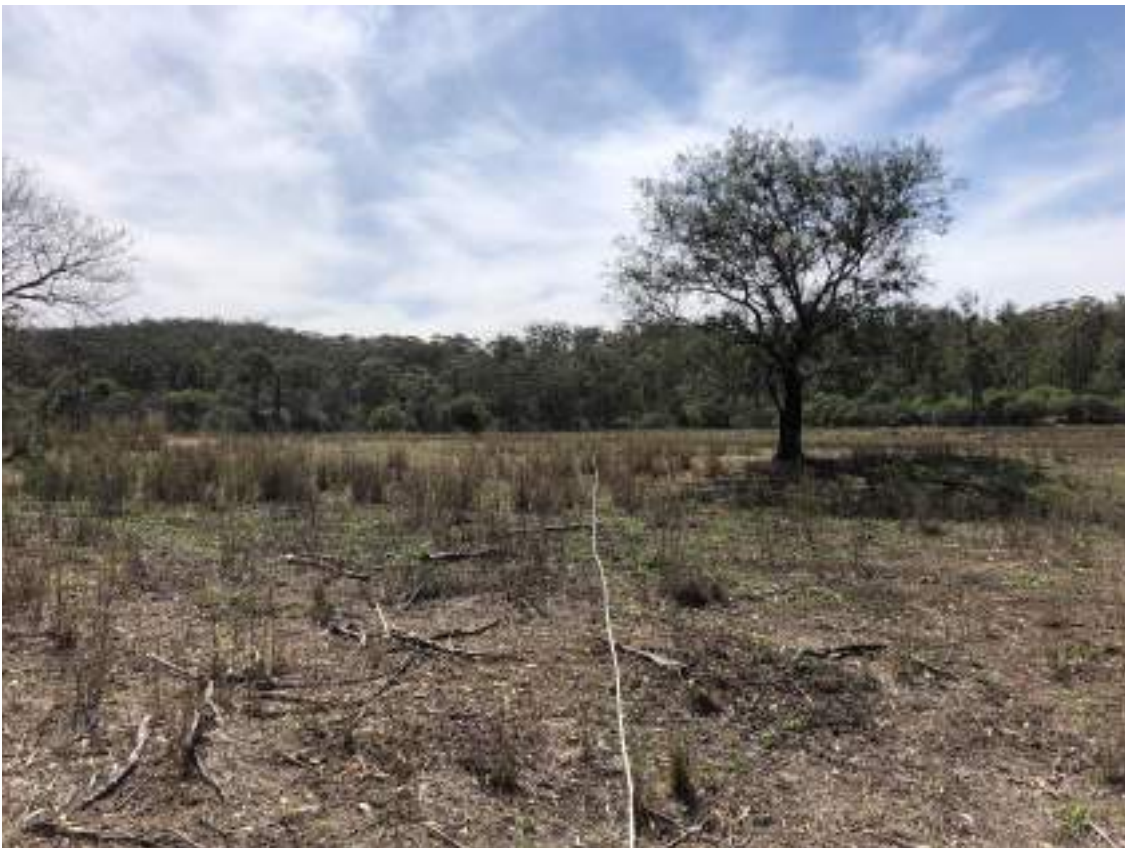
**Photograph 26: Transect 14 at stony Creek 2 in 2019 showing drought impacted ground cover**

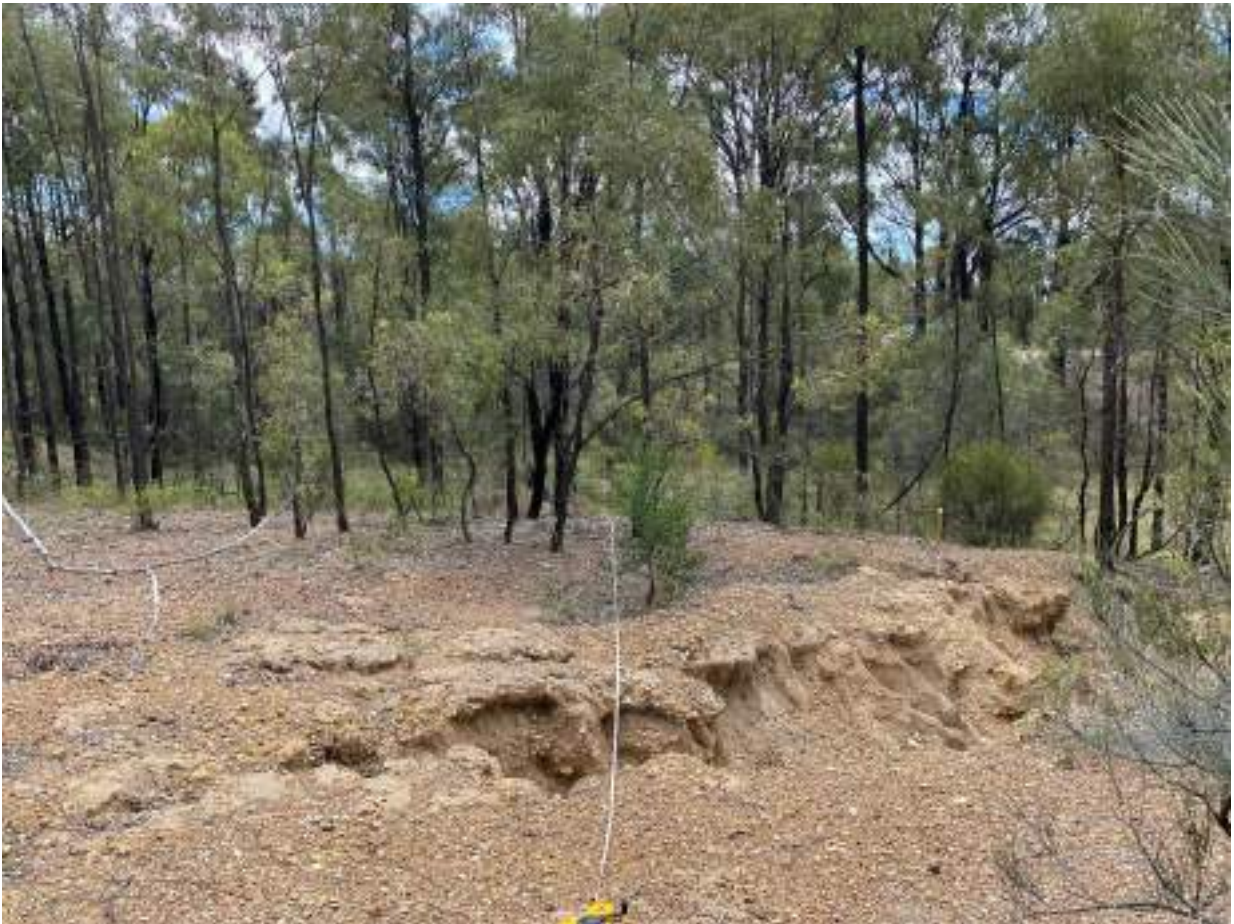
Of the four sites within the Slaty Box - Grey Gum shrubby woodland, two (V10-A1 and V10-A2) have been undermined and two (SBX1-SG-I and SBX3-SG-C) are acting as current reference sites. NOS was still slightly below target at both impact sites and grass cover high at V10-A1. NOS has fluctuated over time with most sites across the monitoring program scoring higher in 2021 than the previous year. Site V10-A2 scored slightly lower for canopy cover, however review of plot photographs (Photograph 36) shows canopy in good condition, with all trees healthy and no observable impacts to the canopy from undermining. The two current reference sites within this community met the performance criteria for most attributes. At one site, SBX1-SG-I, NMS was below target although this is considered likely to representing natural variation within the community.

**Photograph 27: Site V10-A2 in 2021 with canopy in good condition**

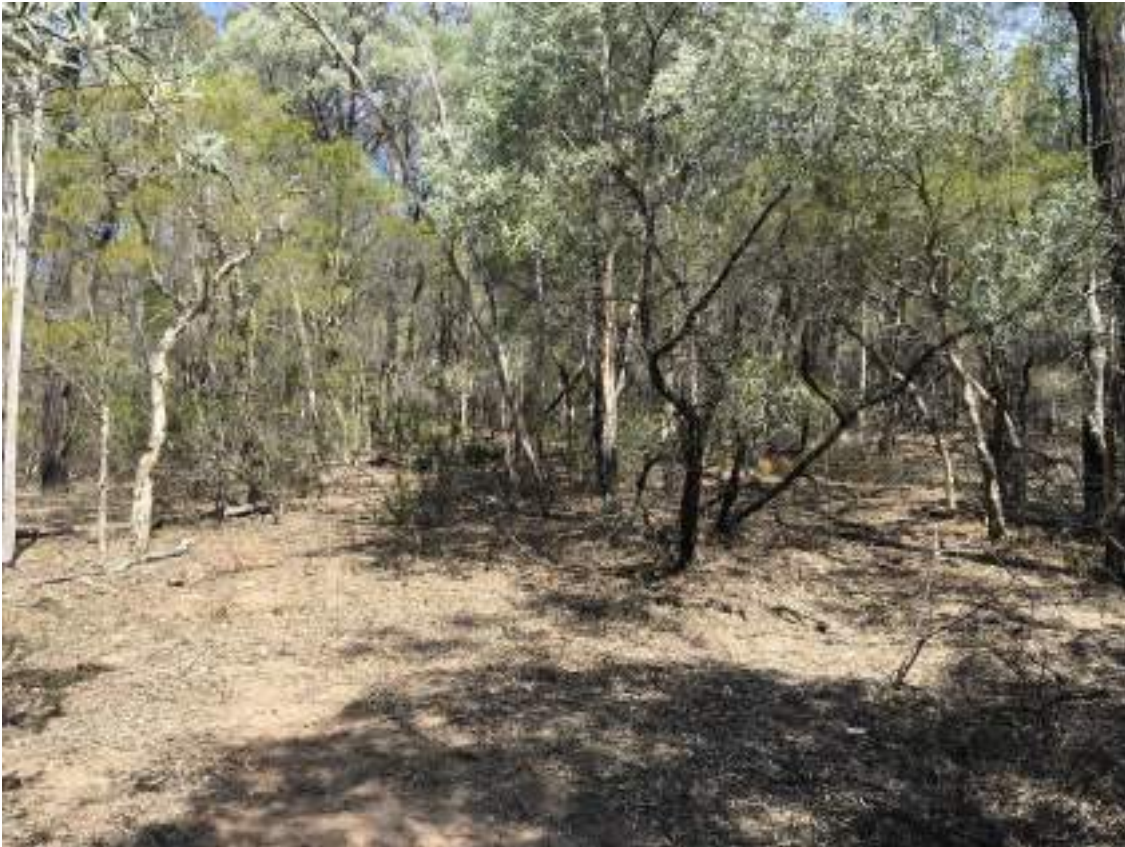
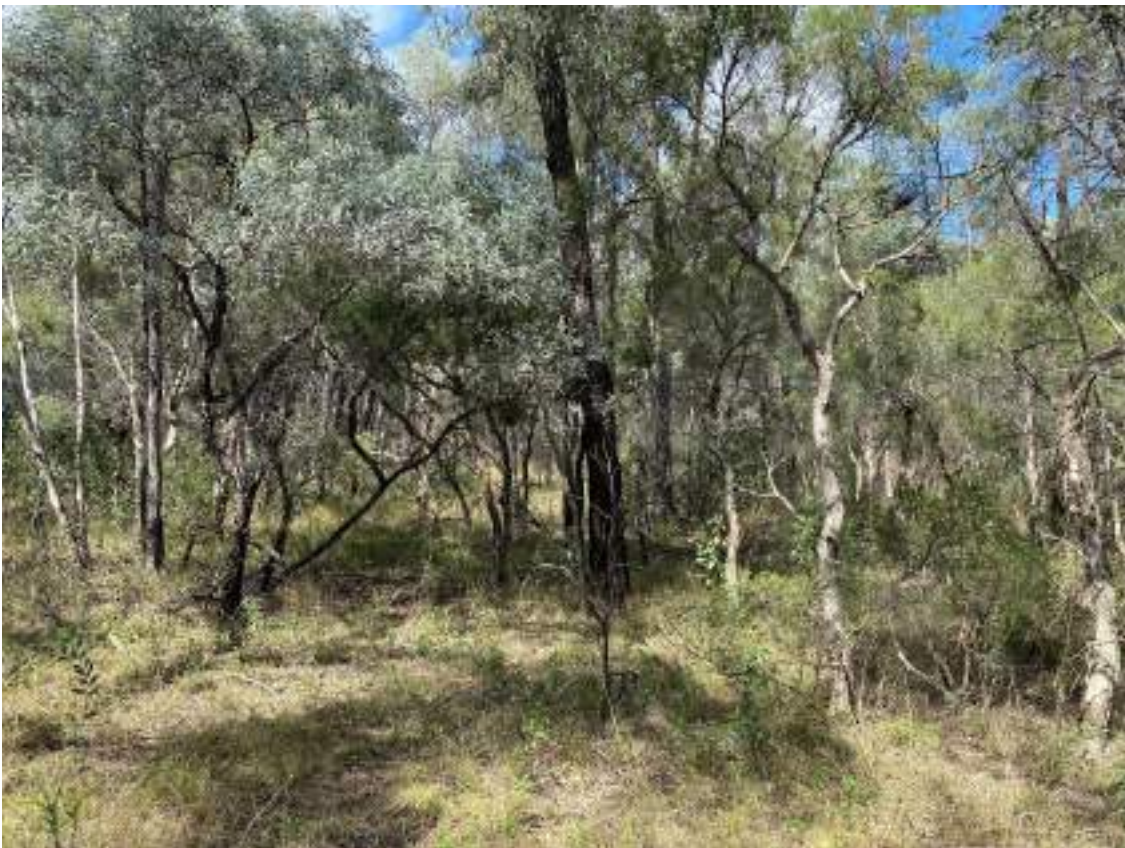
Review of images from photo monitoring points show GDE vegetation in good condition in 2021. A noticeable increase in ground cover vegetation is visible in both *Melaleuca decora low forest* and *River Oak riparian tall woodland* GDE communities since site establishment in 2019 (Photograph 37 to 40).

**Photograph 28: GDE Photo monitoring point M2 (facing south) in *Melaleuca decora* low forest in 2019**

**Photograph 29: GDE Photo monitoring point M2 (facing south) in *Melaleuca decora* low forest in 2021**

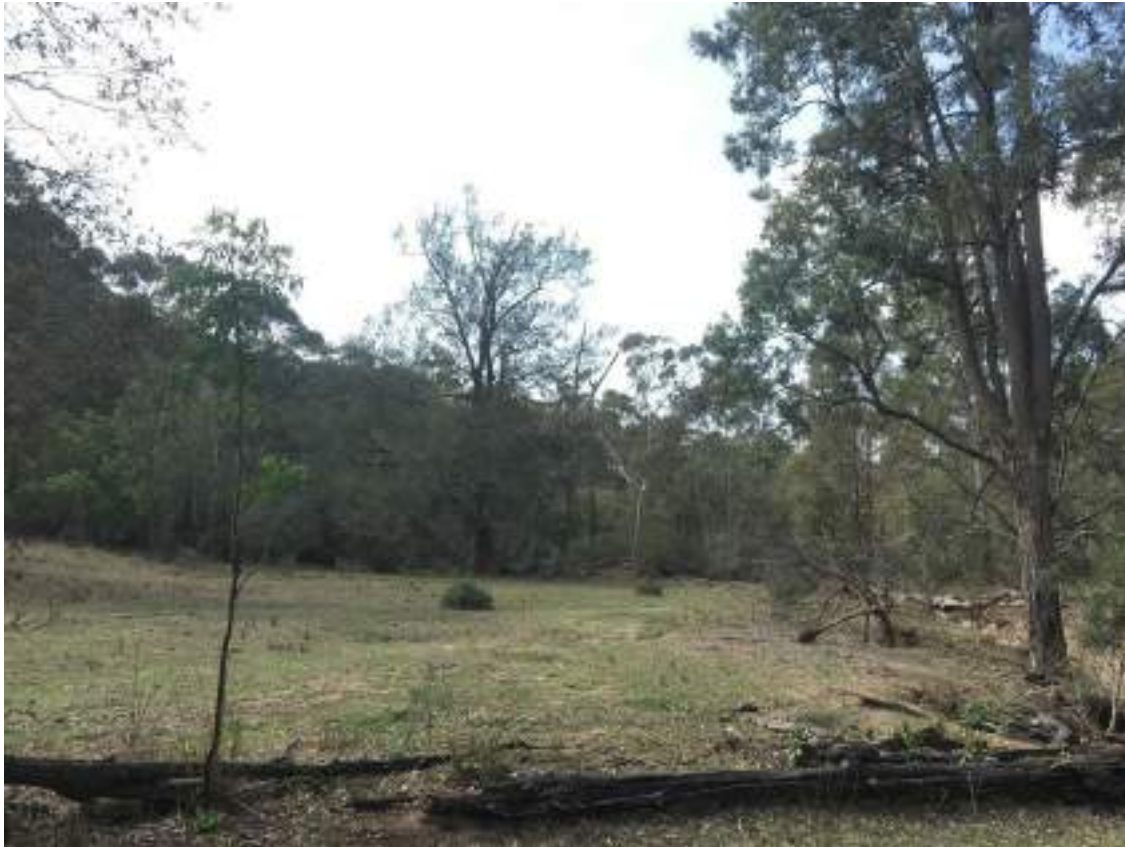
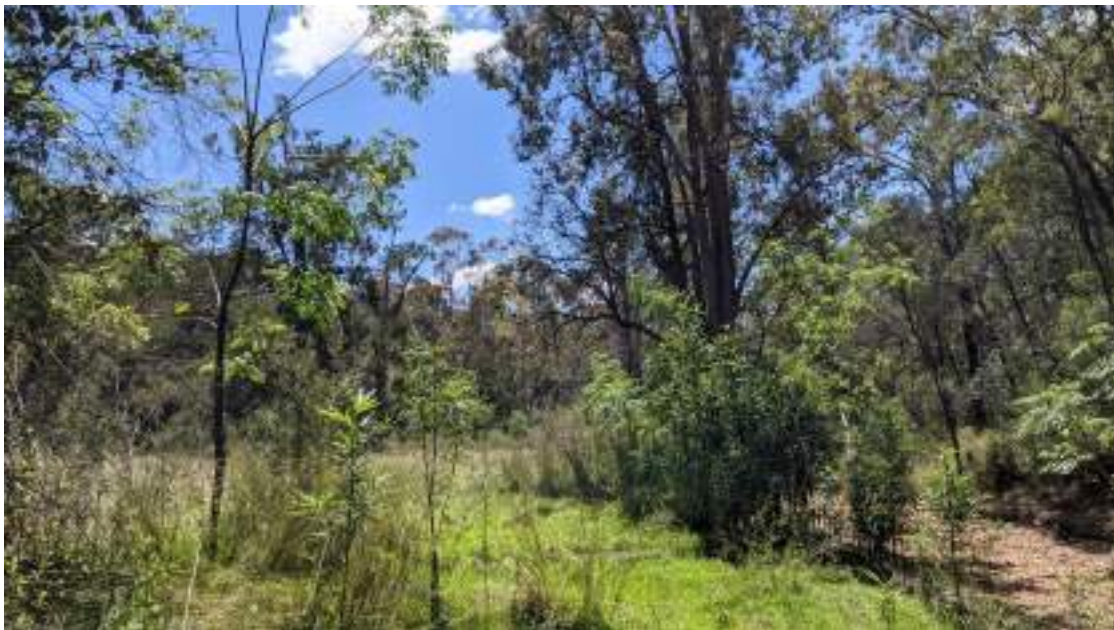
**Photograph 30: GDE Photo monitoring point M7 (facing north) in River Oak riparian tall woodland in 2019**

**Photograph 31: GDE Photo monitoring point M7 (facing south) in River Oak riparian tall woodland in 2021**

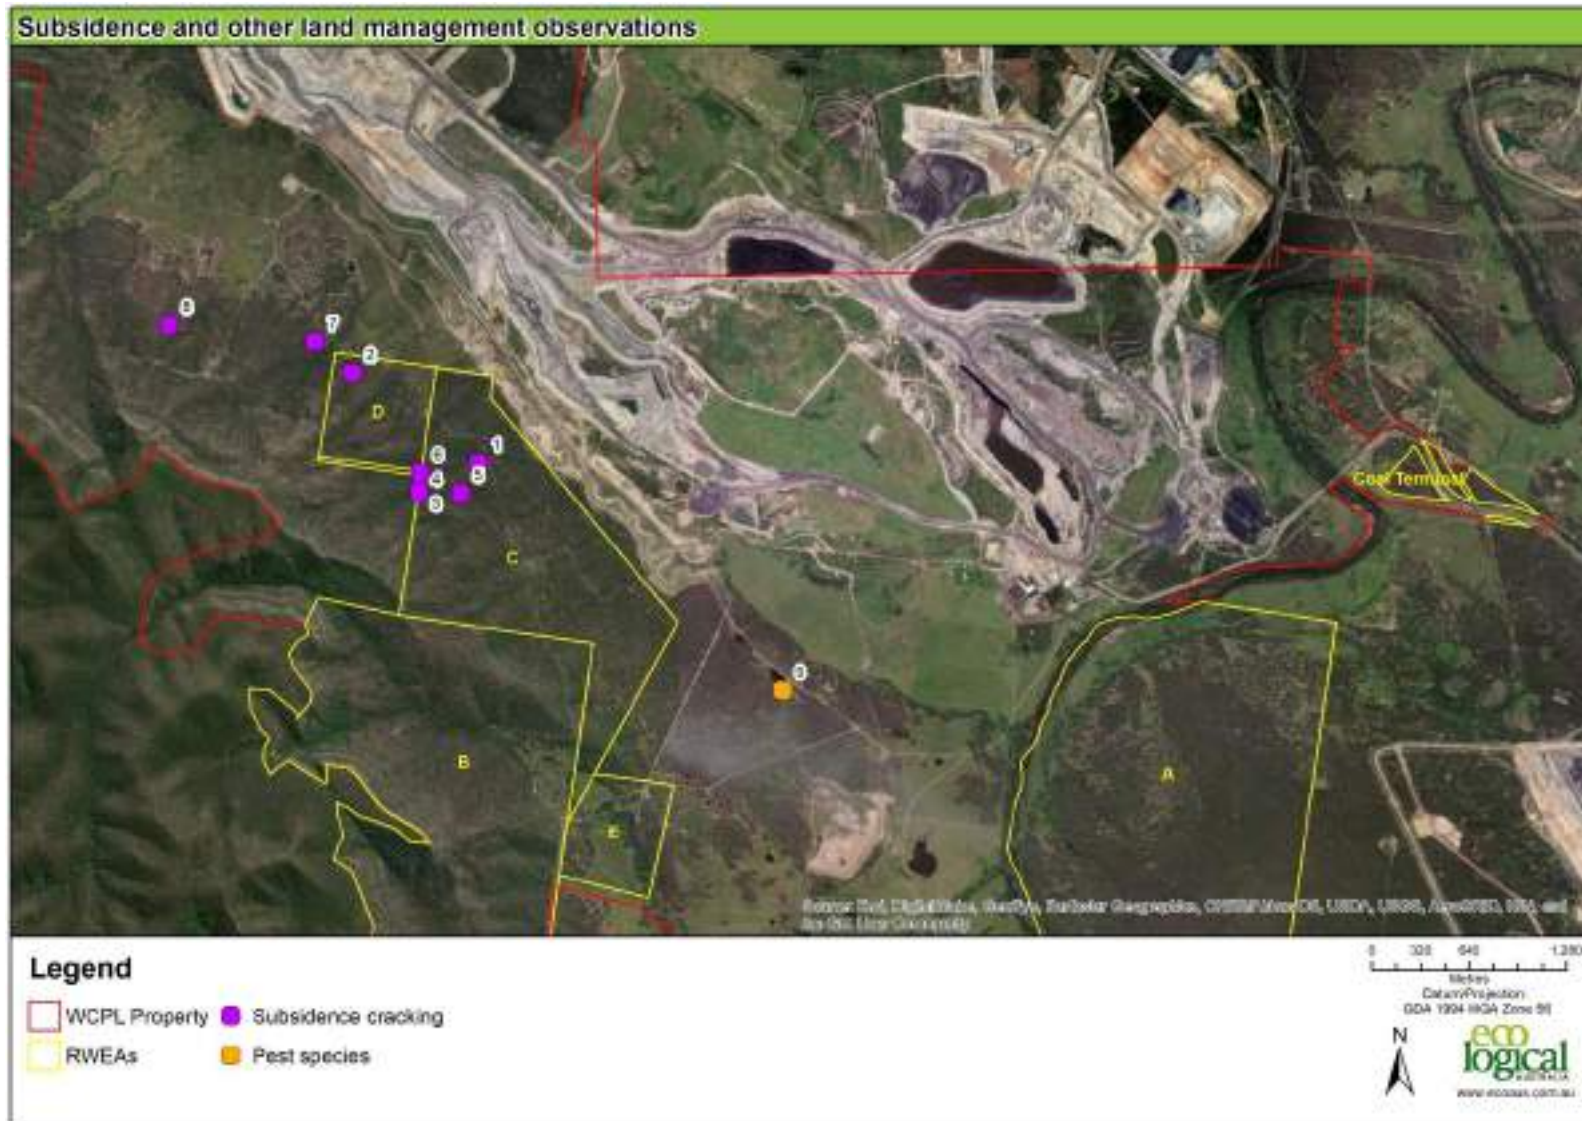
Figure 29. Subsidence and other land management observations from Spring 2021 biodiversity monitoring surveys

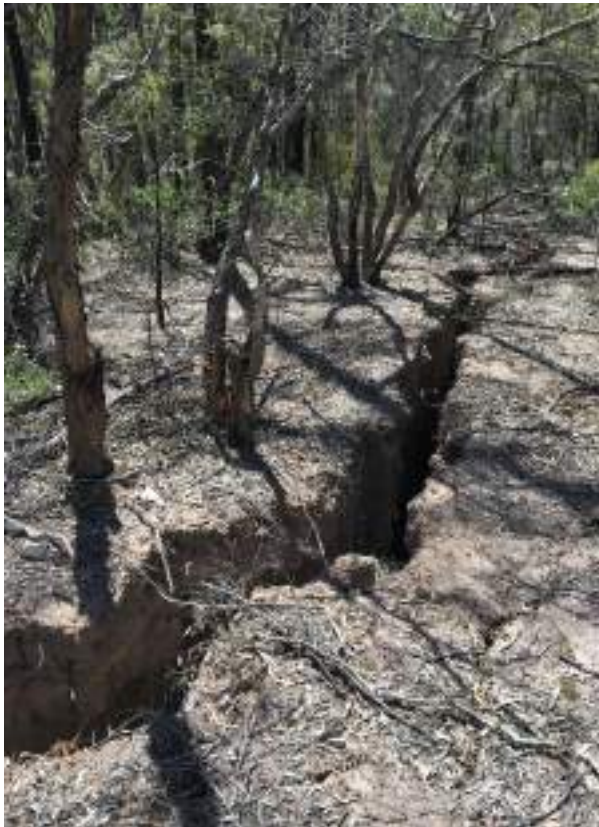
**Photograph 32: Large subsidence cracks near flora monitoring site V11-B1 (in 2019)**

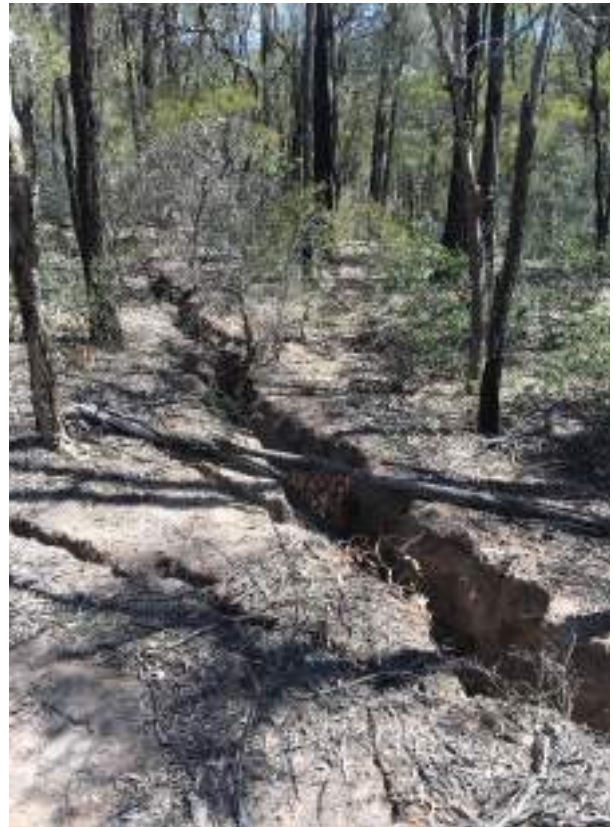
**Photograph 33: Large subsidence cracks near flora monitoring site V11-B1 (in 2019)**

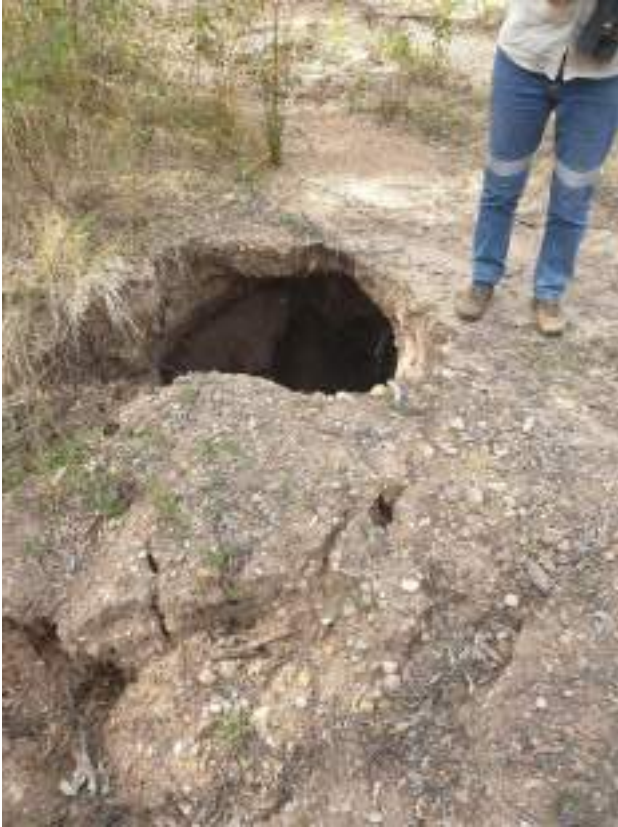
**Photograph 34: Large hole on edge of track within RWEA C**

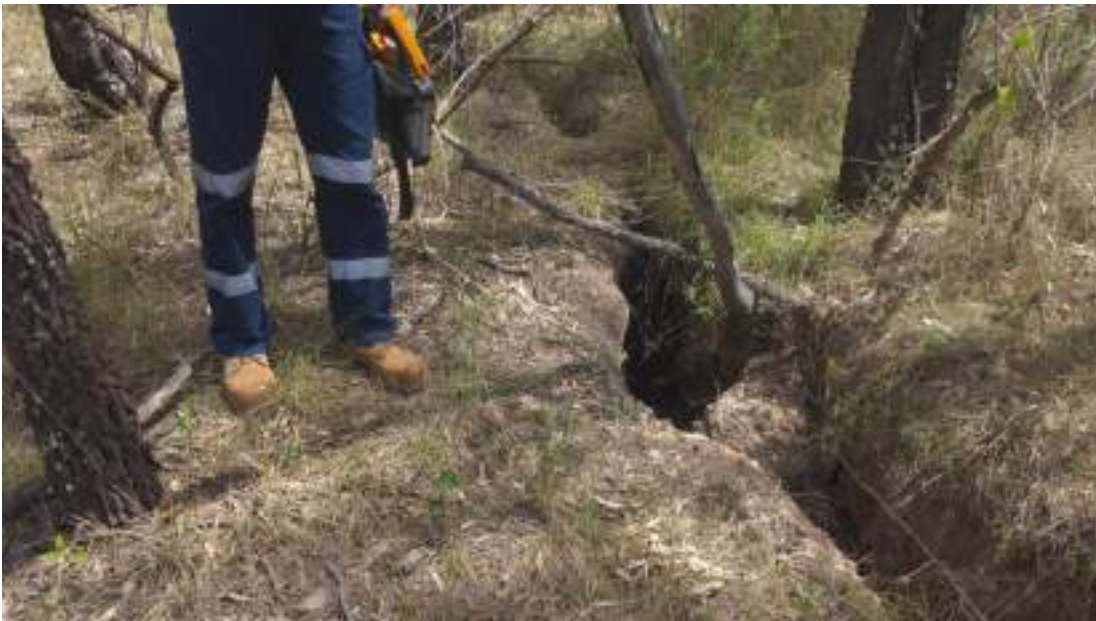
**Photograph 35: Large subsidence crack in RWEA C**

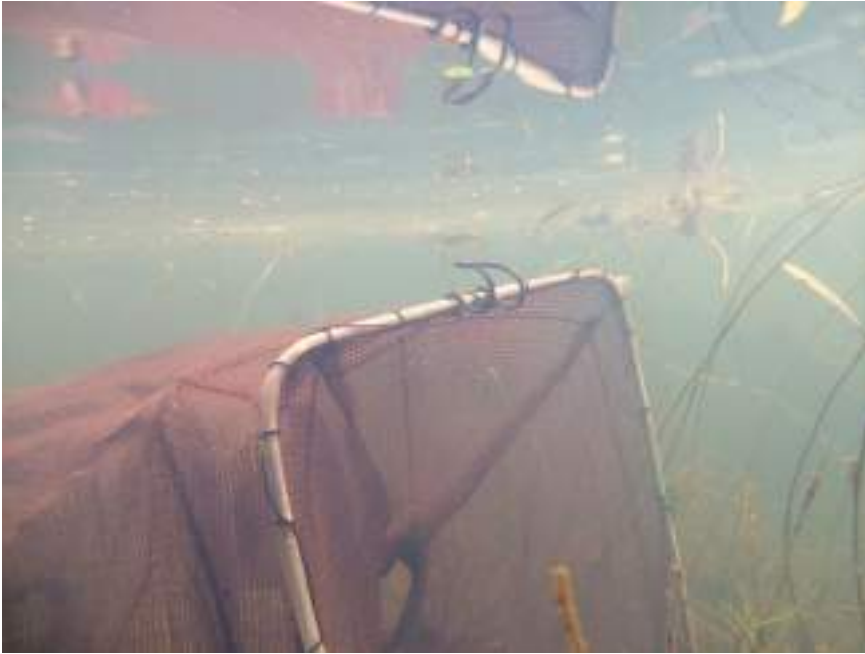
**Plate 1. Concertina baitfish trap**

Fish collected by dip net sampling techniques as part of the macroinvertebrate sampling were separated from the sample *in situ* and recorded. To further sample the fish assemblage, four concertina type baitfish traps (Plate 1) were set at each site. The main aim was to detect if fish have recruited into the North Wambo stream realignment. The fish were identified and counted and returned to the water. Fish and macroinvertebrate sampling was conducted under Section 37 *Fisheries Management Act 1994*- scientific collection permit number P13/0008-1.1
