# **WAMBO COAL PTY LTD 2021 ANNUAL REVIEW**

1 January – 31 December 2021

<b>Name of operation</b>	Wambo Coal Mine
<b>Name of operator</b>	Wambo Coal Pty Ltd
<b>Development consent /Project Approval #</b>	DA305-7-2003, DA177-8-2004, EPBC 2003/1138, EPBC 2016/7636, EPBC 2016/7816
<b>Name of holder of development consent</b>	Wambo Coal Pty Ltd
<b>Title/Mining lease #</b>	CL365, CL374, CL397, CCL743, ML1402, ML1572, ML1594, ML 1806, A444, EL7211
<b>Name of holder of mining lease</b>	Wambo Coal Pty Ltd
<b>Water licence #</b>	As per <b>Table 3</b>
<b>Name of holder of water licence</b>	Wambo Coal Pty Ltd
<b>MOP/RMP start date</b>	1 December 2020
<b>MOP/RMP end date</b>	31 December 2023
<b>Annual Review start date</b>	1 January 2021
<b>Annual Review end date</b>	31 December 2021
<p><b>I, Peter Jaeger, certify that this audit report is a true and accurate record of the compliance status of Wambo Coal Mine for the period 1 January 2021 to 31 December 2021 and that I am authorised to make this statement on behalf of Wambo Coal Pty Ltd.</b></p> <p><i>Note:</i></p> <p>a) <i>The Annual Review is an ‘environmental audit’ for the purposes of section 122B(2) of the Environmental Planning and Ass

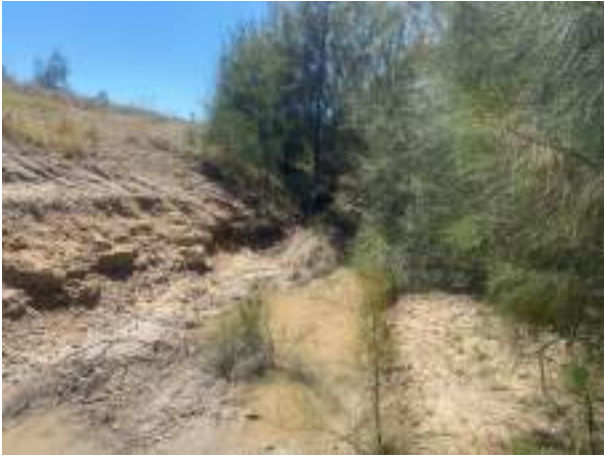
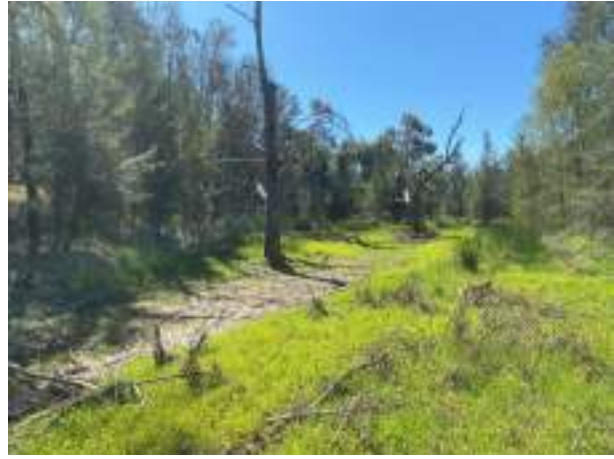
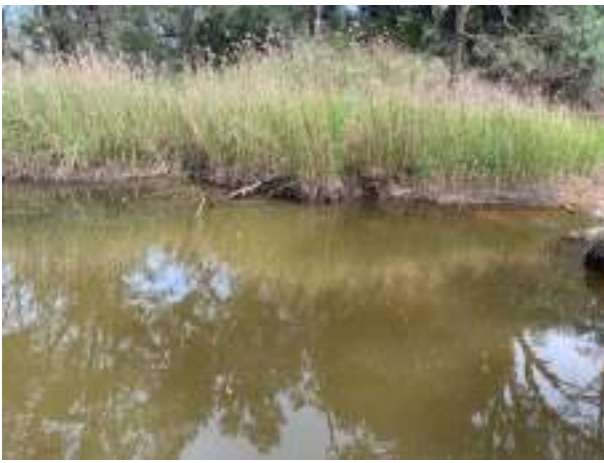
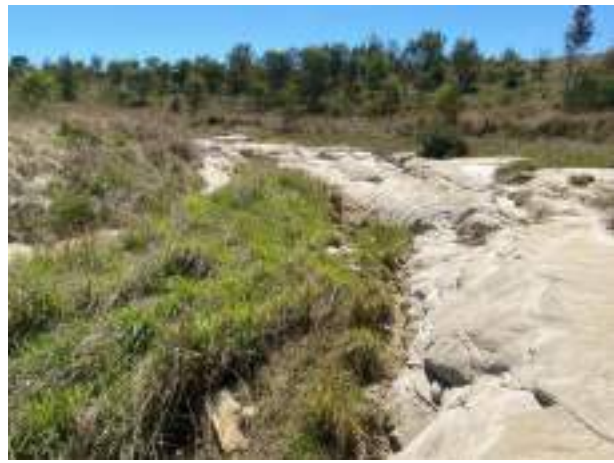
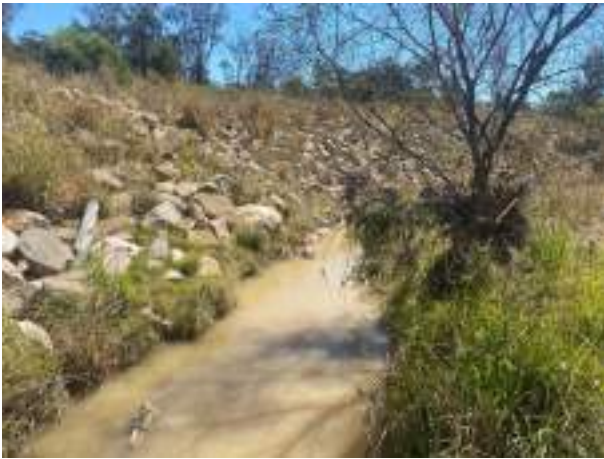
**Plate 2. North Wambo Creek. A- Site 1, B- Site 2, C- Site 3, D- Site 12, E- Site 13**

North Wambo Creek sites within the stream realignment (Site 1, Site 12 and Site 13) (Plate 2A, D and E) had increased riparian vegetation and improved bank stability with areas susceptible to erosion being reshaped and lined and banks protected as part of the stream remediation works. There was limited water in the stream alignment, however pool aquatic habitat was evident in some sections of the waterway. These pools generally were shallow and turbid with limited aquatic vegetation and shading. Site 13 provided the best aquatic habitat within the stream realignment with a deeper pool and some aquatic vegetation (*Juncus* sp. and *Cyperus* sp.) and evidence of yabbies using the location. Site 2 downstream of the alignment also provided limited aquatic habitat, however, in general had healthier riparian vegetation and aquatic habitat compared to the stream alignment. Site 3 had relatively good riparian vegetation cover and provided a large pool habitat with a broad range of habitat types including undercut banks, fine sediment and rocky substrate, and aquatic vegetation including *Phragmites australis*.

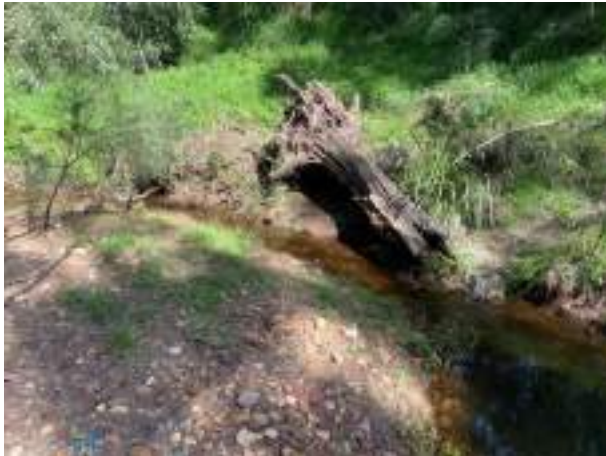
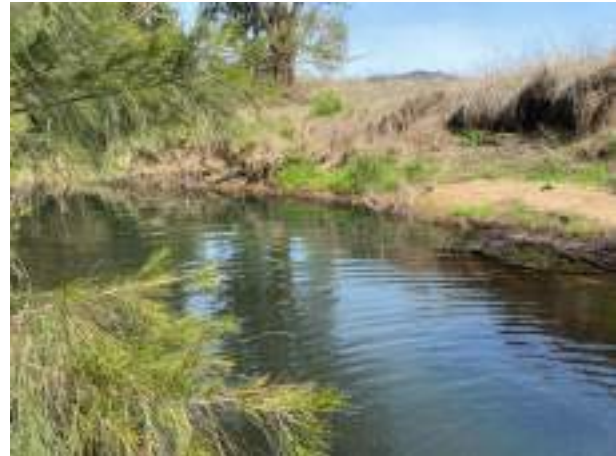
**Plate 3. South Wambo Creek. A- Site 4, B- Site 5**

shrubs) present, the Casuarina (*Casuarina cunninghamiana*) dominated riparian vegetation was in moderate condition and provided shading to the waterway.

Site 5 (downstream) (Plate 3B) had limited aquatic habitat, with only one large pool present. The aquatic habitat there was dominated by fine sediment and coarse-grained sand. There was riparian vegetation present, however, this was limited and provided only partial shading to the waterway. The pool was clear and was up to 0.5 m deep.

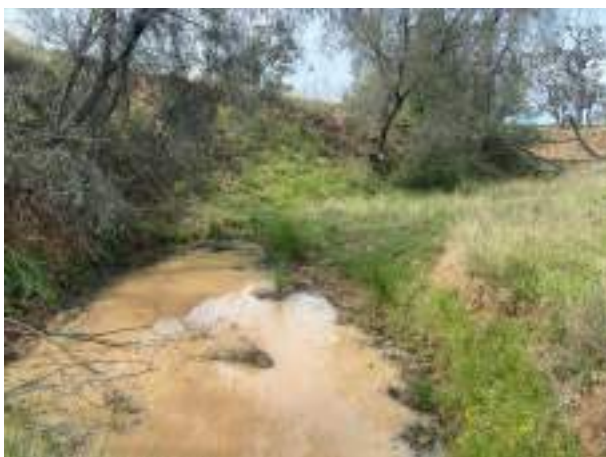
**Plate 4. Waterfall Creek. Site 6**

Waterfall Creek is considered an ephemeral stream and has very limited aquatic habitat (Plate 4). There was one pool present at Site 6, which consisted of shallow, muddy aquatic habitat. While there were some canopy riparian vegetation trees present (*Casuarina* and *Acacia* species) these provided limited stream-bank protection and shading. There were also signs of bed and bank erosion in the waterway and evidence of cattle use.

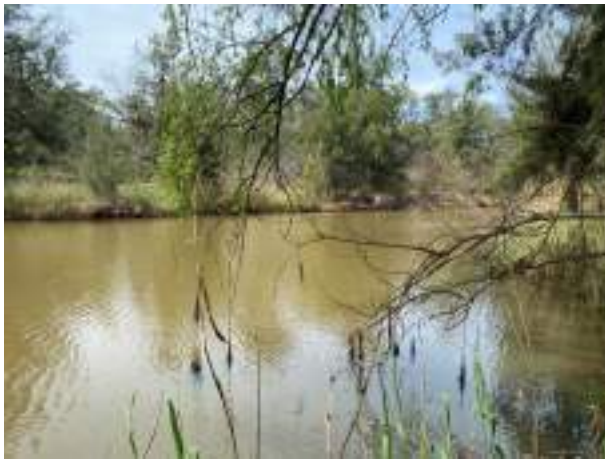
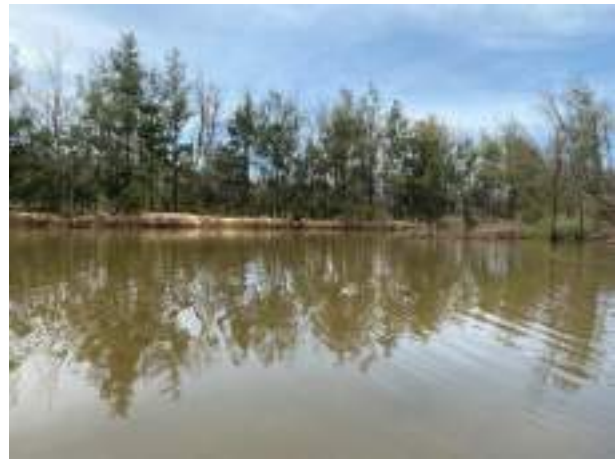
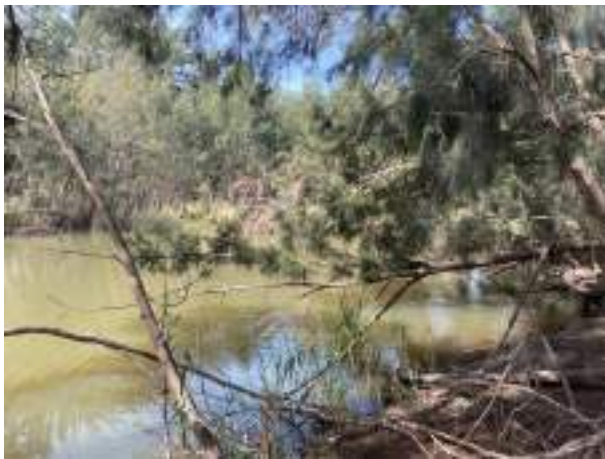
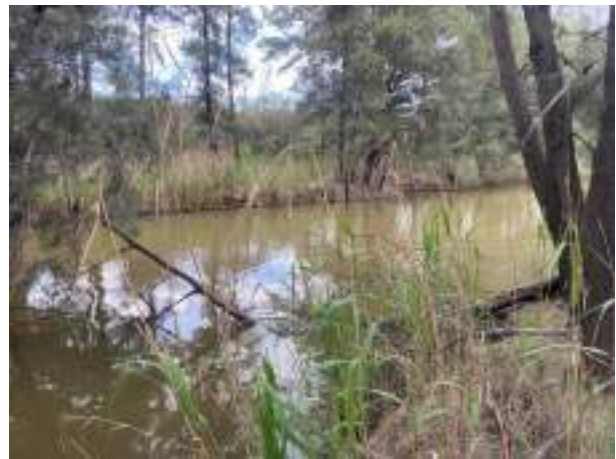
**Plate 5. Wollombi Brook. A- Site 8, B- Site 9, C – Site 10, D – Site 11.**

Site 7 could not be sampled as there was bridge construction at Bulga and the site could not be accessed. Of the sites that were surveyed (Site 8-11) all showed very similar aquatic habitat types. The waterway provided large pool habitat which was relatively deep in places (>1 m) and wide (approximately 15 m). The benthos was dominated by sand-sized sediment with few gravels, cobbles or boulders.

The riparian zones were in fair condition showing moderate disturbance such as the presence of weeds. The canopy was dominated by River Sheoak (*C. cunninghamiana*), with the midstory consisting of Willow (*Salix* sp) and smaller River Sheoak. Tall groundcover species included Common Rush (*Phragmites australis*) and Marsh Club-rush (*Bolboschoenus fluviatilis*). Exotic weeds were present. Vegetation cover provided a low to moderate shading of the river.

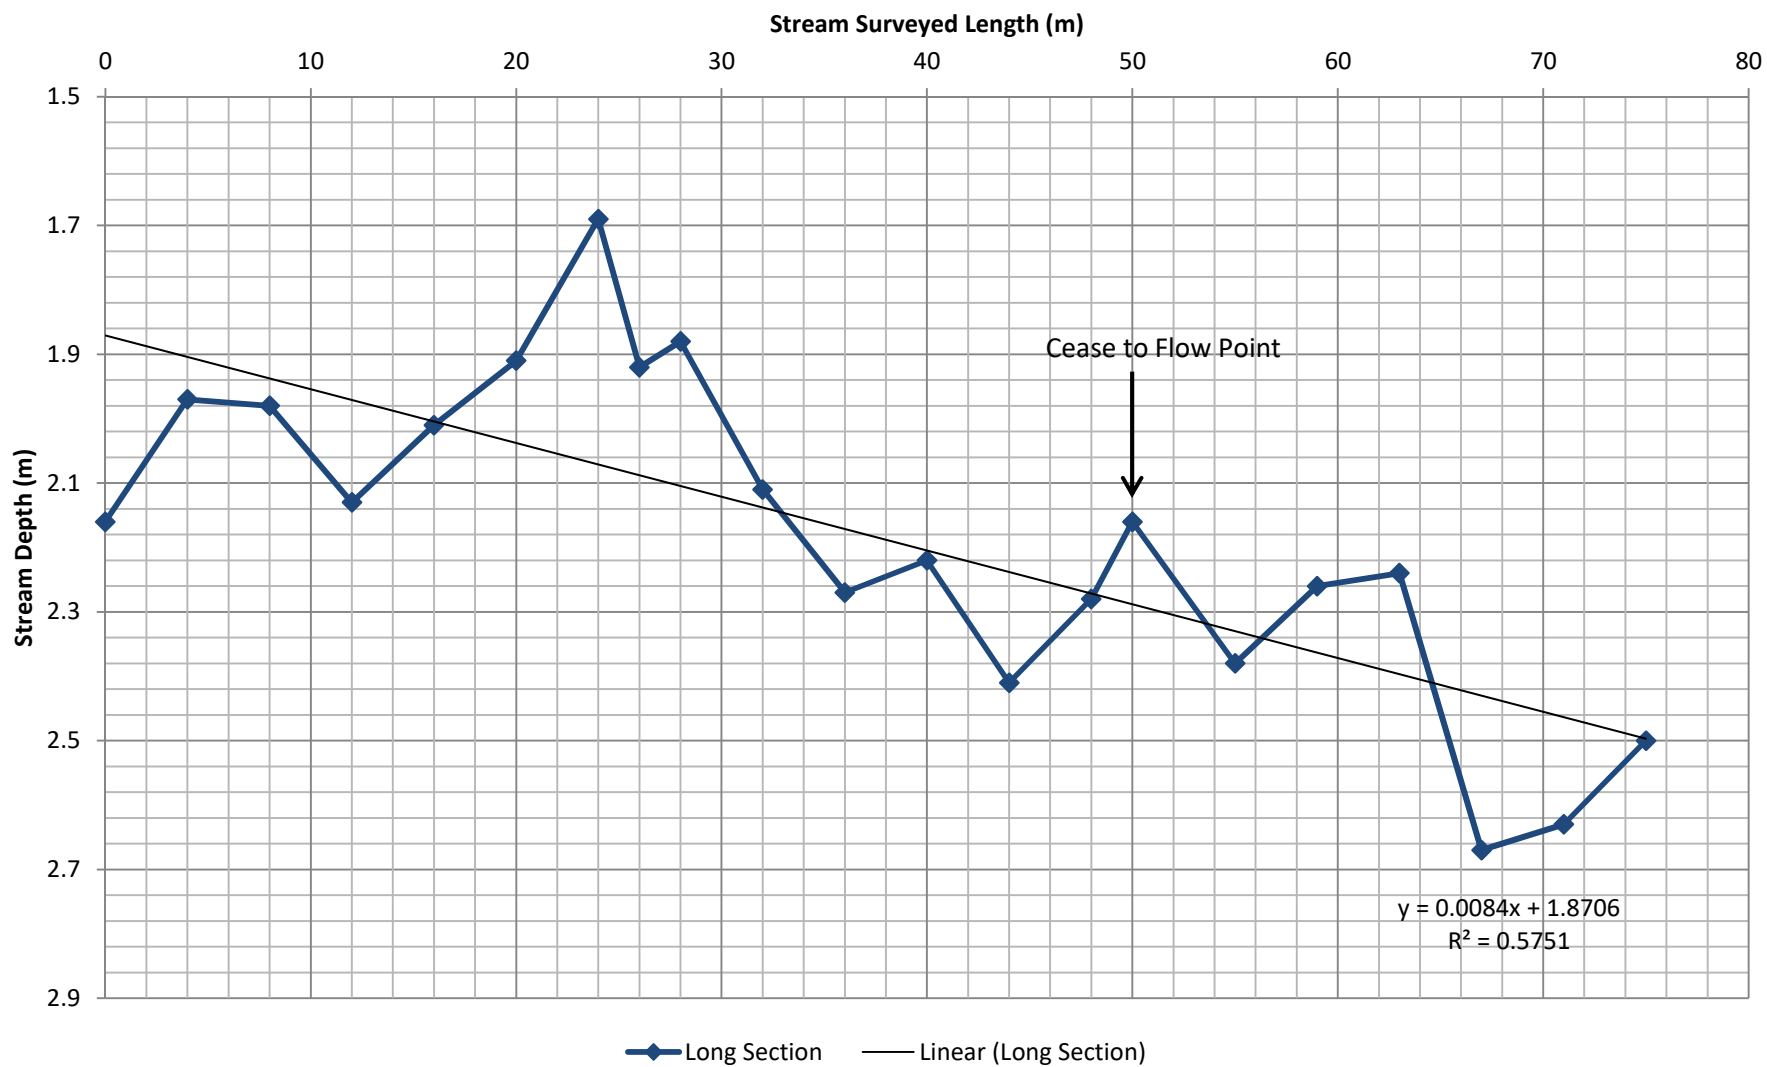
# Flow Monitoring Station 13 Stoney Creek Down Theoretical Flow Curve January 2022
