# **WAMBO COAL PTY LTD 2019 ANNUAL REVIEW**

1 January – 31 December 2019

<b>Name of operation</b>	Wambo Coal Mine
<b>Name of operator</b>	Wambo Coal Pty Ltd
<b>Development consent /Project Approval #</b>	DA305-7-2003, DA177-6-2004, EPBC 2003/1138, EPBC 2016/7636, EPBC 2016/7816
<b>Name of holder of development consent</b>	Wambo Coal Pty Ltd
<b>Title/Mining lease #</b>	CL365, CL374, CL397, CCL743, ML1402, ML1572, ML1594, MLA 557, A444, EL7211
<b>Name of holder of mining lease</b>	Wambo Coal Pty Ltd
<b>Water licence #</b>	As per <b>Table 3</b>
<b>Name of holder of water licence</b>	Wambo Coal Pty Ltd
<b>MOP start date</b>	September 2019
<b>MOP end date</b>	31 December 2020
<b>Annual Review start date</b>	1 January 2019
<b>Annual Review end date</b>	31 December 2019
<p><b>I, Albert Scheepers, certify that this audit report is a true and accurate record of the compliance status of Wambo Coal Mine for the period 1 January 2019 to 31 December 2019 and that I am authorised to make this statement on behalf of Wambo Coal Pty Ltd.</b></p> <p><i>Note:</i></p> <p>a) <i>The Annual Review is an 'environmental audit' for the purposes of section 122B(2) of the Environmental Planning and Assessme

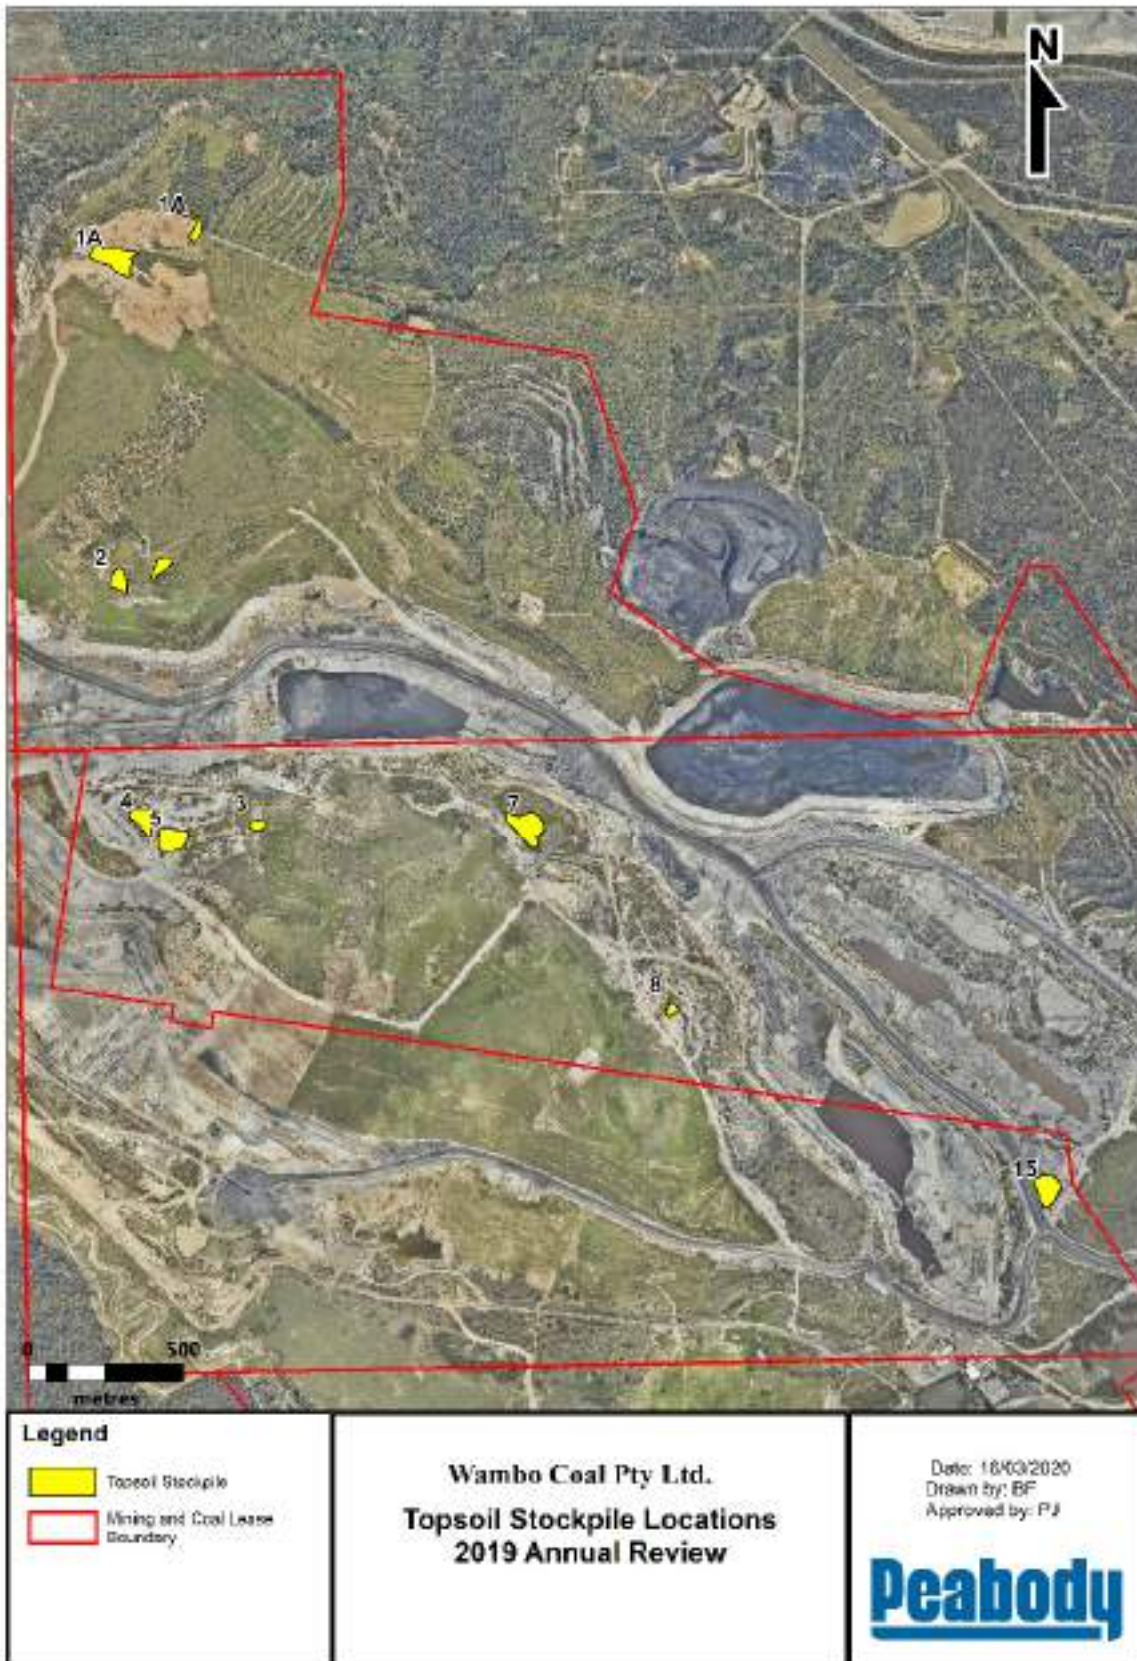
**Figure 8: Topsoil Locations**

During the reporting period, WCPL undertook an inventory of topsoil stockpiles on-site, including location, volume and condition. This inventory (as at the end of the reporting period) is summarised in **Table 29** below. Topsoil stockpile locations, as at the end of the reporting period, are shown on **Figure 8**.

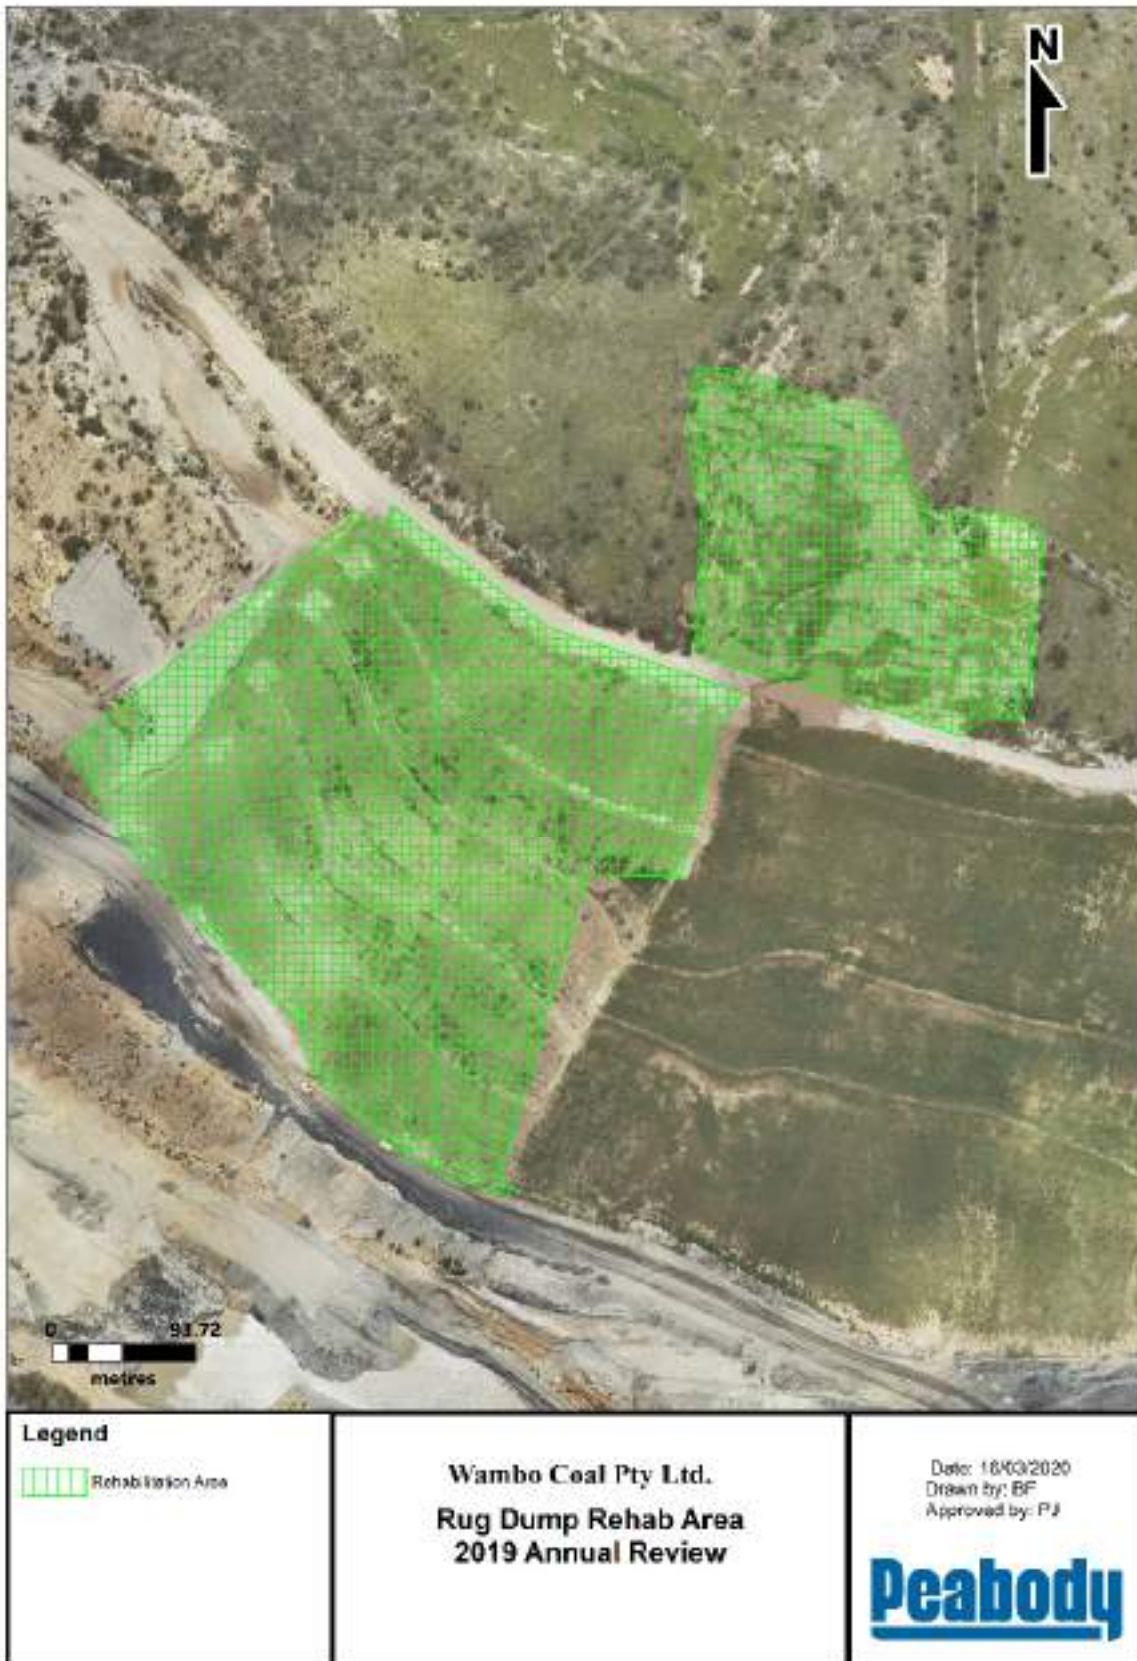
**Figure 11: Rug Dump Rehabilitation Undertaken in 2019**

**Figure 11** and **Figure 12** show the rehabilitation areas progressed during the reporting period.

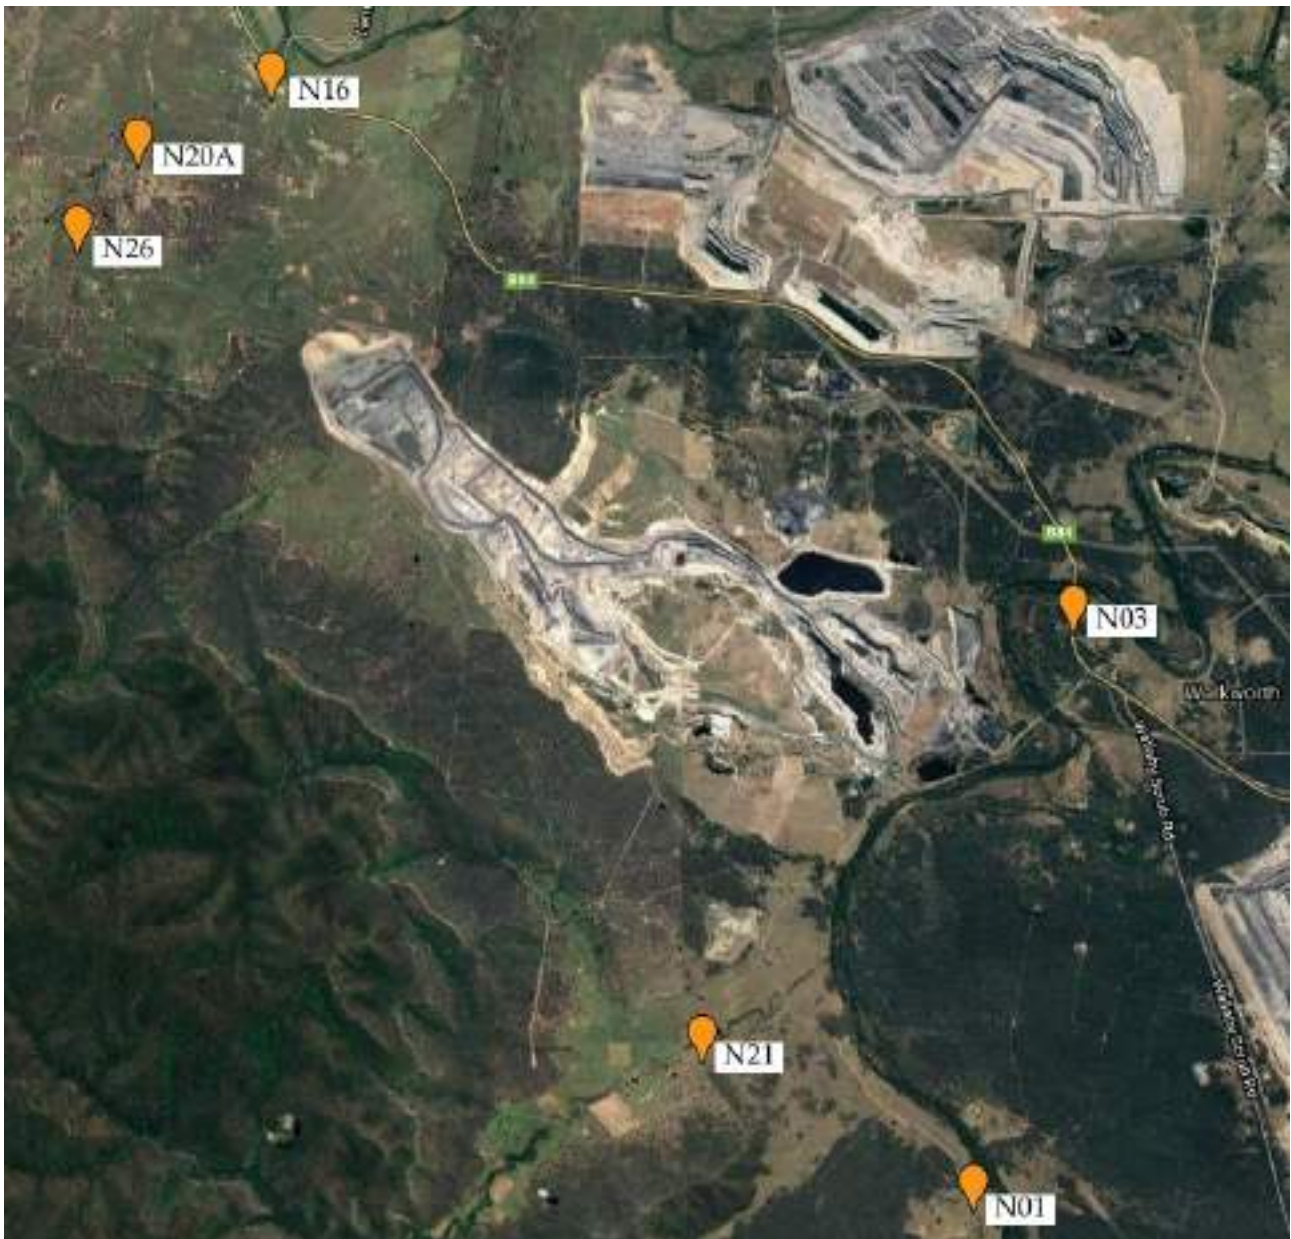
Figure 1: WCM Attended Noise Monitoring Sites

1. Sourced from the NMP – WA-ENV-MNP-503, January 2018; and
2. N20 is not an attended noise monitoring location, but is the location of a real-time continuous noise monitor.

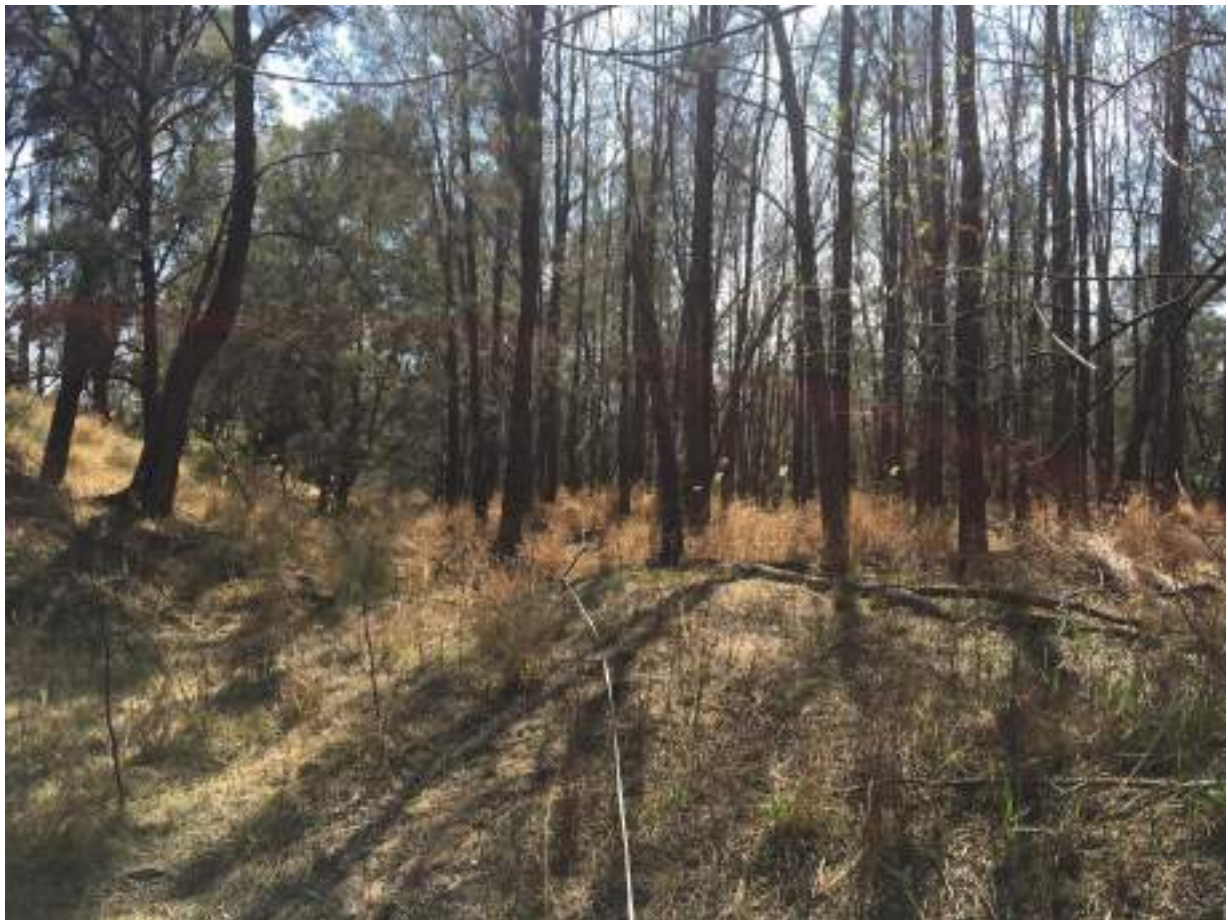
**Plate 1: River Red Gum / River Oak riparian woodland wetland on North Wambo Creek in 2019 (Site V1-A1 within the Wollombi Brook channel)**

The River Red Gum / River Oak riparian woodland at WCPL is typical of other remaining stands throughout the Hunter Valley, with generally a high cover of weed species and a reduced number of native species (**Plate 1**).

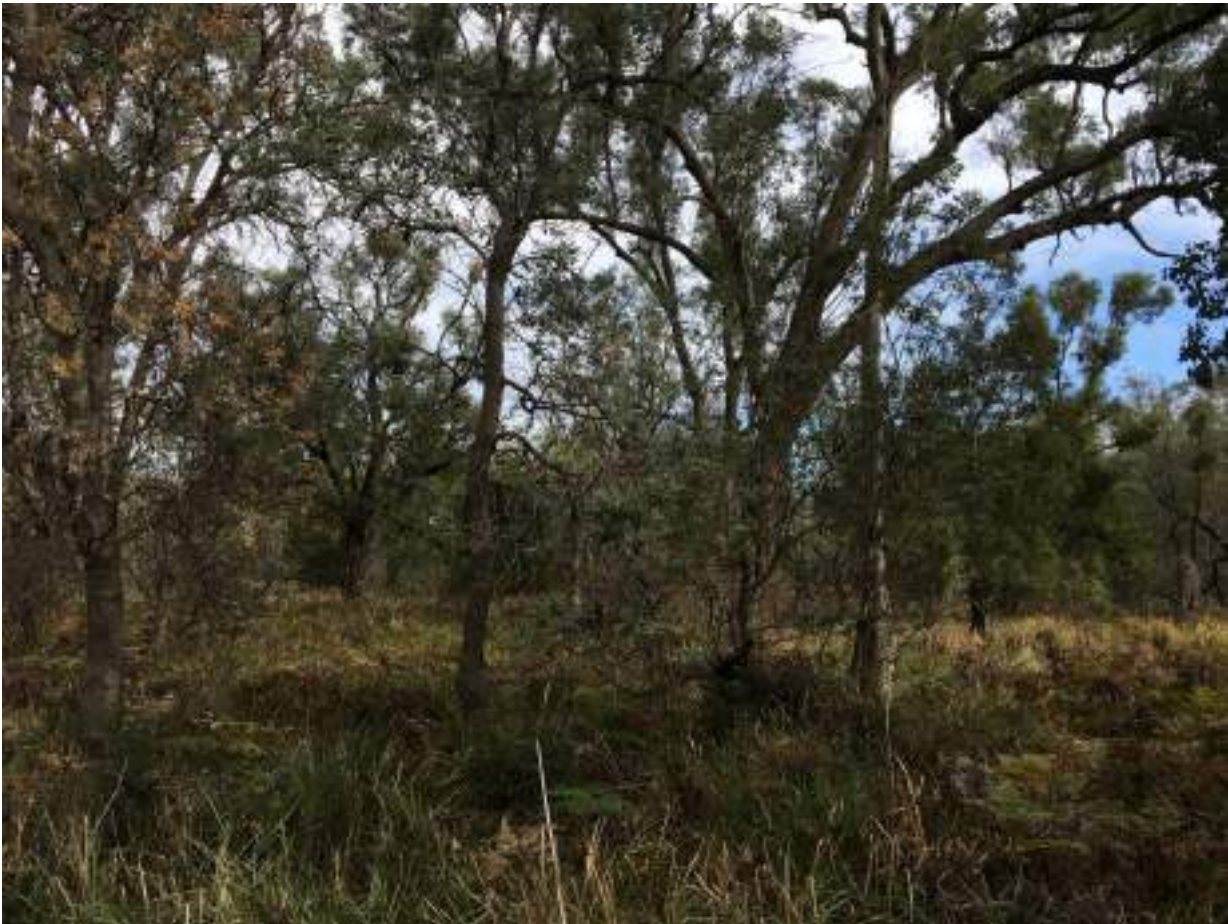
**Plate 6: Warkworth Sands Woodland within RWEA A**

Within WCPL owned land, this community is mostly restricted to the eastern side of Wollombi Brook, primarily within the RWEA area A (**Plate 6**). This PCT corresponds to the Commonwealth EPBC Act listed Critically Endangered Ecological Community (CEEC) *Warkworth Sands Woodland of the Sydney Basin Bioregion* and is also listed under the NSW BC Act. This PCT occurs on aeolian sand deposits and is restricted to the Warkworth area.

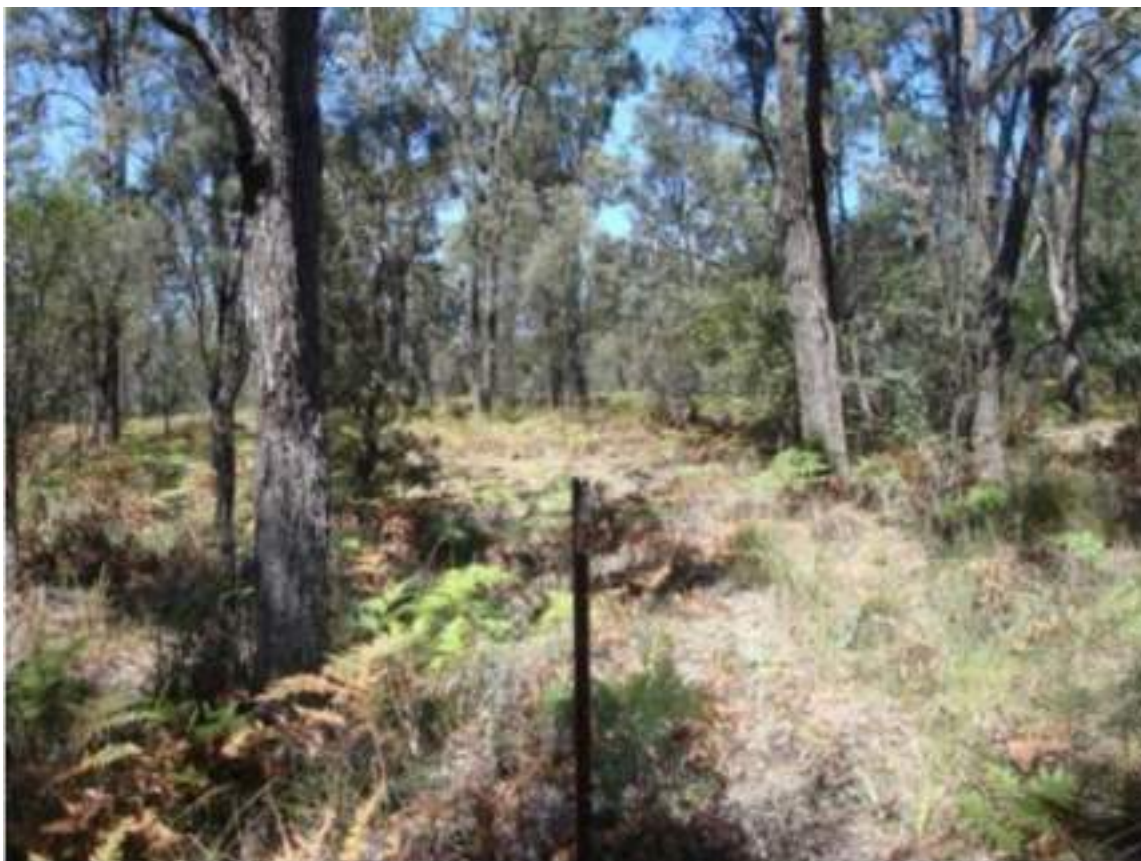
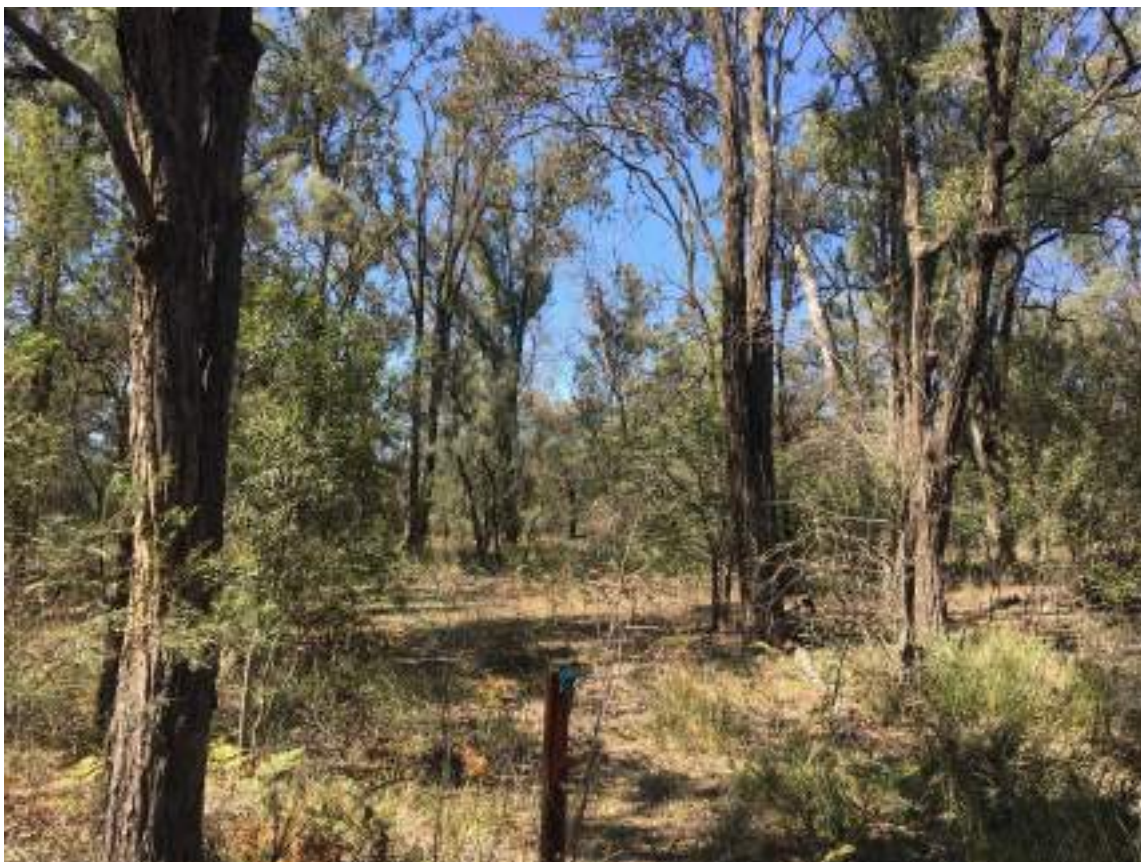
Photo-monitoring point A2 within this PCT shows little change in vegetation structure between the 2013 and 2019 monitoring periods (**Plate 7 & Plate 8**). Canopy dieback of *A. floribunda* in some areas of this community was observed during the 2016 monitoring program. These trees displayed abundant epicormic growth in 2017, and during 2018 and 2019 this recovery continued, and it appears most trees have survived this dieback event to date (**Plates 9 & 10**). Canopy and mid-storey cover scores collected by ELA from the 2015 to 2019 monitoring periods have remained generally similar between years.

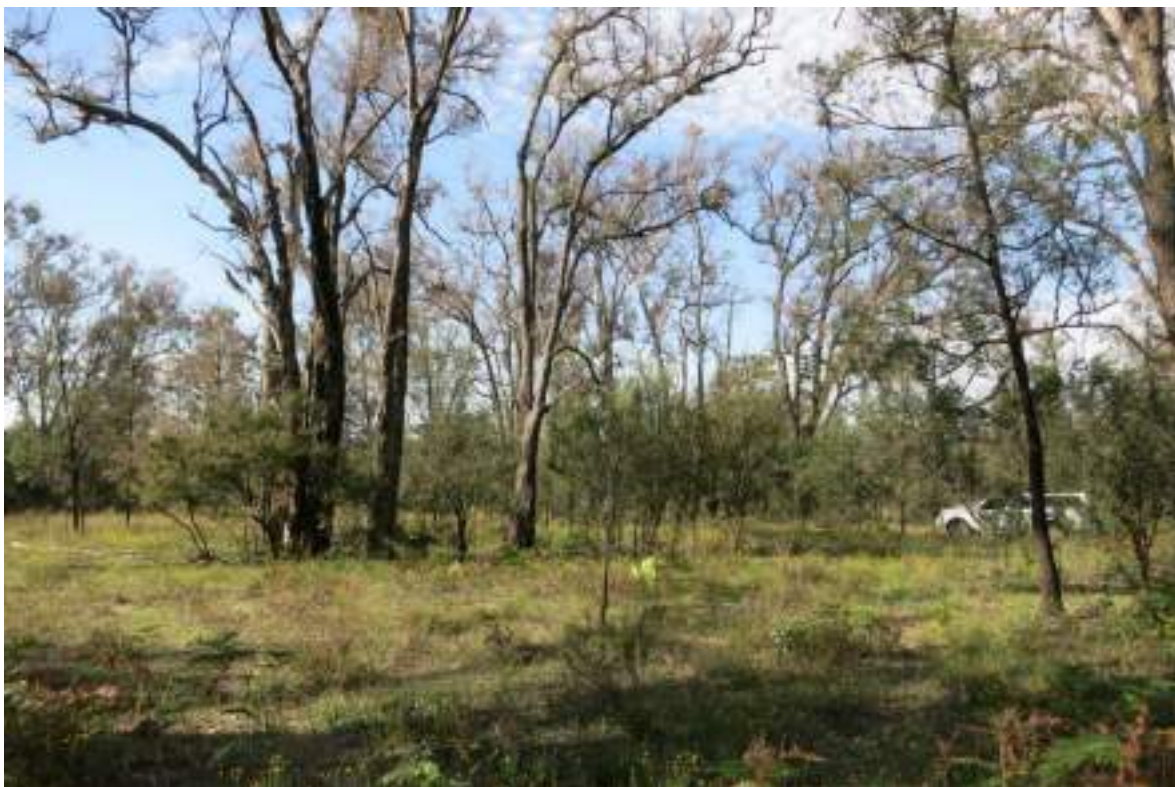
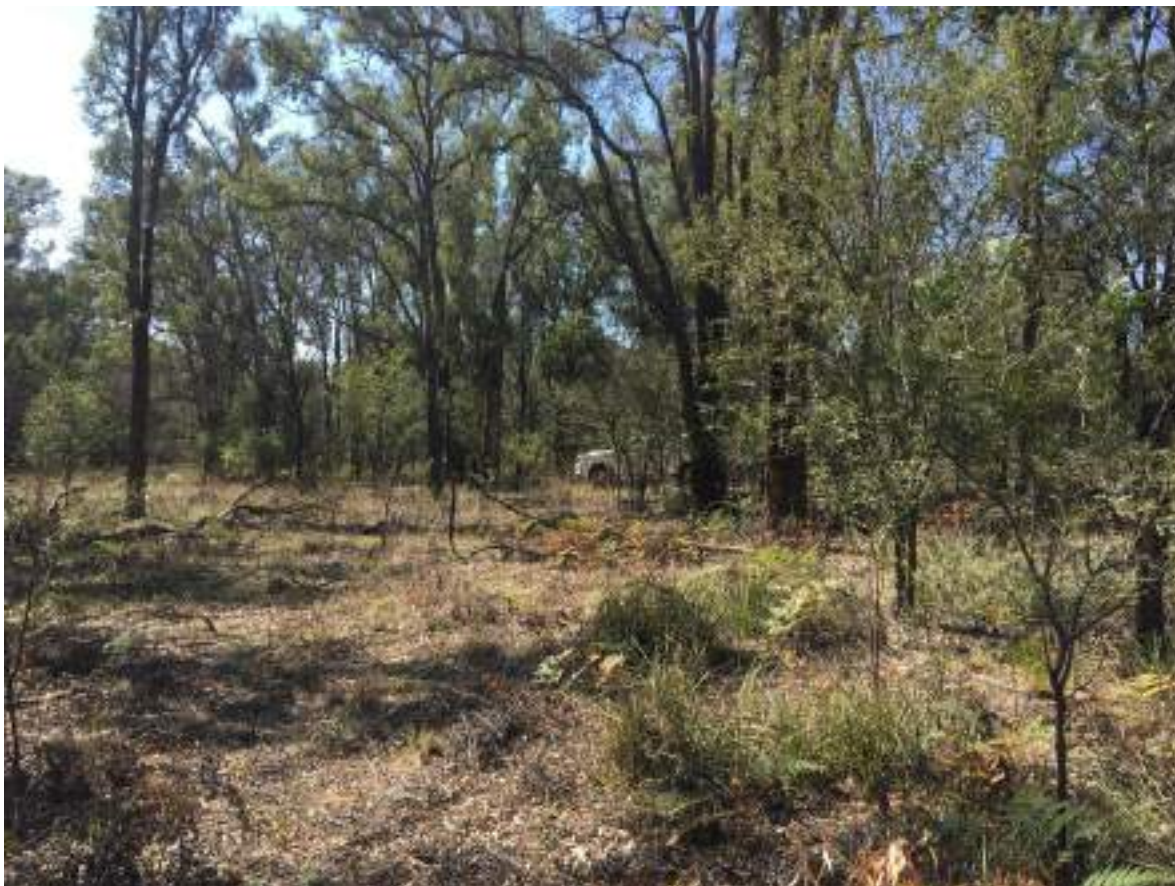
Plate 9: Severe *Angophora floribunda* canopy dieback in parts of Warkworth Sands Woodland in RWEA A during 2016

Plate 10: Continued recovery of *Angophora floribunda* canopy dieback observed in 2019

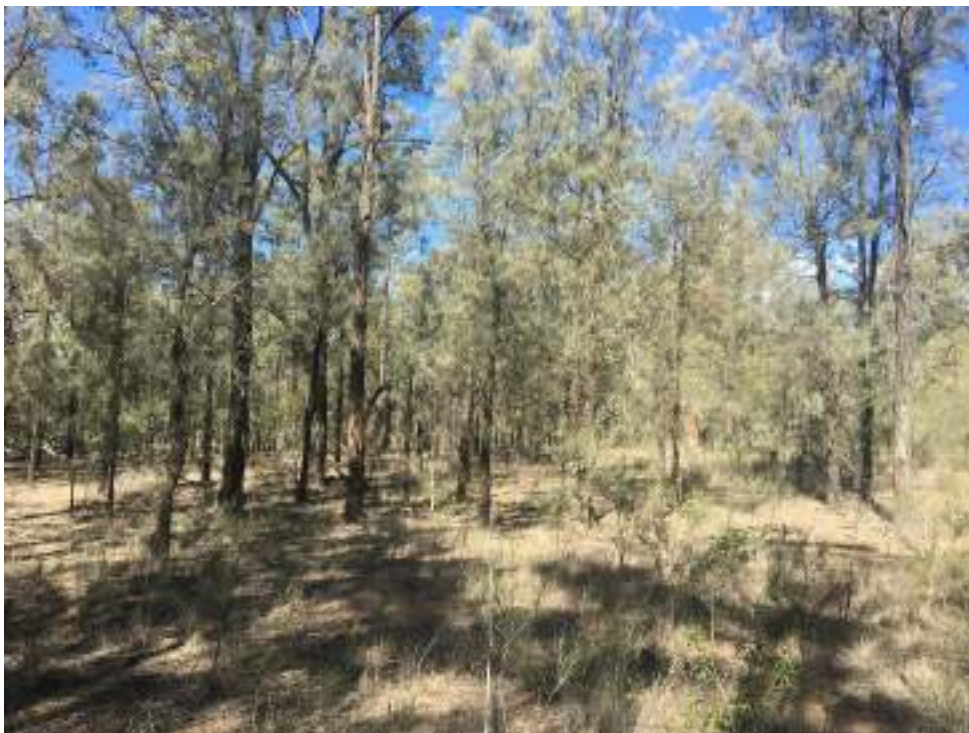
**Plate 11: Narrow-leaved Ironbark - Bull Oak - Grey Box shrub - grass open forest at WCPL (site V6-A3 in 2019)**

This community on land owned by WCPL is generally dominated by the canopy species *Eucalyptus crebra* (Narrow-leaved Ironbark) and occasionally *Eucalyptus moluccana* (Grey Box) (**Plate 11**). A sparse mid-storey or shrub layer of *Allocasuarina luehmannii* (Bull Oak), *Bursaria spinosa* subsp. *spinosa* (Blackthorn) and *Notelaea microcarpa* var. *microcarpa* (Mock Olive), with a grassy understorey is often present. *Eucalyptus punctata* (Grey Gum) and *Melaleuca decora* also occur in patches.

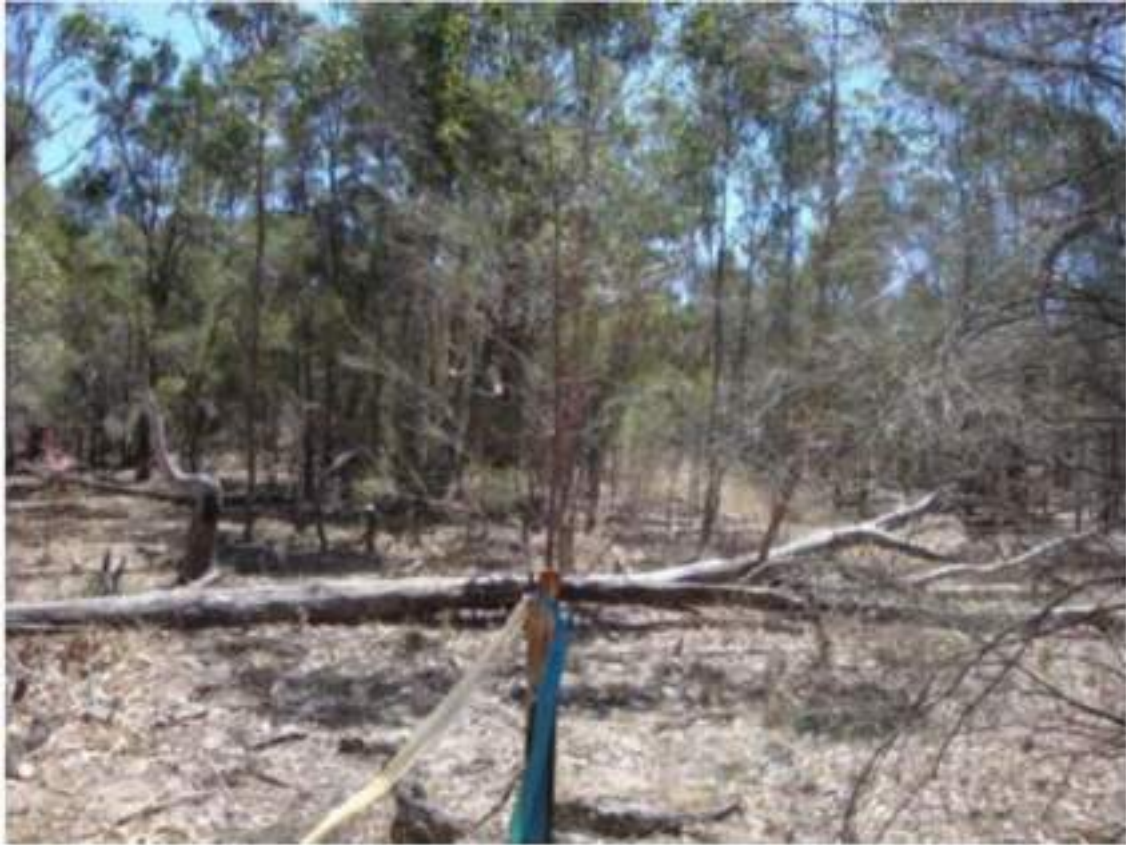
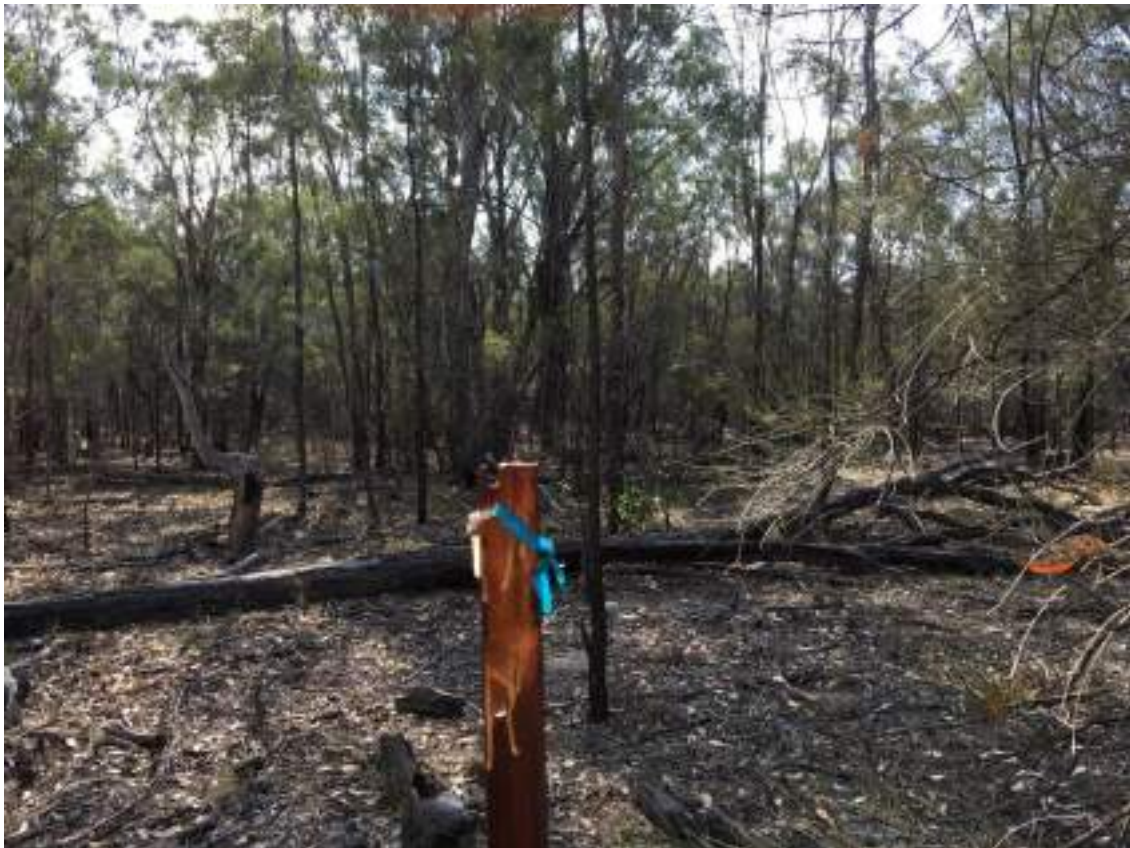
This community appears to be performing well with generally very low cover of exotic species and high diversity of native species present at each monitoring plot. The number of native species recorded dropped slightly from 2018, but still achieved the target for the performance criteria for this attribute (**Table 7**). The number of native species recorded at the reference site also dropped from 2018. Performance criterion were met or acceptable for all other attributes, except for Native Ground Cover Other. Examination of biometric data reveals that no significant changes in exotic cover, canopy or mid-storey have occurred in the majority of these monitoring plots since 2014 when biometric data was first collected. This stability over time can be seen in the photo monitoring point A4 (**Plates 12-13**) with no major changes visible between the 2013 and 2019 monitoring periods.

Minor mine subsidence cracks are present at four of the eight monitoring plots within this PCT. However, no significant vegetation damage has been observed.

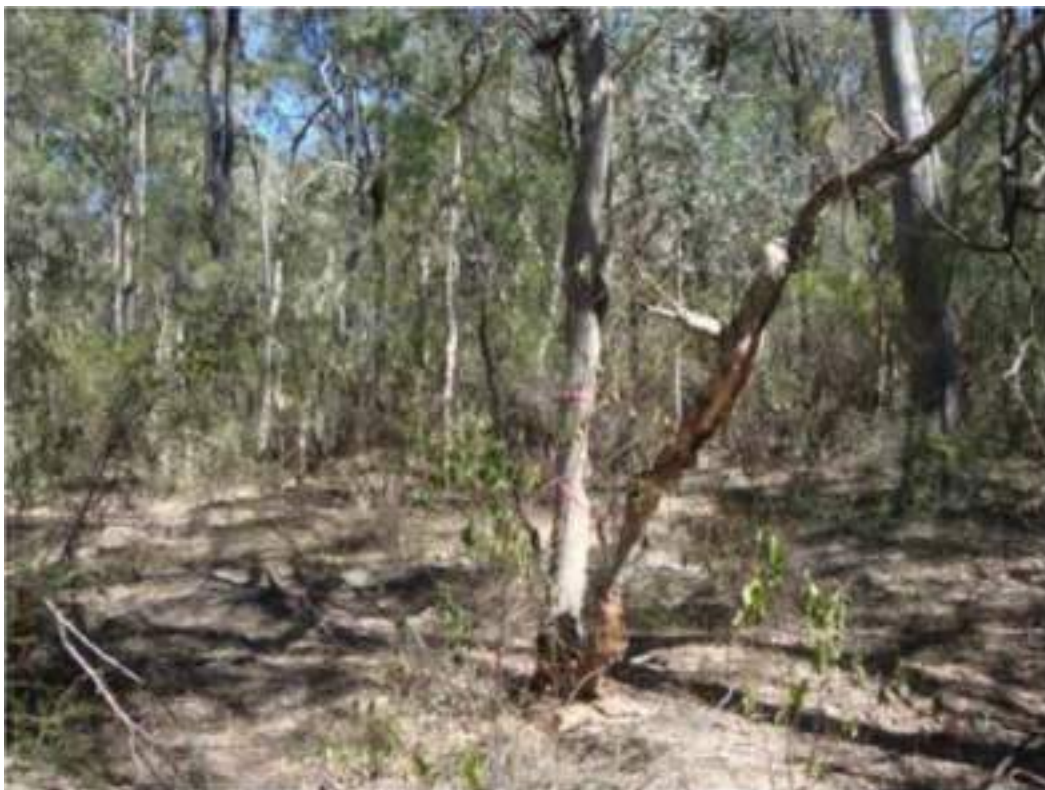
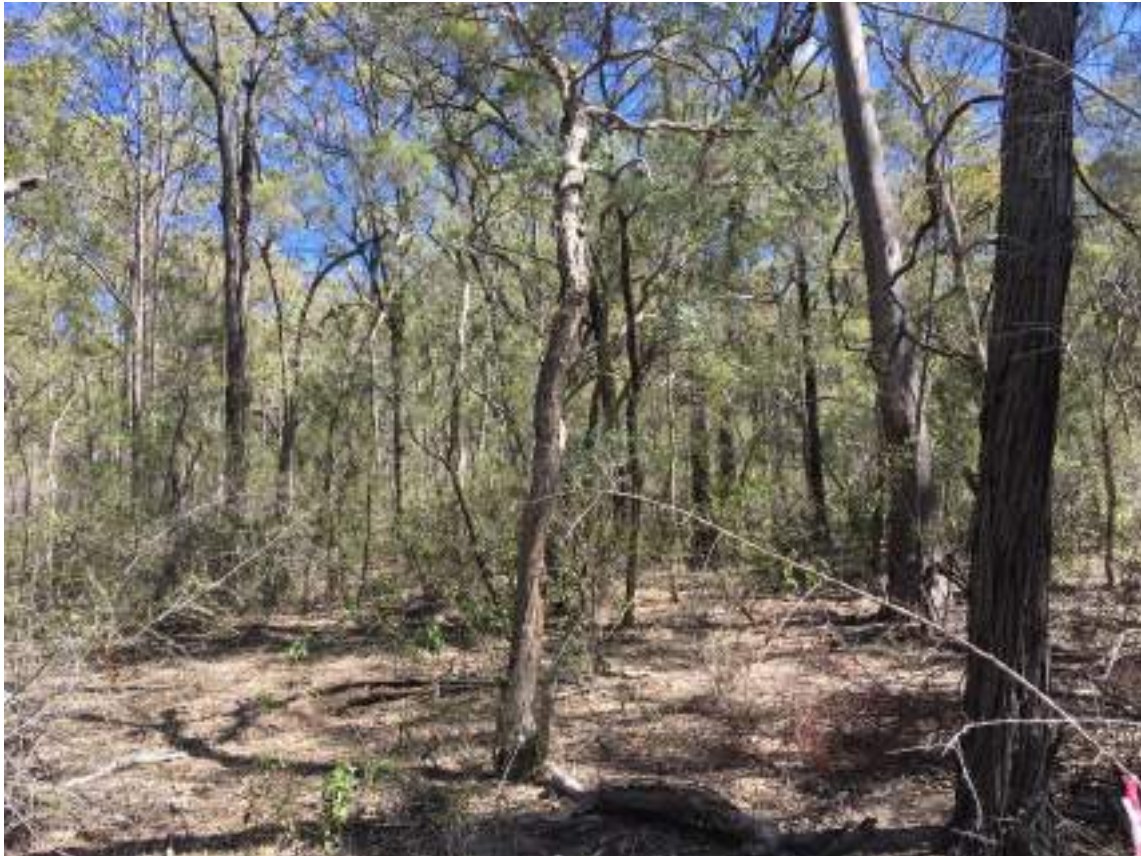
Photo-monitoring points in this community show little change in vegetation structure between the 2013 and 2019 monitoring periods (**Plate 14 & Plate 15**).

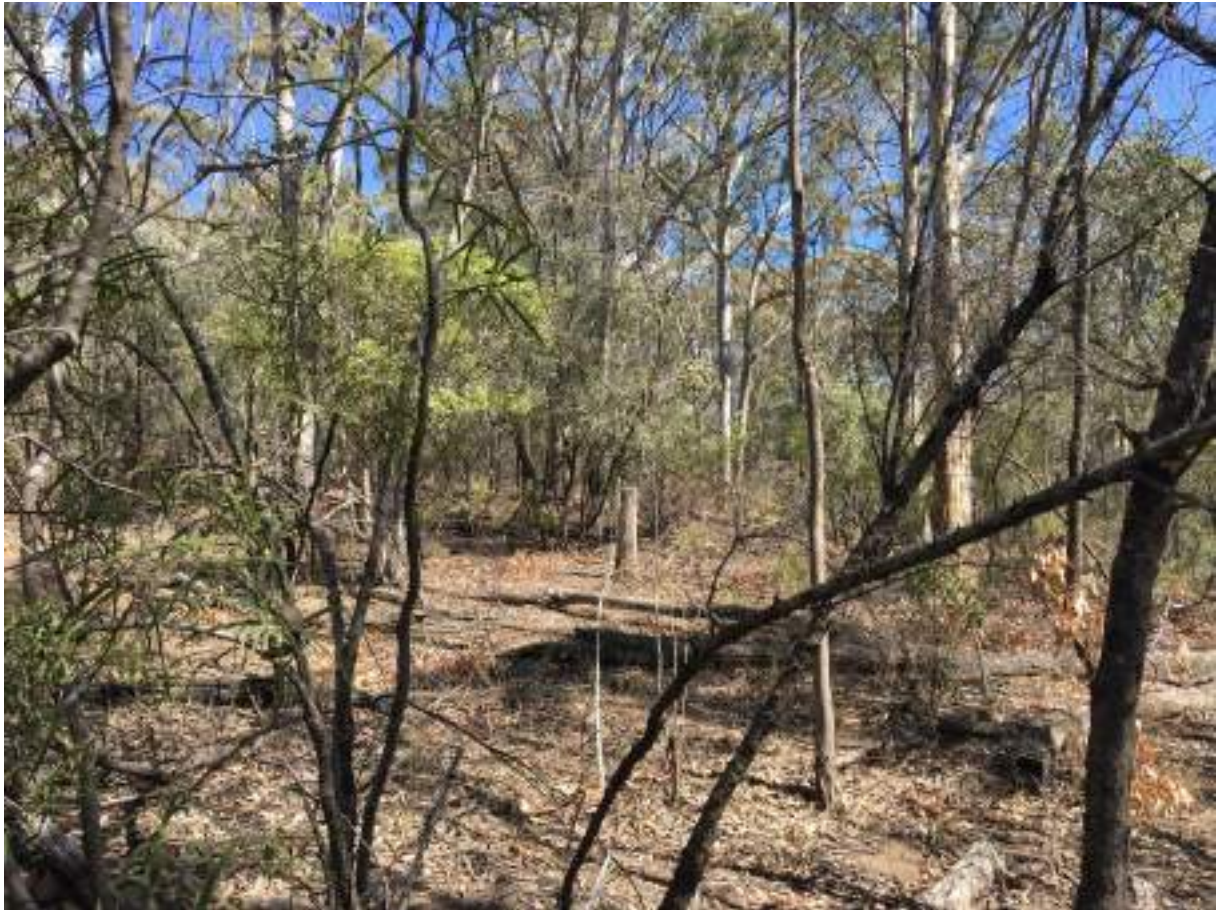
Plate 16: A typical example of Slaty Box woodland at WCPL during 2019 (site V10-B3)

The monitoring sites in this community are located in or near RWEA D. All performance criteria were met in 2019, except for NOS and NGCG which were below the target range. Plot photographs show the canopy in good condition and the lower score is likely a result of observer bias. Native ground covers are likely to be lower due to drought conditions. No management actions are recommended above general weed control. The recorded number of native species in 2019 was within the range previously recorded and similar to recent years (**Figure 8**).

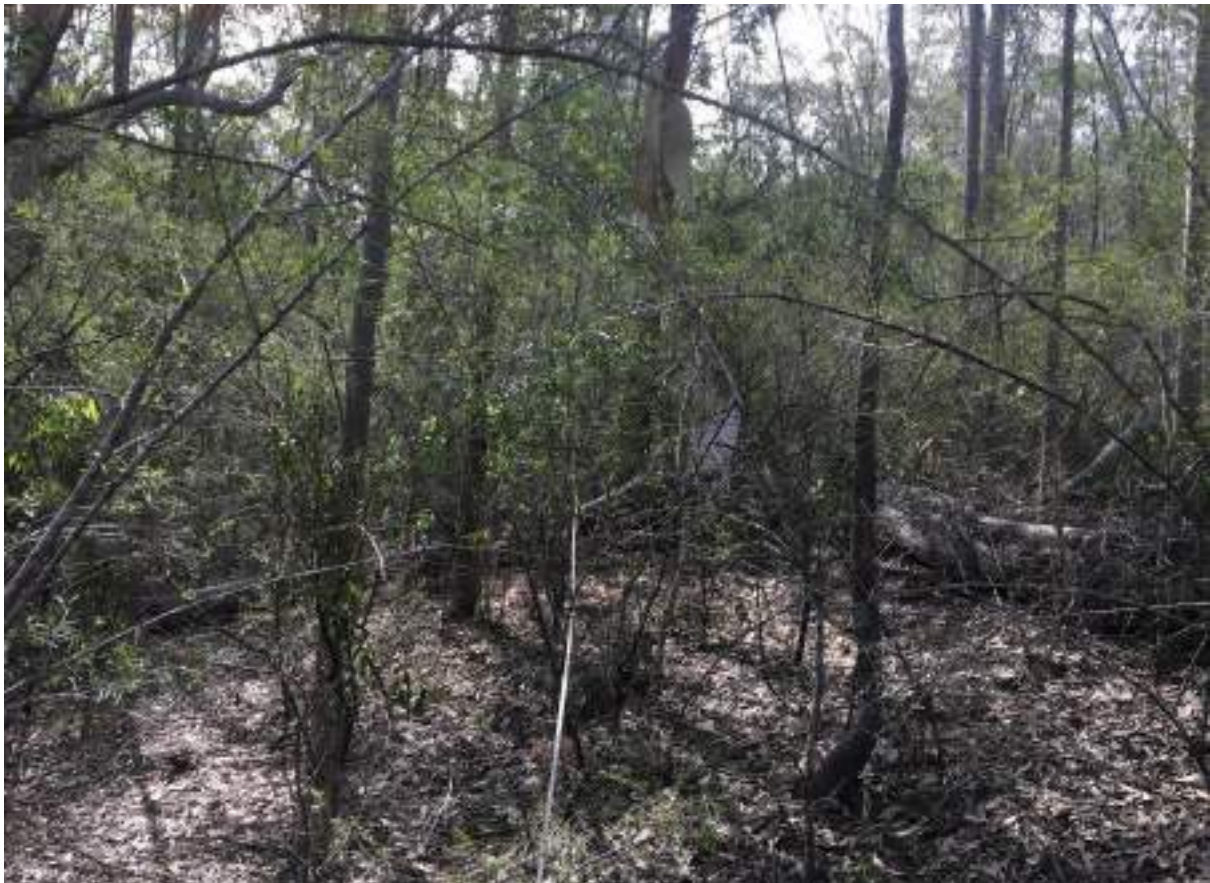
**Plate 17: White Mahogany - Spotted Gum - Grey Myrtle forest at V13-B1 in 2019**

At WCPL, this community occurs along Stony Creek and is sheltered by steep sandstone escarpments to the south and a large ridgeline to the north. This PCT is in good condition with many native species and occasional large remnant trees with hollows. One monitoring plot (V13-B1) samples this PCT. Exotic plant species cover is very low and sparse with no exotic cover recorded along the biometric transect (Table 10).

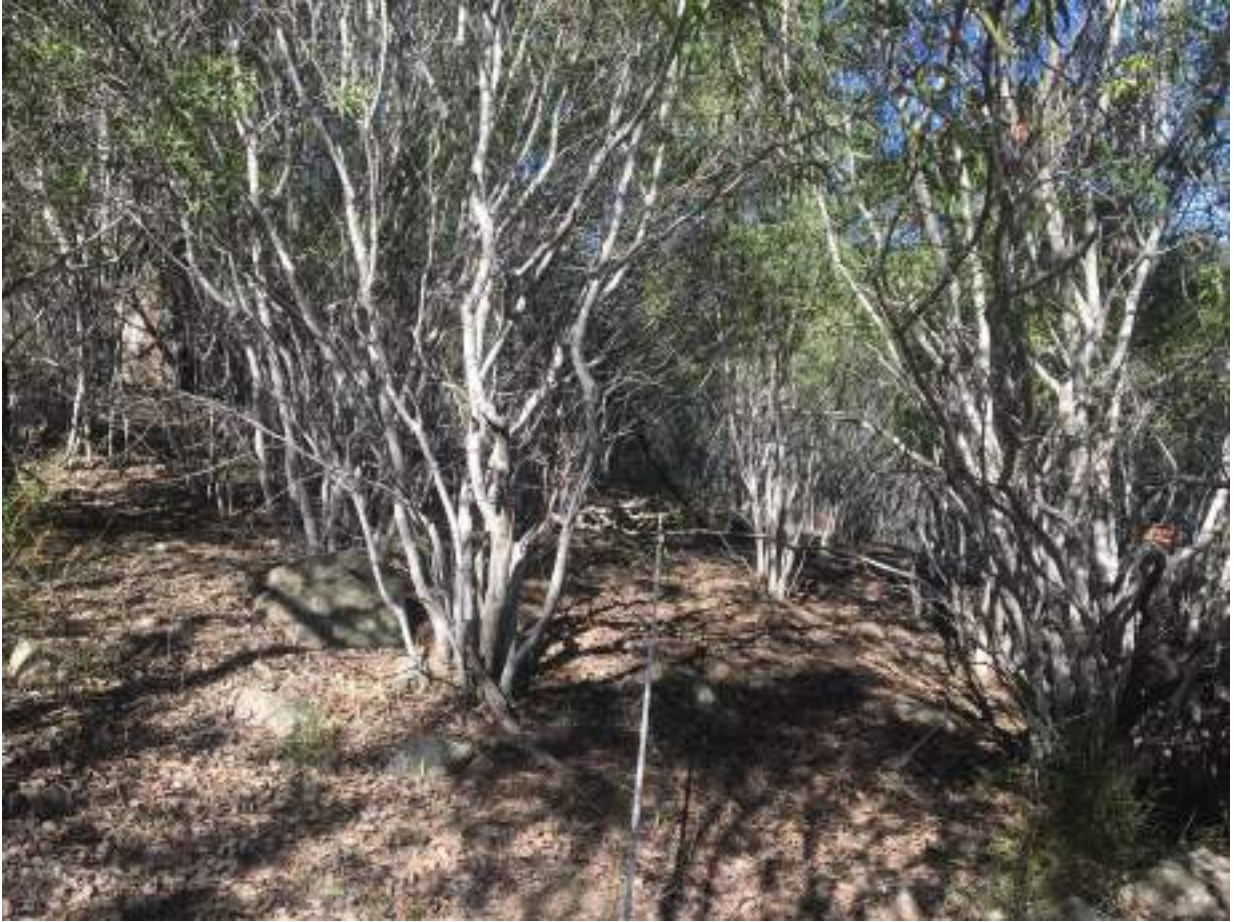
**Plate 18: Brush Wilga/Native Olive Shrubland at V14-A1 in 2019**

The monitoring plots within this PCT are dominated by the shrubs *Notelaea microcarpa* var. *microcarpa*, *Geijera salicifolia* (Brush Wilga), *Olearia elliptica* and the small tree *Brachychiton populneus* (Kurrajong) (Plate 18). Occasional *Eucalyptus crebra* or *E. moluccana* are present as canopy species. The PCT sampled by floristic monitoring may be partially a derived community, resulting from the historic removal of overstorey species in Narrow-leaved Ironbark - Bull Oak - Grey Box shrub - grass open forest combined with a south facing aspect. These areas are in good condition, with a large number of native species and few exotic species. Exotic species cover has remained consistently very low over time at these monitoring plots.

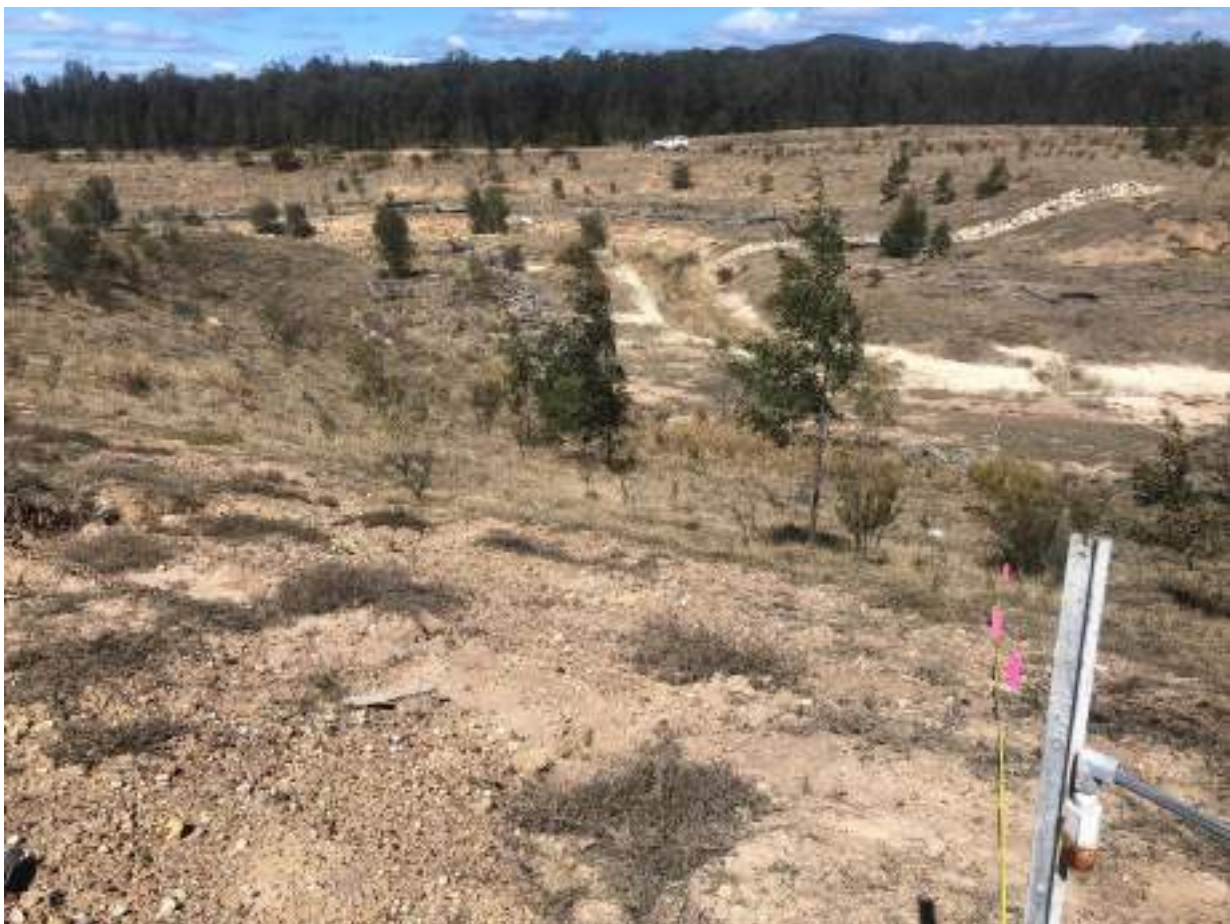
**Plate 19:** North Wambo Creek Diversion during 2019 at site 26R showing grasses with native shrubs and some bare soil
