# **WAMBO COAL PTY LTD 2019 ANNUAL REVIEW**

1 January – 31 December 2019

<b>Name of operation</b>	Wambo Coal Mine
<b>Name of operator</b>	Wambo Coal Pty Ltd
<b>Development consent /Project Approval #</b>	DA305-7-2003, DA177-6-2004, EPBC 2003/1138, EPBC 2016/7636, EPBC 2016/7816
<b>Name of holder of development consent</b>	Wambo Coal Pty Ltd
<b>Title/Mining lease #</b>	CL365, CL374, CL397, CCL743, ML1402, ML1572, ML1594, MLA 557, A444, EL7211
<b>Name of holder of mining lease</b>	Wambo Coal Pty Ltd
<b>Water licence #</b>	As per <b>Table 3</b>
<b>Name of holder of water licence</b>	Wambo Coal Pty Ltd
<b>MOP start date</b>	September 2019
<b>MOP end date</b>	31 December 2020
<b>Annual Review start date</b>	1 January 2019
<b>Annual Review end date</b>	31 December 2019
<p><b>I, Albert Scheepers, certify that this audit report is a true and accurate record of the compliance status of Wambo Coal Mine for the period 1 January 2019 to 31 December 2019 and that I am authorised to make this statement on behalf of Wambo Coal Pty Ltd.</b></p> <p><i>Note:</i></p> <p>a) <i>The Annual Review is an 'environmental audit' for the purposes of section 122B(2) of the Environmental Planning and Assessme

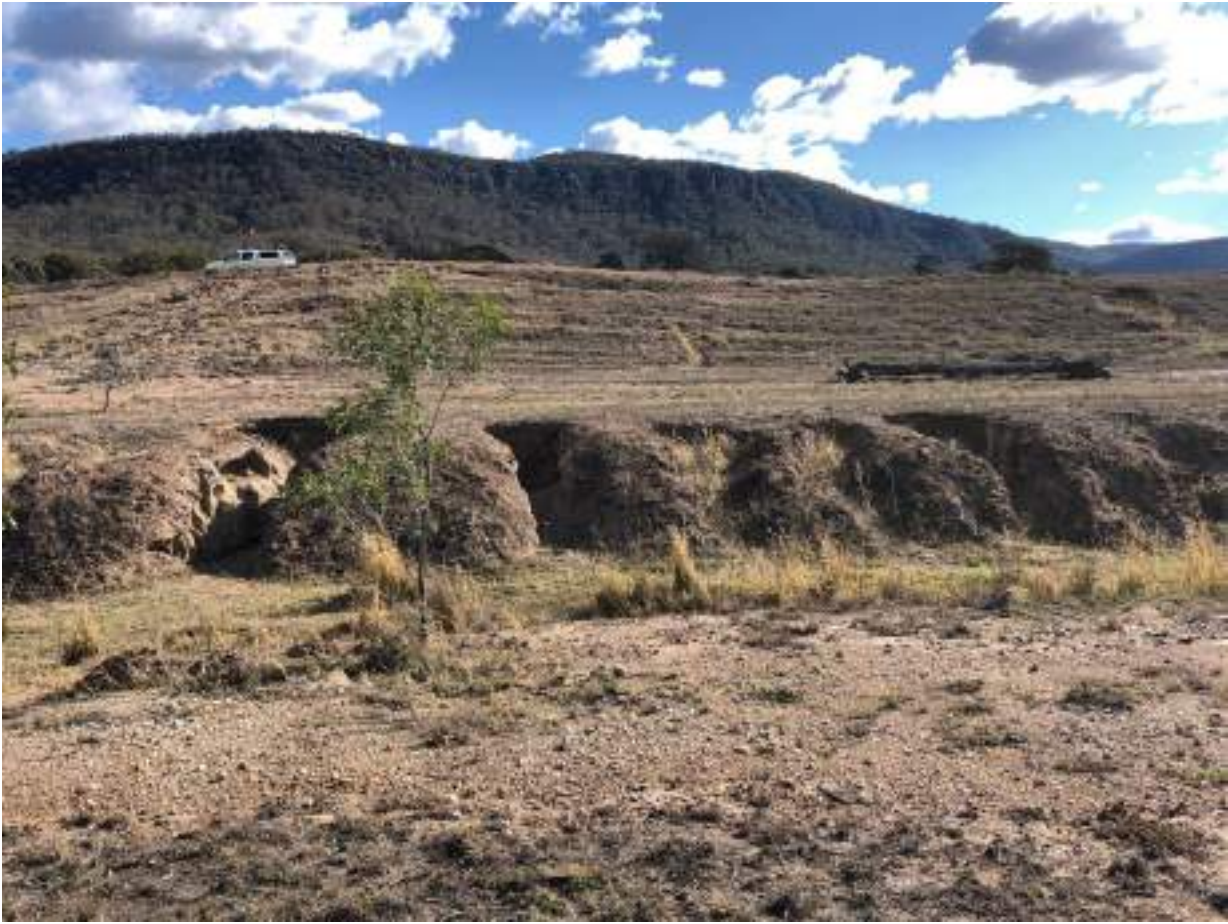
Plate 20: Gully erosion within the North Wambo Creek Diversion (near site 23R)

Site 23R had the lowest scores, resulting from a bare slope in the middle of the transect, which is a lower slope of the broader creek diversion channel. Site 23R and adjacent areas have issues with erosion (also noted in previous reports), with rills, scalds and eroding creek banks recorded close by. Several rills are likely to exceed the depth specified in the completion criteria in regard to erosion control (WCPL 2015).

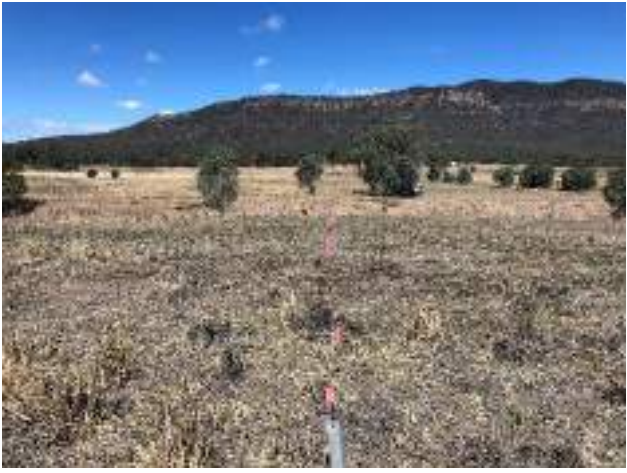
19R	<p>Transect relatively flat and comprised primarily of low grass (81%) dispersed with patches of bare soil (17%). The percentage of grass has increased since 2018, resulting in an improved LOI score for this site.</p> <p>Young <i>Eucalyptus</i> and <i>Acacia</i> species are growing on creek banks downstream. Evidence of ripping activity from 2018 is visible near this transect, and the soil has been disturbed by vehicle tracks.</p>

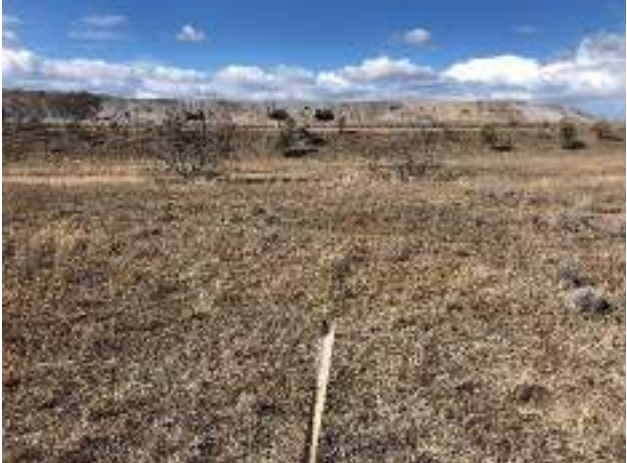
21R	<p>Transect relatively flat grassland dominated by low grass (42%) and bare soil (29%). Low grass and soil percentages have remained reasonably stable when compared to 2018. Annual vegetation cover was 29%.</p>

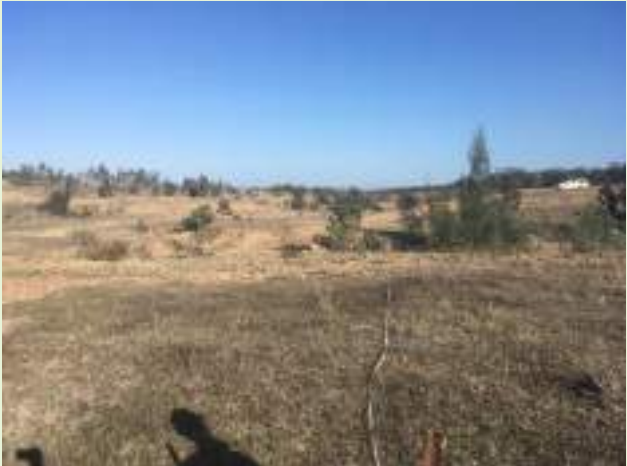
28R	<p>Transect primarily samples the relatively steep eastern creek bank. The majority of this transect was ripped to control <i>Galenia pubescens</i> and erosion prior to the 2017 monitoring.</p> <p>The dominant components were low grass 56% and bare soil comprises 37%. <i>Galenia pubescens</i> (6%) cover has reduced by 6% since 2018.</p> <p>Logs and dense tussock grasses are present at the bottom of the slope. Subsidence cracks were observed near this transect. Minimal vegetation has developed on the ripped slope and minor new erosion is evident.</p>

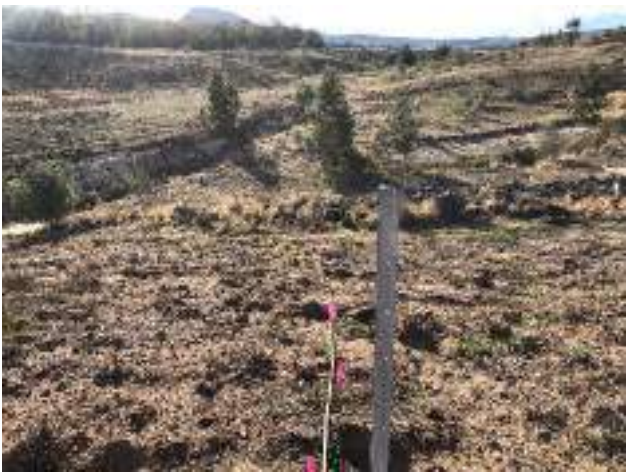
27R	<p>Transect samples the relatively steep western bank of the cutting. The majority of this transect was ripped to control <i>Galenia pubescens</i> and erosion prior to the 2017 monitoring. Low sparse grasses and logs dominate the flat area adjacent to the creek channel.</p> <p>The transect is dominated by low grass (53%), litter (23%) and tussocks (9%). Bare soil (9%) and logs (6%) comprise the remainder. The low grass <i>Cynodon dactylon</i> has continues to establish contributing to an improved LOI score for this site.</p>

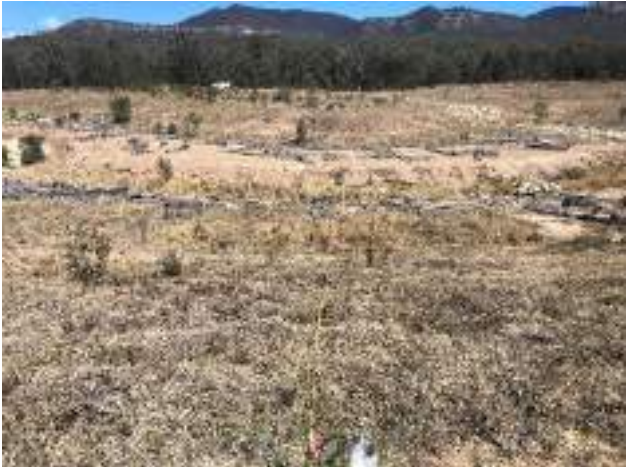
Transect	Notes	Photograph
26R	<p>Transect samples the relatively steep eastern bank to the edge of the creek channel. Low grass (56%) and tussocks (17%) dominated this transect in 2019. Bare soil areas (19%) and logs (8%) make up the remainder.</p> <p><i>Acacia</i> sp. shrubs are continuing to establish on some sections of the bank near this transect.</p>

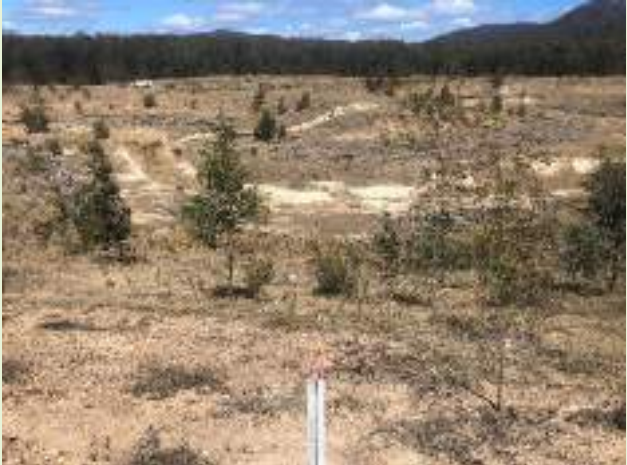
25R	<p>Grass areas have shown an improvement of 13% within the sampled transect. This slope is relatively steep with low grass dominating 74% of transect and having the highest contribution to soil stability.</p> <p>Bare soil is most prevalent at the top of transect where some minor erosion is occurring and makes up 17% of the transect.</p> <p>Large tussock grasses (<i>Chloris gayana</i>) and logs are present at the bottom of the transect near the creek channel.</p> <p><i>Acacia</i> sp. shrubs are continuing to develop on the bank near this transect.</p>

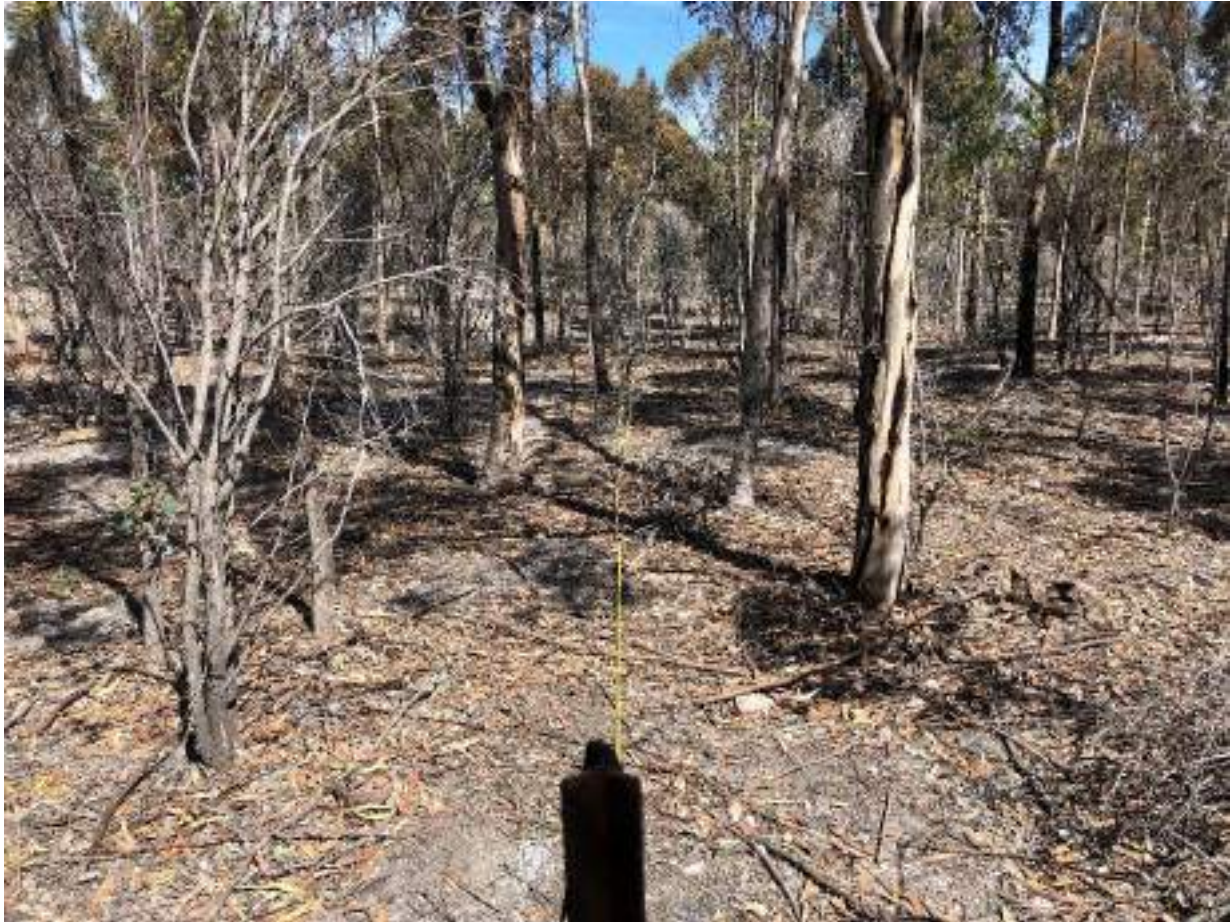
Vegetation in woodland rehabilitation areas consisted primarily of *Eucalyptus cladocalyx* and occasionally *Corymbia maculata* (**Plate 21**). *Acacia saligna* (Golden Wreath Wattle) forms the dominant mid-storey species at site 4R and is also present at 8R, however, this species has mostly died-off within the woodland rehabilitation areas. *E. cladocalyx* is native to South Australia and *Acacia saligna* is native to the south of Western Australia, but both have been planted widely in eastern Australia.

**Plate 21: Woodland rehabilitation area dominated by *E. cladocalyx* at site 8R in 2019**

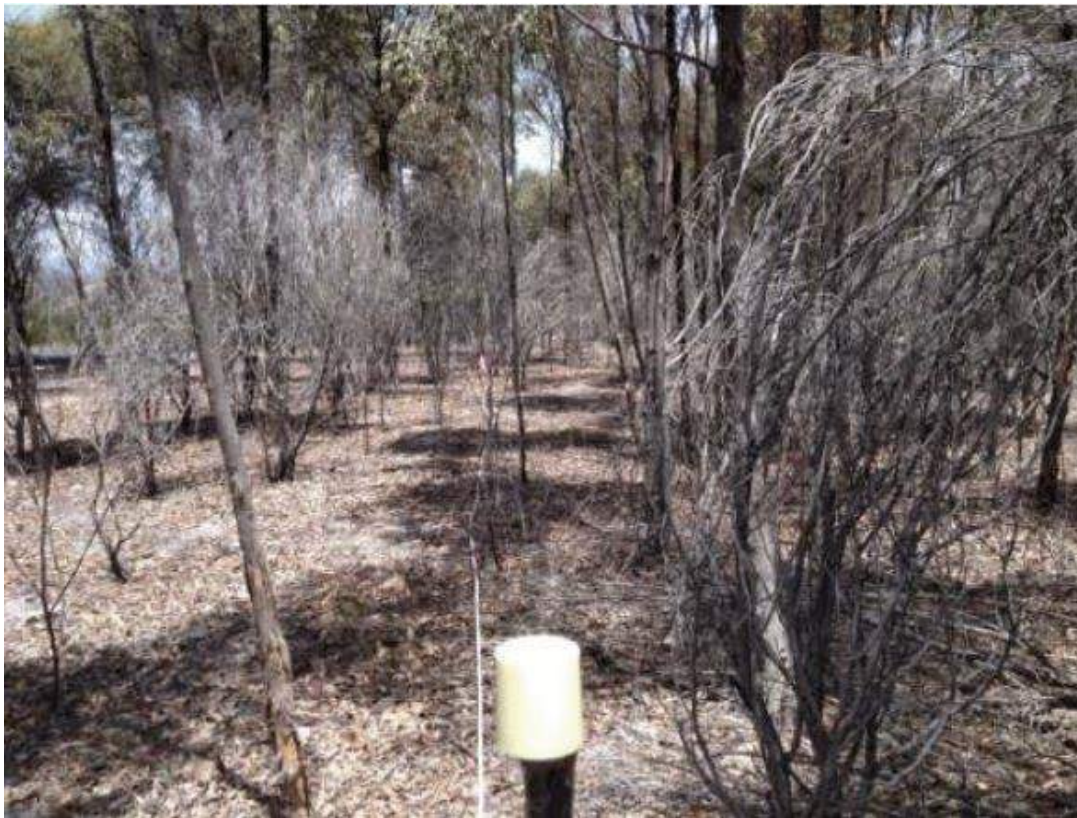
Plate 22: Site 3R during 2014

Both photos taken at the sites and collected data, show that these sites have remained quite stable over the last five years notwithstanding some dieback of *Acacia saligna* and growth of trees (**Plate 22** and **Plate 23**).

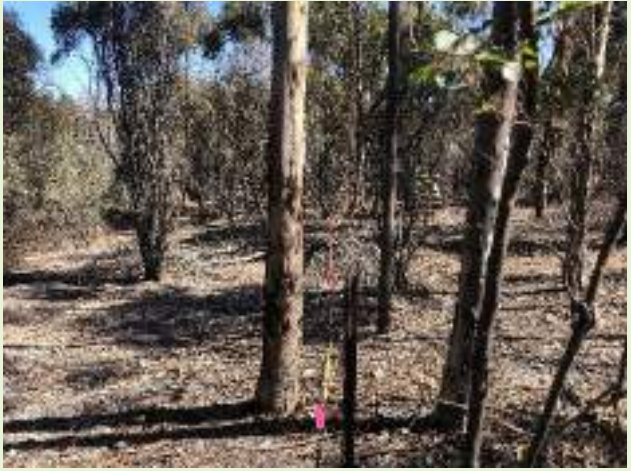
6R	<p>This site is the best performing woodland rehabilitation monitoring site. A canopy of <i>Eucalyptus cladocalyx</i> is present with several native mid-storey species and native grasses and herbs. The weed <i>Galenia pubescens</i> also occurs in small patches.</p> <p>A dense and deep cover of leaf-litter is present (85% of transect length) and is by far the major contributor to site stability, infiltration and nutrient cycling scores</p>

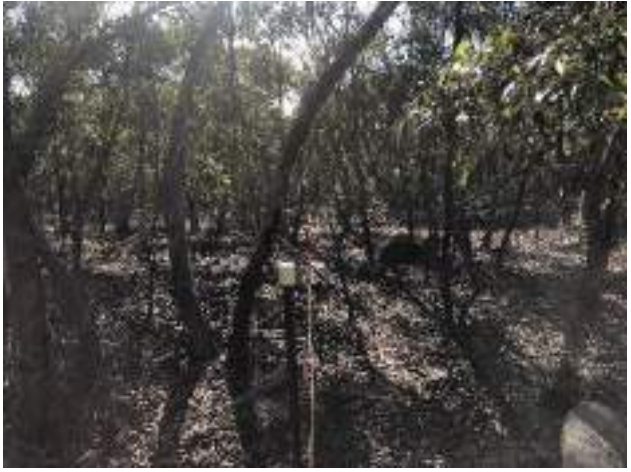
8R	<p>This transect is located on a lightly sloping site with plantings of <i>Eucalyptus cladocalyx</i> and <i>Corymbia maculata</i>. A few native grasses are scattered across the site.</p> <p>Leaf litter covers 70% of the transect length, with 30% bare soil and the remainder of rock.</p>

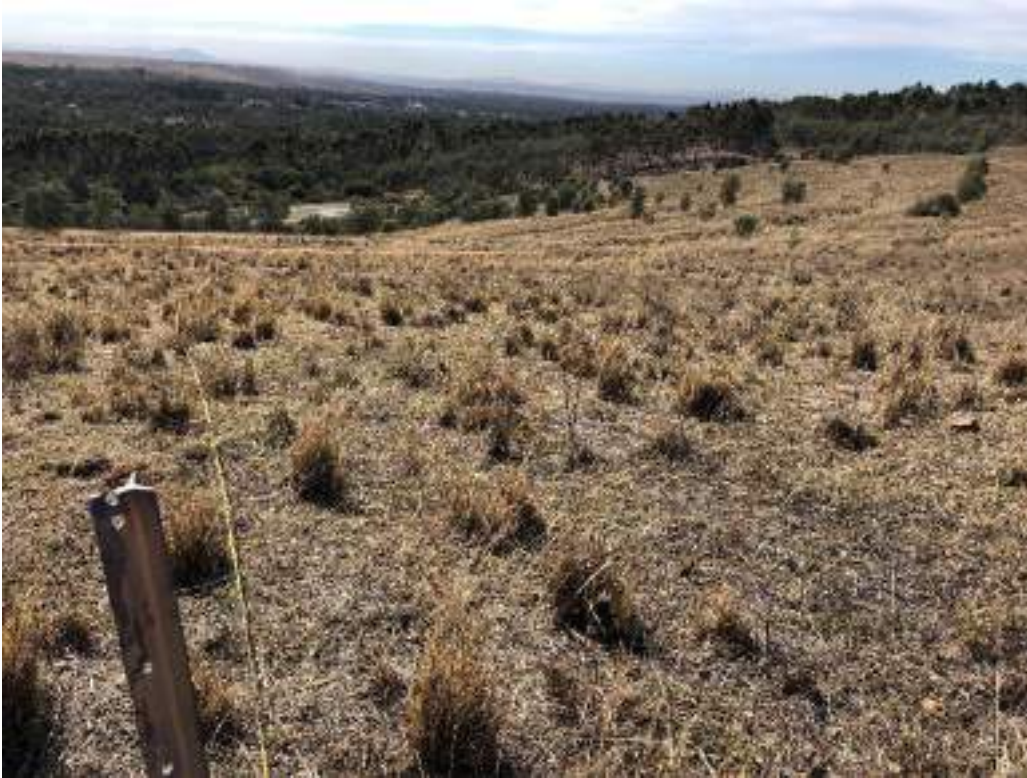
Plate 24: Pasture rehabilitation area dominated by *Chloris gayana* (Rhodes Grass), near site 33R in 2019

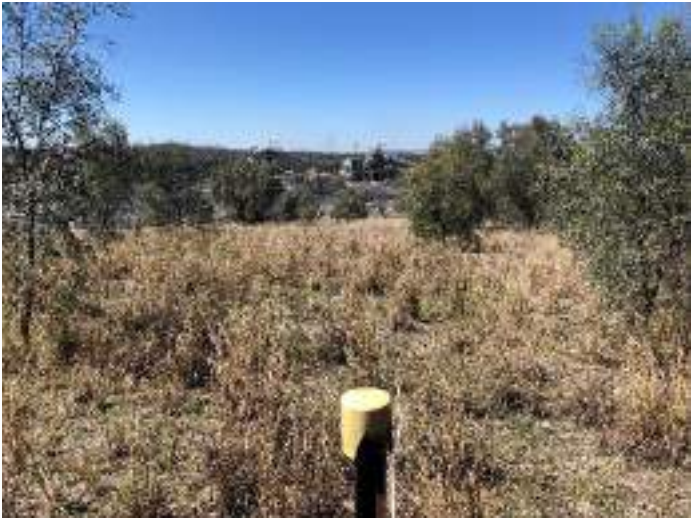
2R	<p>This transect runs down a very slight slope and was dominated by grassy patches (60.5%), bare soil (23%) and tussocks (13%).</p> <p>When compared to 2018 results, grass cover had improved by 38% and bare soil has also reduced. This site is meeting the target scores for stability, infiltration and nitrogen cycling, however the LOI target has not been met. The LOI score has improved since 2018, however 23% bare soil continues to reduce the ability of the landscape to capture and utilise resources. The LOI score for this site is the lowest result recorded during the 2019 survey, indicating this site has the largest amount of bare soil.</p>

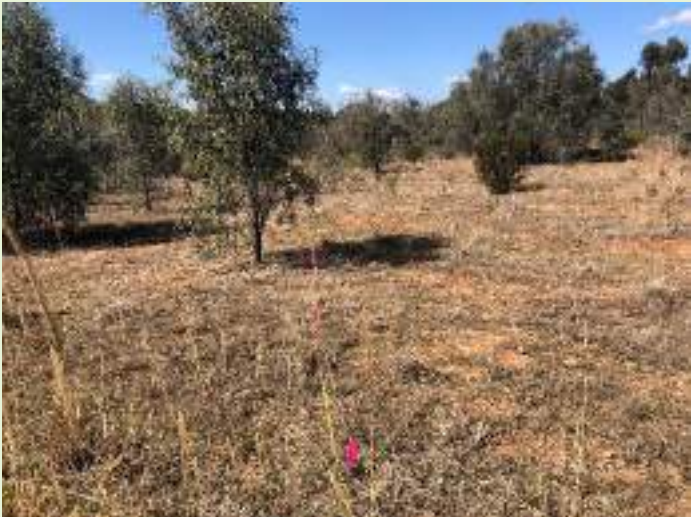
5R	<p>This site is dominated by exotic tussock grasses (<i>Setaria</i> sp.) (41.5%) and litter (39%). The remainder of the site is bare soil (19.5%). Scattered large <i>A. salicina</i> are present surrounding the transect area.</p> <p>Tussock grass and litter results have improved when compared to 2018 results, however the site is still failing to meet the target score for LOI. Bare soil (23% of the transect) continues to reduce the ability of the landscape to capture and utilise resources.</p>

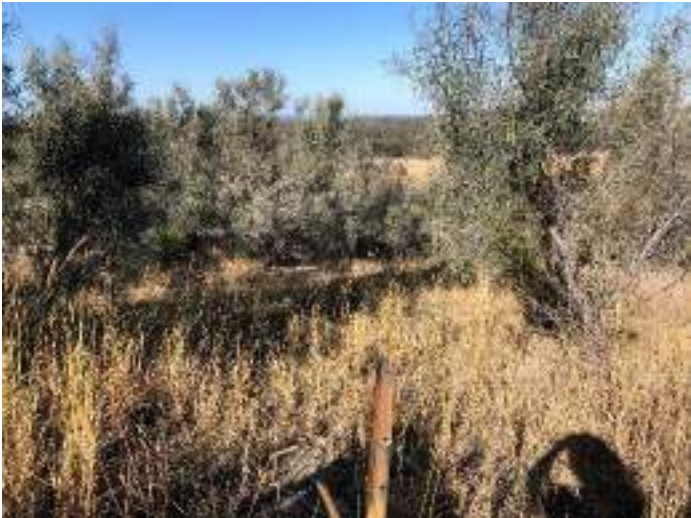
Transect	Notes	Photograph (2019)
7R	<p>Transect was dominated by litter (52%), short grass (19%) and exotic <i>Chloris gayana</i> tussocks (12%). The remainder of the cover comprised of exotic <i>Galenia pubescens</i> (13%) and bare soil (4%).</p> <p>The reduction in bare soil from 2018 corresponds to a 30% increase in litter cover and a 14% increase in short grass and the exotic weed <i>Galenia pubescens</i>. The locally native <i>Acacia salicina</i> continues to colonise the rehabilitation in this area.</p> <p>This site is meeting all performance criteria including the LOI target.</p>

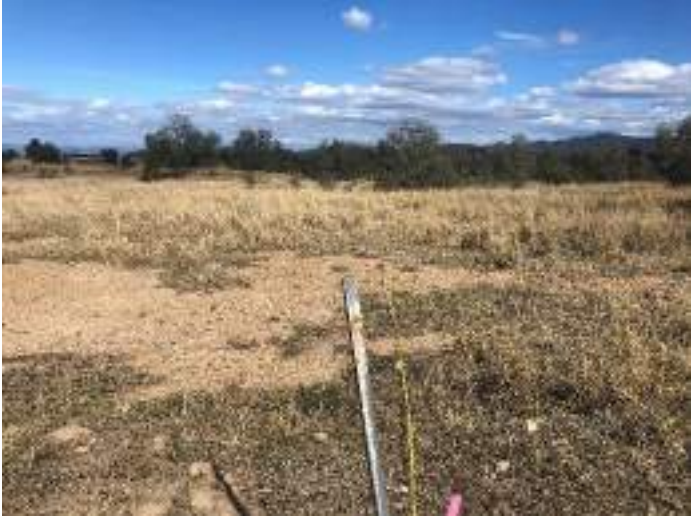
9R	<p>A large rocky soil scald dominates the start of this transect, however grassy patches and tussock growth has resulted in a stability index for this site above the performance criteria. Grassy patches (78%) and tussocks (5%) dominate the plot, the soil scald and other bare patches cover 17% of the transect.</p> <p>The LOI score did not meet the performance criteria target, indicating a significant proportion of the transect is bare soil.</p>

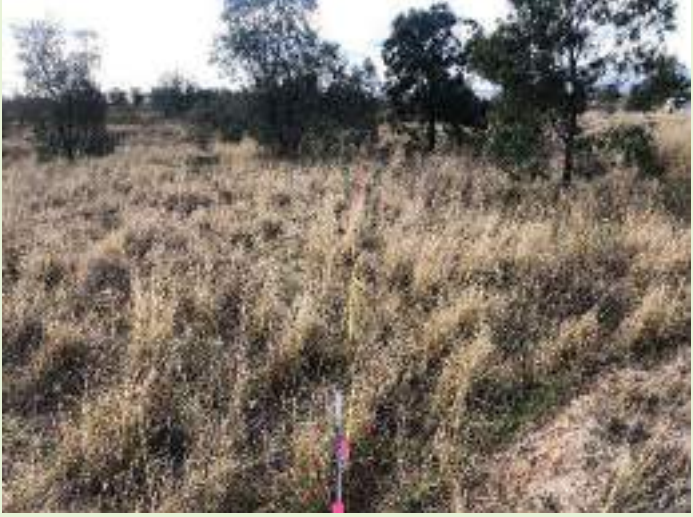
10R	<p>Dense tussocks of <i>Chloris gayana</i> (52%), leaf litter fallen from the dense tussocks and dry dead exotic perennial vegetation (32 %) and grassy patches (12%) made up the majority of this transect. Bare soil patches were minimal making up just 2% of the transect length.</p> <p>This scores for this site meet all performance criteria. This site has the highest LOI score recorded in the 2019 surveys, indicating this transect has the least bare soil.</p>

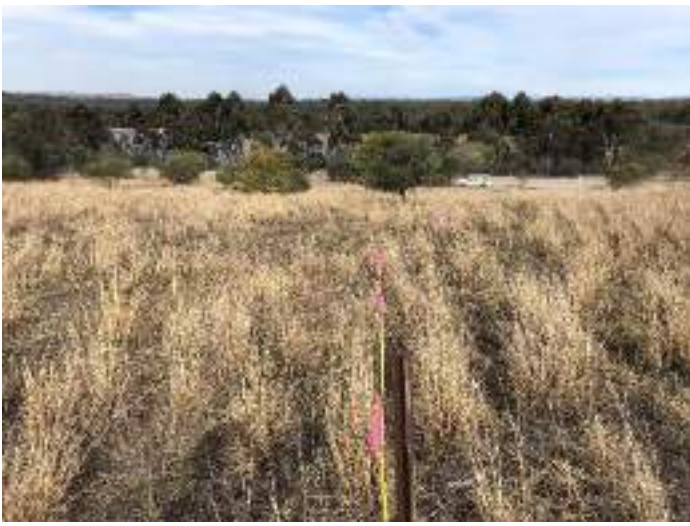
33R	<p>Transect primarily composed of litter (65%) and dense tussocks of <i>C. gayana</i> (17%) and low grass and (15%). Bare soil patches made up 3% of the transect.</p> <p>The 2018 survey showed that this site was primary composed of dense tussocks of <i>C. gayana</i>, it appears that these tussocks have broken down and contributed to the high litter composition present in 2019 surveys.</p> <p>This site is meeting all performance criteria including the LOI target.</p>

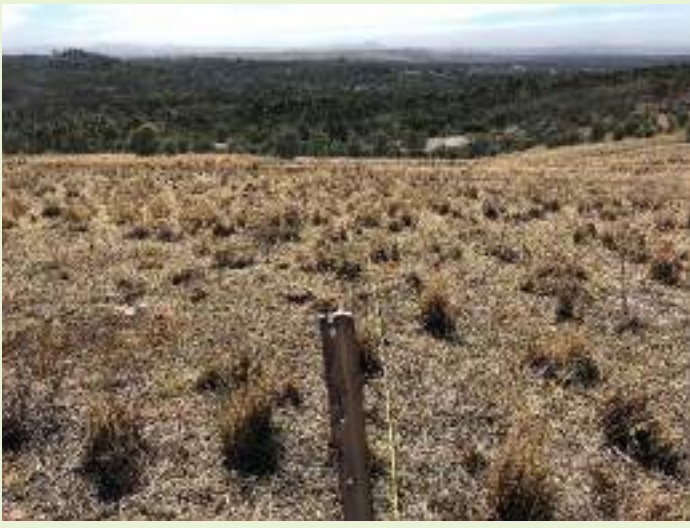
34R	<p>Transect is composed of low spreading grassy patches (30%), dense tussocks of <i>C. gayana</i> (27%) with fallen dead grass (leaf litter - 23%) and bare soil patches (20%).</p> <p>Grassy patches and tussocks were the primary contributor to the site stability and infiltration scores which exceed the targets for this site. The LOI score has not been met for this transect due to the amount of bare soil (interpatch).</p>

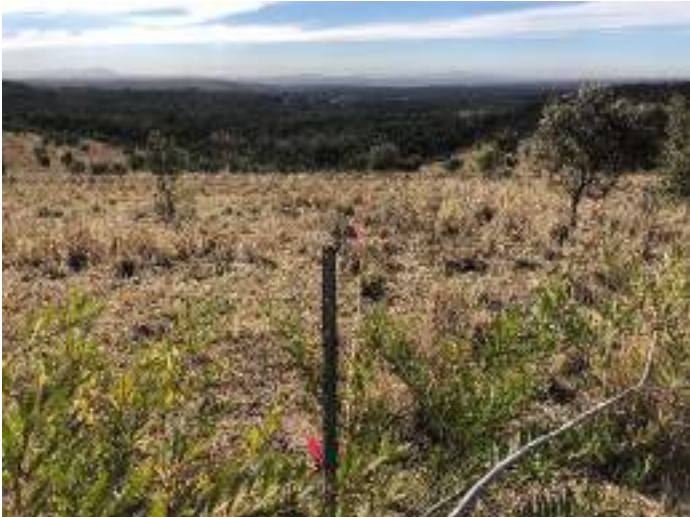
Transect	Notes	Photograph (2019)
35R	<p>Low grass (86%) dominated this new area of rehabilitation, with bare soil (14%) making up most the remaining transect.</p> <p>The LOI score has not been met for this transect due to the amount of bare soil (interpatch).</p>

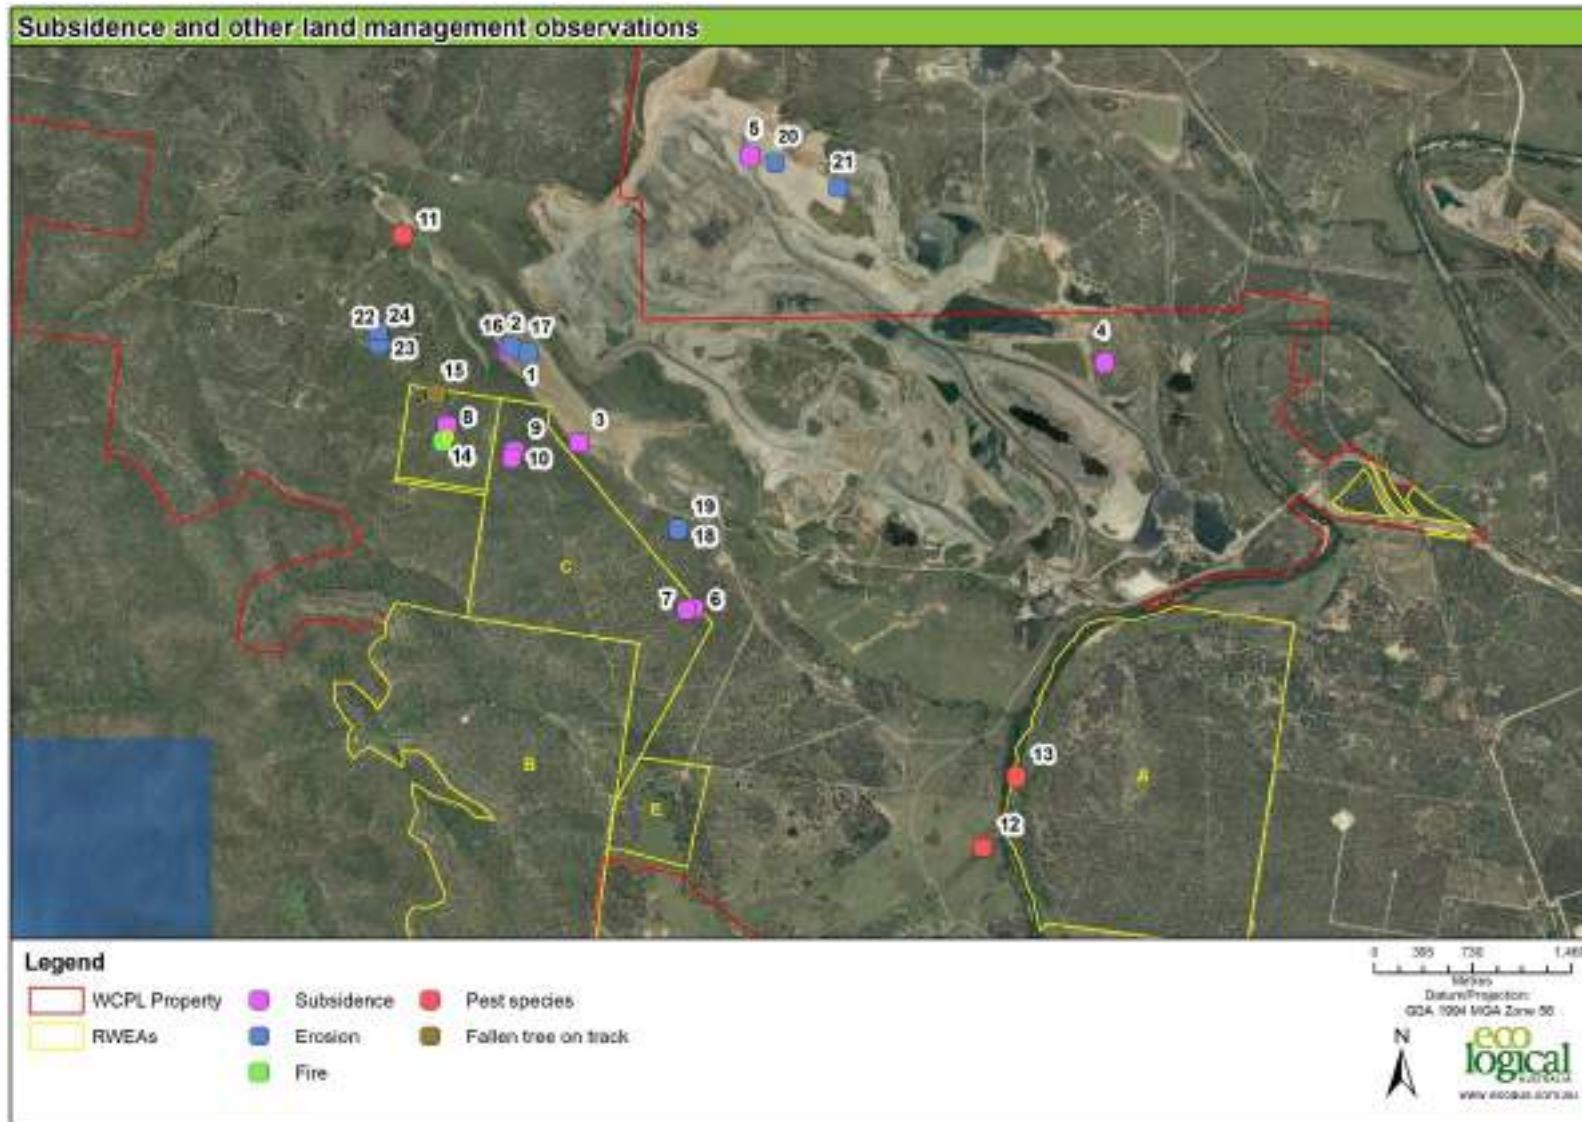
Figure 31. Subsidence and other land management observations from Spring 2019 biodiversity monitoring surveys

#	Type	Location	Notes
1	Subsidence	North Wambo Creek Diversion	25m x 5cm
2	Subsidence	North Wambo Creek Diversion	10m x 10cm, slump on bank slope
3	Subsidence	North Wambo Creek Diversion	50m x 15cm, many moderate cracks adjacent to road at top of bank and on embankment
4	Subsidence	Rehabilitation area	2 x 2m wide and 1m deep, slump hole in woodland rehabilitation near start of 4R
5	Subsidence	Rehabilitation area	20m x 15cm, crack at top of rehabilitation bank
6	Subsidence	RWEA C	20m x 40cm
7	Subsidence	RWEA C	1.5 x 1.5m wide and 2m deep
8	Subsidence	RWEA D	20m x 10cm
9	Subsidence	RWEA C	>30m long x 0.5m wide, very deep. Larger than in 2018
10	Subsidence	RWEA C	1m wide. Very large crack, both sides of side of road. Continues from Vegetation Plot v11-b1
11	Pest animal	North Wambo Creek Diversion	Rabbit warrens
12	Pest animal	General surface area	Pig rooting
13	Pest animal	RWEA A	Wild dog/dingo with 2 pups

14	Fire	RWEA D	Evidence of a recent low intensity fire
15	Fallen tree on track	RWEA D	Fallen tree blocking track
16	Erosion	North Wambo Creek Diversion	Erosion on lower creek bank
17	Erosion	North Wambo Creek Diversion	Rill erosion near 23R
18	Erosion	North Wambo Creek Diversion	Erosion of bank of creek diversion channel near LFA site 26R
19	Erosion	North Wambo Creek Diversion	Erosion near LFA site 26R. Topsoil eroded from bank, trough ripping failed. Topsoil deposited at base of slope. Bank now bare and pebbly
20	Erosion	Rehabilitation area	Erosion sheet and fill in pasture rehabilitation
21	Erosion	Rehabilitation area	Gully erosion in woodland rehabilitation
22	Erosion	General surface area	12m x 2m erosion
23	Erosion	General surface area	8m x 2.5m erosion
24	Erosion	General surface area	Minor erosion

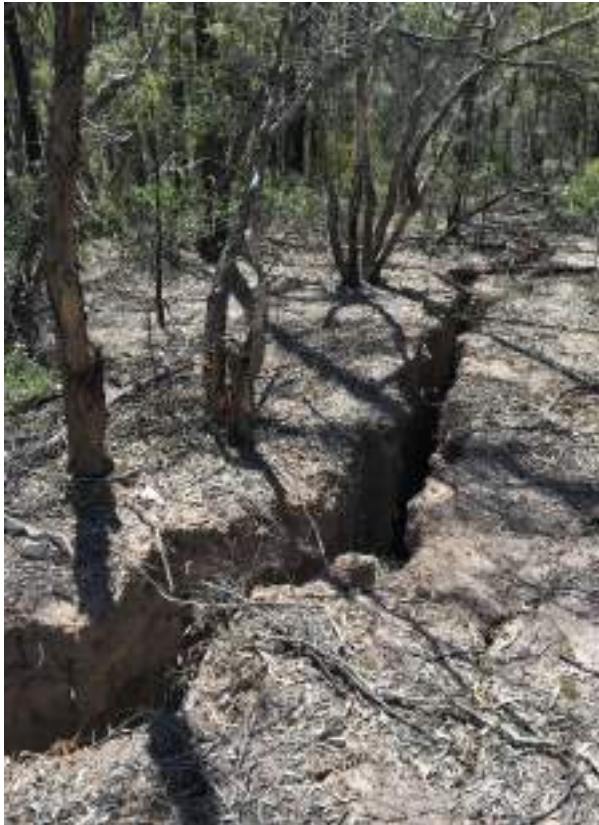
**Plate 25:** Large subsidence cracks near flora monitoring site V11-B1

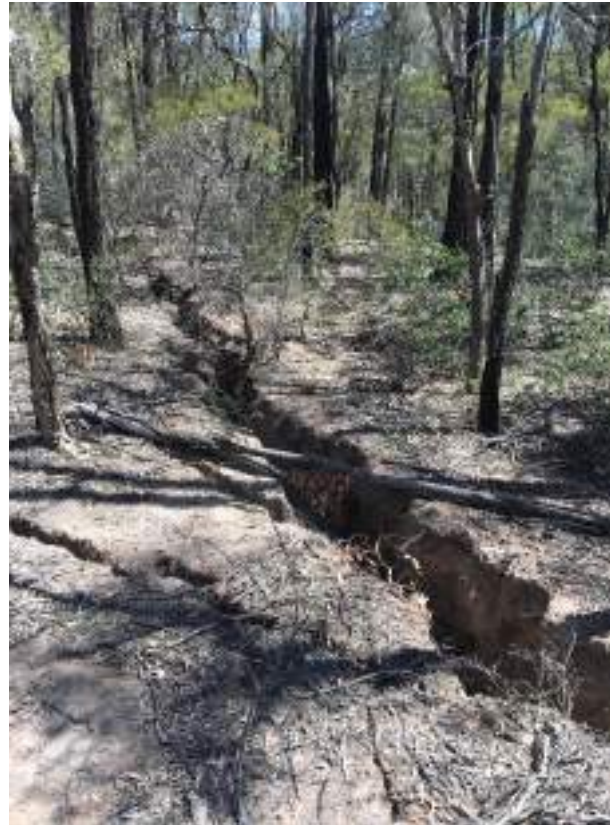
**Plate 26:** Large subsidence cracks near flora monitoring site V11-B1

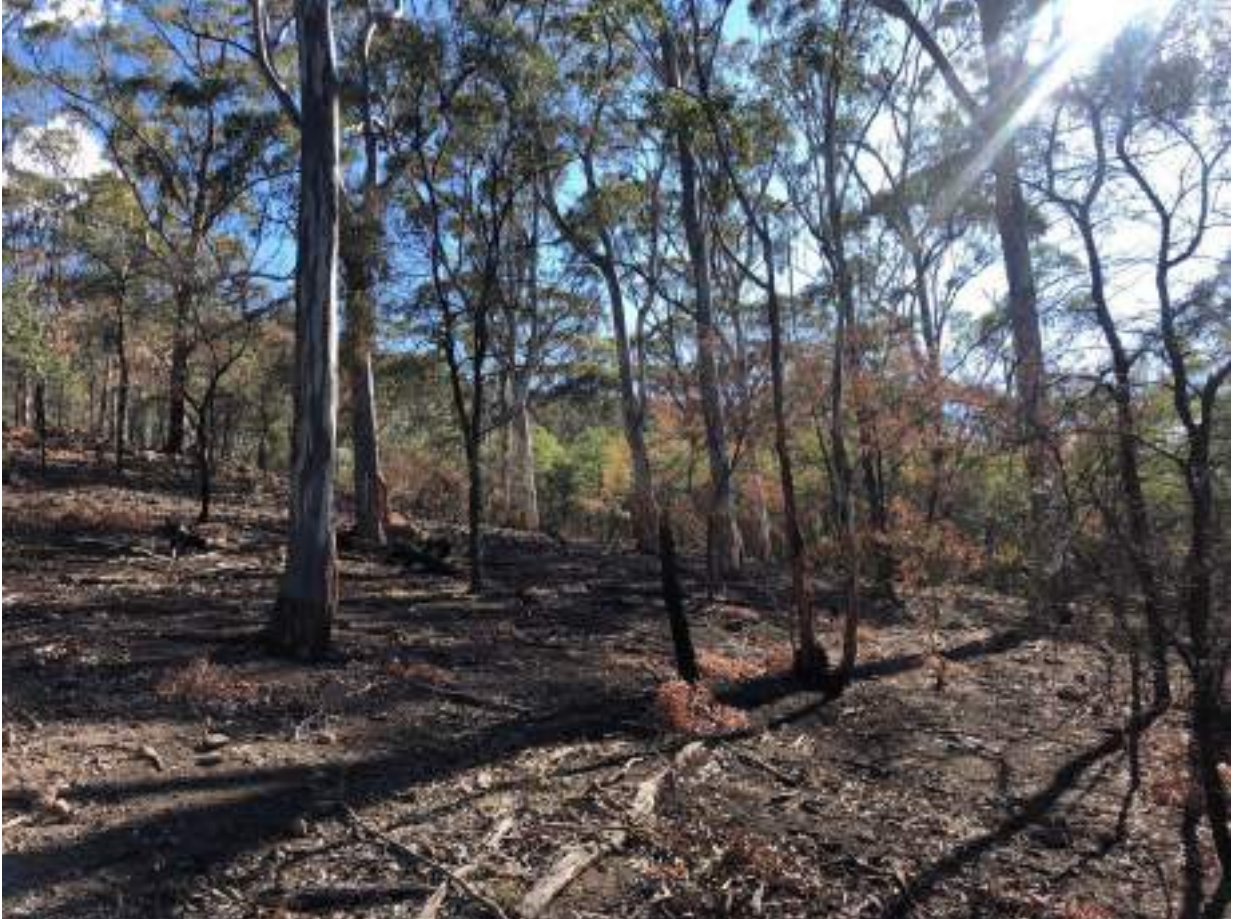
**Plate 27.** Recent low intensity fire has burnt within RWEA D near BP 25.

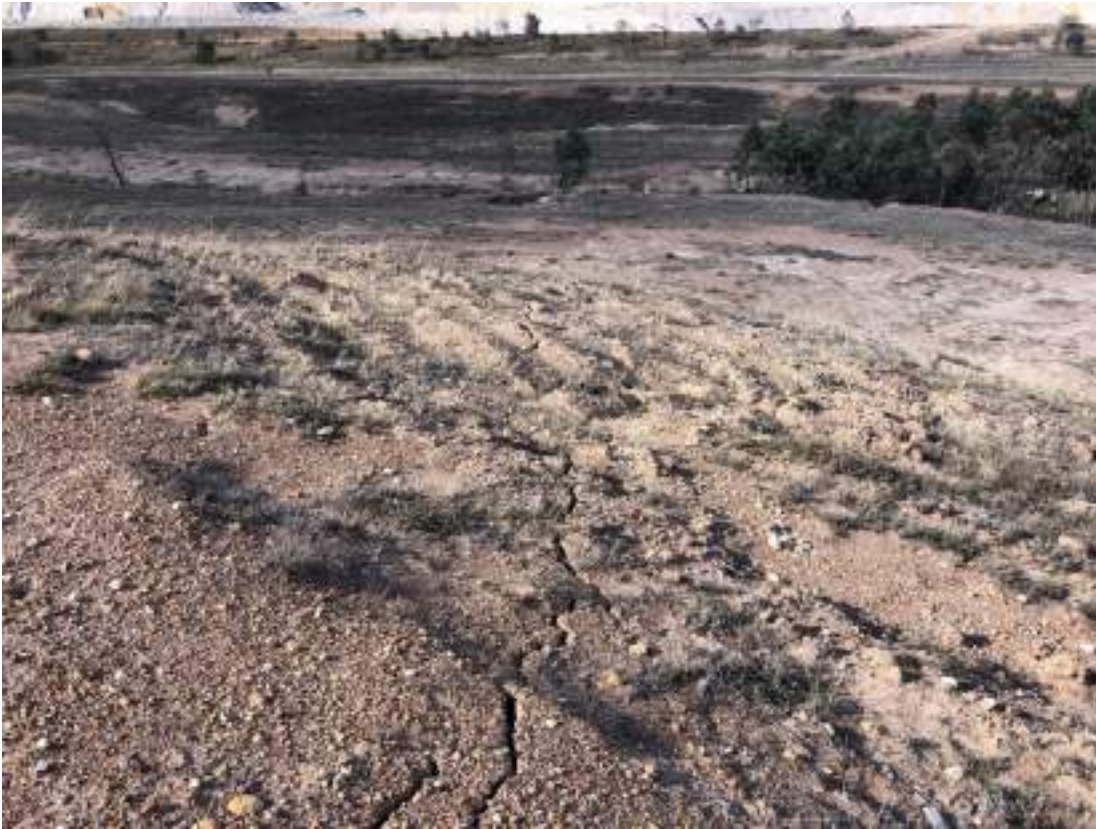
**Plate 28. Subsidence cracks, erosion and bare soil along the North Wambo Creek Diversion near site 23R**

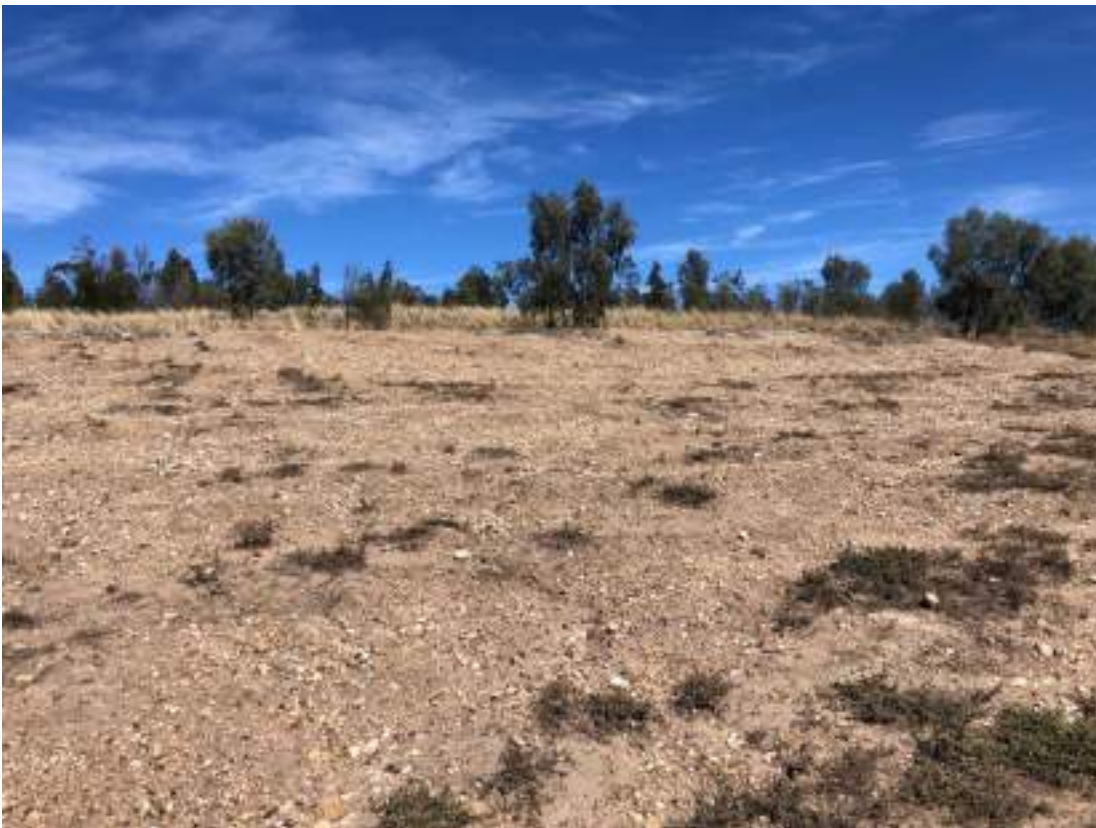
**Plate 29. Large area of erosion/bare soil at failed pasture rehabilitation near site 33R (exceeding completion criteria)**

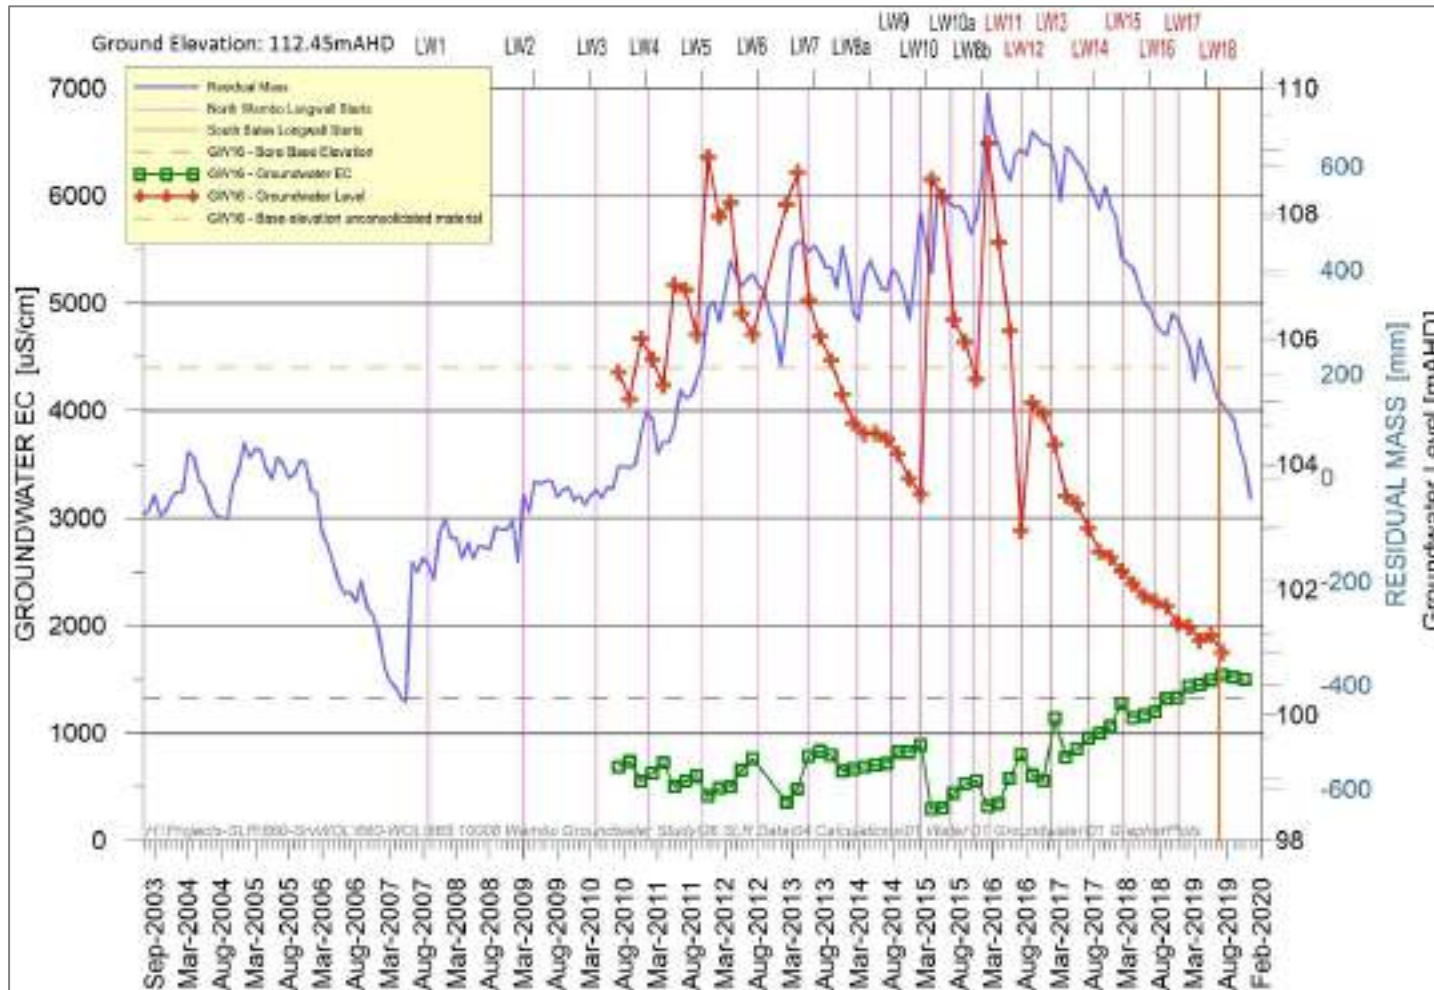
Figure 9 GW16 groundwater level and EC

Groundwater levels at bore GW16 (**Figure 9**) ranged between 3.5 mbgl and 9.5 mbgl until 2016, after which levels fell below the base of the unconsolidated material (7 mbgl). The initial water level readings for GW16 appear to correlate to periods of above average rainfall, reaching levels of up to approximately 109 mAHD, indicating a saturated thickness of unconsolidated material of approximately 3 m. The decline in groundwater levels from 2016 may relate to nearby open cut mining and below average rainfall.

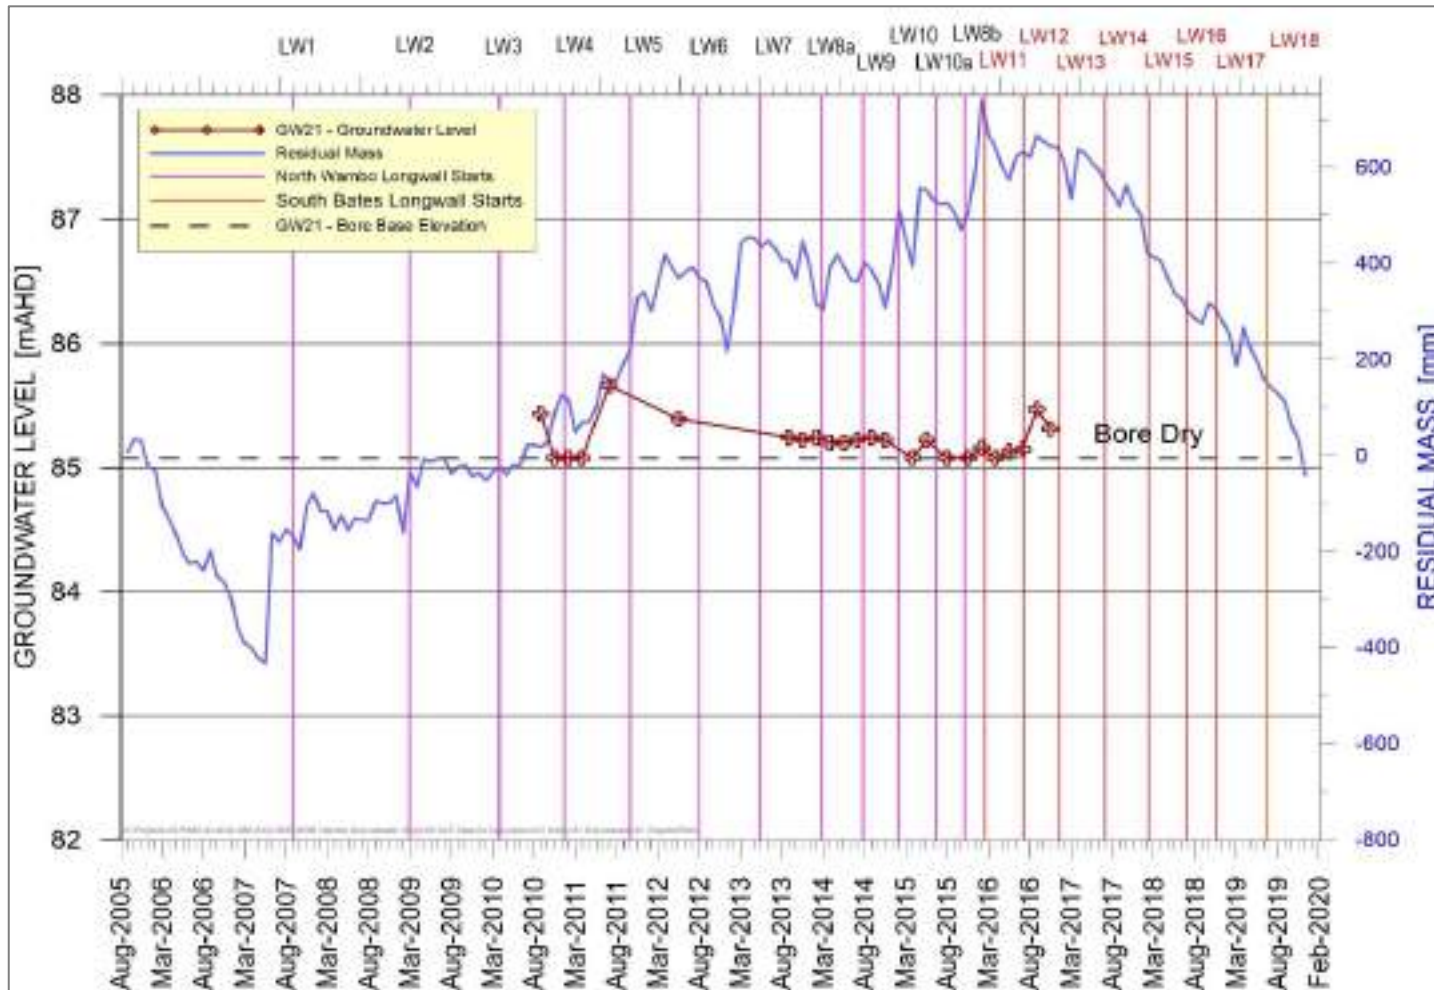
Figure 14 GW21 Groundwater Level

Bore GW21 (**Figure 14**) is located within 10 m of VWP N2 (**Figure 1**), between NWU LW1 and SBU LW13. A mining effect is likely at GW21 resulting from NWU longwall extraction prior to the first observation made. Due to dry conditions at this bore a mining effect caused by SBU is not observed. A lack of an expected mining effect from SBU longwall extraction has previously been suggested due to the mitigating effect of a fault between GW21 and SBU (HydroSimulations, 2017a). However, analysis of the Permian Overburden sensors in N2 shows a clear SBU mining effect and desaturation of the same strata in which GW21 is located. During 2019, no further mining effect can be observed at GW21 due to the groundwater level being below the base of the bore. It should be noted that the examination of data from a new bore drilled between LW14 and the fault could be of interest to determine the behaviour of groundwater in the area.
