# **WAMBO COAL PTY LTD 2019 ANNUAL REVIEW**

1 January – 31 December 2019

<b>Name of operation</b>	Wambo Coal Mine
<b>Name of operator</b>	Wambo Coal Pty Ltd
<b>Development consent /Project Approval #</b>	DA305-7-2003, DA177-6-2004, EPBC 2003/1138, EPBC 2016/7636, EPBC 2016/7816
<b>Name of holder of development consent</b>	Wambo Coal Pty Ltd
<b>Title/Mining lease #</b>	CL365, CL374, CL397, CCL743, ML1402, ML1572, ML1594, MLA 557, A444, EL7211
<b>Name of holder of mining lease</b>	Wambo Coal Pty Ltd
<b>Water licence #</b>	As per <b>Table 3</b>
<b>Name of holder of water licence</b>	Wambo Coal Pty Ltd
<b>MOP start date</b>	September 2019
<b>MOP end date</b>	31 December 2020
<b>Annual Review start date</b>	1 January 2019
<b>Annual Review end date</b>	31 December 2019
<p><b>I, Albert Scheepers, certify that this audit report is a true and accurate record of the compliance status of Wambo Coal Mine for the period 1 January 2019 to 31 December 2019 and that I am authorised to make this statement on behalf of Wambo Coal Pty Ltd.</b></p> <p><i>Note:</i></p> <p>a) <i>The Annual Review is an 'environmental audit' for the purposes of section 122B(2) of the Environmental Planning and Assessme

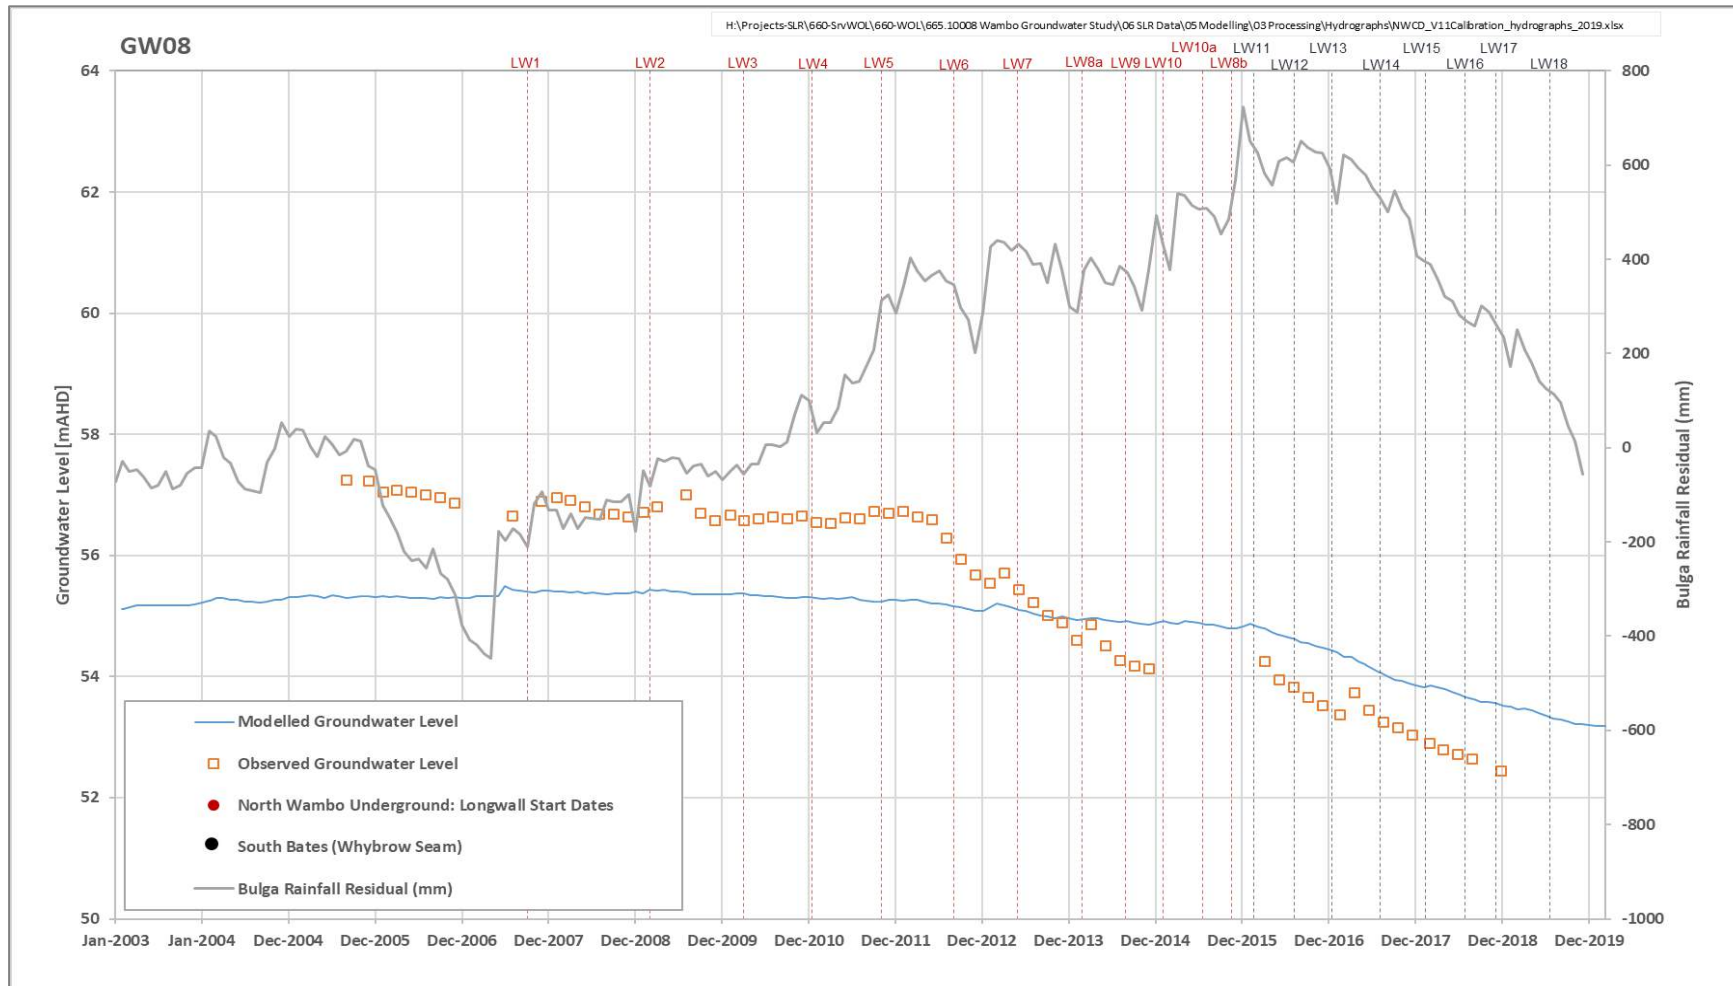
Figure 29 GW08 Calibration Hydrographs

HydroSimulations' modelled heads at GW08 (**Figure 29**) show a good match with the overall trends seen in the observed data. The timing of mining related drawdown in both modelled and observed heads, following the extraction of NWU LW5 is well correlated despite simulated heads being lower than observed. At GW08, observed water levels fell below simulated heads in 2013. This relationship continues during the 2019 monitoring period with modelled heads showing a milder response to drawdown than that seen in the observed heads. Despite this, the difference in elevation between modelled and observed heads is quite small, being within 1 m of one another. GW08 was dry from the beginning of 2019, limiting the ability to compare modelled versus observed groundwater levels for the reporting period.
