***CENTENNIAL COAL
MYUNA COLLIERY
ANNUAL REVIEW***

January 2023 to December 2023

March 2024

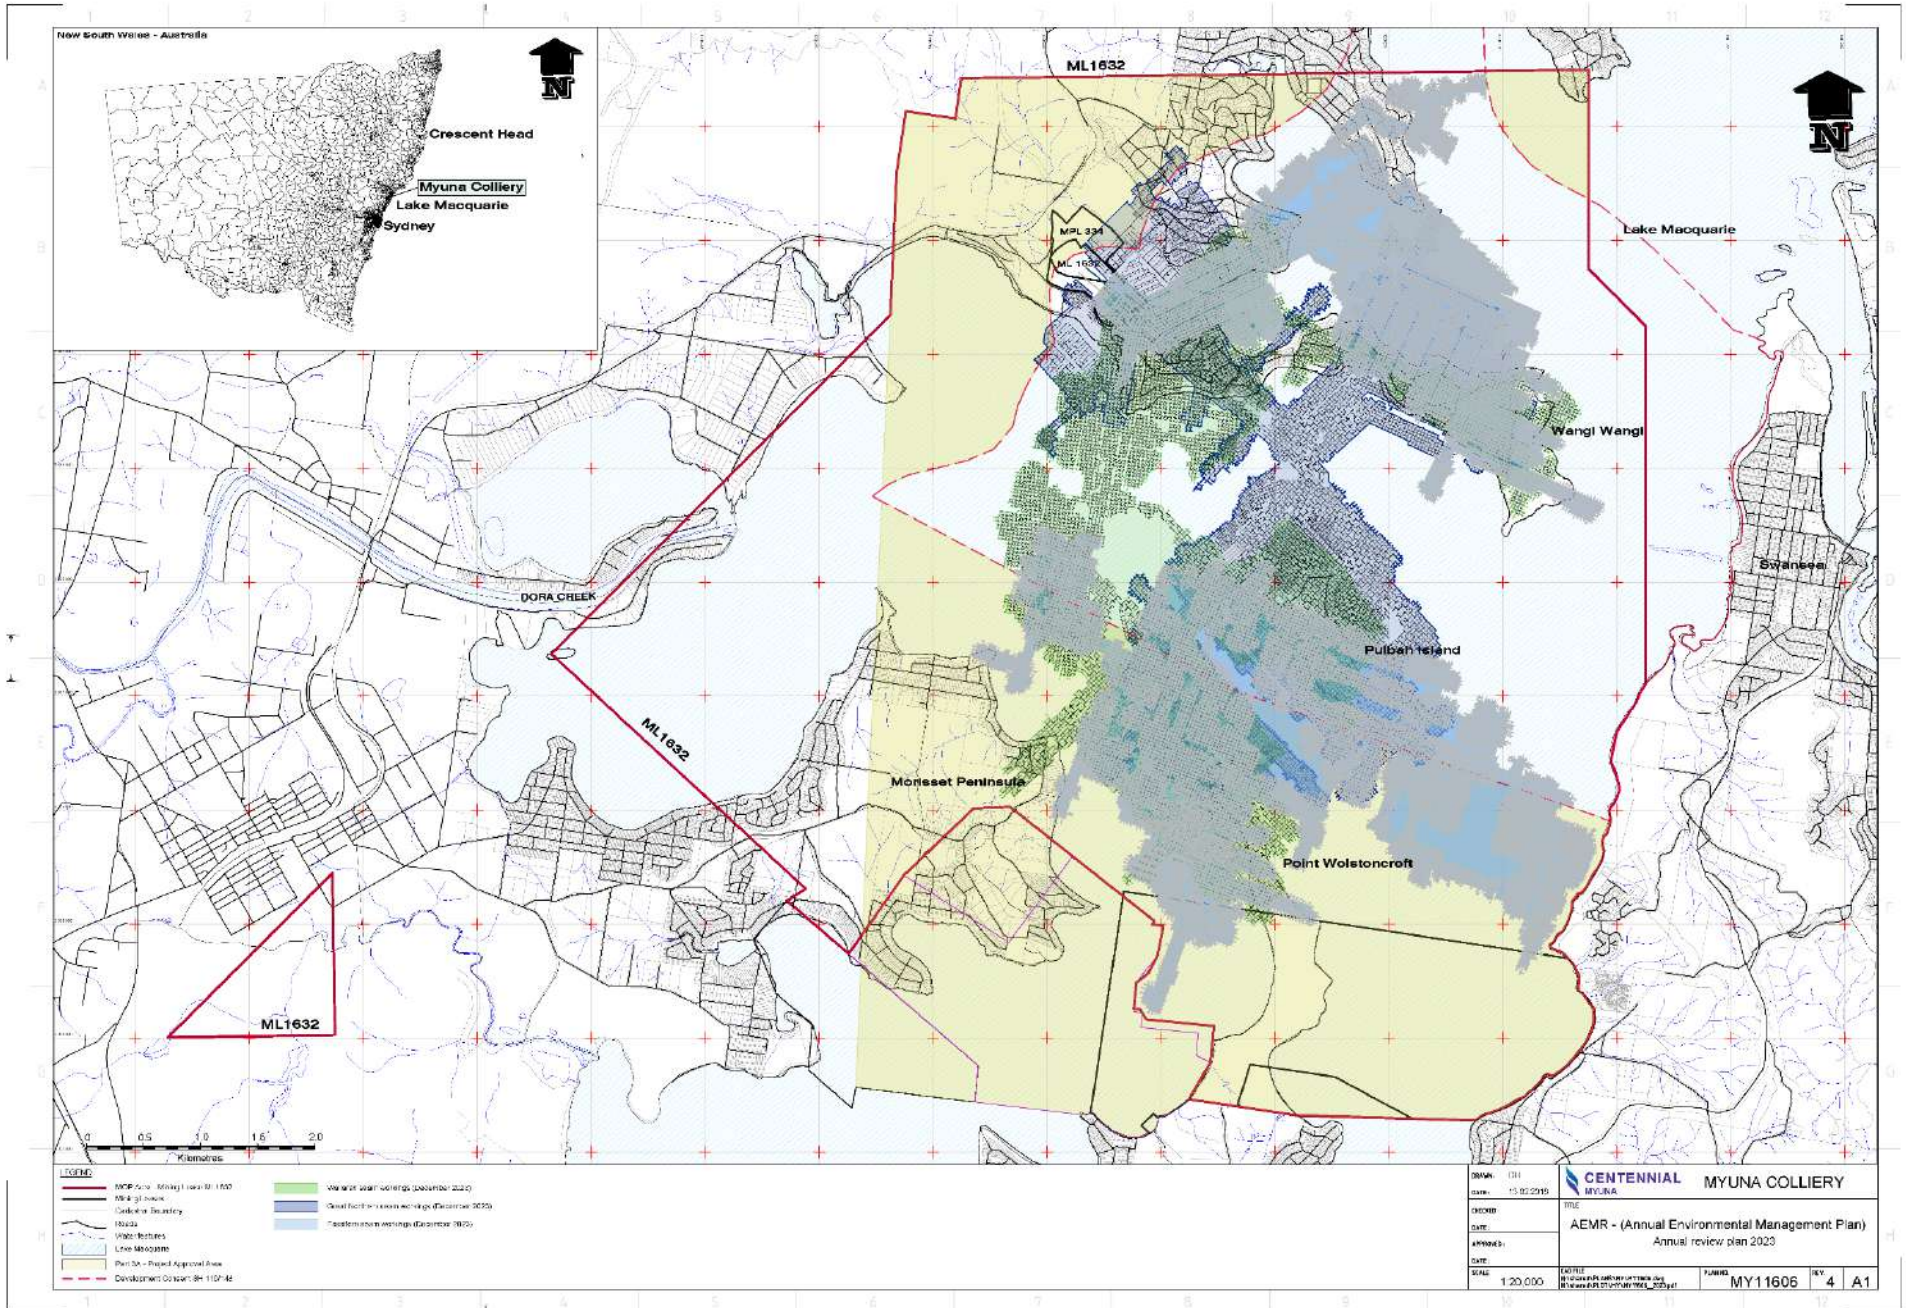
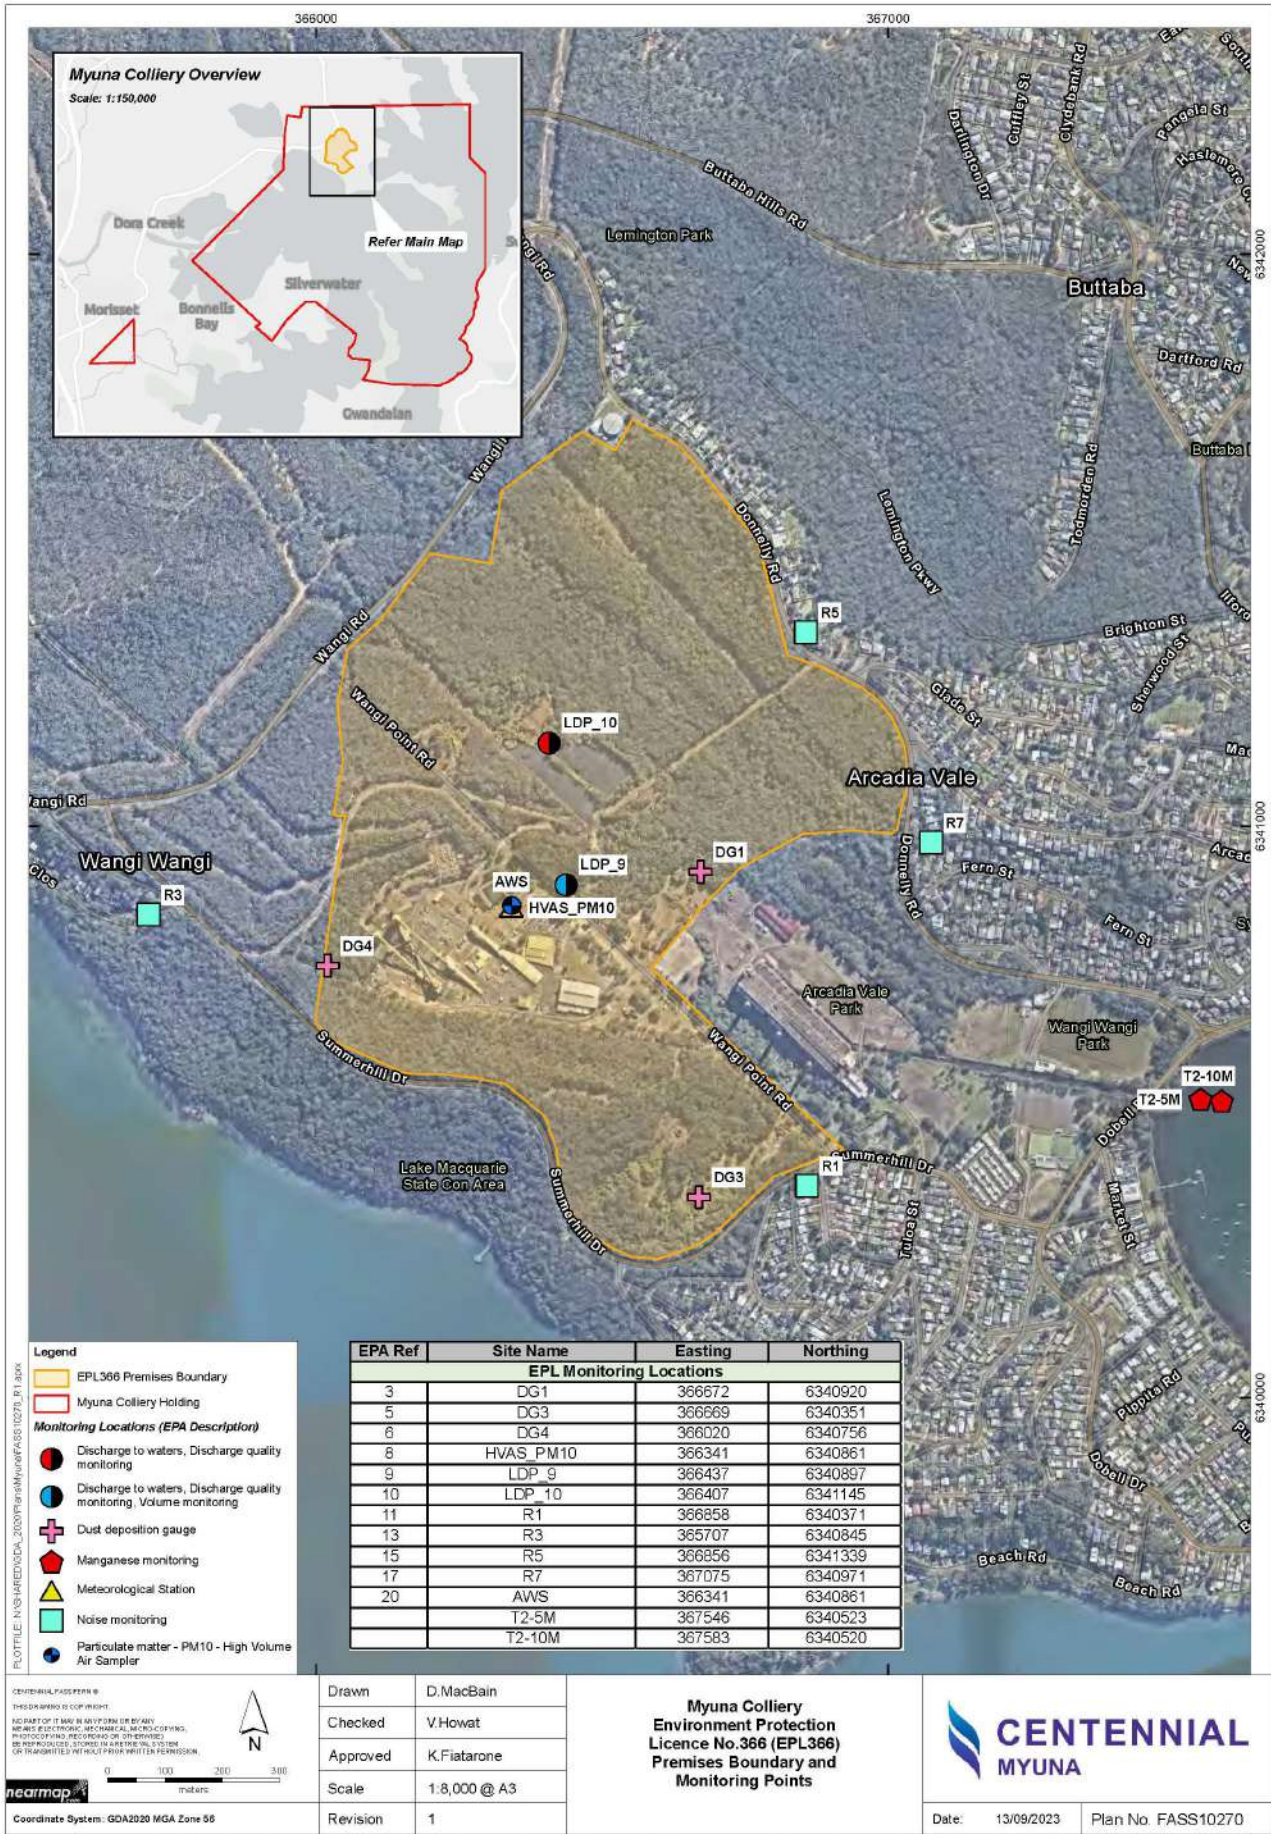
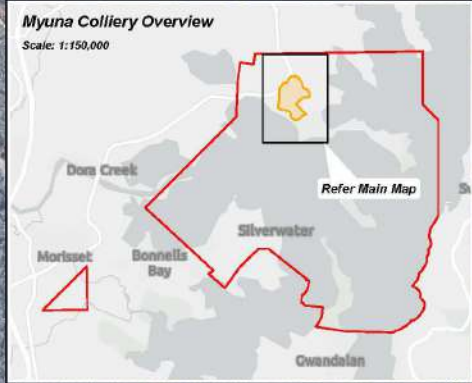
EPA Ref	Site Name	Easting	Northing
EPL Monitoring Locations			
3	DG1	366672	6340920
5	DG3	366669	6340351
6	DG4	366020	6340756
8	HVAS_PM10	366341	6340861
9	LDP_9	366437	6340897
10	LDP_10	366407	6341145
11	R1	366858	6340371
13	R3	365707	6340845
15	R5	366856	6341339
17	R7	367075	6340971
20	AWS	366341	6340861
	T2-5M	367546	6340523
	T2-10M	367583	6340520

- Legend**
- EPL366 Premises Boundary
 - Myuna Colliery Holding
- Monitoring Locations (EPA Description)**
- Discharge to waters, Discharge quality monitoring
 - Discharge to waters, Discharge quality monitoring, Volume monitoring
 - + Dust deposition gauge
 - ⬠ Manganese monitoring
 - ▲ Meteorological Station
 - Noise monitoring
 - Particulate matter - PM10 - High Volume Air Sampler

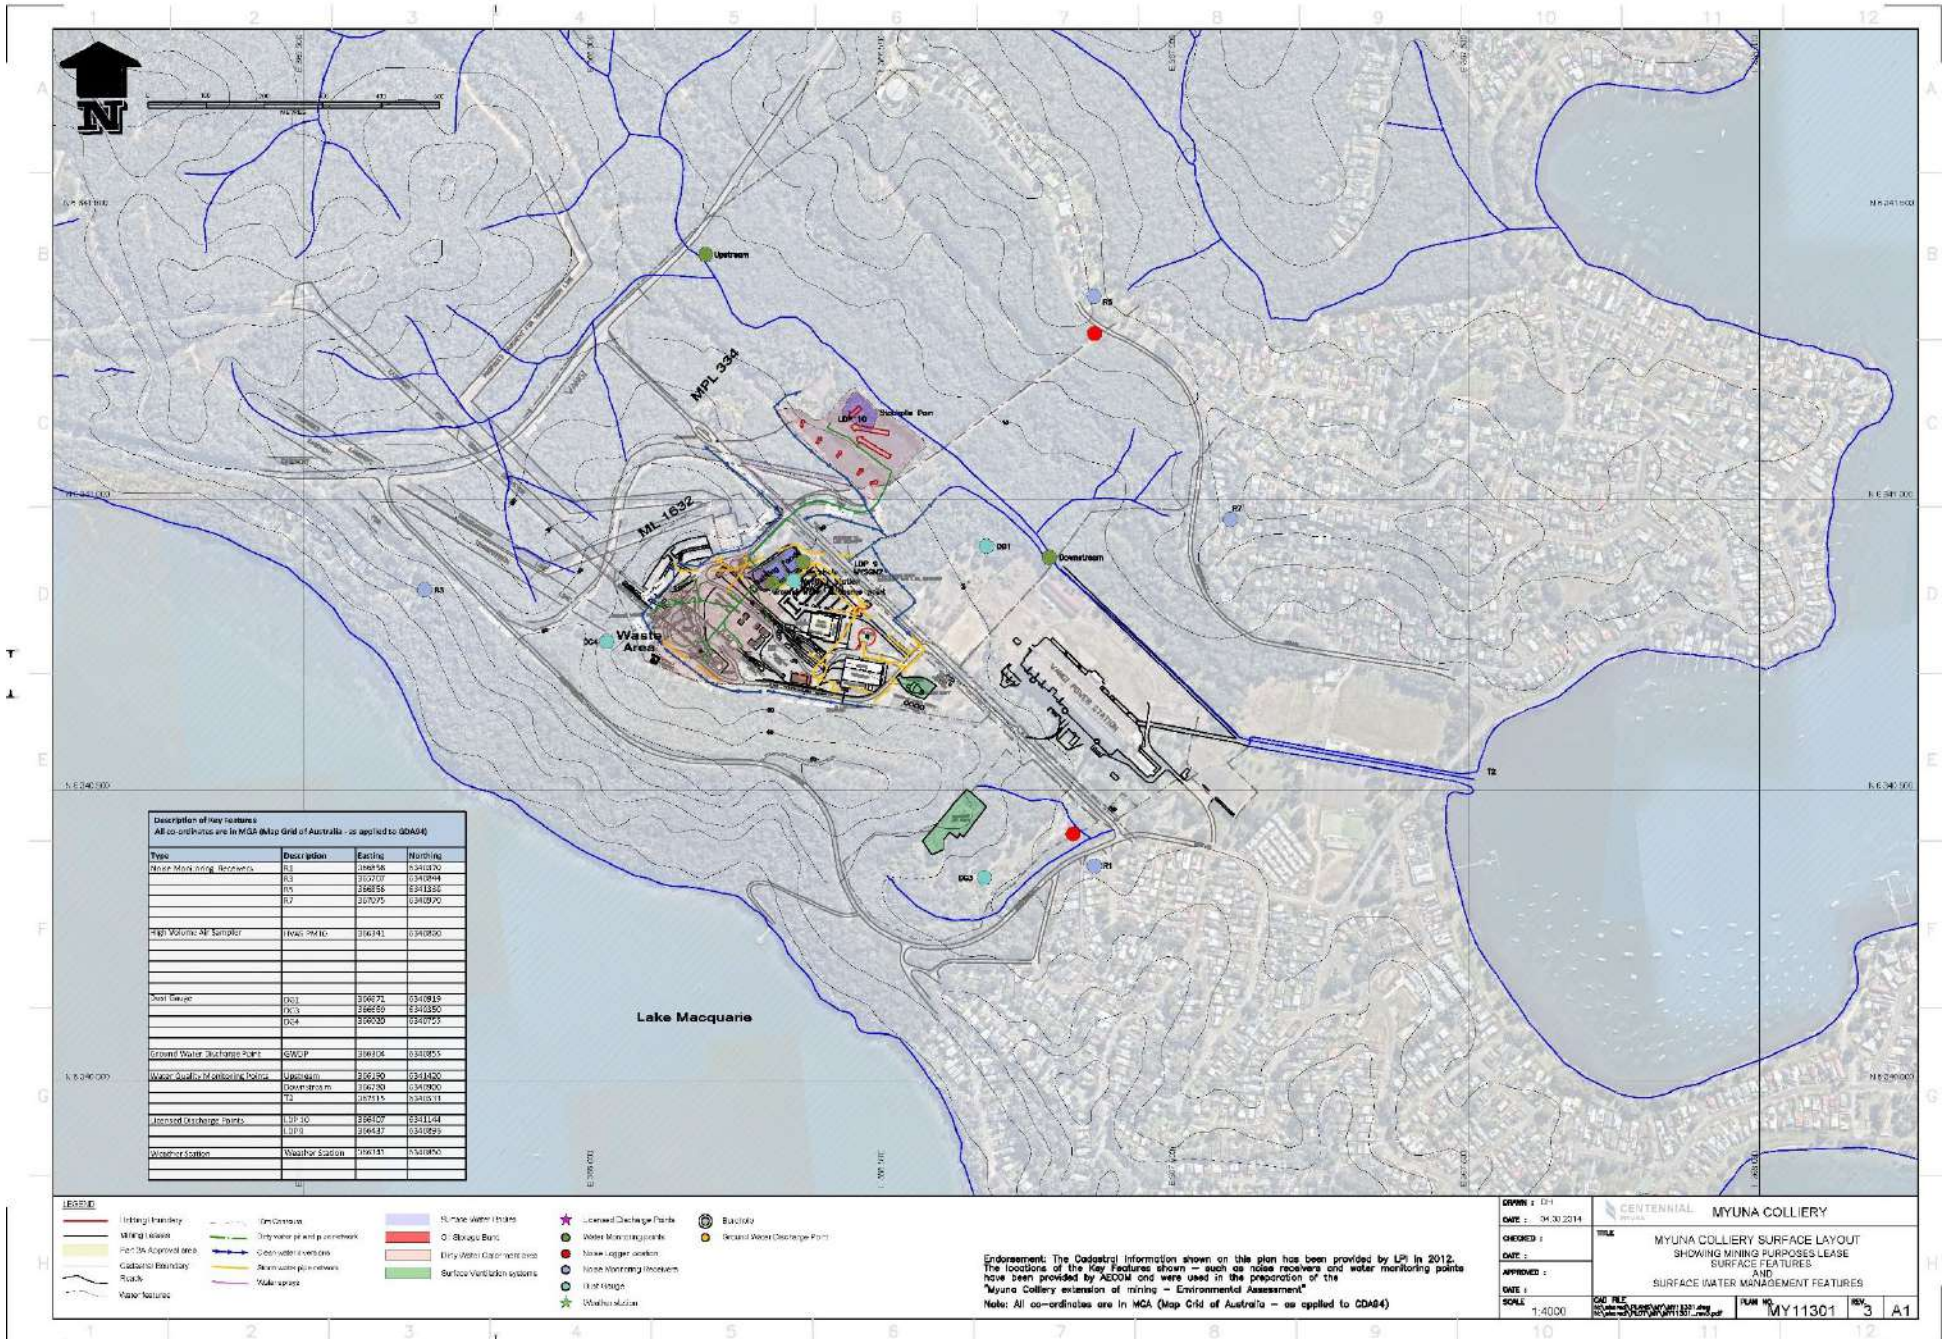
Description of key features
All co-ordinates are in MGA (Map Grid of Australia - as applied to GDA94)

Type	Docu ID	Easting	Northing
Noise Monitoring Receiver	RS	216658	341370
	RS	216707	341394
	RS	216858	341335
	RS	217079	341395
High Volume Air Sampler	HVAC-PM10	216741	341350
Dust Gauge	DG1	216671	341319
	DG2	216659	341330
	DG4	216620	341353
Ground Water Sampling Point	SWCP	216808	341355
Water Quality Monitoring Point	Upstream	216780	341430
	Downstream	216730	341390
	TS	216715	341311
Decant Discharge Point	LDP 30	216809	341464
	LDP 10	216447	341393
Weather Station	Weather Station	216781	341390

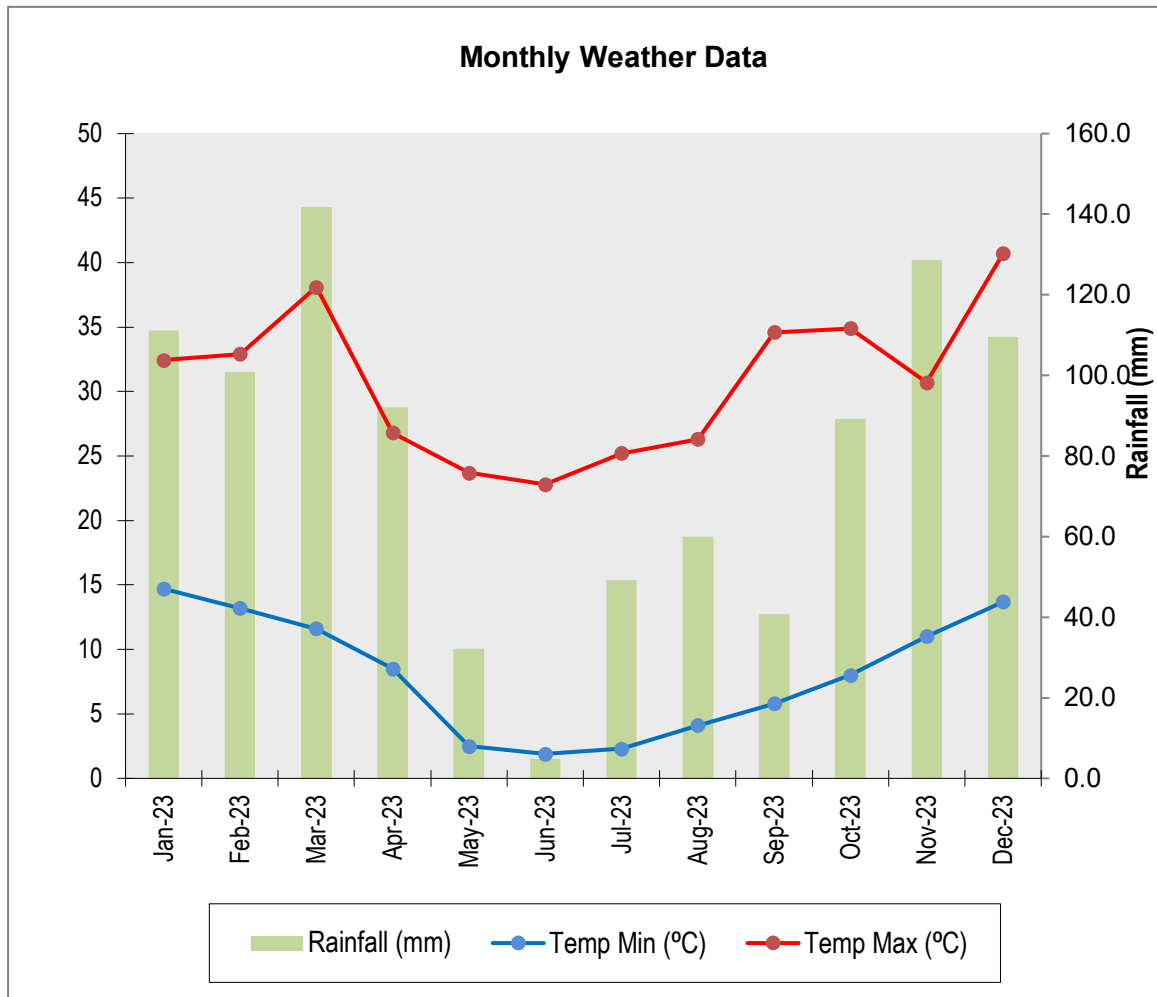
Figure 1. Meteorological Data from Myuna AWS 2023

Meteorological monitoring is completed as per conditions M5.1 and M5.2 of EPL 366 and Section 4.4.4 of the approved Northern Region Air Quality and Greenhouse Gas Management Plan. The location of the Myuna onsite weather station is shown on Plan MY11301, above. The weather station is maintained to conform to the requirements of the NSW EPA Approved Method AM-2 and NSW EPA Approved Method AM-4.

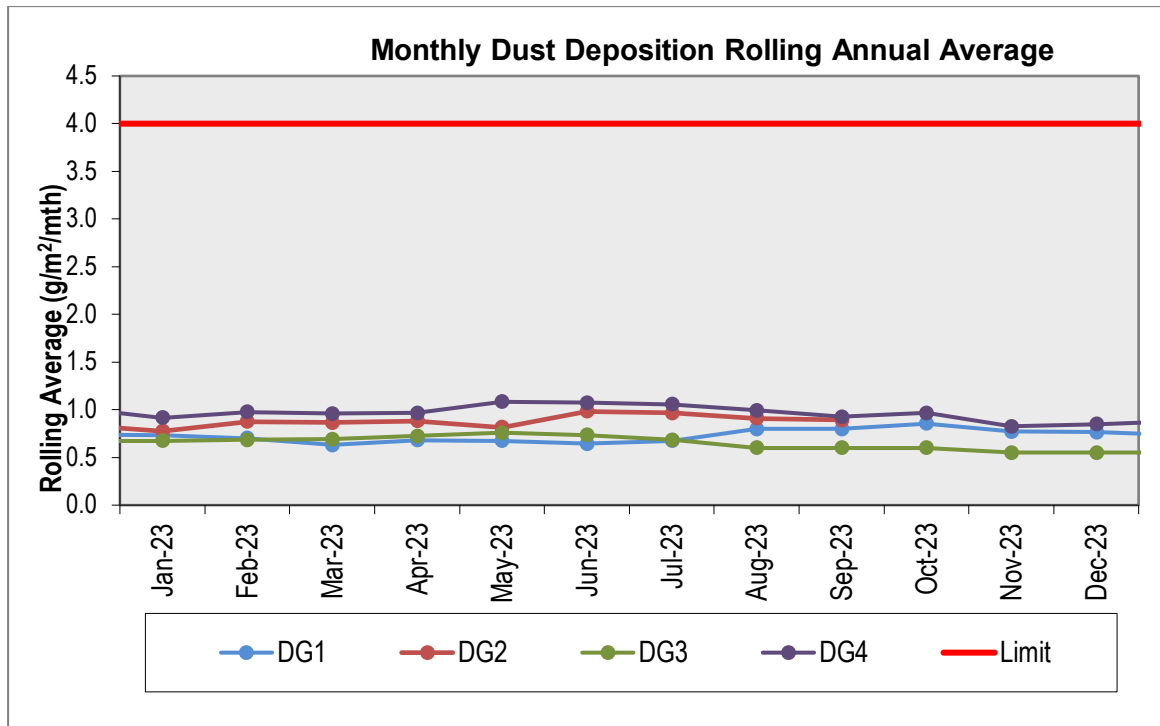
Figure 2. Dust Depositional Gauge – Rolling Annual Average

Figure 2 and Table 13 below show the depositional dust monitoring results of Myuna Colliery for 2023 in comparison to the long-term results and EIS predictions. At all four dust gauges the annual averages were similar to the long-term averages. The 2 g/m²/month max annual average increase limit was not exceeded. As of October 2023, DG2 is no longer required to be monitored.

The 2023 annual average and long-term average for each dust gauge is provided in Table 13. The 2023 annual averages for all dust gauges are less than the 19-year long term averages. The long-term trend lines of DG 3 and 4 display a slightly decreasing trend for the monthly dust deposition while DG 1 is stable and DG2 displays a slightly increasing trend.

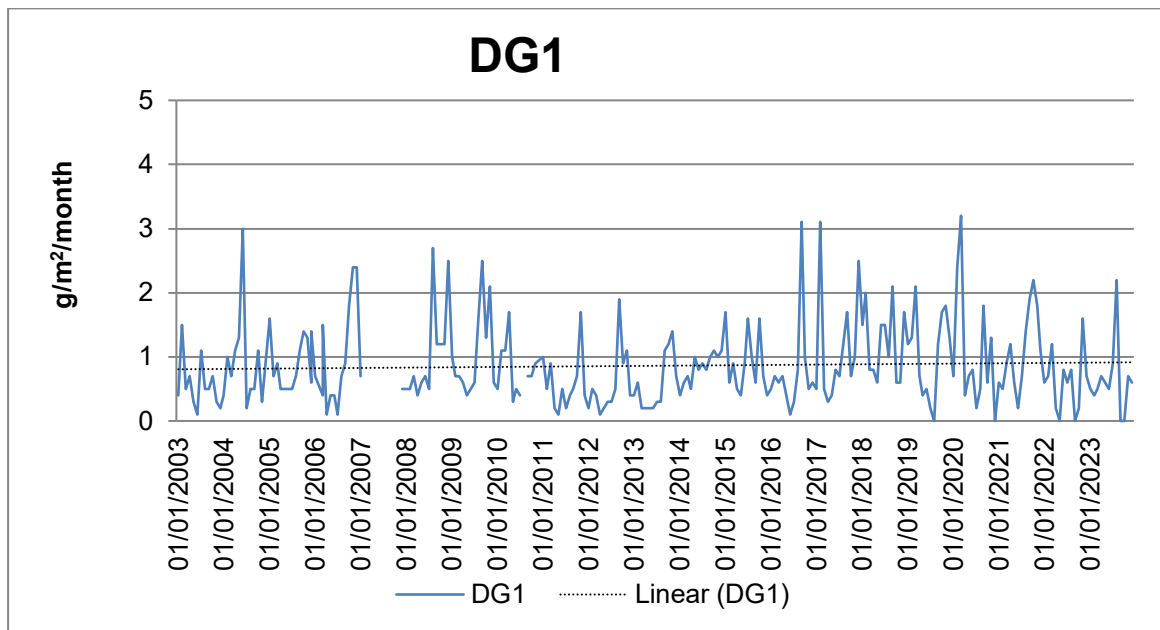
Figure 3. *DG1 Trend Analysis Graph*

Trend - Myuna Colliery has 20 years of dust monitoring data over the period from January 2003 to December 2023, excluding data for a 10-month period from February 2007 to November 2007 which is not available. A trend analysis was undertaken using a linear trend line for the dust deposition monitoring from January 2003 to December 2023.

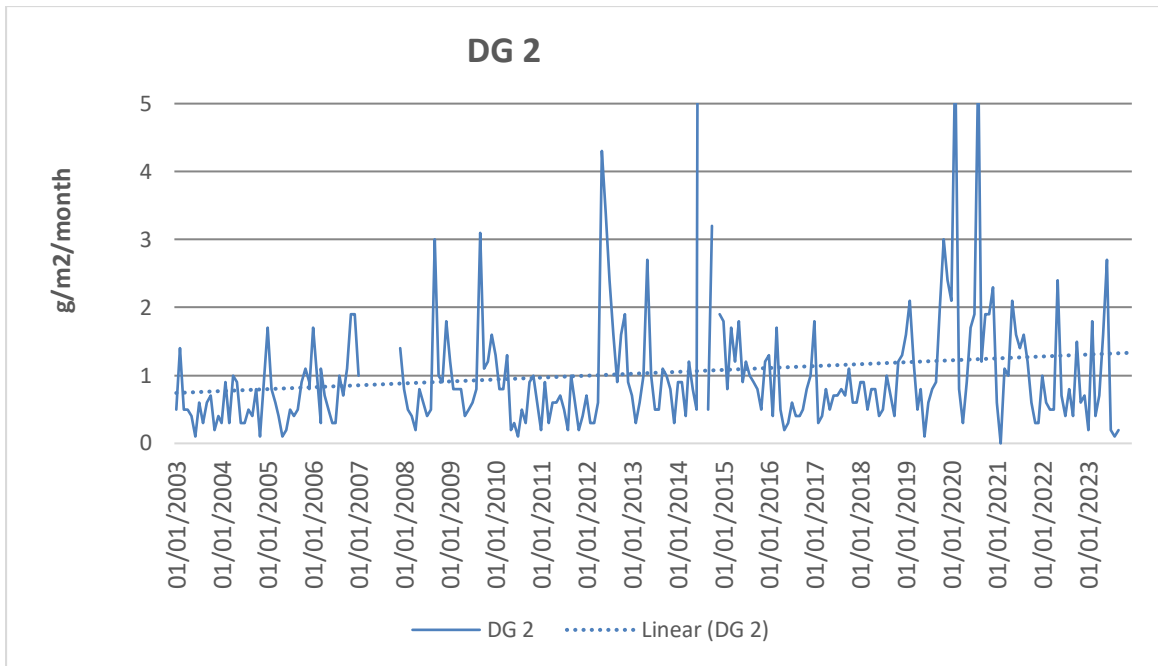
Figure 4. DG2 Trend Analysis Graph

*No data for DG2 beyond October 2023 due to the cessation of monitoring at this point following the adoption of the long-term monitoring program in accordance with the AQGGMP and corresponding EPL366 variation.

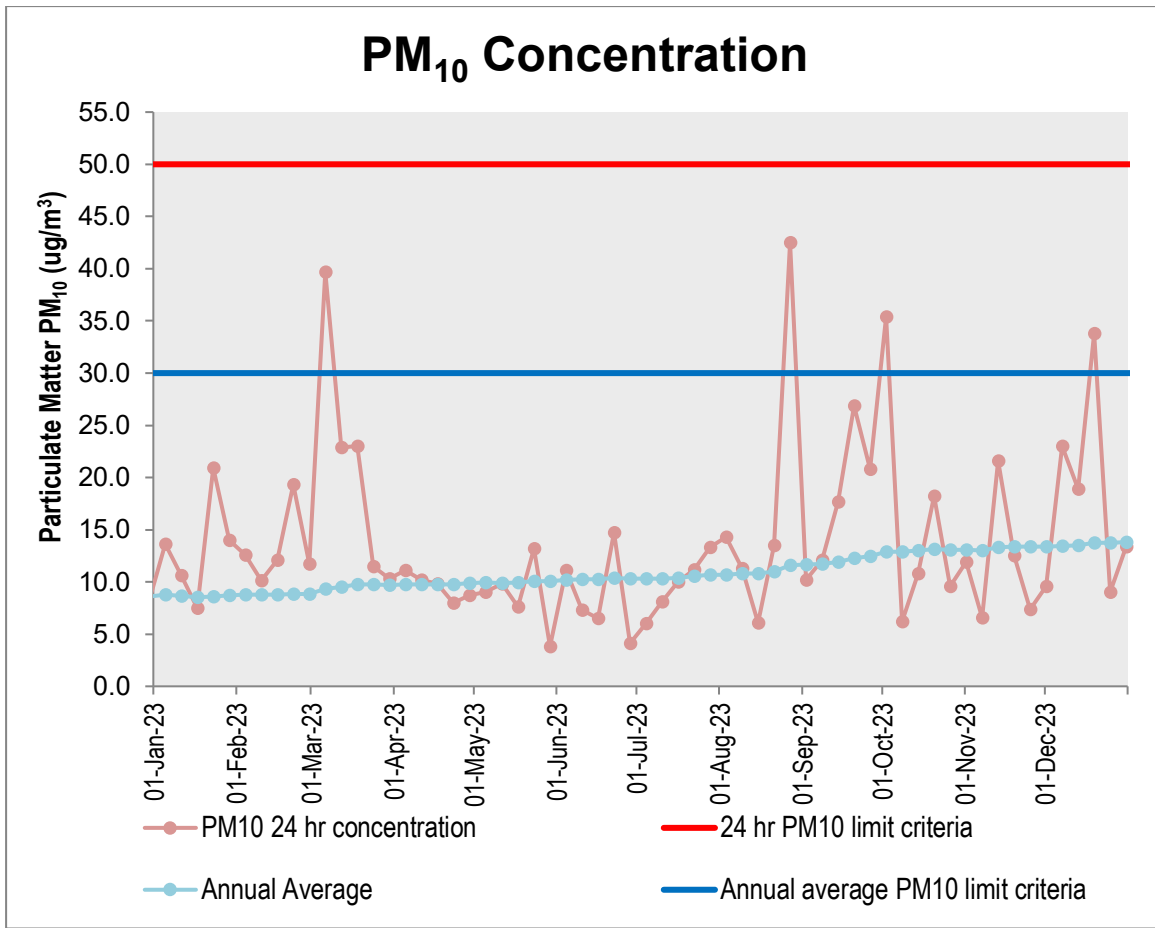
Figure 7. HVAS PM₁₀ Rolling Annual Average & 24 hr Results.

The air quality monitoring results are assessed against Schedule 3 Condition 17 of the Project Approval. The annual average limit criterion for TSP is 90 µg/m³ and for PM10 is 30 µg/m³. The 24-hour limit criterion for PM10 is 50 µg/m³. There were no exceedances of the 24-hour limit criteria for PM10, or the annual average limit during the report period. As of October 2023, Myuna Colliery has adopted the long-term monitoring program as prescribed in the AQGGMP and the corresponding EPL366. This includes the consolidation of the PM10 and TSP HVAS units. From October 2023, TSP is now modelled from measurements of PM10 to determine compliance with annual averages. TSP has been removed entirely from EPL366.

The maximum recorded 24-hour PM₁₀ concentration for the report period was 42.5 µg/m³ and the maximum recorded 24 hour TSP concentration for the report period was 66 µg/m³.

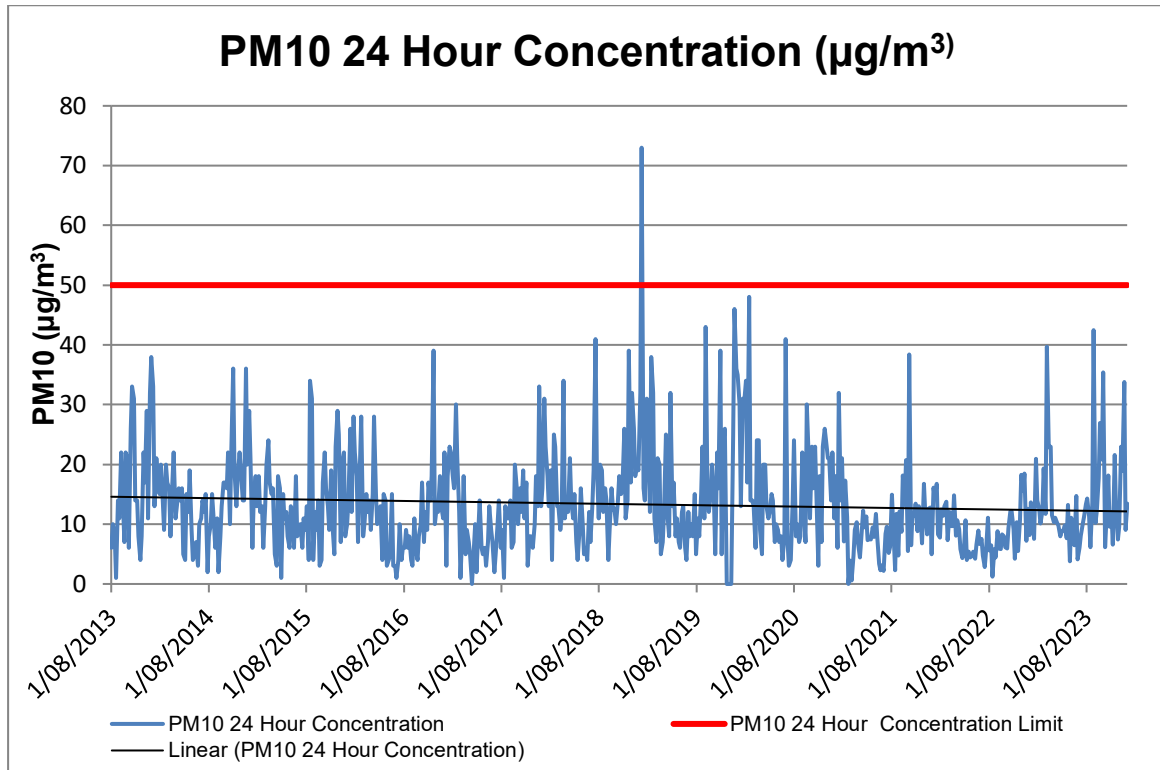
Figure 9. HVAS PM₁₀ Trend Analysis Graph

The trend analysis was undertaken using a linear trend line for the TSP and PM₁₀ monitoring data from August 2013 to December 2023. The trend lines indicate slightly decreasing trends for the TSP and PM₁₀ over the long-term monitoring period.

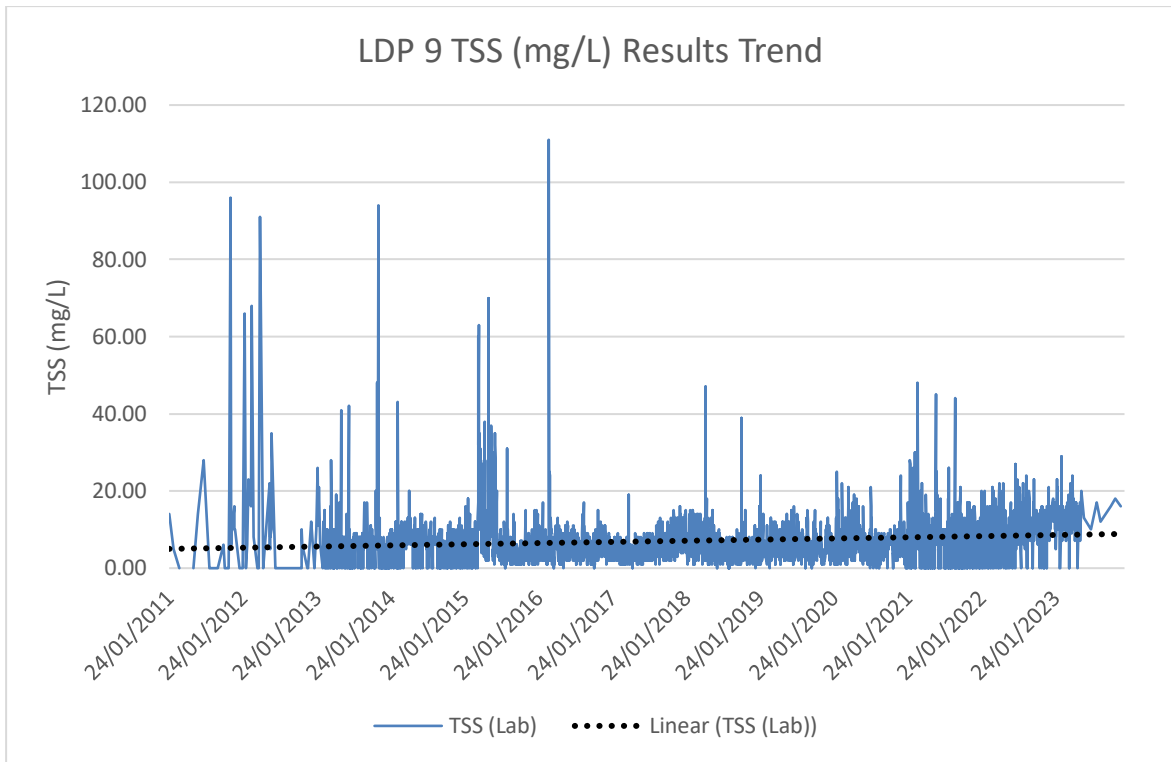
Figure 14. LDP 9 TSS Monitoring Results and Linear Trend Line

As shown in the figures below, linear trend lines were applied to the monitoring data from 2011 to December 2023 for pH, TSS and Oil & Grease. The trend lines show that results have been relatively consistent over this period.

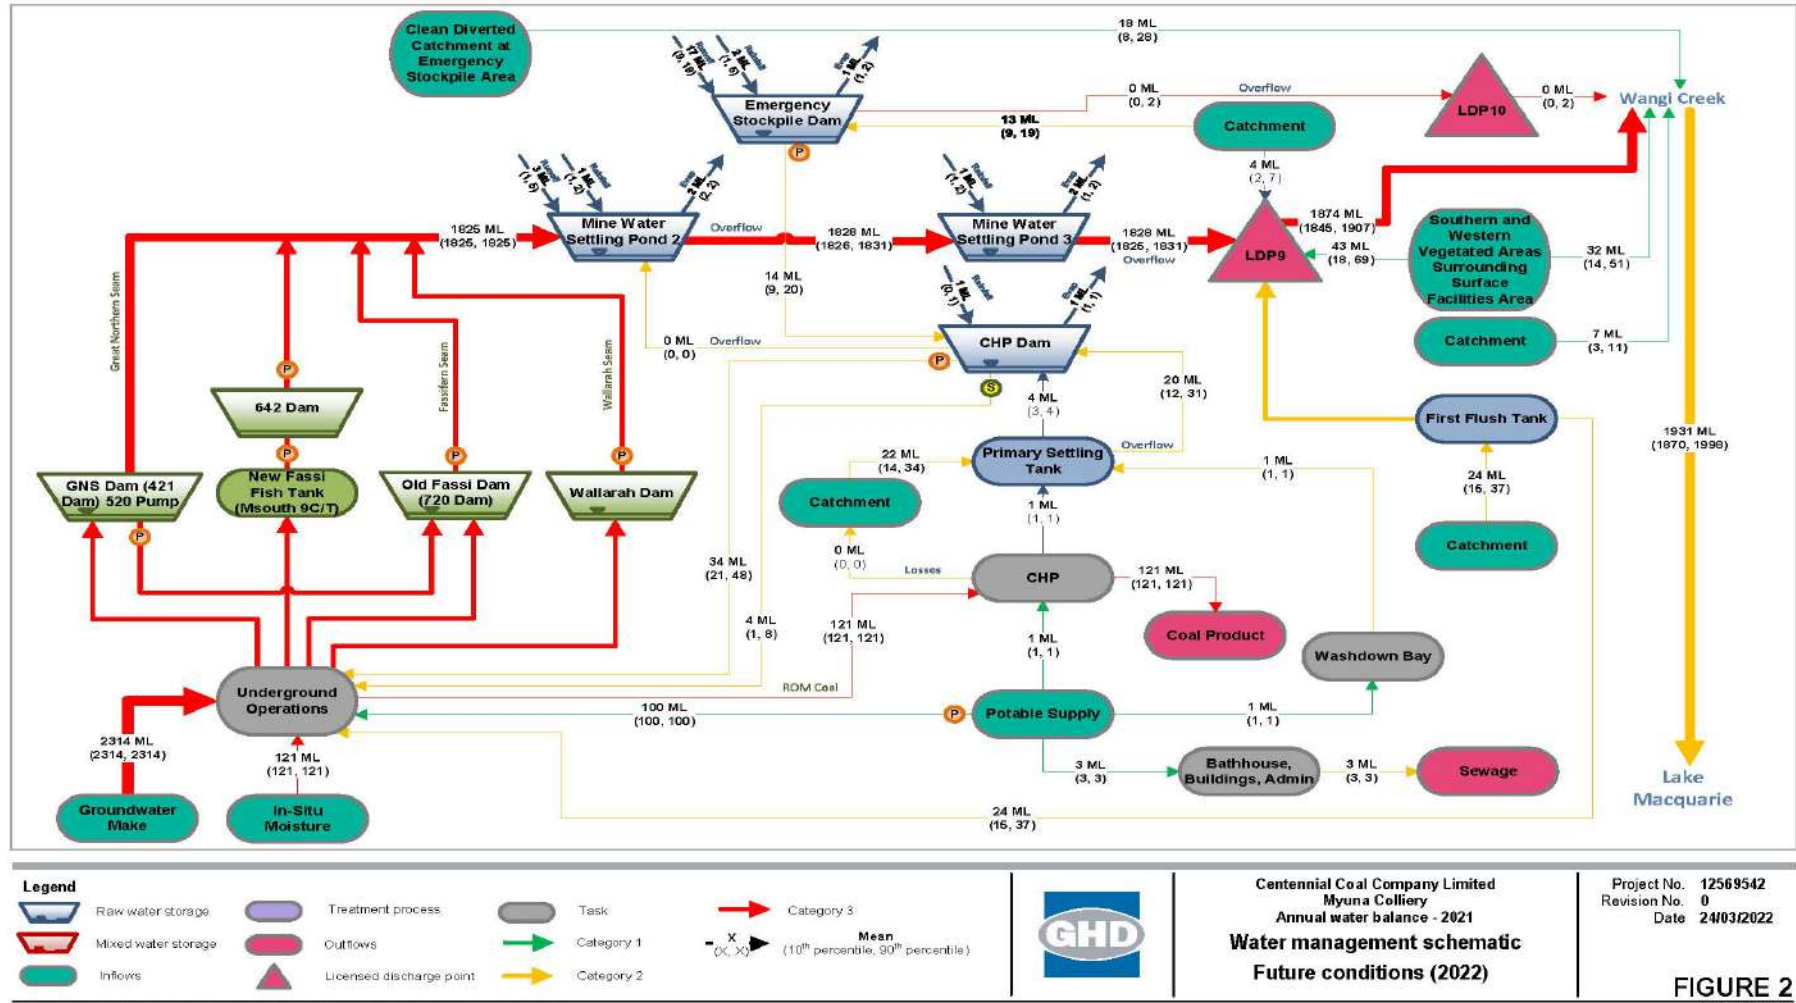
Figure 17. Water Balance Schematic

Element	2023 (simulated) (ML/year)
INPUTS	
Runoff into storages	92.82
Precipitation	3.43
Potable water supply	92.71
Groundwater inflows	2332.20
In situ moisture	120.44
TOTAL INPUTS (rounded)	2642
OUTPUTS	
Evaporation	5.56
Tank loss (CHP)	120.44
Tank loss (washdown)	0.39
Sewage	2.68
Discharge through LDP009	2262.90
Discharge through LDP010	0
Consumption	213.15

TOTAL OUTPUTS (rounded)	2605
CHANGE IN STORAGE	
Change in storage	224.1
TOTAL CHANGE IN STORAGE (rounded)	224
BALANCE	
Inputs – outputs – change in storage	-187

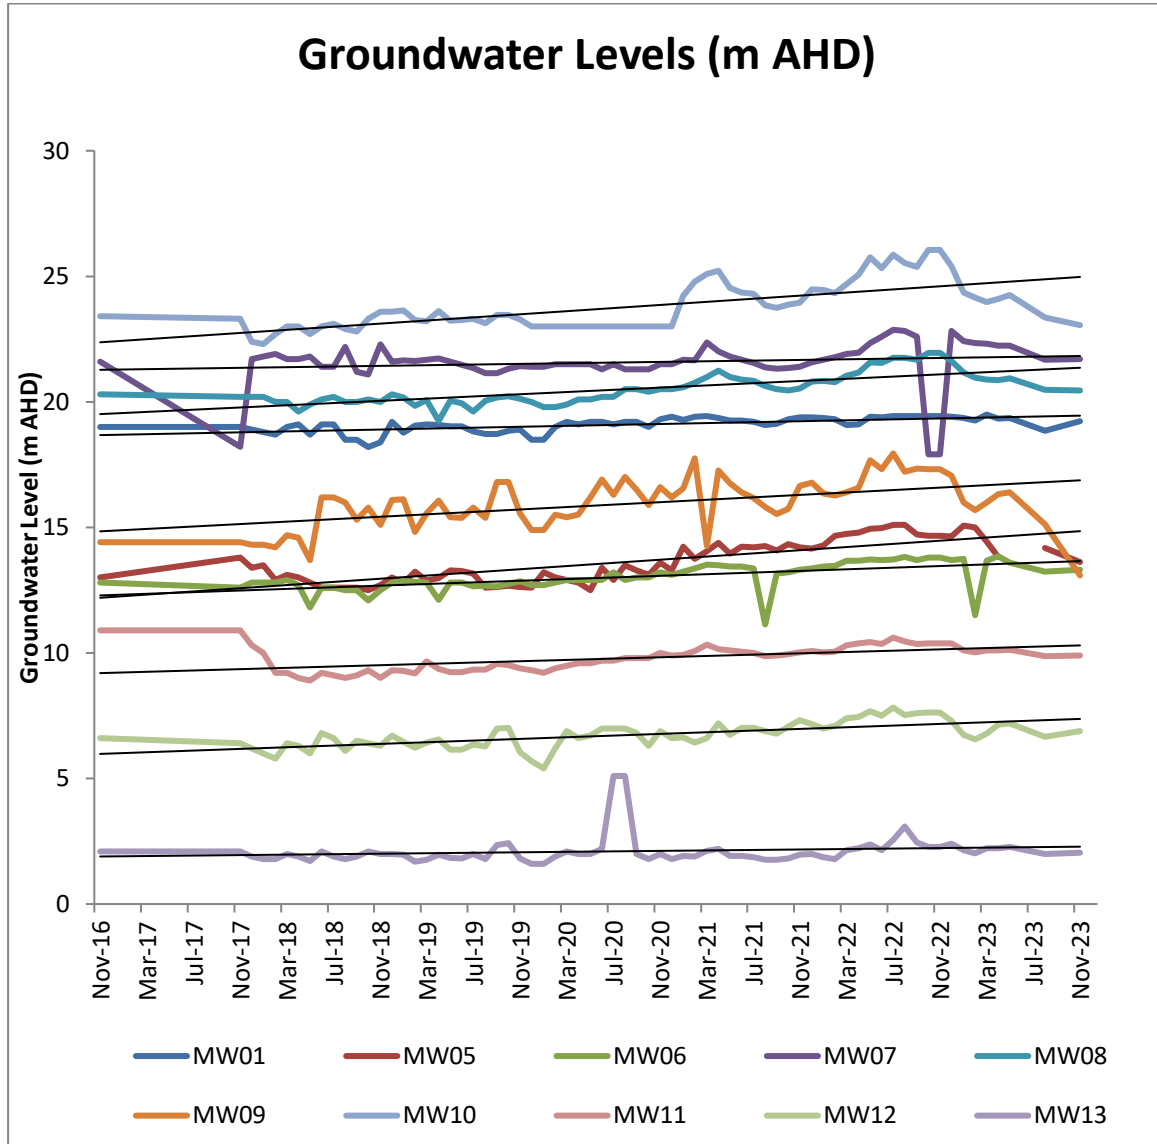
Figure 18. Groundwater Levels (m AHD) 2016 - 2023

Groundwater levels at all monitoring locations remained relatively stable during the reporting period. Groundwater levels have been relatively stable at all other groundwater monitoring locations since November 2016.

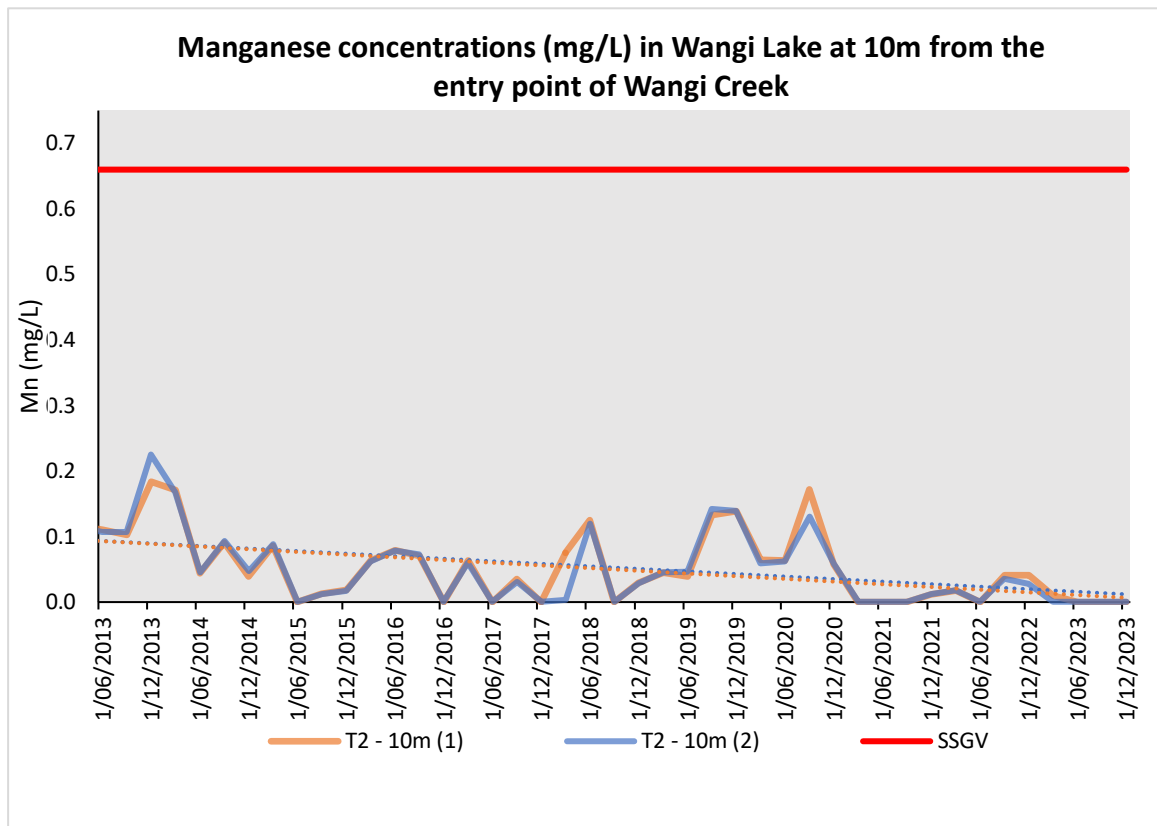
Figure 19. Manganese Monitoring Results and Linear Trend Line

The Manganese monitoring has been conducted over a period of ten years from 2011. Manganese concentrations recorded in Wangi Bay over the ten-year period of monitoring display a relatively constant trend at T2 10m and a downward trend at T2 5m.

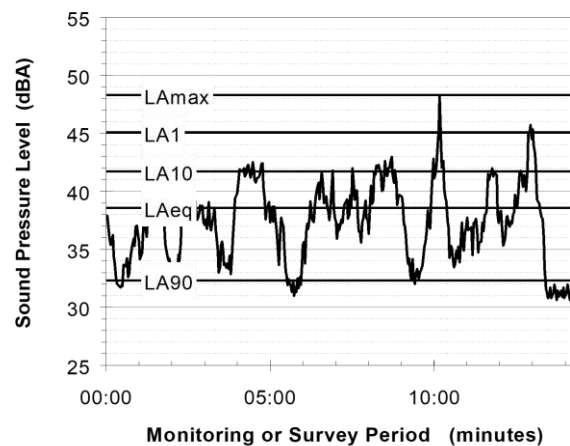
Sounds that vary in level over time, such as road traffic noise and most community noise, are commonly described in terms of the statistical exceedance levels LAN, where LAN is the A-weighted sound pressure level exceeded for N% of a given measurement period. For example, the LA1 is the noise level exceeded for 1% of the time, LA10 the noise exceeded for 10% of the time, and so on.

The following figure presents a hypothetical 15 minute noise survey, illustrating various common statistical indices of interest.

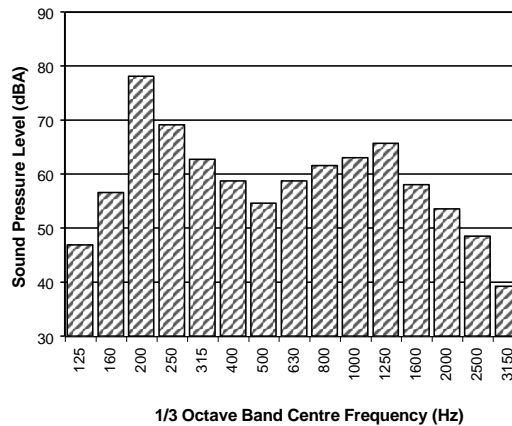
The following figure shows a 1/3 octave band frequency analysis where the noise is dominated by the 200 Hz band. Note that the indicated level of each individual band is less than the overall level, which is the logarithmic sum of the bands.

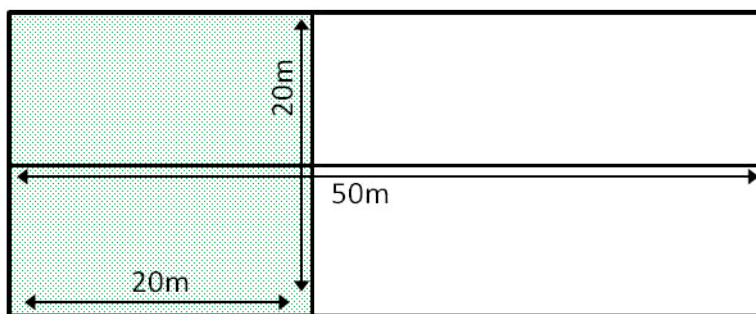
Figure 2 Biometric plot dimensions

Biometric plots (20 x 50 m) were established, marking the start and end points of the transect using GPS and permanent pegs. The dimensions of the standard biometric plot are shown in **Figure 2**.

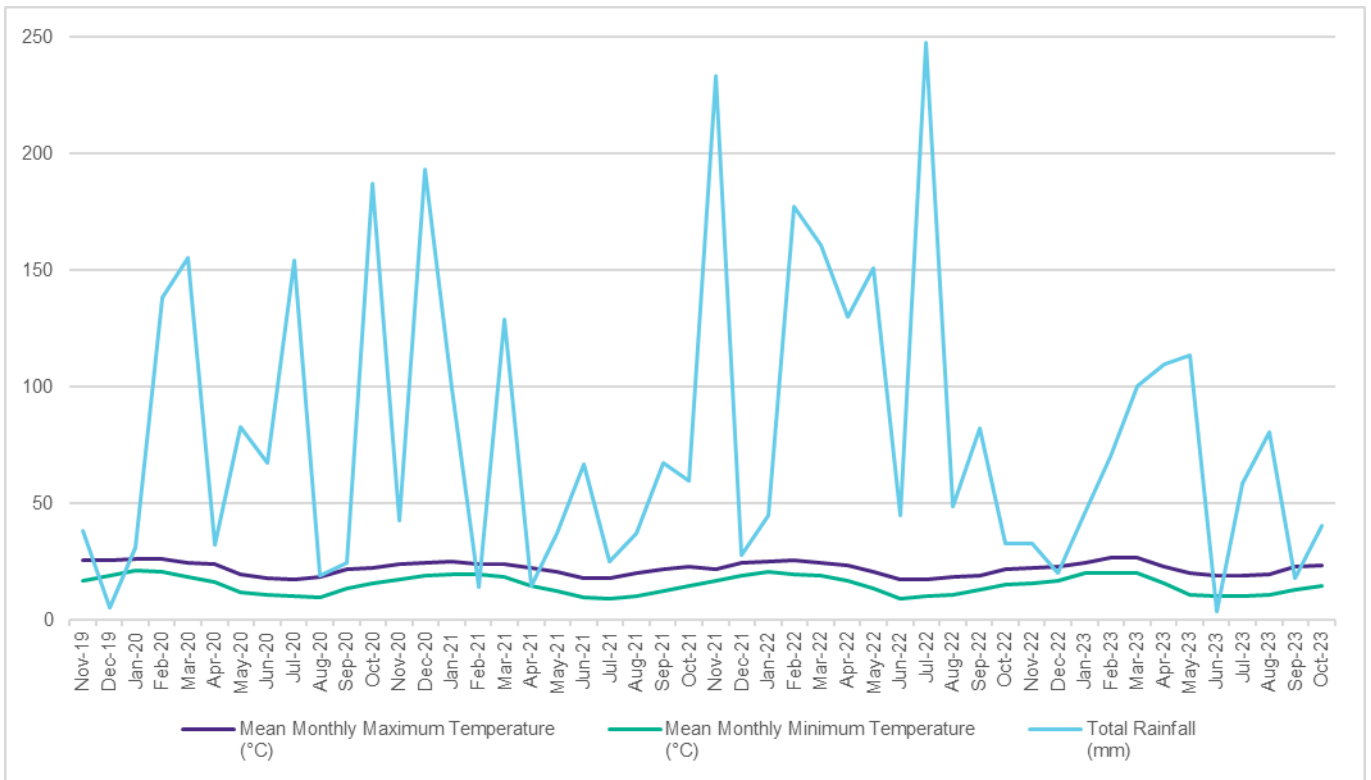
Graph 1 Long term weather patterns (November 2019 to October 2023) preceding the 2023 monitoring event

A summary of the weather data for the 12-month period preceding the 2023 monitoring event (i.e., November 2022 to October 2023), along with historical monthly data (1862 to 2023; BoM, 2023), is outlined in **Table 4**. Long term weather patterns (November 2019 to October 2023) are outlined in **Figure 3**. The data was obtained from Newcastle Nobbys Signal Station AWS (61055), located approximately 28km north of the monitoring sites.
