***CENTENNIAL COAL
MYUNA COLLIERY
ANNUAL REVIEW***

January 2023 to December 2023

March 2024

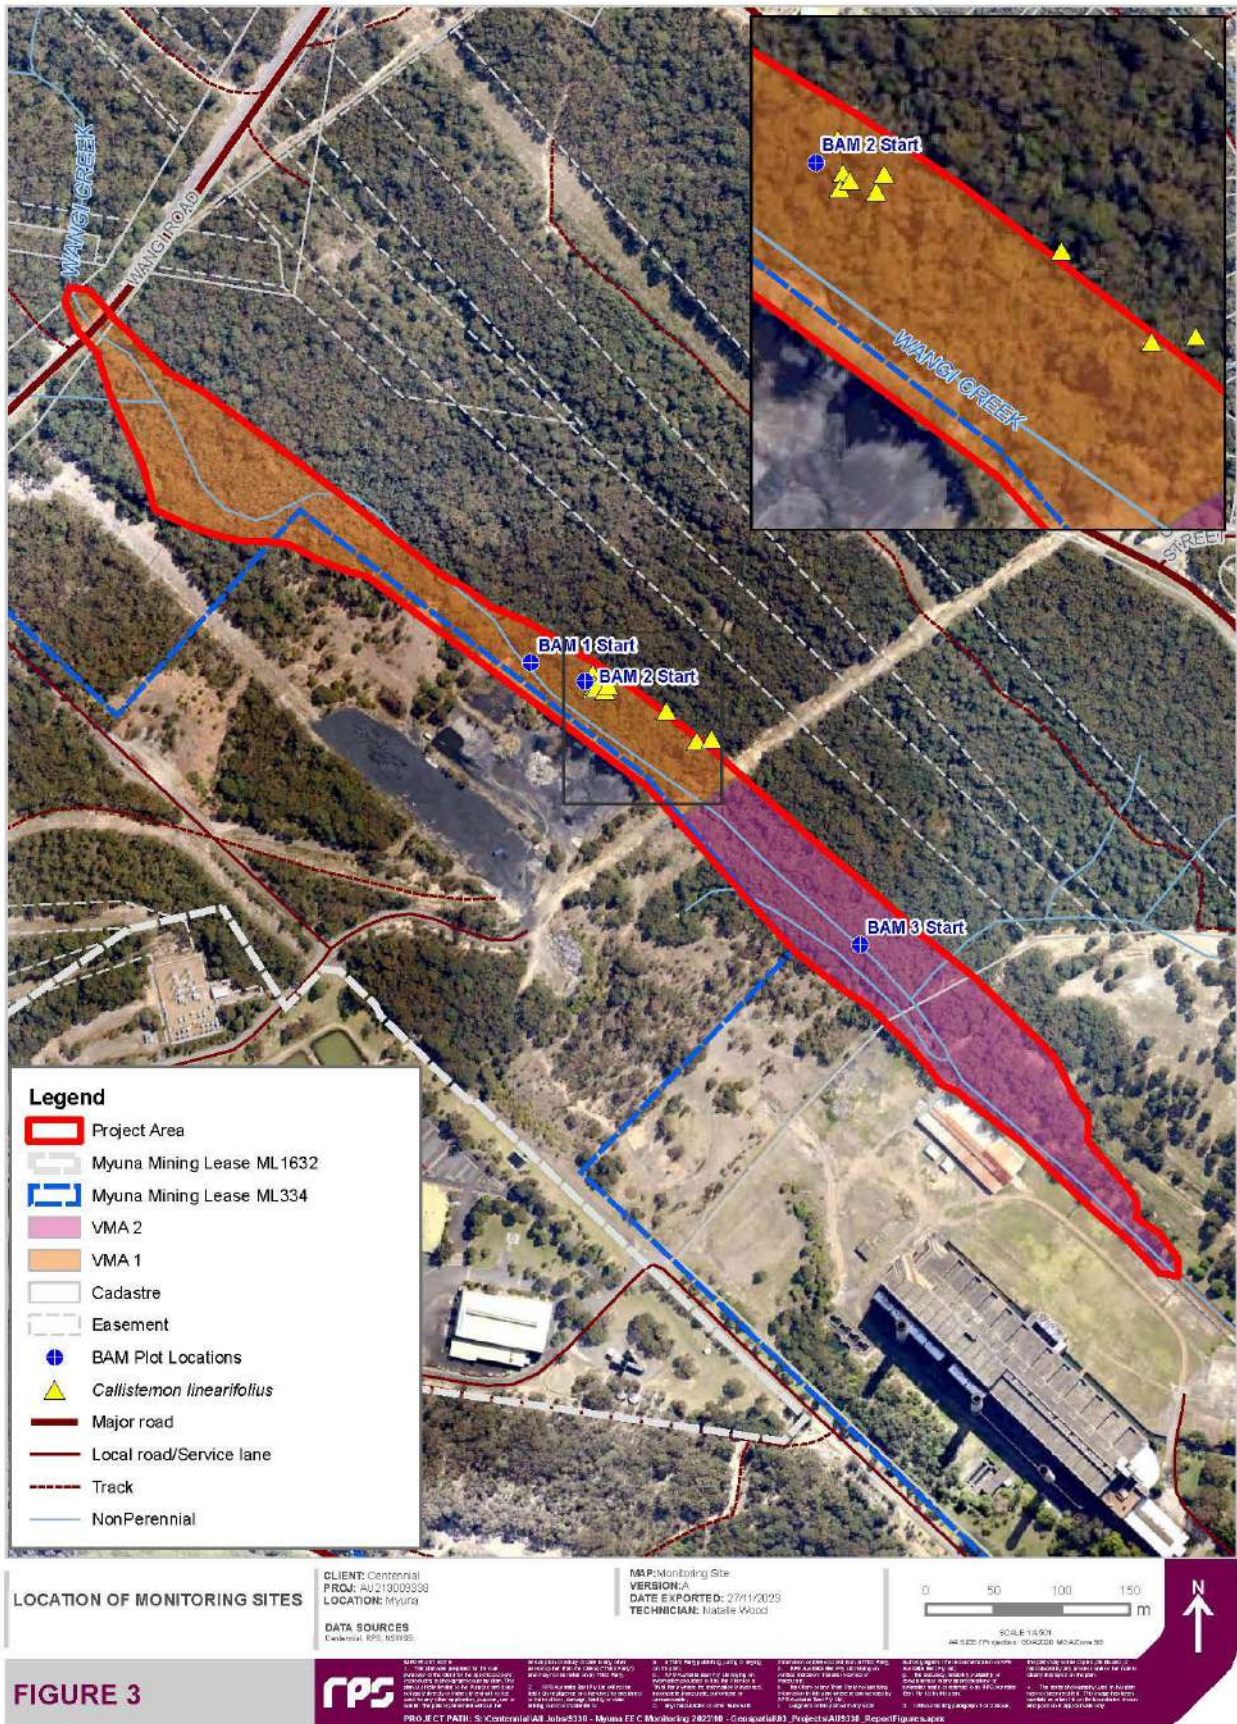
Figure 3 Location of monitoring sites

VMA 1 consists of two plots of high condition native vegetation (**Figure 3**). These plots are in locations which have historically experienced relatively high levels of water inundation due to rainfall events. This inundation appeared to be a low energy influx, with minimal deposition of vegetative debris and unconsolidated material. The following section reports on data collected from the 2023 monitoring event. There were no visual indicators of mining related activities or impacts (i.e., subsidence or ponding). Evidence of rubbish were present within both monitoring plots.

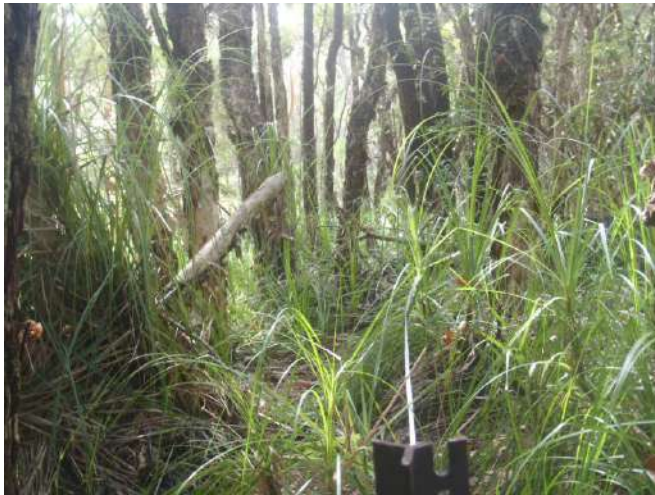
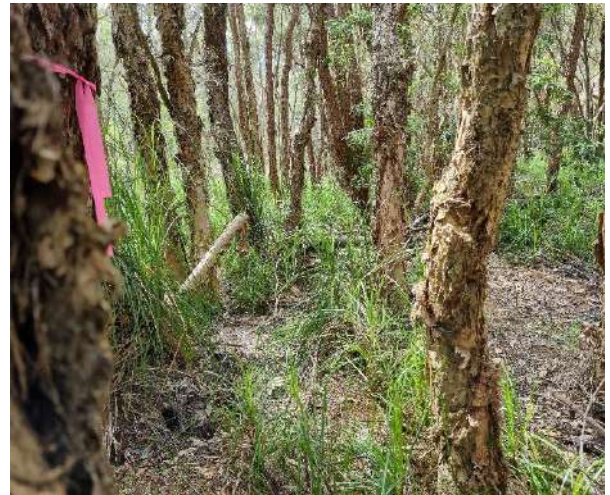
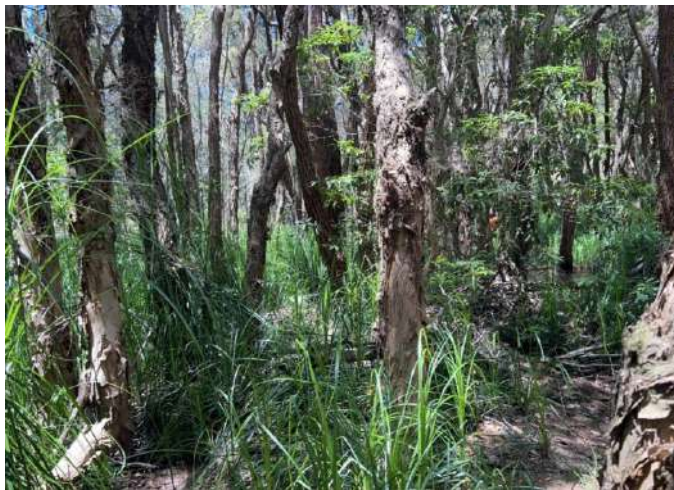
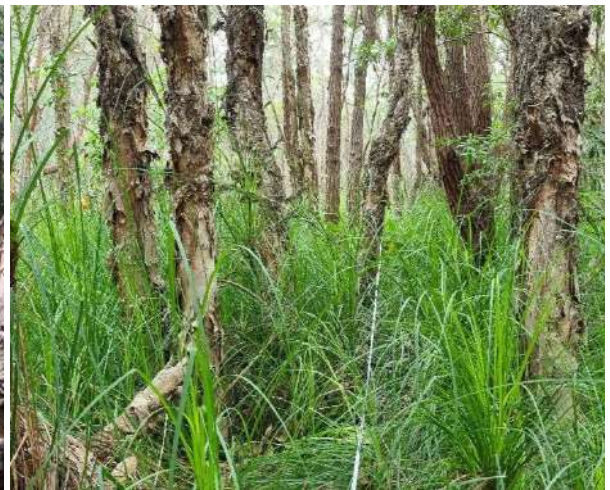
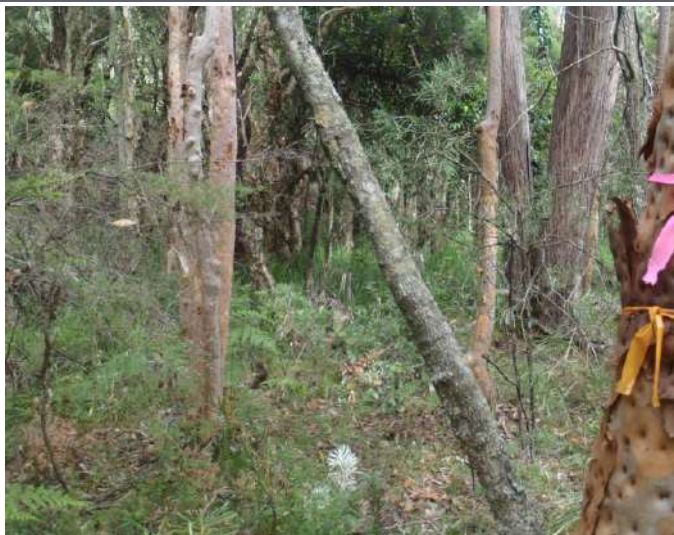
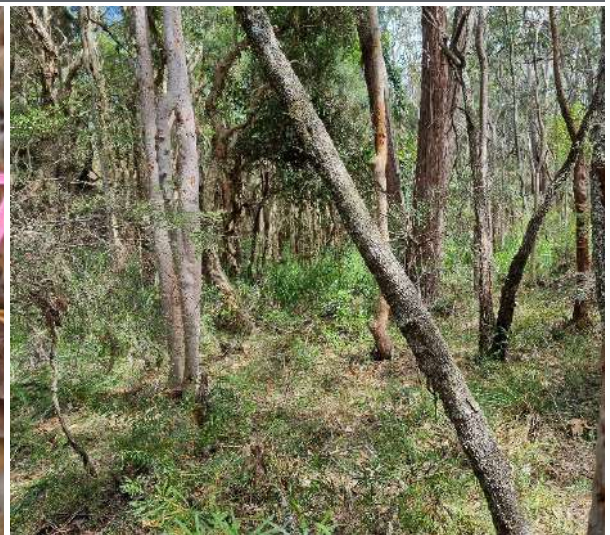
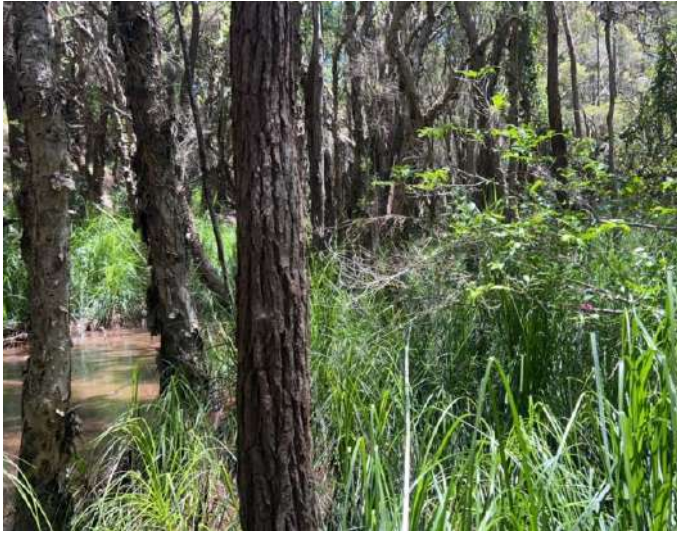
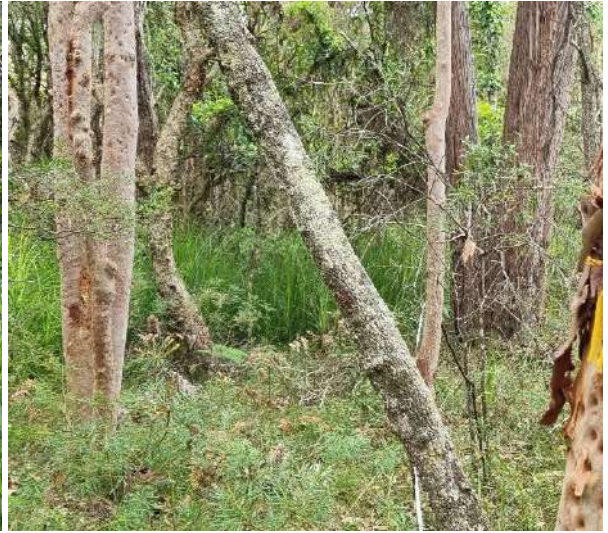
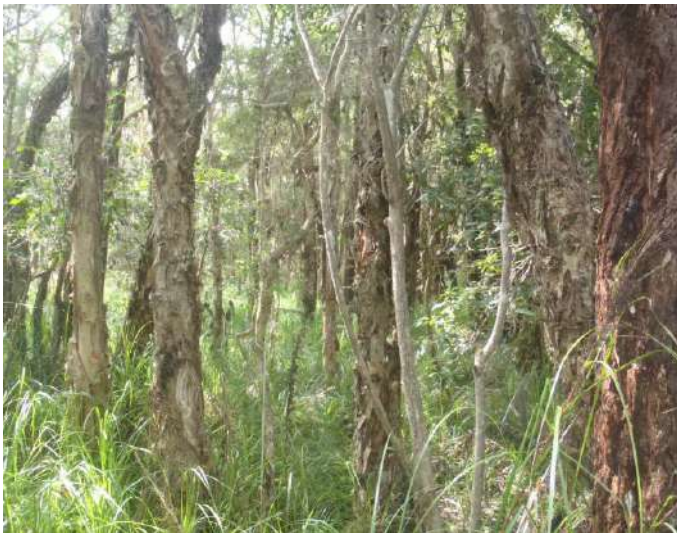
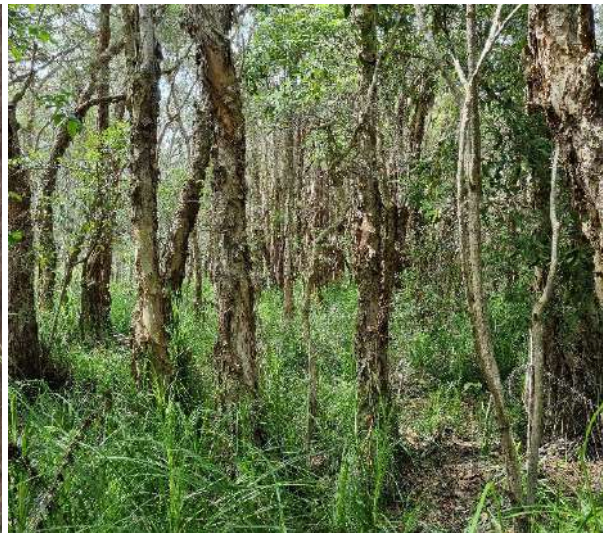
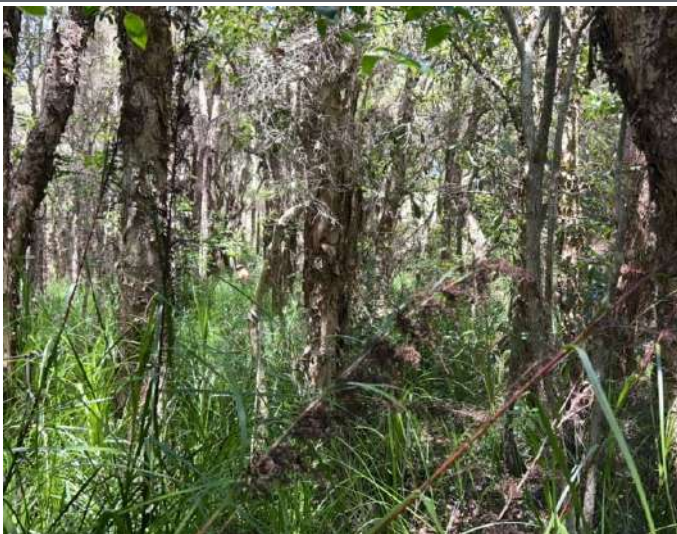
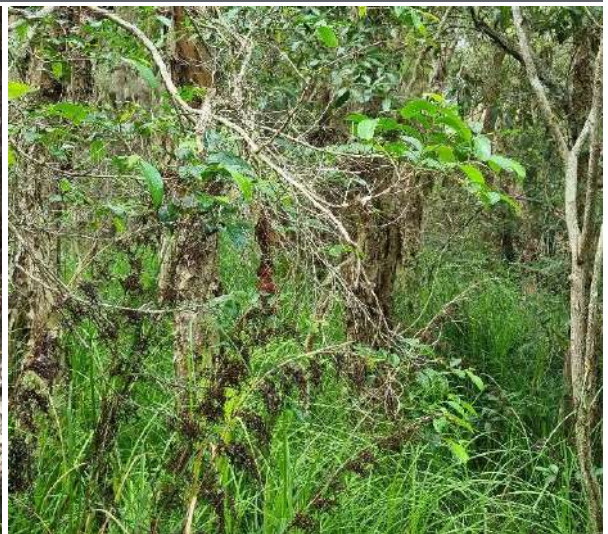
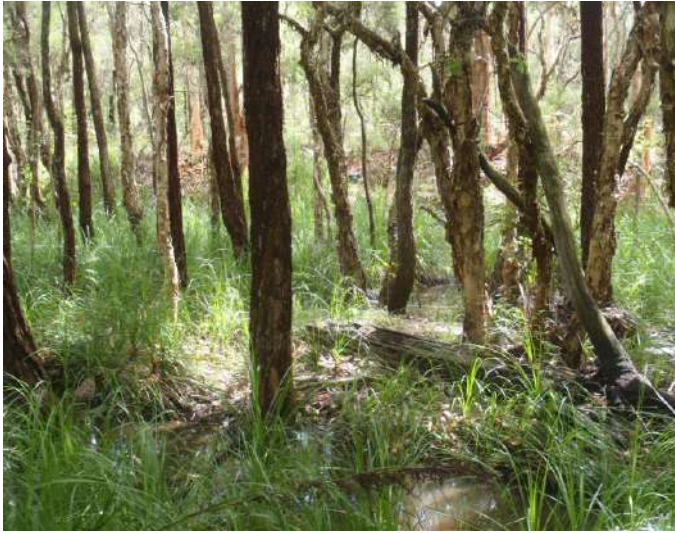
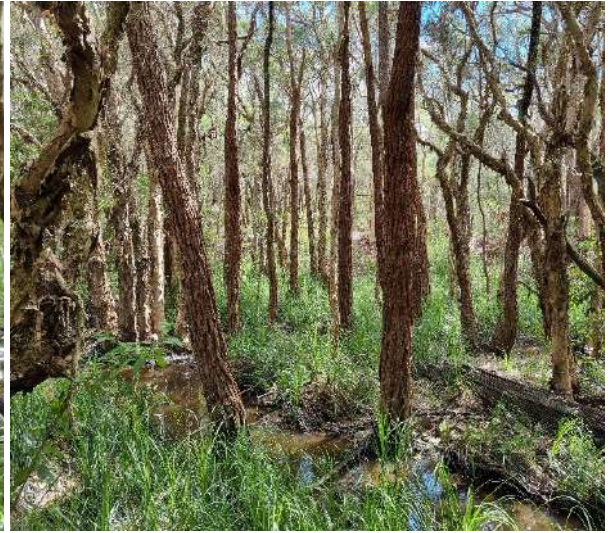
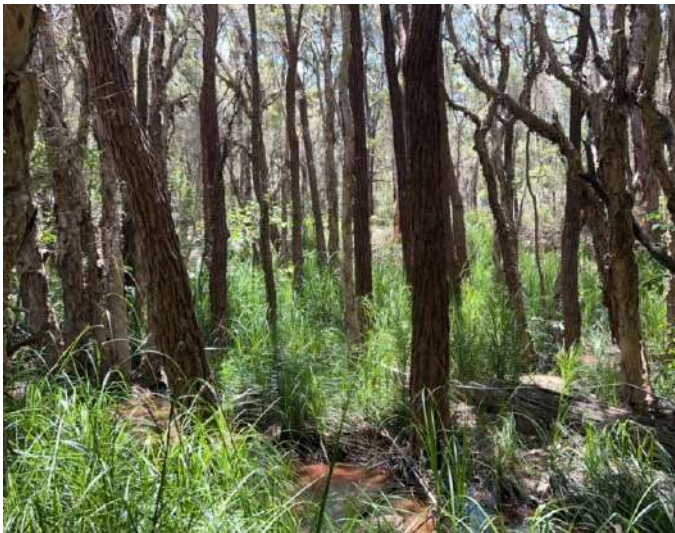
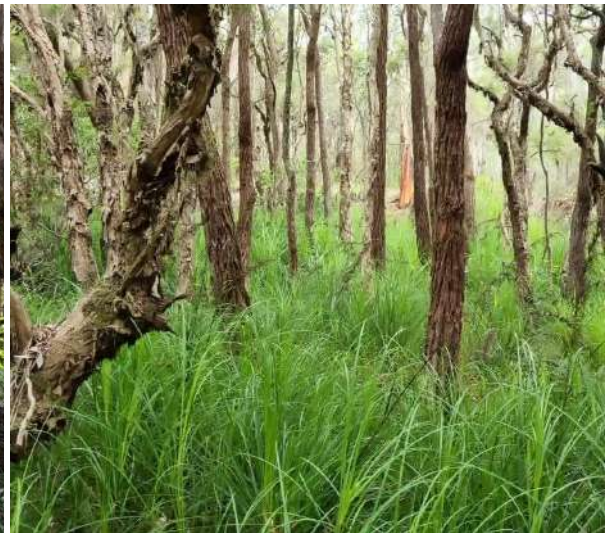
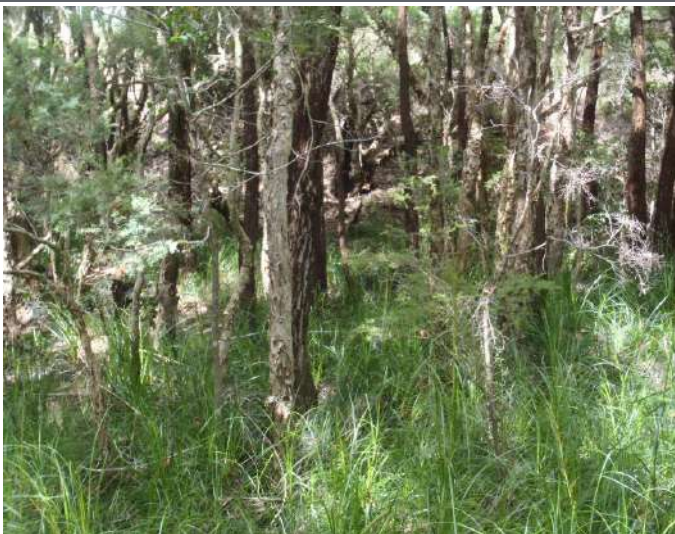
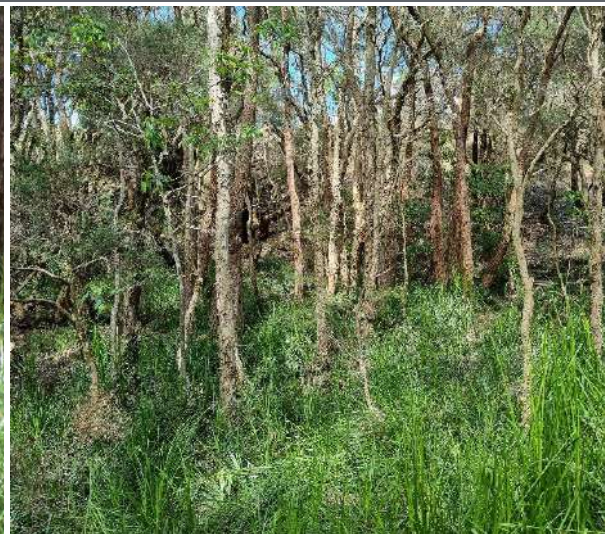
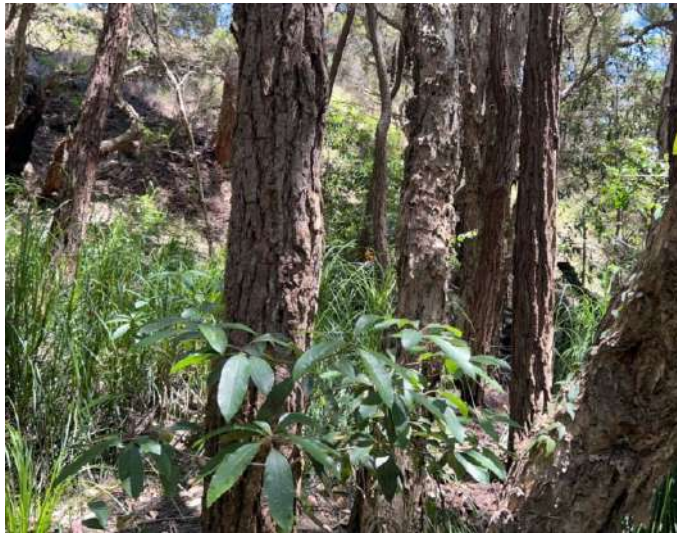
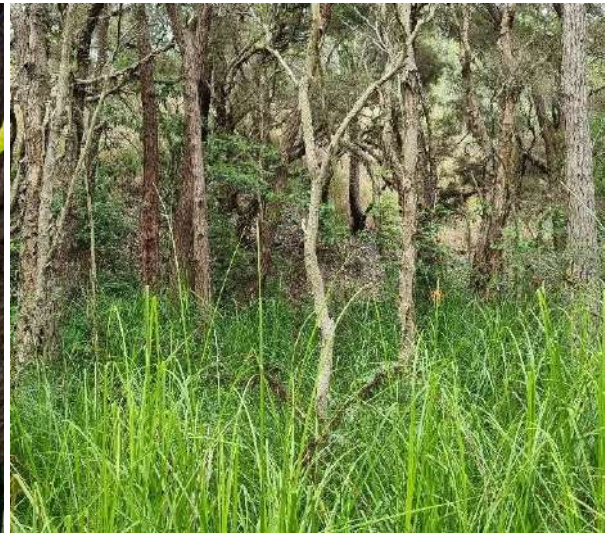
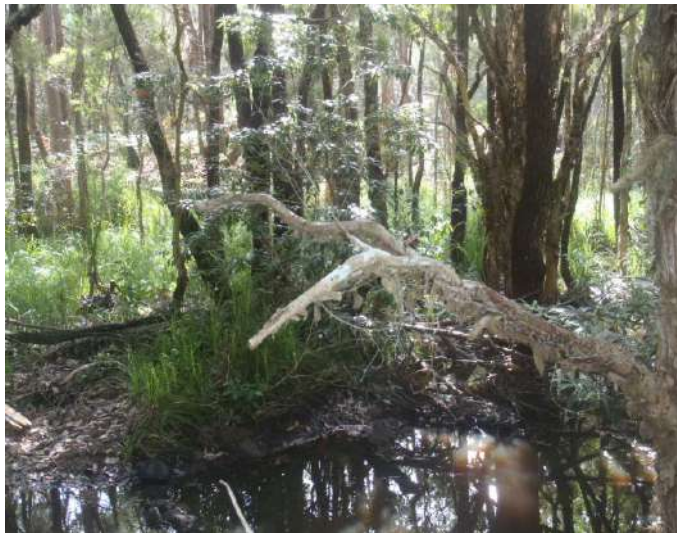
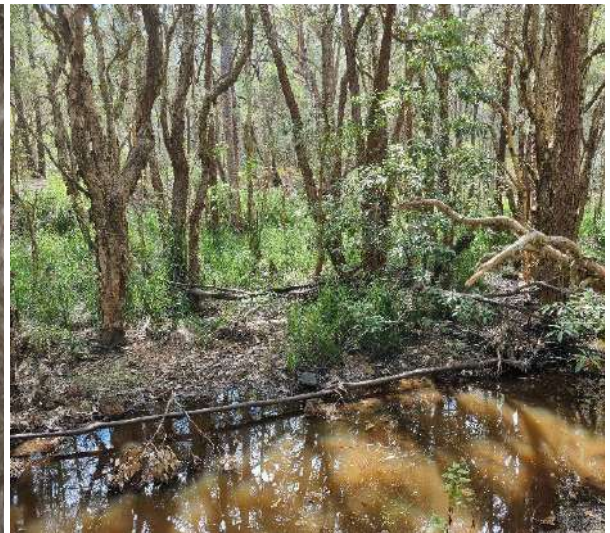
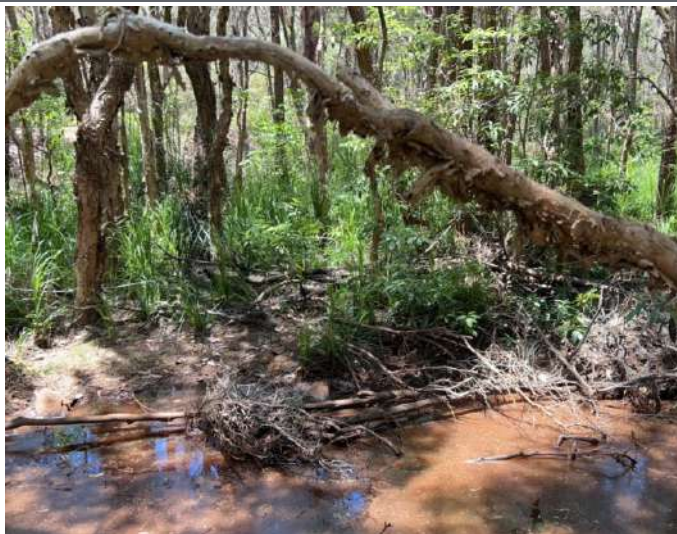
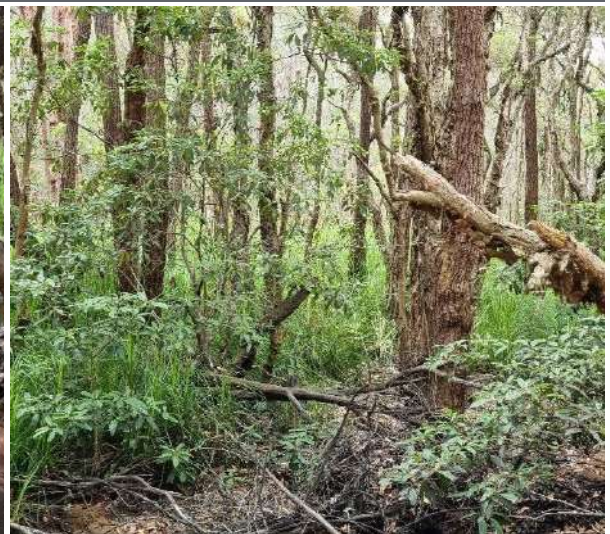
Table 7 Plot 1 – photo monitoring points

A comparison of images captured at the photo monitoring locations displays minimal variation in vegetation composition and structure, with any changes likely to be attributed to seasonal variations, or a change in camera positioning. Care will be taken in 2024 to ensure photos are lined up correctly.

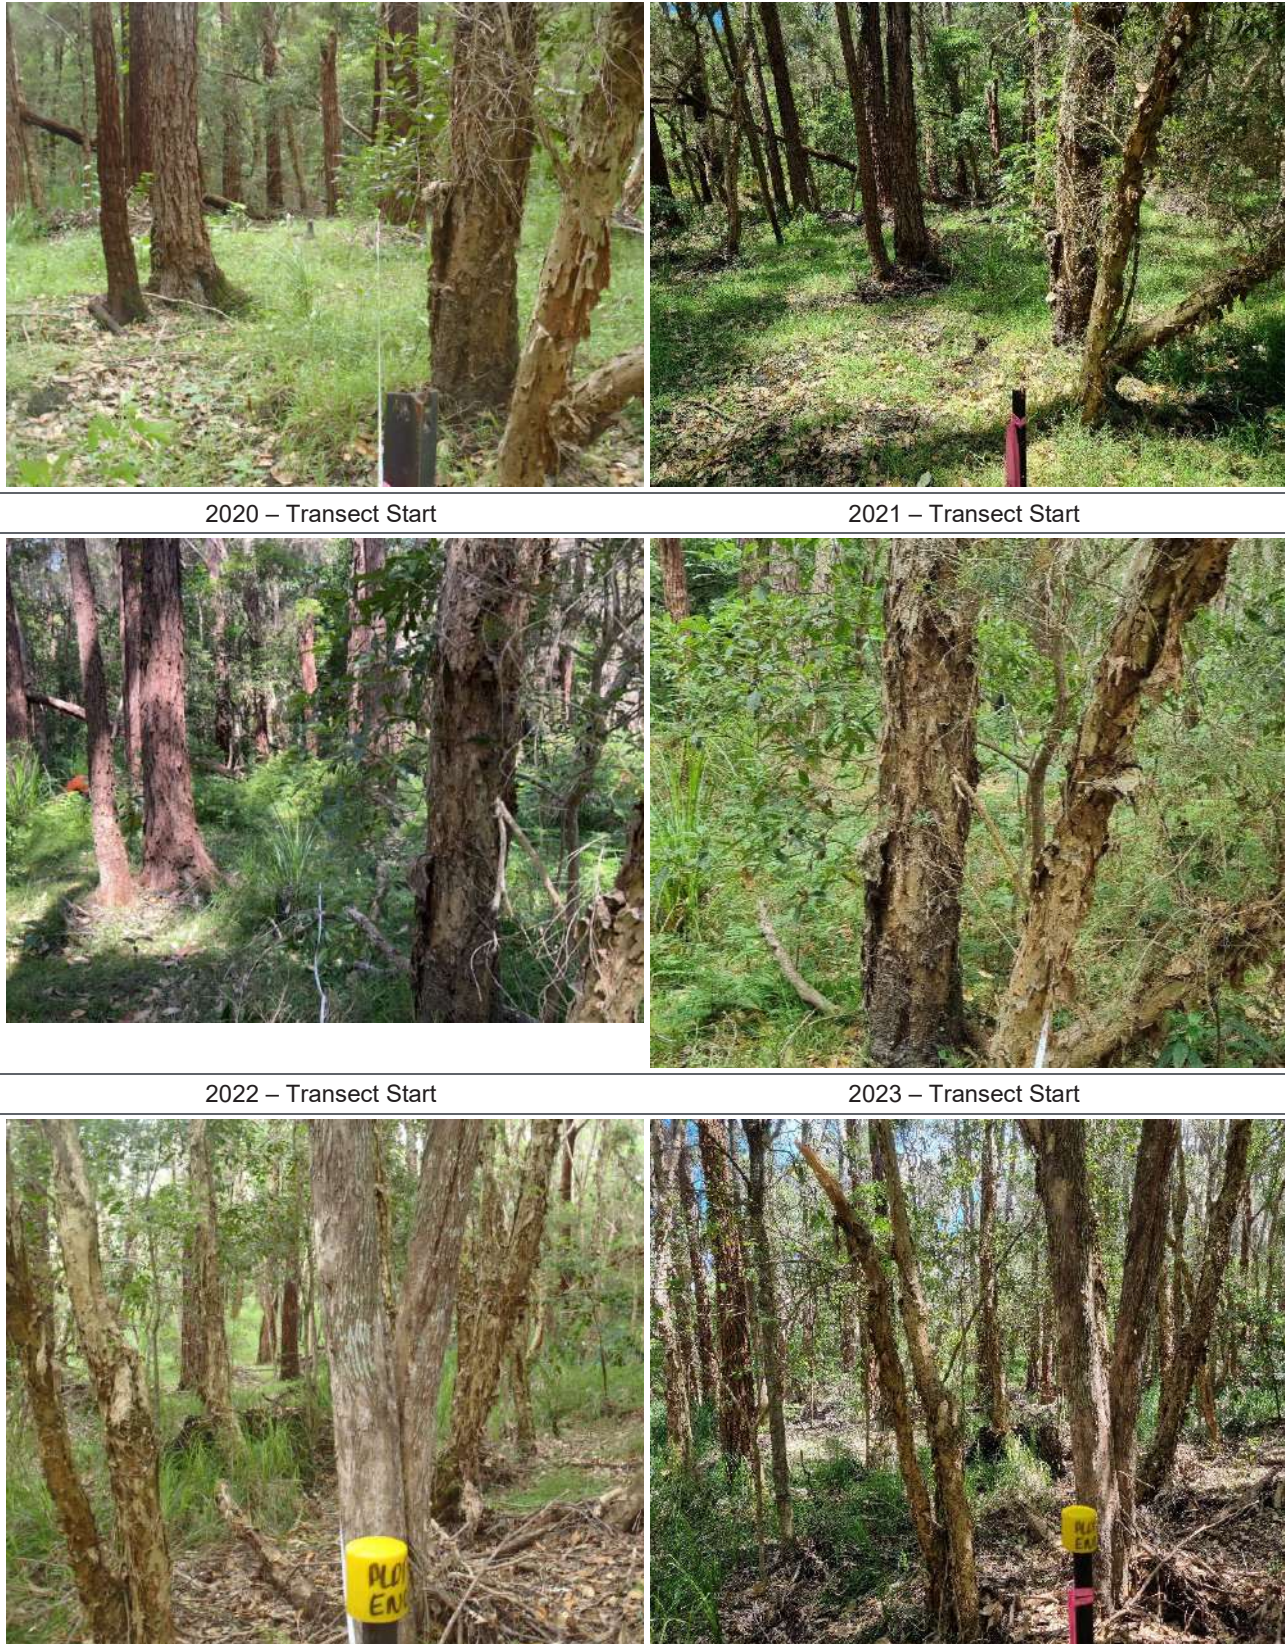
Table 13 Plot 3 – photo monitoring points

Photographs at specified monitoring points over the last 3 years are shown in **Table 13**.

A comparison of images captured at the photo monitoring locations displays minimal variation in vegetation composition and structure, with any changes likely to be attributed to seasonal variations.
