2023 Annual Review

Wilpinjong Coal Mine

This 2023 Annual Review (AR) (this Report) presents a summary of regulatory compliance, environmental performance and community engagement activities for the *Reporting Period* from 1 January 2023 to 31 December 2023.

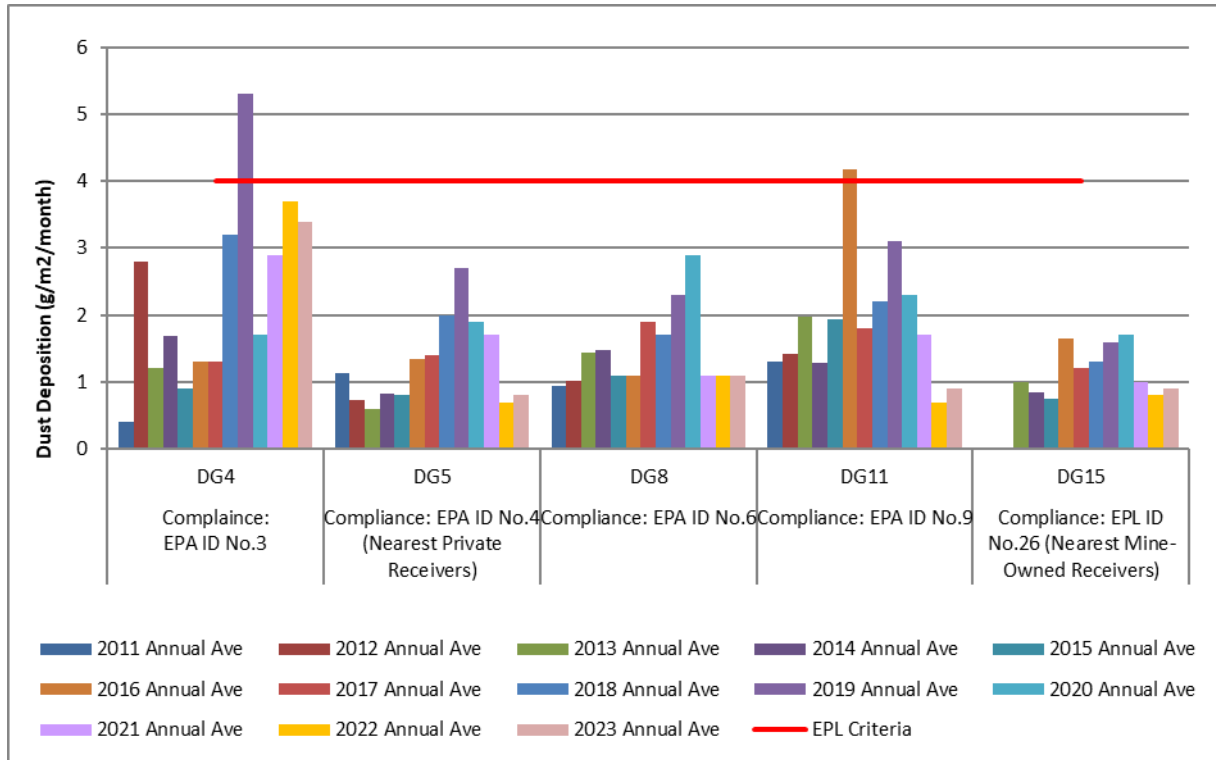
Figure 6-1 Compliance Annual Average Dust Deposition Results 2011 – 2023

Notes: Based on the positioning of the compliance monitors at WCM, it can be assumed that the DG8 monitor is sufficiently away from mining activity and is generally represented of background levels for the area. On this basis, the potential incremental contribution from WCM can be estimated as the level recorded at the compliance monitors minus the level at DG8.

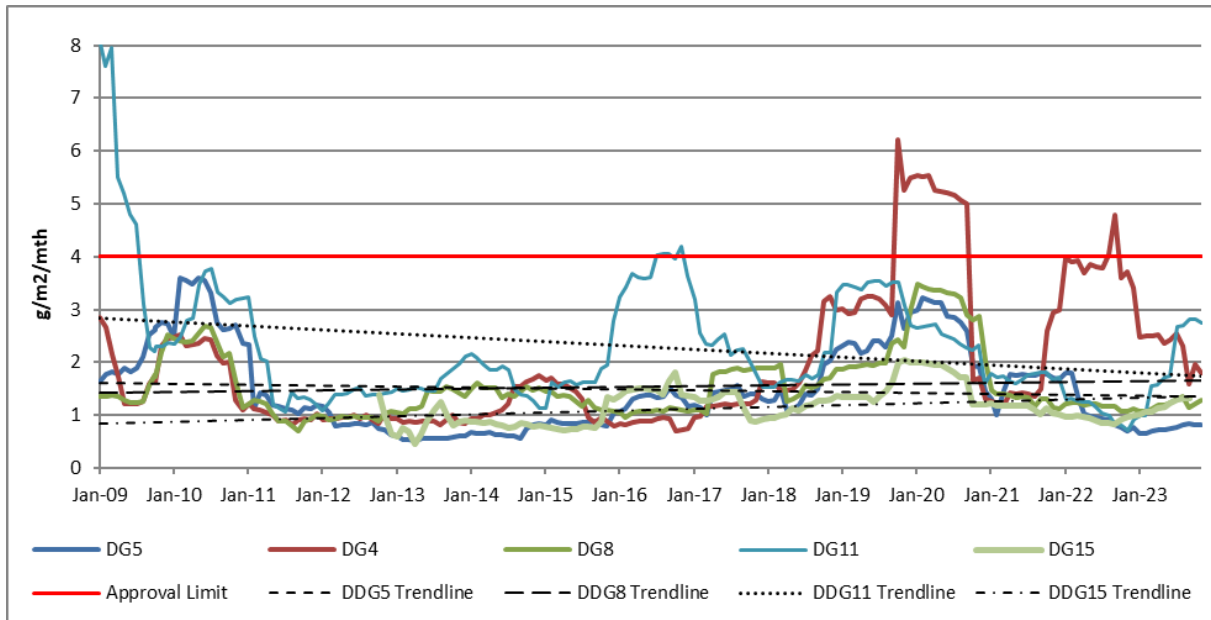
Figure 6-2 Compliance Dust Deposition Trends (Rolling Averages) 2009-2023

Notes: Drought conditions and extraordinary events impacted the background deposited dust levels in 2020. Currently, the nearest privately-owned residence to the DG4 monitor is located over 5km away and thus the DG4 monitor is no longer considered to be representative of dust levels at privately owned residences.

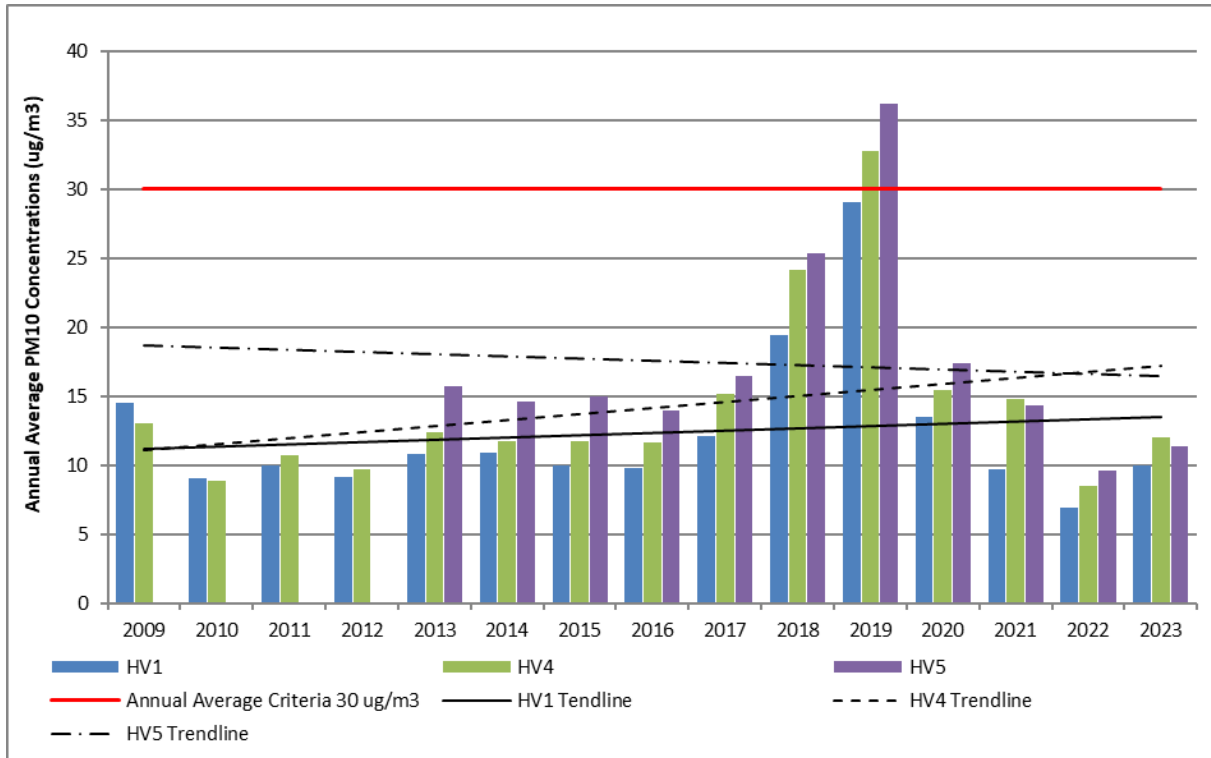
Figure 6-3 Compliance HVAS Annual Average PM₁₀ Results and Trends 2009 – 2023

Notes: Elevated results in 2019 were caused by regional extraordinary events as described the 2019 Annual Review.

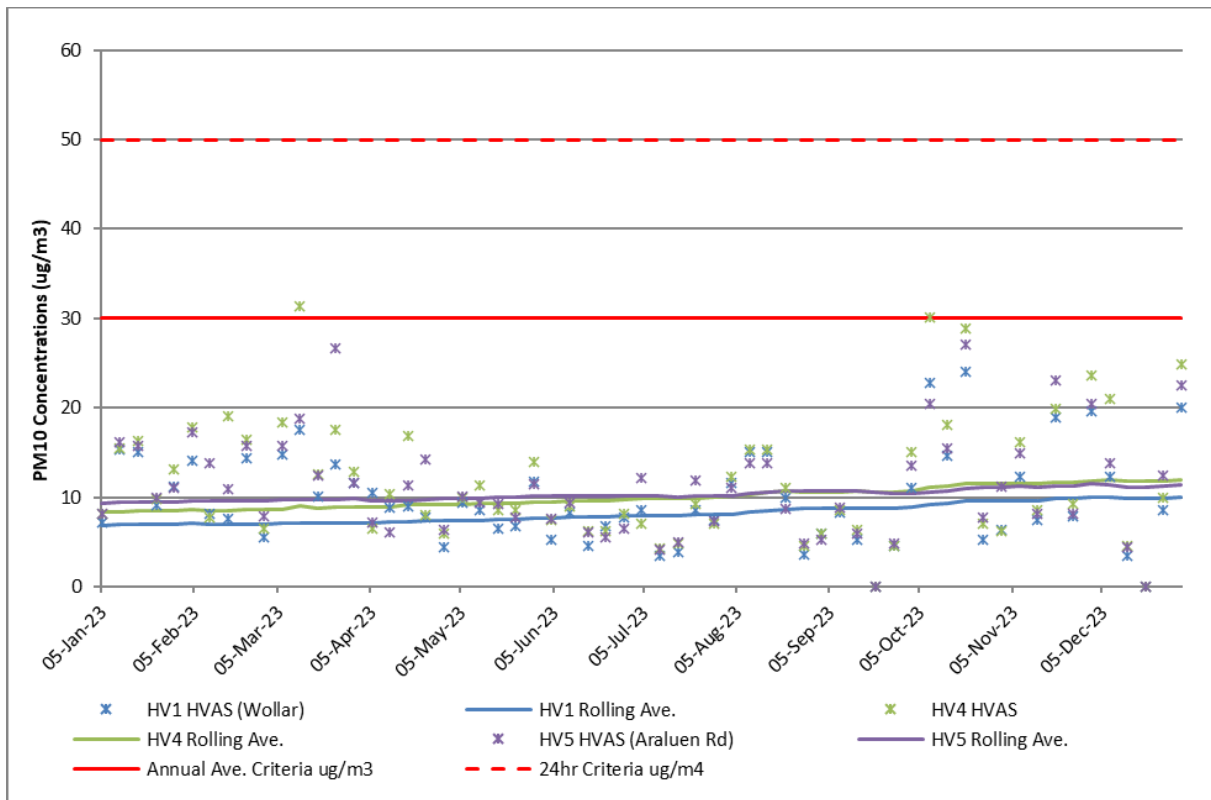
Figure 6-4 Compliance HVAS (Rolling Averages) Annual Average & 24hr 6-Day Cycle PM₁₀ Results 2023

Notes: The nearest private residence to the HV4 monitor is located over 5km away from the monitor, the private residency response protocol (which includes an investigation of elevated readings at monitors representative of privately owned residences) is not triggered when elevated levels are recorded at this location as such, it may be more appropriate use to use HV4 as a management monitor rather than compliance monitor.

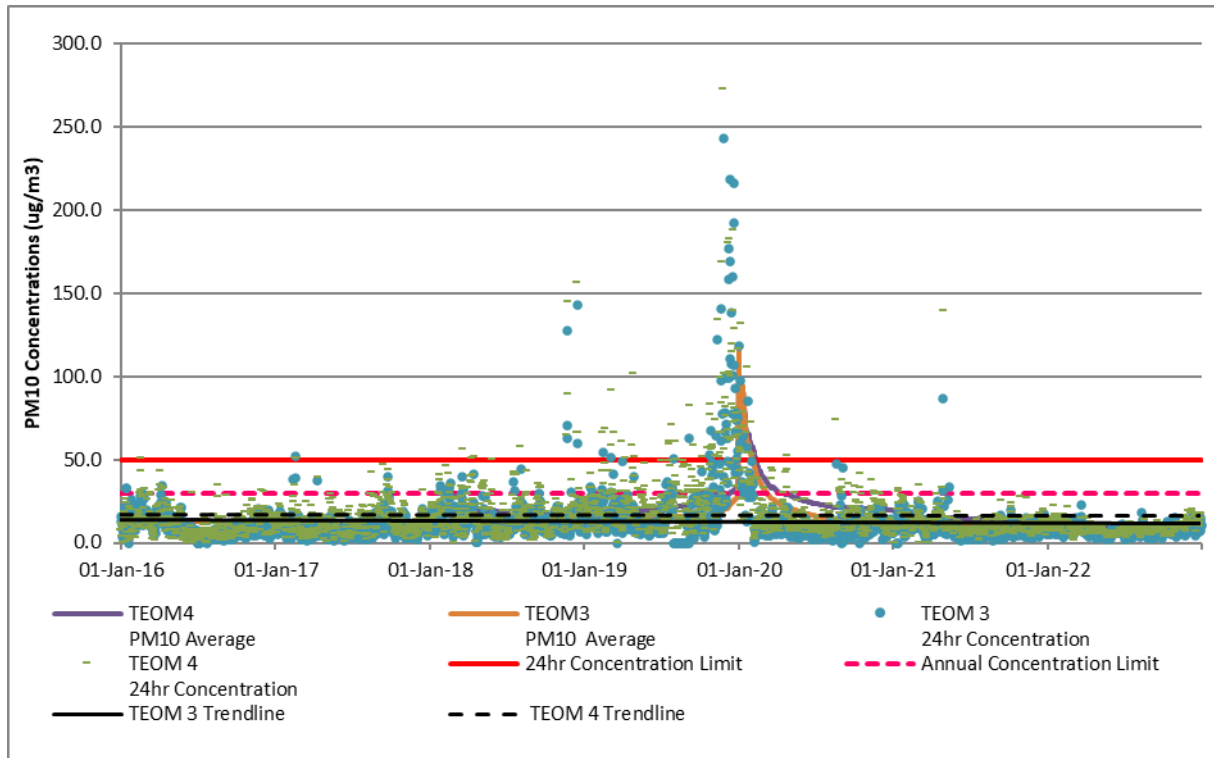
Figure 6-6 Compliance TEOM PM₁₀ 24hr Results and Trends (Rolling Averages) 2015-2023

Notes: The rolling annual average levels in generally show a trend of increasing levels, with the monitors all showing a sudden increase in levels at the end of 2019 associated with the 2019/2020 NSW bushfires and a sharp drop towards the end of 2020. It is noted that in 2021 there were two days considered to be “extraordinary events” for WCM, 28/04/2021 and 29/04/2021. These days were considered extraordinary events due to smoke associated with nearby hazard reduction burns.

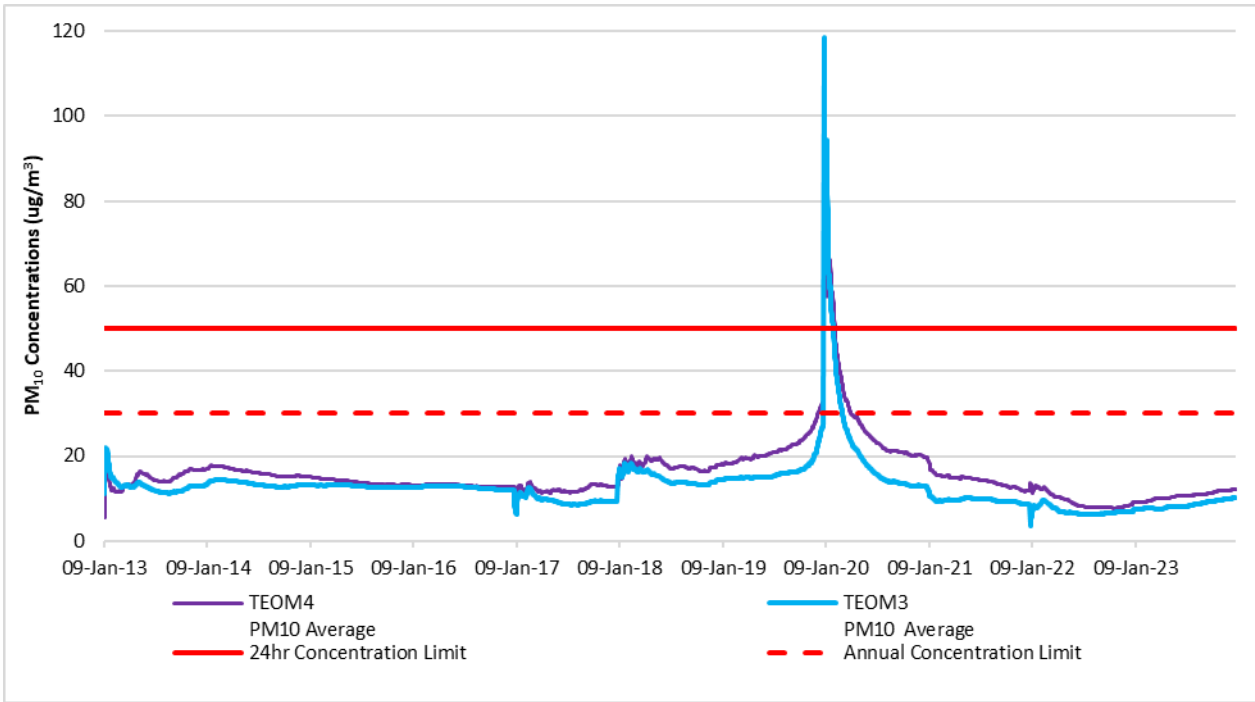
Figure 6-7 Compliance TEOM PM₁₀ (Rolling Averages) 2015-2023

Notes: The rolling annual average levels in generally show a trend of increasing levels, with the monitors all showing a sudden increase in levels at the end of 2019 associated with the 2019/2020 NSW bushfires and a sharp drop in 2020 coinciding with the return of above average rainfall.

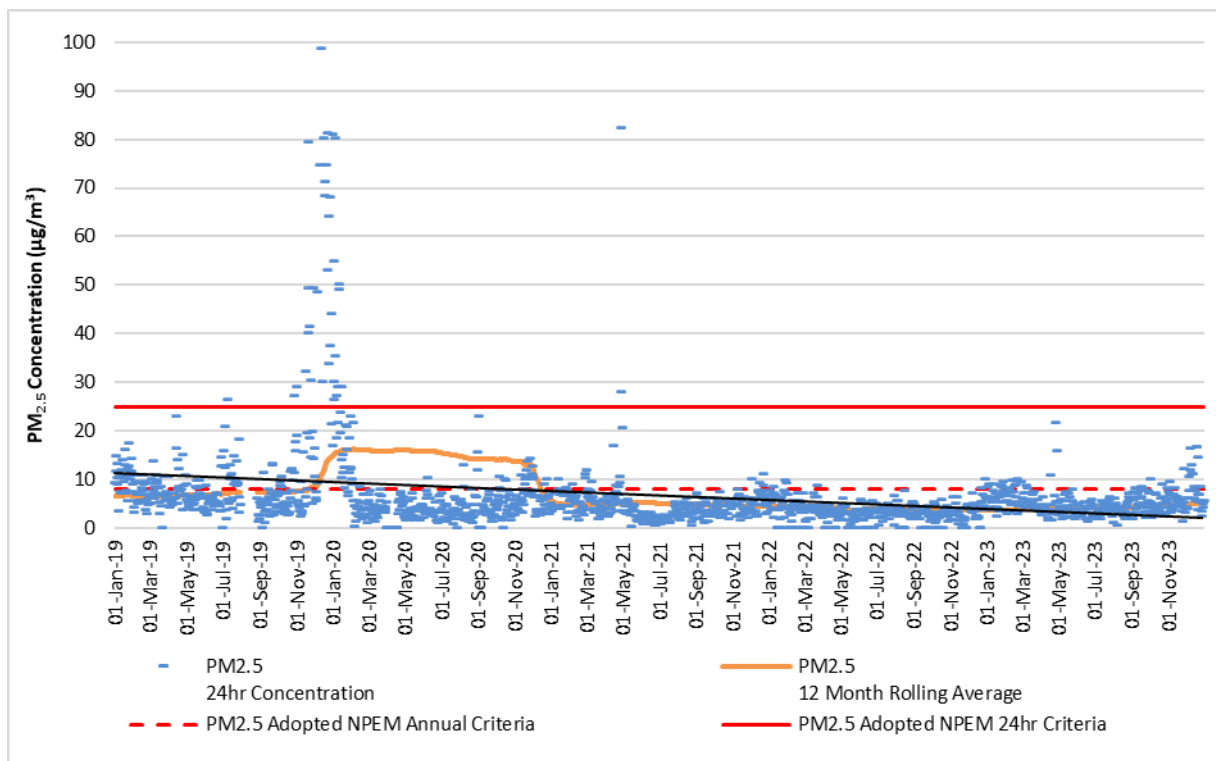
Graph 1 Compliance TEOM PM_{2.5} 24hr Results and Trends (Rolling Averages) 2018-2023

Notes: PM_{2.5} levels at the end of 2019 and start of 2020 are significantly elevated compared with the rest of the data. The levels were affected by bushfire smoke across NSW during the 2019/2020 bushfire season. It is noted that in 2021 there were two days considered to be “extraordinary events” for WCM, 28/04/2021 and 29/04/2021 due to smoke associated with nearby hazard reduction burns.

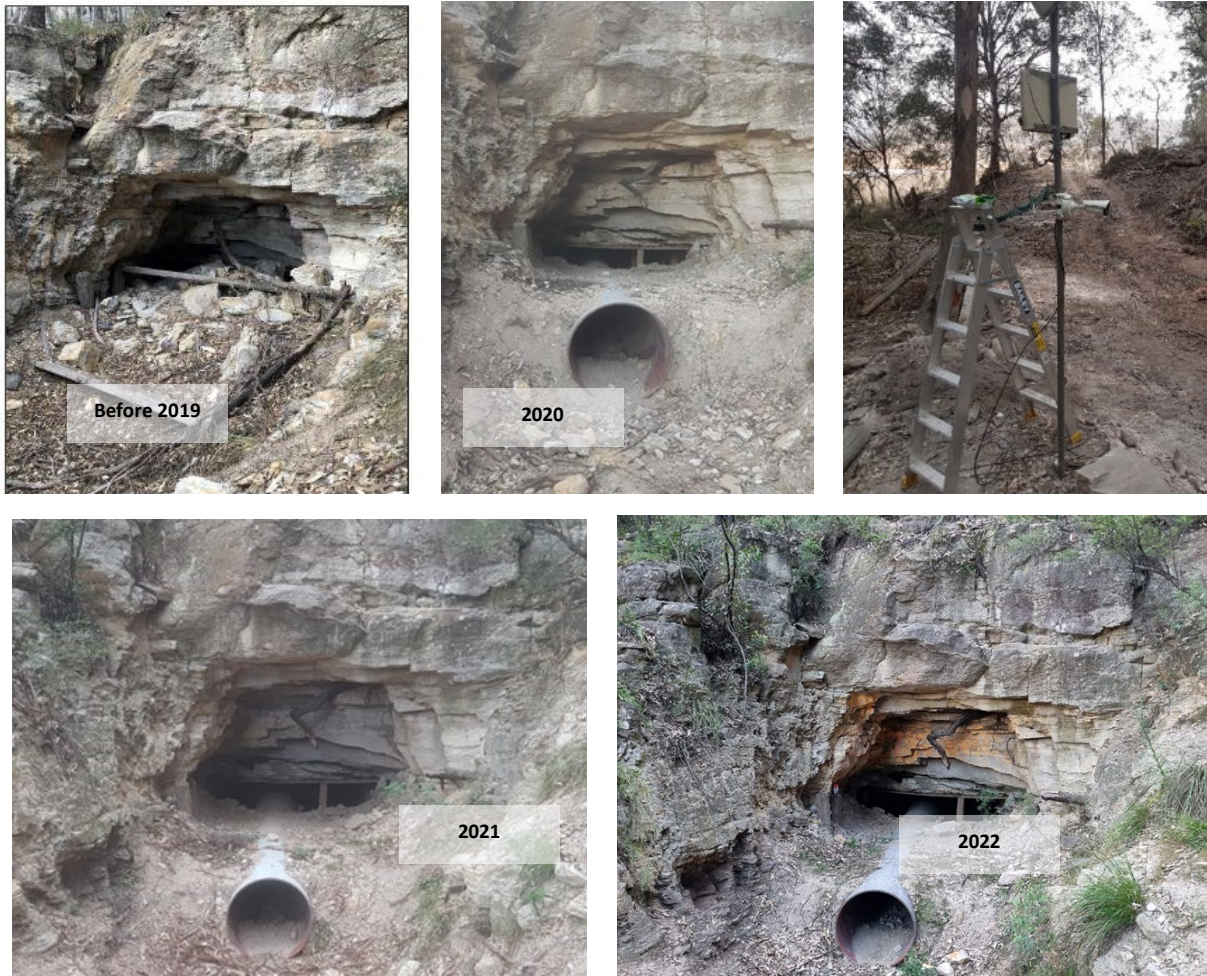
Photo 1 Culvert Support & Bat Detector with Solar Panel setup 20m in front of Adit

In accordance with the BMP, Eastern-Bentwing Bat Management Strategies were undertaken in 2019 with the installation of a section of 1000mm diameter steel pipe culvert inserted into the adit to ensure access/egress for microbat species. To mitigate the potential for future collapse, rock debris was removed from around the entrance. On further recommendations provided by WCPL's microbat specialist, further rock material was removed in 2020 from around the top of the pipe to maintain access for microbats through the existing adit entry (**Photo 1**). In 2023 upgrades to the bat adit culvert were undertaken (**Photo 2**). The much larger 1200mm wide new culvert was designed and installed in consultation with UCML's microbat specialists and is considered above the requirement for bats to maximise their ability to leave and return to the Adit, as this had previously been reached with the 1000mm (wide) culvert.

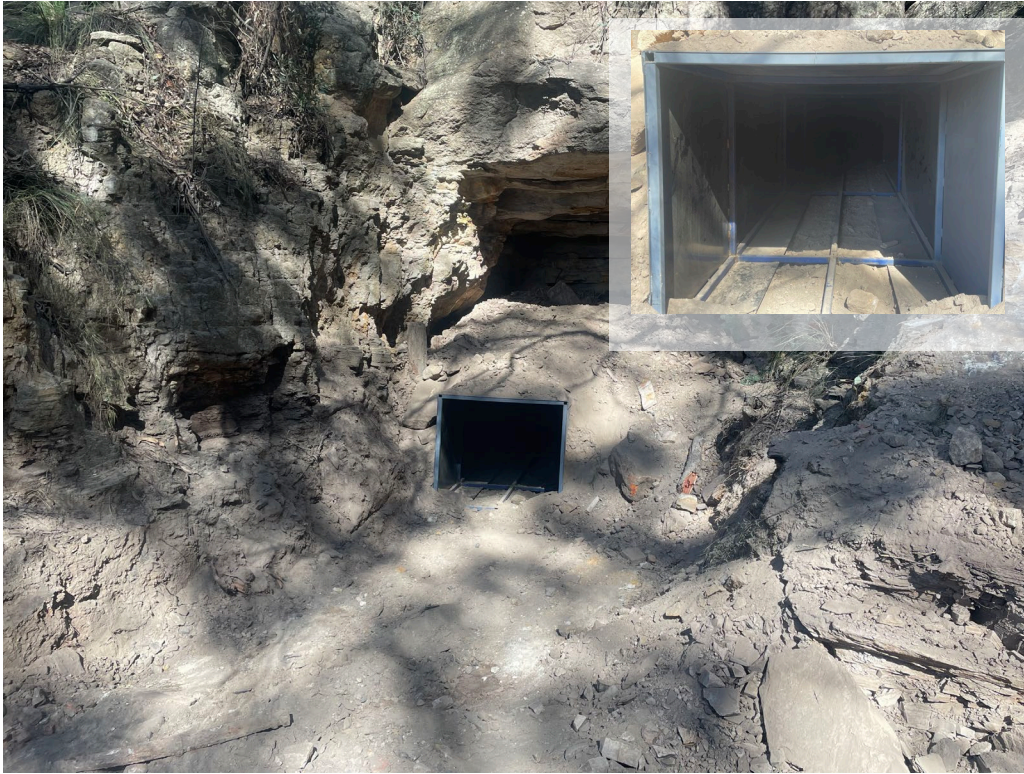
Photo 2 Upgrades to the Bat Adit Culvert in 2023

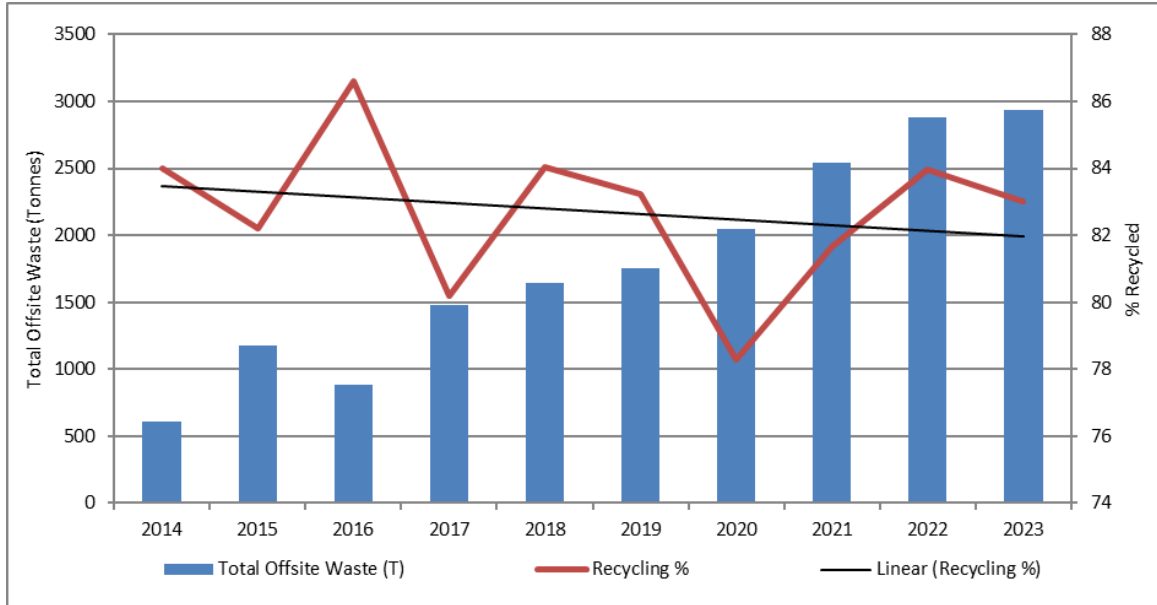
Figure 6-10 Waste Statistics and Trends

As required by Condition 58(f), Schedule 3 of SSD-6764, WCPL are required to report on waste management and minimisation (**Table 6-10 & Figure 6-10**) in the 2023 Annual Review. During the reporting period approximately 83% of the total waste removed from the Mine was recycled.

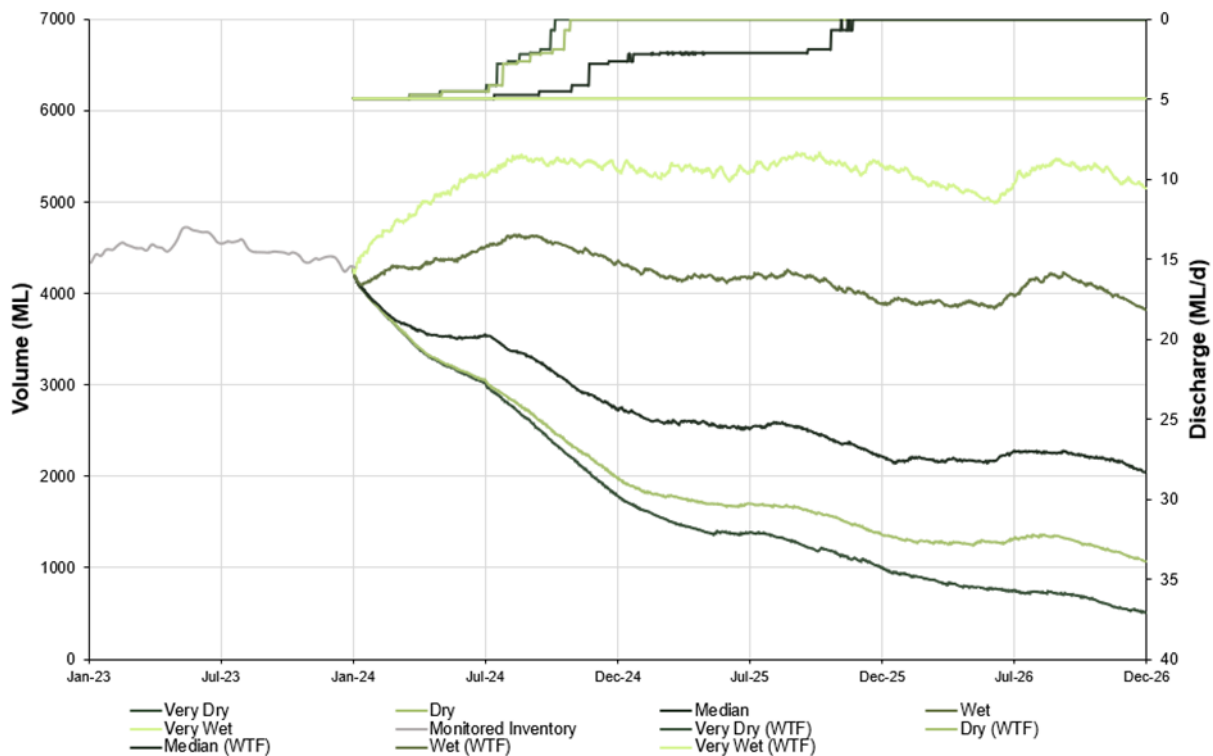
Figure 7-12 Forecast Water Inventory 2024-2026

Model simulated volumes have been forecast for the period 1 January 2024 to 31 December 2026. Results have been plotted for the combined water inventory in the WMS (comprising Pit 2W, Pit 1S, RWD, CWD, Pit 5N, Pit 4 and Pit 3). **Figure 7-12** shows the forecasted total site inventory and associated WTF discharge for the period 1 January 2024 to 31 December 2026 through varying climatic conditions (SLR 2024).

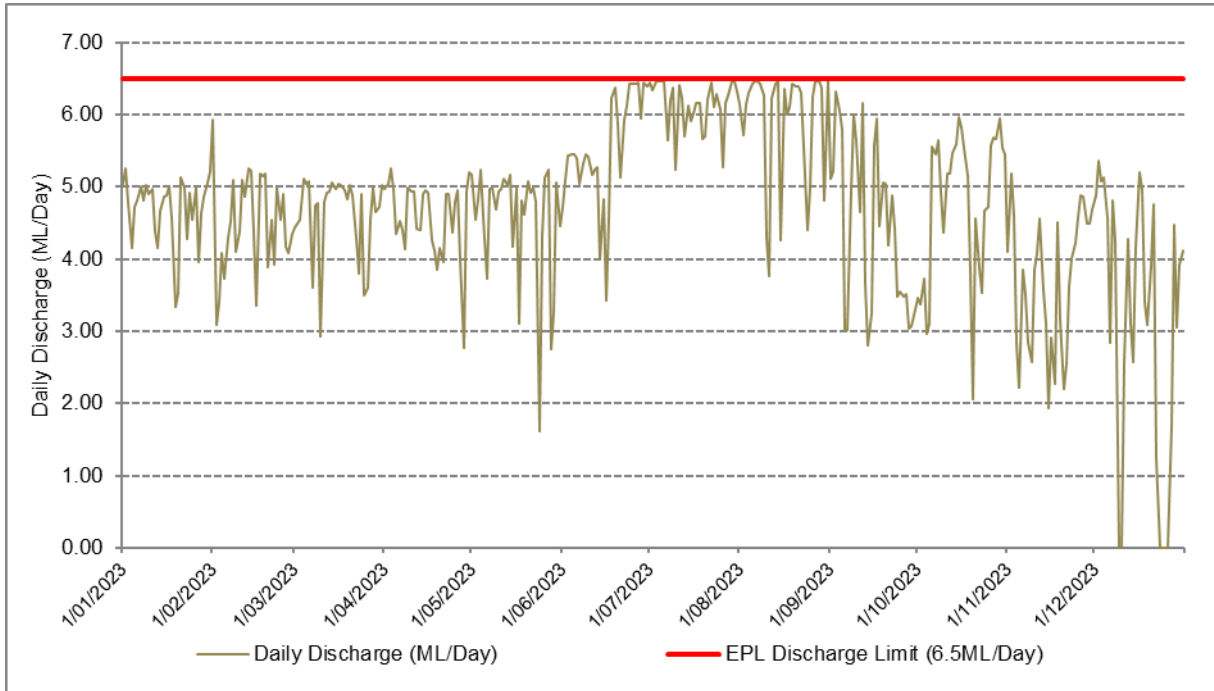
Figure 7-13 RO Daily Discharge Volumes

During 2023 WCPL complied with EPL water quality and quantity limits for LDP Point 24 (**Figure 7-13** and **Figure 7-16**).

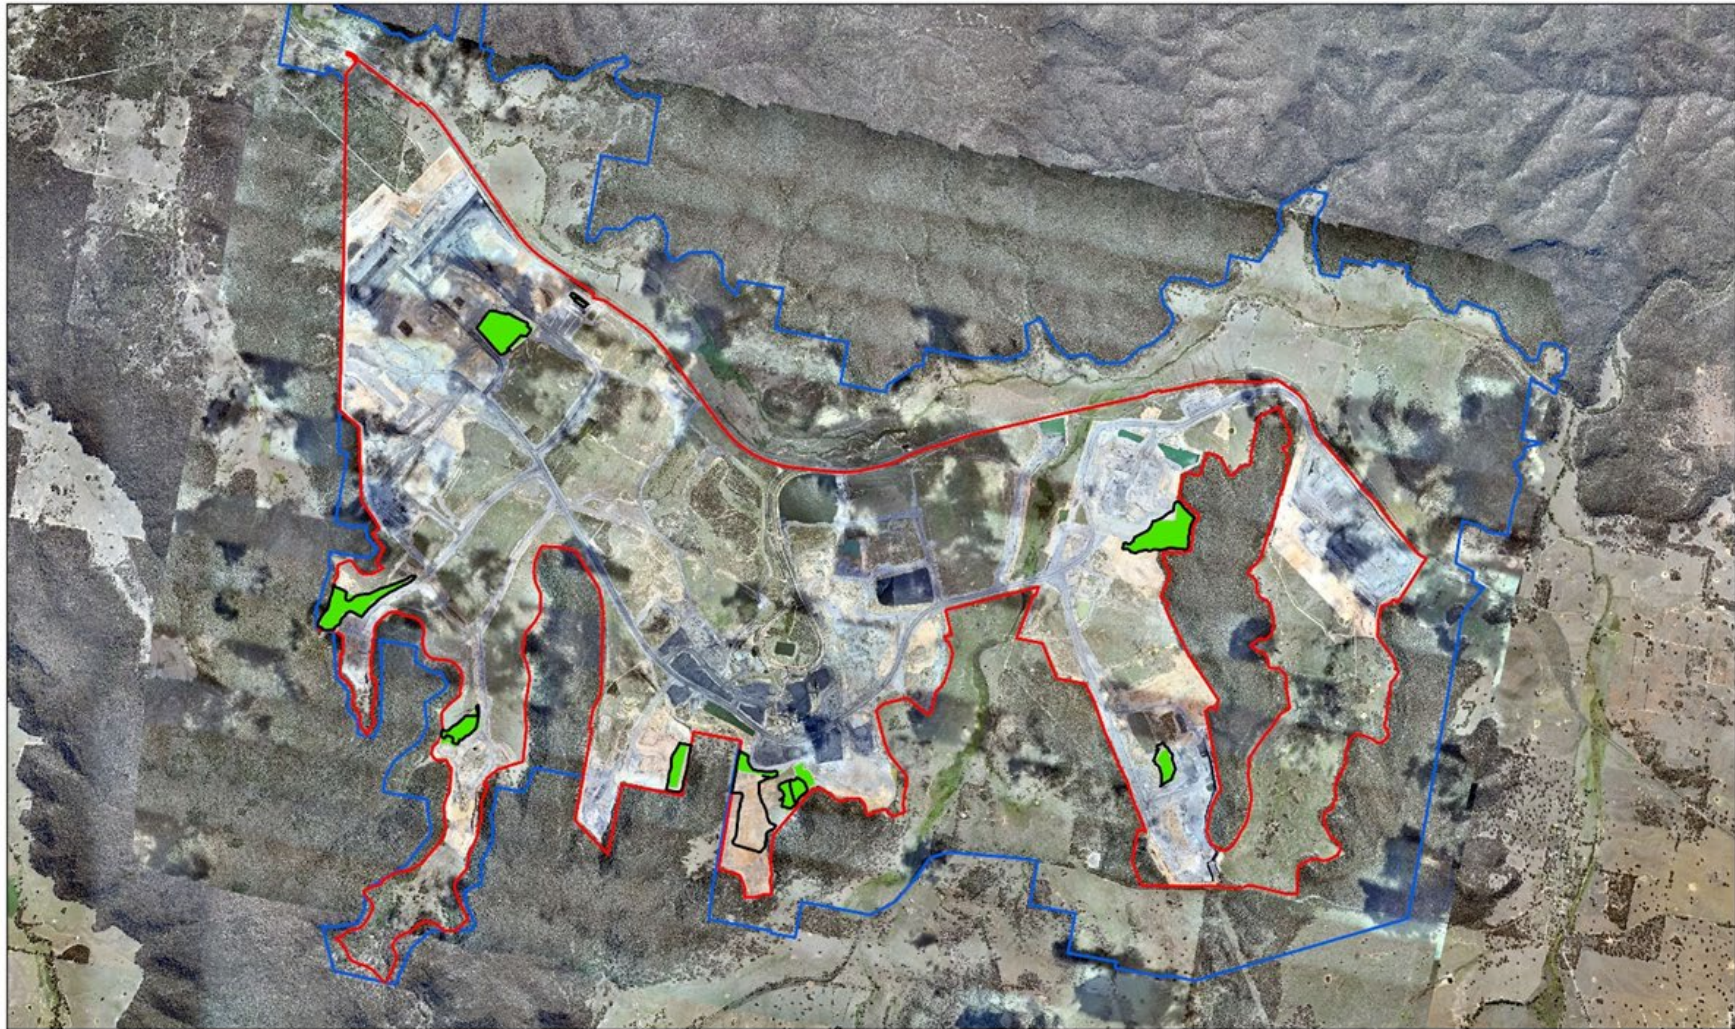
Figure 8-1 Rehabilitation Forecast Vs Actual 2023

<p>Legend</p> <ul style="list-style-type: none"> 2023 RMP Ecosystem and Land Use Establishment Areas (59.32Ha) 2023 Claimed Ecosystem and Land Use Establishment Areas (73.99Ha) SSD-6764 Disturbance Boundary SSD6764 Project Approval Boundary <p>0.85 0.42 0 0.85 1.7 2.55 3.4 Kilometers</p>		<p>Wilpinjong Coal 2023 Rehabilitation Domains</p> <table border="1"> <tr> <td data-bbox="1131 1300 1332 1385">SpatialReference Name:GDA1994MGAZone65</td> <td data-bbox="1332 1300 1433 1385">Review ID: 1</td> <td data-bbox="1433 1300 1534 1385">DateExported: 12/02/2024 12:52PM</td> <td data-bbox="1534 1300 1612 1385">Drawn By: JH</td> <td data-bbox="1612 1300 1724 1385">Drawing No. KB_DWH-30</td> </tr> </table>	SpatialReference Name:GDA1994MGAZone65	Review ID: 1	DateExported: 12/02/2024 12:52PM	Drawn By: JH	Drawing No. KB_DWH-30	<p><small>Peabody makes every effort to ensure the quality of the information available on this map. Before relying on the information on this map, users should carefully evaluate its accuracy, currency, completeness and relevance for their purposes, and consult with any appropriate professional advisor relevant to their particular use. Peabody cannot guarantee and assumes no responsibility for the accuracy, currency or completeness of the information and for using this map you accept the Peabody has no liability for any loss or damage in any form whatsoever caused directly or indirectly by the use of this map.</small></p>
SpatialReference Name:GDA1994MGAZone65	Review ID: 1	DateExported: 12/02/2024 12:52PM	Drawn By: JH	Drawing No. KB_DWH-30

The predictive versus actual cumulative and rehabilitation progression for Year 1 (i.e. Plan 2A) as presented in the current ARRFP completed during the Reporting Period is provided in **Table 8-1** and **Figure 8-1**.

During 2023, a combination of approximately 66ha within the Mining Domain of overburden emplacement areas were completed in preparation for topsoil placement, ripping and seeding (**Figure 8-1**).

During 2023, a combination of approximately 74ha within the Mining Domain of overburden emplacement areas were topsoiled and ameliorated (**Figure 8-1**).

Areas rehabilitated in 2023 were directly seeded with specific native seed species aligning to particular BVTs (**Figure 8-1**). These BVT mixes did include a small ratio of cover crops (cereals) to provide quick germination, soil stability and structure. Of the 74ha rehabilitated in 2023, a total of 2 BVT's were established onsite with specific BVT seed mixes, these included;

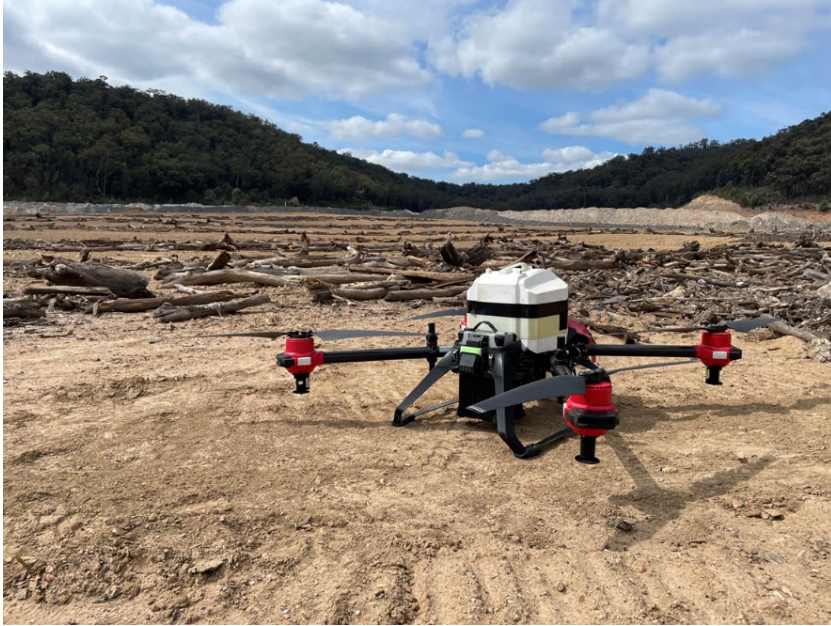
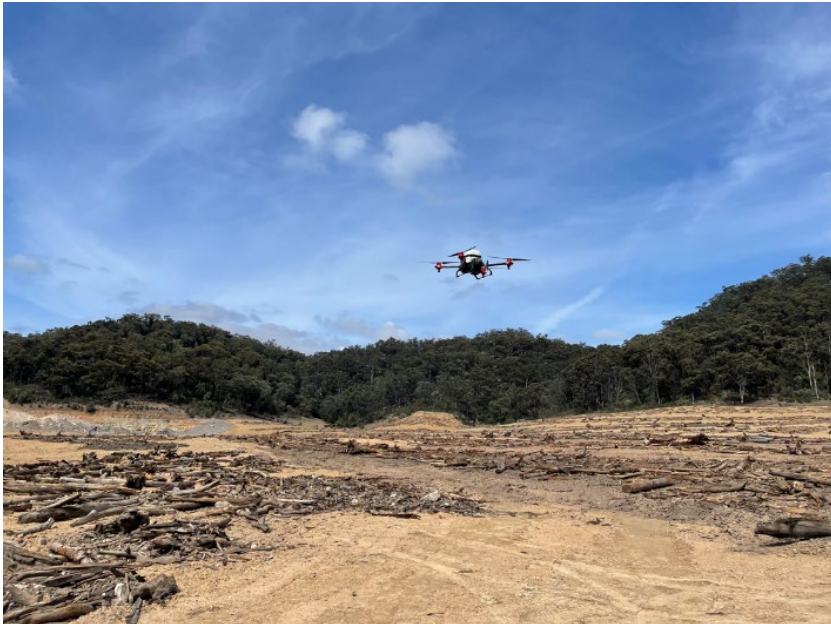
Photo 3 XAG P30 Drone Seeding Trial

Native grass seed is notorious for its inability to flow through a spreader or auger. For this reason, the seed was pre-coated to form a harder shell, and cracked lupins were mixed through the seed to increase the overall flowability. This application is part of a trial which investigates the value of utilizing drones for seeding and maintenance on rehabilitation slopes and areas deemed a risk for wheeled equipment to access.
