CENTENNIAL COAL Clarence Colliery 2024 ANNUAL REVIEW

March 2025

Annual Review Title Block

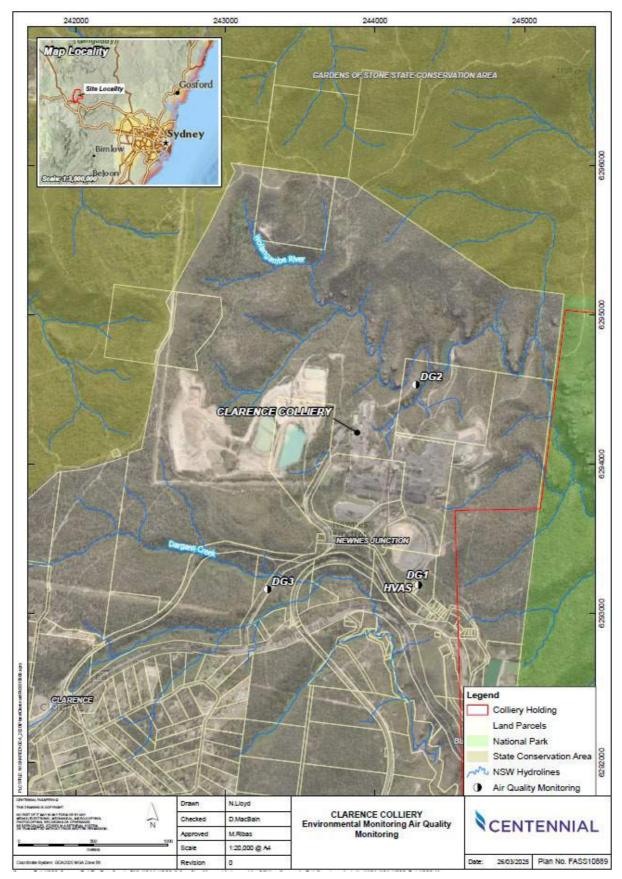
Figure 6-7: Clarence Colliery Air Quality Monitoring Locations

The Air Quality Monitoring Locations at Clarence Colliery are displayed in **Figure 6-7** and outlined in **Table 6-4**.

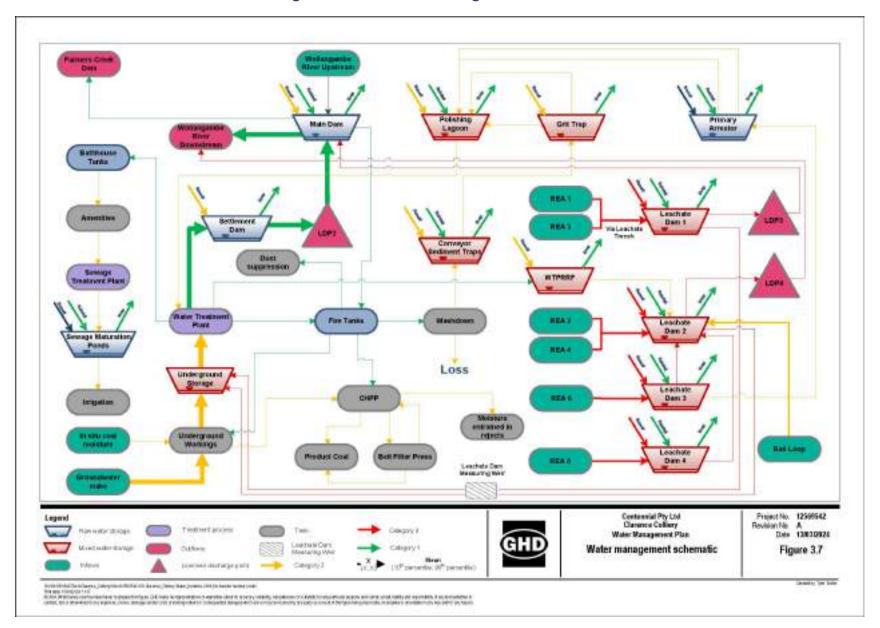
Figure 7-1: Site Water Management Schematic

Clarence Colliery 2024 Water Balance	Volume (ML)					
Water Sources (Inflows)						
Direct rainfall onto storages	10					
Catchment runoff	74					
Groundwater inflows into underground workings	5,706					
In-situ coal moisture	44					
Transfers from Main Dam	280					
Total Inputs (rounded)	6,114					
Water Loss (Outflows)						
Evaporation from storages	12					
Discharge through LDP002	6,988					
Discharge through LDP003	19					
Discharge through LDP004	2					
Irrigation	14					
Dust suppression losses	172					
Wash down losses	47					
Coal product	123					
Moisture entrained in reject material	16					
Total Outputs (rounded)	7,393					
Change in Storage						
Total Change in Storages	-1039					
Water Balance						
Change in water inventory (inputs – outputs – change in storage)	0

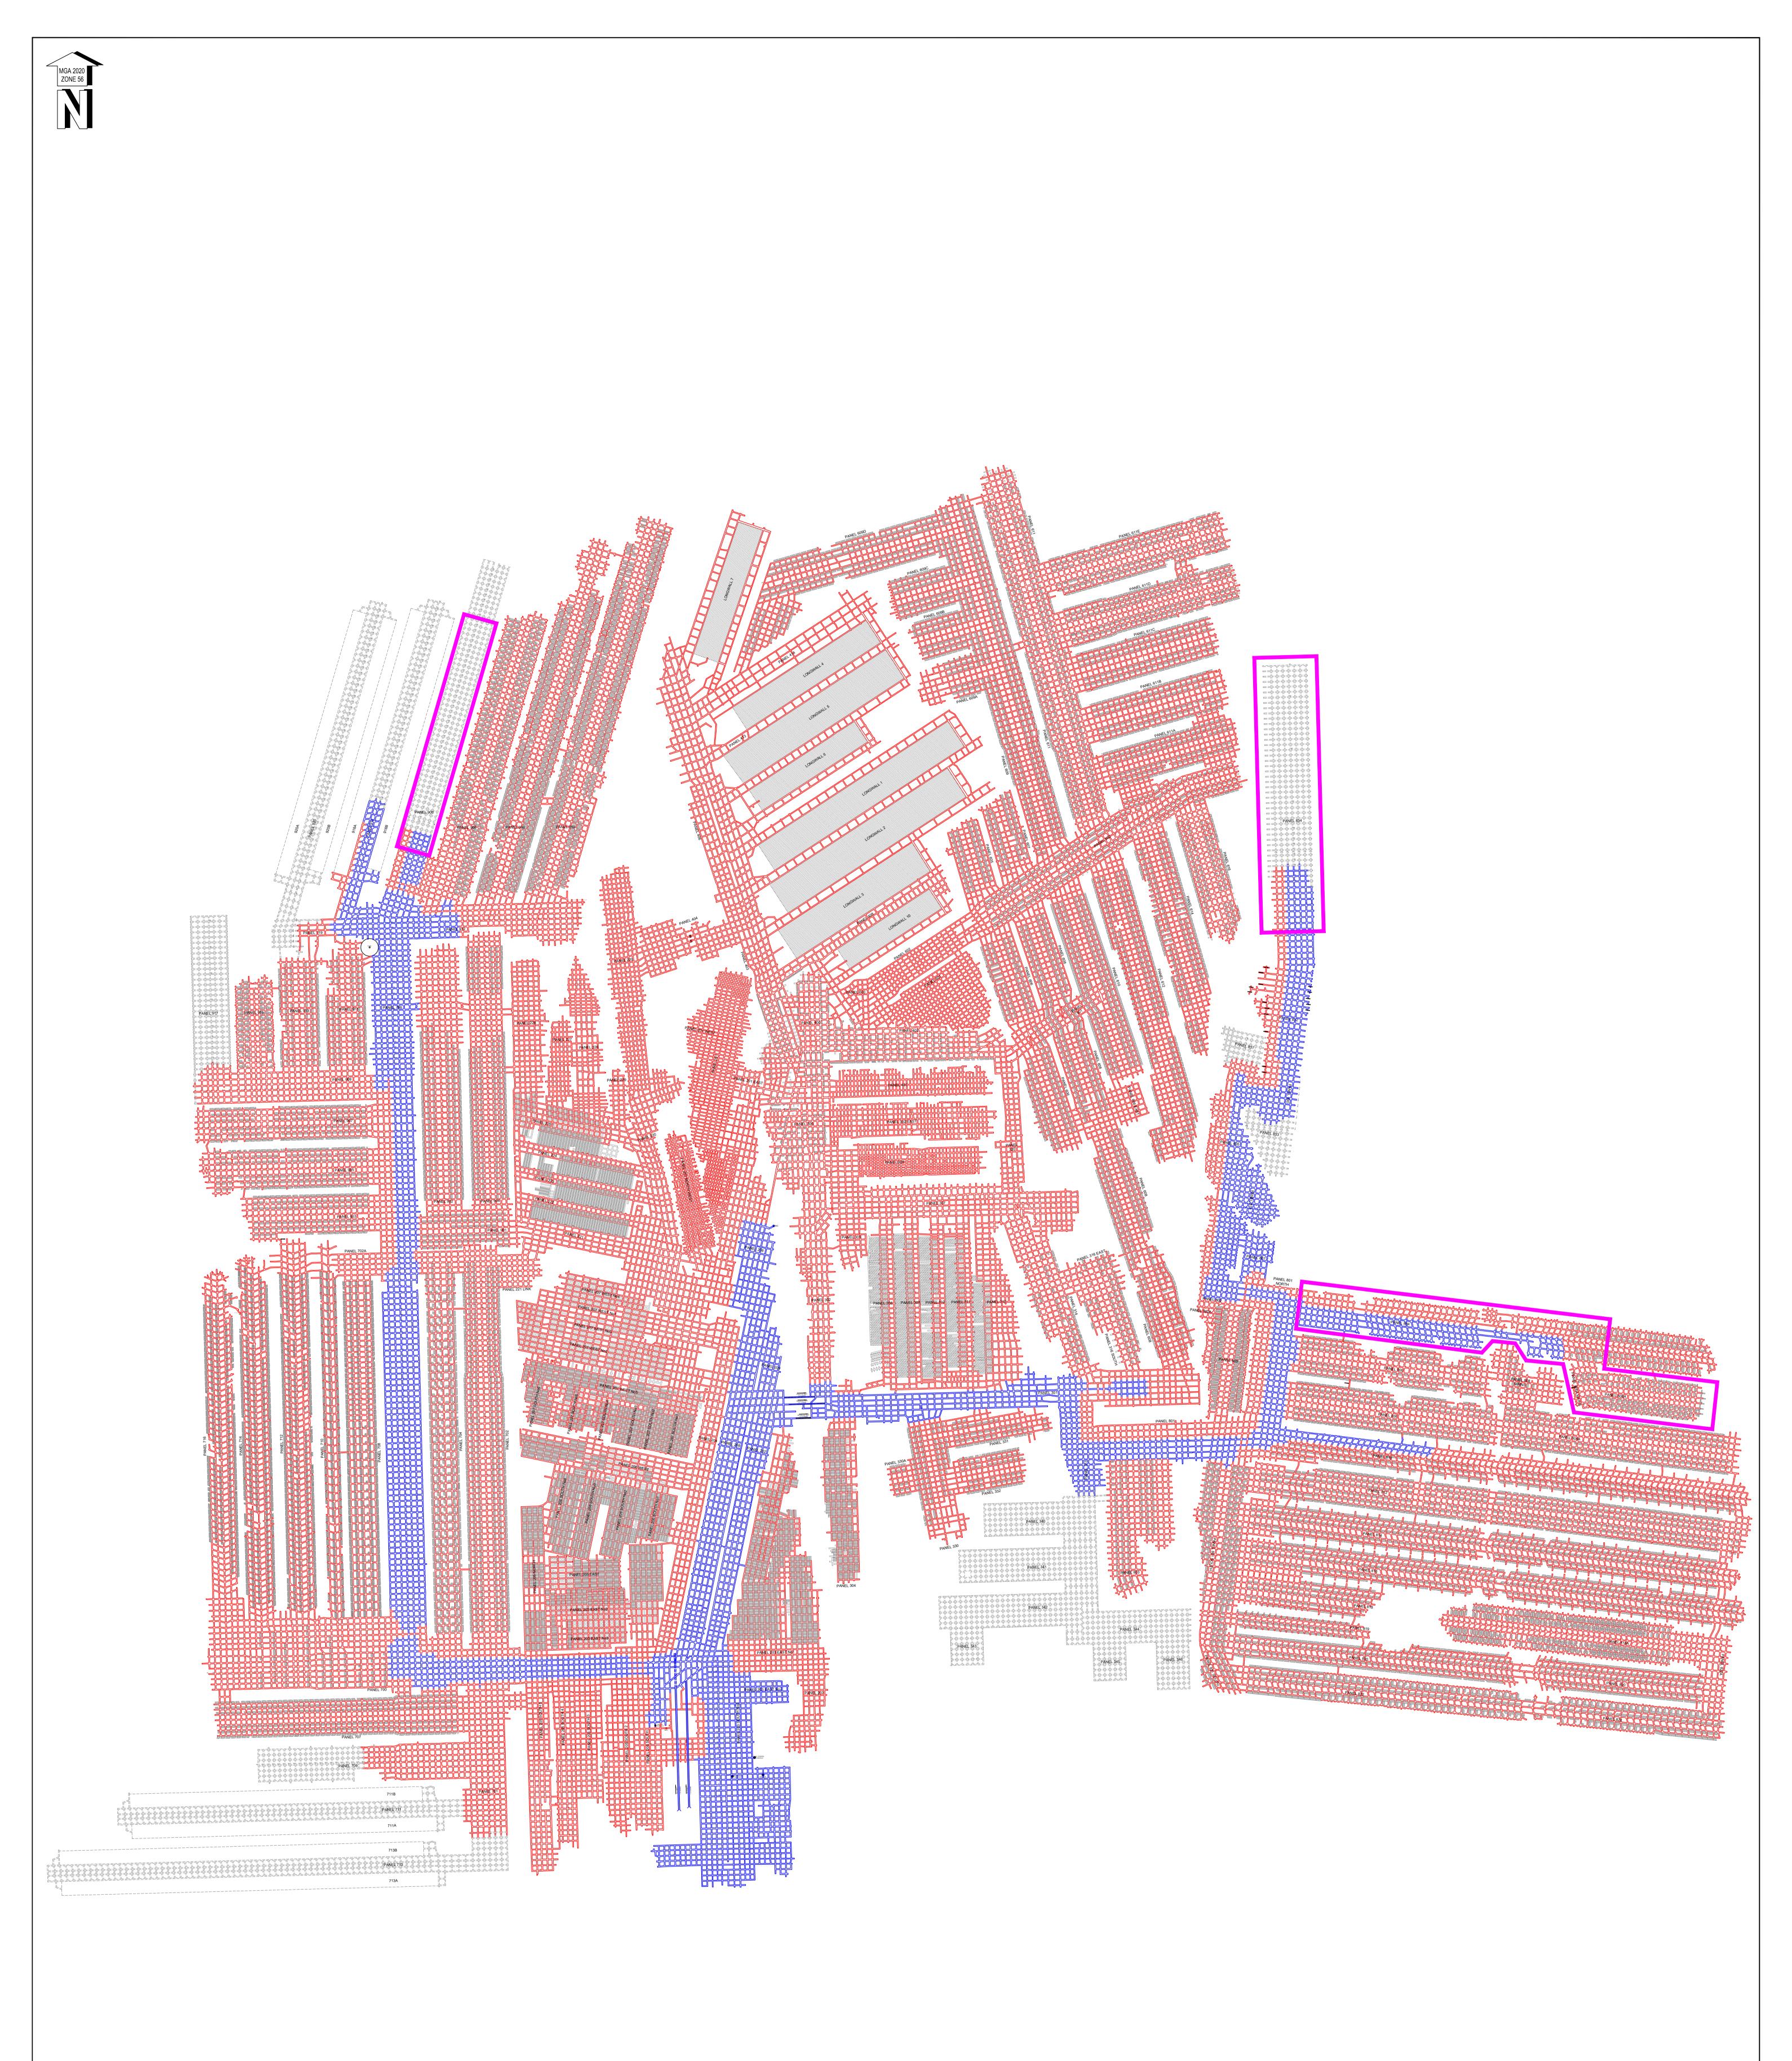
Plan 2: Forecast Mining Activities for 2025

Any queries on the workings - refer to the survey department at Clarence Colliery					
LEGEND First Workings First Workings Proposed 2025 Intake Proposed Production First Workings Second Production Returns Workings Workings	CLARENCE COLLIERY PROPOSED 2025 PRODUCTION	DATE 31/03/2025 SCALE NOT TO SCALE DRG. No. CL2282 REFERENCE N:\Plans\Surface\Enviro	CENTENNIAL CLARENCE THIS DRAWING IS THE PROPERTY OF CLARENCE COLLIERY PTY. LTD.

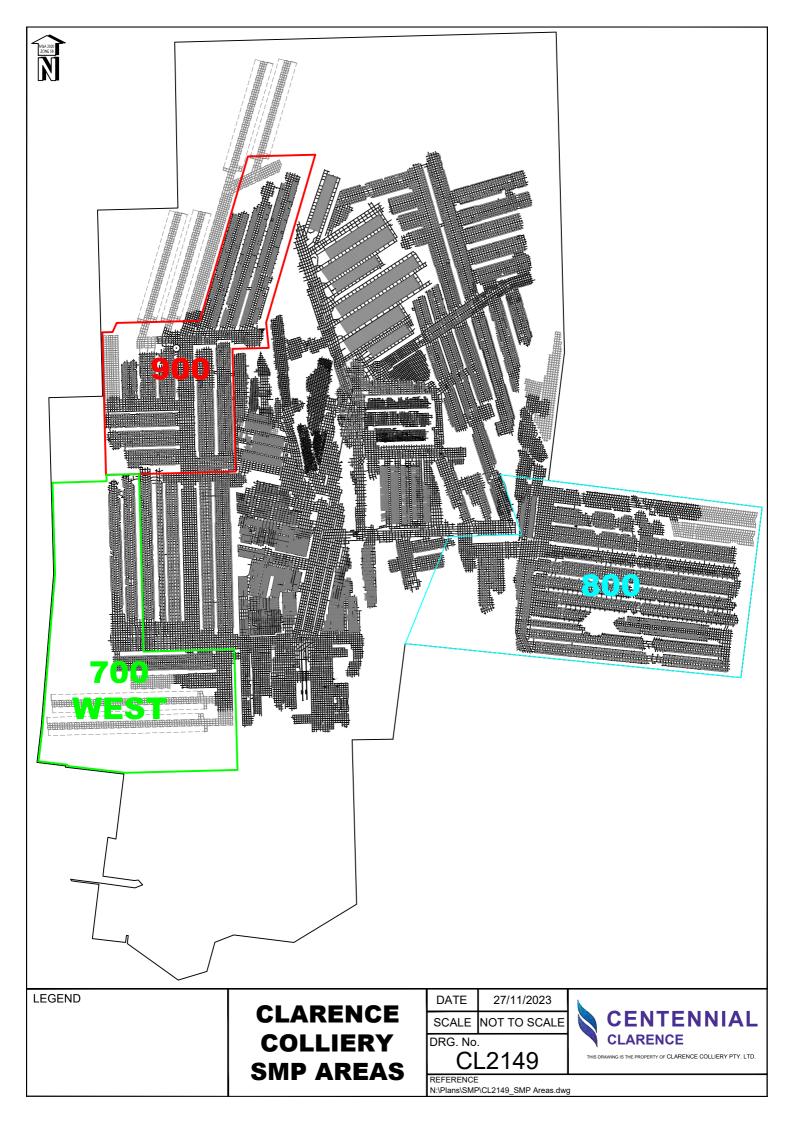
Plan 3: Clarence Colliery SMP Areas

Subsidence Management Plans (SMPs) were a condition of the mining leases and approved under the *Mining Act 1992*. Underground mining at Clarence Colliery is undertaken in accordance with approved SMP which are prepared to satisfy the requirements of relevant mining authorities (refer to **Table 3-1**).

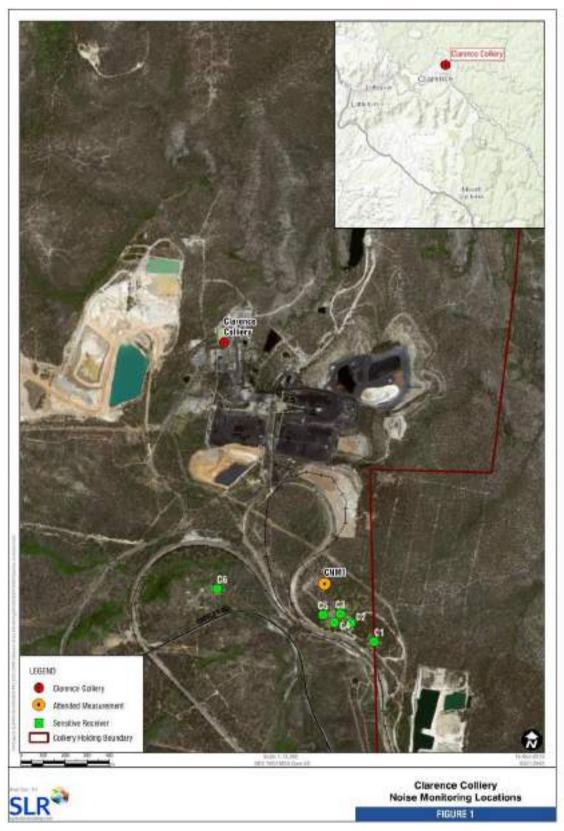
Figure 1 Attended Noise Monitoring Locations

Location	Description
CNM1	Annual Attended Monitoring Location - To the south-east of Clarence Colliery.
C3	Nearest residential receiver to the south-east of Clarence Colliery on Sandham Road.
C6	Nearest residential receiver to the south-west of Clarence Colliery on Chifley Road.

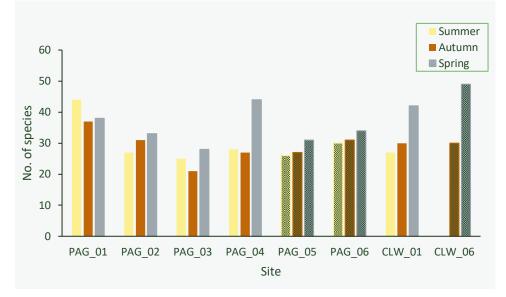
The species richness of the seven heath and pagoda sites in Clarence East and West generally followed a seasonal pattern with a peak in Spring and reductions in Summer and Autumn (Figure 2).

Figure 2. Species richness at the Clarence East and West heath and pagoda sites in 2024. Solid fill indicates an impact site, patterned fill indicates a control site.

There does not appear to be any large difference in species richness between the control and impact sites during any season. The exception to this is the higher number of species recorded at impact site PAG_01 in summer (44 species) compared to that at control sites PAG_05 and PAG_06 (26 and 30 species, respectively) in the same month. However, the discrepancy between species richness in the control and impact site does not appear to be a cause for concern; the extra species recorded at impact site PAG_01 during the summer are native species and the number of species recorded at each of the sites is similar to previous years.

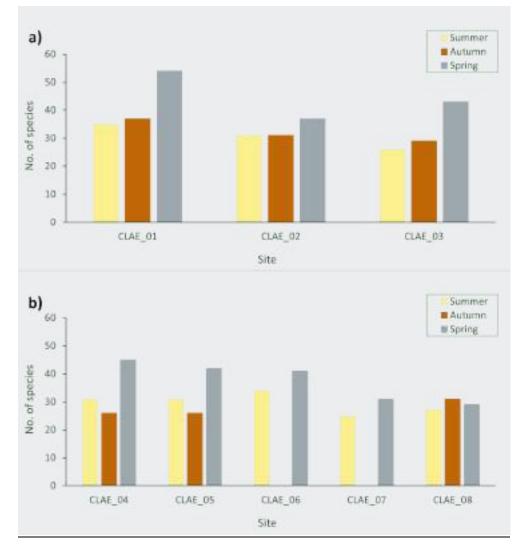
Figure 5. Species richness at the Clarence 800 a) heath sites and b) swamp sites in 2024. Solid fill indicates an impact site, patterned fill indicates a control site.

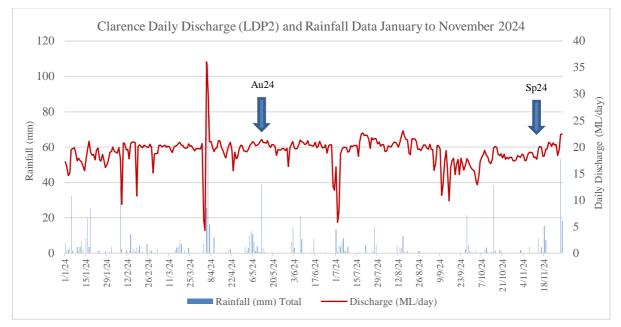
- May 2024 was wet with 99mm, most of which (97mm) fell over the two-week period leading into the autumn survey in mid-May.
- The combined total for June and July (135mm) was very close the combined average (132mm), with 25 of the 29 rainfall days recording less than 8mm rainfall over the two-month period.
- The three-month period from August to October 2024 saw mostly light rain events occurring over 35 rainfall days, and the combined three-month total (111mm) was only 63% of the combined average total.

Figure 3 Clarence monthly rainfall & discharge January to November 2024.

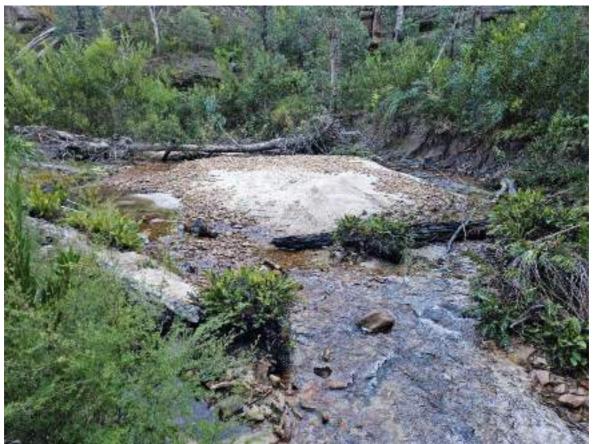
Plate 19: Looking upstream at erosional point on bend at BCDn3.

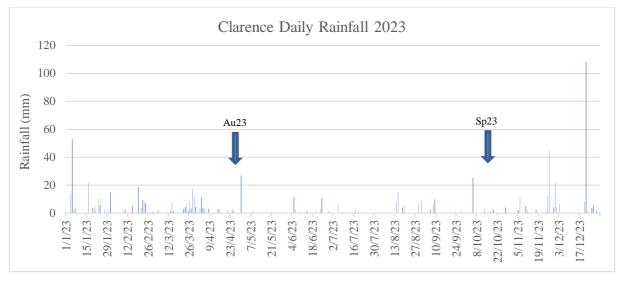
- May was very dry with only 3mm recorded over six rainfall days, and the combined three-month total for May to July of 50mm (spread over 24 rainfall days) is only 27% of the combined mean monthly total.
- August saw more regular precipitation, albeit less than average with 50mm recorded over 13 rainfall days, however dry conditions continued into September where 22mm was recorded, mostly over two days of light showers on the 8th and 9th (totalling 17mm).

Figure 3 Clarence mine site daily rainfall January to December 2023.
