# HUNTER VALLEY OPERATIONS

## 2024 ANNUAL REVIEW

HVOOC-1061437028-2251

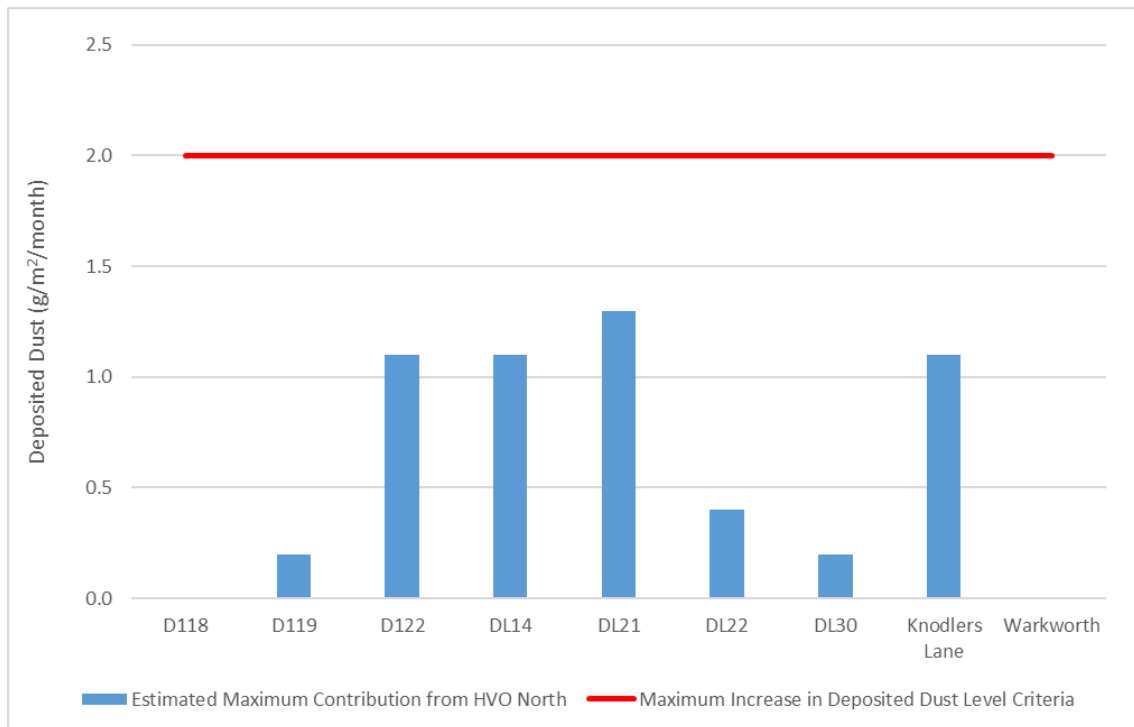
Figure 6-13: Maximum Allowable Increase in Deposited Dust Level 2024

The DL30 and Warkworth monitoring locations exceeded the annual average insoluble matter deposition rate criteria of 4 g/m<sup>2</sup>/month (HVO North only) during 2024. However, all results were below the maximum insoluble solids incremental increase criterion of 2 g/m<sup>2</sup>/month and hence compliant with criteria (**Figure 6-13**).

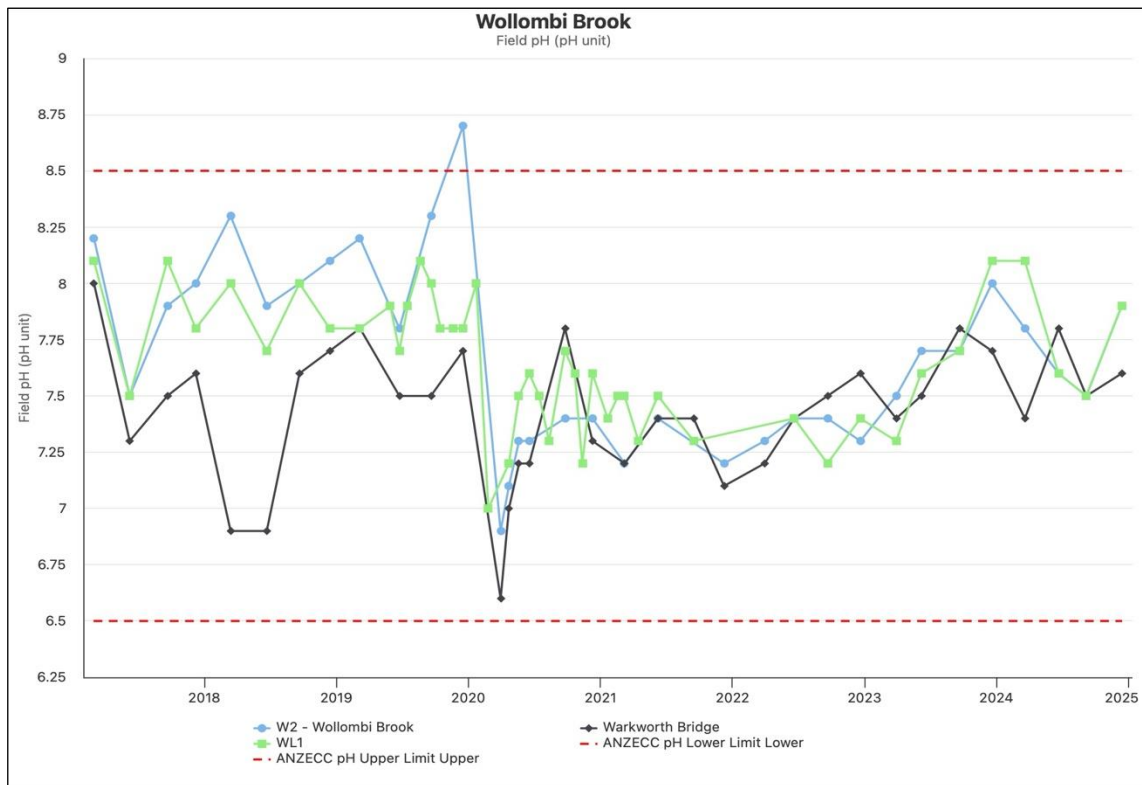
Figure 7-8: Wollombi Brook pH Trends 2017 - 2024

Wollombi Brook was sampled from three monitoring locations during 2024. Long term trends for pH, EC and TSS from Wollombi Brook are shown in **Figure 7-8** to **Figure 7-10**. Results were generally consistent with historical trends and acceptable ranges.

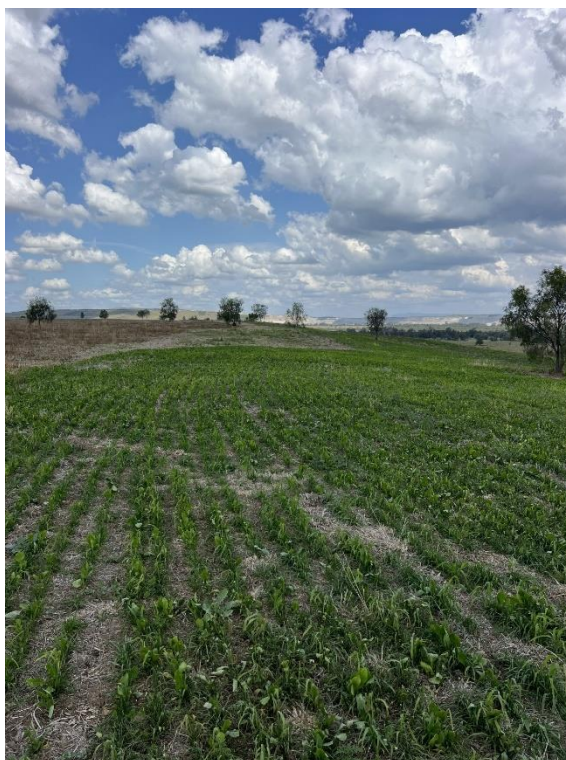
*Figure 8-5: Seeding of Final Land Use Species at Carrington*

Since 2020, HVO has seeded 328 hectares of rehabilitation that was initially seeded with cover crop with final land use including 88.5 hectares at Carrington in 2024. Maintenance works completed included mulching the area, boom spraying, amelioration and seeding with pasture final land use.

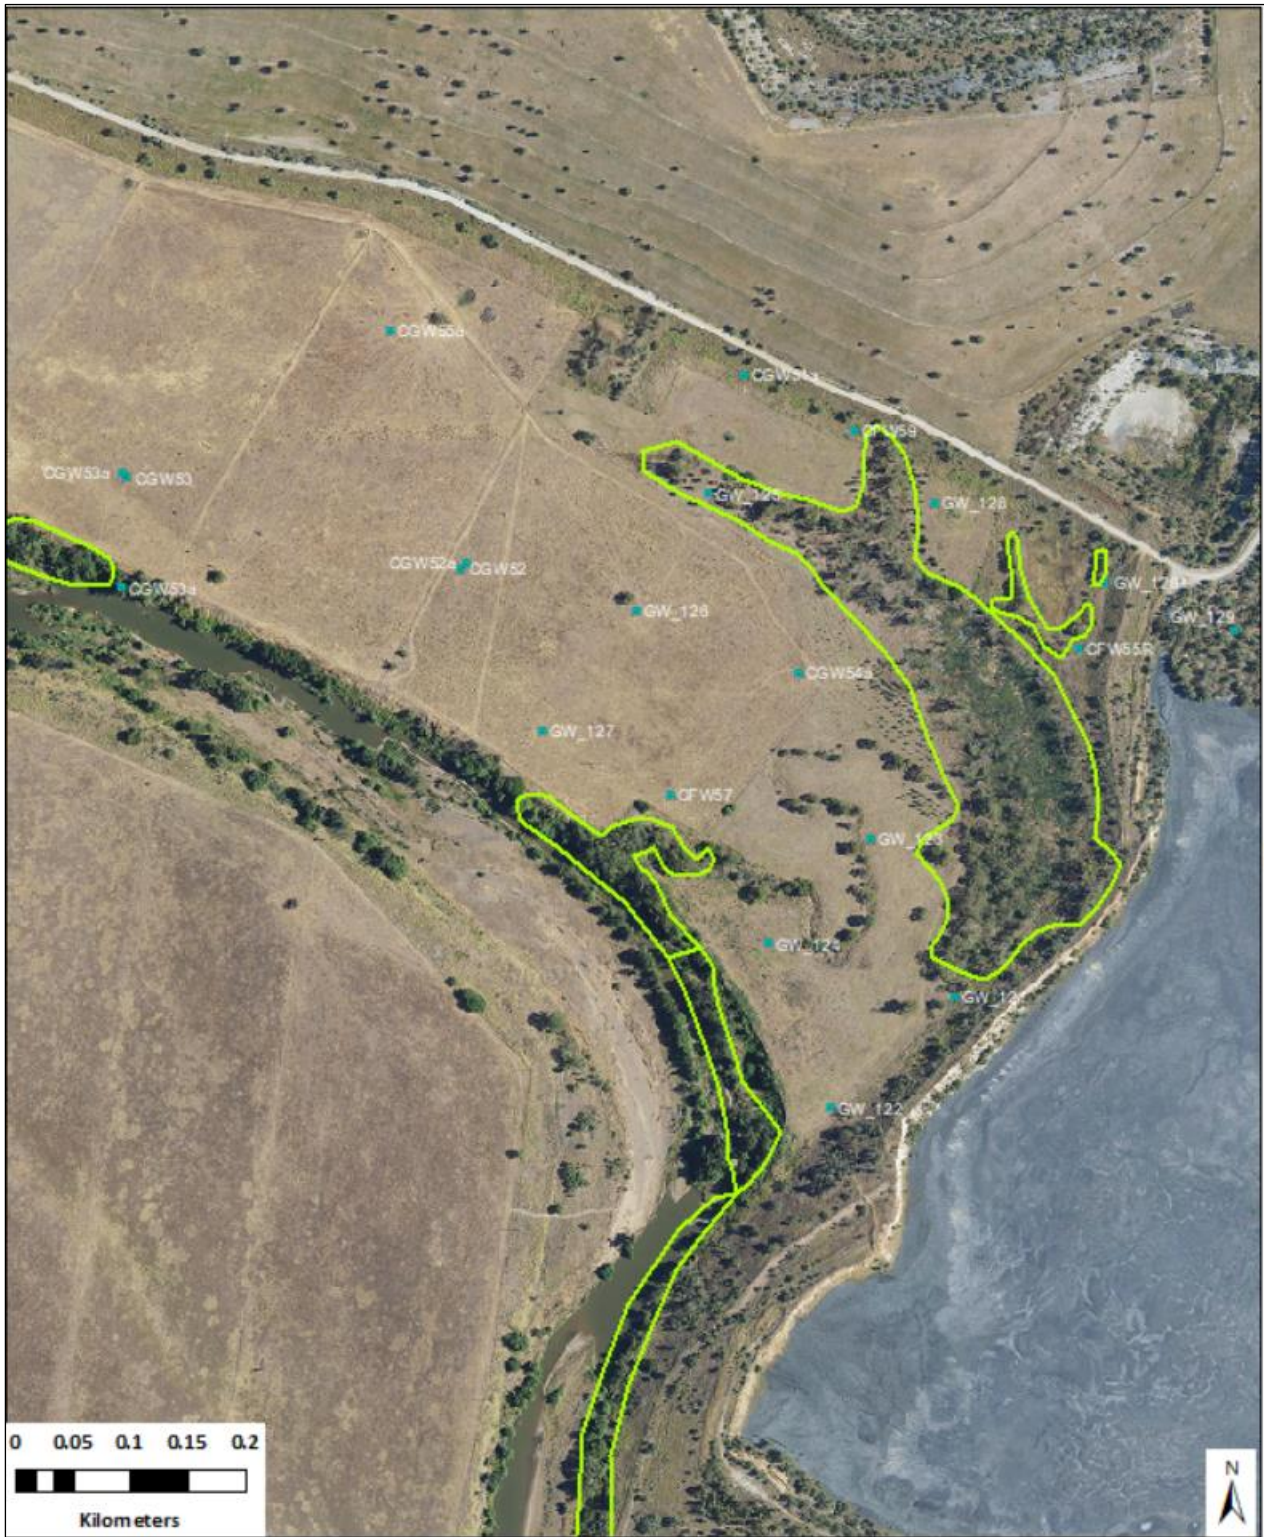
Figure 8-5: Groundwater Monitoring Locations adjacent to the Carrington Billabong

The location of the trigger bores in the vicinity of the Carrington Billabong can be seen in **Figure 8-5**.

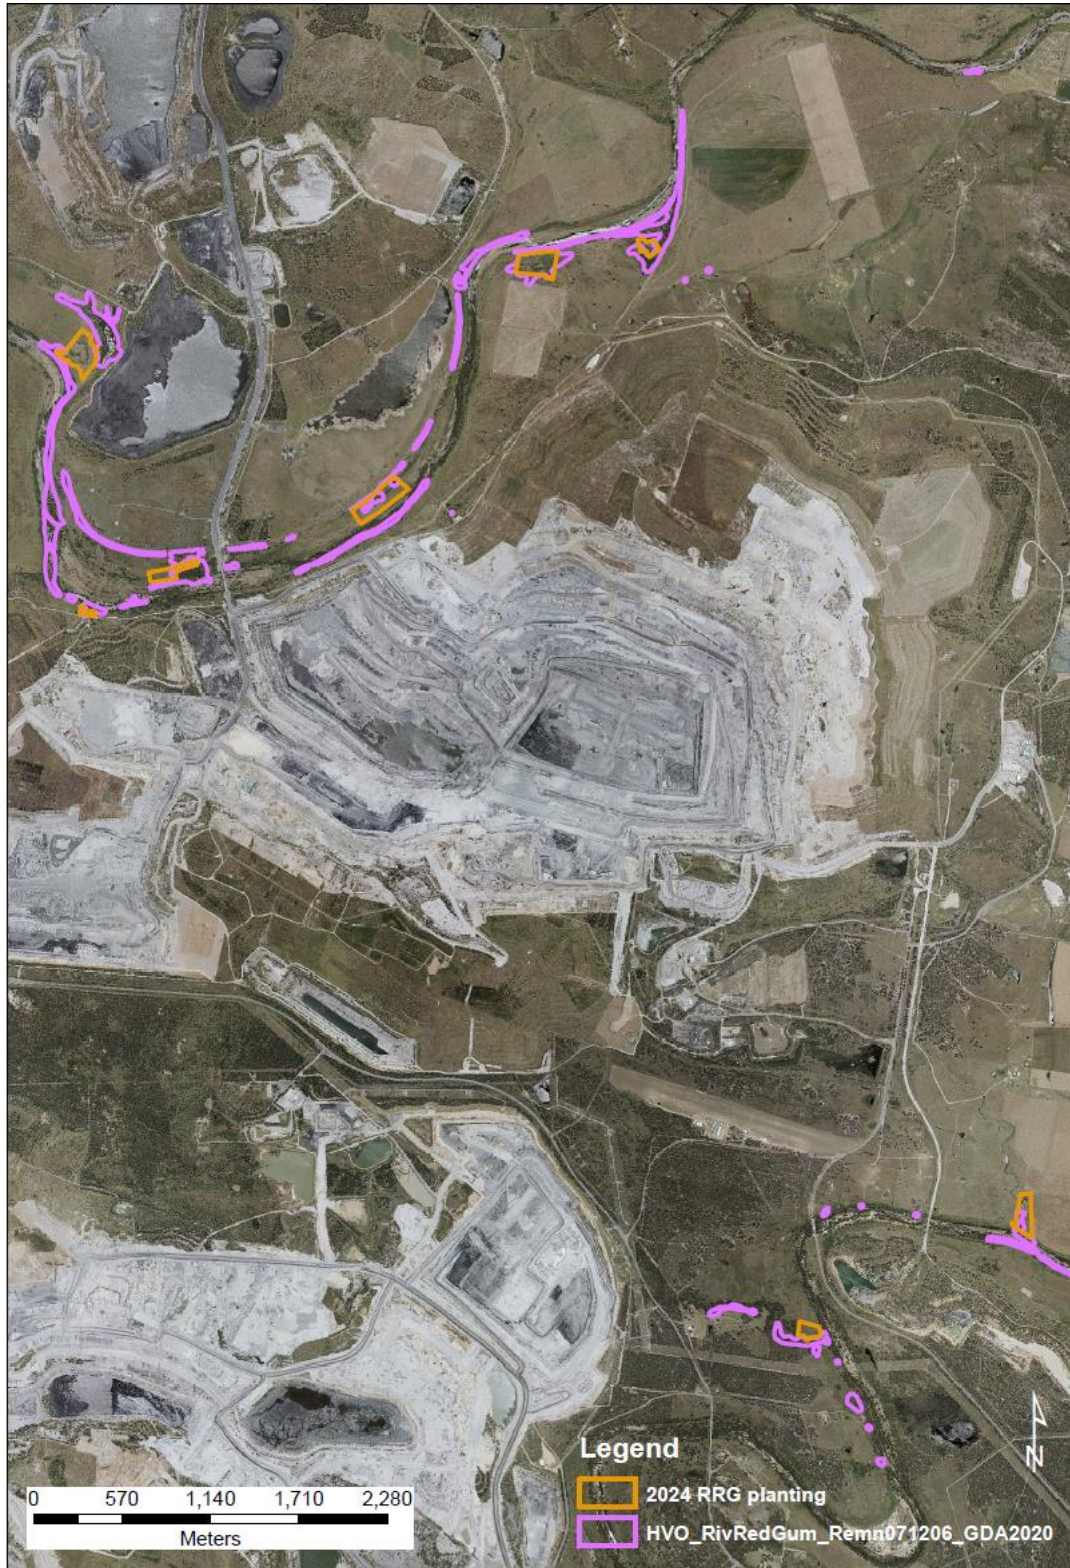
Figure 8-6: 2024 Priority River Red Gum planting areas.

A tubestock planting campaign did occur during March and April 2024. The focus was on the priority areas identified within the River Red Gum Rehabilitation and Restoration Strategy. 1400 tubestock were planted in the areas indicated in **Figure 8-6**.

The plants received supplementary watering post-planting to assist with establishment, but, in some areas, were subject to kangaroo grazing, pig rooting and overshadowing by thistle growth which reduced survival. These areas will be replanted during 2025 with the aim to expand the individual stands to reduce edge effects, develop connections between stands where possible, and improve ecological processes within the community.

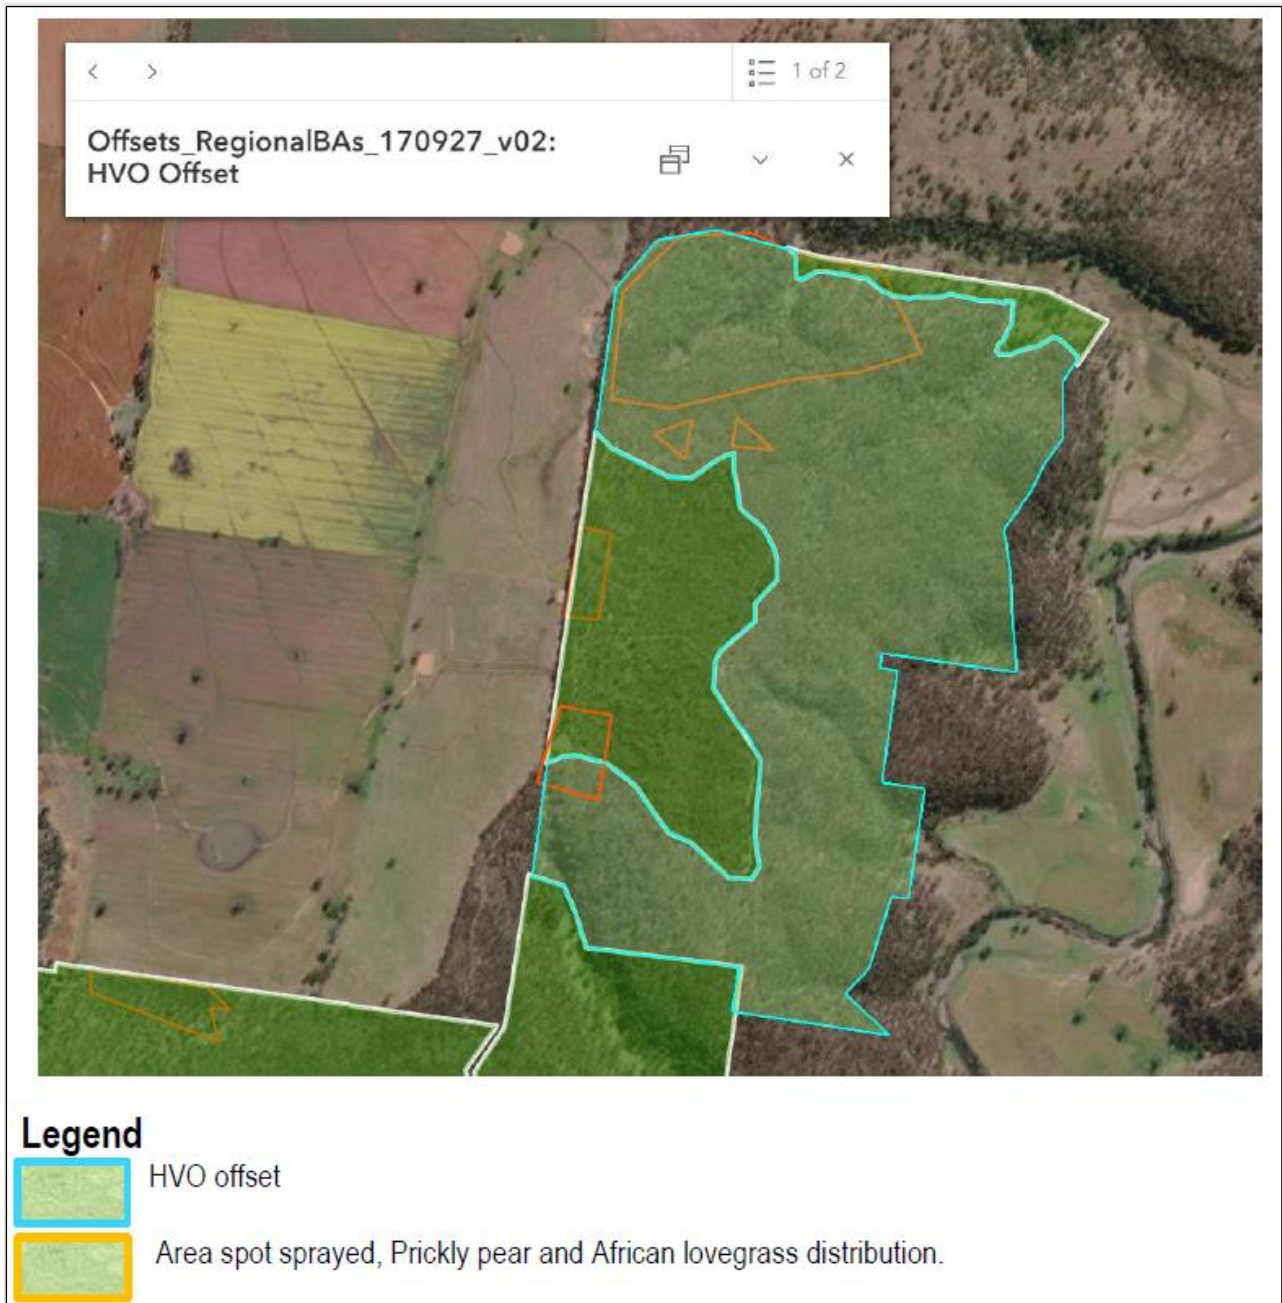
Figure 8-10: Areas of weed control within HVO's Goulburn River Offset and adjoining Warkworth Mine Offset

The tracks and fence lines were slashed during 2024 and the areas treated for weeds is shown in **Figure 8-10**. The majority of the HVO offset is in good condition with few weeds. The need for weed and feral animal intervention is assessed during the regular property inspections.
