CENTENNIAL MANDALONG PTY LTD
Mandalong Mine
2024 ANNUAL REVIEW

March 2025

Annual Review Title Block

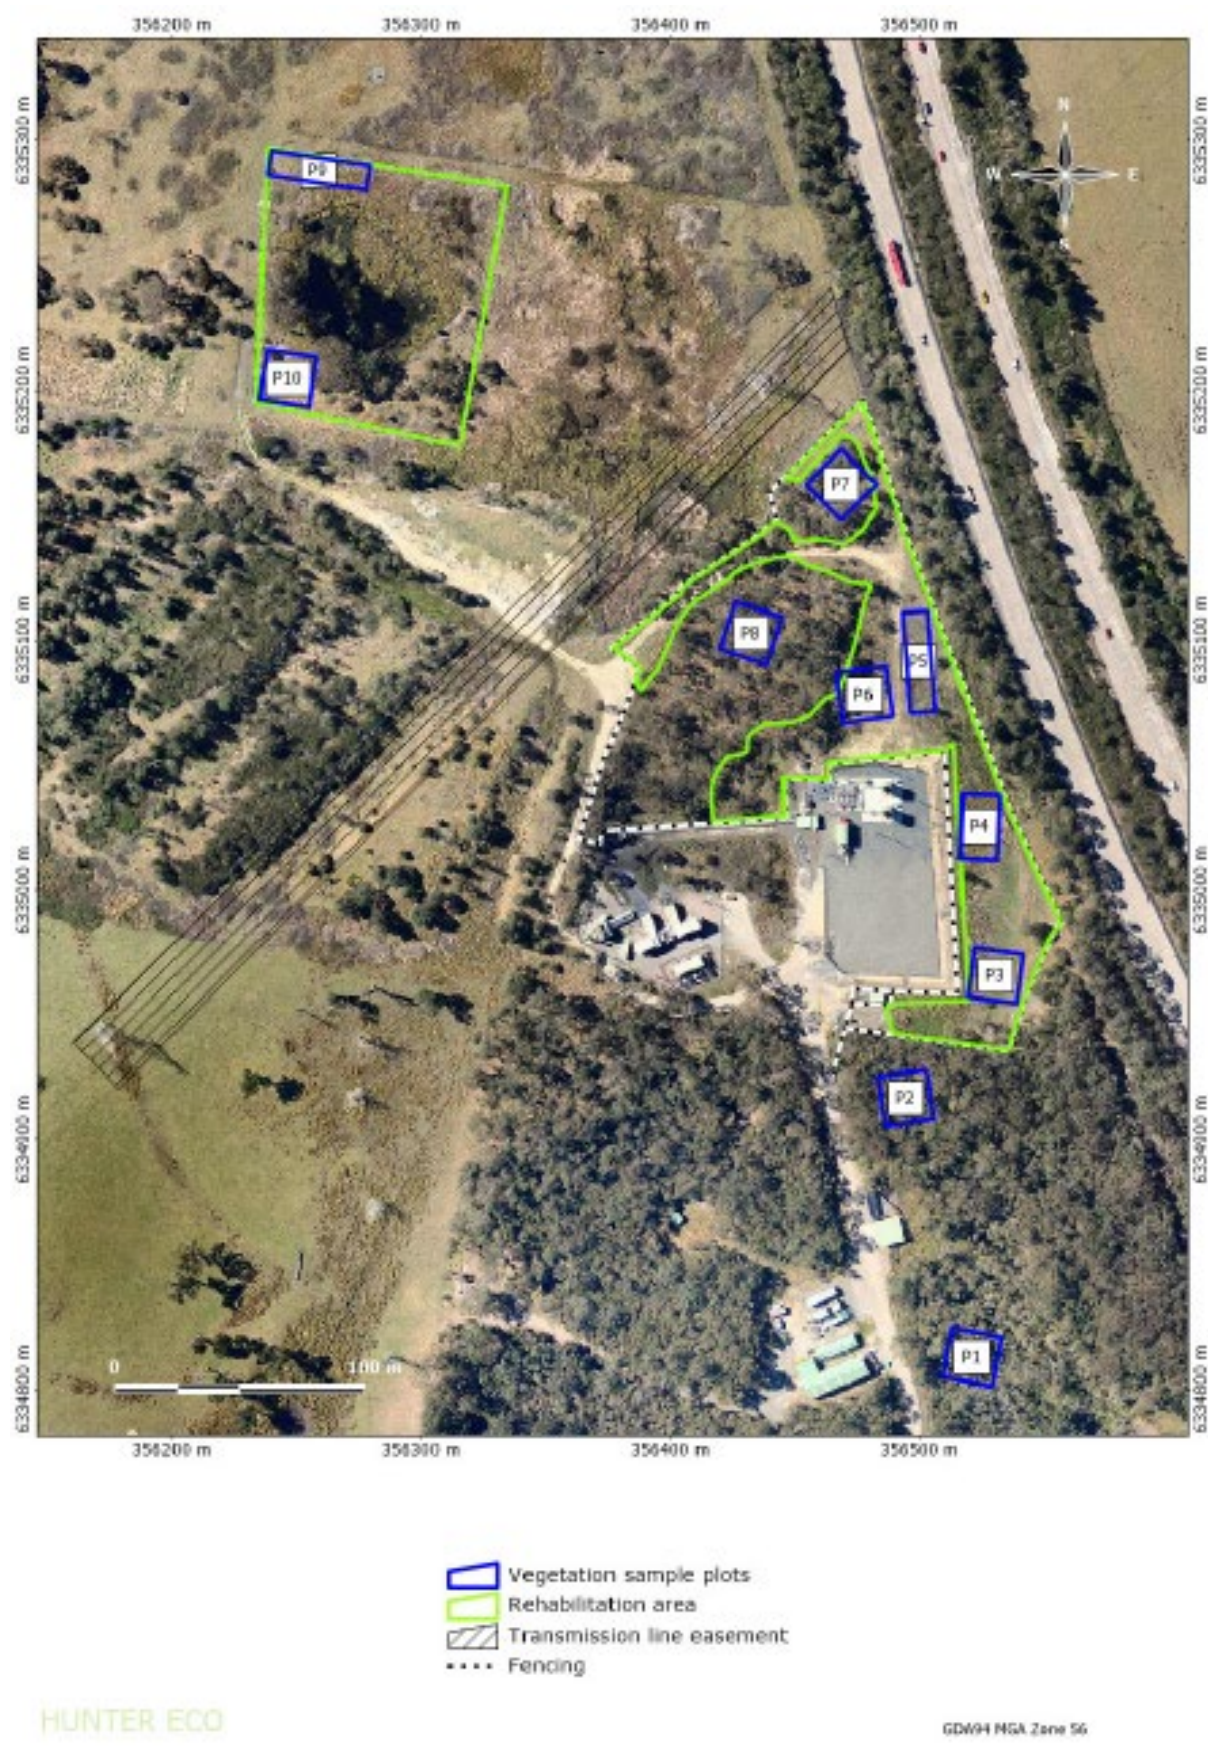
Figure 6-20: Location of Floristic Sample Plots

The aim of the monitoring program conducted by Hunter Eco was to collect data that would enable a quantitative comparison between the relatively undisturbed communities and the areas being rehabilitated. This is achieved through the collection of floristic data from 400 m² permanently established plots. The normal plot size is 20 m x 20 m but the dimension can vary depending on the configuration of the available space. Two plots were established in each of the two undisturbed communities and two in each of the two areas being rehabilitated to these communities: eight plots in all.

All plots were permanently established with star pickets at each corner in 2012, and floristic data was collected on 19 December 2024. Hunter Eco (2024) has concluded that due to the rehabilitated areas being fenced from herbivores and being left undisturbed, have added a combined 0.43 ha of additional canopy area from the expansion of pre-existing trees along with growth of planted trees. Overall, weeds are continuing to diminish but coverage of the large millet (*Setaria sphacelata*) is increasing in some locations and should be controlled.

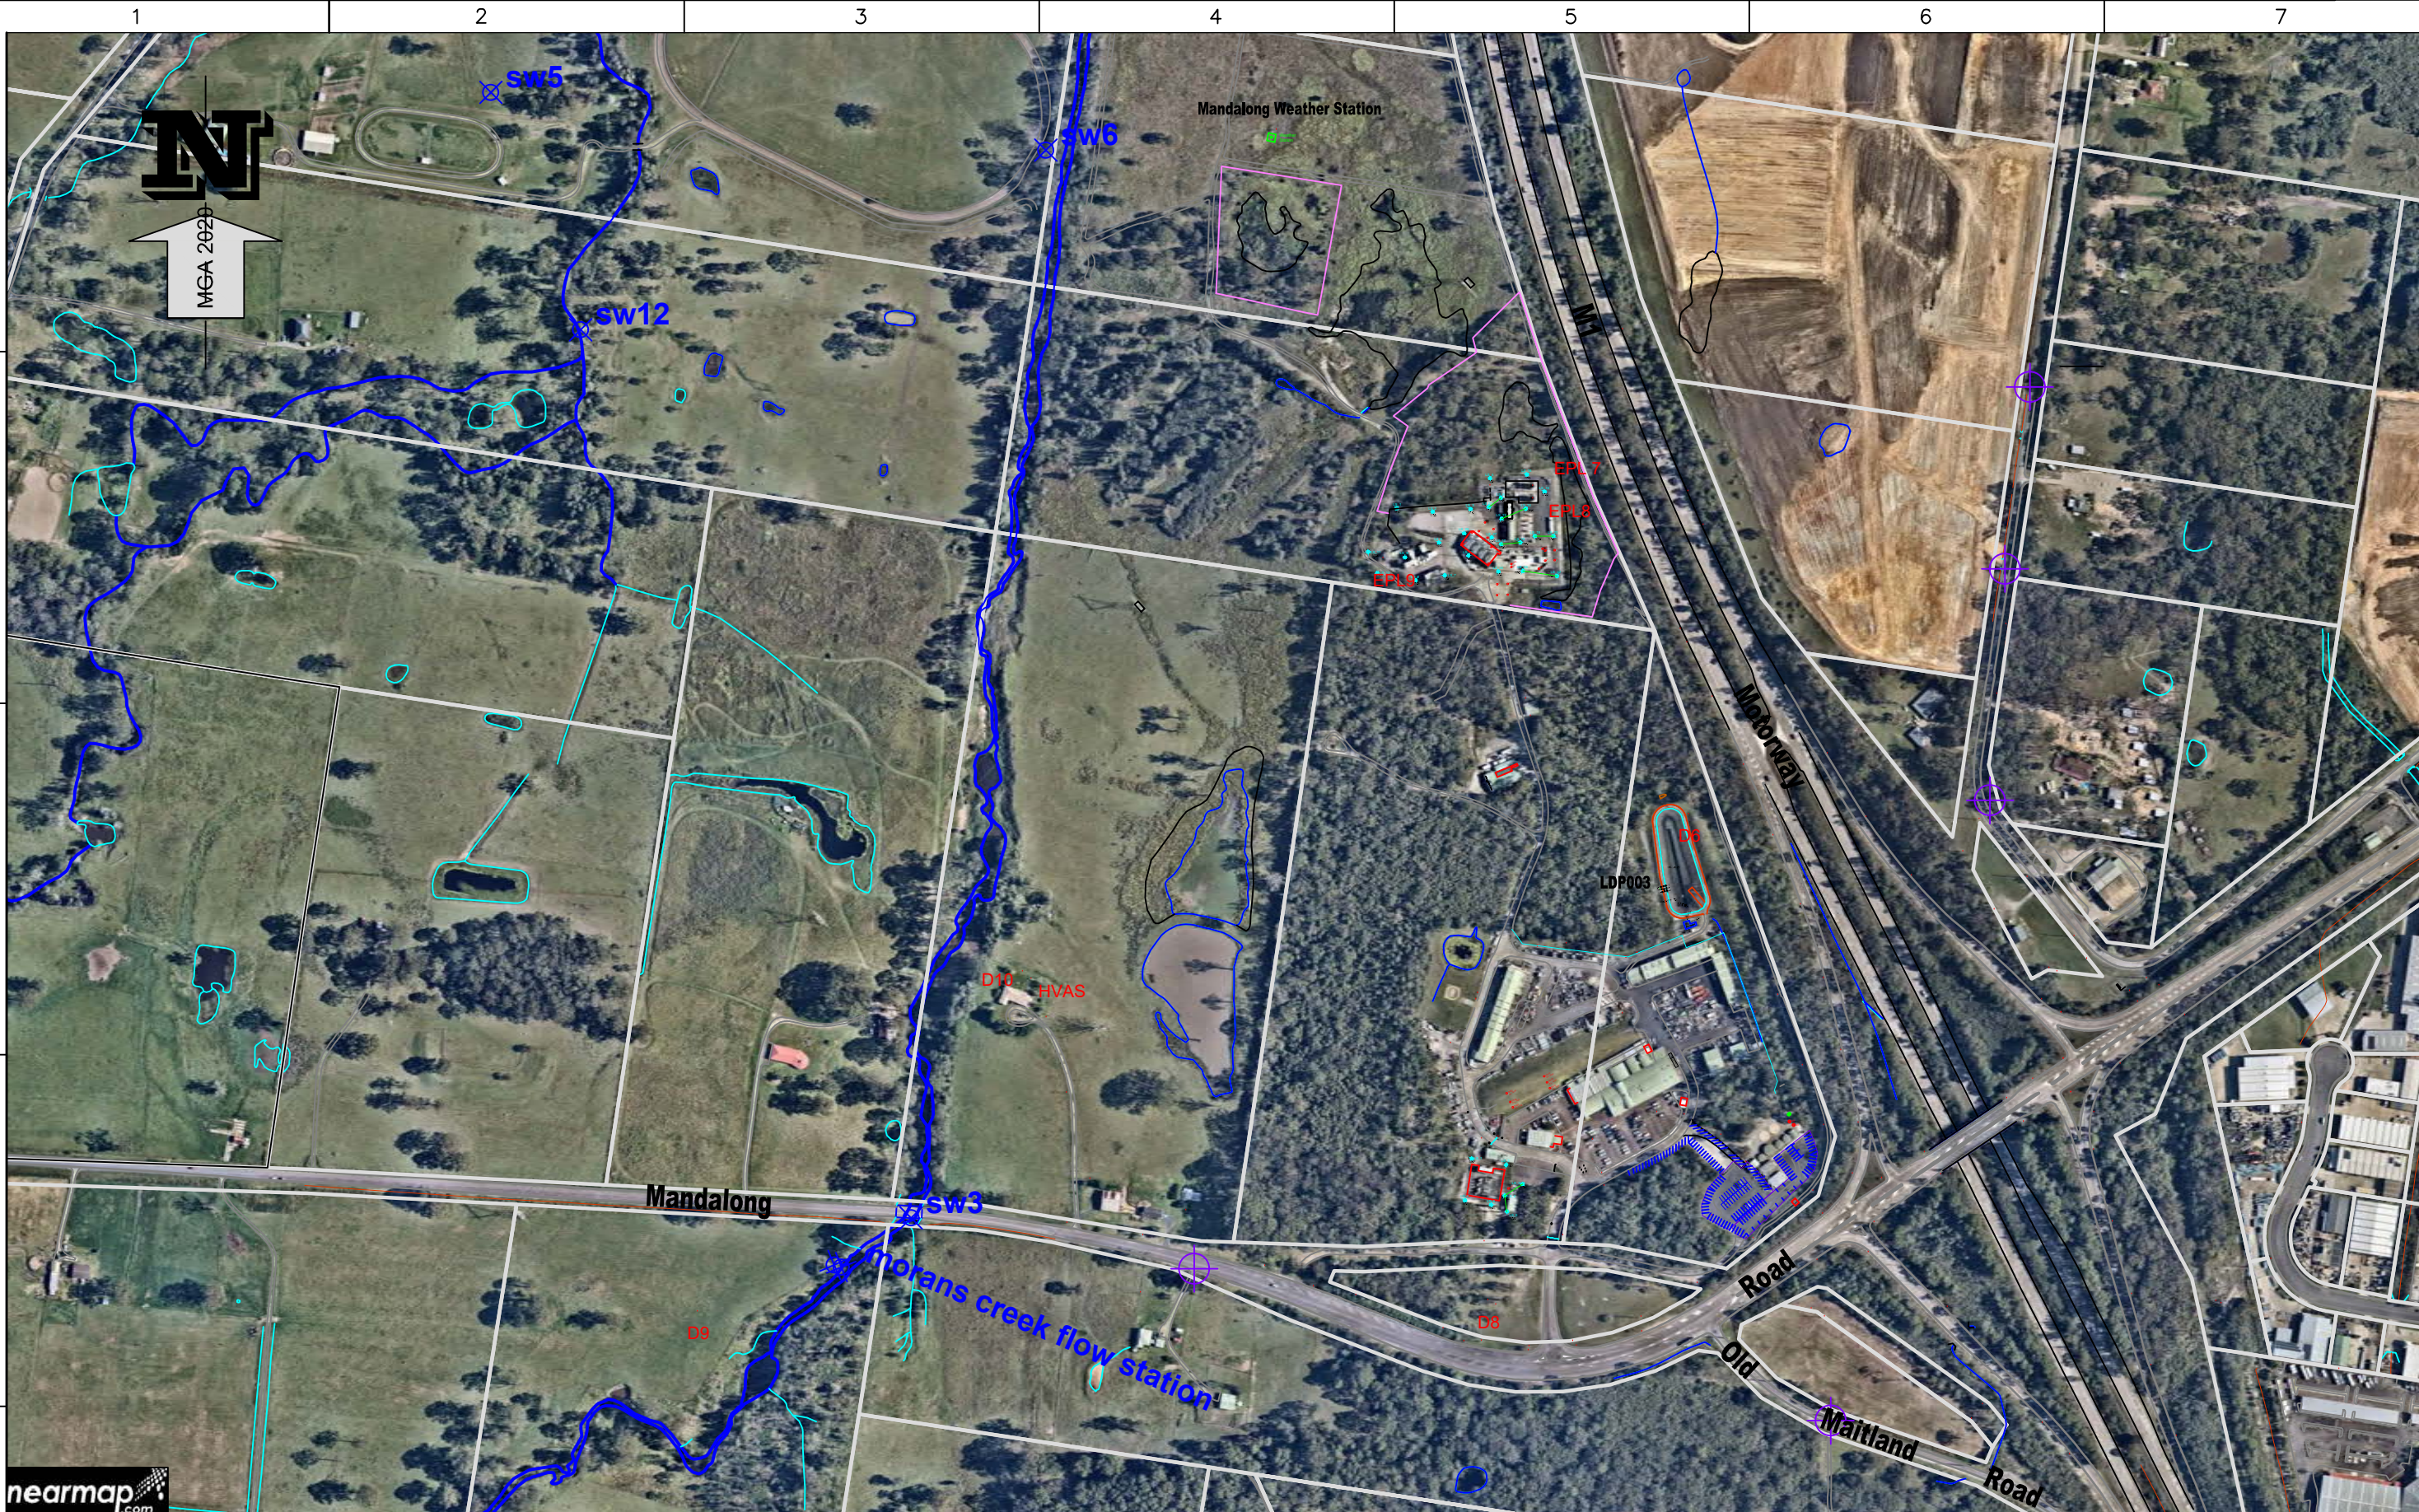
<div>LEGEND</div> <div><div><div></div></div> Dust Monitoring Point</div> <div><div><div></div></div> Surface Water Monitoring Point</div> <div><div><div></div></div> Weather Station</div> <div><div><div></div></div> Noise Monitoring Point</div>	<div>CENTENNIAL MANDALONG PTY LTD ©</div> <div>THIS DRAWING IS COPYRIGHT.</div> <div>NO PART OF IT MAY IN ANY FORM OR BY ANY MEANS (ELECTRONIC, MECHANICAL, MICRO-COPYING, PHOTOCOPYING, RECORDING OR OTHERWISE) BE REPRODUCED, STORED IN A RETRIEVAL SYSTEM OR TRANSMITTED WITHOUT PRIOR WRITTEN PERMISSION.</div>	LOCATION	MANDALONG	<div><div><div></div></div><div>CENTENNIAL MANDALONG</div></div>	CONTRACT	
		SEAM	WEST WALLARAH		PLOTFILE: CM00315c_rev0.pdf	
		DRAWN	PJS 08/10/07		A3	CM00315c
		CHECKED				
		APPROVED		DRAWING REV. 0 - 22.02.2023		
		SCALE 1: 5000		Delta Entry Site - Location of Environmental Monitoring Points
