CENTENNIAL COAL
Myuna Colliery
2024 ANNUAL REVIEW

March 2025

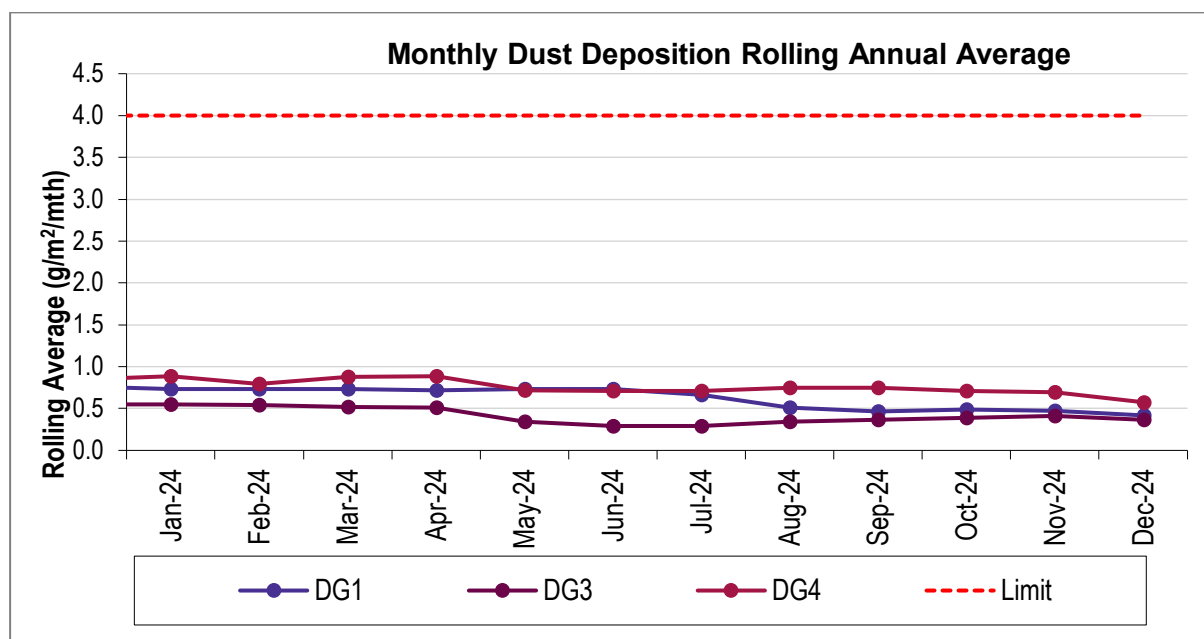
Figure 6-2: Monthly Depositional Dust Rolling Annual Average

Figure 6-2 below show the depositional dust rolling annual average results of Myuna for 2024 in comparison to the limits and EIS predictions. At all three dust gauges the annual averages were comparable to the long-term averages, within the maximum total limit of 4 g/m²/month. The 2 g/m²/month maximum annual average increase limit was not exceeded. DG2 was removed from the monitoring network in October 2023 and is no longer monitored following approval of the AQ&GHG MP version 6 by DPHI on 22 August 2023.

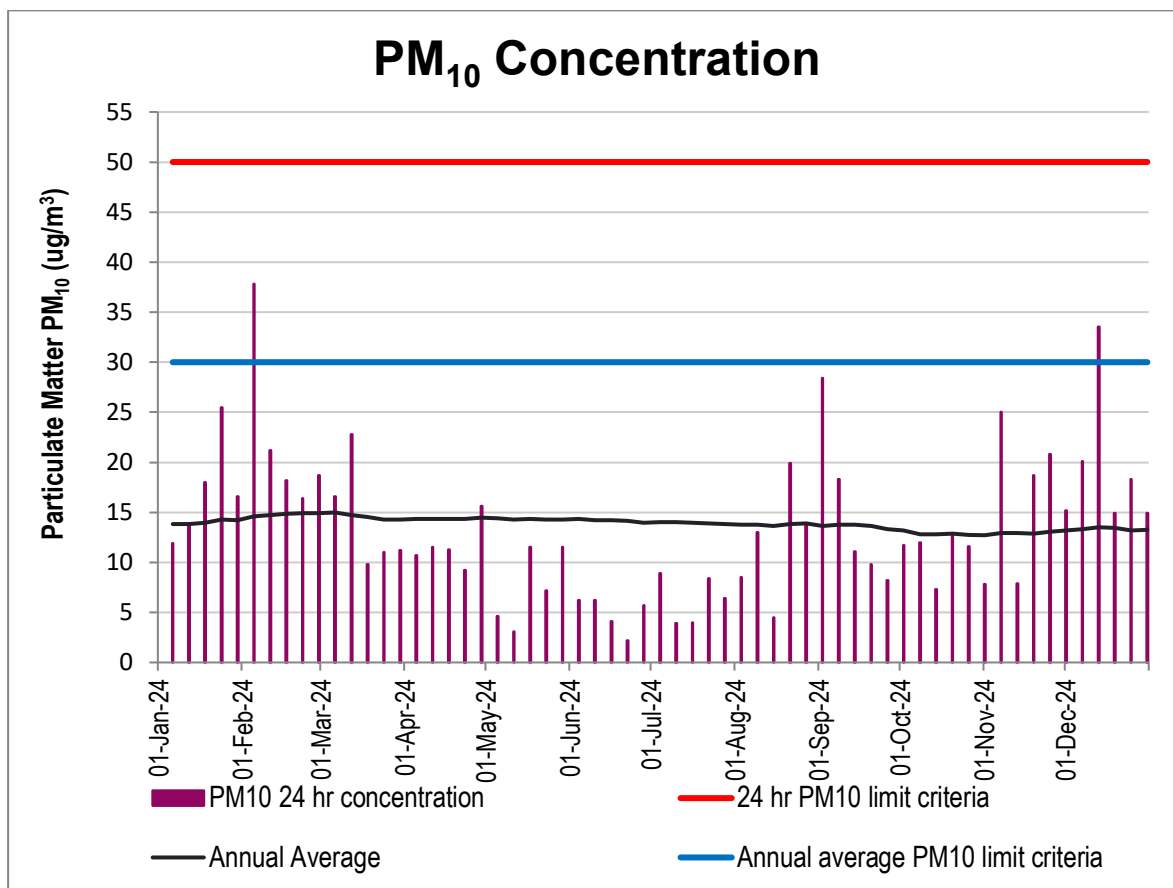
Figure 6-3: Annual PM¹⁰ Concentration Results ($\mu\text{g}/\text{m}^3$)

The 24-hour average and annual average results for PM₁₀ are below the criteria of 50µg/m³ and 30µg/m³, respectively, remaining compliant with the limits set in PA10_0080 and the AQ&GHG MP. The annual average results for TSP are also below the criterion of 90µg/m³, maintaining compliance with the limits in PA10_0080 and the AQ&GHG MP.

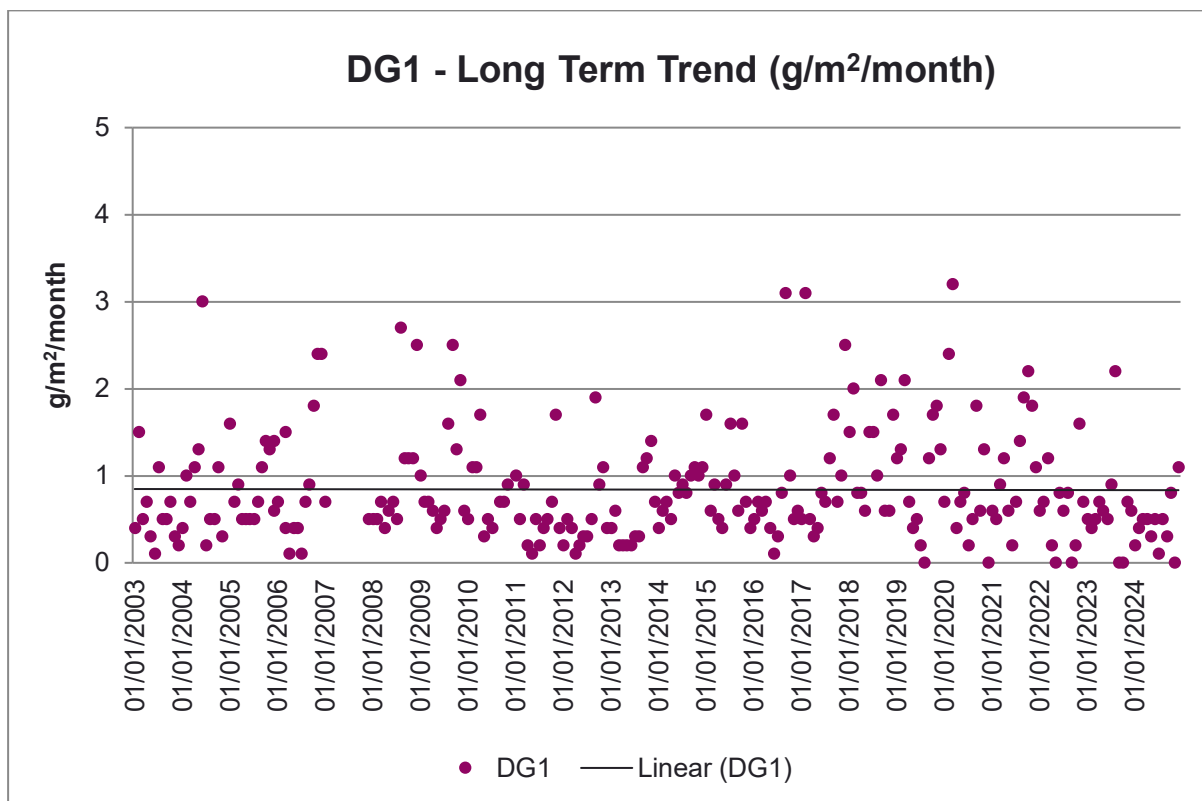
Figure 6-5: Long term trend analysis of depositional dust gauge ‘DG1’.

There have been no exceedances of air quality criteria for the past 5 years. Generally, the concentrations measured for 2024 are consistent with long term trends. Long term trends for the three dust gauges, are shown in **Figure 6-5**, **Figure 6-6** and **Figure 6-7** below.

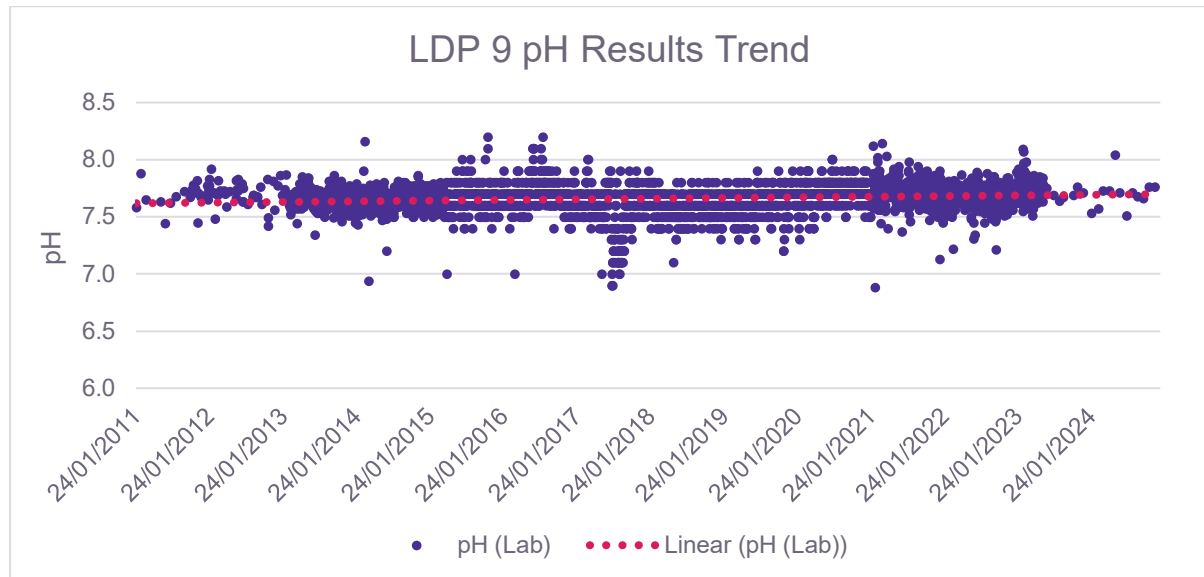
Figure 7-5: LDP 9 Long Term (pH)

As shown in the **Figure 7-5**, **Figure 7-6** and **Figure 7-7** below, linear trend lines were applied to the monitoring data from 2011 to December 2024 for pH, TSS and Oil & Grease. The trend lines show that results have been relatively consistent over this period.

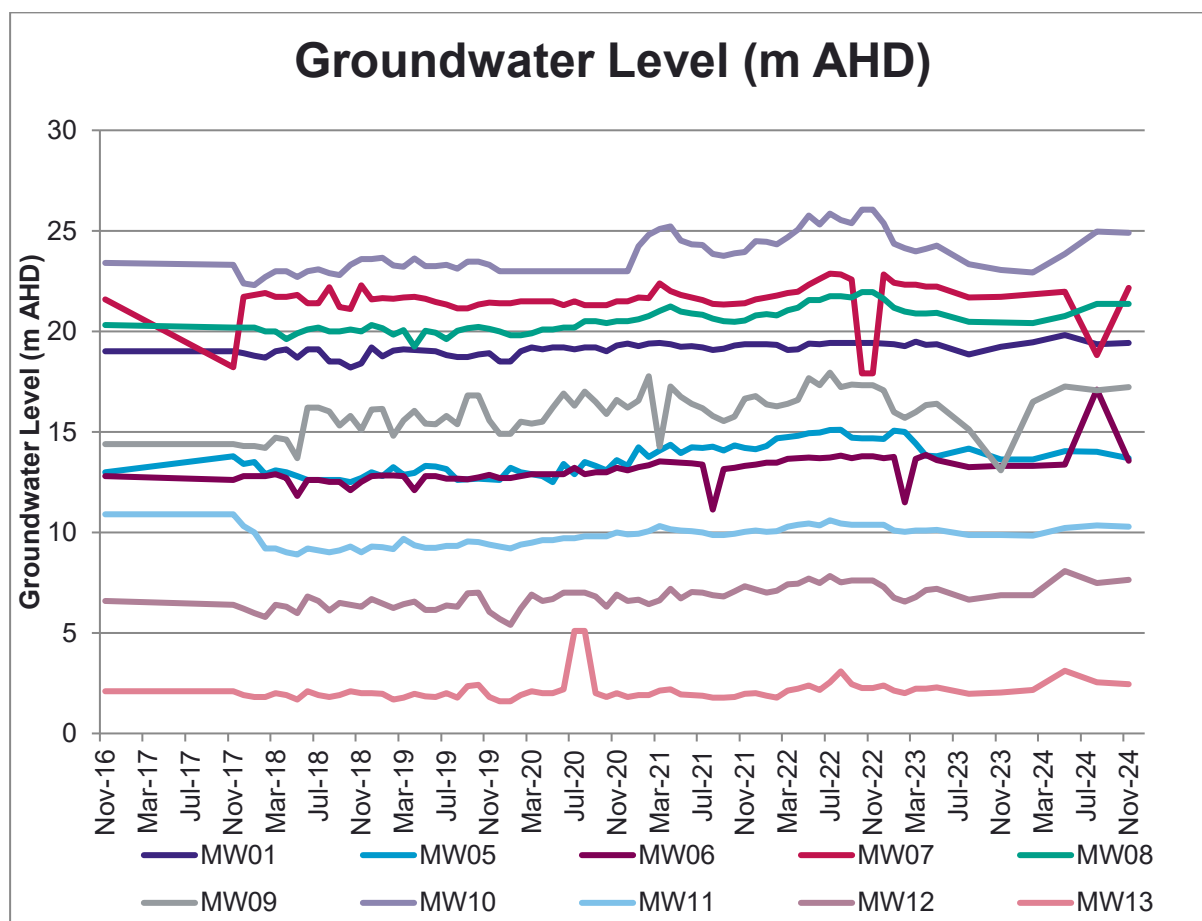
Figure 7-8 Groundwater Levels Summary (m AHD)

Figure 7-8 below shows the long term trend in groundwater water levels (m AHD). Groundwater levels have been relatively stable at all other groundwater monitoring locations since November 2016. There have been no exceedances or impacts to alluvial groundwater levels since monitoring began.

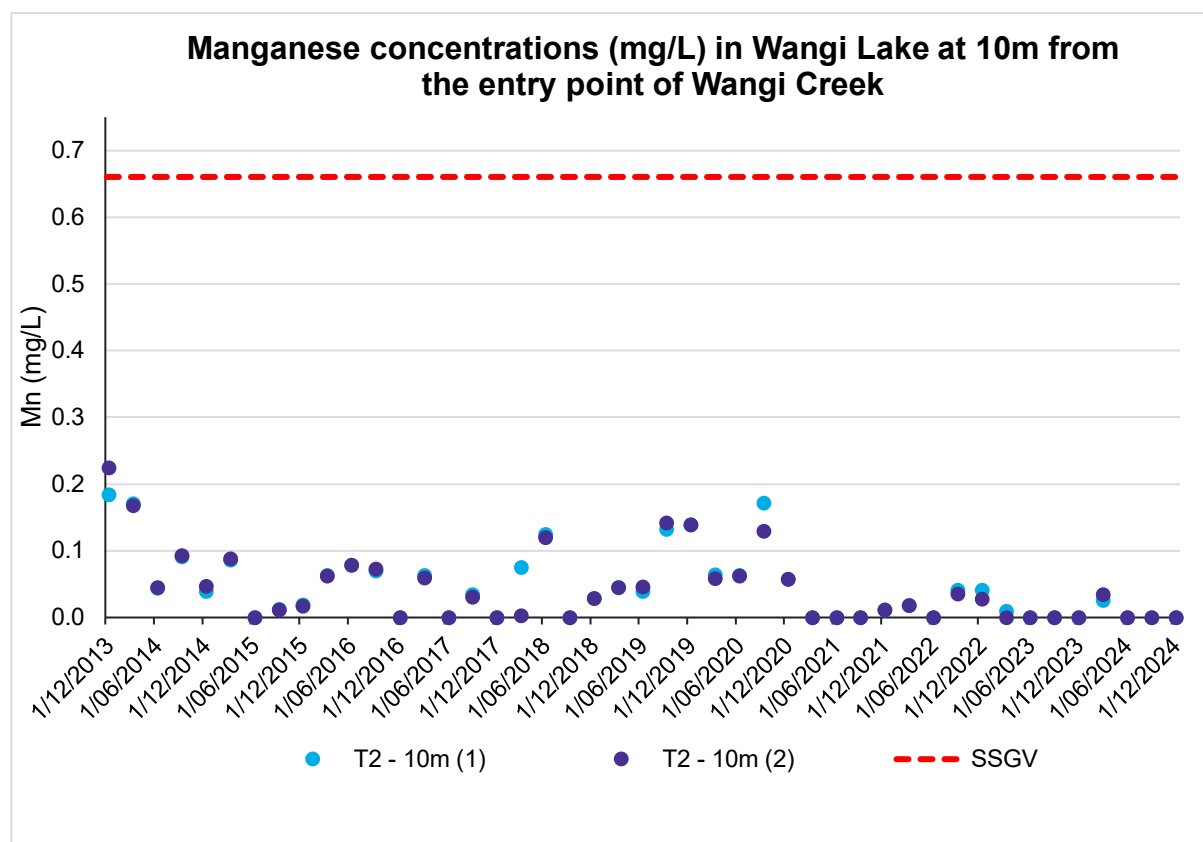
Figure 7-9: Manganese Concentrations (mg/L) Long Term Average (10m)

The Manganese monitoring has been conducted from 2011. Manganese concentrations recorded in Wangi Bay over the ten-year period of monitoring display a relatively constant trend at T2 10m and a downward trend at T2 5m. The long-term trend is shown in **Figure 7-9** and **Figure 7-10** below. Note: SSGV of 0.66mg/L is as per the 'Manganese Discharge from the Myuna Colliery ANZECC/ARMCANZ Study, 2004'.

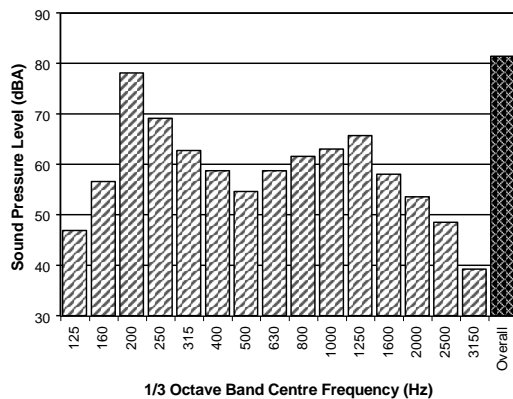
The following figure shows a 1/3 octave band frequency analysis where the noise is dominated by the 200 Hz band. Note that the indicated level of each individual band is less than the overall level, which is the logarithmic sum of the bands.

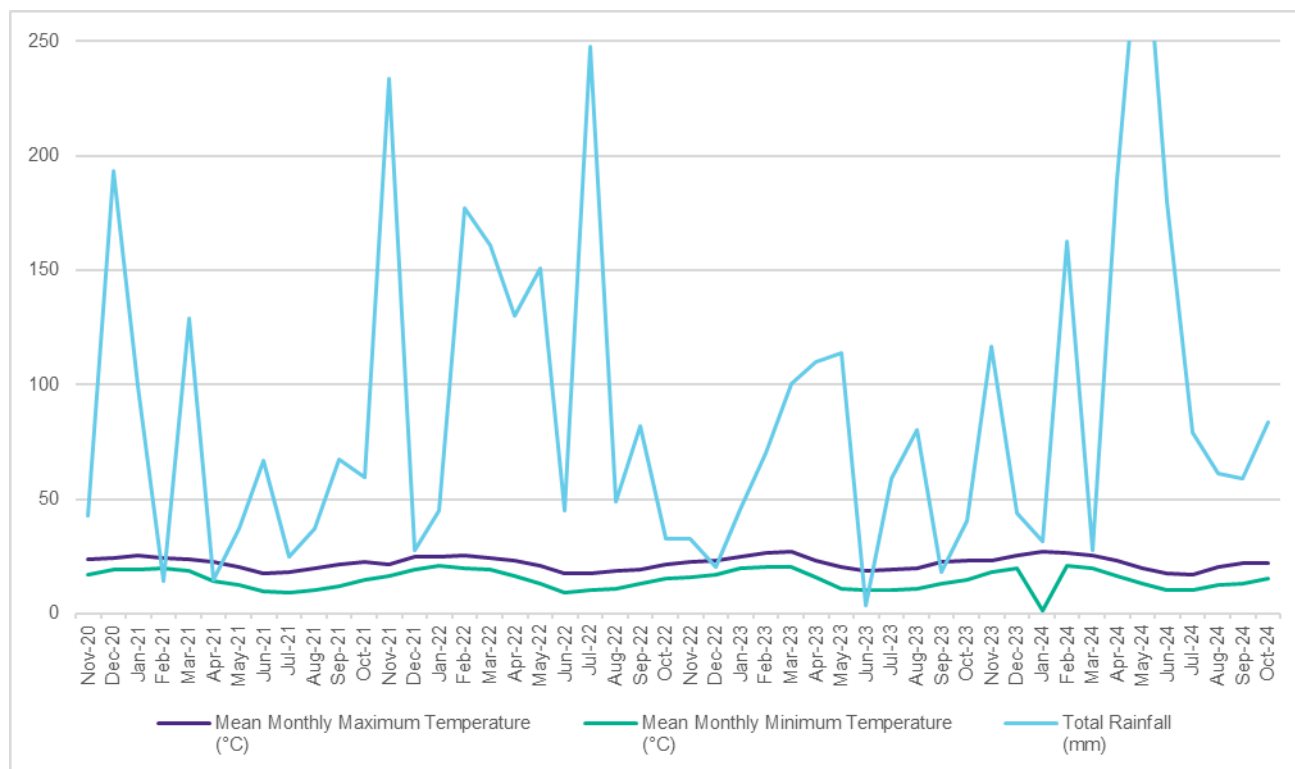
Graph 3-1 Long-term weather patterns (November 2020 to October 2024) preceding the 2024 monitoring event

Weather over the 12-month period preceding the 2024 monitoring event was generally above the historical average for both mean maximum monthly temperatures (exceeding November 2023 and October 2023 which were below the average) and mean monthly minimum temperatures (exceeding January 2024 below the average). Rainfall was above the historical average for six months of the year, particularly the three-month period from April to June. The month prior to monitoring also saw rainfall above average and upon inspection of the site in November the study area was visibly flooded.

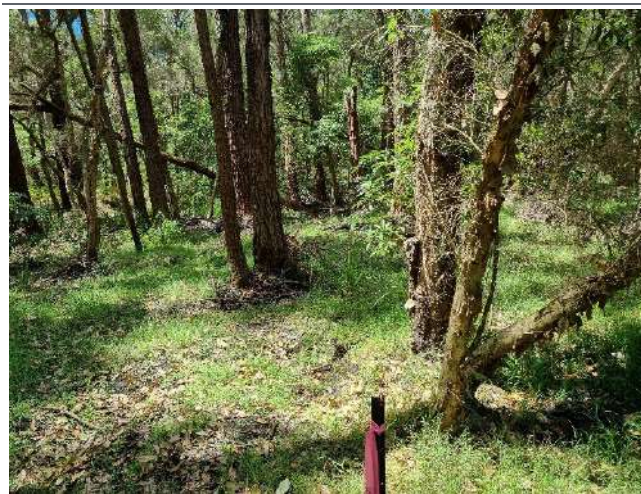
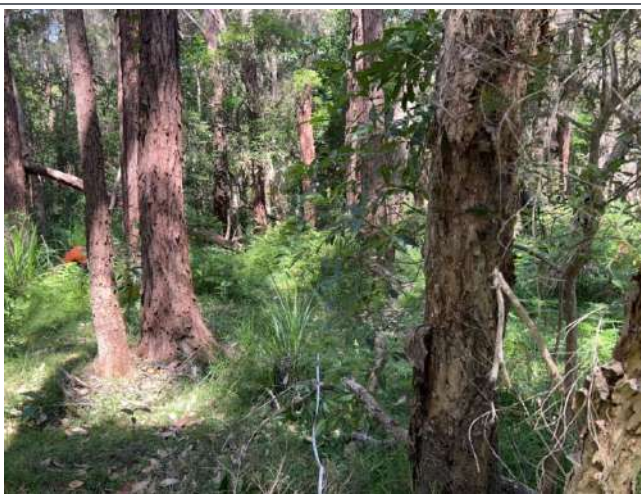
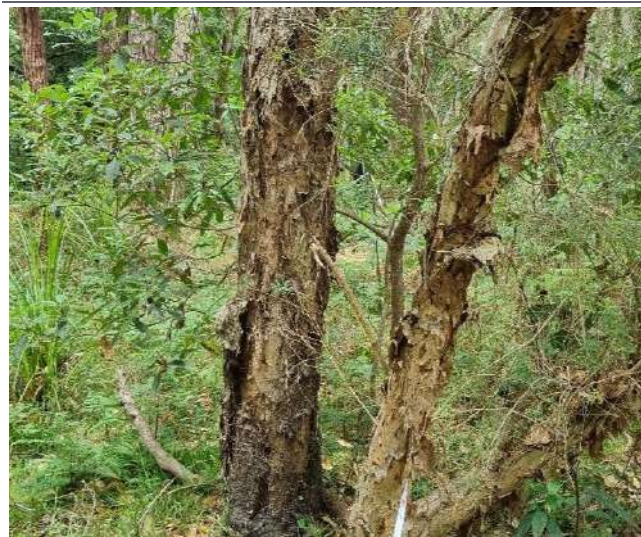
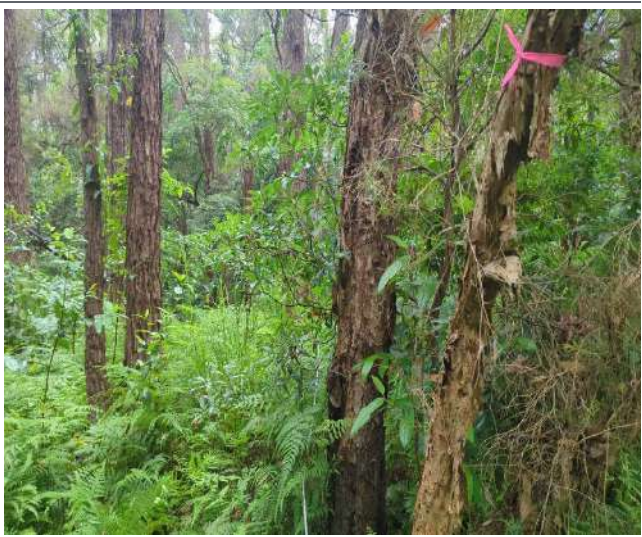
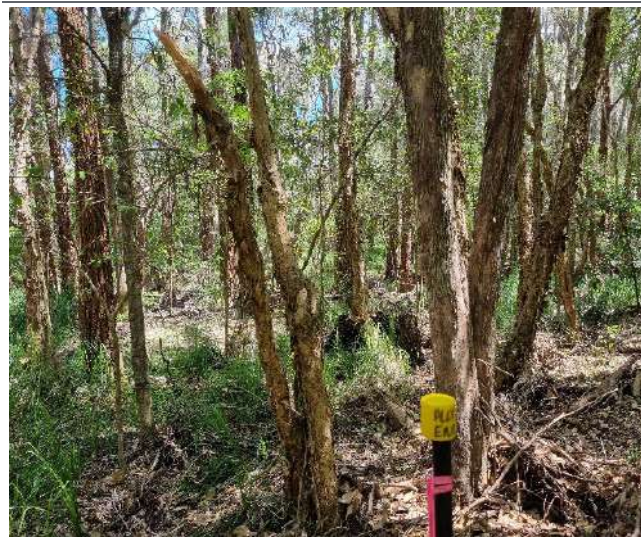
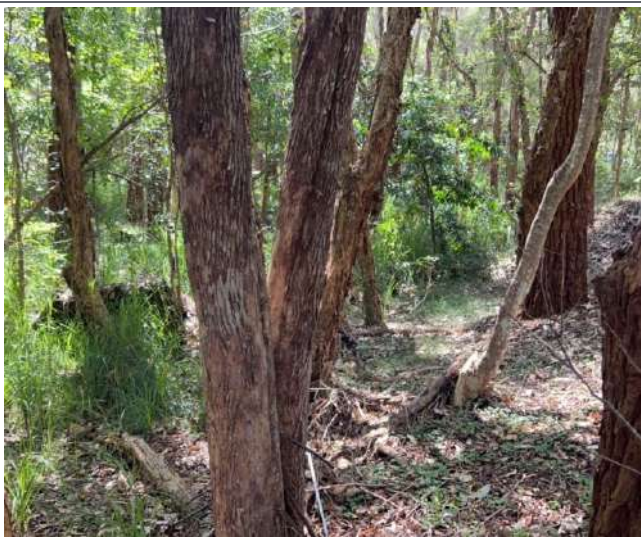
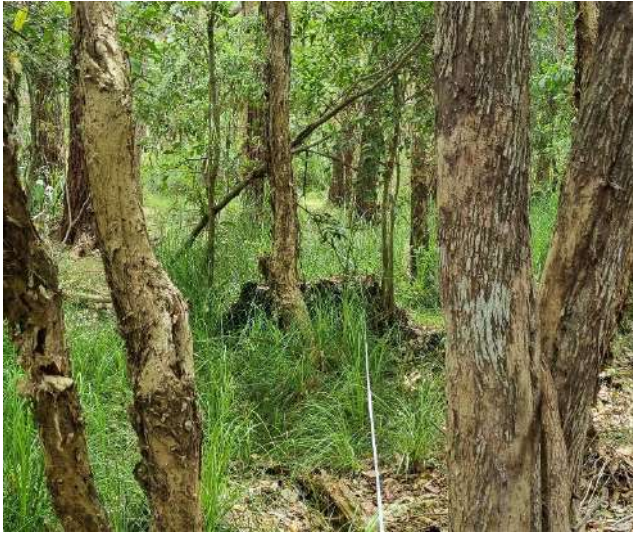
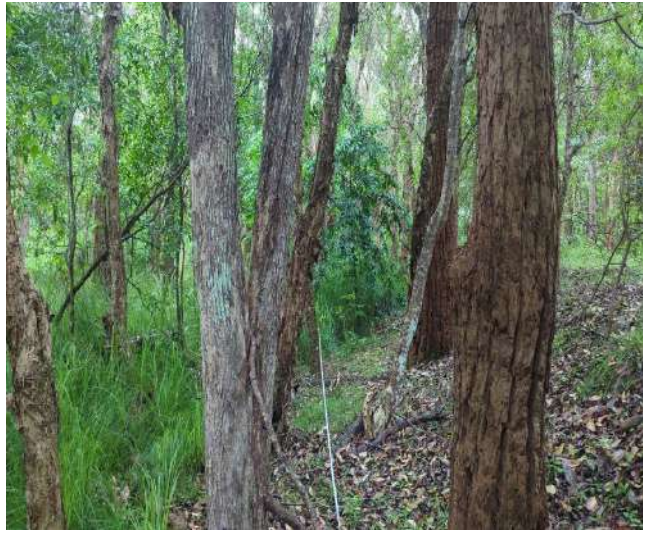
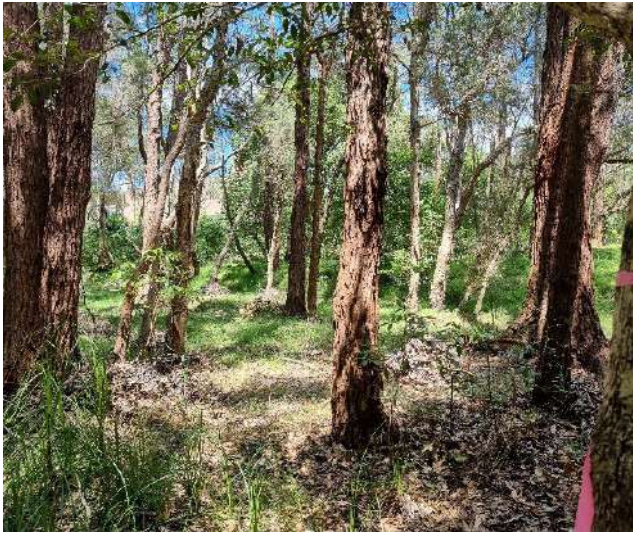
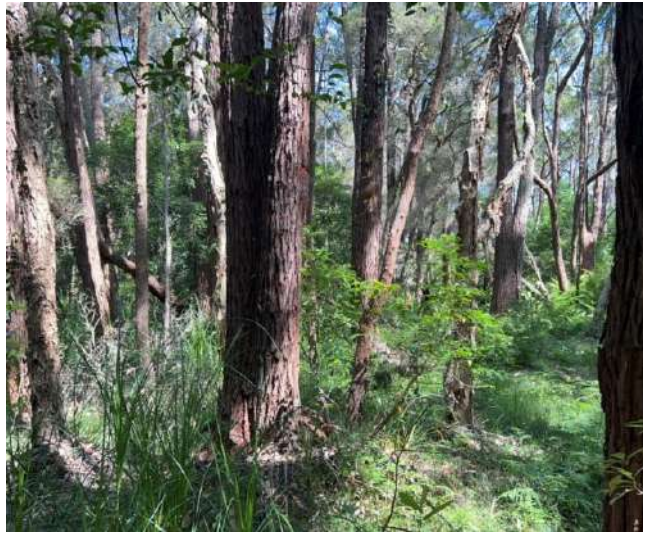
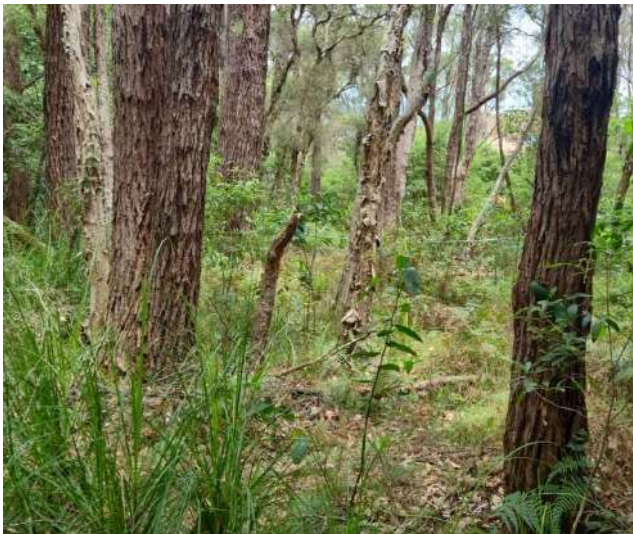
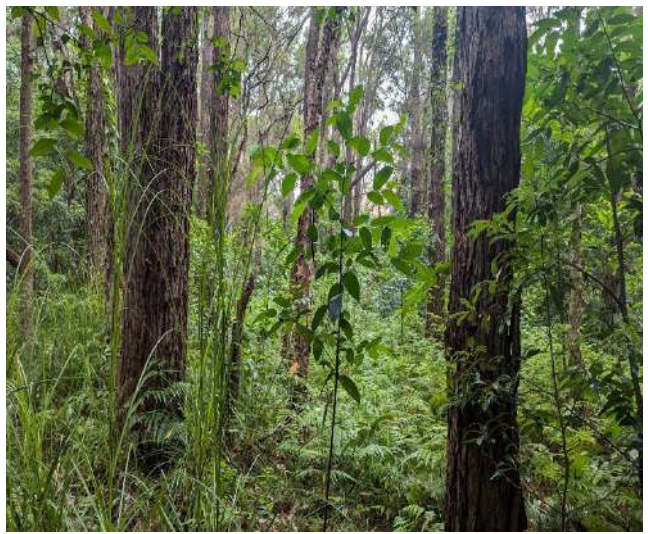
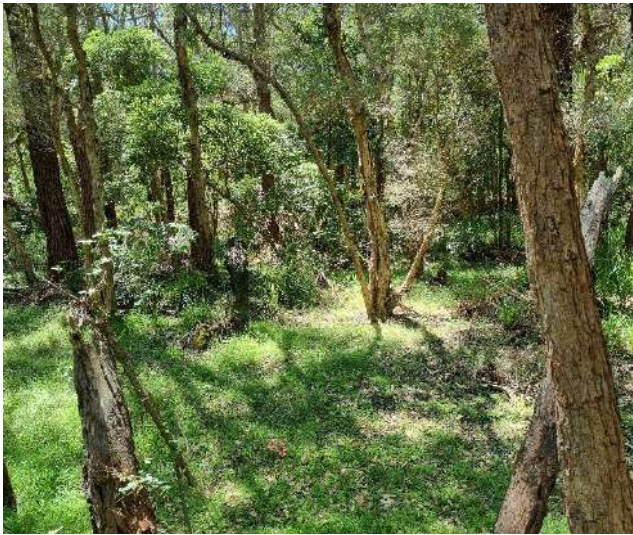
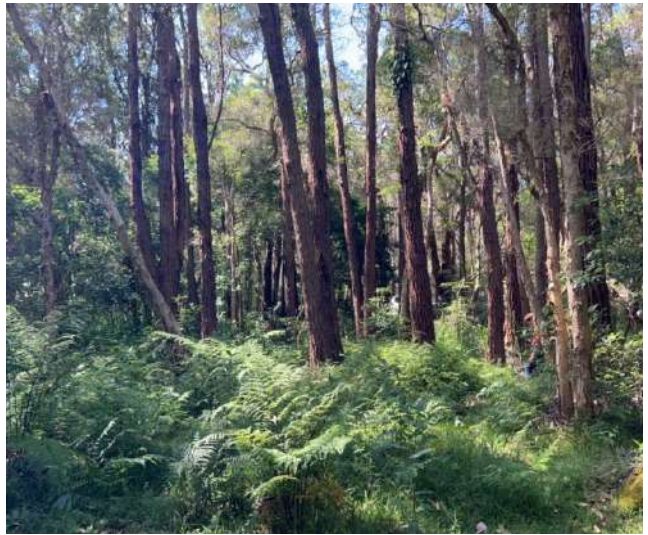
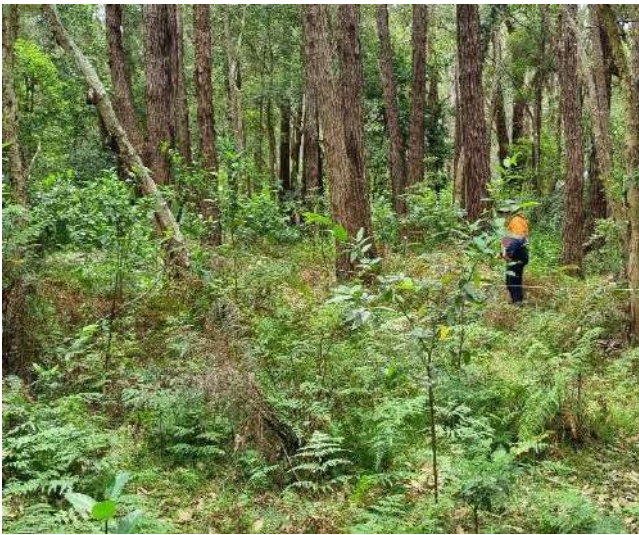
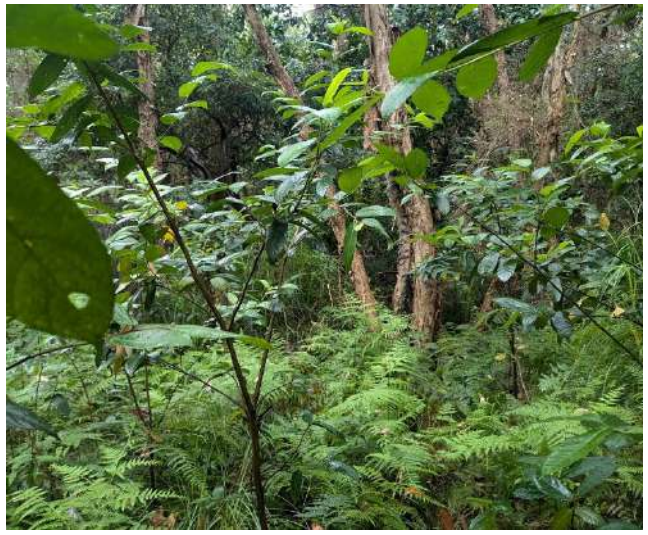
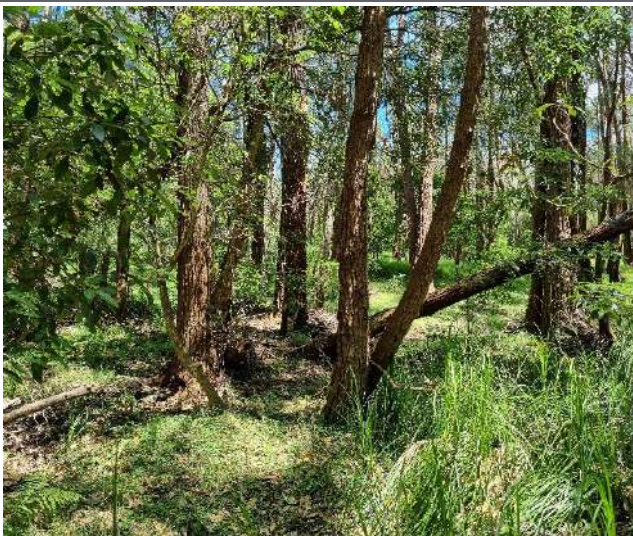
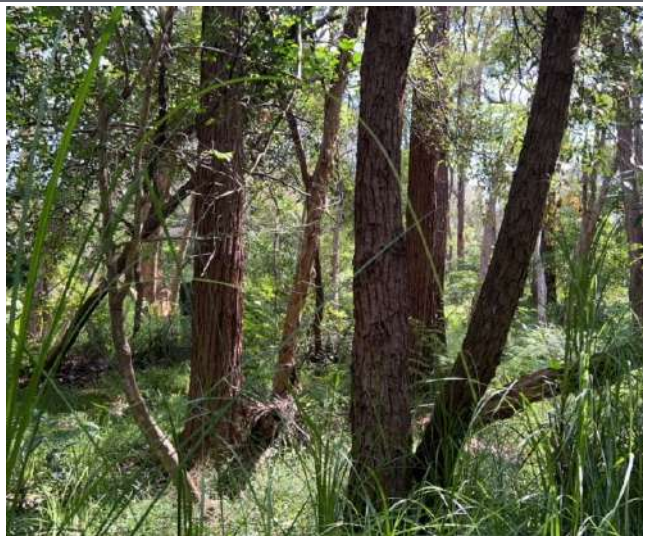
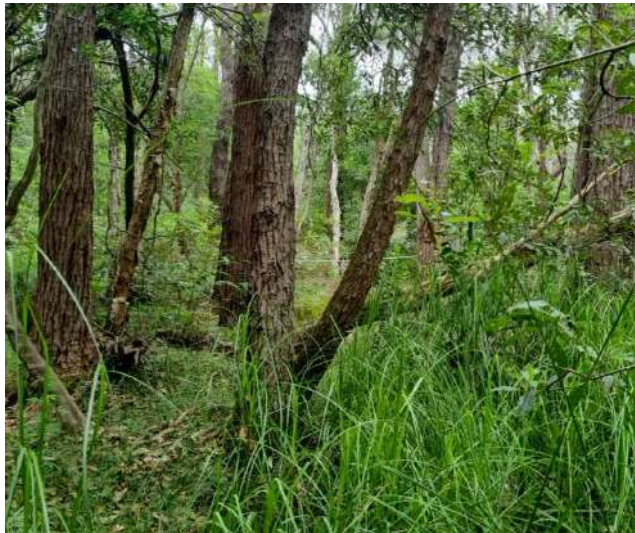
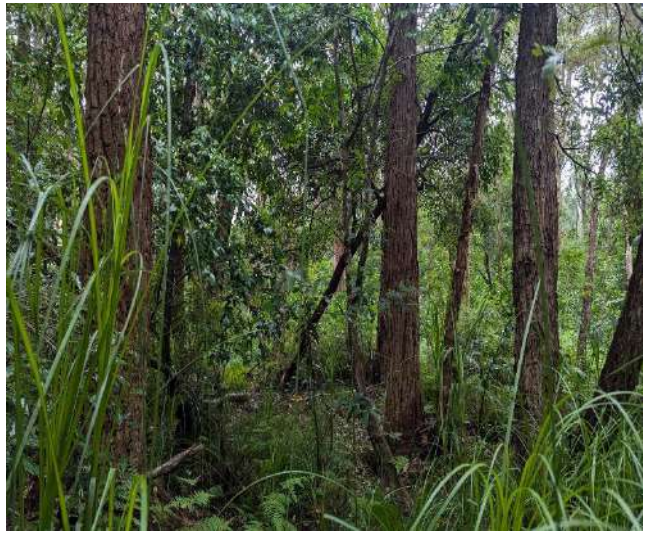
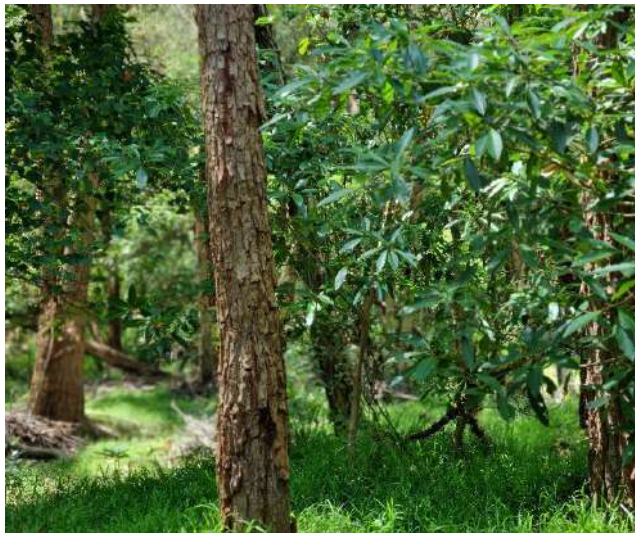
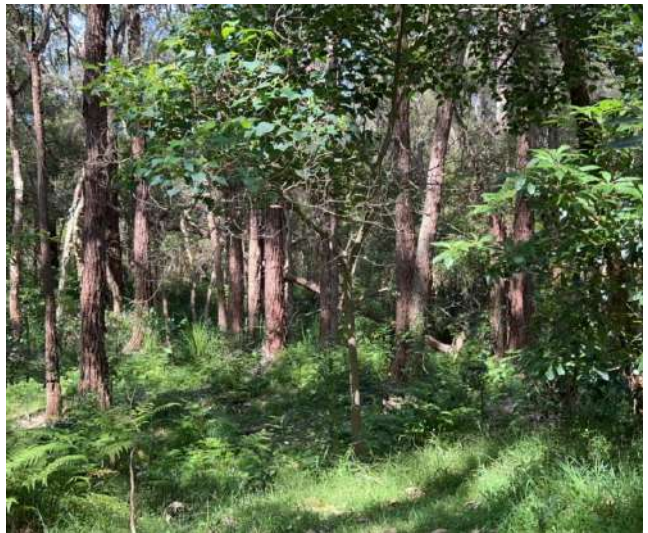
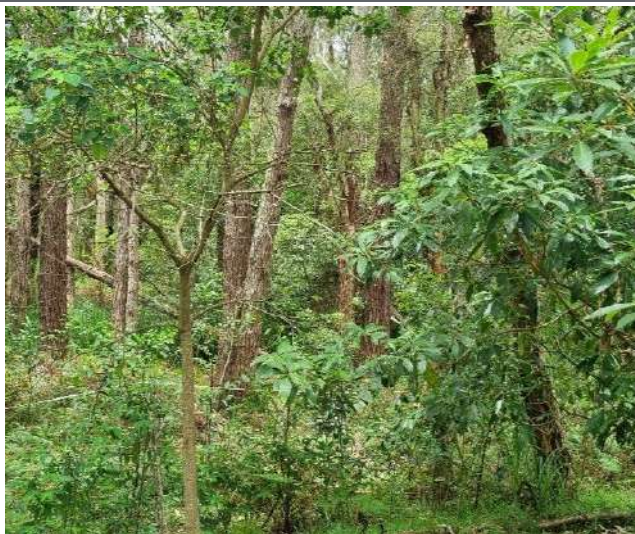
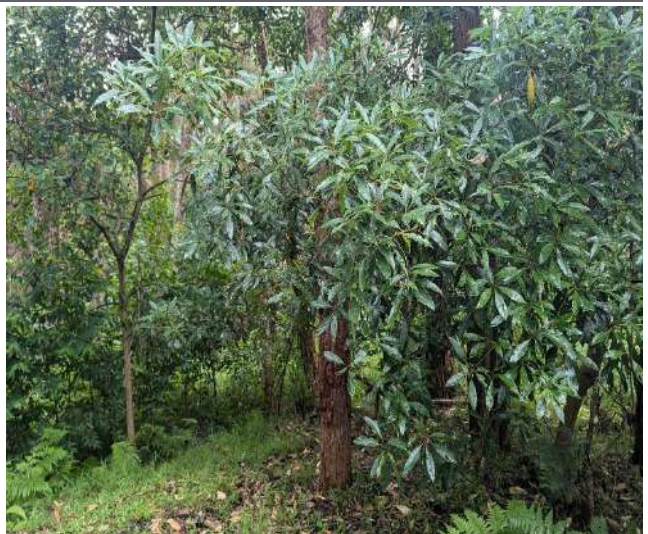
Table 3-10 Plot 3 - photo monitoring points

A comparison of images captured at the photo monitoring locations displays minimal variation in vegetation composition and structure, with any changes likely to be attributed to seasonal variations.
