ULAN COAL MINES PTY LTD

Ulan Underground Mine: Longwall W5
End of Panel Subsidence Report

ULA5114

DATE 19 April 2020

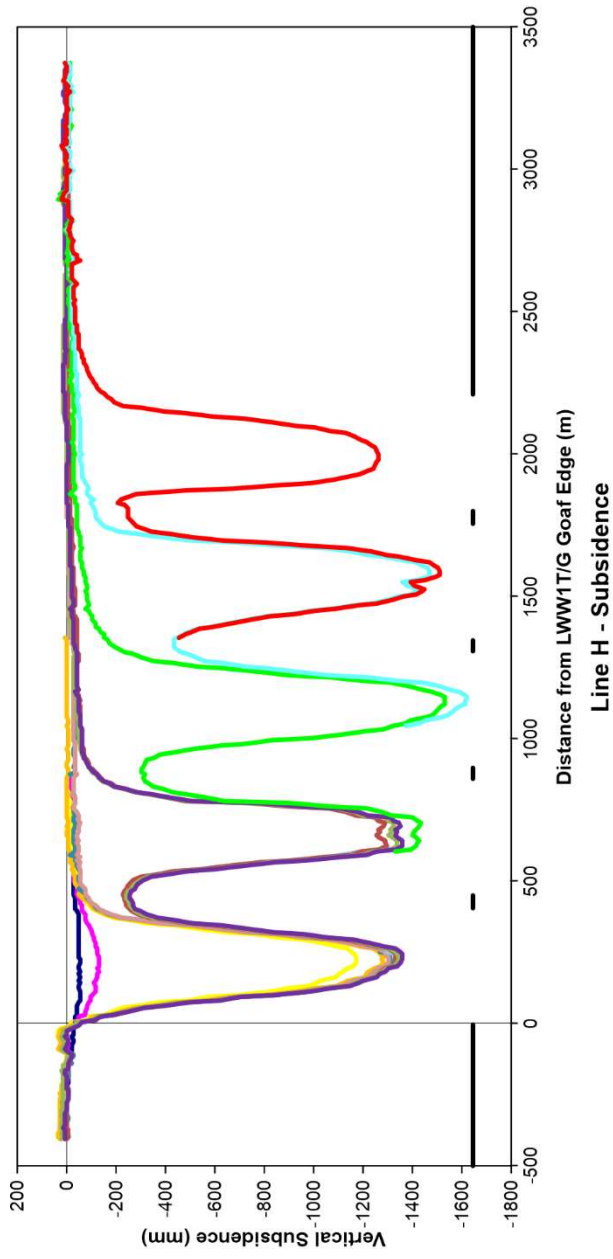
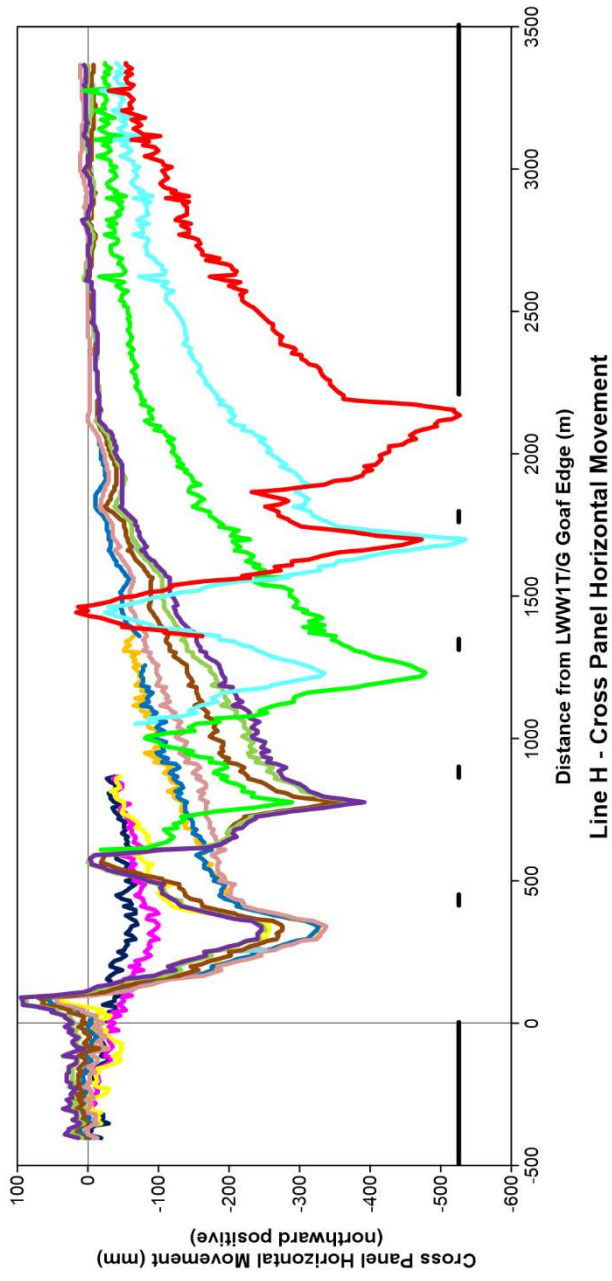
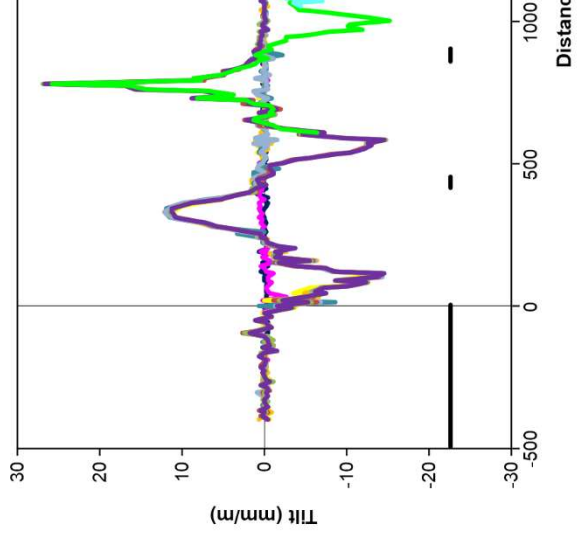
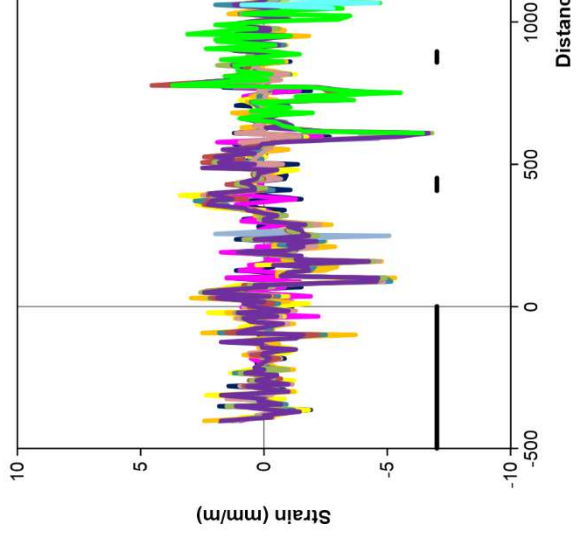
Maximum vertical subsidence measured above the first three panels in the western domain has increased across each successive panel. Vertical subsidence over the inter-panel chain pillars also increased. Maximum subsidence over Longwalls W4 and W5 has reduced so that maximum subsidence over Longwall W5 is similar to the maximum subsidence measured over Longwall W1.
