COBAR MANAGEMENT PTY LTD

The CSA Mine

Annual Environmental Management Report (AEMR) 2021

Name of Mine CSA Mine

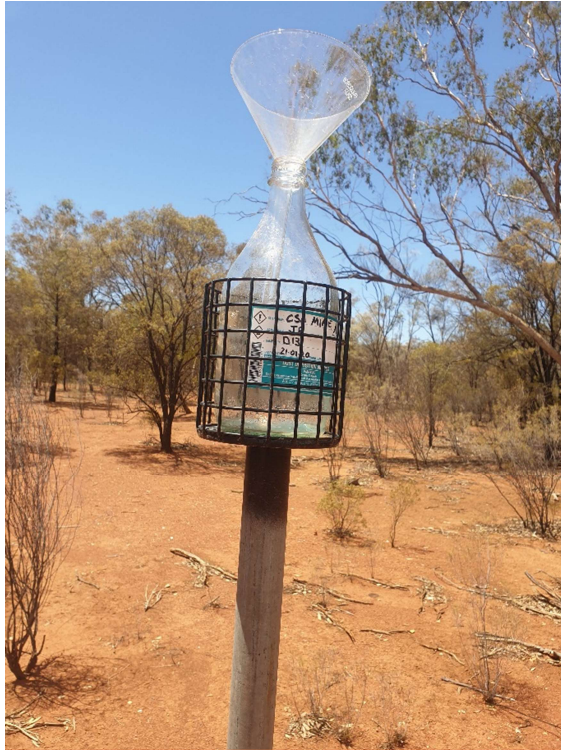
Figure 5 - Dust deposition gauge.

There were a total of 16 exceedances in 2021 (shaded in red – Table 21) which is significantly less when compared to 2020, which had 51. This reduction is attributed to better dust management practices onsite, which have included a new dust suppressant additive, frequency of water trucks increased, highly trafficked roads were gravel sealed, and the wetting frequency of tailings reclaim stockpiles at the Paste Fill Plant was increased.

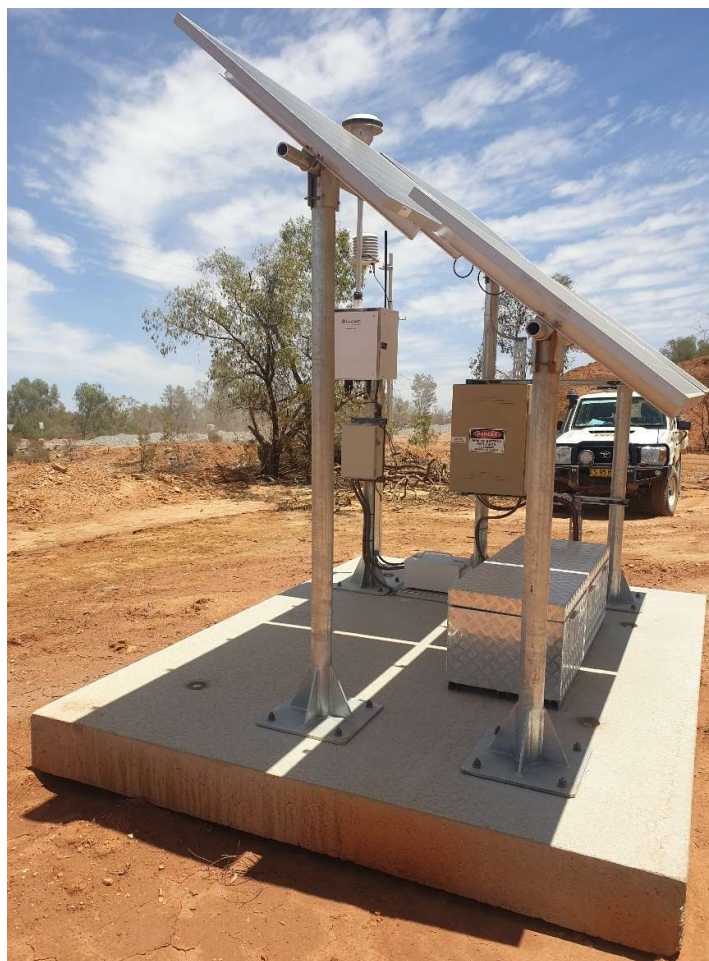
Figure 6 - EBAM Dust monitoring station.

CSA Mine also uses an additional ambient air quality monitoring station or EBAM (Figure 6), set up in 2019 which is located in the centre of site. This unit measures PM₁₀ dust particulate emissions continuously and a monthly NATA accredited report is provided by an external consultant. The EBAM station records average daily PM₁₀ dust emissions. These values are compared with the National Environment Protection Measures (NEPMs) standard of daily PM₁₀ dust emissions of 50 µg/m³. All exceedances are recorded.

The dust exceedances recorded on site in 2021 could be attributed to ongoing drought conditions in Cobar, above average wind run, increased haulage of excess waste rock, material storage associated with the commissioning and running of the Paste Fill Plant and the general construction works on site.

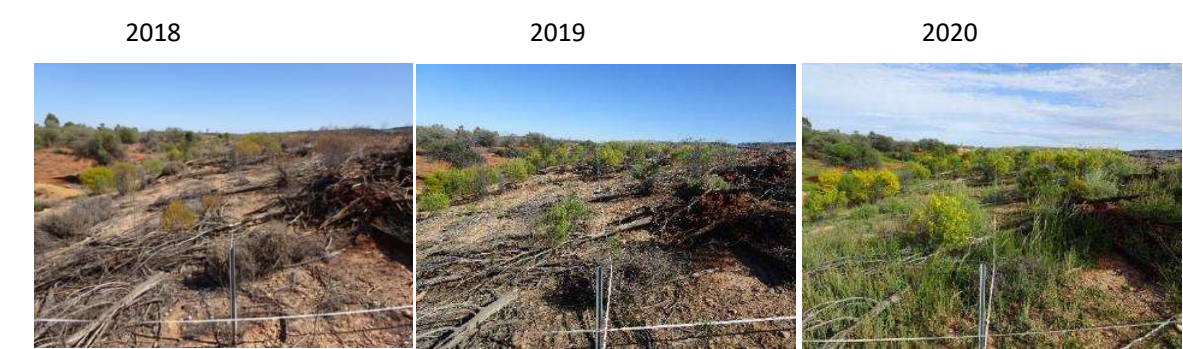
5.1.4 Property Vegetation Plan (PVP) Monitoring Sites

2019 Photo-point	2021 Photo-point
<p>PVP 01: This site was cleared in 2014 as part of the PVP project initiated by the LLS. There were large bare patches, and occasional litter patches had developed (annual plants had died off). There were occasional large deep holes which were probably created with the removal of mature trees. Scattered were scattered seedlings of <i>Senna</i> (two species), <i>Geijera parvifolia</i> (Wilga), <i>Eremophila mitchellii</i> (Budda) and <i>E. sturtii</i> (Turpentine). The soil was extremely hard. In 2018 there was little live ground cover and the litter and cryptogam patches had also deteriorated. Some <i>Calotis</i> spp. had germinated after relatively recent rainfall. Persisting shrubs had grown. In 2019, persisting shrubs had grown however there has been further loss of and deterioration of the litter and cryptogam patches, and there was limited live ground cover. In 2021 patch area continued to be very low ranging from 0 – 14%.</p>
