Tahmoor Coal Pty Ltd

MINE OPERATIONS PLAN

Tahmoor Coking Coal Operations – SIMEC Mining

2020-2024

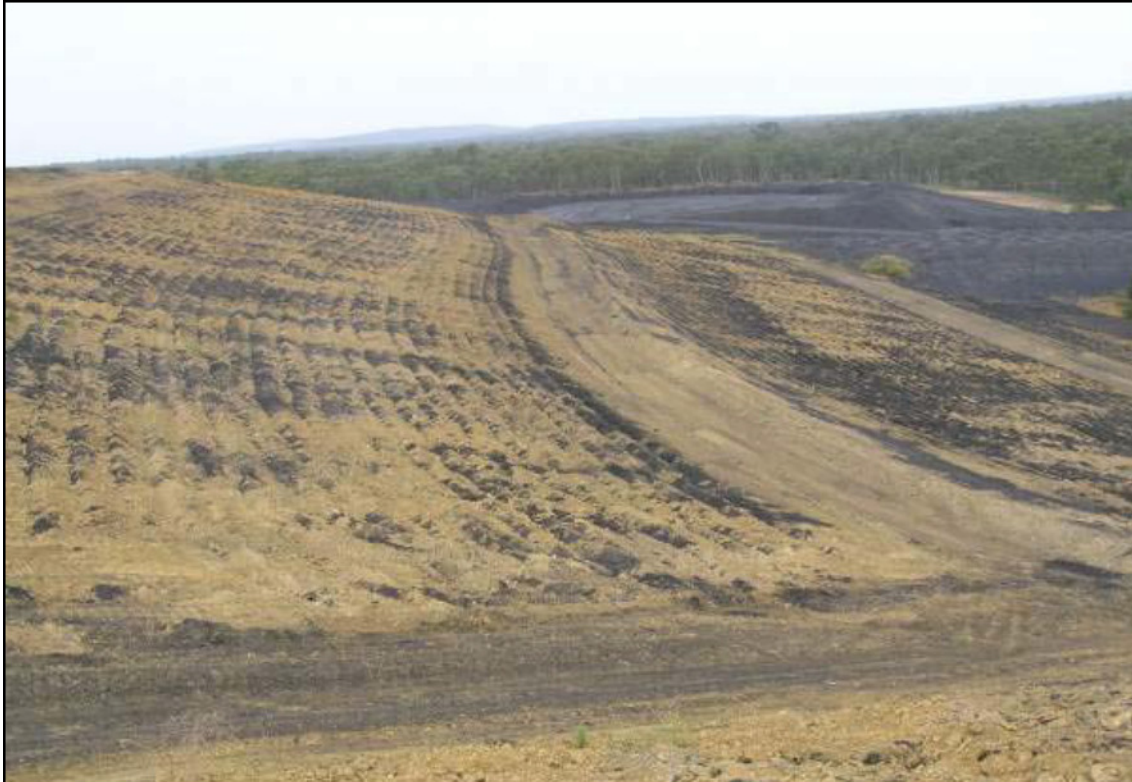
Prior to top soiling and seeding the REA rehabilitation site, the underlying material (reject or subsoil) is to be contour ripped down to the first graded bank to between 400 and 500mm depth. This method is shown in Figure 1 below and is undertaken in this sequence to avoid reject material being brought to the surface.

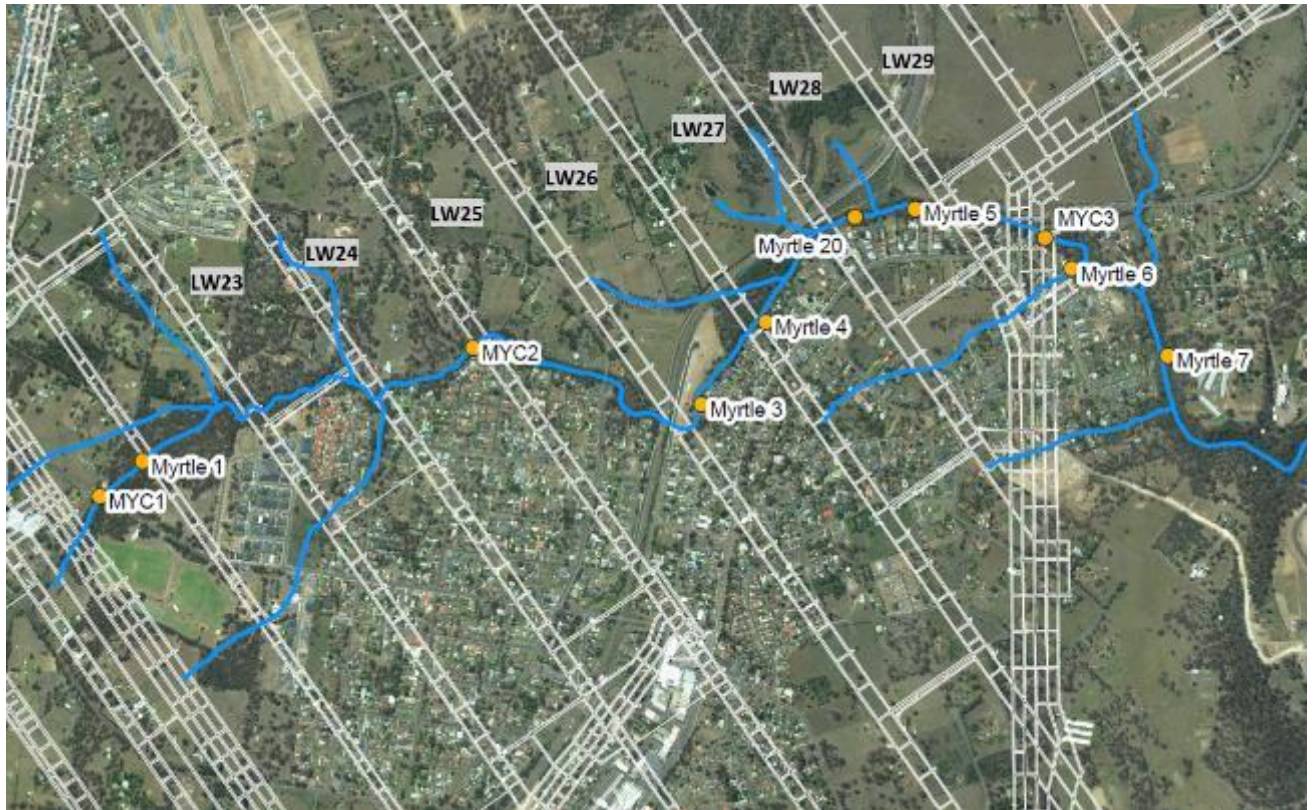
Level monitoring are conducted at various locations along Myrtle Creek (refer to **Figure 1**).

Figure 1: Myrtle Creek Surface Water Monitoring Locations

Flow monitoring are conducted at various locations along Myrtle Creek (refer to **Figure 1**).

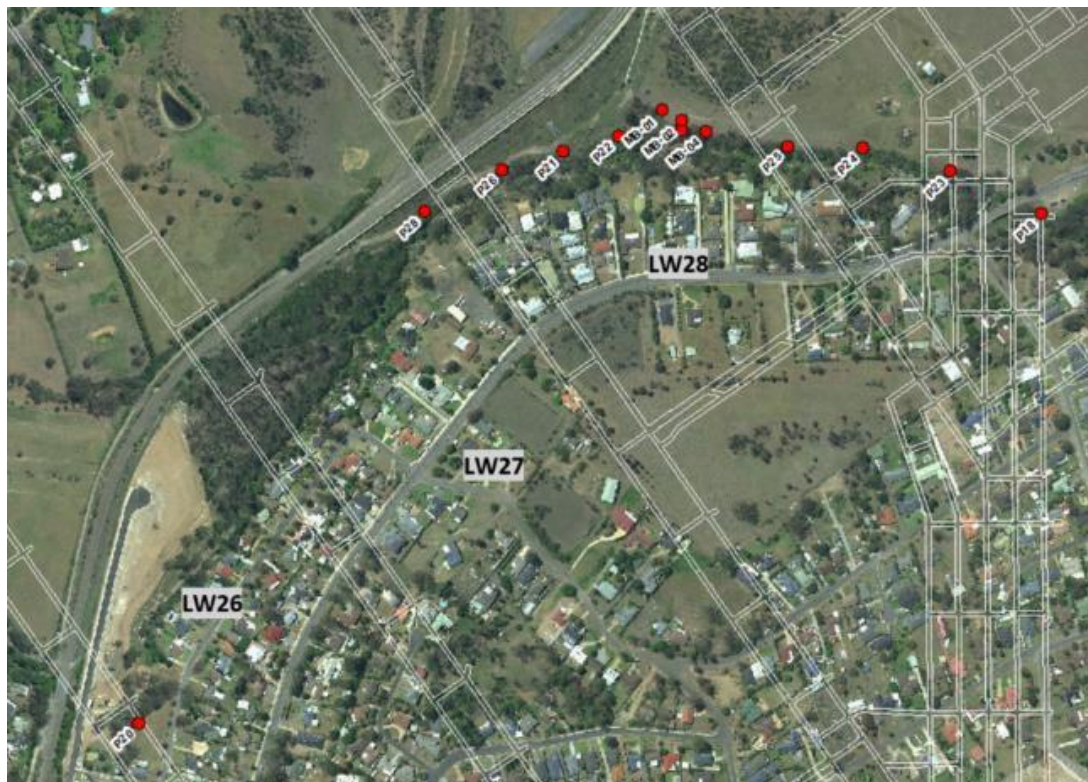
Figure 2 illustrates locations of groundwater monitoring bores along the banks of Myrtle Creek that were installed following characterisation drilling as part of the CMAP. Further piezometers were also installed to the first water intersection depth, as observed where dust cut out during the open hole PCD drilling process, plus an additional 5m (P18A, P20A, P21A, P21A, P24A and P28A). Piezometers monitor standing water levels within the groundwater system. Additional groundwater monitoring bores (MB-01 to MB-04) were installed as part of the Pool 23 Trial Project. Groundwater monitoring at all sites at Myrtle Creek will continue during Stage 2.

Figure 2: Myrtle Creek Groundwater Monitoring Piezometers

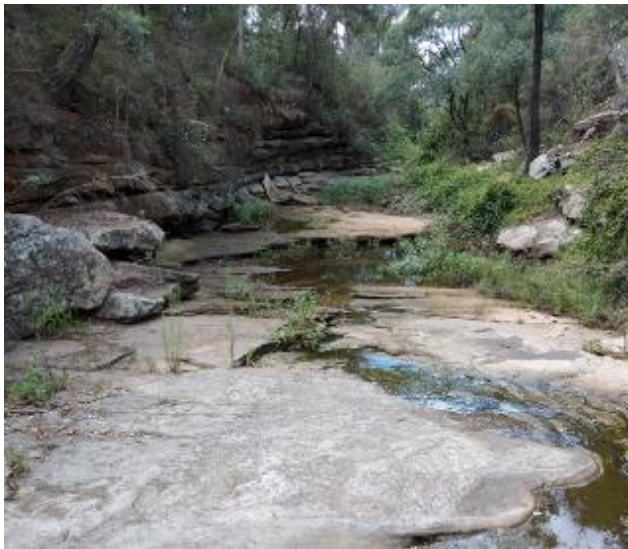
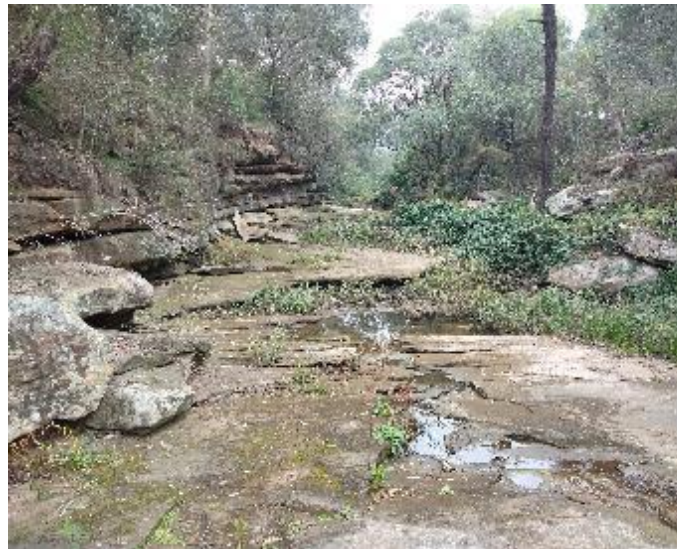
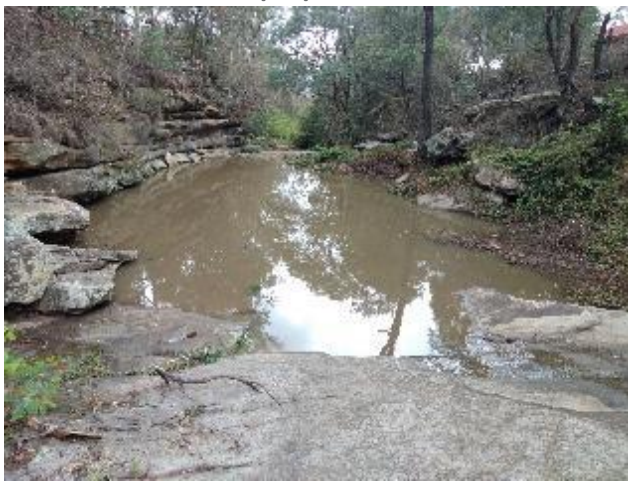
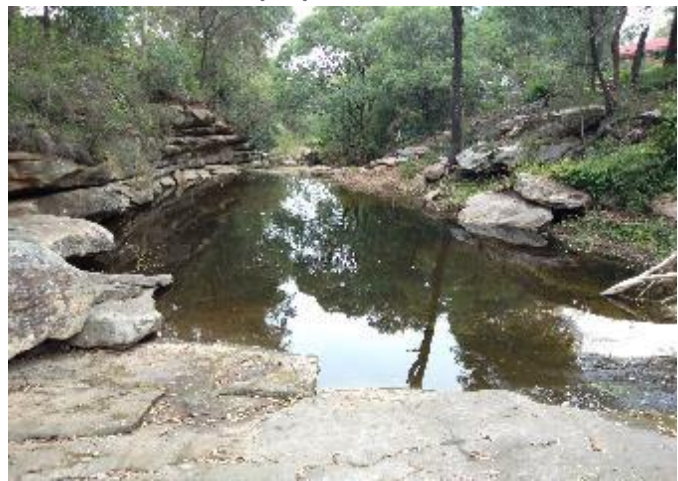
Following the completion of Stage 4 in February 2020, Pool 23 has filled and overtopped its rock-bar. At the time of writing this report there has been no observable drop in pool level and long-term monitoring will continue to inform the remediation of Pool 23. **Figure 8** demonstrates the pre and post remediation impact at Pool 23.

Pre-remediation – 05/03/2019

Pre-remediation - 01/05/2019

Post-remediation – 21 January 2020

Post-remediation – 8 March 2020

Figure 8: Pool 23 pre and post remediation

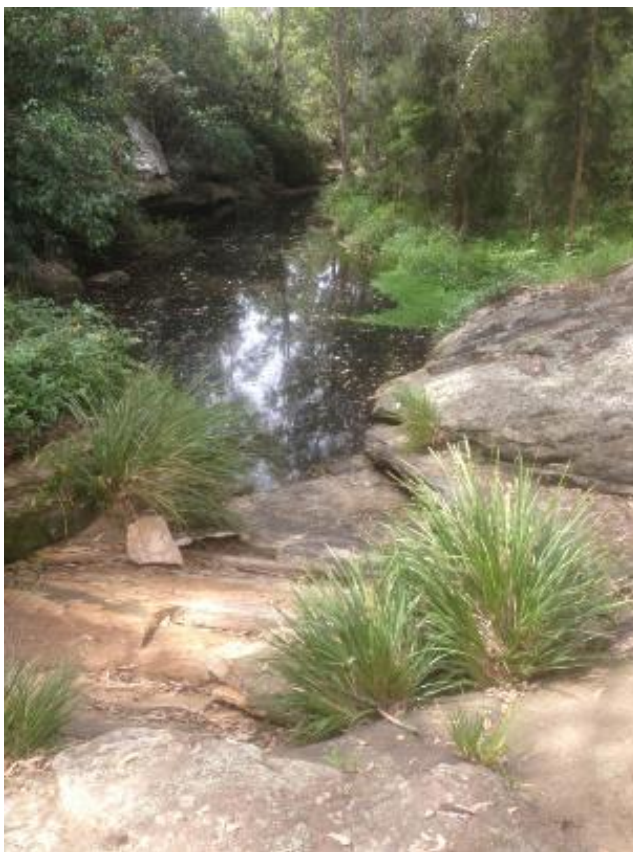
Cracking and loss of flow was first observed during LW27 and 13 June 2014. The TARP was triggered on 20 August 2014. **Figure 11a** is a photograph of Pool 20 pre-mining, and **Figure 11b** shows the typical condition of Pool 20 post-mining. **Figure 12** shows subsidence related cracks observed on the controlling rock bar at Pool 20. Prior to impacts, Pool 20 was observed to hold water during normal environmental conditions.

Figure 11a: Pool 20 Pre-Mining (23/03/2012)

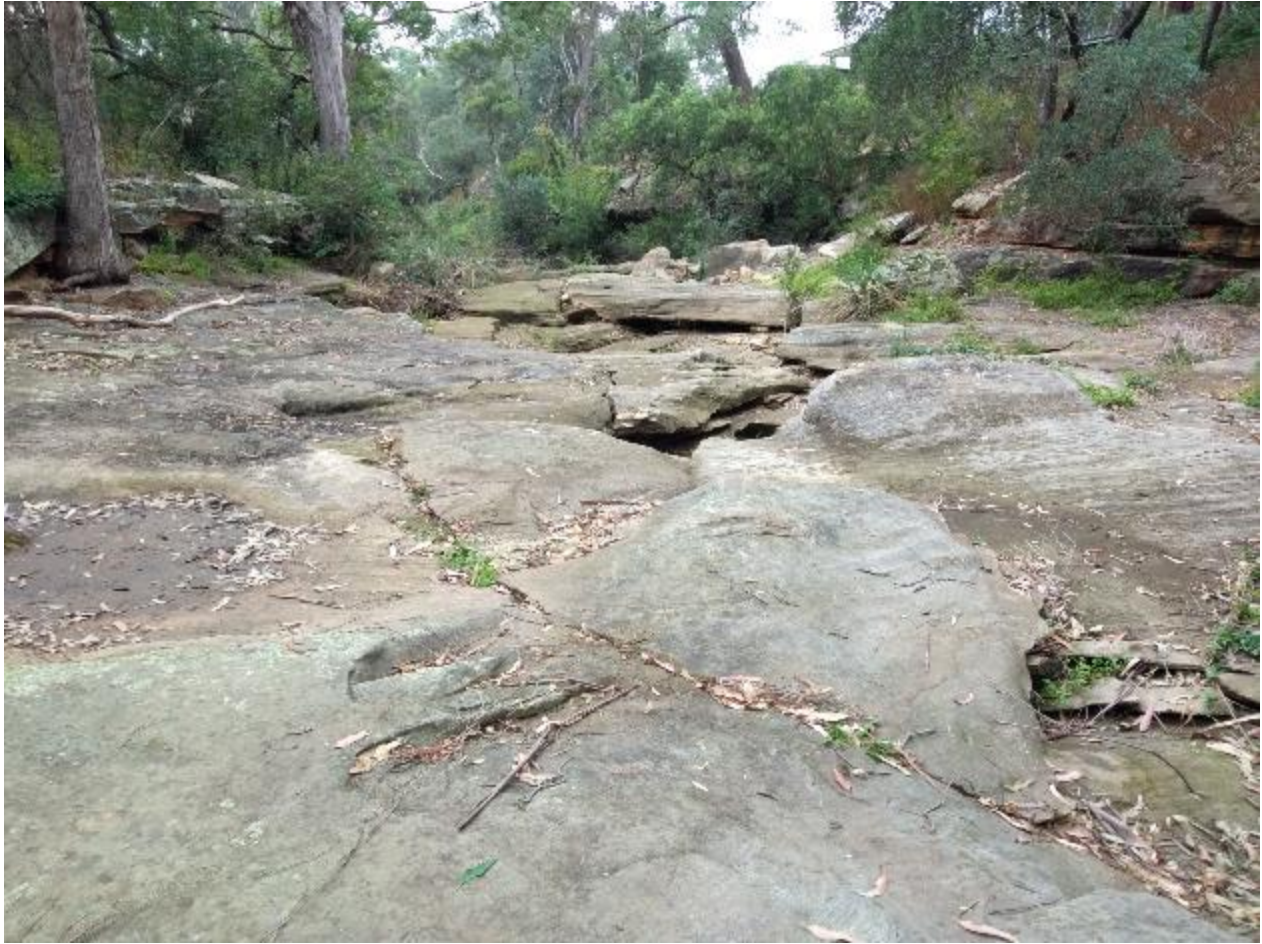
Figure 12: Pool 20 Controlling Rock Bar

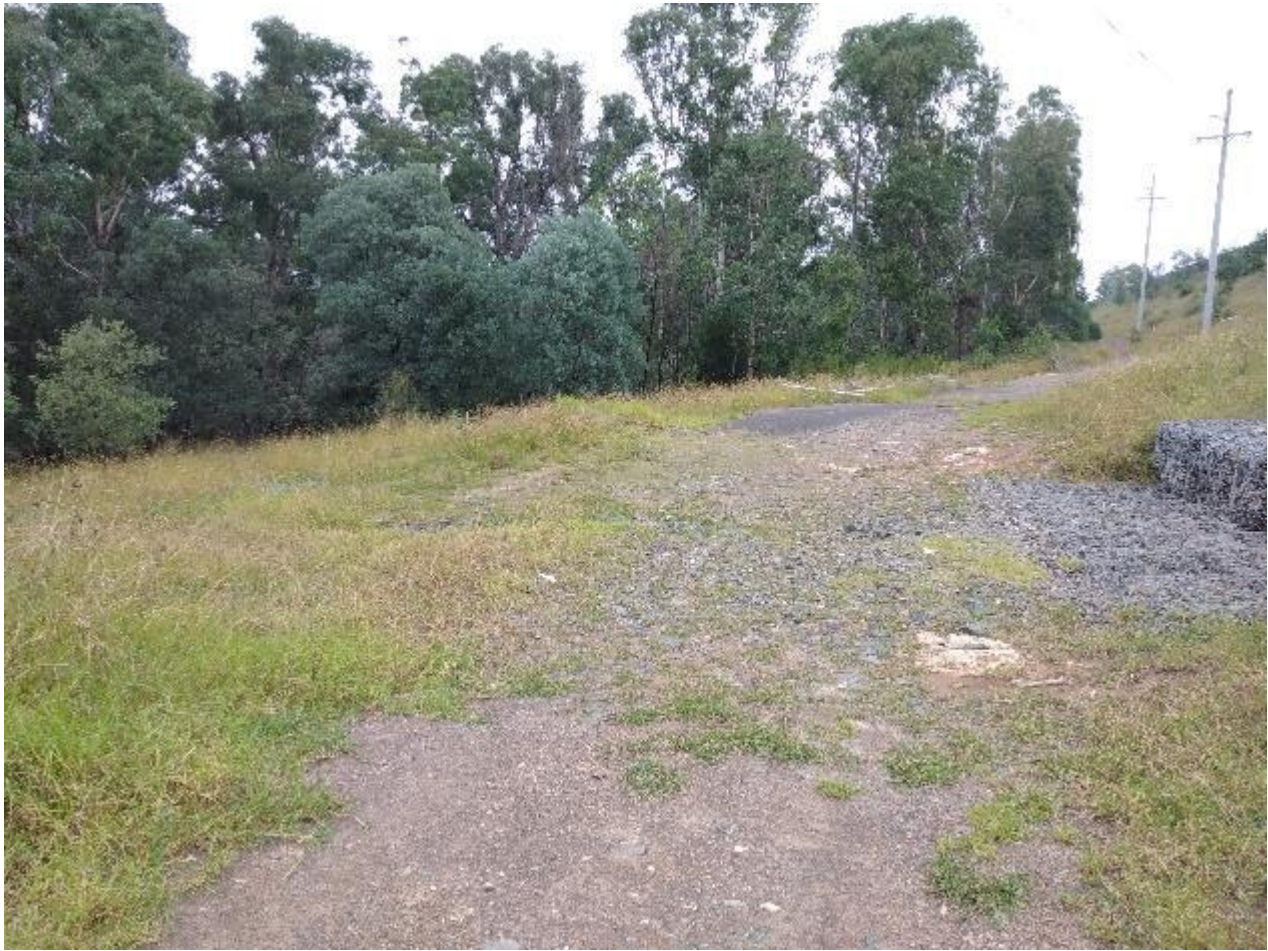
The southern bank is bound by residential dwellings. The northern bank allows for a laydown area and space for a site compound. Tahmoor Coal has previously secured land access via a property to the north of Pool 20 for previous remediation works and it is anticipated this will continue for this project. **Figure 13** shows the northern banks, which is anticipated to set up a small Site Compound for remediation works at Pool 20 and Pool 18, and possibly further upstream.

Figure 13: Northern bank of Pool 20

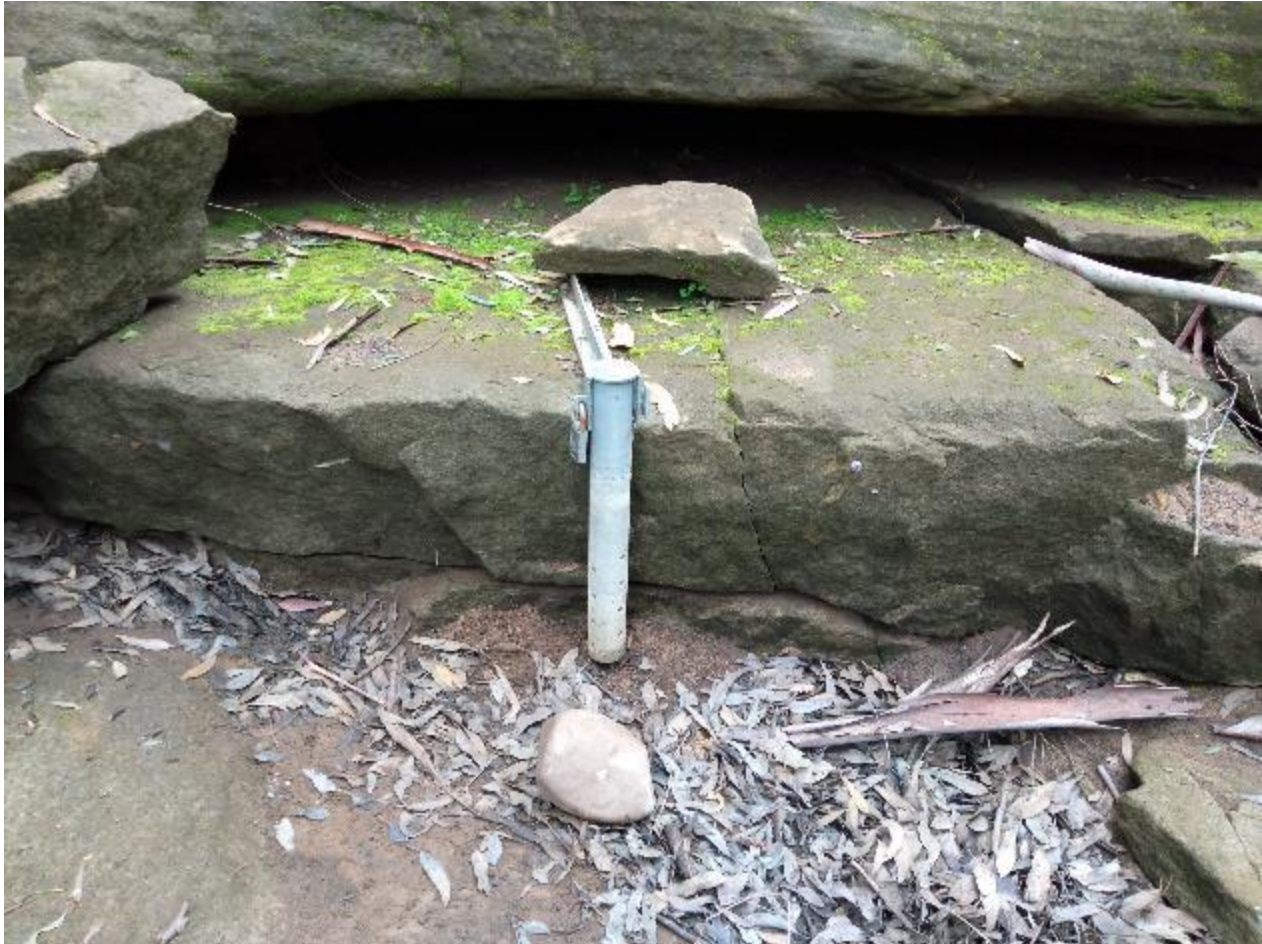
A level monitoring device was installed in Pool 20 in June 2019 (see **Figure 14**). This will be used to determine the recession rate using natural and artificial pool testing.

Figure 14: Water Level Monitoring Device at Pool 20 (M20)

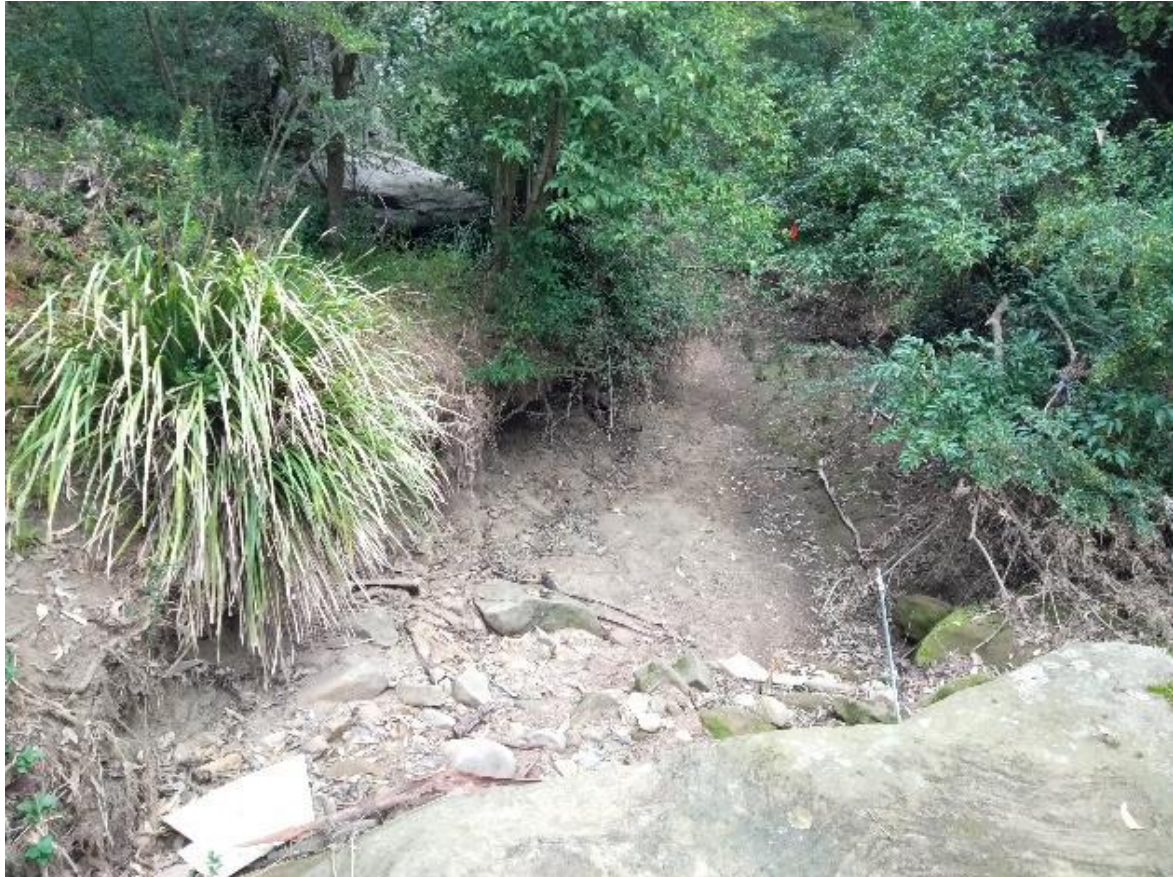
Pool 18 is located within Longwall 27, approximately 22m west of the chain pillar between Longwall 27 and Longwall 28. **Figure 15** shows the typical condition of Pool 18 following subsidence impacts.

Figure 15: Pool 18 Post-Mining

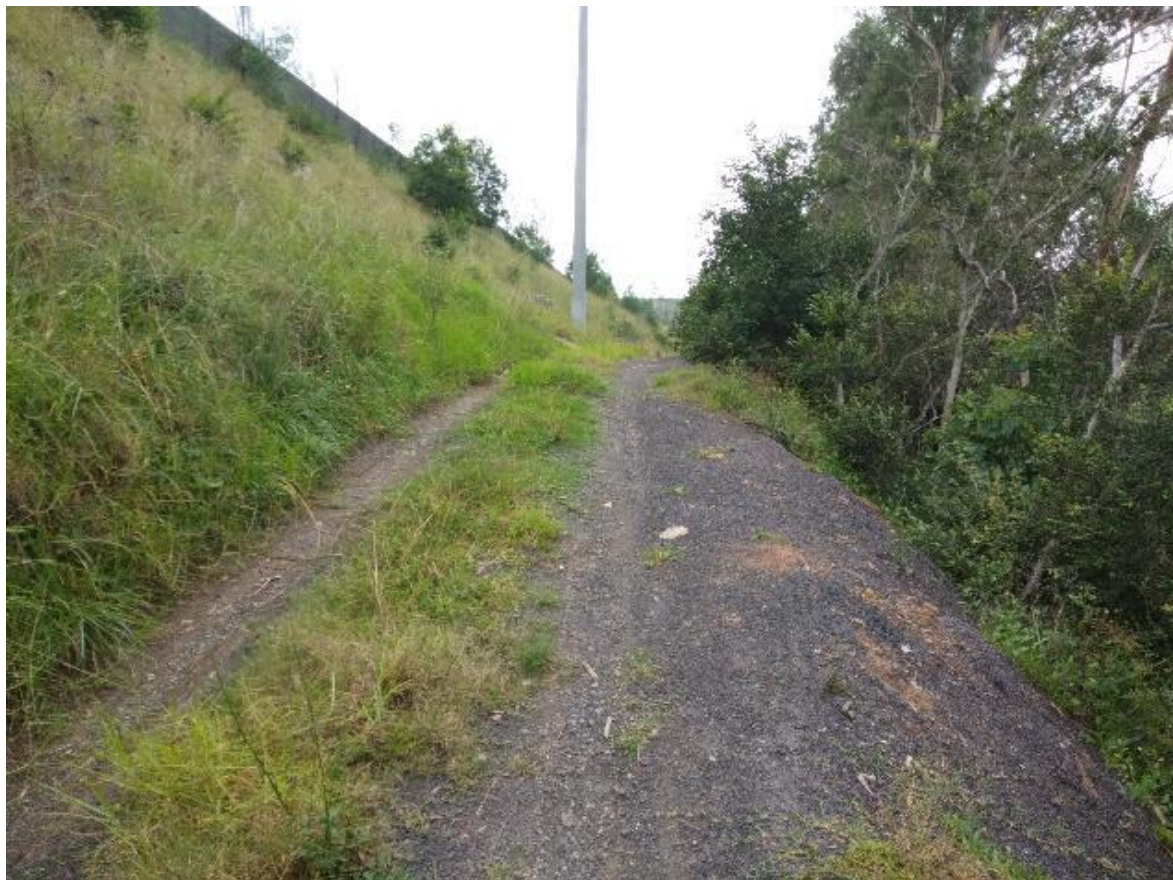
Figure 16: Proposed access way to Pool 18

The southern bank at Pool 18 is bound by residential dwellings, while the northern bank is bound by the Great Southern Railway rail corridor. **Figure 16** illustrates the narrow access path to the proposed Pool 20 Site Compound. Access is proposed using the railways corridor access path, using the Pool 20 Site Compound at land with which Tahmoor Coal has a land access agreement.

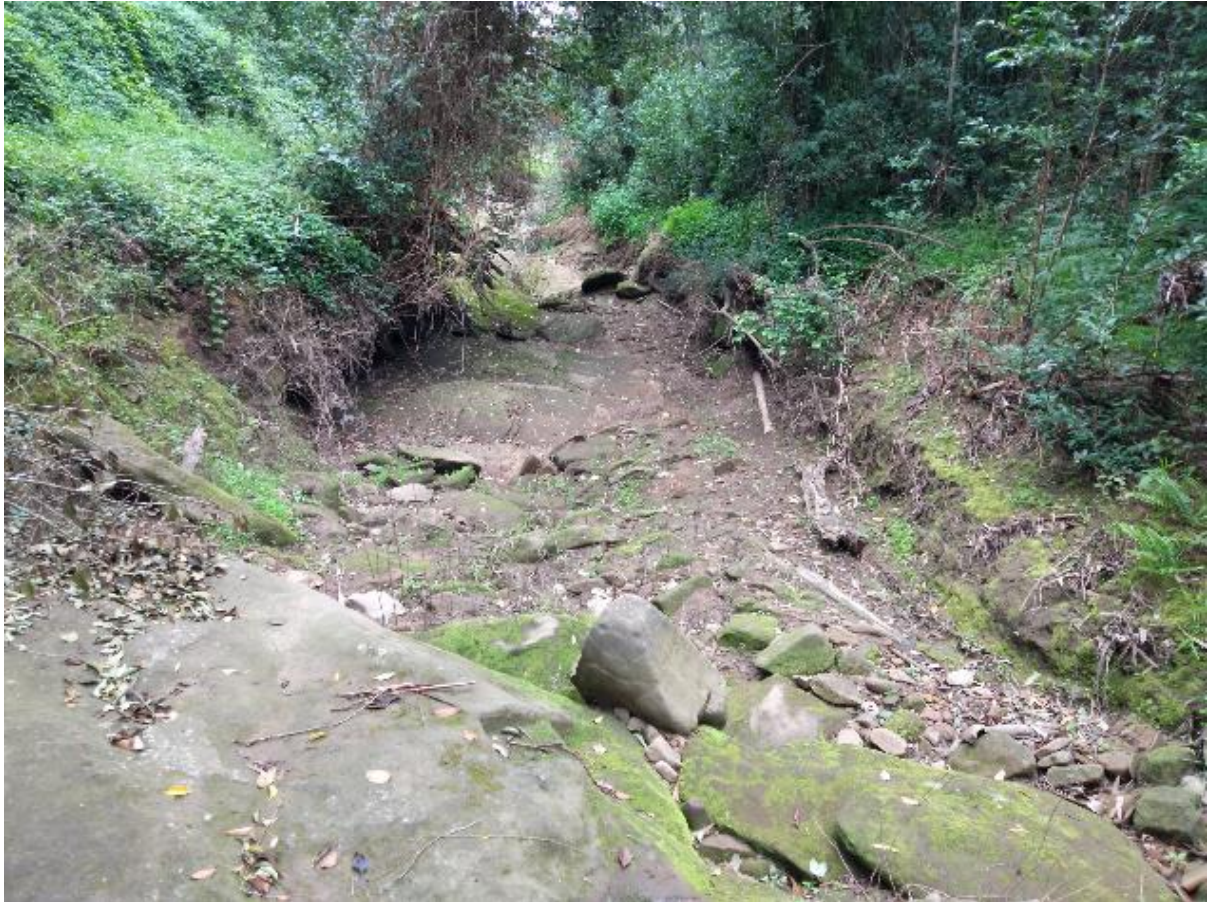
Figure 17: Pool 14 Post-Mining (facing downstream)

Pool 14 is located in the centre of Longwall 27, approximately 140m east of the western border of the chain pillar between Longwall 26 and Longwall 27. **Figure 17** and **Figure 18** shows the typical condition of Pool 14 following subsidence impacts.

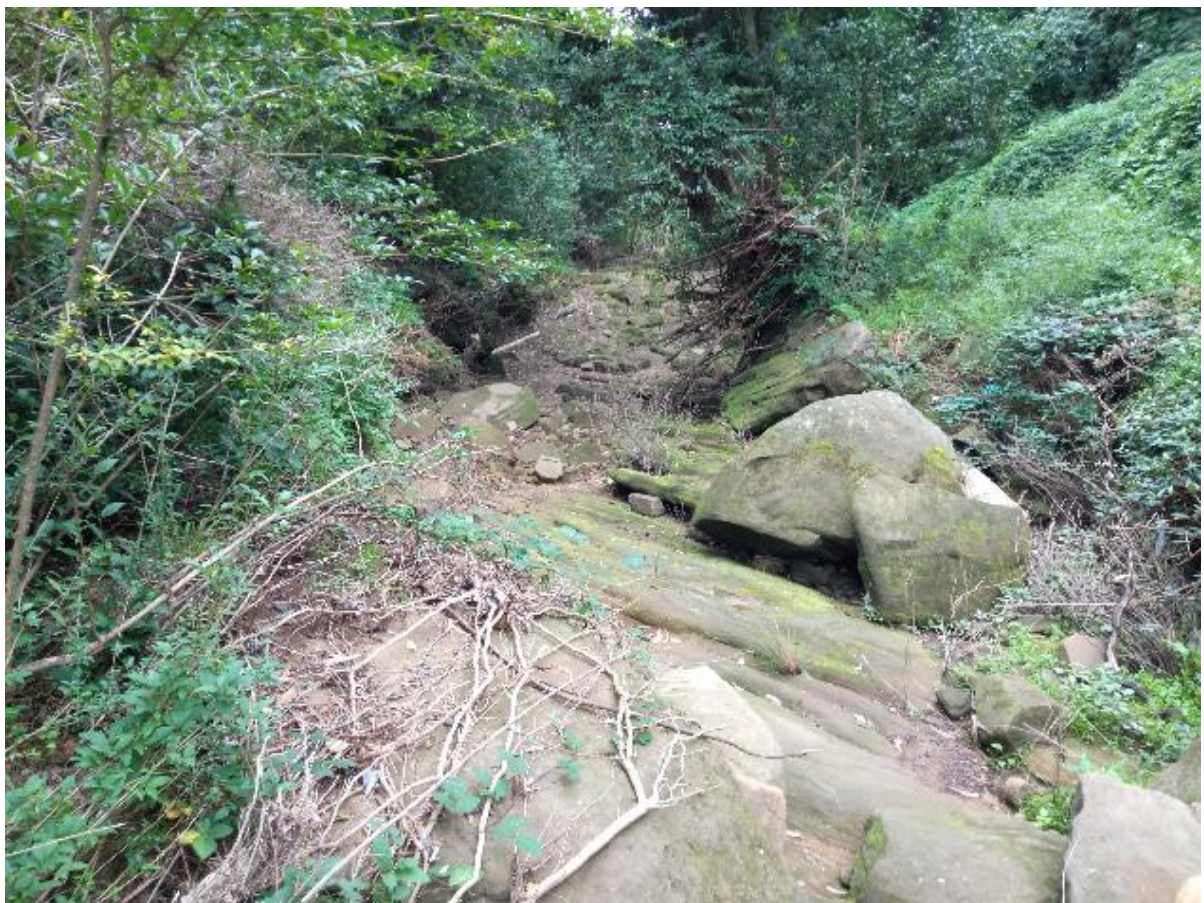
Figure 18: Pool 14 (facing upstream)

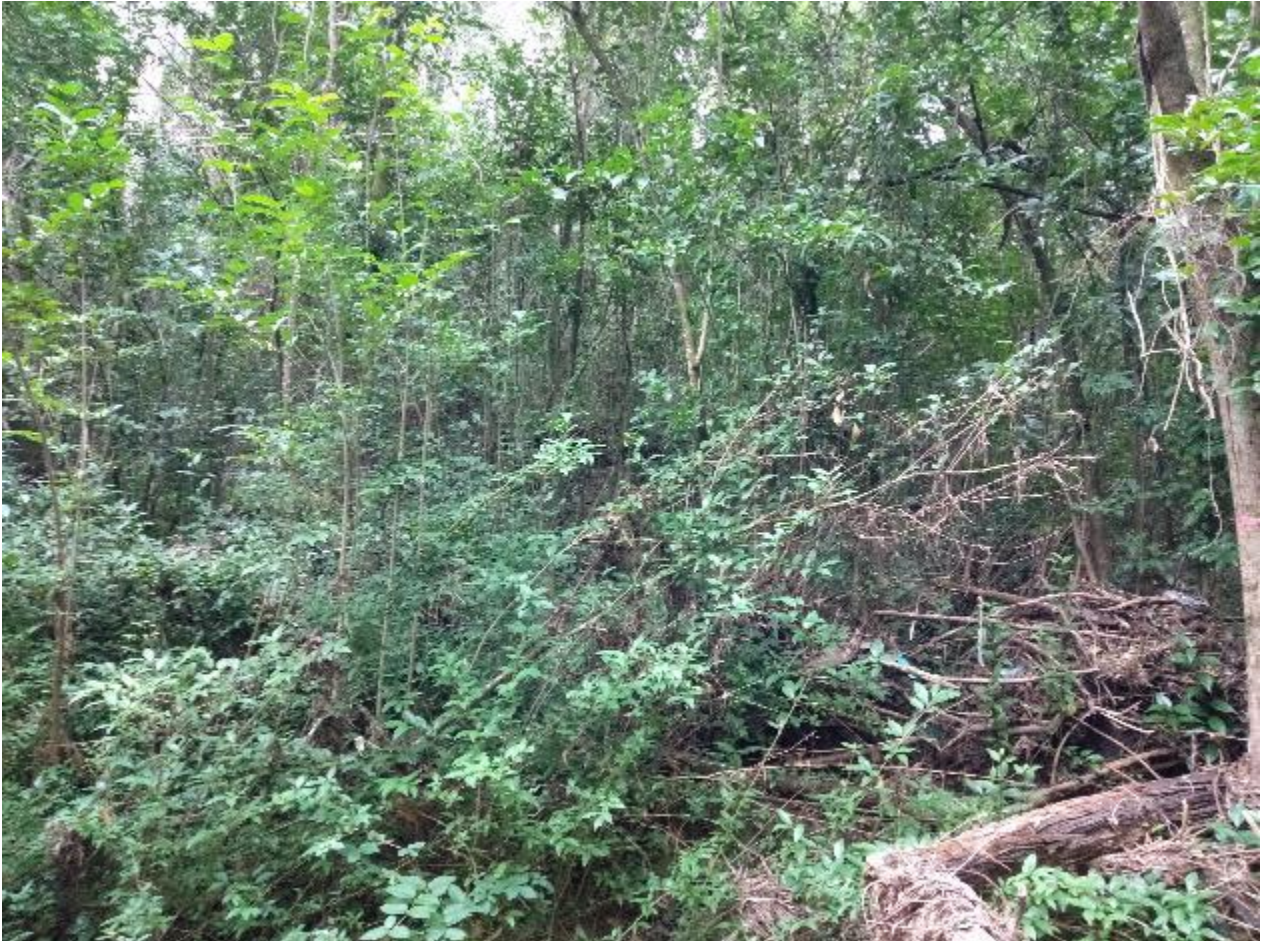
Pool 14 is heavily vegetated on both banks and access is poor. **Figure 19** illustrates the heavily vegetated and steep northern bank. Access is proposed via the north bank, through a narrow pathway and onto landowner's property with whom Tahmoor Coal has a land access agreement.

Figure 19: Northern banks at Pool 14

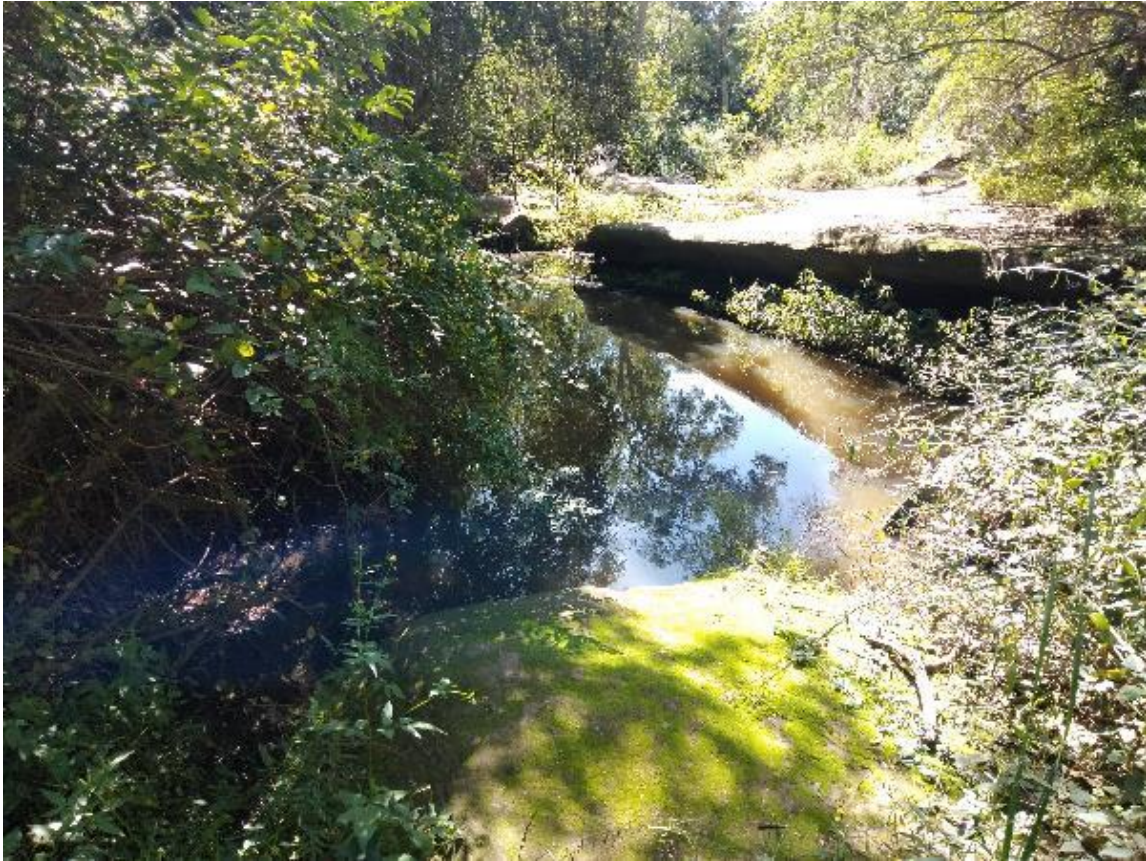
Figure 20: Pool 12a

Pool 12a is a small round pool at the end of Pool 12; which is a long, narrow pool that is typically dry. Its controlling structure is a large sandstone rock bar with a height of approximately 2m above the base of the pool base. **Figure 20** shows the typical pool holding capacity at Pool 12a, while **Figure 21** shows Pool 12. Pool 12a is located approximately 96m east of the eastern roadway of the chain pillar between LW26 and LW27.

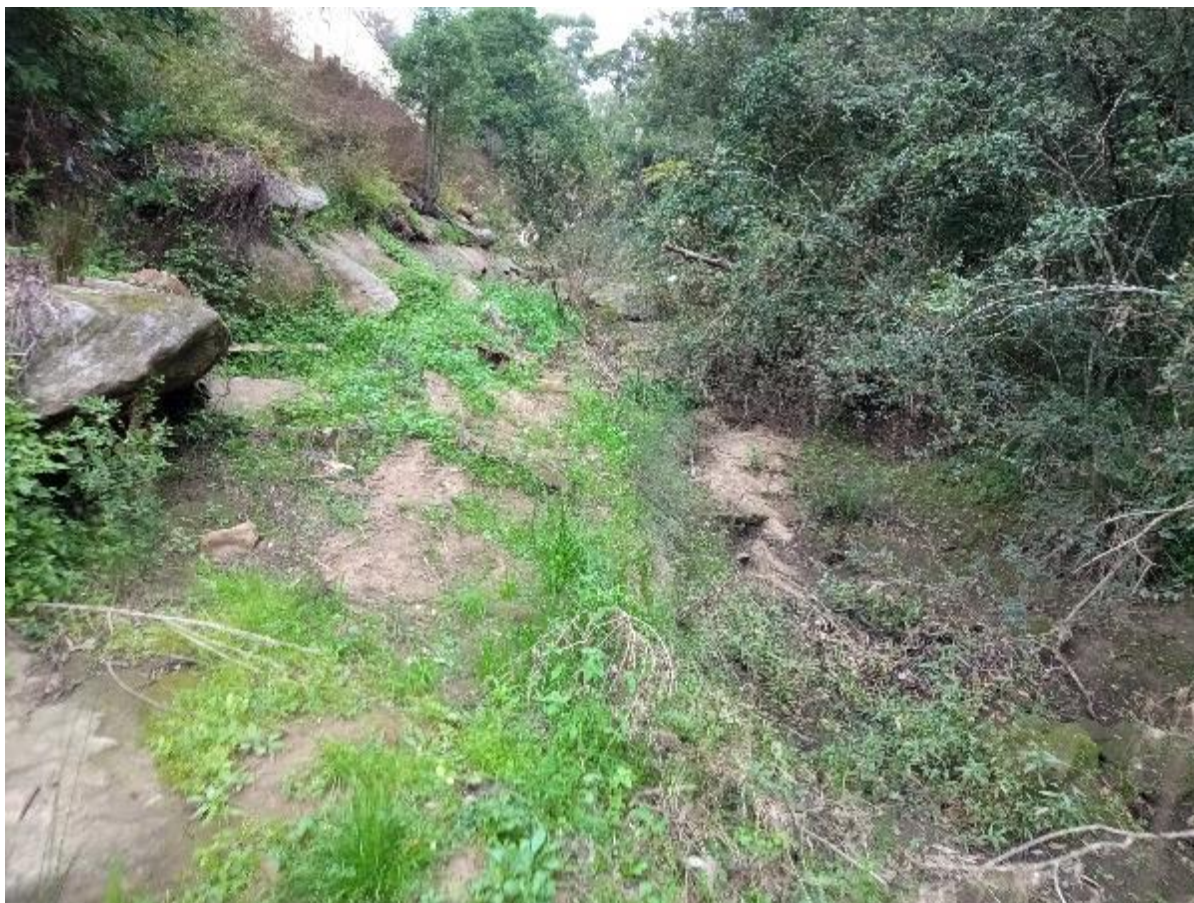
Figure 21: Pool 12

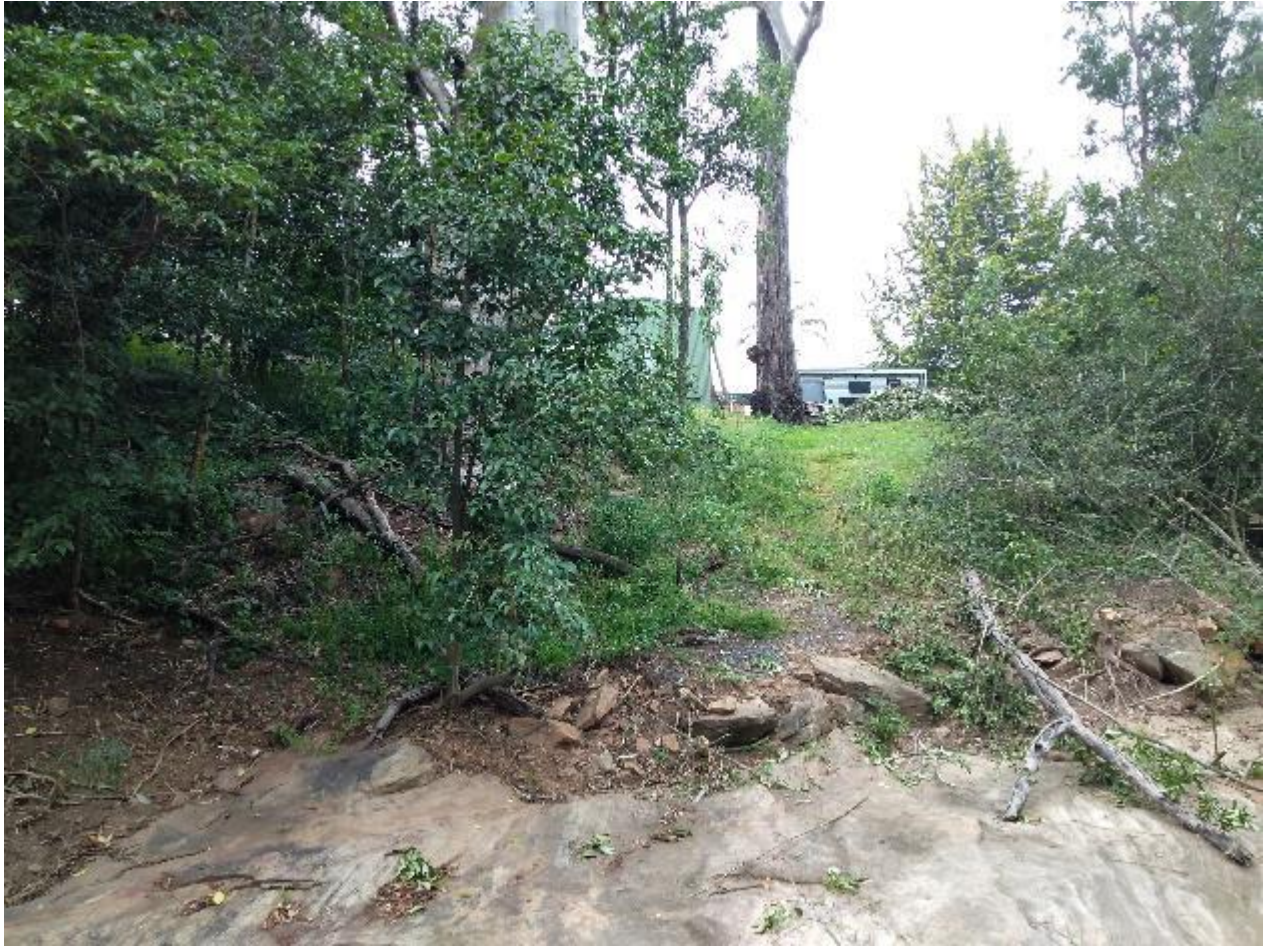
The northern bank of Pool 12a is heavily vegetated. The southern bank backs onto residential dwellings. Access is preferred via the southern bank as it would allow for drilling equipment to easily be transported to site (see **Figure 22**). Land access with the landowner will be required. Alternatively, access will be restricted via the centre of Myrtle Creek. If this option is required, specialised equipment will be required.

Figure 22: Southern banks at Pool 12a

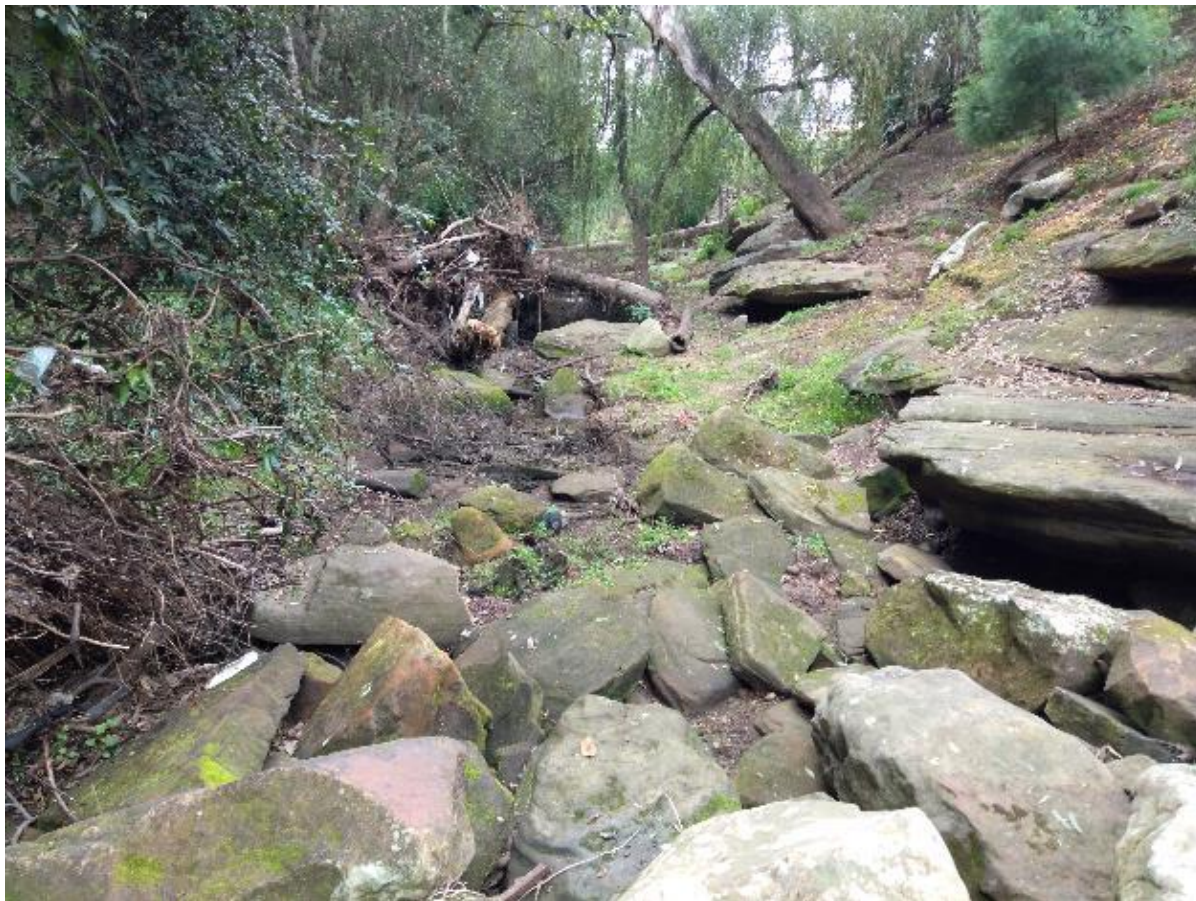
Figure 23: Pool 11 (facing upstream)

Pool 11 is a long, narrow pool with a sandstone bed. It is approximately 28m long and 2-3m wide. It is controlled by a narrow sandstone rock bar with a height of approximately 0.6m above the pool base. **Figure 23** and **Figure 24** show Pool 11. Pool 11 is located within the chain pillar between Longwall 26 and Longwall 27.

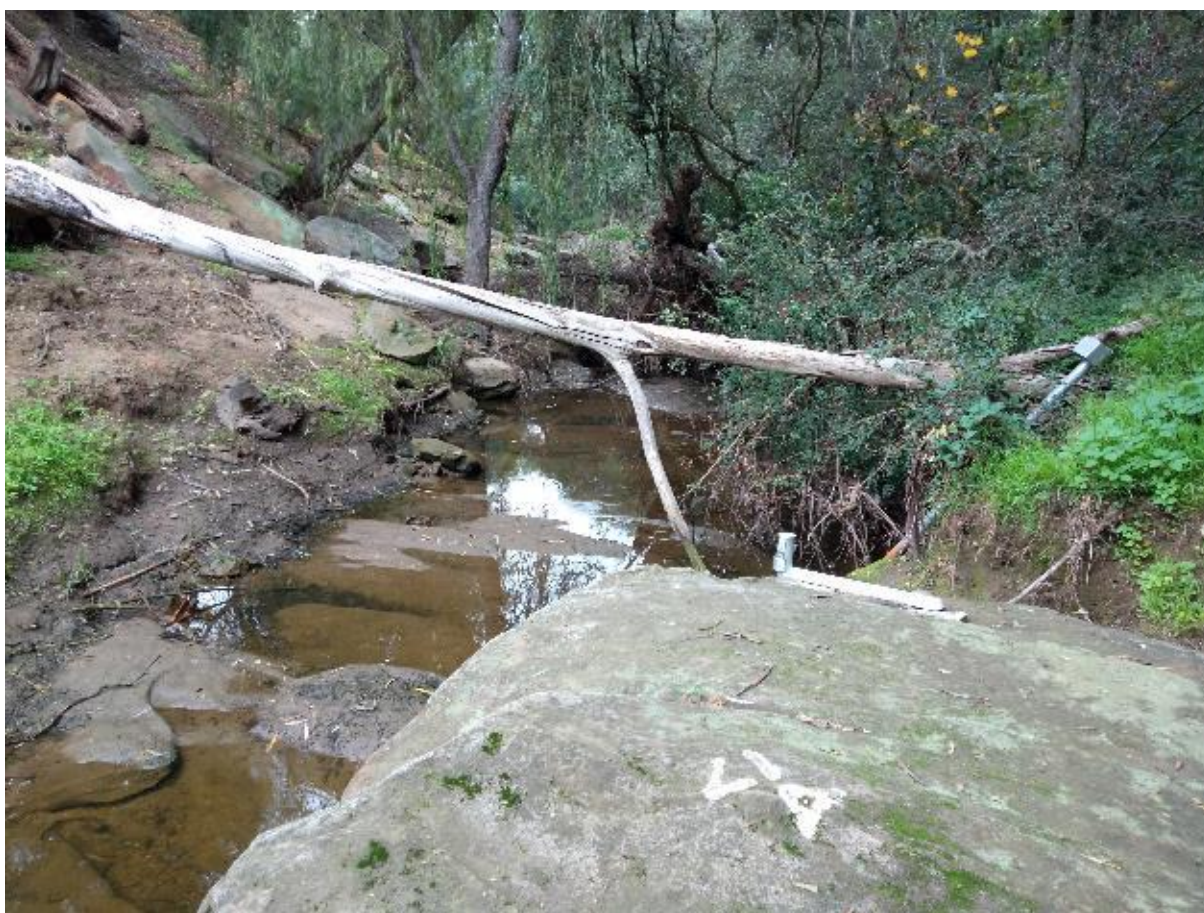
Figure 24: Pool 11 (facing downstream)

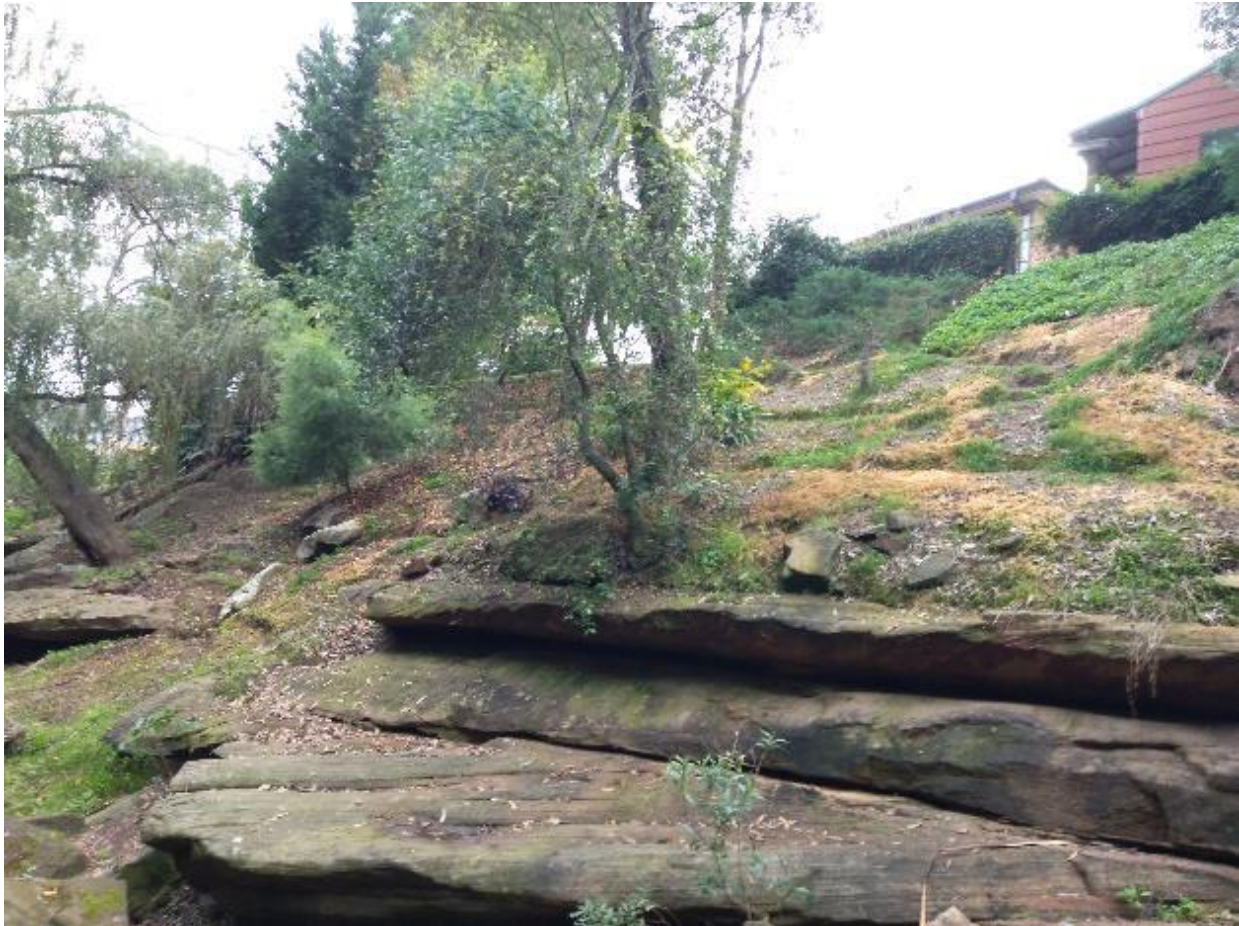
The northern bank at Pool 11 is heavily vegetated. The southern bank is confined by residential dwellings. Tahmoor Coal proposes to negotiate a land access agreement with the resident on the southern bank of Pool 11 and gain access via the residence (see **Figure 25**).

Figure 25: Southern banks at Pool 11

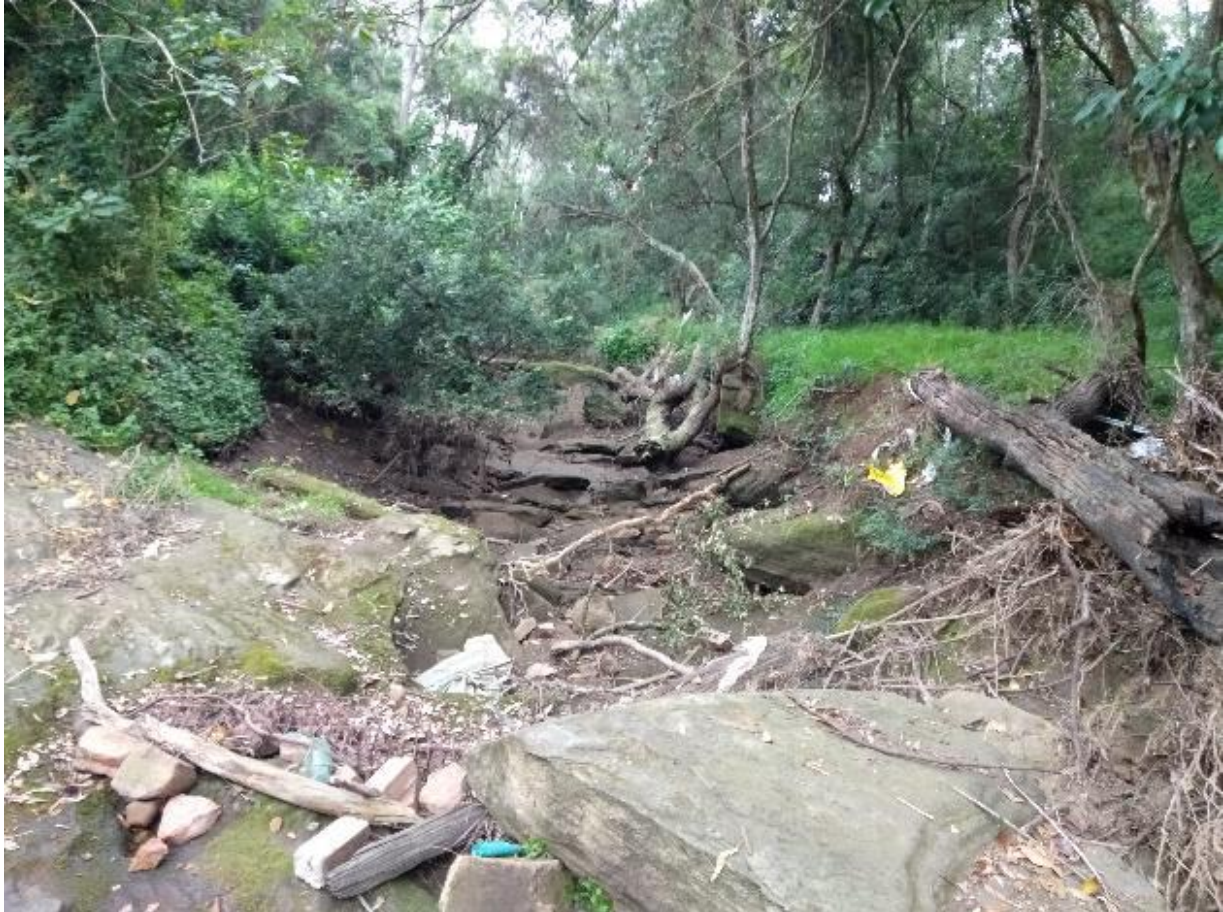
Pool 10 is a long pool with lined with sediment and sand. It is approximately 20m long and 4m wide (see **Figure 26**). The pool is controlled by a sandstone rock bar with a height of approximately 1.0 above the pool base. The pool contains vegetation on both banks. Pool 10 is located approximately 10m east of the eastern roadway of the chain pillar between LW26 and LW27.

Figure 26: Pool 10 (facing downstream)
