Tahmoor Coal Pty Ltd

MINE OPERATIONS PLAN

Tahmoor Coking Coal Operations – SIMEC Mining

2020-2024

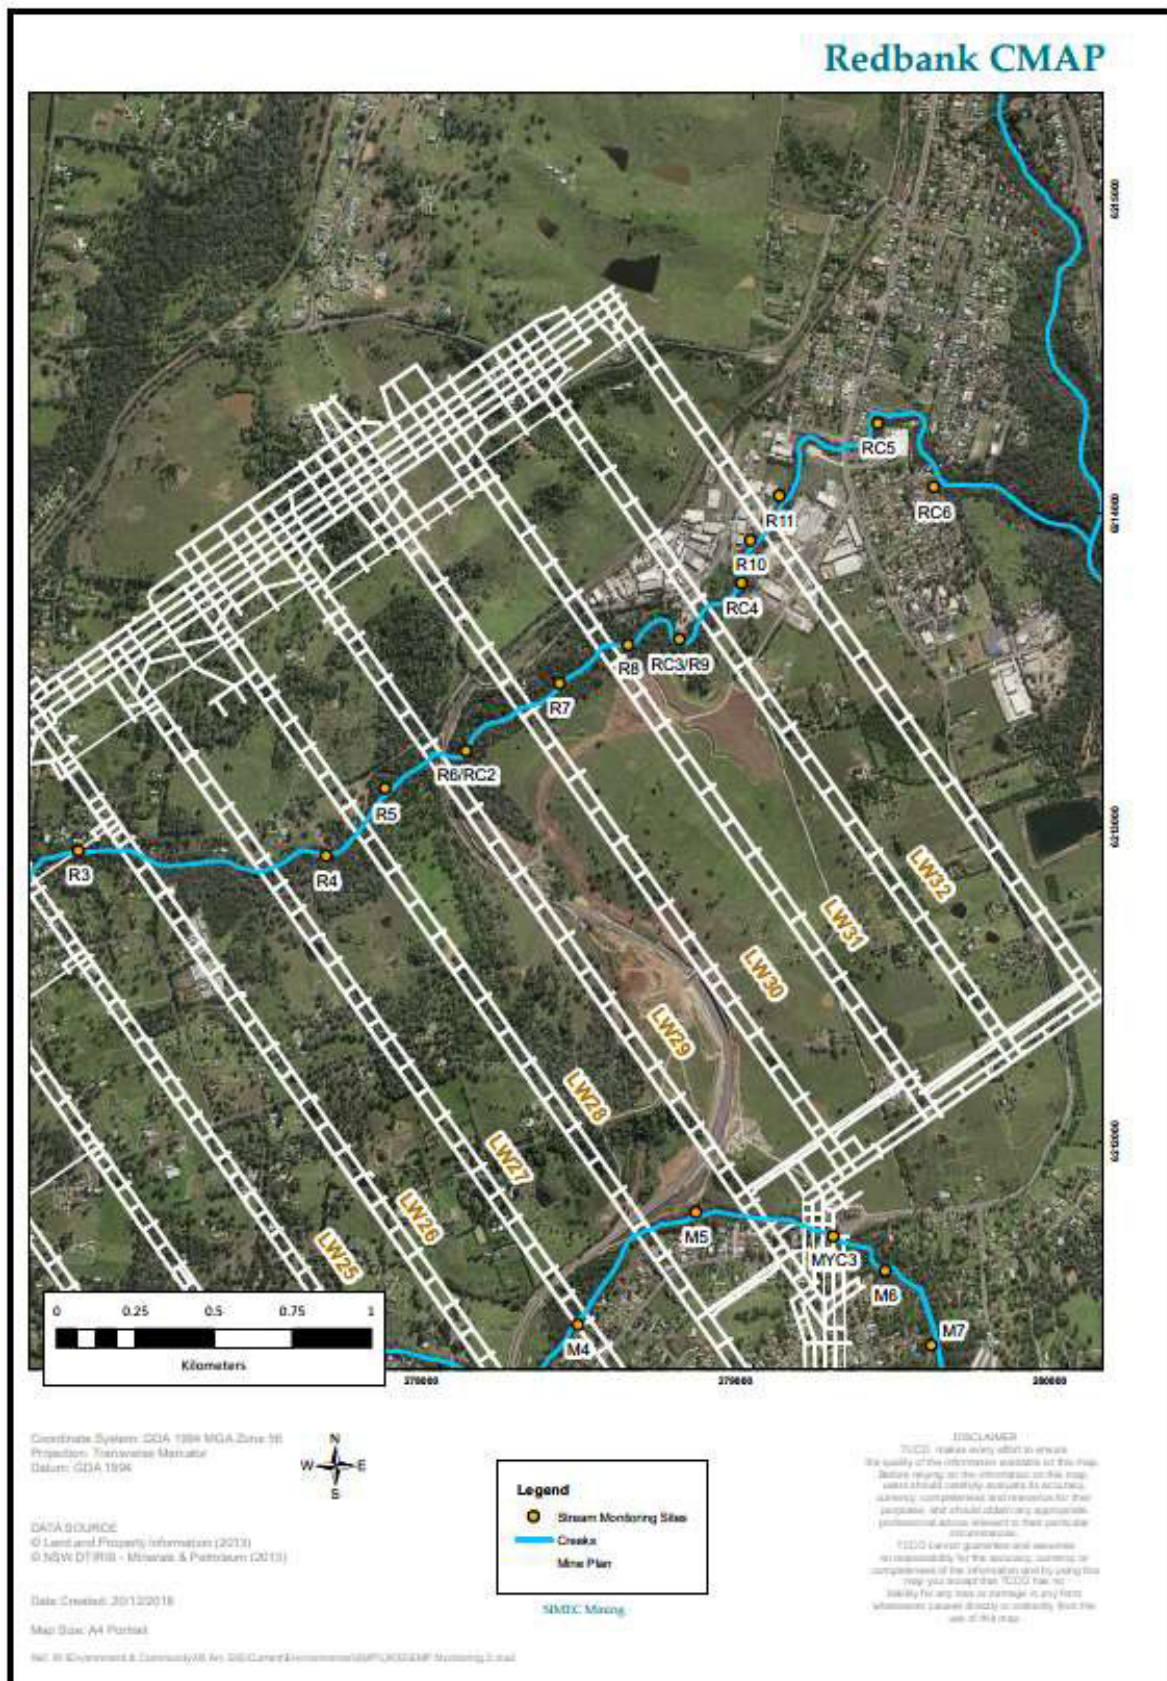
Plan 3 Redbank Creek Monitoring Gauge Stations

Site R4 has a reliable low flow rating and is within the potentially subsidence affected reaches of Redbank Creek. Site R11 is the site which is furthest downstream of the potential impacts of longwall mining and has the most reliable rating. The potential effects of subsidence on streamflow would affect low flows. If longwall mining in the Redbank Creek catchment has had a measurable effect on flows it would be detectable as a change to low flows and low flow recessionary behaviour. It has been observed at other locations where surface flows are lost to subsidence induced subsurface fracture systems that the subsurface flow “reappears” at the
