# 2019 Annual Review

**BULGA  
COAL**

GLENCORE

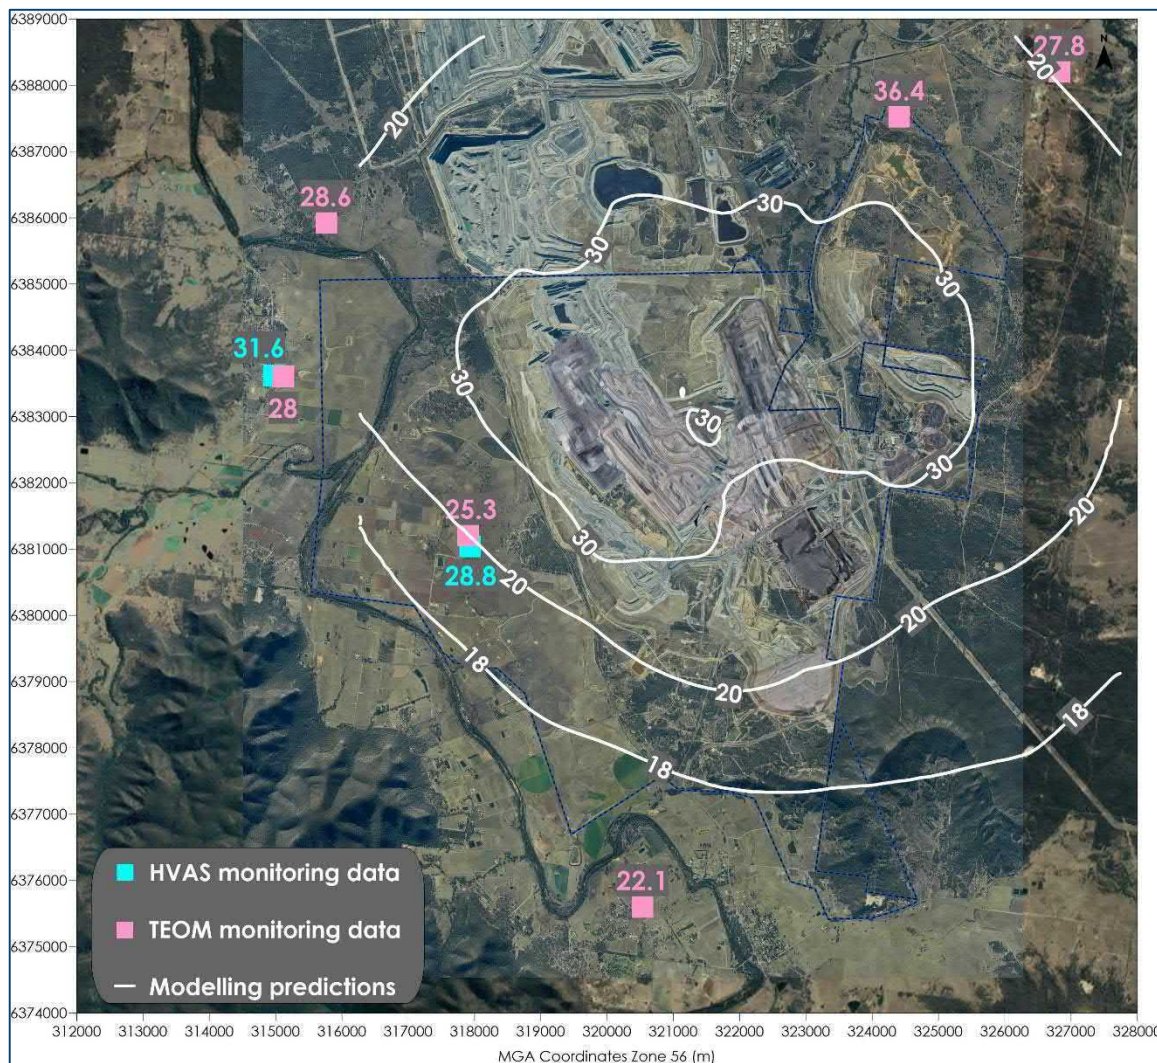
**Figure 3-2: 2019 PM<sub>10</sub> annual average monitoring data (all days) superimposed over the predicted PM<sub>10</sub> annual average modelling contour (Year 3 Bulga plus background)**

**Figure 3-2** and **Figure 3-3** present the measured 2019 annual average PM<sub>10</sub> data, for all days and excluding extraordinary events respectively, superimposed over the dispersion modelling contours reproduced from the *Bulga Open Cut Eastern Emplacement Area Modification Air Quality Impact Assessment (Year 3) (Jacobs, 2016)*. The measured and predicted data in the figures include dust levels from Bulga and other sources.

**Figure 3-2** shows that the measured PM<sub>10</sub> levels are higher than the Year 3 modelled levels at the Bulga Complex monitoring stations. The elevated annual average PM<sub>10</sub> levels measured in 2019 are primarily attributed to smoke associated with the south-east Australian bushfires of 2019/2020.
