**Bulga Open Cut
Mining Operations Plan
1 July 2020 – 30 June 2023**

Report Number: 630.30025

Bulga Open Cut

Mining Operations Plan

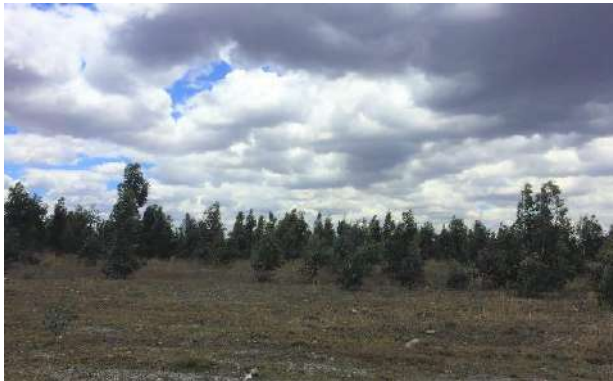
Plate 1 – Phase 3 Rehabilitation at NB6

Plates 1 - 3 provide examples of the range of growth in vegetation in rehabilitation phases 3 and 4 at Bulga Coal at the commencement of the MOP. These examples have been taken from recent rehabilitation monitoring, further details of which are included in **Section 8**. It is noted that although rehabilitation monitored at a particular site may have satisfied performance indicators for a particular

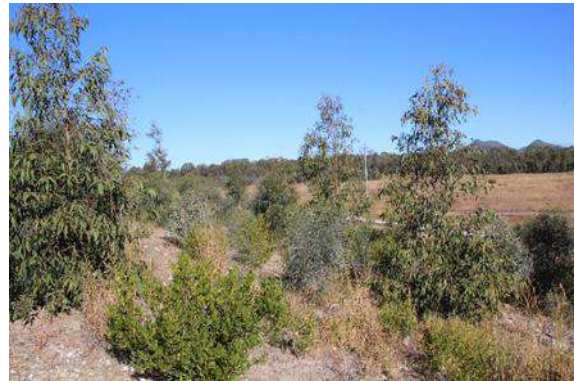
Plate 2 – Phase 4 Rehabilitation at NVB1

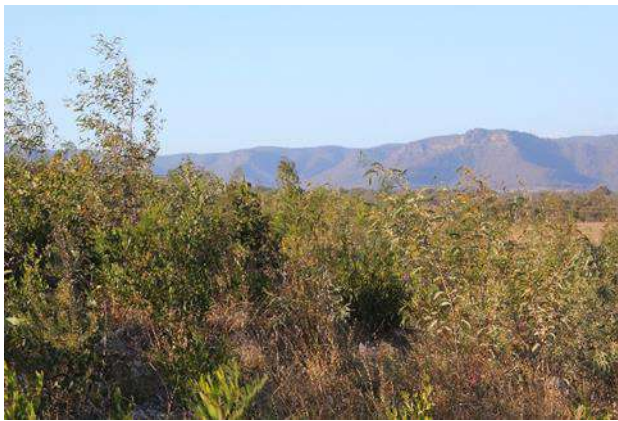
Plate 3 – Phase 4 Rehabilitation at NVB2
